CHURCHEND MILL, STROUD, GLOUCESTERSHIRE

Historic Building Recording

commissioned by The Environment Agency

July 2014

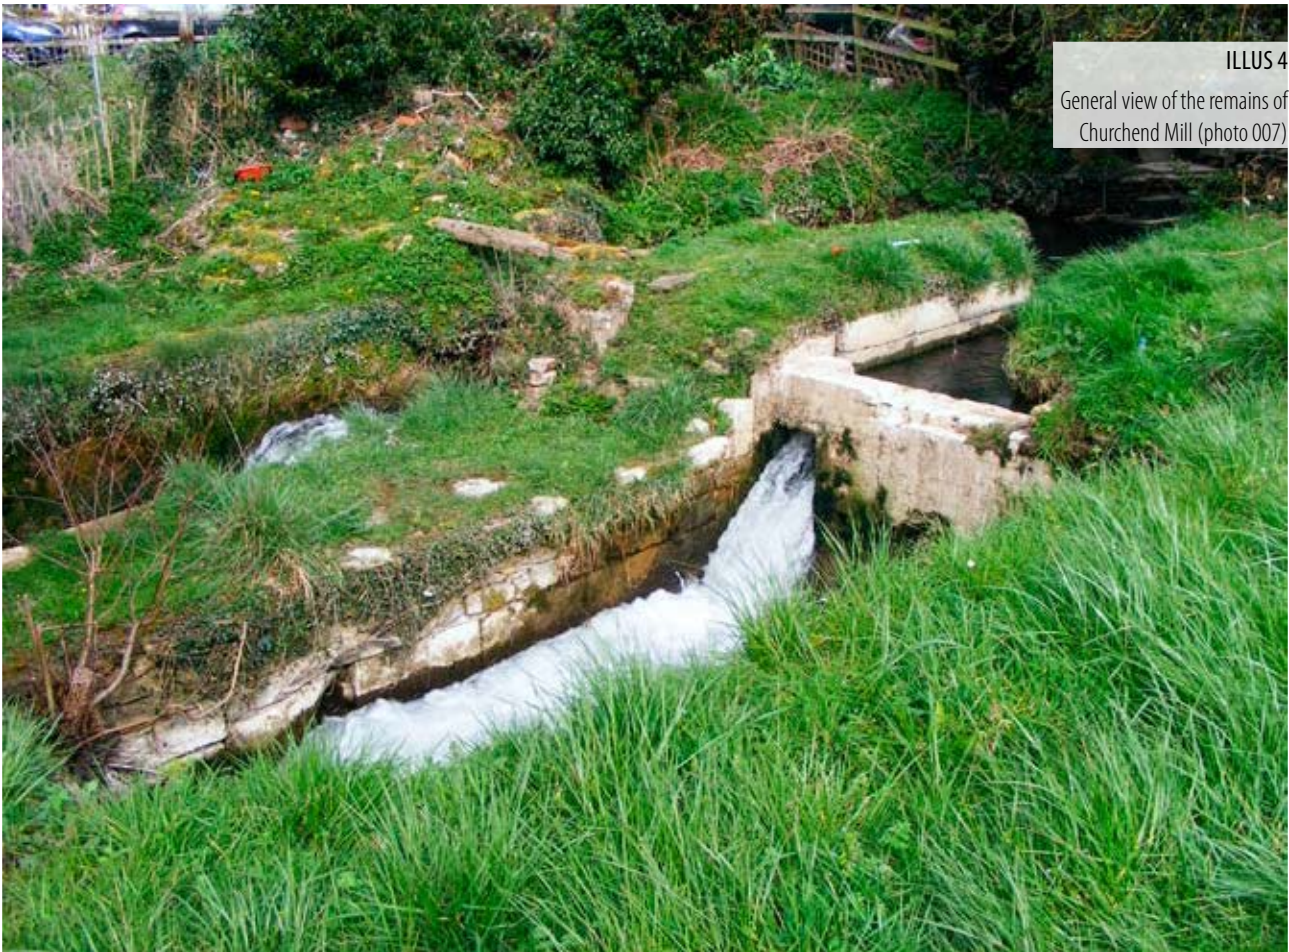
ILLUS 4
General view of the remains of
Churchend Mill (photo 007)

No upstanding masonry relating to the former mill complex exists above the current ground level at the allotment site (**Illus 4**). The double channel weir arrangement survives within the river channel itself which may explain the preservation of this feature.

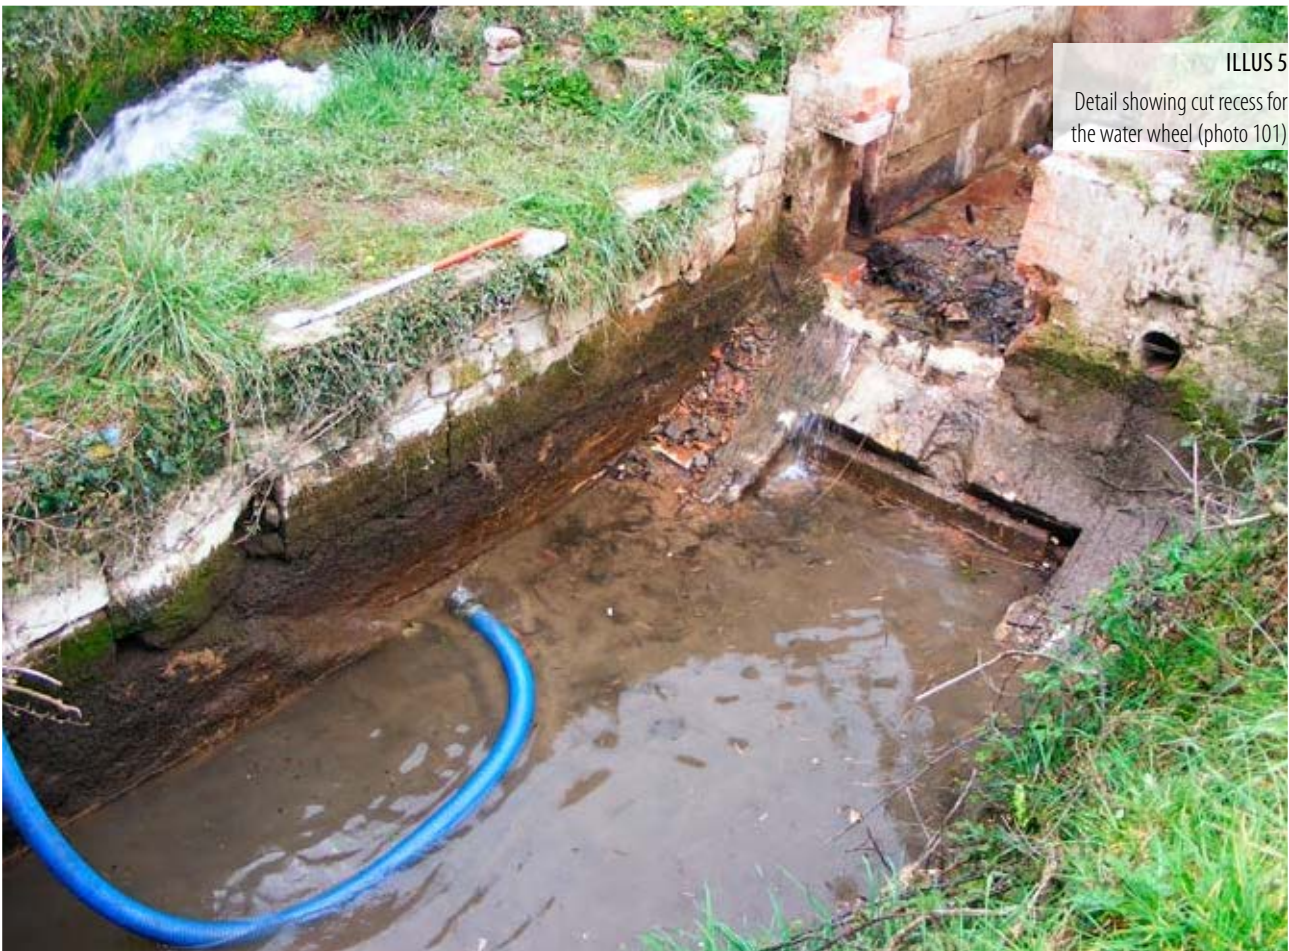
ILLUS 5
Detail showing cut recess for
the water wheel (photo 101)

Within the lower courses of the masonry a semi-circular curved recess cut into the masonry, which once housed the water wheel was observed (Illus 5). The bed of the wheel pit was curved at the eastern end. A central void was present within the curved masonry to allow the passage of water beneath the wheel.

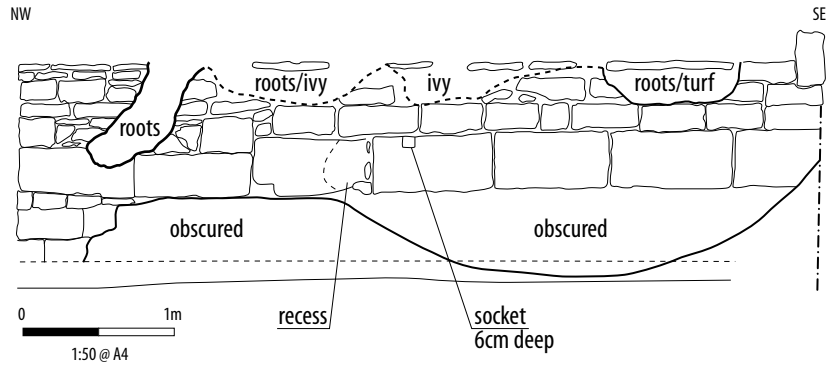
ILLUS 6

South facing elevation drawing showing water wheel recess

The semi-circular recess on the northern wall (Illus 6) and curvilinear score lines visible on the southern wall of the wheel pit allow an

estimation of the wheels diameter to be made. Based on these calculations the water wheel had a diameter of 4.56m (15ft).

The cut recess and predicted diameter of the wheel also allows the projected centre point of the water wheel to be estimated, indicating that in order to support the axle of the wheel, the existing wheel pit wall level would have been approximately 0.90m higher than exists today.

The head of water in the race would have intersected the wheel at approximately 0.77m below the axle of the water wheel, suggesting that the Churchend water wheel was of under-shot design. The water feed channel or flume continues to follow the curve of the wheel downwards to a point directly underneath the axle where it flows into the tail water stream and flattens out to form the bed of the tail race.

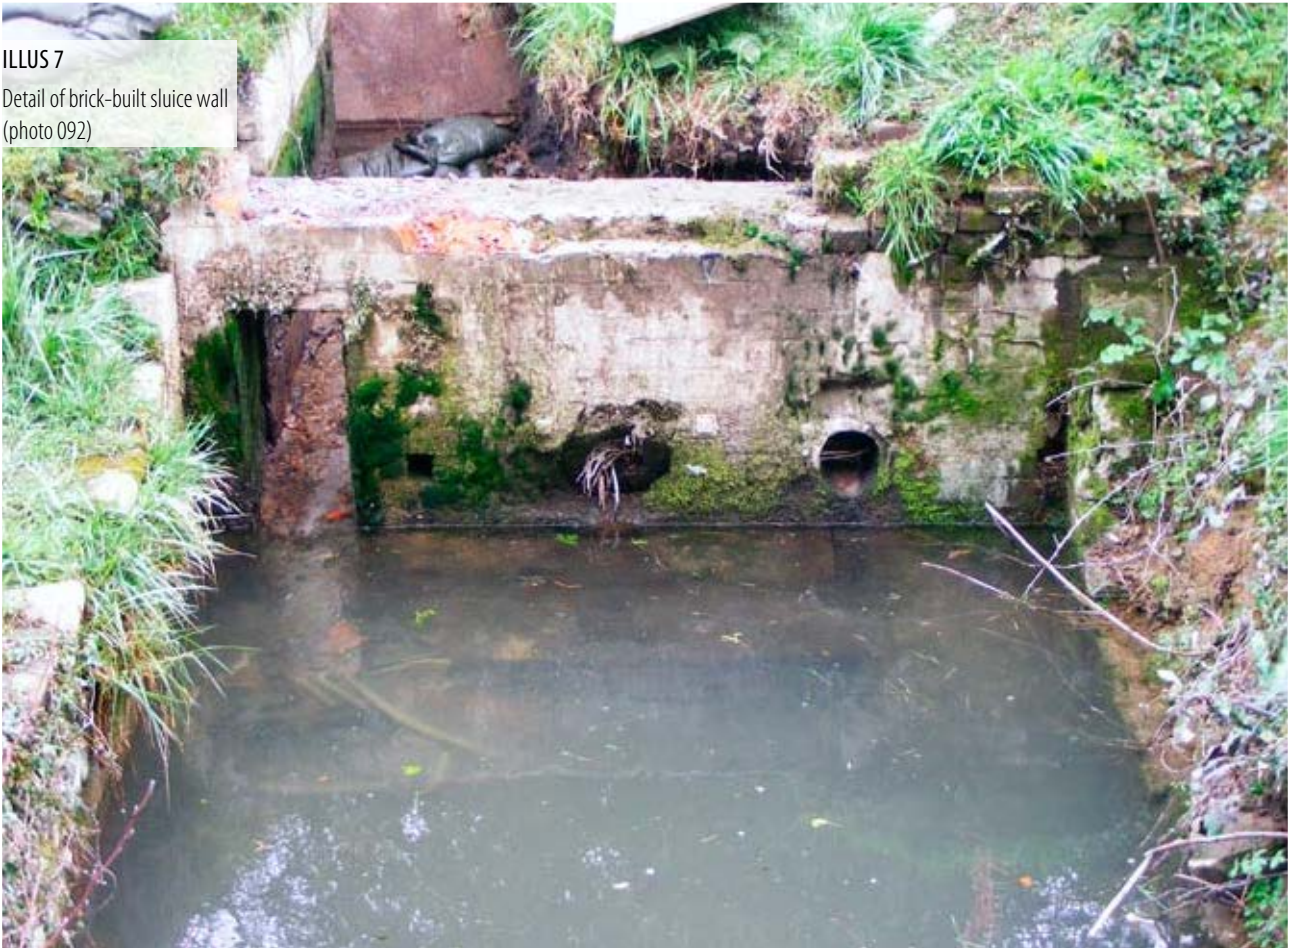
ILLUS 7

Detail of brick-built sluice wall (photo 092)

A small partition wall has been constructed in brick and breeze block across the wheel pit water feed channel (**Illus 7**). Prior to the current works, this wall restricted the flow and created a head of water in the southern channel. A rectangular aperture measuring 0.15m x 0.45m within the wall allowed water to flow at high velocity into the wheel pit.

The wall appears to be a replacement for the wooden sluice gate that formerly controlled the flow of water into the wheel pit. The location of the wall, slightly intruding upon the projected position of the water wheel, suggests that it post dates the removal of the wheel.

The wall represents a change of function for the weir and wheel pit. The purpose of the alteration may have been to maintain the level of river water upstream of the Allotment Weir after the removal of the sluice gate and water wheel which previously served this purpose.

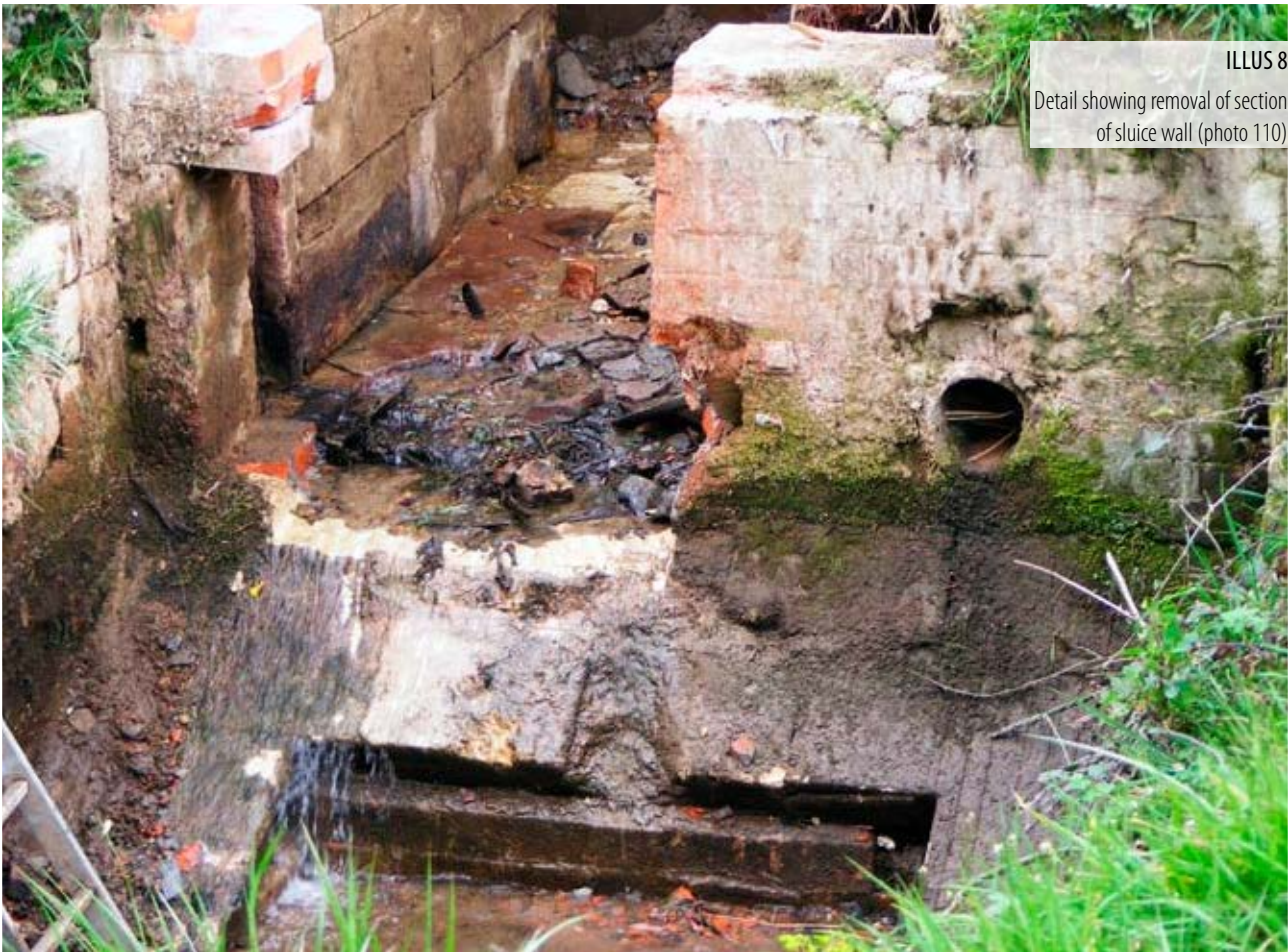
ILLUS 8
Detail showing removal of section
of sluice wall (photo 110)

An 840mm section of the phase 2 brick weir crest in the southern channel was lowered by 1000mm using hand tools to accommodate

the fish pass (**Illus 8 & 9**). Removed pieces of brick were re-used where patching of the brickwork was required.

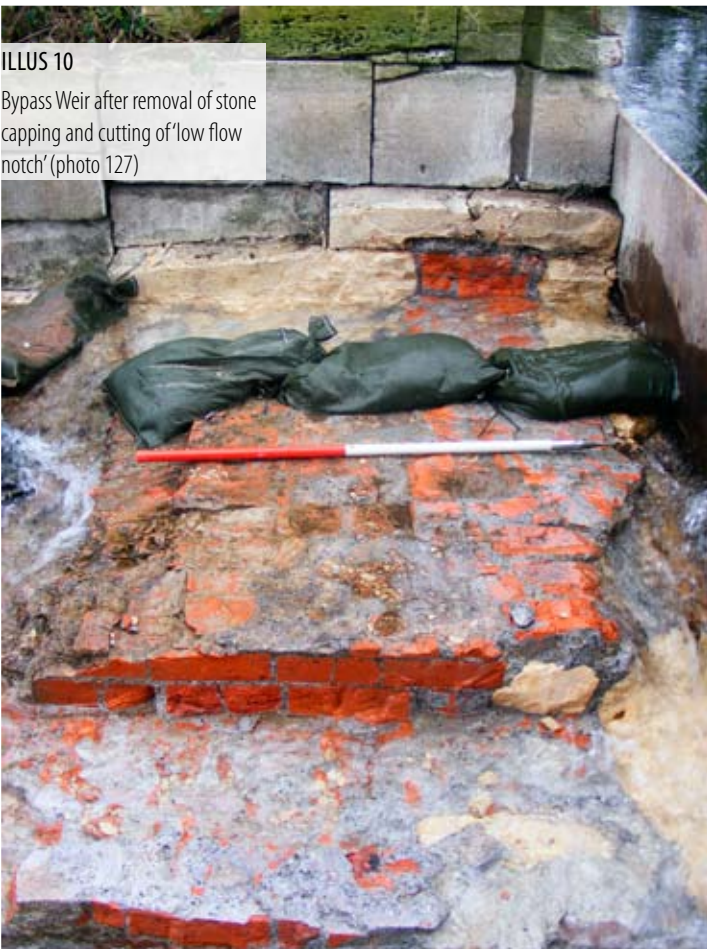
ILLUS 10
Bypass Weir after removal of stone capping and cutting of 'low flow notch' (photo 127)

The subsequent alterations (phase 2) to the structure involved the cutting and removal of some of the ashlar slabs forming the base of the structure. A mortared brick core was identified, with the stone slabs acting as a capping (**Illus 10**).

The bonded brick structure was presumably a cost-effective way to create a strong structure. The purpose of the overlying stone may relate to its durability and aesthetic properties.

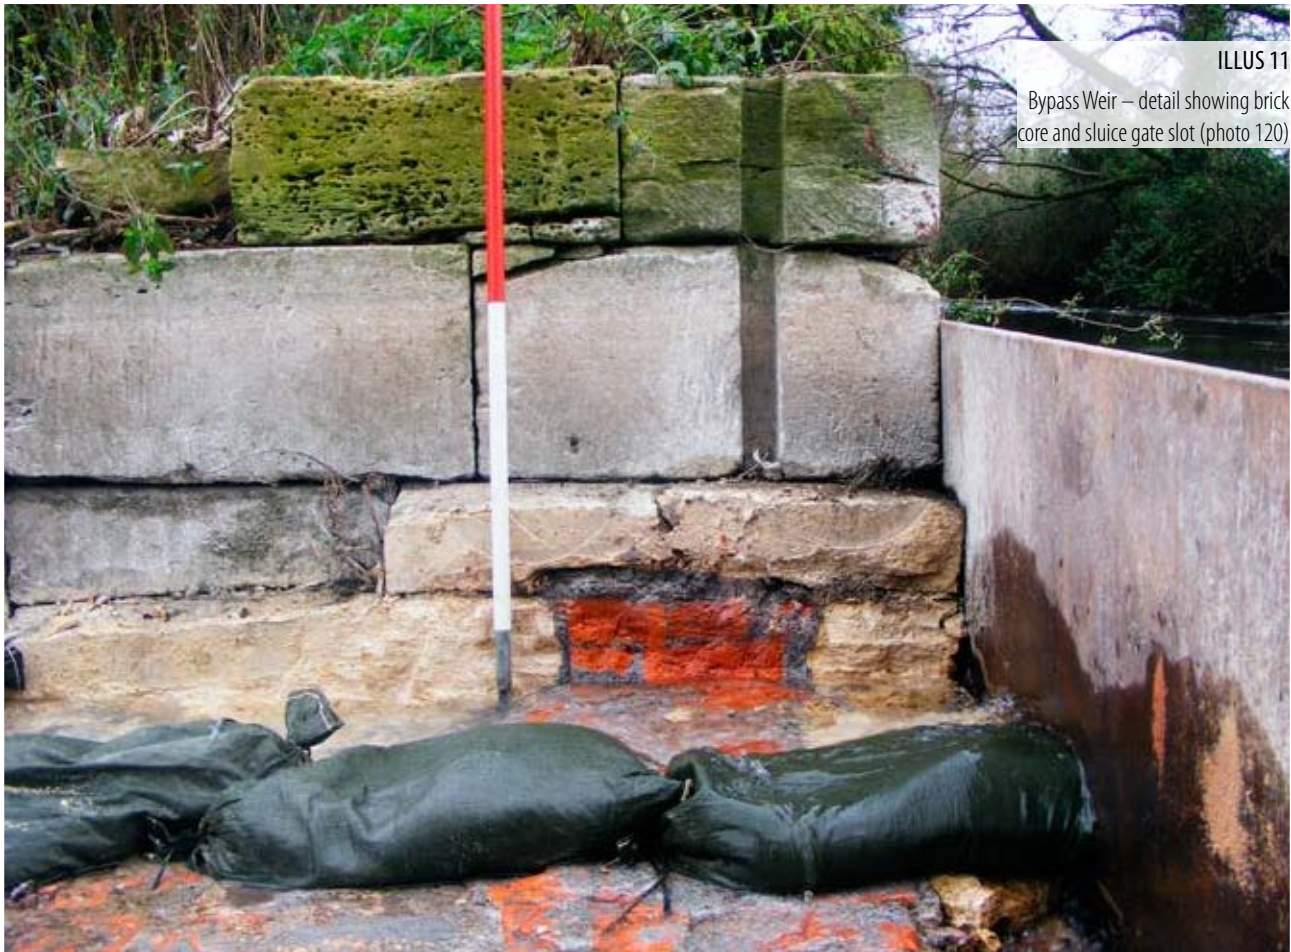
ILLUS 11

The construction of the low flow notch in the bypass weir has allowed the core work and the construction methods involved in the original construction of the bypass weir to be examined. The core of the weir is formed of bonded red brick with a stone facing, it seems unusual that the weir would be formed of brick and faced in stone and the method may reflect a cost saving in the construction of the weir when compared to a weir completely built from stone, however it may be a deliberate design feature; the close bonded brick core being easier to water proof than a loose stone rubble core. The capping stones have the benefit of being more resilient to water erosion than the brick and are more aesthetically pleasing.

Bypass Weir – detail showing brick core and sluice gate slot (photo 120)

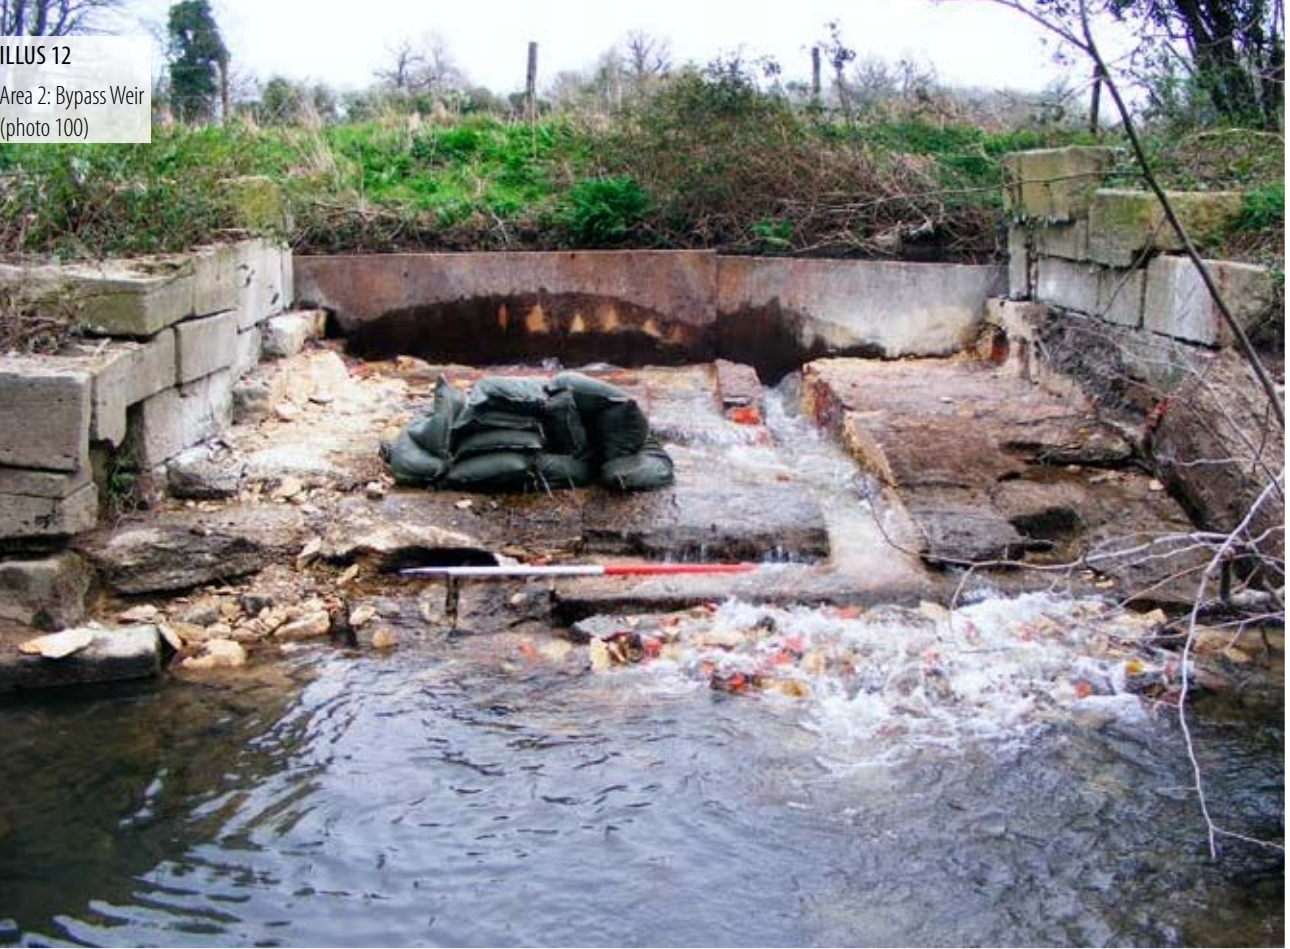
ILLUS 12
Area 2: Bypass Weir
(photo 100)

A low flow notch measuring 0.30m wide by up to 0.35m deep was cut into the base of the weir to allow for the passage of fish, and a parallel channel was cut to a depth of 0.16m to allow for the passage of eels (**Illus 12**).
