HEREFORD CATHEDRAL JUNIOR SCHOOL 28 CASTLE STREET, HEREFORD

Wall Repairs

P140894/L

November 2014

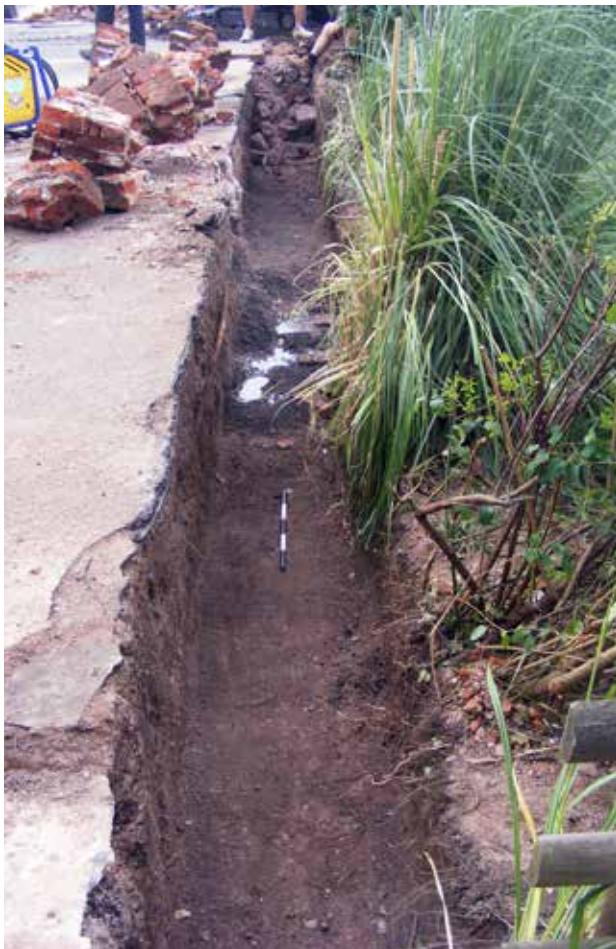
ILLUS 3
Wall footings looking S

The wall separated two areas within the grounds of the Cathedral School Junior School. The area to the east of the wall was a tarmac surface currently in use as a playground. A garden set to lawn and flower beds was present to the west of the wall and was approximately 0.50m lower than the playground (Illus 3).

The stratigraphy was generally consistent across the site. In the west facing section a tarmac surface [100] was observed, 0.06m in thickness, and was present across the entire eastern extent of the site. Below this was a dark grey/brown loamy silt [101], 0.43m in thickness, which contained fragments of tarmac and modern pottery suggesting a deposit of made up ground associated with the formation of [100]. The earliest deposit encountered within the western facing section was a mid grey/brown loamy silt [102], measuring 0.43m in depth, containing frequent mortar inclusions. The deposit [102] may be post-medieval soil build up associated with the terraced gardens that were constructed in the 18th century.

In the east facing section an upper light grey brown silt topsoil deposit containing occasional modern brick inclusions [103] measured 0.16m in depth. This overlay [104] a deposit similar to [102], which again may represent the continuation of material associated with the formation of the terraced gardens in the 18th century.
