CLARENCE HOTEL, BEDFORD, BEDFORDSHIRE

Historic Building Recording

13/02450/MAF

September 2014

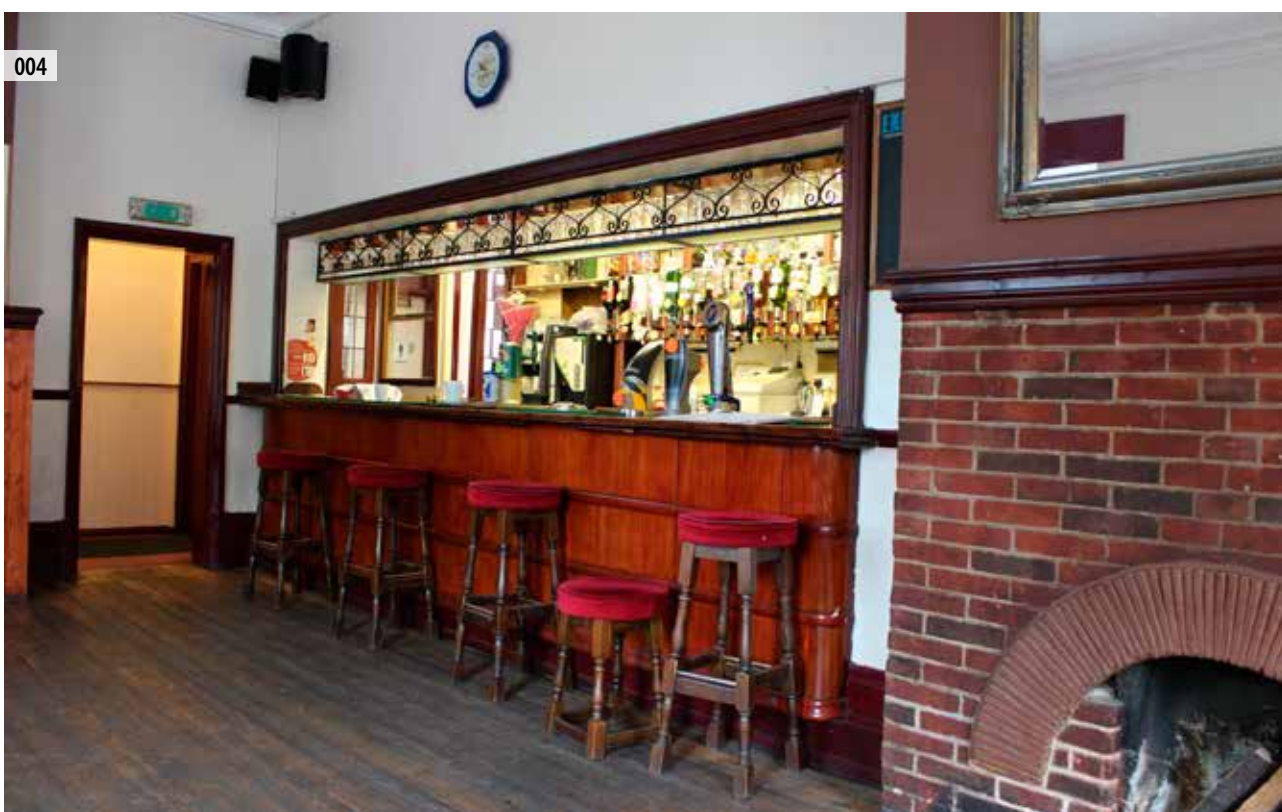
PHOTO 004
Servery in lounge

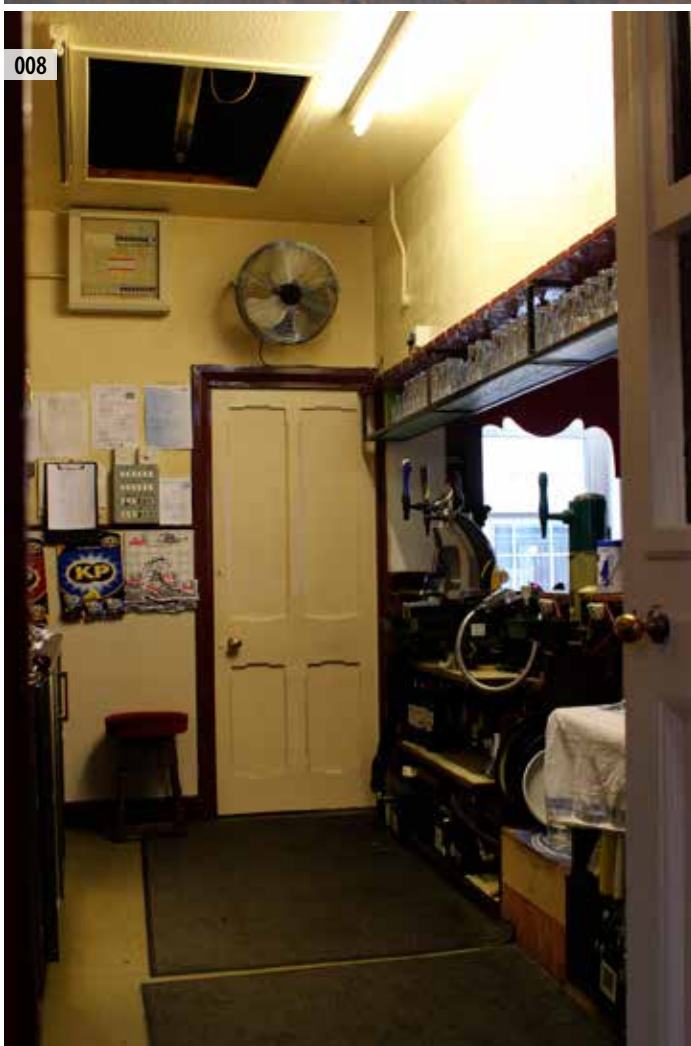
PHOTO 008
Lounge server interior

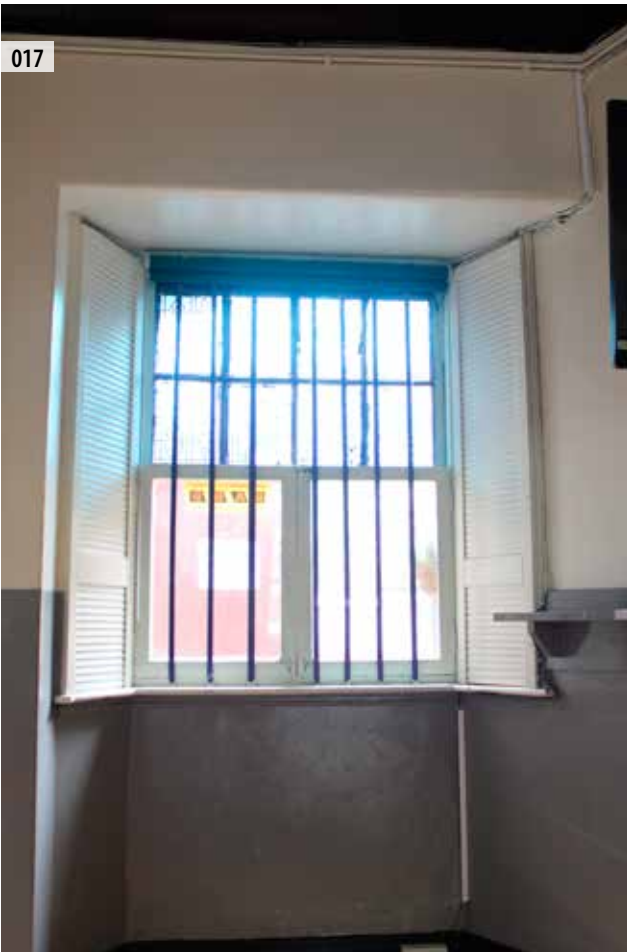
PHOTO 017

Two sash windows are visible on the rear elevation of the core structure: on the ground floor the sash window has been altered to swing open, and has been fitted with security bars, while the example on the first floor, guest room 5, survives intact with its original mechanism fully functioning. On the first floor, guest room 7 has kept an original single pane latch window, with cast iron fittings. The window in guest room 7 sits above and to the left of its predecessor, suggesting that the original floor of the room was at the same height as the others on the first floor. The roof has been altered with the addition of two dormer windows to the second floor attic rooms.

Altered sash window – bar area

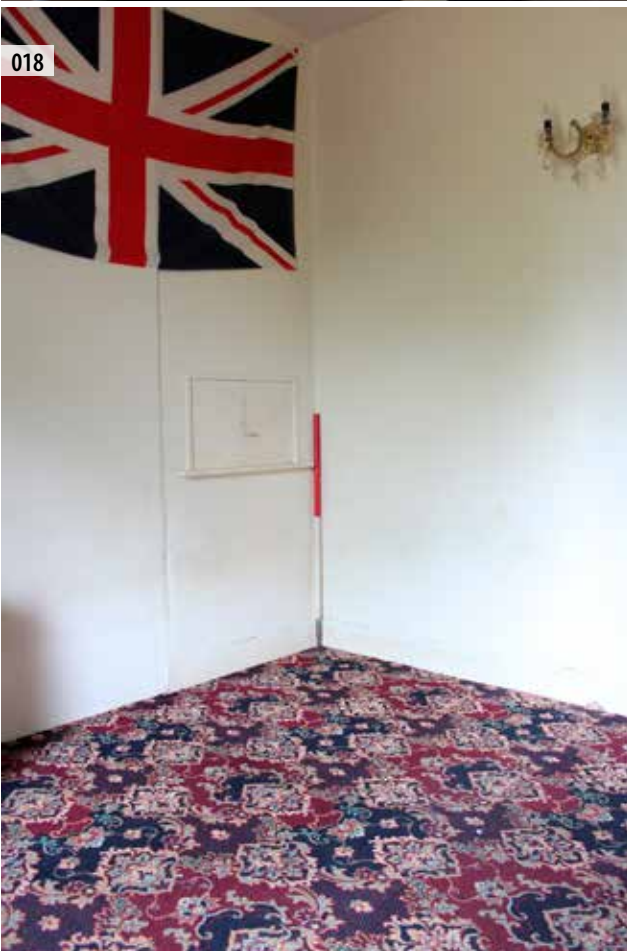
PHOTO 018

GR1/2 was formerly a larger room, broken into two guest rooms, GR1 and GR2, by a modern stud partition wall. The shared hatch with the kitchen suggests an extension of domestic space, possibly as a dining room and living room, before the insertion of the partition wall.

Serving hatch and inserted partition wall, GR02

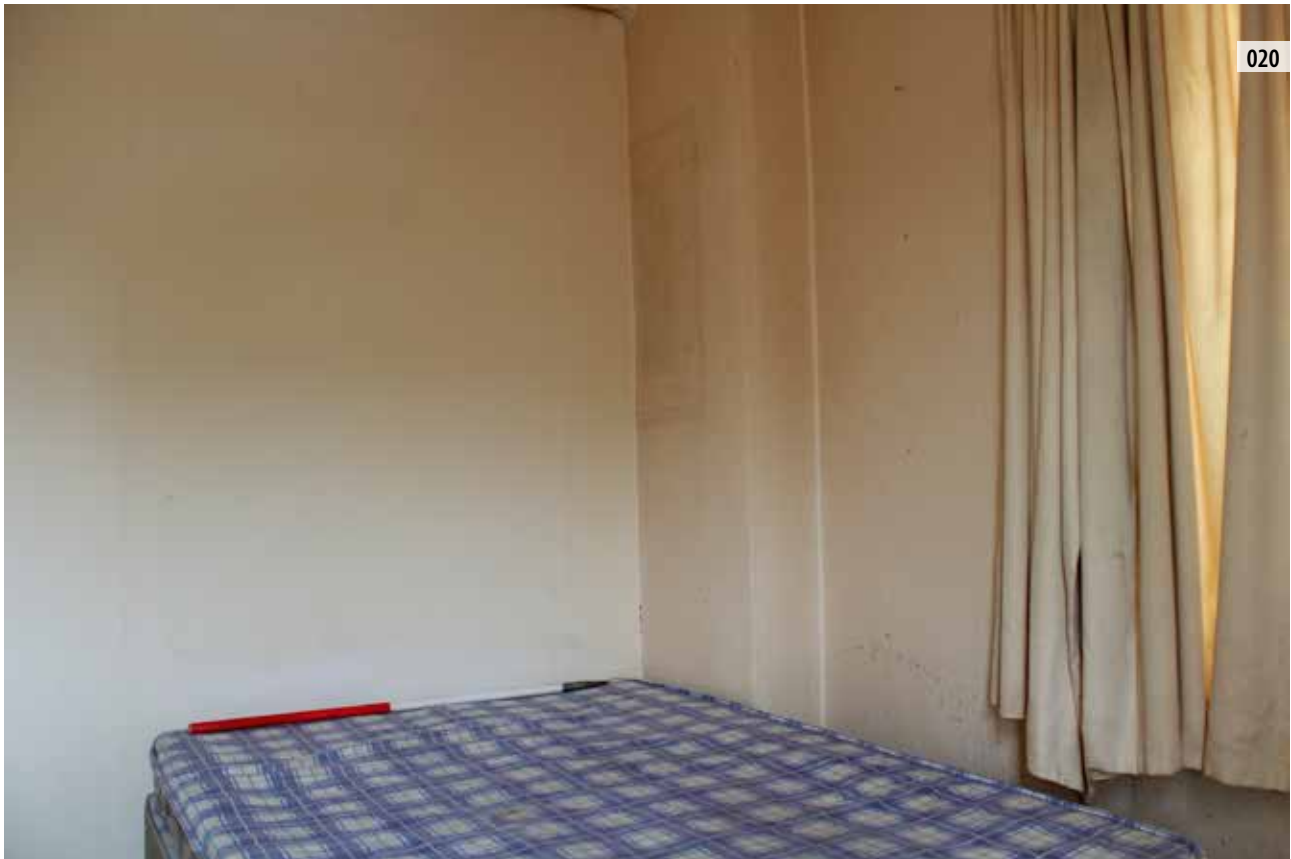
PHOTO 020
Inserted partition wall, GR01

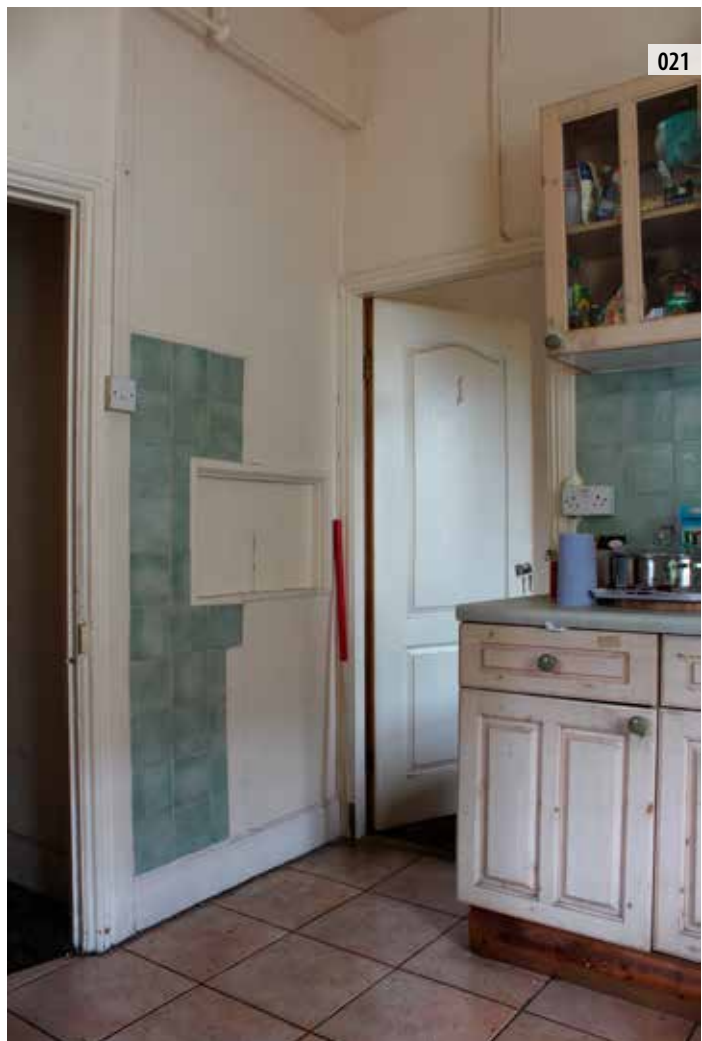
PHOTO 021
Servery hatch – upstairs kitchen

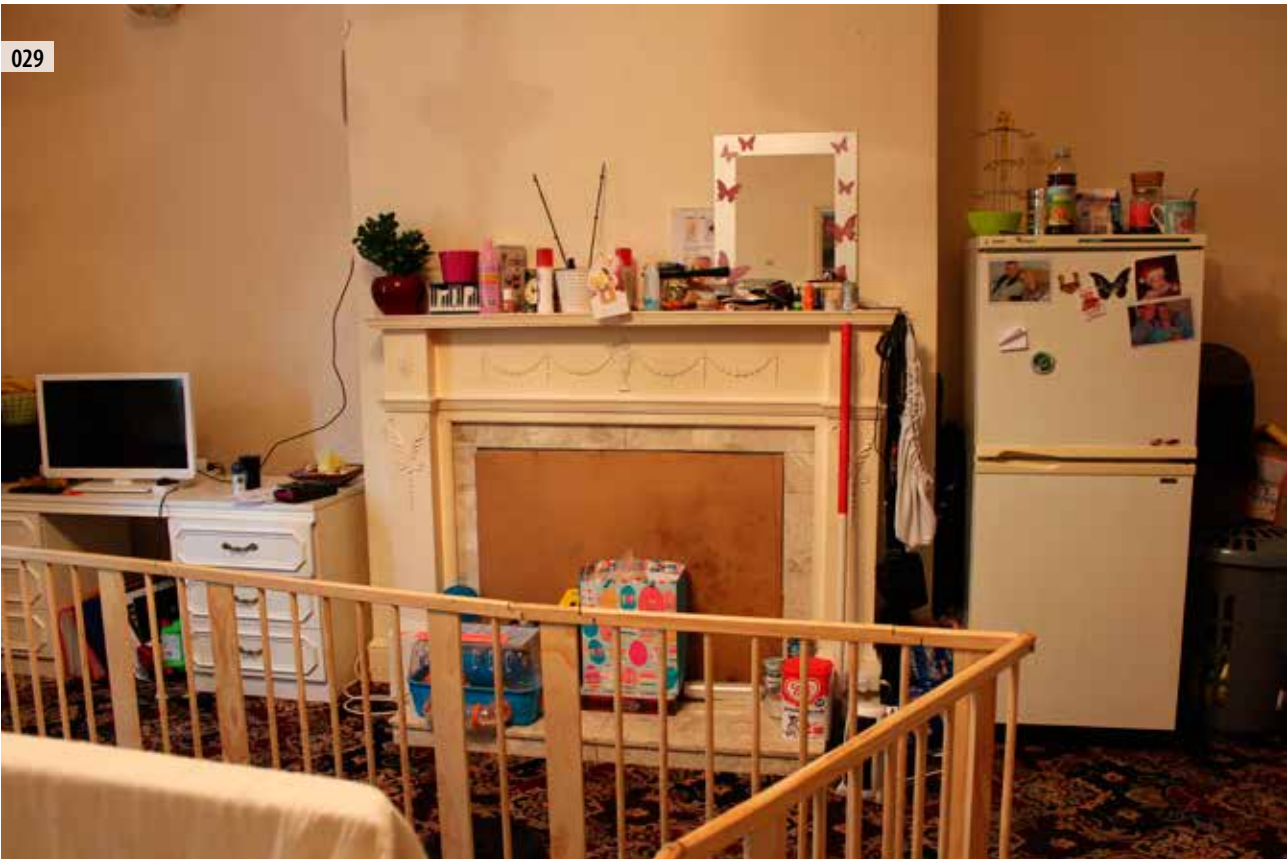
The fireplace in GR3, which was originally interpreted as an early 19th century fitting had been removed by the demolition team at the time of the second visit, and was found to have been covering over a more modern, early 20th century fireplace surround (photo 77). The supposition in this case is that the earlier fireplace surround was recovered from the ground floor around the time that the bar area was remodelled, and inserted upstairs.

PHOTO 029
Fireplace, GR03

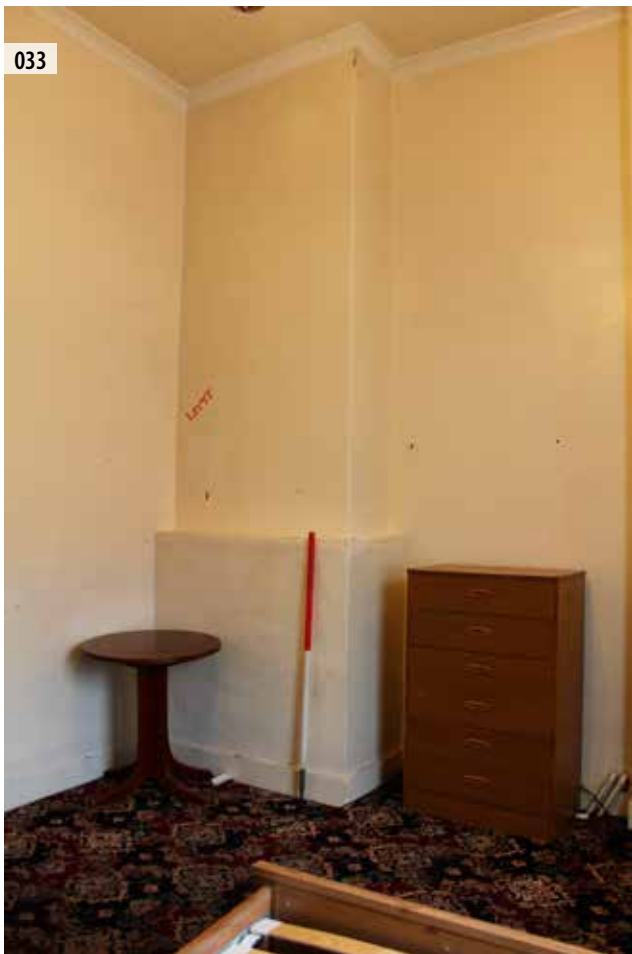
PHOTO 033
Possible exterior wall in GR05

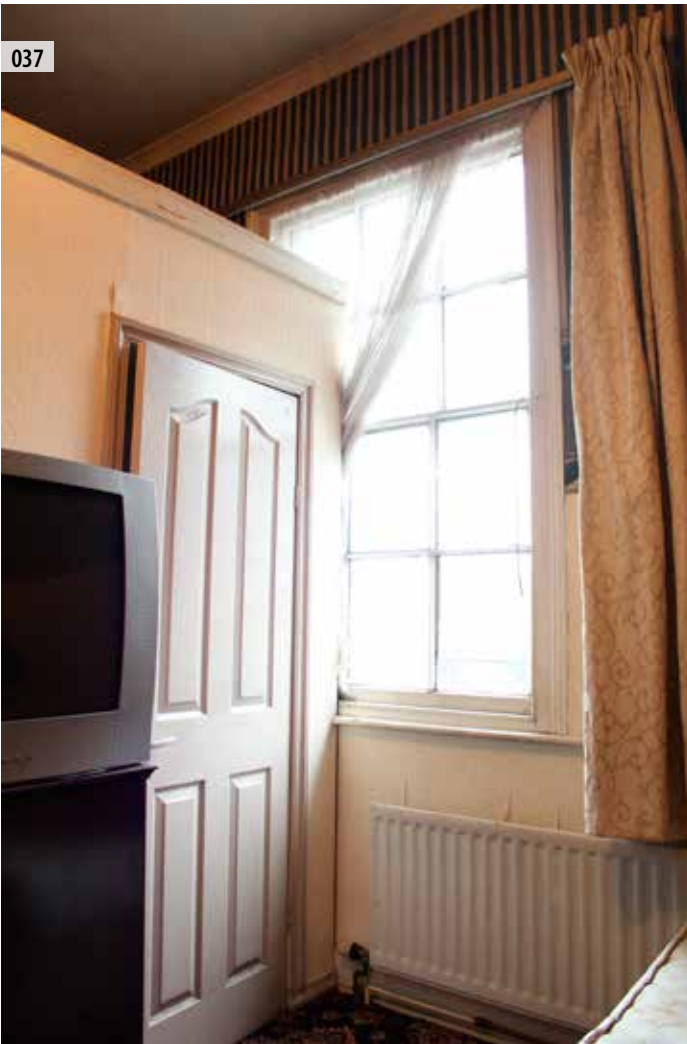
PHOTO 037

Interior partition obscuring window GR06

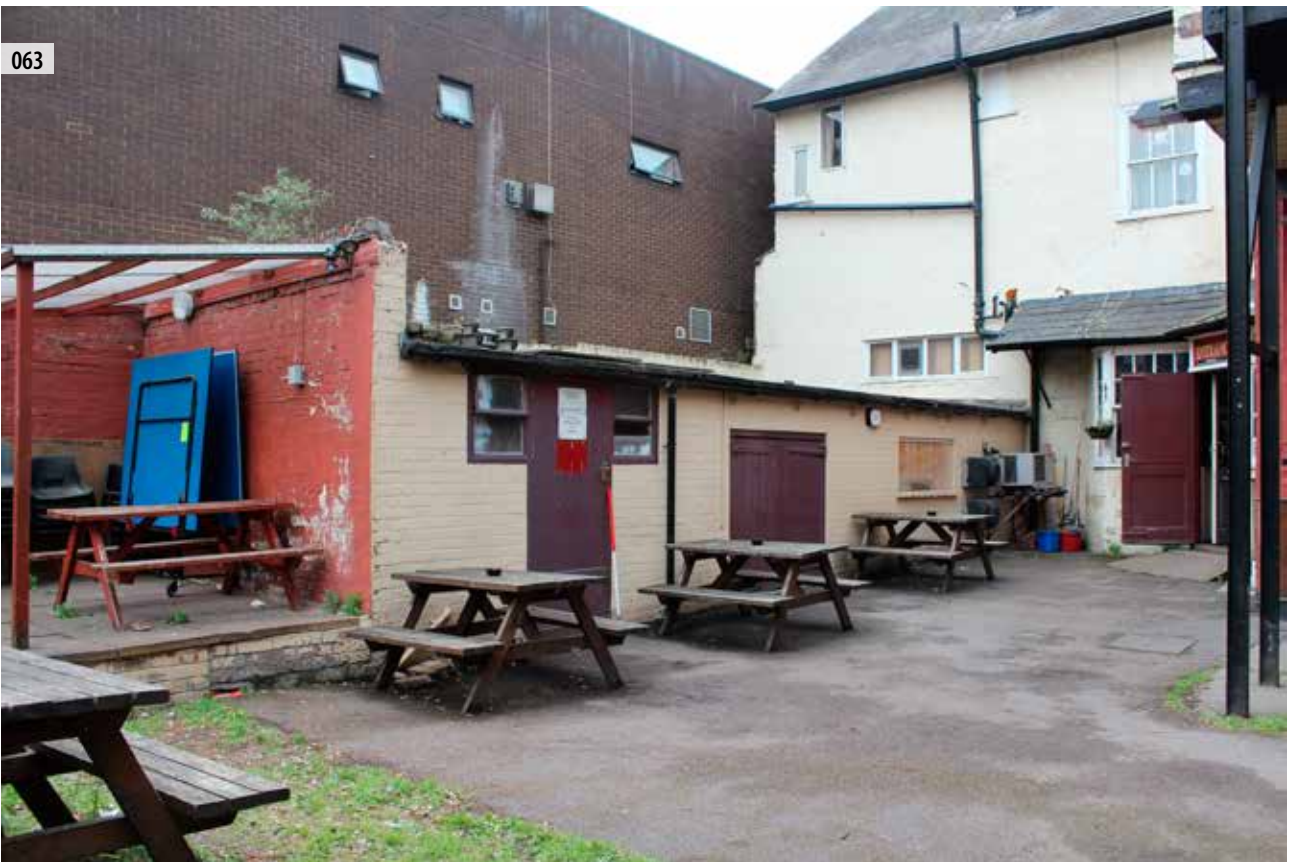
PHOTO 063

length of the yard plot. This small range houses the cellar, carbon dioxide and barrel store, as well as a small store for wood. The flat roof, which is felted, has begun to collapse due to the disintegration of its supporting timbers.

Exterior of cellar

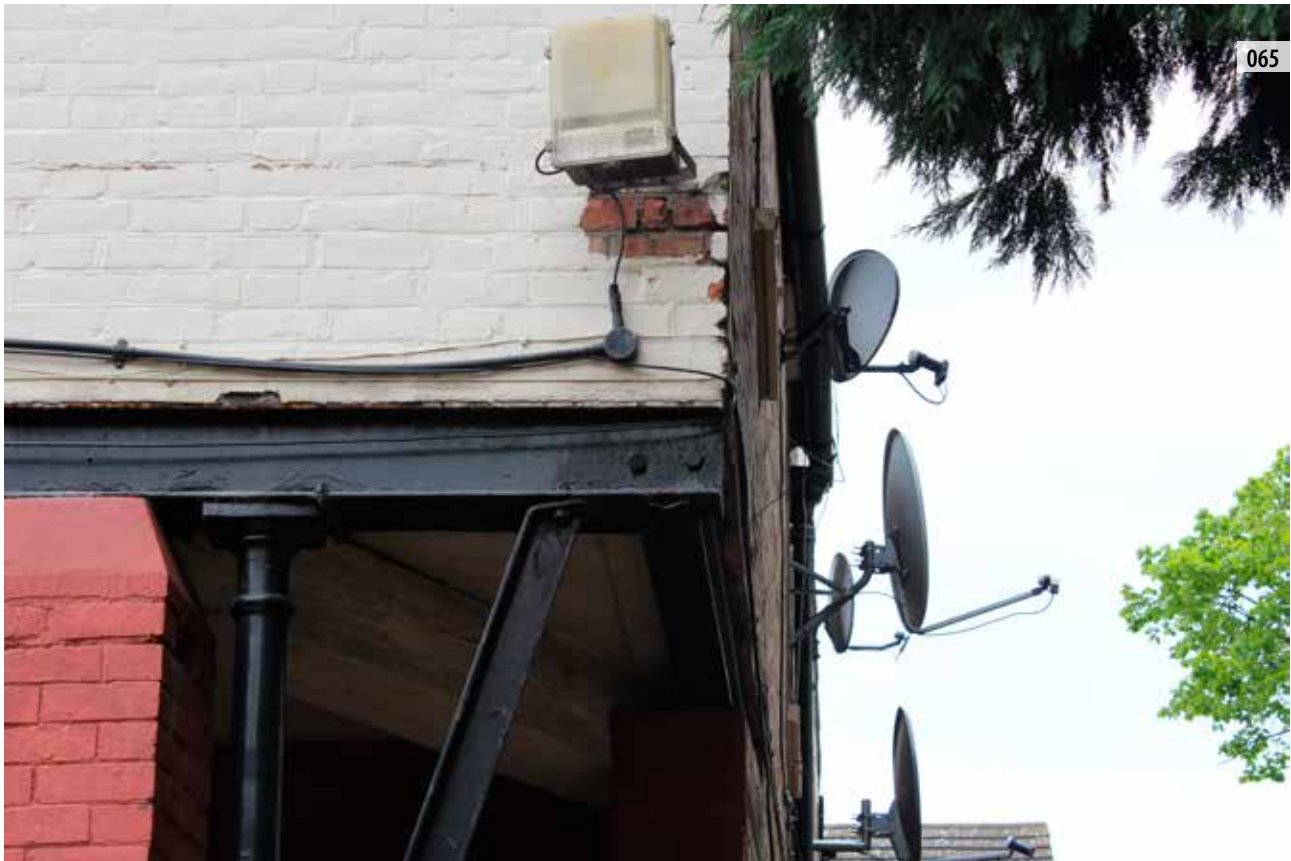
PHOTO 065

Detail shot of ironwork in Phase 3 extension

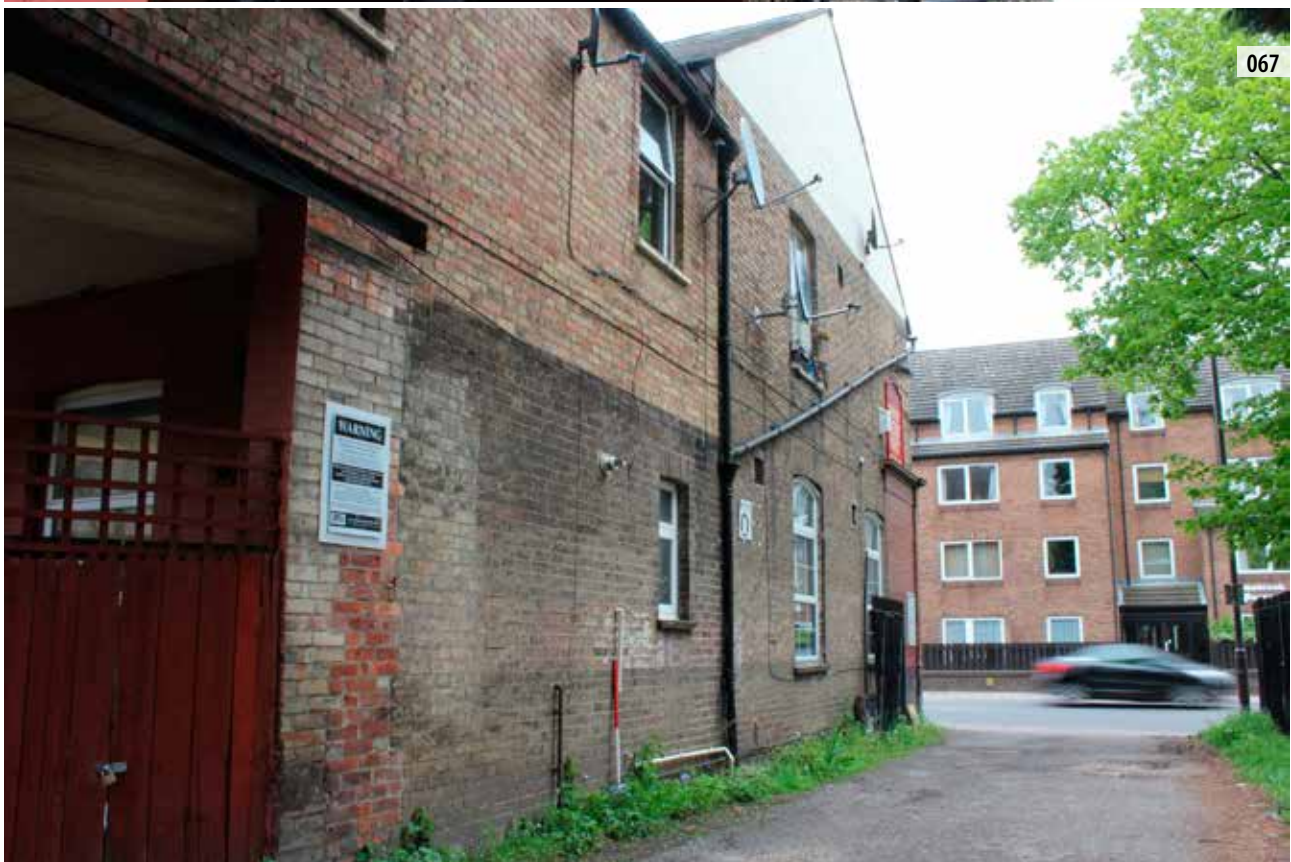
PHOTO 067

The south facing elevation faces onto the access to the rear of the hotel and the yards; it is constructed from regular 2.5inch x 9inch red bricks, which have been left clean. There is evidence of a single blocked in window on the ground floor, which would have let light into the space which is currently used as a kitchen. The former kitchen window has been replaced by a smaller sash window – opening into the kitchen store. It is likely that the blocking of the larger window came about as a reaction to increased loading on the exterior wall of the kitchen, as the first floor extension was inserted over this space.

S facing elevation of building

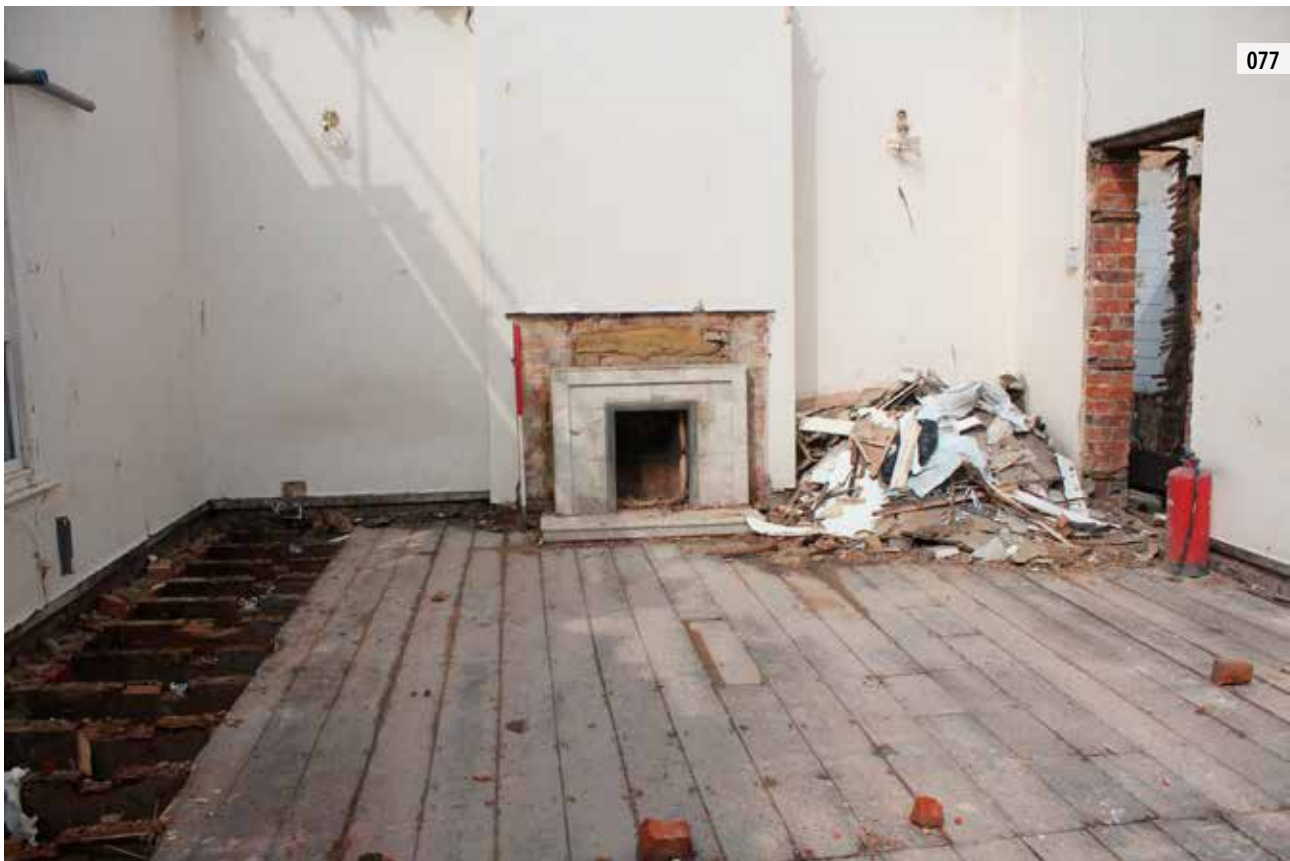
PHOTO 077

Guest Room 3 showing previously obscured 20th century fireplace

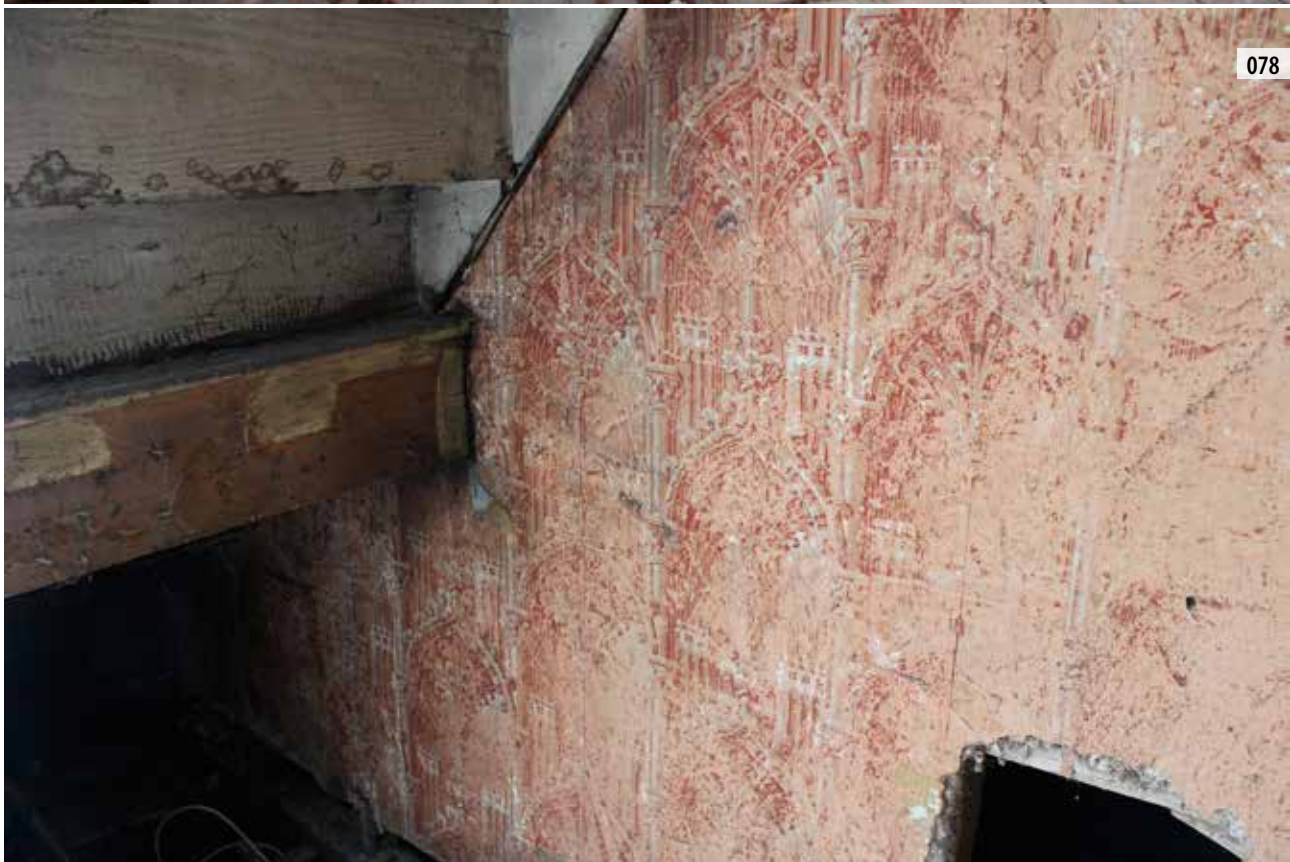
PHOTO 078

Block printed wallpaper behind inserted staircase to second floor
