THE GAS WORKS, POWICK, WORCESTERSHIRE

Historic Building Recording

MH/13/0958 – Condition No.14

January 2015

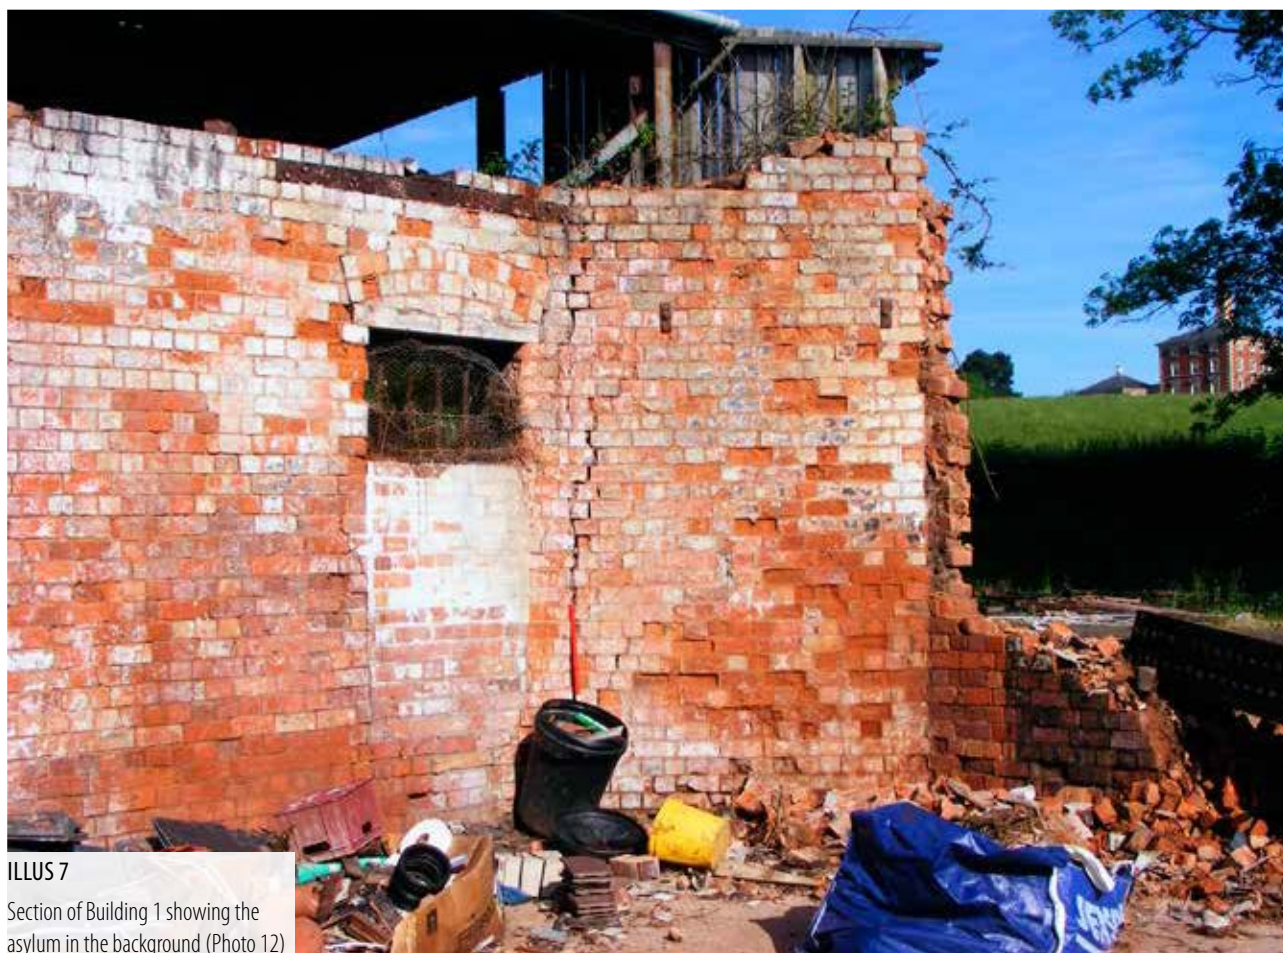
ILLUS 7

Section of Building 1 showing the asylum in the background (Photo 12)

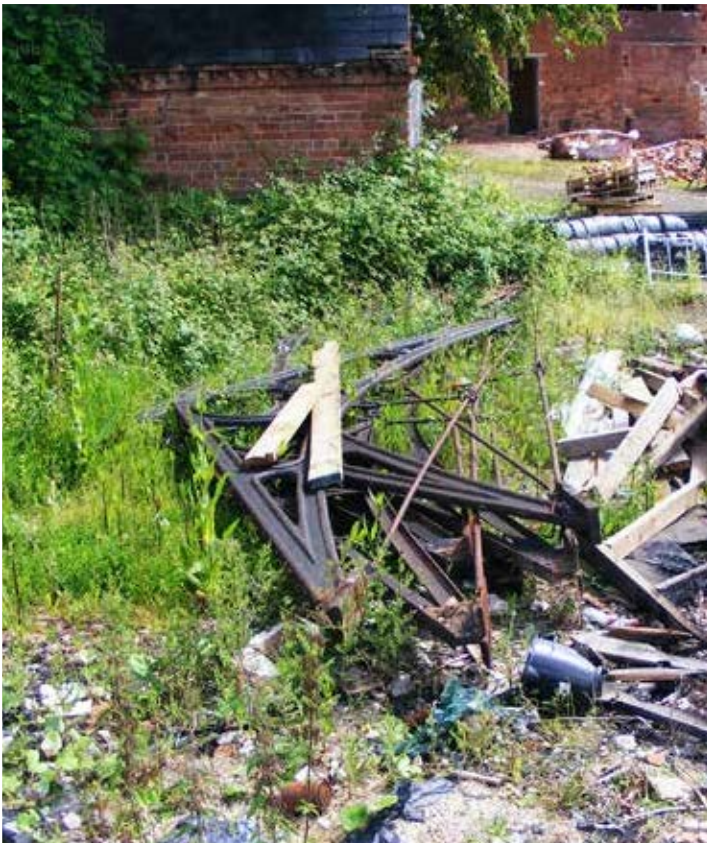
ILLUS 8

General view of the iron roof trusses (Photo 60)

gritty grey cement. A series of cast iron roof trusses (Illus 8) and a large iron beam have been removed and are currently stored within the site compound. These indicate that the roof super-structure was made of a series of cast iron roof trusses with pierced openings and rolled edge details with adjustable tie rods. There appear to have been three central trusses to each bay based on the remnants left on site.

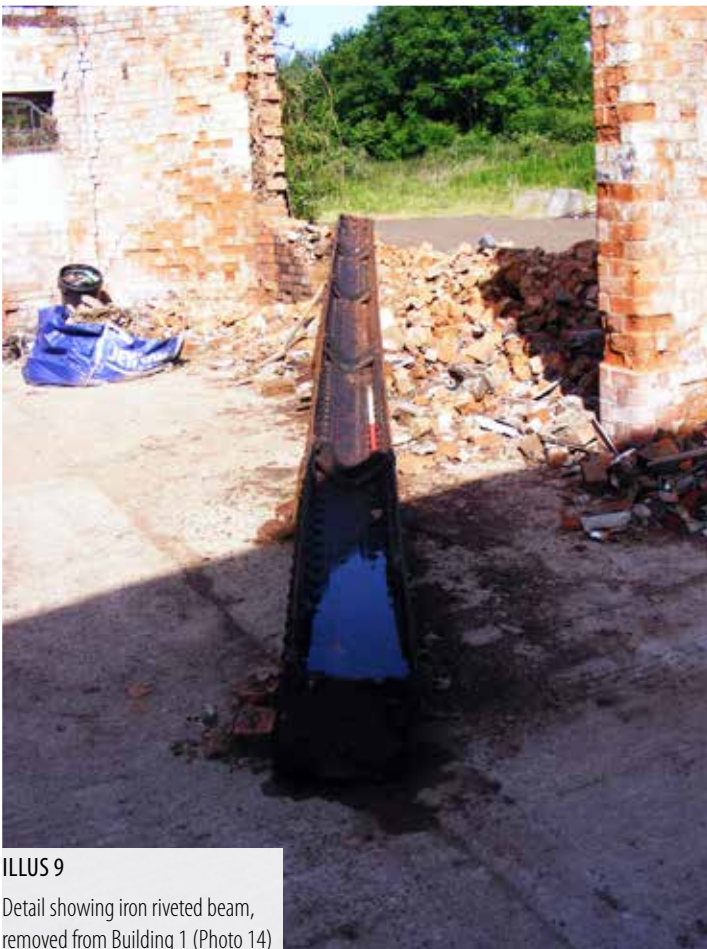
ILLUS 9

Detail showing iron riveted beam, removed from Building 1 (Photo 14)

The iron beam (no longer in situ) would have subdivided the building into its two bays at wall plate level (Illus 9).

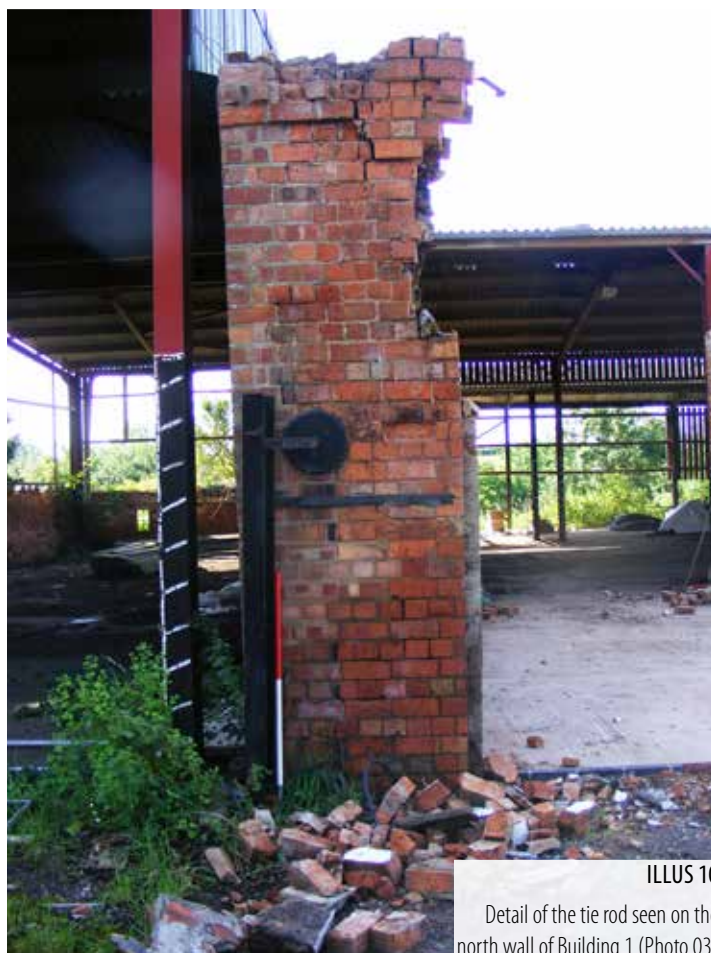
ILLUS 10

Detail of the tie rod seen on the north wall of Building 1 (Photo 03)

The building has had to undergo remedial repairs to maintain its structural integrity. Apart from patches of rebuilding a number of tie bars were also observed. The largest was a three part iron tie rod with round spreading plates linking the north and south elevations on the inside of the east wall of the building (Illus 16). Also an external flat iron strap helps to secure the chamfered corner between the north and west elevations above the window opening (Illus 17) and as previously mentioned a small iron tie rod has been inserted on an east west alignment above the arch on the inside of the south wall (Illus 12). The latter suggests that the SW wall opening was a later feature that caused problems with the structural integrity of the building. The angled strap on the external face of the south wall has already been mentioned above (Illus 13).

At a much later date the insertion of larger openings through the brick work, combined with the weight of the roof are likely to have resulted in the need to insert tie beams to try and hold it together (although it is possible that with the weight of the roof and relatively thin walls these may have been required earlier). In either case these did not manage to fully address the problem and the building had to be demolished. Had this not been the case then the building may have been of regional significance, however, the few elements that survived at the time the survey was undertaken could only be viewed as now providing information of local significance.

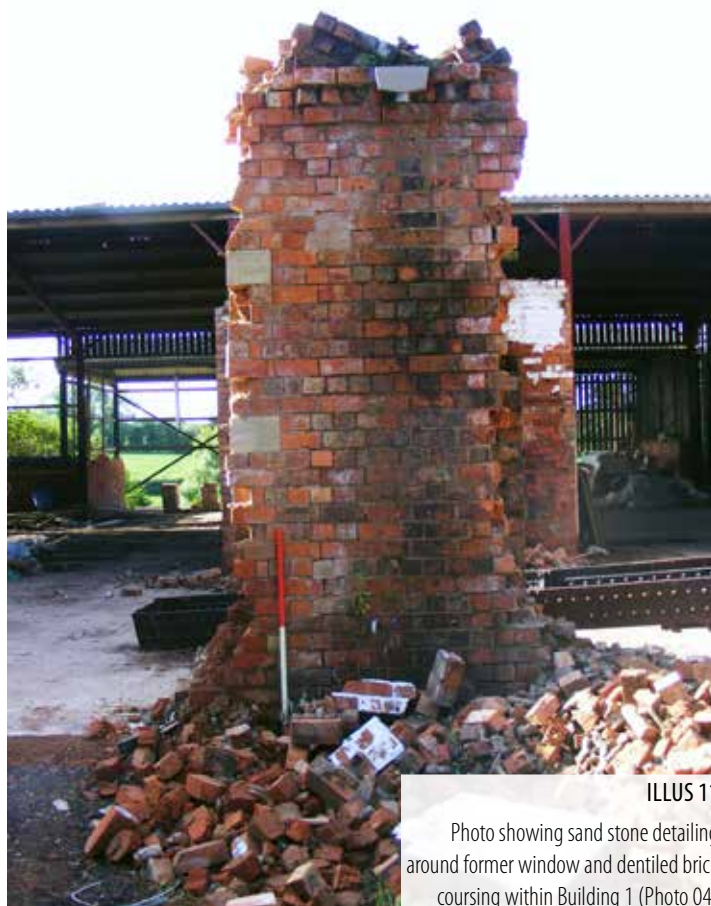
ILLUS 11

Photo showing sand stone detailing around former window and dentiled brick coursing within Building 1 (Photo 04)

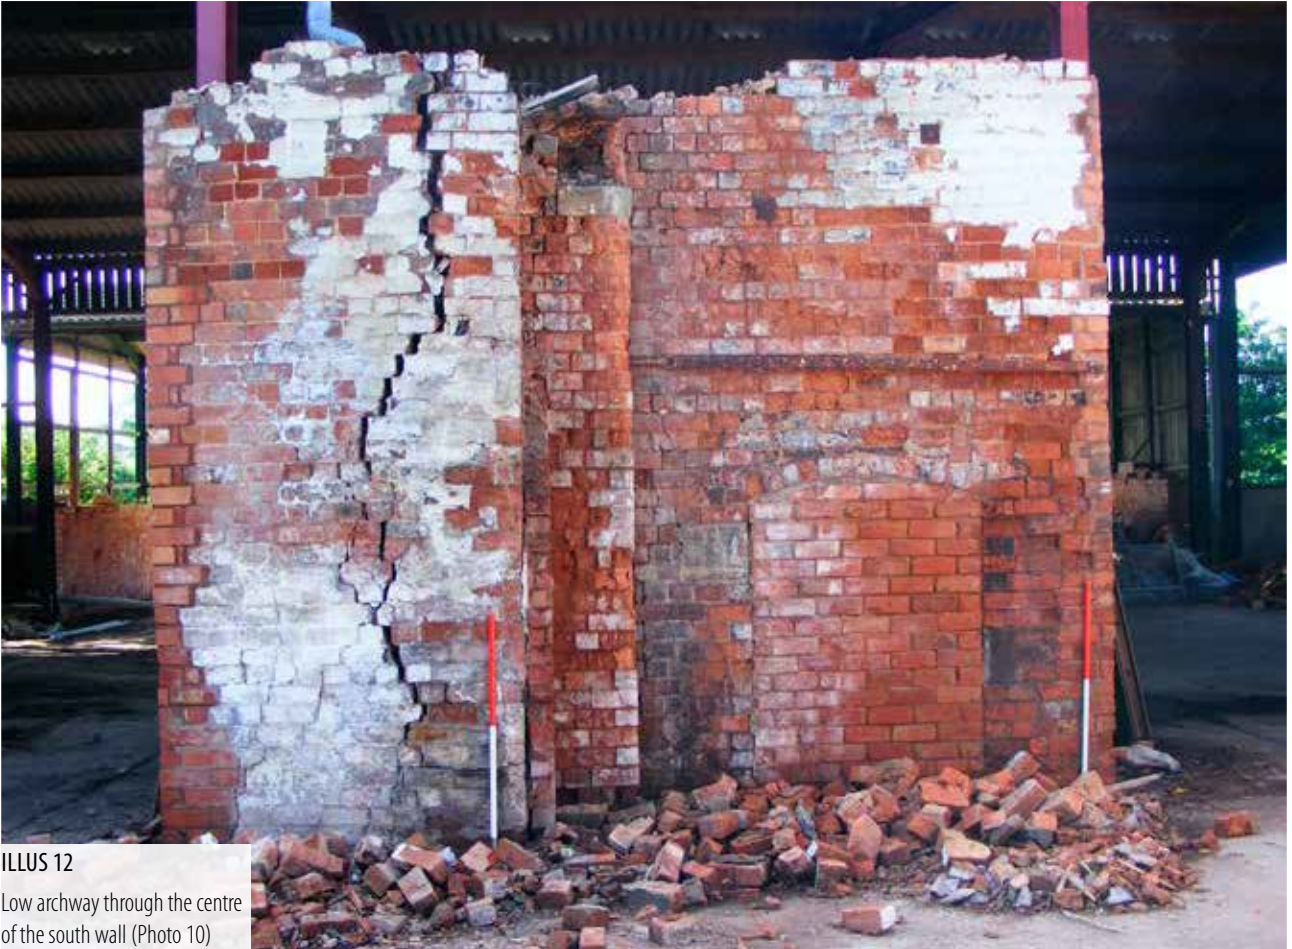
ILLUS 12
Low archway through the centre
of the south wall (Photo 10)

It is only worth considering the evidence from the central portion of the wall. This contains a segmental arched opening approximately 1.2m wide with a height of 1.5m and later blocked using bricks 230 x 850 x 100mm (*Illus 12*). A single stone block lies just beneath the point at which the arch springs on its east side and the external, southern face, of the arch is rebated to half a brick's thickness with a stone block at half arch height on the west side of the arch (*Illus 13*). There appears to be a half skin brick wall to the east of the arched entrance on the inside of the building. This was not a full building height partition but there is no evidence to suggest it ran the width of the building as no stub wall is visible on the opposing fragment of wall (*Illus 14*). An iron tie rod is aligned east west above the blocked arch and ties into new brickwork forming a later entrance between this building and the sheds behind.

of the two bays and therefore any plant was likely to be housed in the southern half of these bays. Some further evidence for this can be observed in the central part of its south elevation. Here an arch is clearly too low to afford sensible access for workmen, also a low single skin wall separates this arch from the east bay (at least partly). One suggestion is that the wing to the south (no longer surviving) was an open sided coal store and the arch was located to barrow or cart fuel from this wing into the building where it was converted to gas.

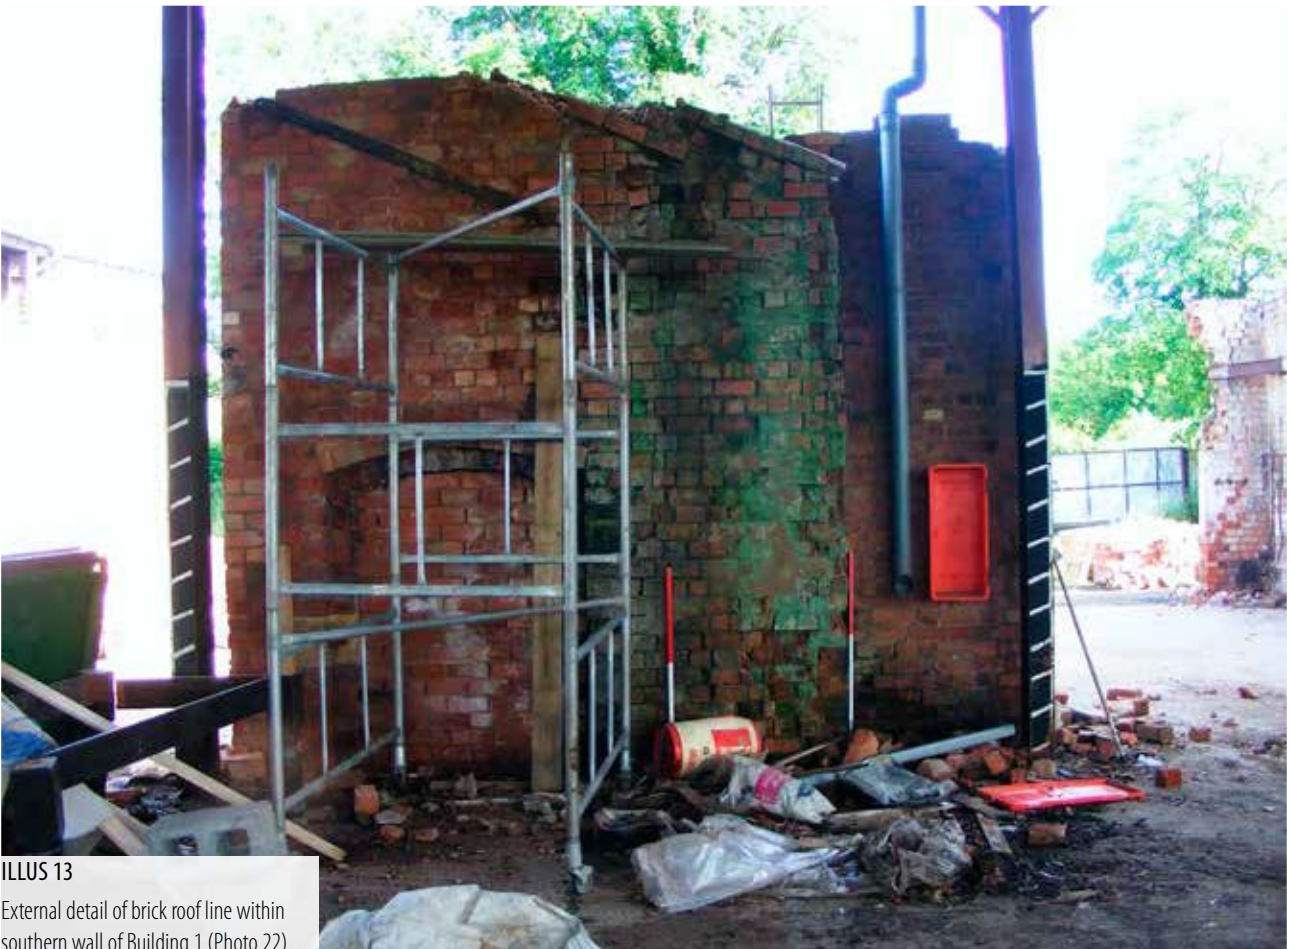
ILLUS 13
External detail of brick roof line within
southern wall of Building 1 (Photo 22)

On its external face an angled line of bricks located towards the upper courses of the wall indicates the pitch of the original roof line providing further evidence that the building was originally roofed with a double pitch roof and gully (*Illus 13*). Beneath this and also illustrated is an angled metal strap about 0.5m below the eaves line of Building 1. This most likely acts as a tie beam meaning there is little evidence showing where the end of a structure that once abutted the south side of the building stopped. Given the lack of any wall scars it seems probable that at least the east side of this building was open.

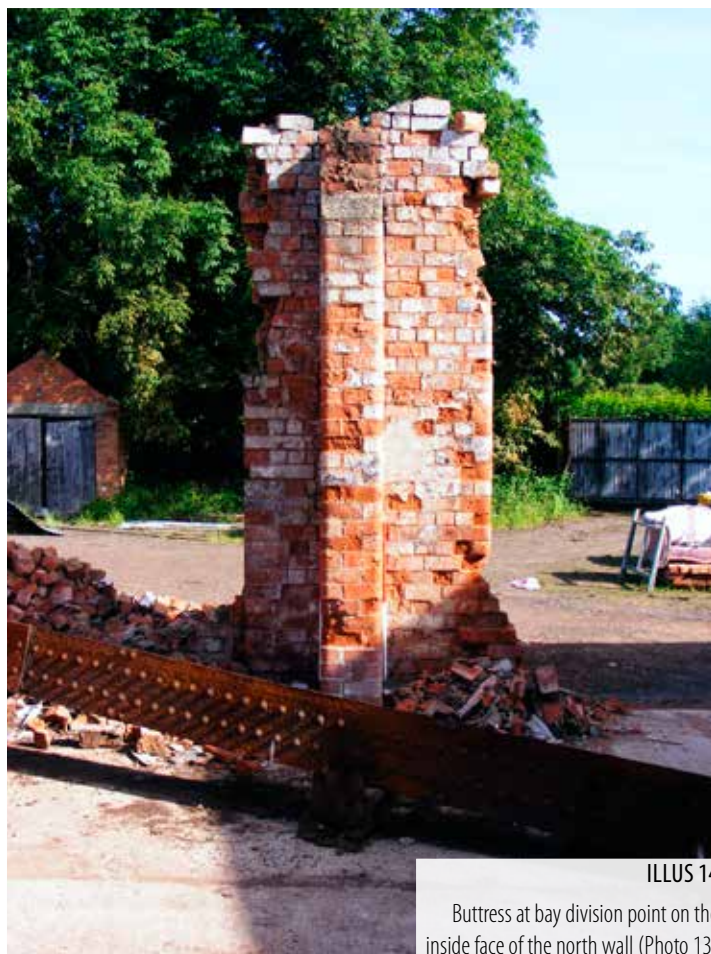
ILLUS 14

Buttress at bay division point on the inside face of the north wall (Photo 13)

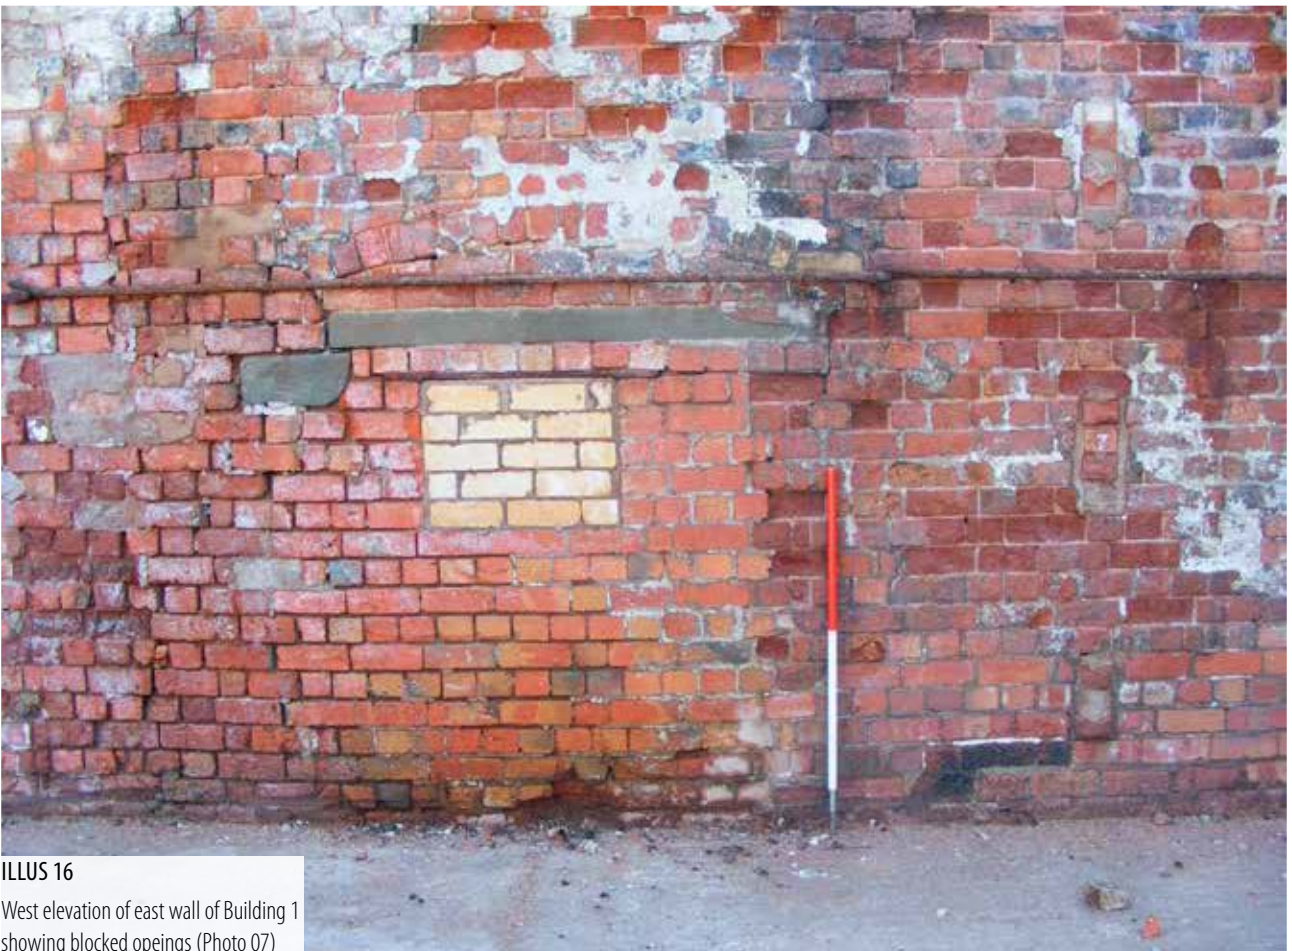
The one and a half brick thick east wall of Building 1 is probably the most complicated and contains evidence of multiple blocked openings (*Illus 15, 16*). The primary opening appears to have been a large segmented arch also 1.2m wide by 1.5m high. This also has a small stone block beneath the point at which the north side of the arch springs. However, unlike its counterpart in the south wall it appears to have had a stone lintel, the arch above acting as a relieving arch. Its blocking has been keyed into the south jamb of the arch on its east face and both jambs on its west face. In the blocking of the latter a square opening (0.5m wide x 0.4m high) was left, later blocked with fire bricks. The east face behind this is also blocked using the same types of brick, but keyed into the surrounding blocking. Also in this face of the wall a smaller arched opening was inserted through both original wall, the end of the stone lintel (on this side) and the original blocking. This is located about 1.3m above current ground level and measured 0.4m x 0.4m. It did not pass through the entire thickness of the wall. One possibility is that this was a vent of some description, later blocked.

ILLUS 16
West elevation of east wall of Building 1
showing blocked openings (Photo 07)

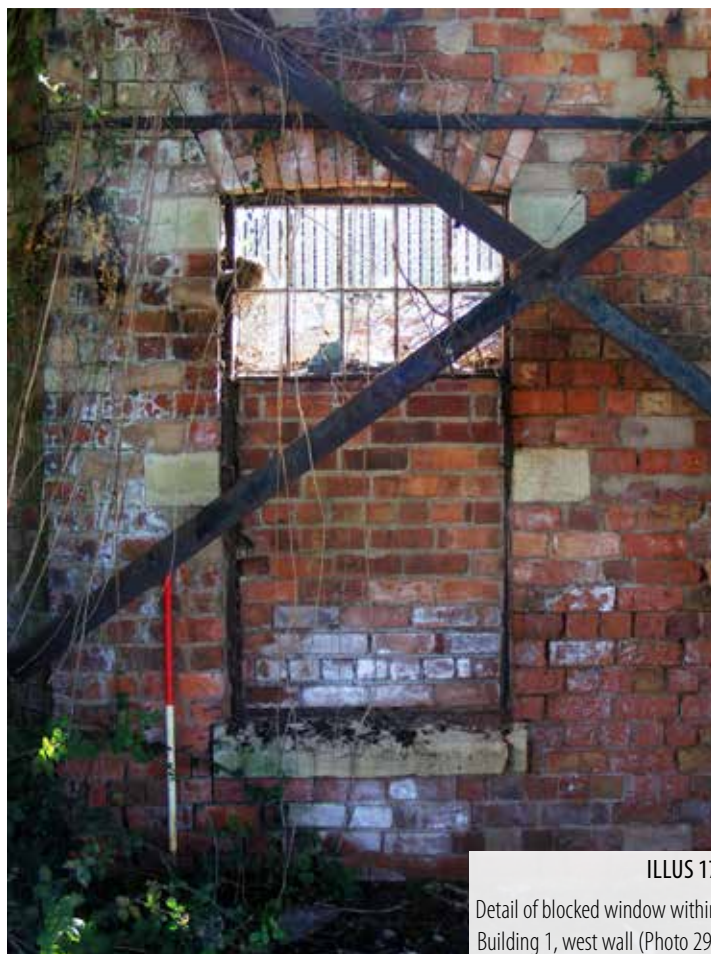
ILLUS 17

The west wall of Building 1 contains the only complete window opening within its surviving fabric (*Illus 17*). The window opening illustrates the detail afforded in the construction of the building, despite the original building being industrial in nature. The opening contains a chamfered sandstone sill with sand stone blocks positioned to accommodate opening shutters. Above a later partial, brick blocking an iron window frame survives forming a ten light opening with glass dimensions of 270 x 175mm. If this reflected the original glazing for the whole window then it would have contained a total of thirty glazed panels.

Detail of blocked window within Building 1, west wall (Photo 29)

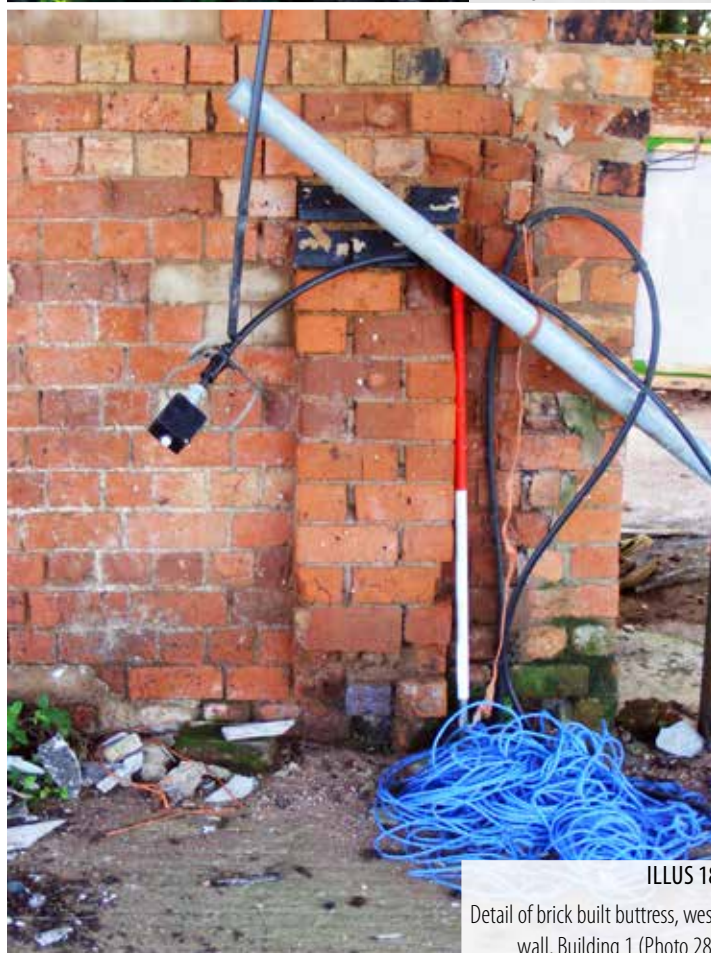
ILLUS 18

An enigmatic feature on the external face of this wall is a half brick thick, c. 1.2m high buttress capped with two courses of chamfered engineering blue bricks. The amount the buttress contributed to the structural integrity of the wall seems limited (*Illus 18*).

Detail of brick built buttress, west wall, Building 1 (Photo 28)

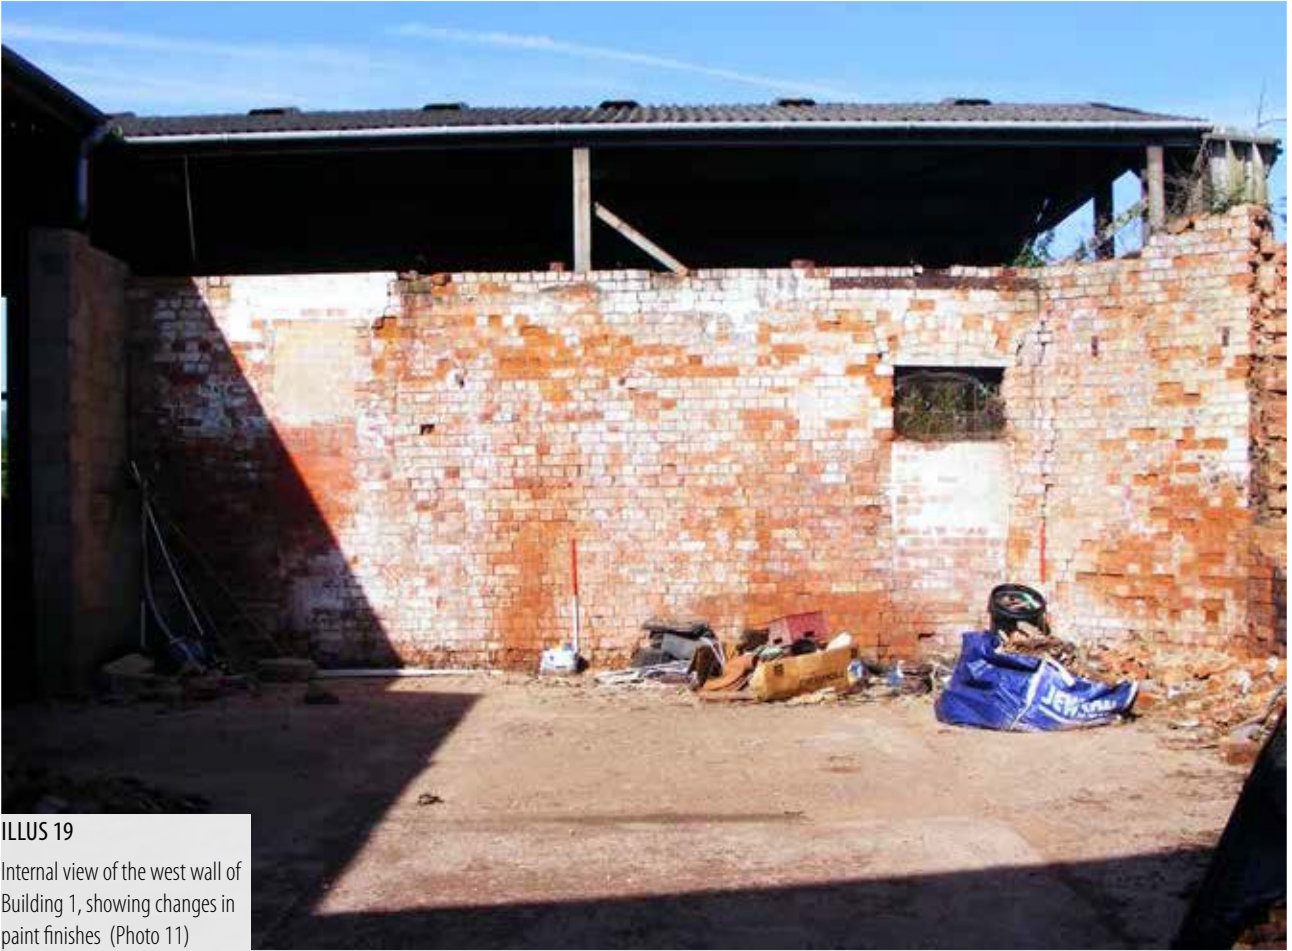
ILLUS 19

The internal fabric of the west wall (*Illus 19*) indicates that the building was painted with a white wash, the presence of various coatings indicating that the building was repainted on a regular basis. A rectangular patch (1 x 0.65m) of yellow bricks located towards the southern portion of the west wall suggests the location of a feature cut into this wall that was later blocked. It did not form an opening

through the wall as there is no evidence for it on the external face. It could be that some part of the plant was located tight against this wall.

Internal view of the west wall of Building 1, showing changes in paint finishes (Photo 11)

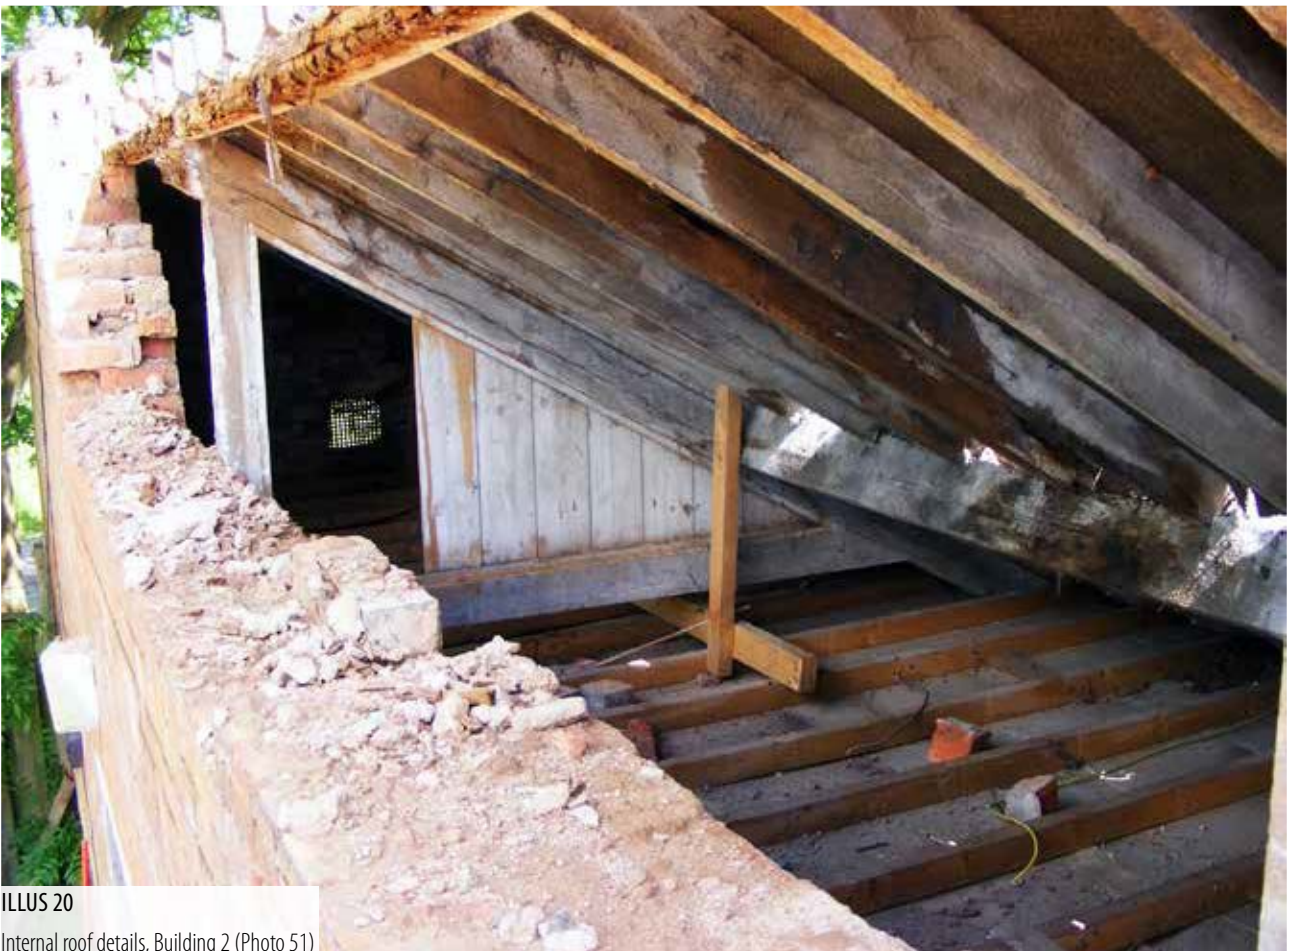
ILLUS 20

The single pitch roof is constructed from machine cut timbers with a single purlin and two boxed in trusses forming three closed sections within the roof space (Illus 20).

Internal roof details, Building 2 (Photo 51)

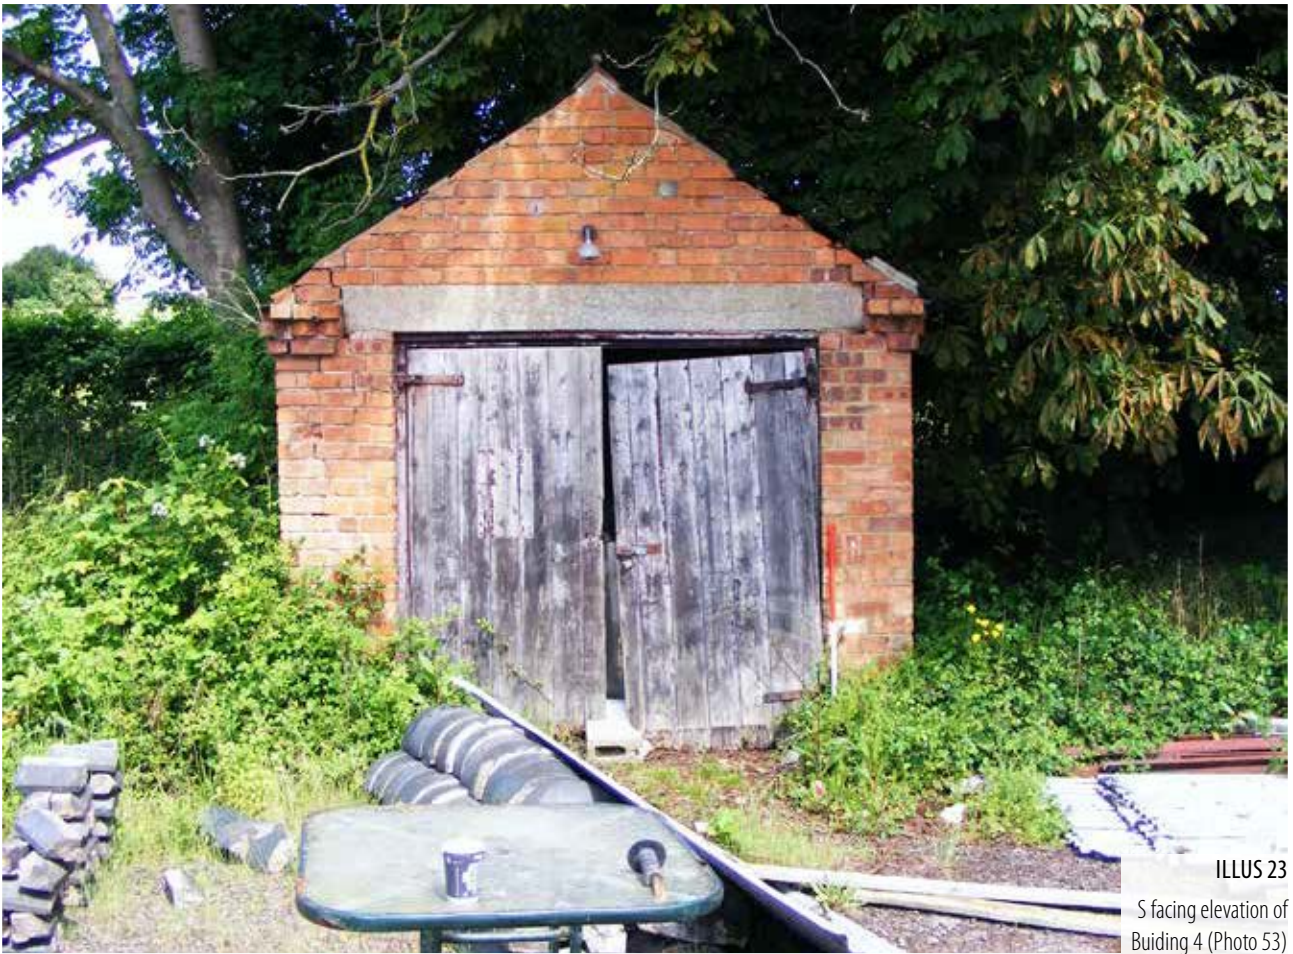
ILLUS 23

Measuring approximately 3 x 5m the building is constructed in red brick with a mixture of English bond and Flemish bond and a concrete floor. The building has an ornate dentiled brick course below the eaves, a feature reminiscent of the dentiled coursing seen on the surviving fabric of the north wall of Building 1. It had a double pitched roof covered in small blue grey slate tiles (Illus 23–24).

S facing elevation of
Building 4 (Photo 53)

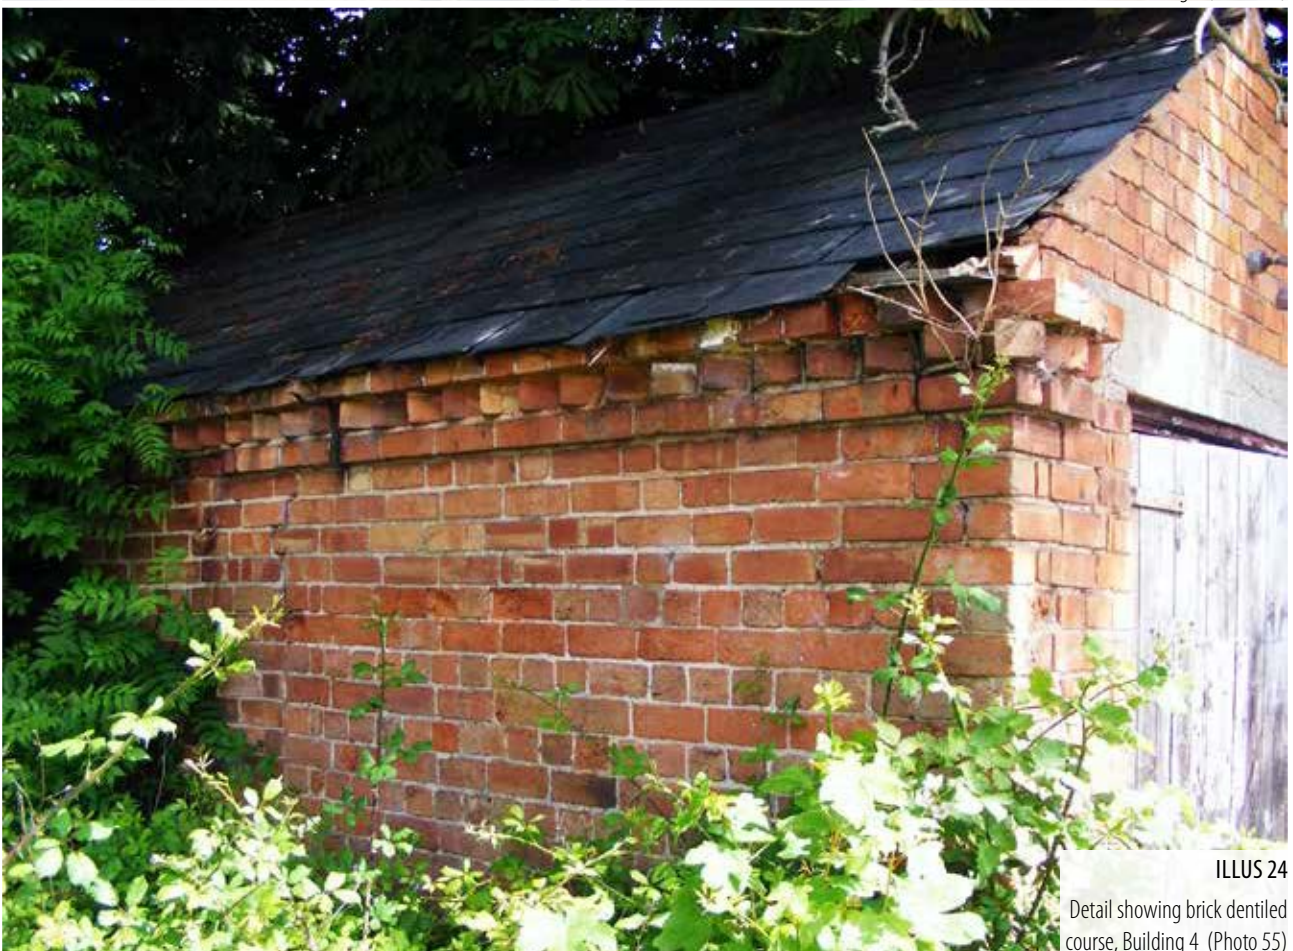
ILLUS 24

Detail showing brick dentiled
course, Building 4 (Photo 55)

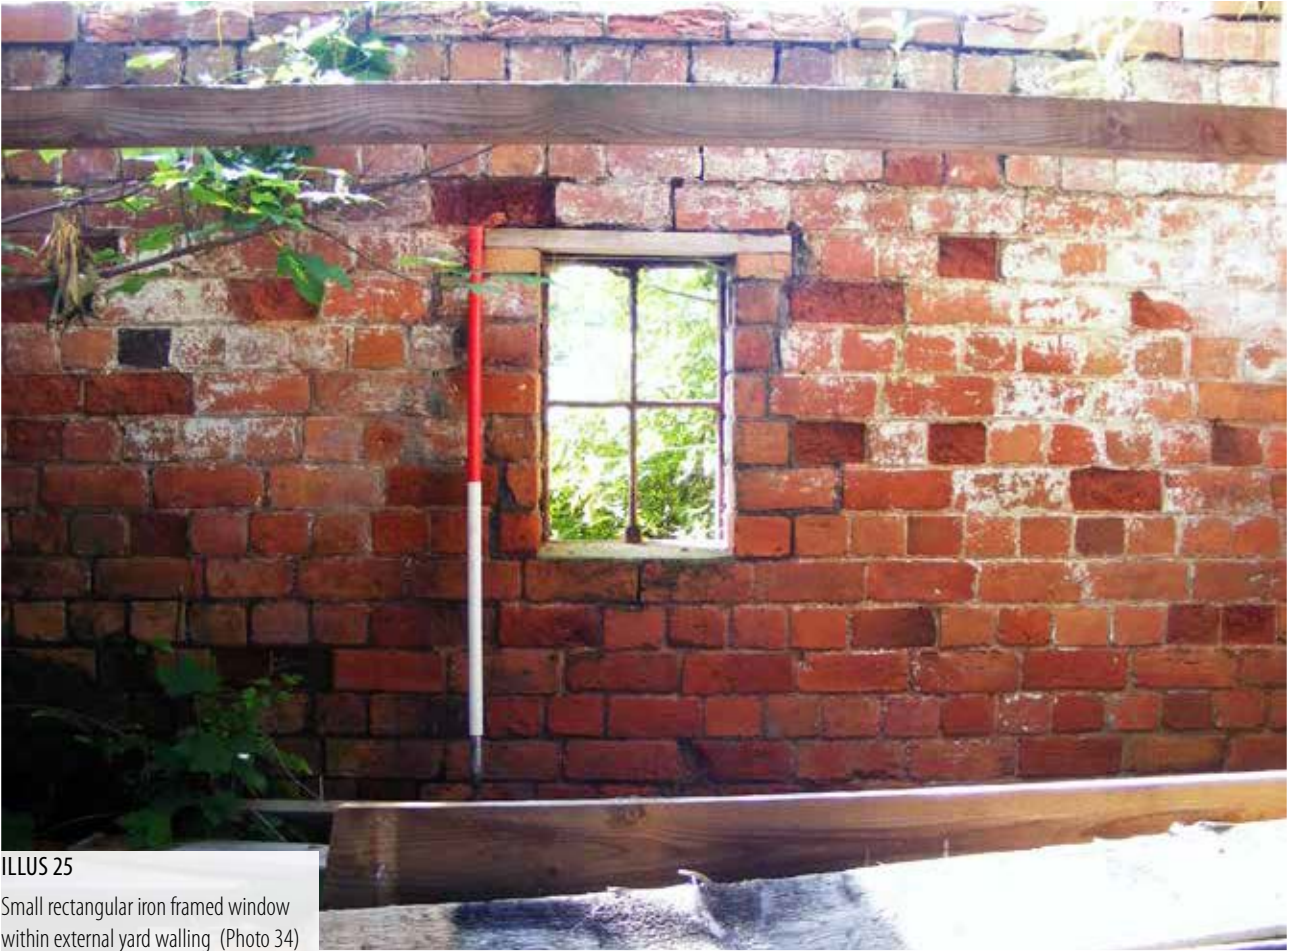
ILLUS 25

walling may relate to the original boundary of the site. A small rectangular, four light, opening was inserted in the south portion of the boundary wall, its function is unclear (Illus 25).

Small rectangular iron framed window
within external yard walling (Photo 34)

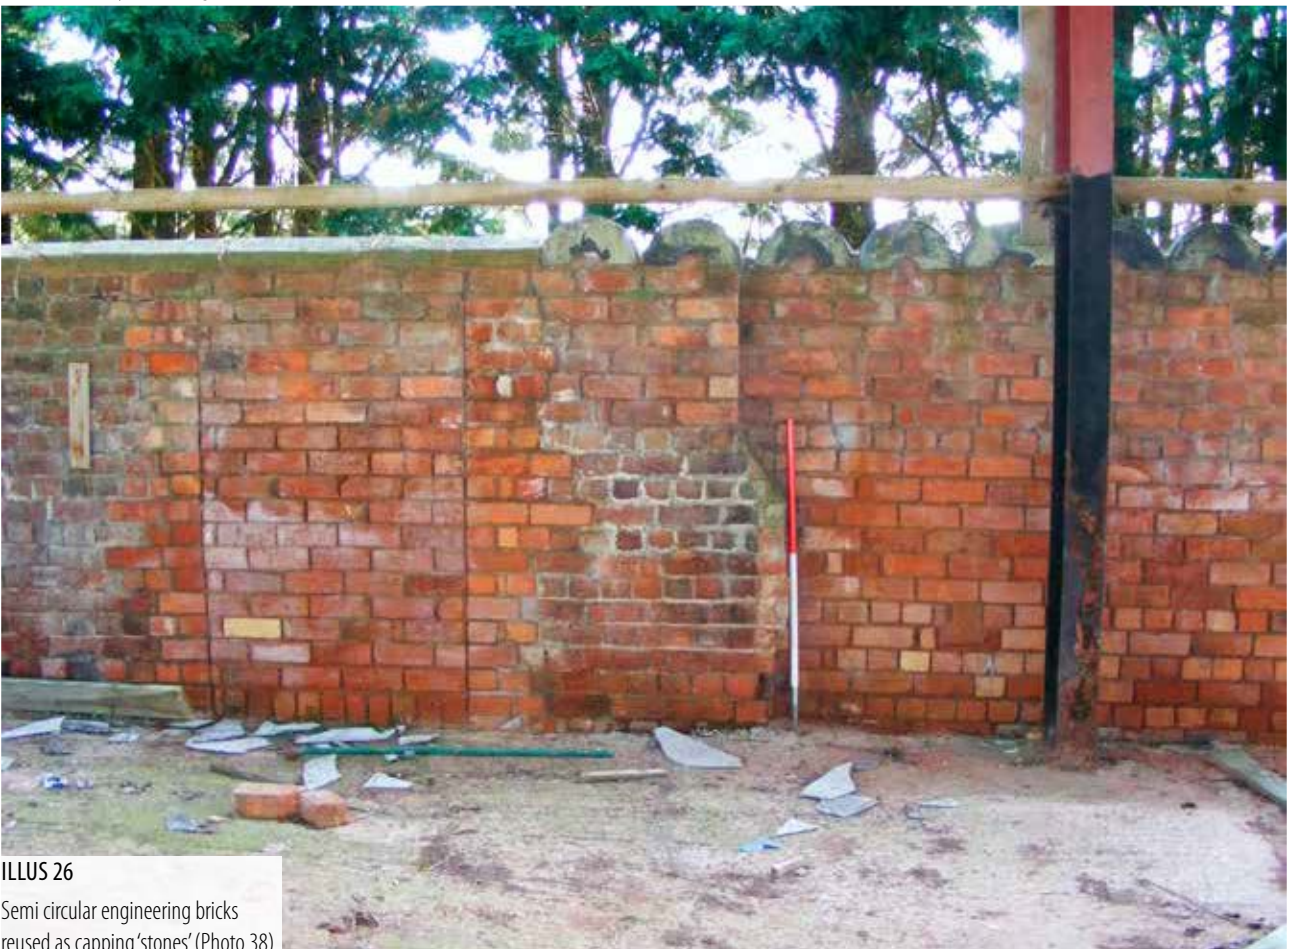
ILLUS 26

An interesting feature of an area of the upstanding boundary walling is the use of semi circular engineering blue bricks as a coping stone to the walling; it is possible that these bricks are reused from a now nonexistent building, the circular moulded bricks possibly originally forming a casing for buried pipe work

Semi circular engineering bricks
reused as capping 'stones' (Photo 38)
