16-18 HIGH TOWN AND 12 EAST STREET, HEREFORD, FIRE DAMAGED BUILDINGS

ARCHAEOLOGICAL BUILDING INVESTIGATION AND RECORDING
LISTED BUILDING CONSENT REF. 161546
HER REF. EHE80307

commissioned by Alban House (Birmingham) Ltd

February 2018

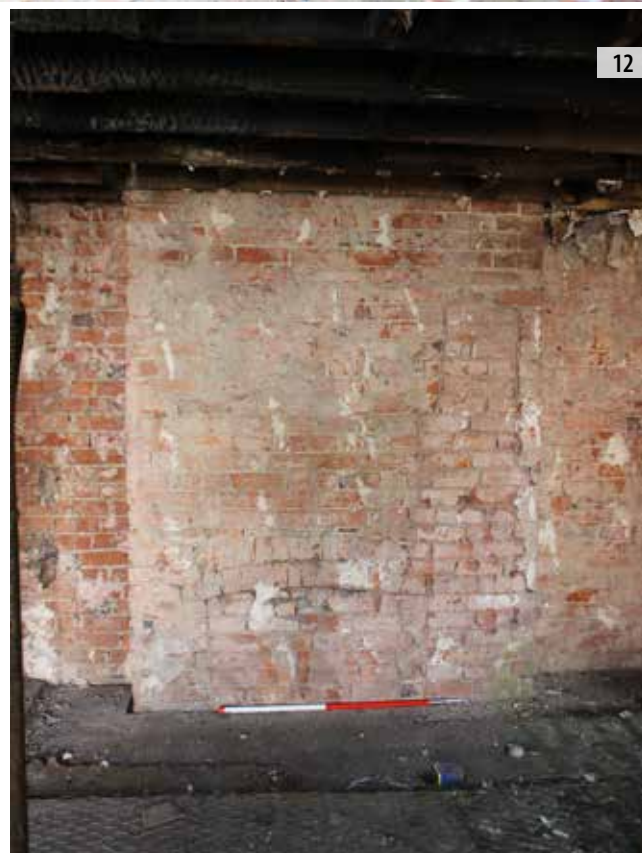
ILLUS 12 View of blocked fireplace, south wall of room 17

The chimney breast observed in Room 7 continued up and was present in the south wall of Room 17. In this chimney breast, roughly 0.50m above the current floor level could be seen the arched top of a fireplace (Illus 12), with a flue on its western side. This fireplace and flue were blocked by brick. It is unclear why the flue was visible, but perhaps this change in brickwork was from an alteration or repair to the flue, rather than a blocking of it. From the positioning of this fireplace, it could be seen that the floor level of this building had been raised significantly. It seems likely that this change in floor level probably occurred in the 20th century, resulting from refurbishment of the building for retail use.

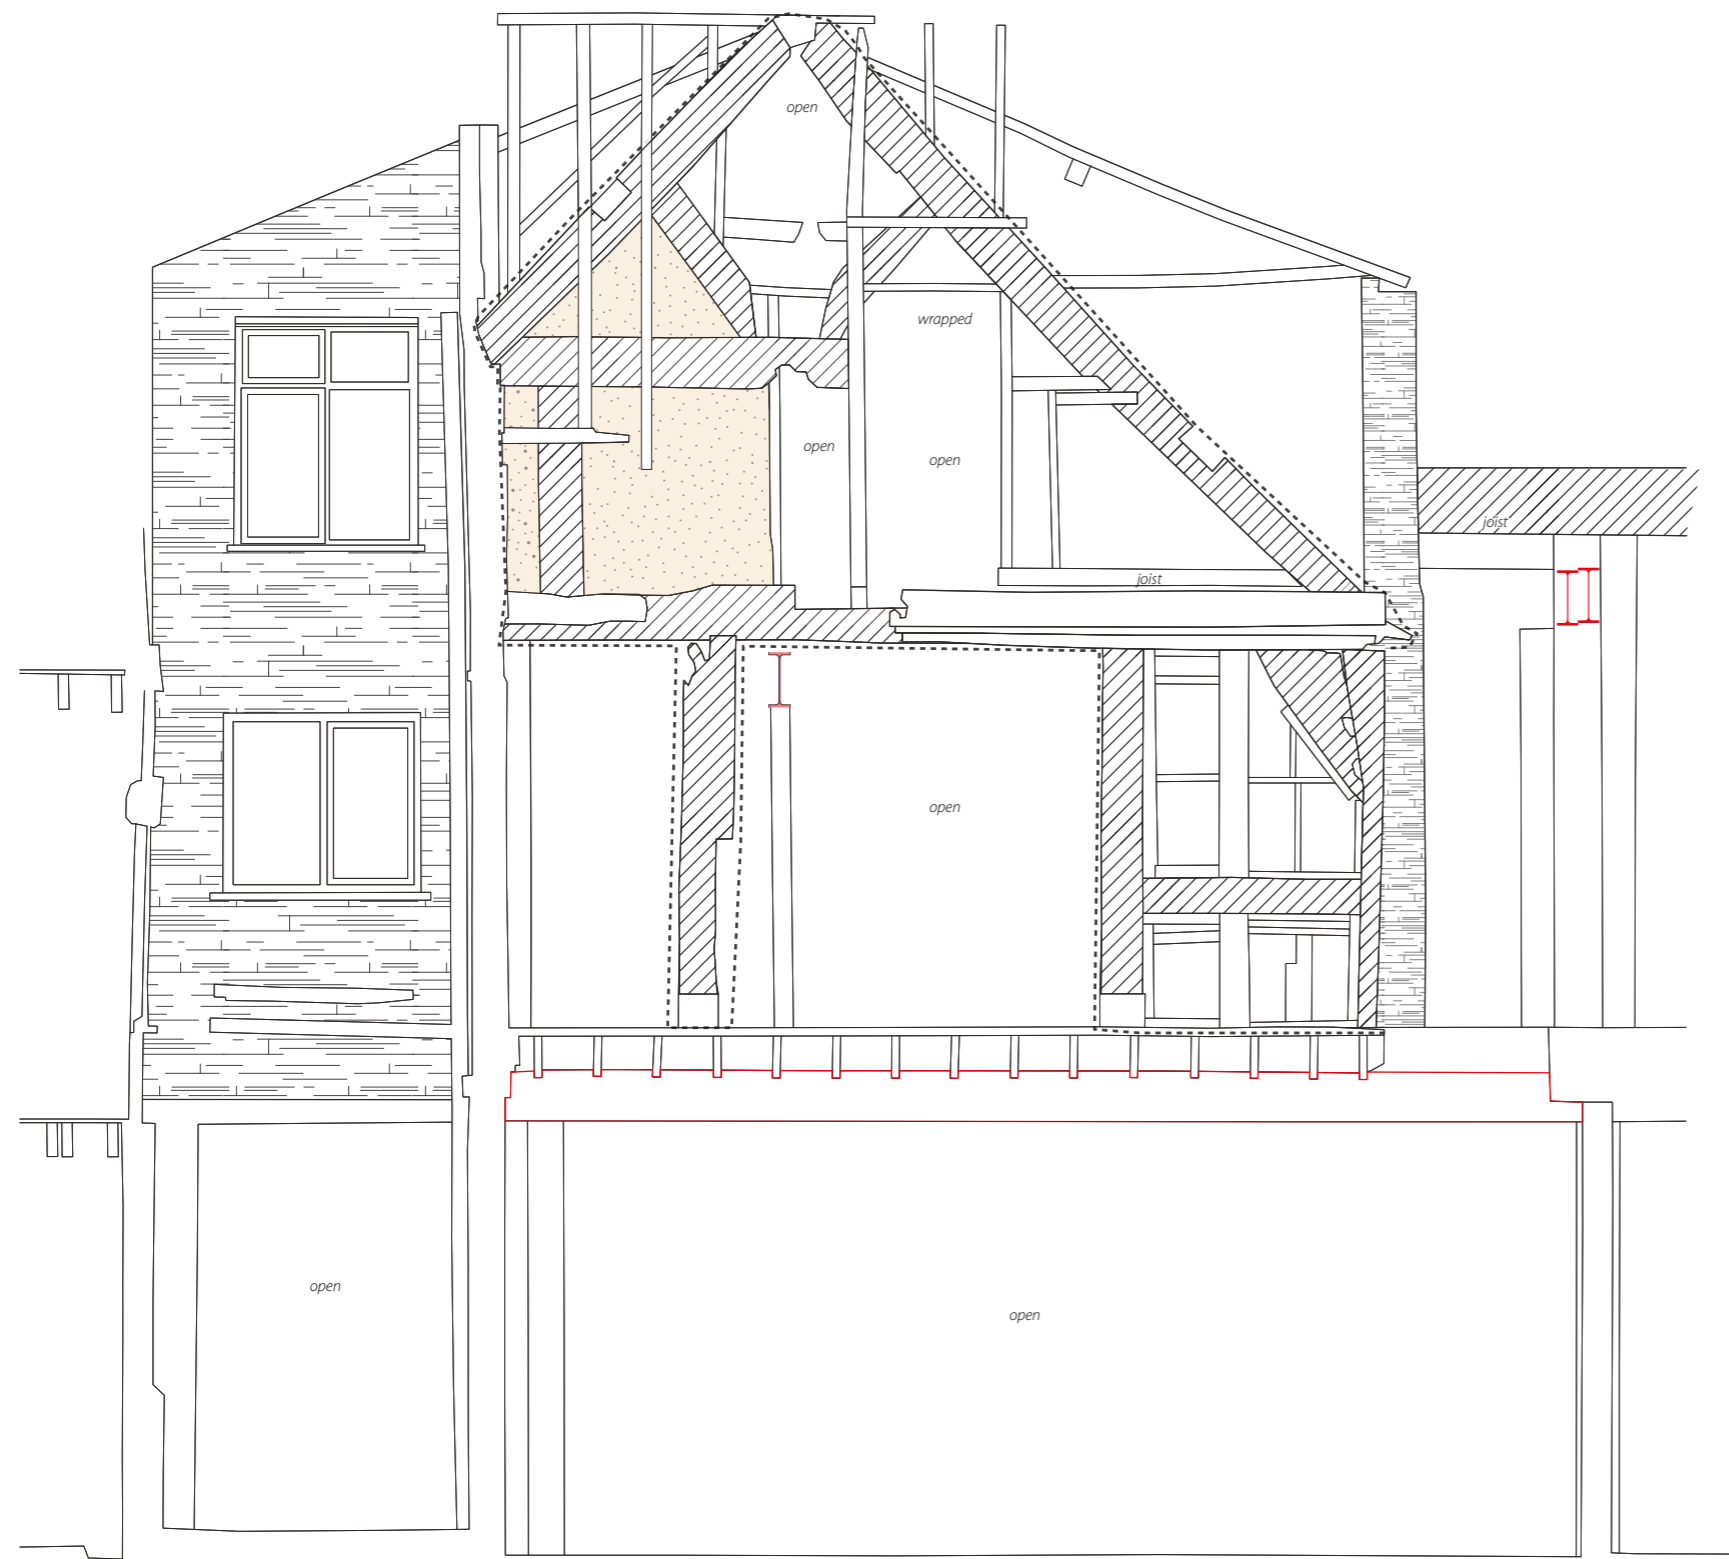
SECTION B - TIMBER FRAME DRAWING
 ↑ E

The north side of this room seemed to be demarcated by an older timber roof truss. At the time of recording this was covered, and coupled with the limited access to Room 27, was difficult to observe. It seems likely, however, that this truss was associated with the fragments of timber framing observed in Room 16/17. It could not be determined how this truss was incorporated into the more recent fabric of the building, but it is possible it was part of a dividing wall (Illus 13).

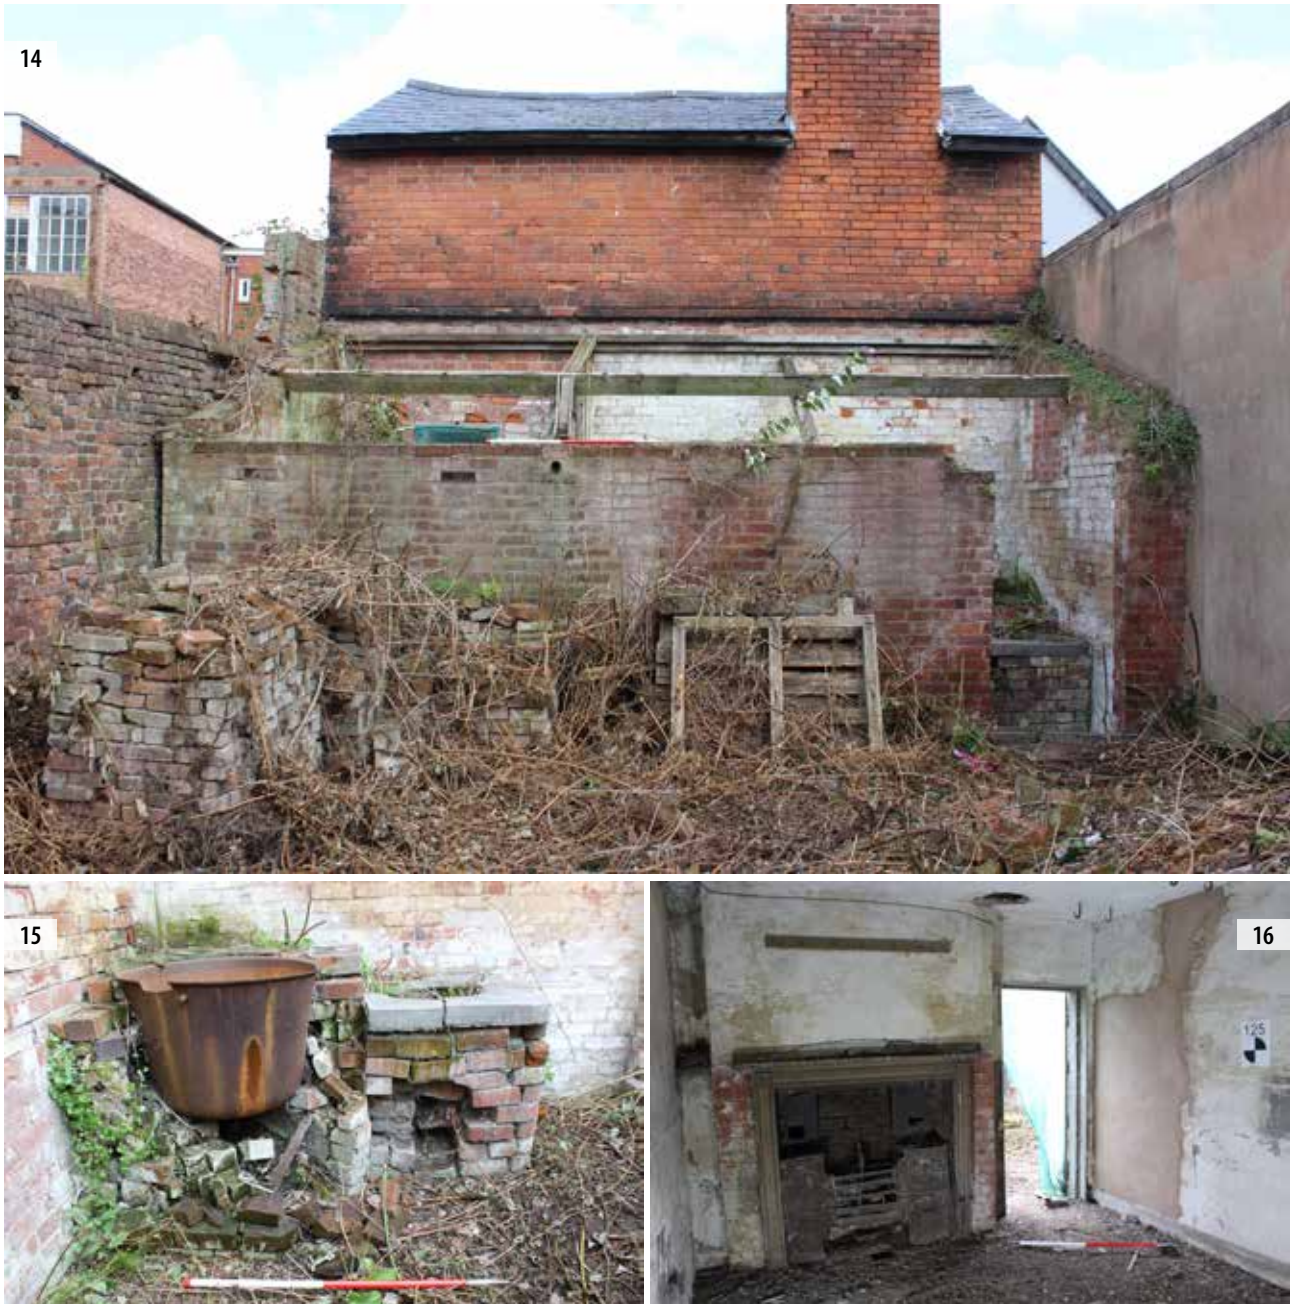
ILLUS 14 General view of Building C exterior, looking north **ILLUS 15** View of copper in Building C **ILLUS 16** View of interior of room 10, looking south-west

north and east edges of the ceiling, appeared to have served a purpose of hanging laundry to dry (Illus 16).

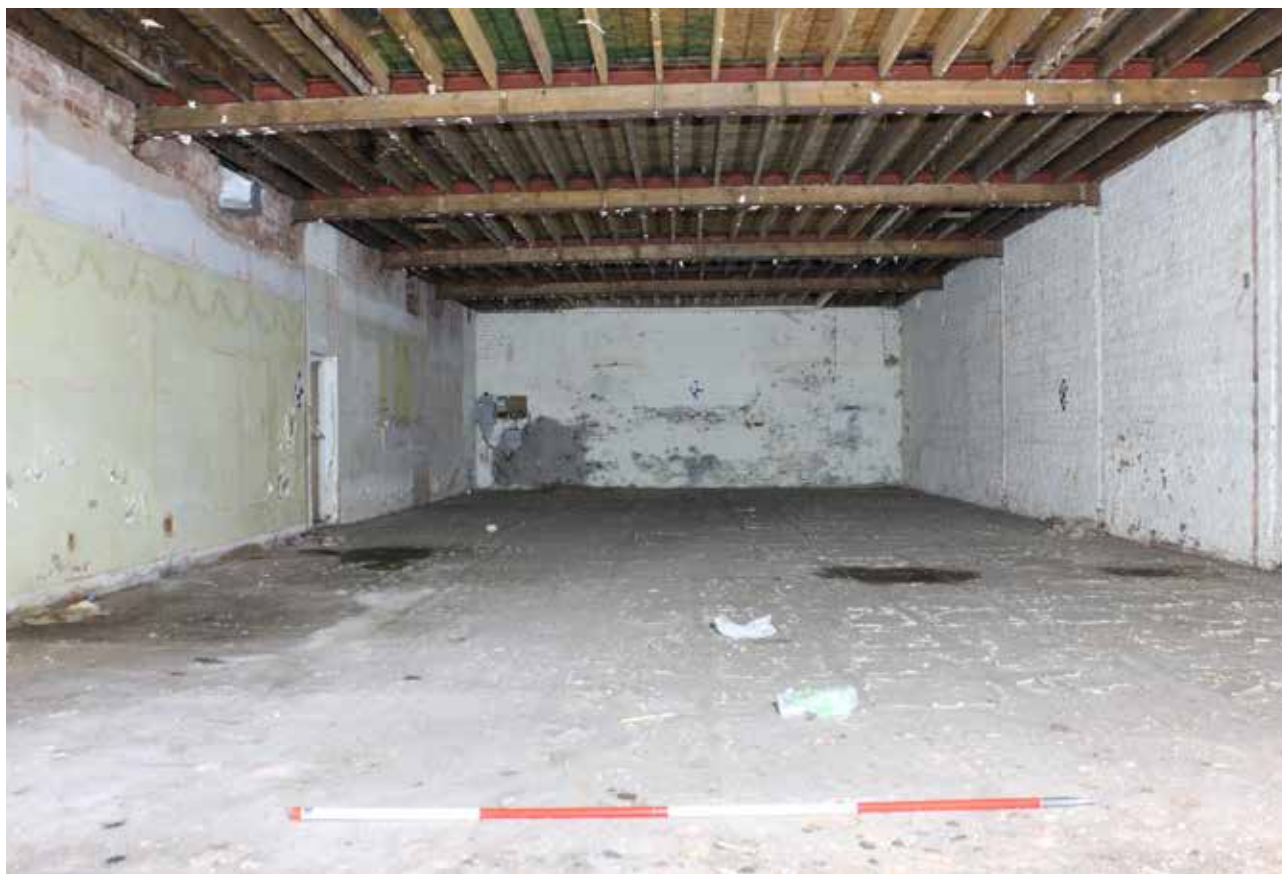
ILLUS 17 General view of building D interior, looking south

Internally the building showed some evidence of dividing walls, particularly around the eastern doorway. However, no such walls survived and so the nature and layout of them were not possible to determine. The building contained a concrete floor, which was painted grey. The south and west walls were painted white over the brickwork, whereas the eastern wall was finished with modern, decoratively painted plaster (Illus 17).
