GLEBE FARM, MAGNA PARK, LUTTERWORTH SOUTH

HISTORIC BUILDING RECORDING

PLANNING REF. 15/00865

October 2019

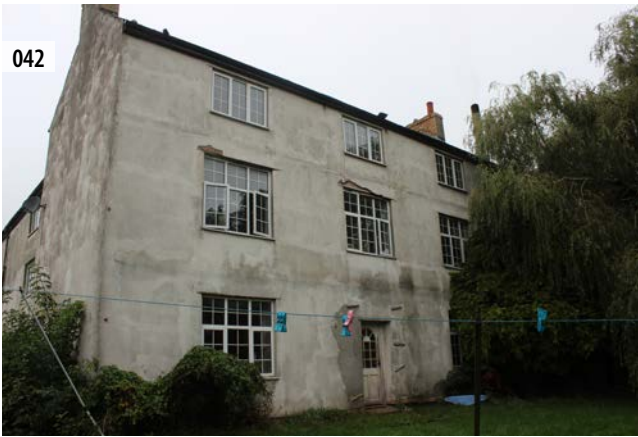
The principal elevation is the east elevation (Photo 042). The front of the building is cement rendered over red brick, visible in damaged areas of the render and painted a light grey colour. A single doorway is located at ground-floor level central to the façade, with eight, multi-light UPVC double glazed windows, two at ground floor level and three on the 1st and 2nd floors. Each window has south and north side casements. The door is of timber construction, with an upper glass, multi-light gothic style central arch. A series of small timber strips are affixed to the frontage surrounding the door indicating the possible presence of a former porch or decorative structure such as trellis fixings (Photo 065). Plastic guttering runs along the eaves over back painted timber fascia boards.

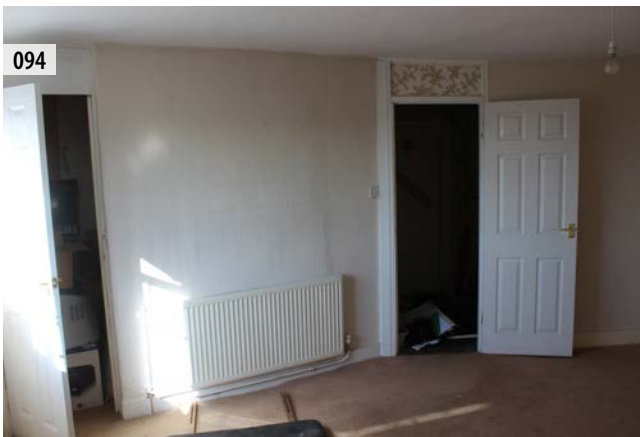
FARMHOUSE 1ST FLOOR SPLL-HBR 094

Located on the south of the corridor, room FH9 was polygonal in shape, with a south-west/north-east oriented segment of wall with an in-swinging door (Photo 094). A small cupboard space was located in the south corner of the west wall, in a probable former chimney breast. A modern UPVC, multi-light casement double-glazed window was located in the south wall. At the end of the corridor which turned to the south creating a polygonal area in front of room FH9, a wooden door out-swung from a timber staircase leading to the second floor. Adjacent to this at the rear of the building, room FH10 was rectangular in plan with a multi-light UPVC window located in the south wall. A small cupboard lay beneath the stairwell to the 2nd floor which formed the east wall.

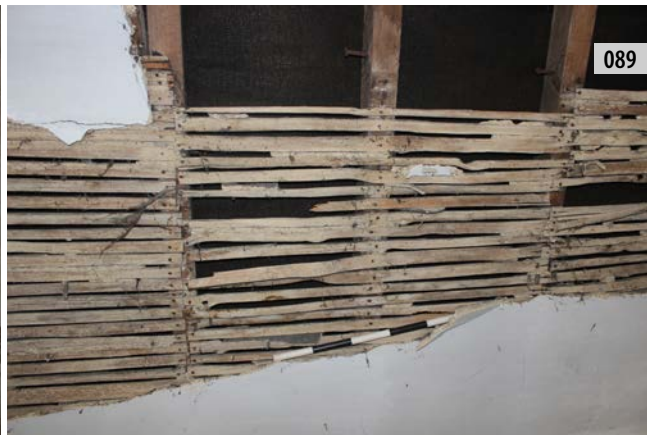
An open doorway leads to room FH14, also broadly square in plan, with white painted brick walls rising to lath and plaster eaves and ceiling (Photo 089). The lath and plaster was in poor condition having collapsed in several areas exposing the timber roof construction, which appeared to be built on to and over the north-south block

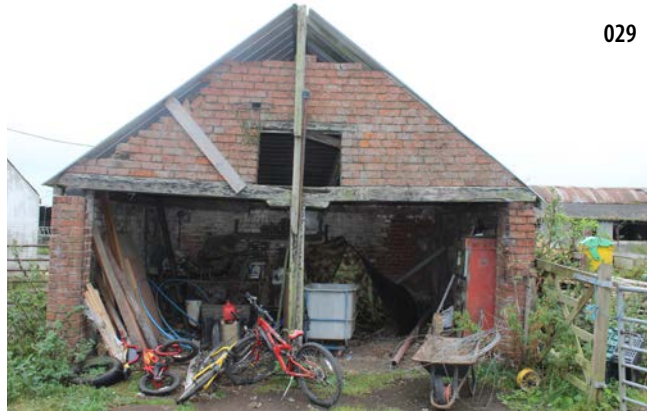
029

The north elevation formed the principal elevation and was a partially open gable end (Photo 029). The upper half of the elevation was of 16 courses of red-bricks in a Flemish Garden Wall bond. A timber lintel lay over a square opening located centrally above an east-west timber beam. A vertical timber support and lintel was located centrally below the beam. Two brick pilasters lay at each end of the elevation, the eastern pilaster having bull-nose bricks on its corners. A pitched roof, with metal sheet cladding affixed to purlins was evidenced, with a gap apparently caused by damage to the brickwork directly below the apex of the roof.

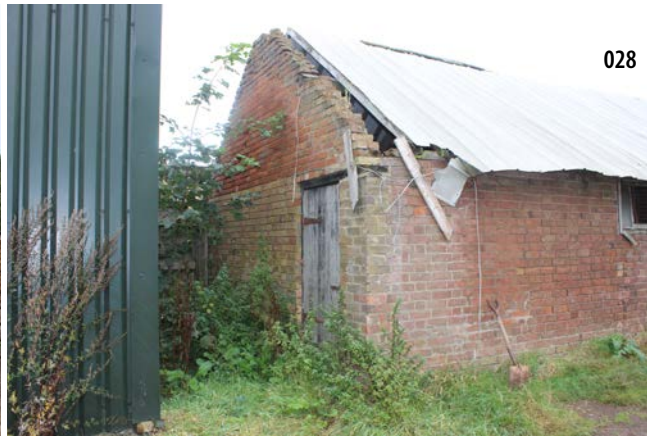
028

The south facing elevation represented a gable end and was constructed in yellow and red bricks (Photo 028). Yellow bricks, in Flemish Garden Wall bond formed the lower half of the wall, extending up to eaves level below a pitched roof. Red brick, in a random bond, extended from the eaves to the roof apex. A timber, out-swinging door was located at the east end of the elevation, with a timber lintel.

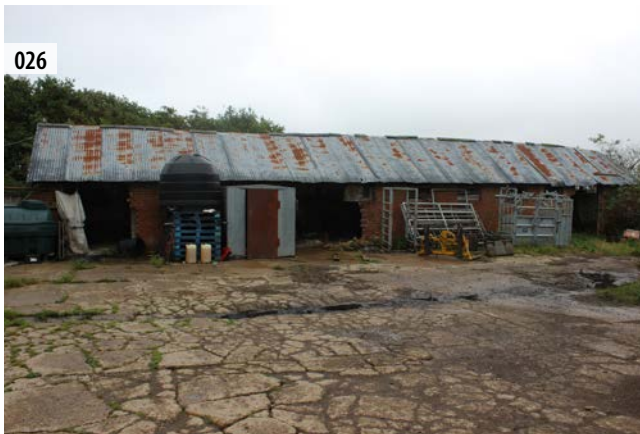
The west facing elevation formed the principal elevation of the building (Photo 026) and was constructed in red brick in a Flemish Garden Wall bond. The façade had been broken through in three areas, north, south and centrally, with damaged brickwork visible and a window frame overhanging in the central void. Partial timber architraving of former doorways was visible in both the north and central voids. Five timber window frames were located in the southern half of the elevation, immediately below the roof eaves. No fascias were present with corrugated metal sheeting forming the roof covering.

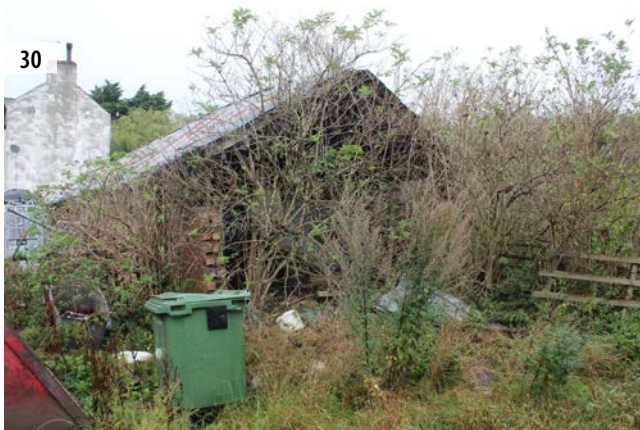
The south facing elevation was partially obscured by vegetation growth. The elevation was open with damaged brickwork and later timber supports visible on the east and west walls indicating probable demolition of the walls at this point (Photo 030).
