BEORMA QUARTER, DIGBETH, BIRMINGHAM

HISTORIC BUILDING RECORDING REPORT

commissioned by Armac

October 2019

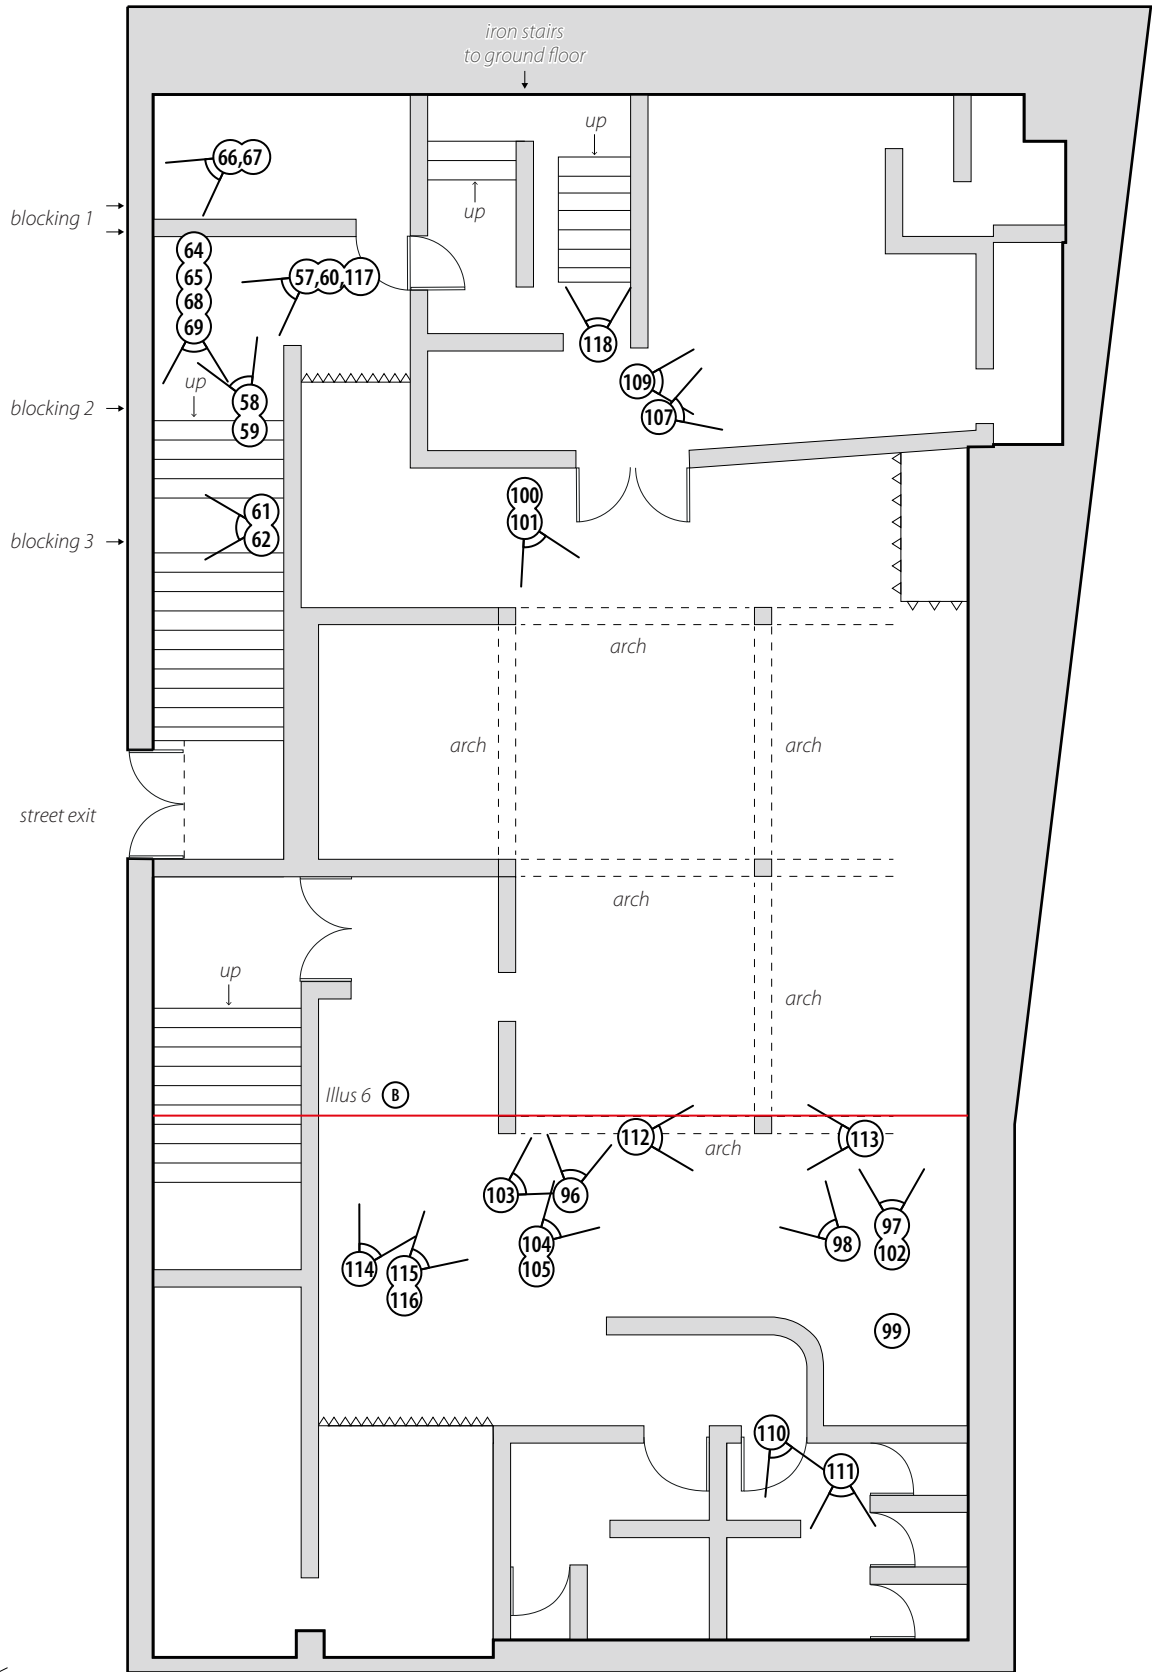
ILLUS 2 Basement floor plan of Music Hall building

The cellar had been extensively remodelled with breeze block and stud-partition internal walls and the former cellar frontage obscured by more recent breeze block and brick construction. Elements of original architectural detail in alcoves on the 1st floor and high skirting boards were observed, together with blockings in the rear of the building in proximity to the present cellar fire escape.

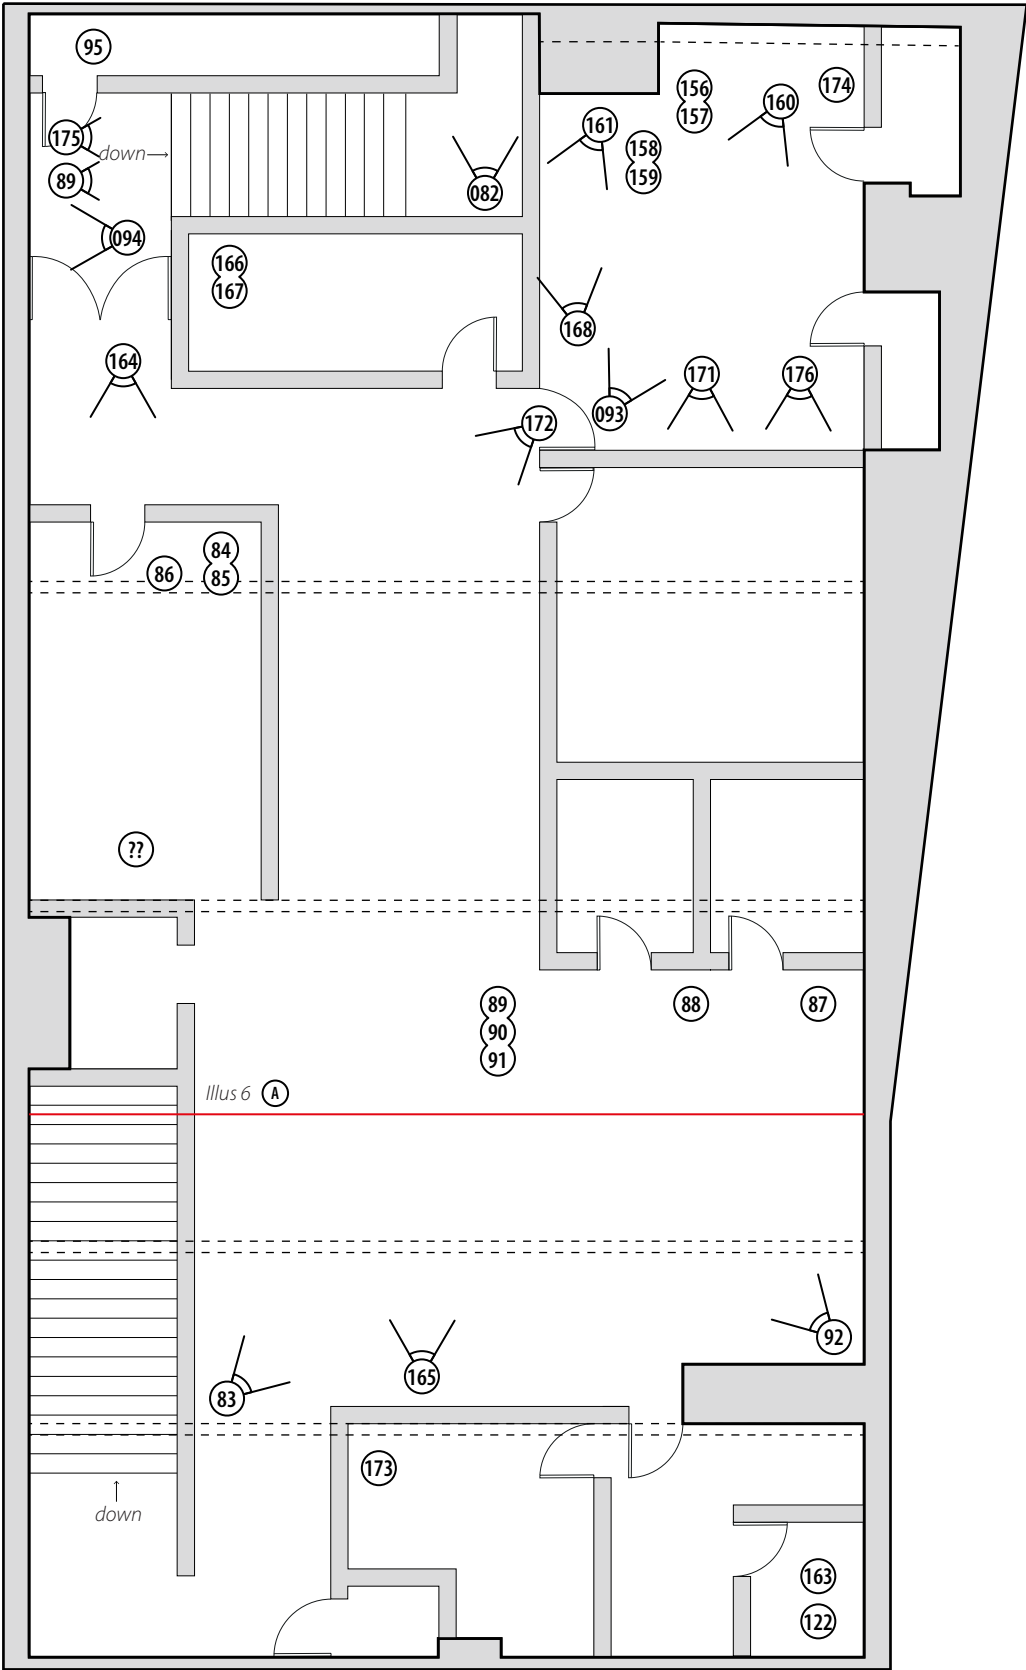
ILLUS 5 Second floor plan of Music Hall building

Above the removed suspended ceiling, elements of a former ceiling survived. This appeared to be a barrel-vaulted plaster ceiling with a painted finish and some surviving former decorative elements possibly surrounding former light fittings (Photos 165, 168 and 170). The plaster ceiling consisted of a series of small, joined panels and appeared to be fixed to the roofing timbers with metal ties and had been broken away or punched through on most of its length to attach the modern suspended ceiling, ductwork and electrical fittings.
