RADWELL GRANGE BARN, BALDOCK, HERTFORDSHIRE

*Historic Building Recording
Strip, Map & Record
Watching Brief*

commissioned by Northerns of Radwell

January 2014

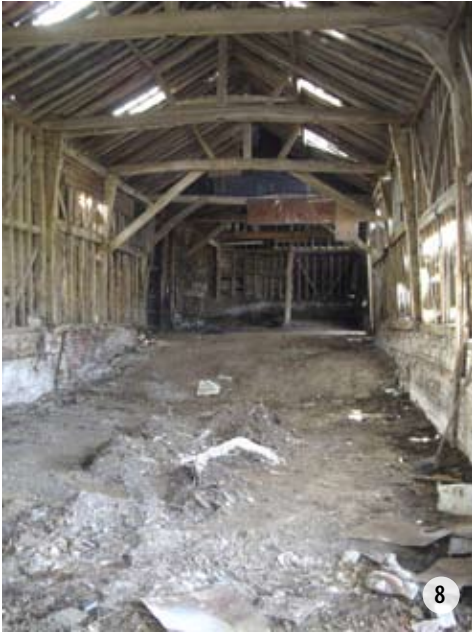
Illus 8
View from barn B2 through to B1

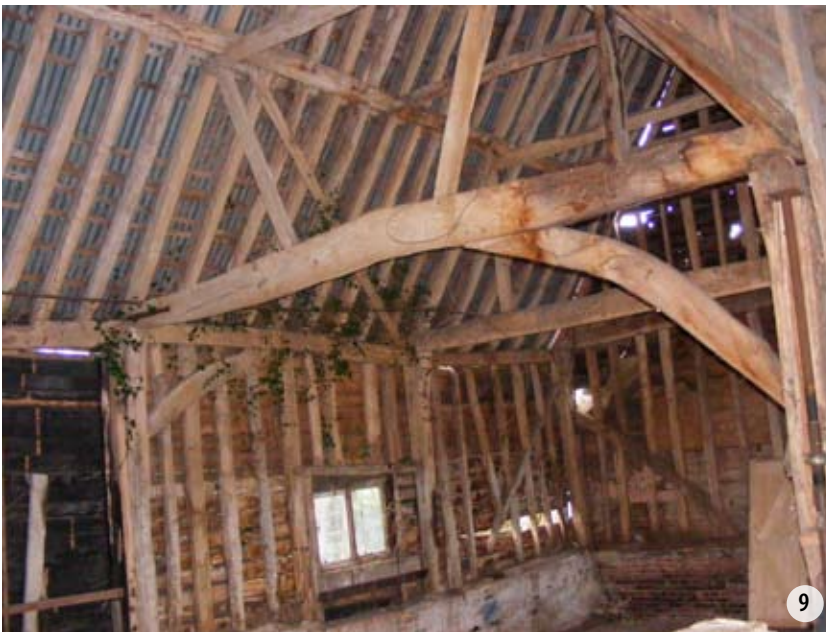
Illus 9
Framing next to truss in Barn B

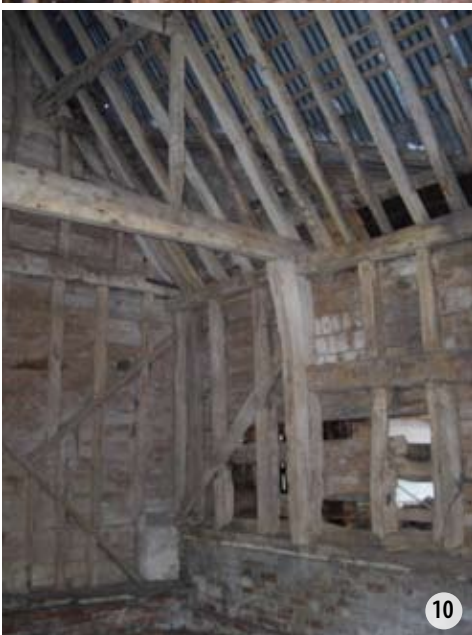
Illus 10
Barn C showing queen-post, clasped purlin truss

A three and a half bay space with both queen post and twin braced trusses. The southeast end frame is simply studded both above and below the tie beam and makes up half a bay, so is not where a truss would originally have been expected. The next truss to its northwest is constructed in a similar way to the trusses in Barn B3, vertical queen posts and jowels with two redundant mortices. Truss 3 appears to be a replacement. It is different in that it has a slightly arched tie beam and rusticated angle brace at its southwest end. The tie beam is now attached at the other end by an iron strap. A similar rusticated angle brace appears in the frame to the south of the barn door at this location implying that the frame was repaired at the same time. Redundant mortices and an attached jowl on the upright here suggest that the lower part of a queen post truss such as the one mentioned above still survives, and that this truss was originally like the one to its southeast and the one mentioned in Barn B3. Between this and the next truss the wall plate has been sawn through to allow Barn D to be attached. This leaves a truss occupying a rather incongruous space halfway across the access from Barn C into Barn D. This truss again appears to use the lower uprights of the original queen post truss but with a twin braced truss above it. The braces below the tie beam are slightly less rusticated and both survive in this case.

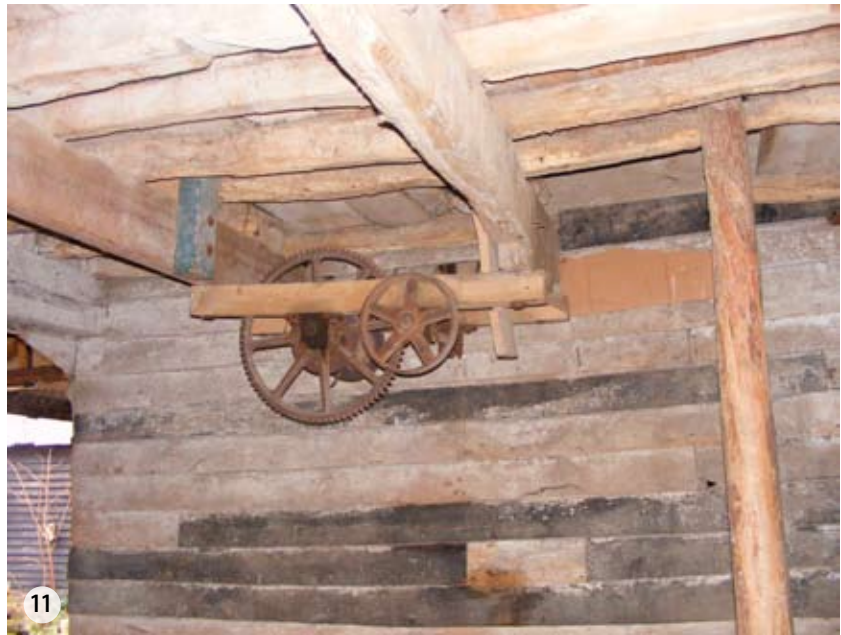
Illus 11

Drive mechanism in barn E

A ground floor later subdivision of the end bay of Barn D with remnants of a belt drive and cog operated mechanism tacked on to the base of two principle joists (Illus 7). An entrance in the northwest side of the barn lines up with the belt drive and could imply that it was intended to be driven by a traction engine parked outside the building on this side. It may be that what is now the open sided car port was previously intended for the purpose of storing the engine when it was not in use. A wood-lined chute enters the ground floor in the opposite corner of the barn to the mounted machinery and adjacent to the door into this part of the building (Illus 8). The ground floor walls are stud partitions with angle braces and horizontal planking. The southeast partition does not line up with the truss implying that it is a later insertion – possibly contemporary with the addition of the machinery into the barn (which appears to be secondary).

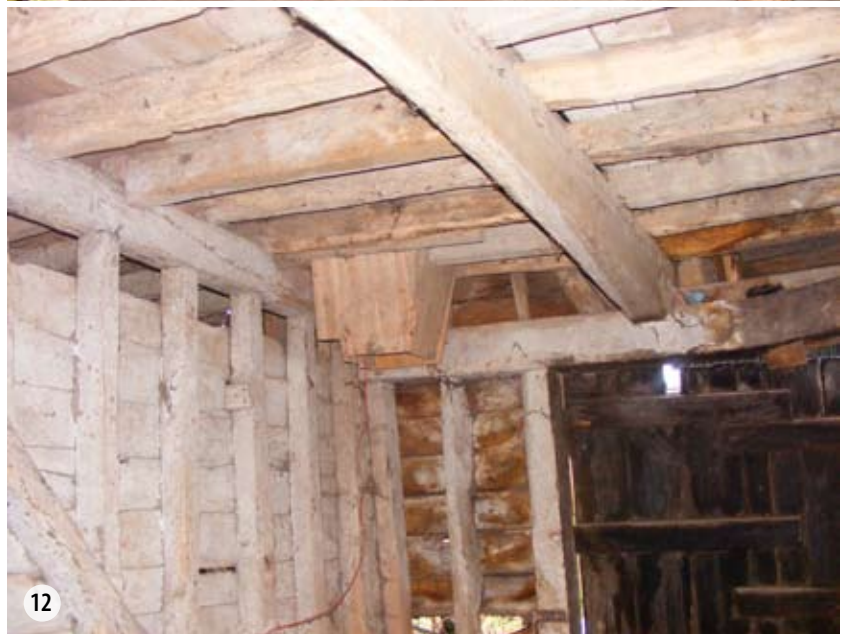
Illus 12

Wooden chute in barn E

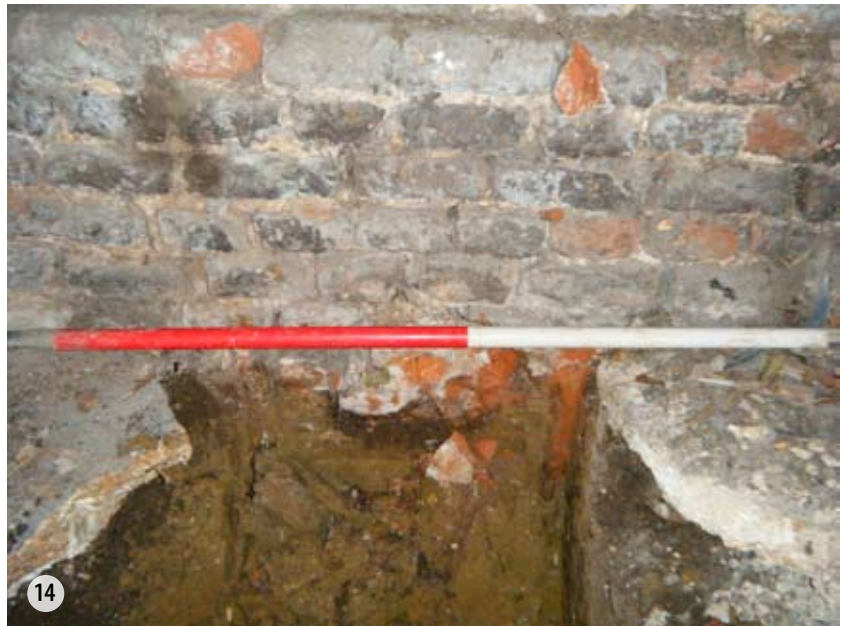
Illus 14

Test pit 17, NE facing section of barn wall overlying natural clay (004)

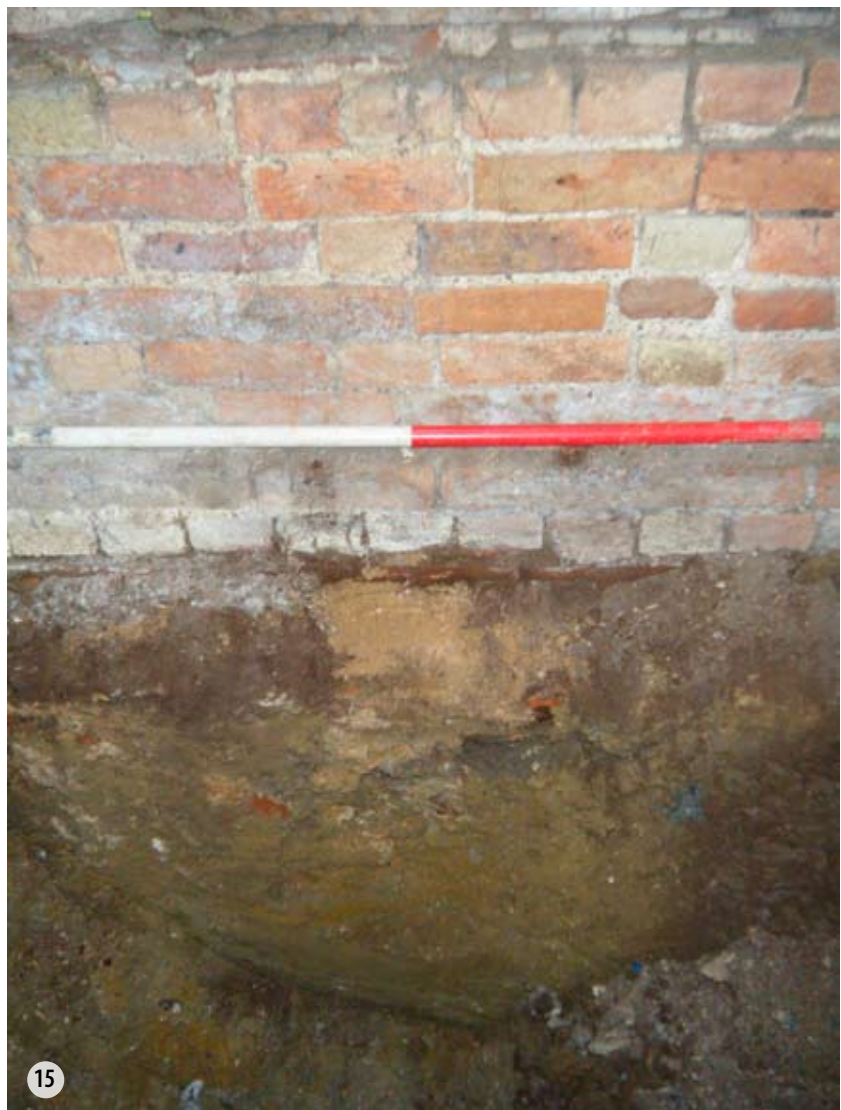
Illus 15

Test pit 10, SE facing section of barn wall overlying natural clay (004)
