Imperial Road Gasworks, Fulham, London

Archaeological Watching Brief

Prepared on behalf of Atkins Ltd.

Site Code: IRFL15

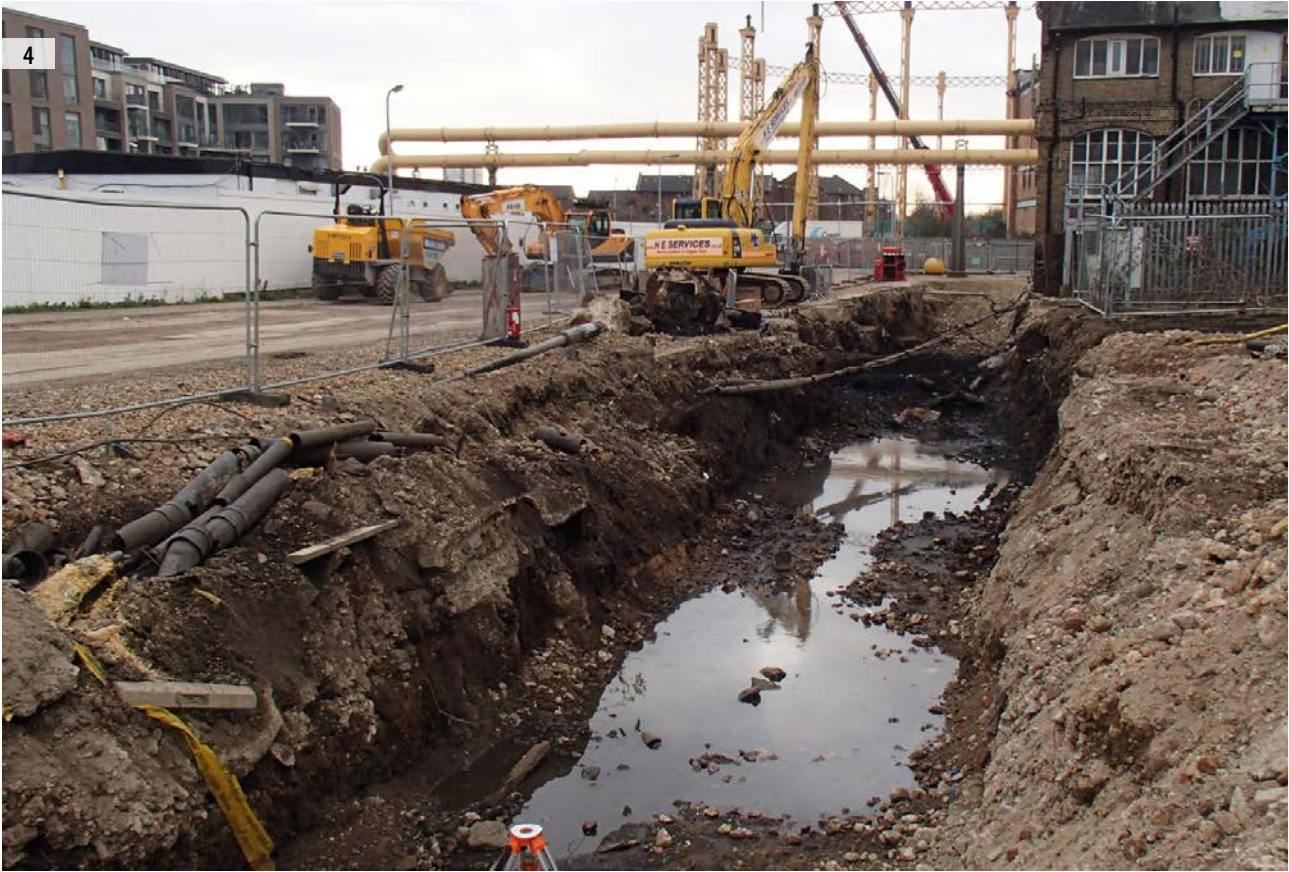
Area 1 was located within the piling intake of the first leg of the gas main corridor and the construction of a pressure reduction station (PRS) (Illus 4). Excavations here exposed various levels of rubble surrounding concrete remains of storage tanks. The deposits typically consisted of mid grey or reddish brown silty sand and contained small to large fragments of concrete, frequent fragments of red and yellow bricks, stones and oily contaminants (Illus 5). Concrete or tarmac car parks, generally between 0.15m and 0.35m deep, overlaid a made ground layer of clay which covered the contaminated remains of the late 19th/ early 20th-century gas works set at an average depth of 2.5m deep. Beneath this, where exposed, the natural substrate appeared as a dark to light greyish yellow clay mottled brown. This part of the site was not accessible due to health and safety concerns.

ILLUS 4 Area 1, facing north-east **ILLUS 5** Section of Test Pit 603, facing west

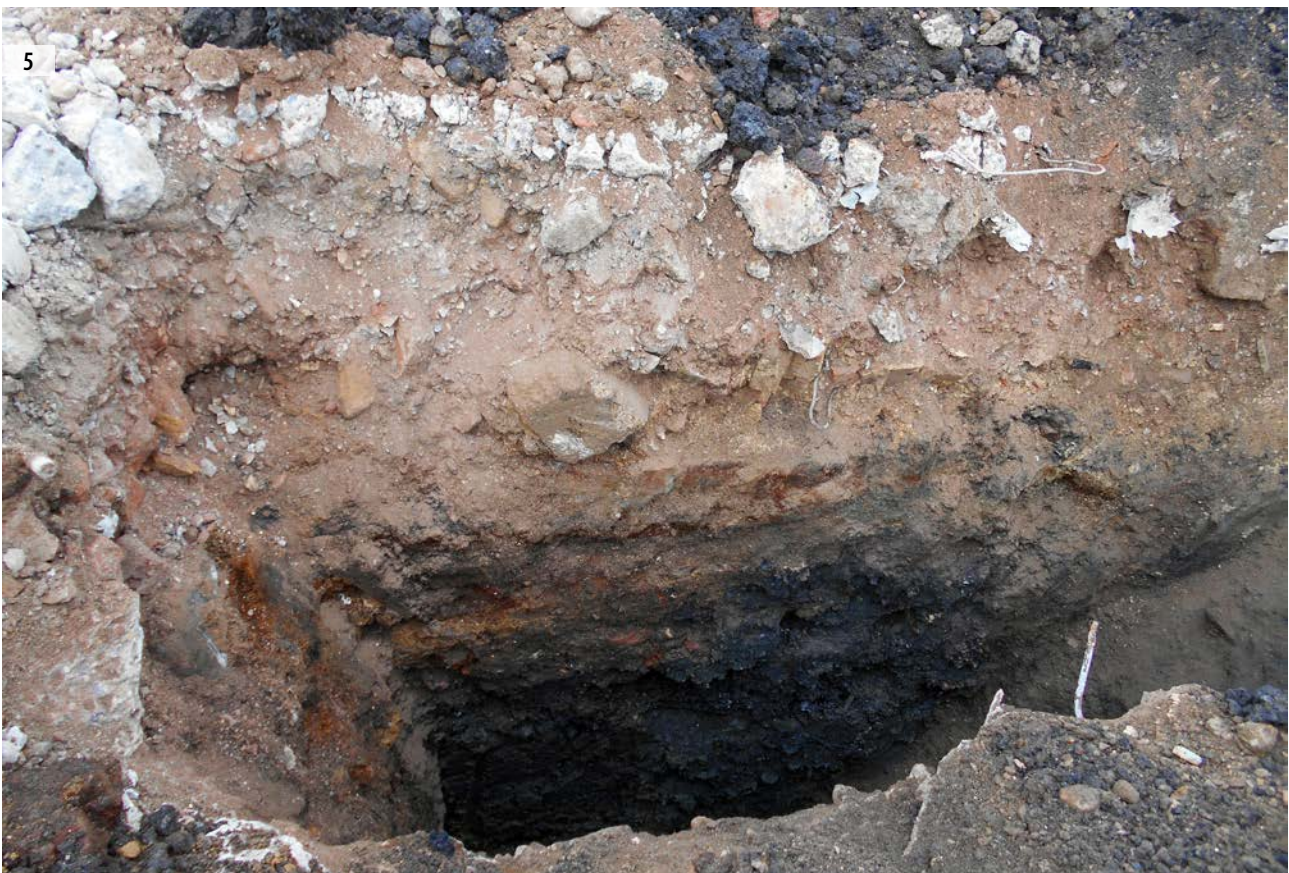
Test Pit 603		Orientation: E-W	
L (m)	W (m)	Min. D (m)	Max. D (m)
3.1	1.1	1.6	3.7
Context	Description	*D BGL (m)	
6030	Concrete slab yard surfacing	0-0.2	
6031	Rubble layer containing red brick fragments and frequent stones	0.2-0.3	
6032	Layer of reddish brown cindery modern industrial waste	0.3-1.6	
6033	Very dark grey silt and containing fragments of timber, concrete, and oily contaminants	3.1	
Summary			
Test Pit 603 excavated through demolition material. No archaeological remains were present

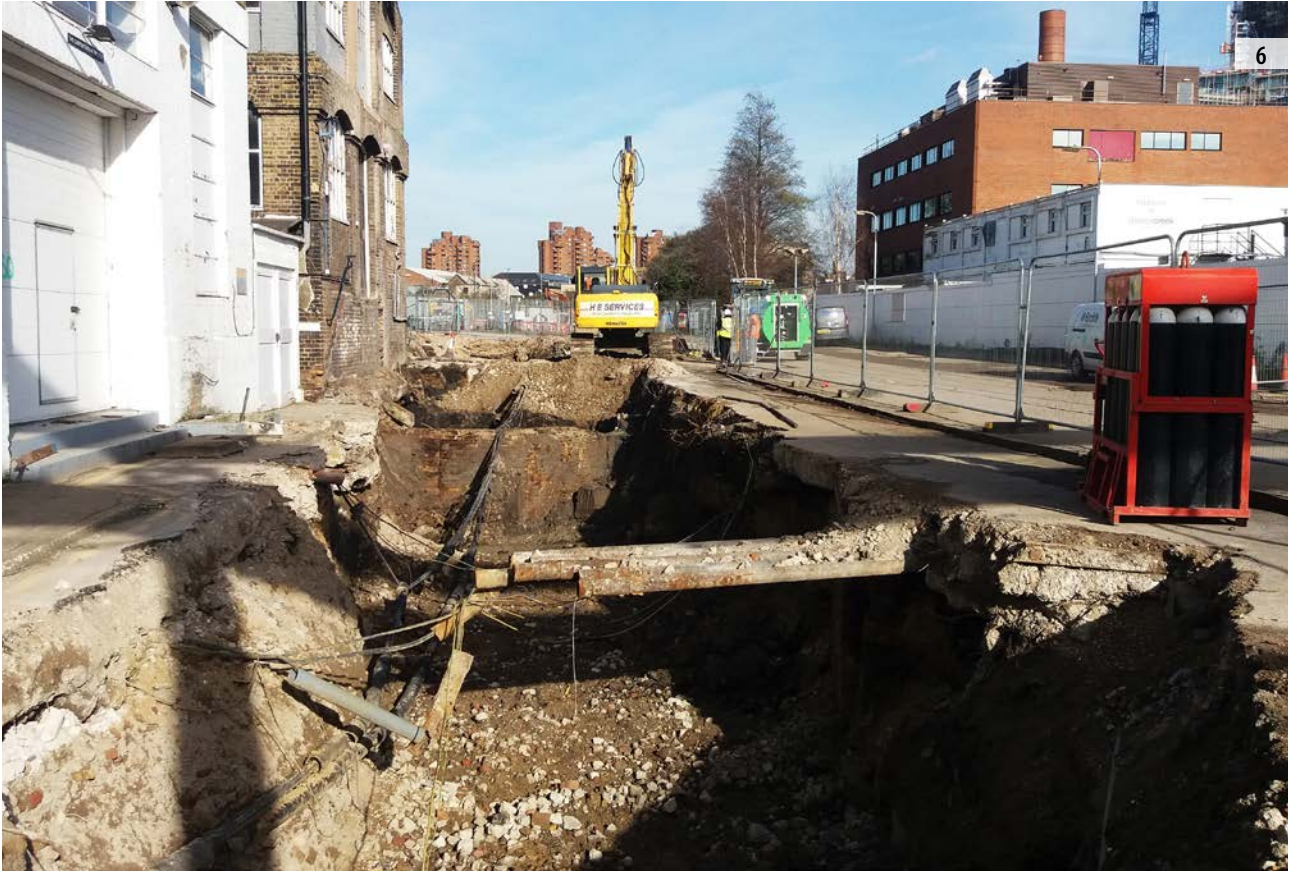
Area 2 consisted of the main section of pipe corridor (Illus 6). For the most part, excavations again exposed several layers of modern made ground. The deposits typically consisted of mid grey or reddish brown silty sand and contained small to large fragments of concrete, frequent fragments of red and yellow bricks, stones and oily contaminants.

ILLUS 6 Area 2, facing west **ILLUS 7** Remnants of rail way in Test Pit 606, facing north-east

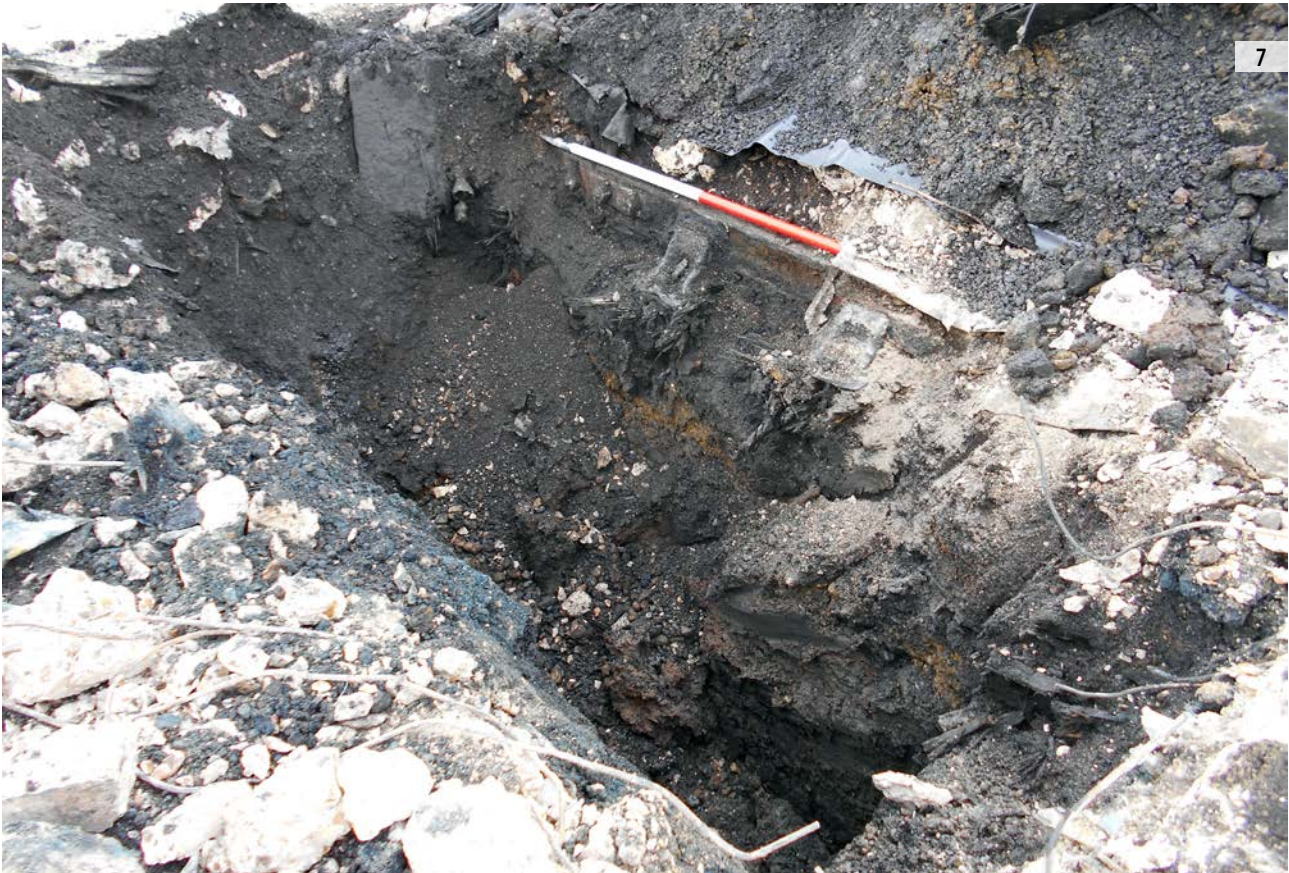
Test Pit 606 contained the remains of a disused railway, consisting of a sleeper and a rail exposed in the baulk (Illus 7). This was part of the off-shoot of the main rail line shown on the 1894 and 1919 OS maps (see Illus 3 and appendix III).

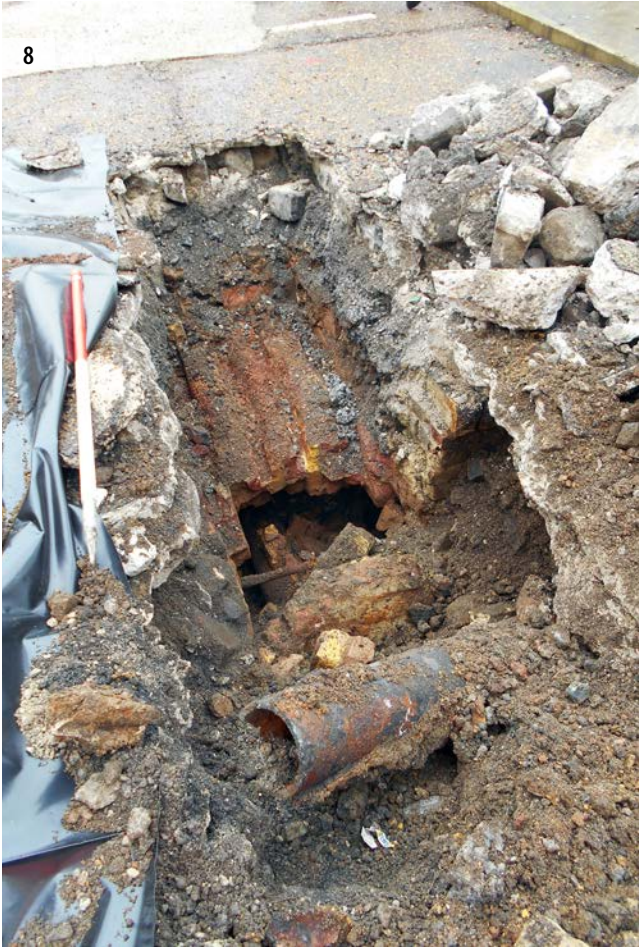
Test Pits 612 and 614 exposed a culvert (Illus 8), possibly linking to Chelsea Creek but since dried up (Illus 3). This culvert consisted of a ceramic pipe approximately 1m in diameter, approximately 0.4m below the existing ground level.

ILLUS 8 Culvert remains in Test Pit 612, facing west **ILLUS 9** Tanks in Area 2, facing south

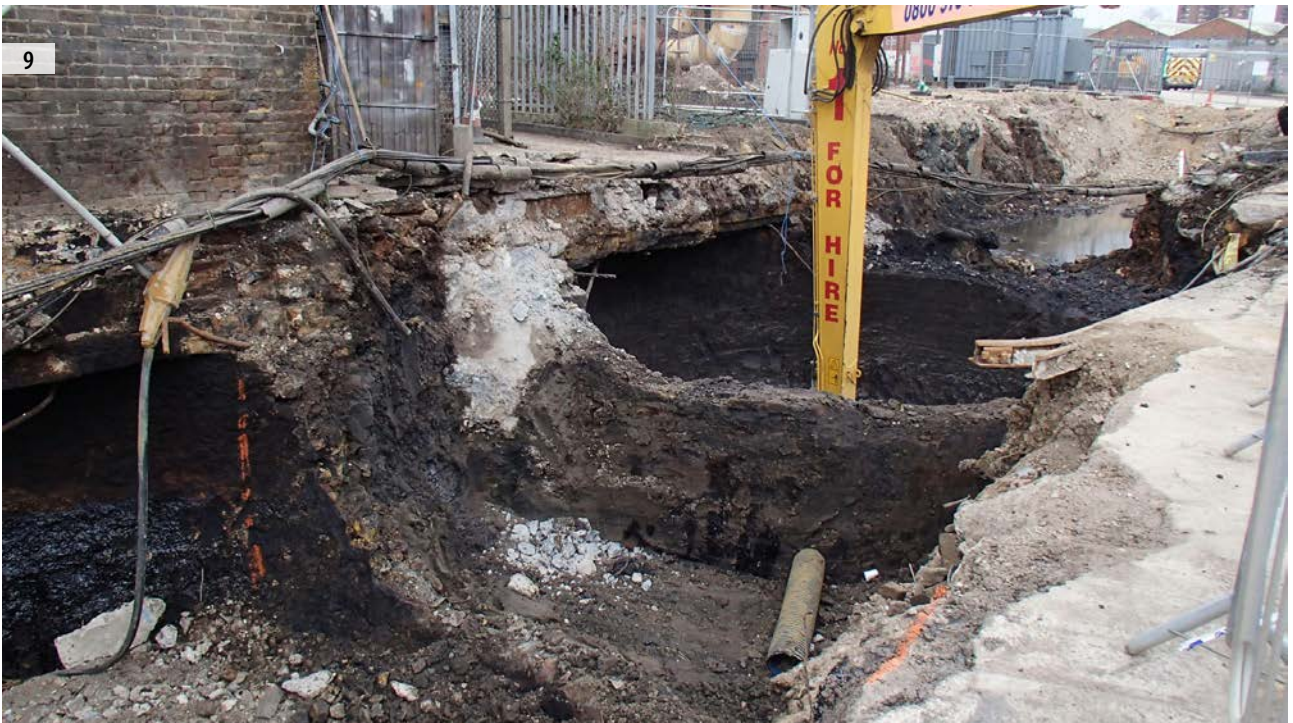
During the monitoring of excavations for the pipeline corridor, the remains of 2 brick lined circular subterranean tanks related to one of the various phases of development of the Imperial Gasworks were discovered (Illus 9). The tanks were both approximately 6m diameter and 6m deep and were 2m apart. These may be those that appear on the 1919 OS map as free-standing tanks apart from the contemporary buildings, but they do not align perfectly with our survey (Illus 3). Access was extremely limited for safety reasons as they were filled with highly contaminated rubble (Illus 10).

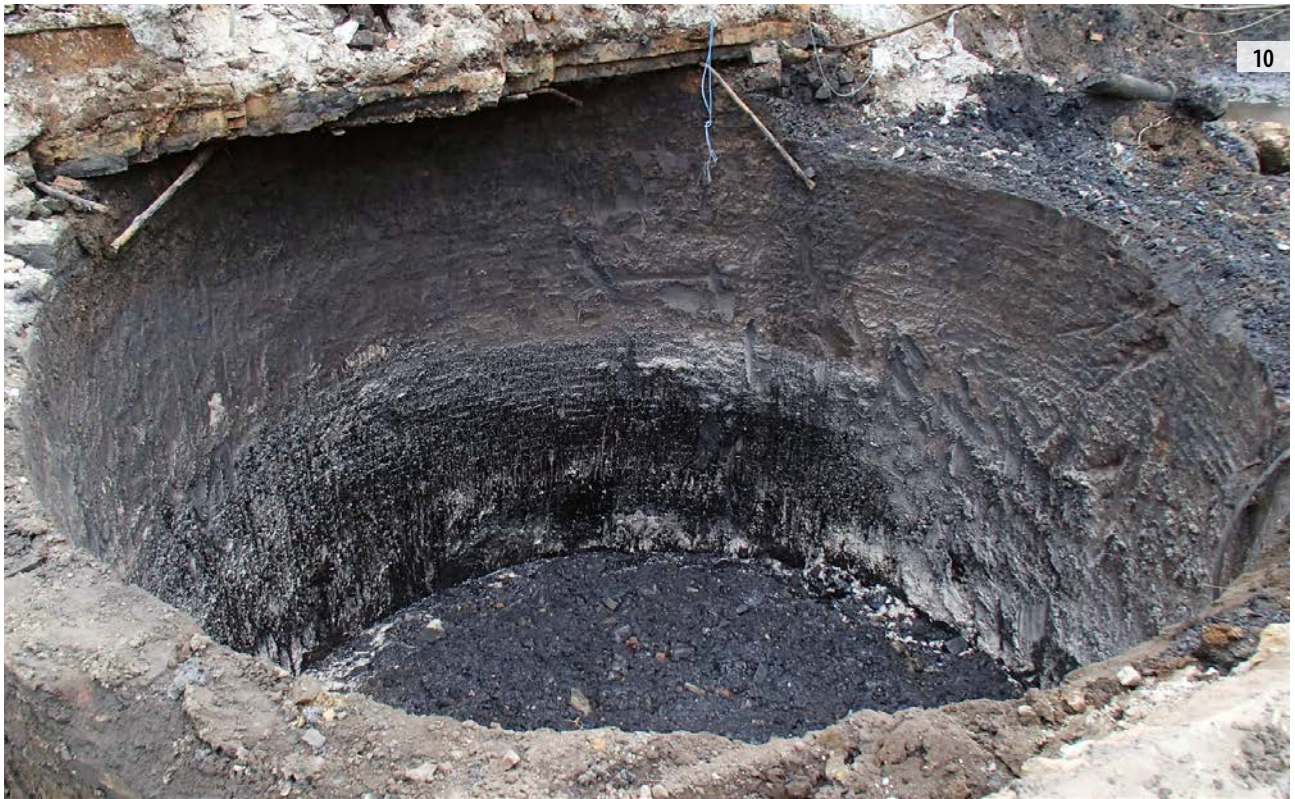
ILLUS 10 Tank filled by contaminated rubble, facing south-east **ILLUS 11** Pipe trench through Area 3, facing north-west

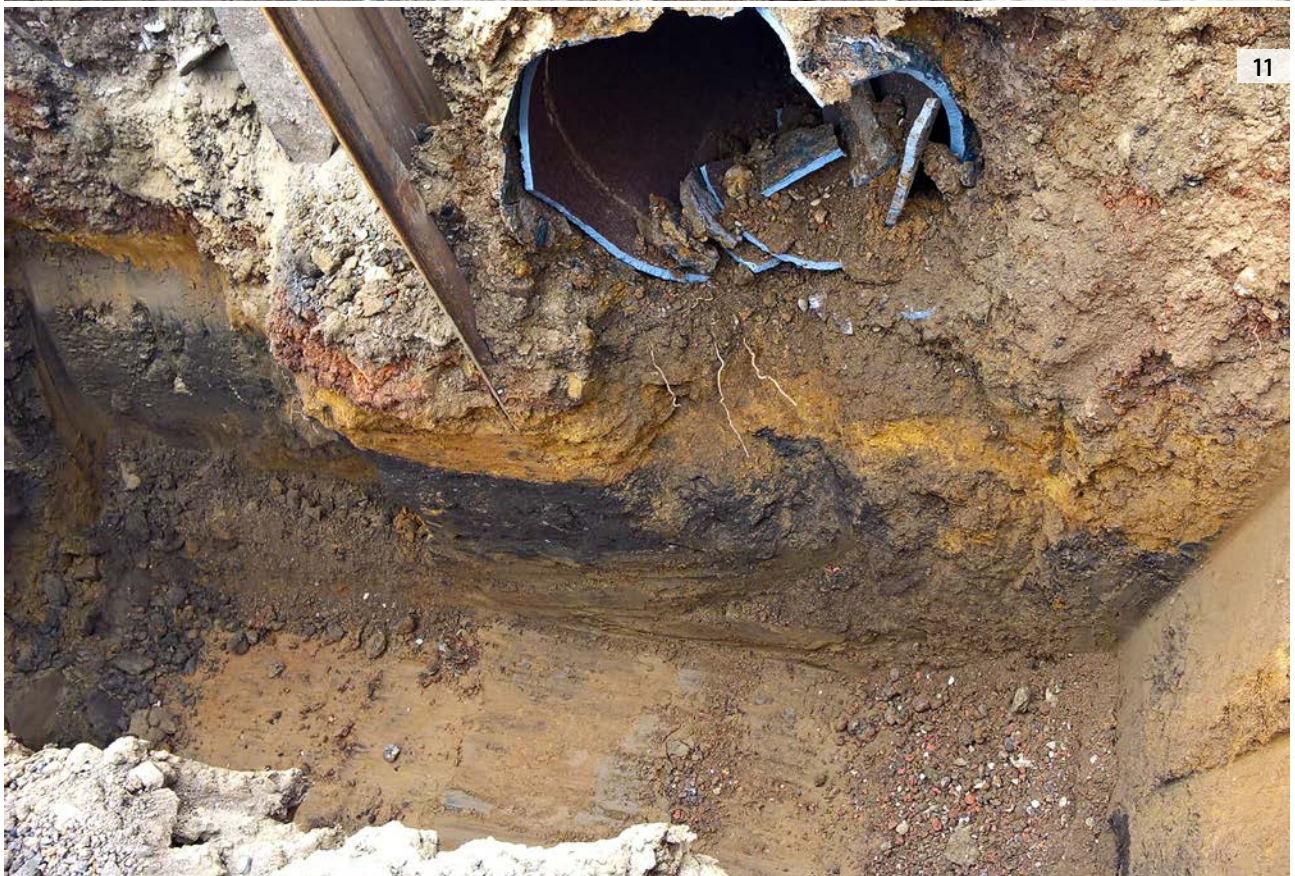
Area 3 consisted of the pipeline corridor between Imperial road and Area 2. Excavations exposed a series of made up ground deposits and geological deposits beneath (Illus 11). Made-up ground deposits again consisted of mixed gravelly sand with concrete and brick fragments frequent throughout. Geological deposits were encountered between 1.8m and 3m below the current ground level. It typically consisted of light brownish yellow sandy clay, in some areas a dark blueish brown clay probably alluvial layer was exposed beneath this with another layer of light brown clay beneath that (Illus 12). This probably relates to intermittent flooding or marshy conditions during the formation of the natural deposits.

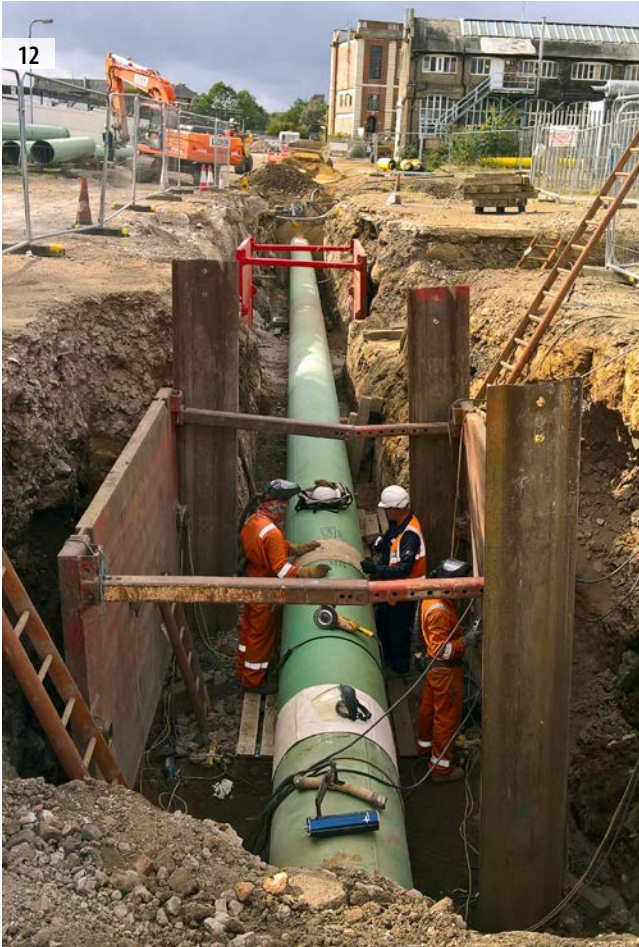
ILLUS 12 Section of pipe trench through Area 3, facing south-west **ILLUS 13** Section of ground reduction in Area 4, facing north-east

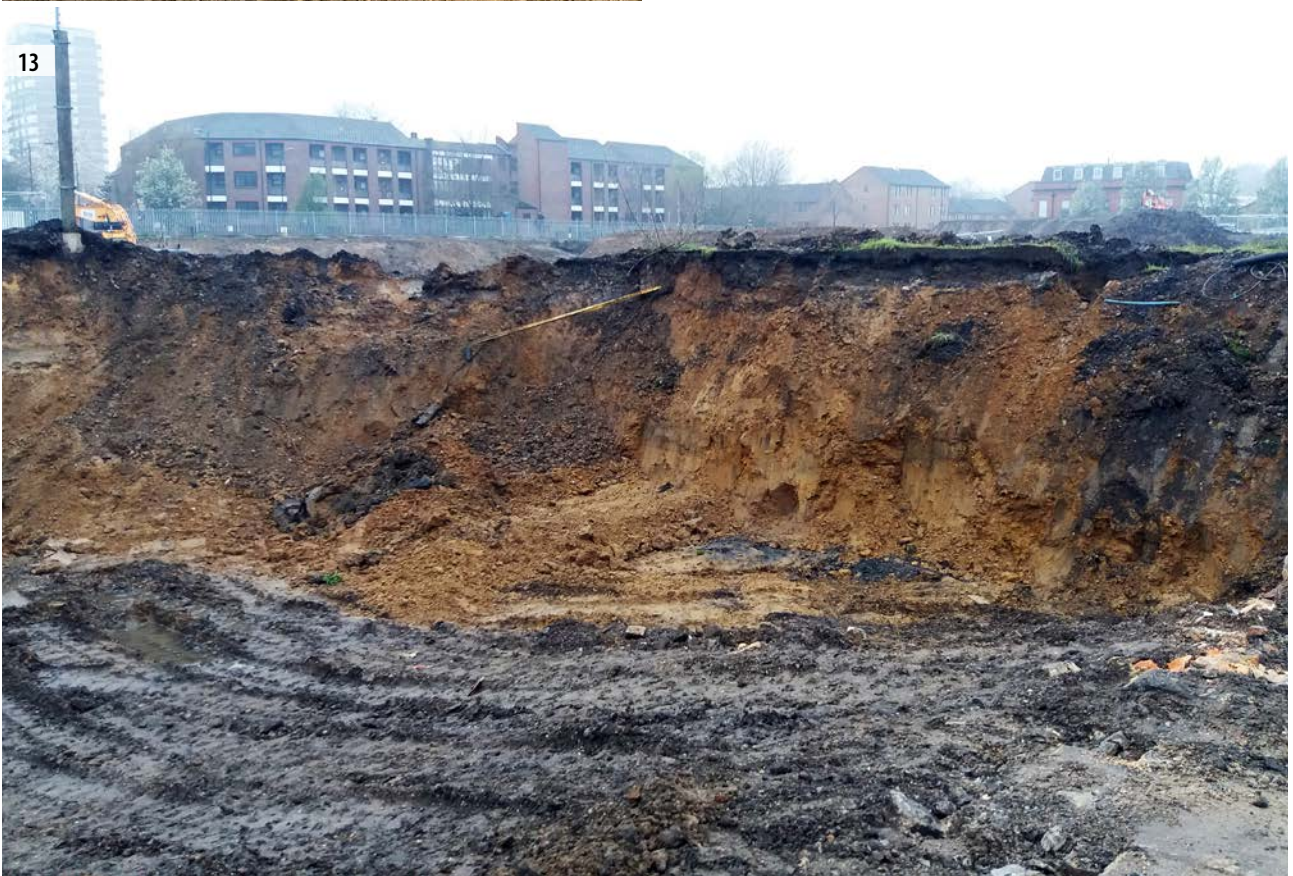
Removal of gas holders 1 and 2 (see Illus 2) and reduction in surrounding ground level to the base of these was undertaken prior to our arrival. A series of made-up ground deposits overlying geological deposits were visible and no archaeological horizon or features were present (Illus 13). The foundation of Gasholder 2 was exposed along its southwestern edge (Illus 14). This consisted of a steel circular substructure extending approximately 5.5-6m below the existing ground level.

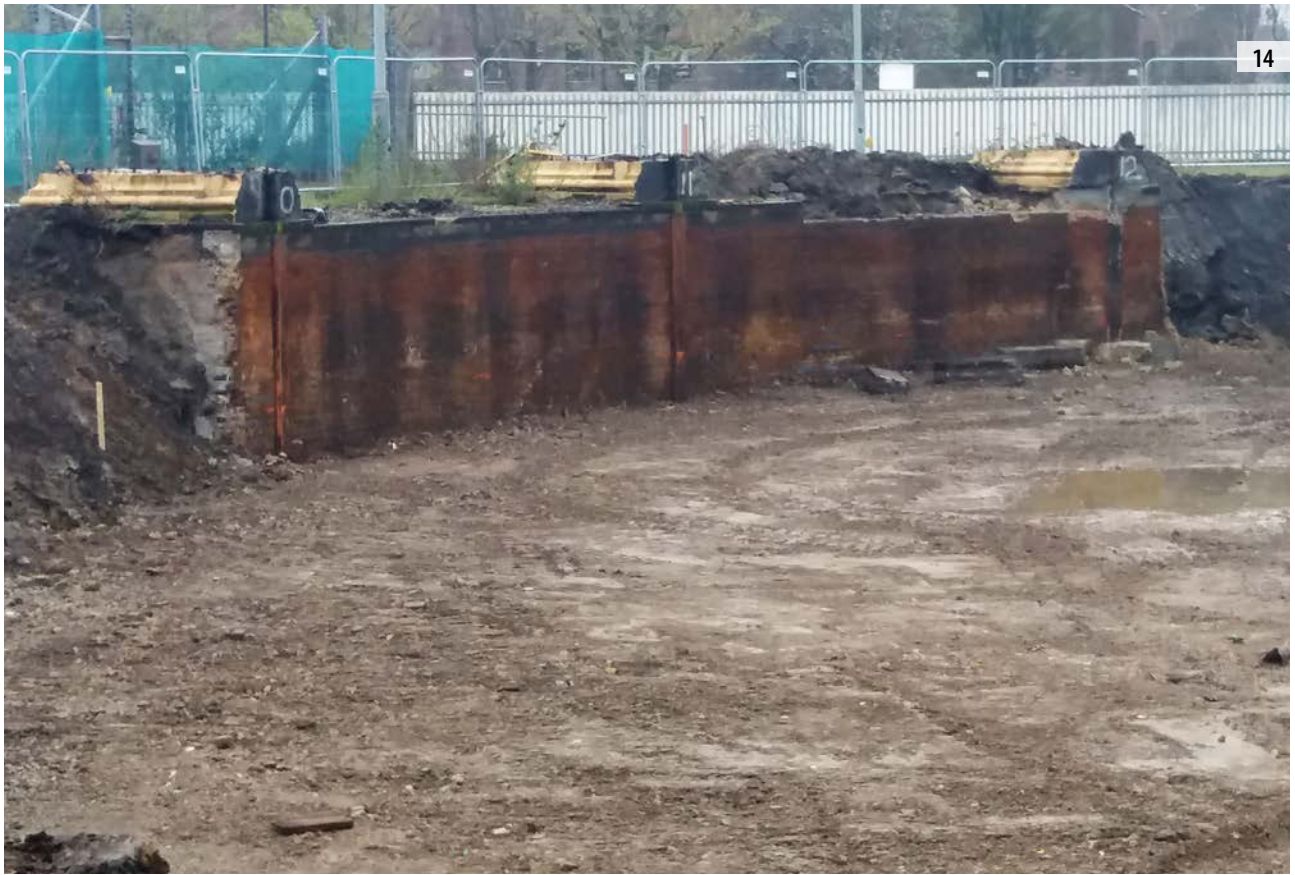
ILLUS 14 Area 4 overview, facing north-east
