**Historic building recording and watching brief at 9-13 Baldock Street, Royston, Hertfordshire**

**Client: Buzz Estates Ltd**

### Historic Building Recording and Watching Brief

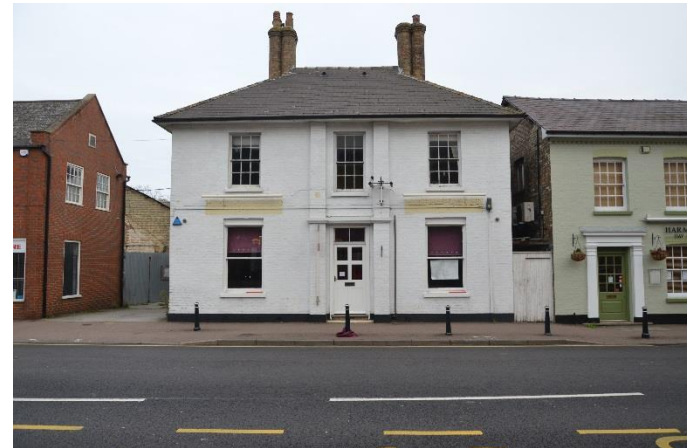
The building is constructed from brick (0.21m x 0.10m x 0.07m), possibly London stock brick, laid in a Flemish bond with a marking course of headers every nine layers, the external faces are painted at ground floor level and rendered at first floor level. The alignment of the building respects the street frontage to the south and follows the boundary of the adjoining property to the east, resulting in the northeast corner of the building being angle to reflect the boundary line.

The ground floor wall and main façade are constructed of double-skinned brickwork, whereas the upper floor walls are a single brick width.

ILLUS 7: South facing elevation of Building A

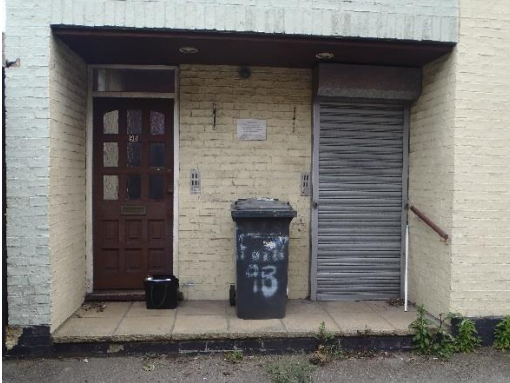
The ground floor of the building has been converted to commercial use (most recently it has been in use as a hair salon) with a first floor flat above. There is a basement and an attic. The building is accessed by a front door onto Baldock Street and two doors set within a large recessed opening in the west facing elevation. (ILLUS 8).

*ILLUS 8: Later inserted doorways set in recessed opening*

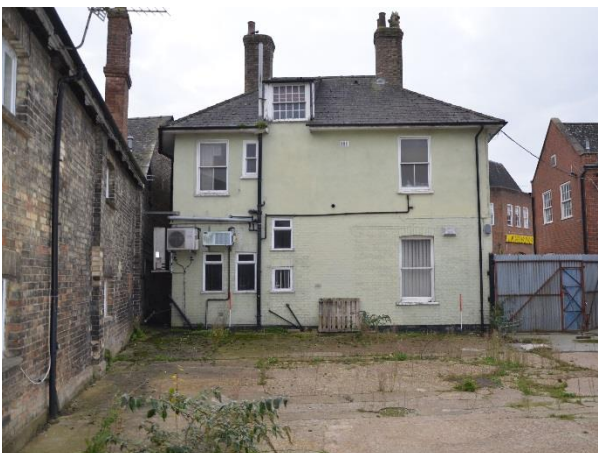
Within the north facing elevation a series of modern windows have been inserted in to the lower elevation possibly associated commercial occupation of the ground floor (ILLUS 9).

Centrally placed within the ground floor elevation and area of repainted brickwork may indicate the location of a previous window opening or doorway.

*ILLUS 9: North facing elevation showing the mixture of modern and original window openings with possible blocked doorway*

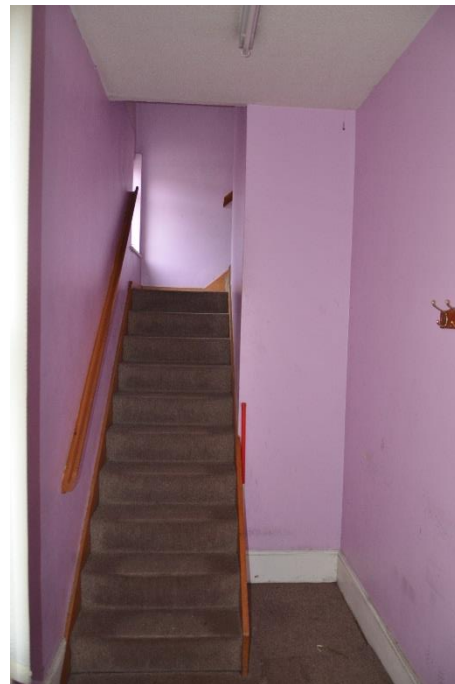
The staircase turns through 90 degrees towards the front of the building and there is a modern inserted timber framed casement window on the small landing (ILLUS 10). The stairs terminate in an open lobby which provides access to all the upstairs rooms. Simple moulded architrave and skirting board is present throughout the first floor, in keeping with the early to mid-19th century date for the building.

*ILLUS 10: Inserted modern staircase to first floor flat*

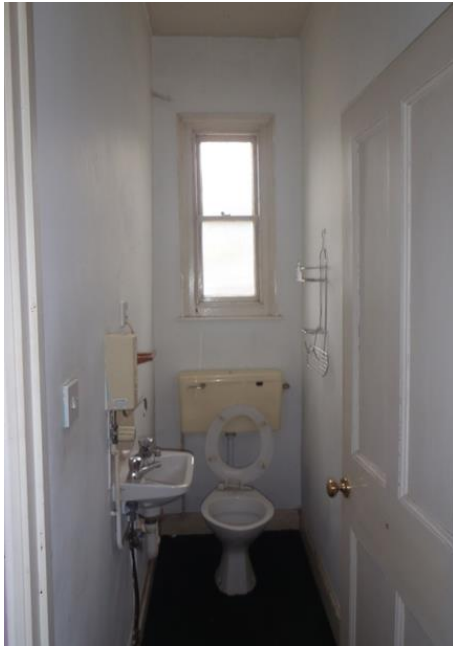
Immediately adjacent to the top of the stairs (in the rear right of the central bay of the building) is a small room containing a WC. There is a small, narrow sash window with textured glass and a scrolled catch to the rear elevation and the door is of four panels (ILLUS 11). There are no other features of architectural interest in this room.

*ILLUS 11: Toilet area and original window opening*

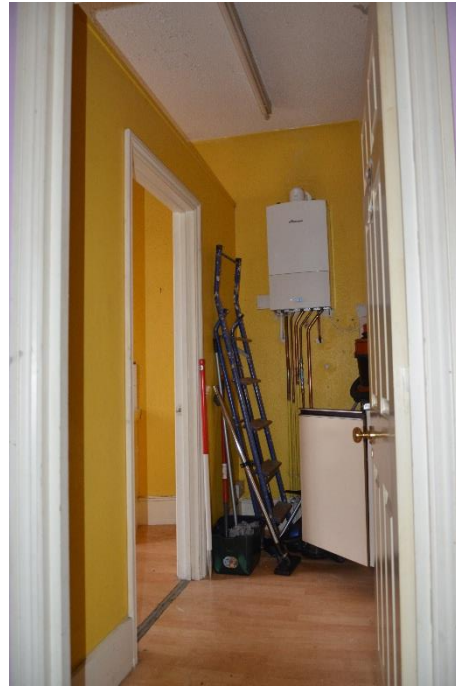
The rear right of the upper floor is divided into two, accessed through a six panelled door (probably a modern replacement) in a simple architrave frame. The front portion contains floor mounted units and a sink as well as a boiler. A modern inserted partition wall (which does not extend the full height of the room) divides the front from the rear part which is used as a bathroom. A modern six panel door leads through this partition wall. A large sash window with textured glass almost fills the rear elevation (ILLUS 12).

*ILLUS 12: Inserted modern wall dividing the original room layout*

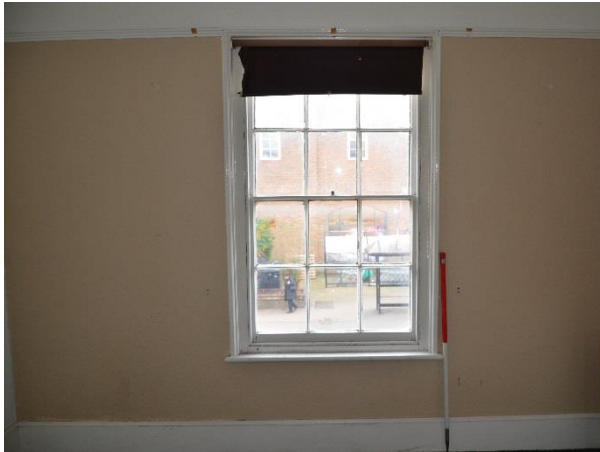
The front room is currently used as a bedroom. A modern six panel door has been inserted into the original frame, a picture rail runs around the room and the front elevation contains a sash window of 12 panes (ILLUS 13). The rear wall of this room contains a blocked fireplace in a wide chimney breast, and a cupboard in the right hand alcove which has an original Victorian four panelled door secured with a brass catch and containing original clothes hooks and an inserted hanging rail.

*ILLUS 13: Original 12 pane sash window and skirting*

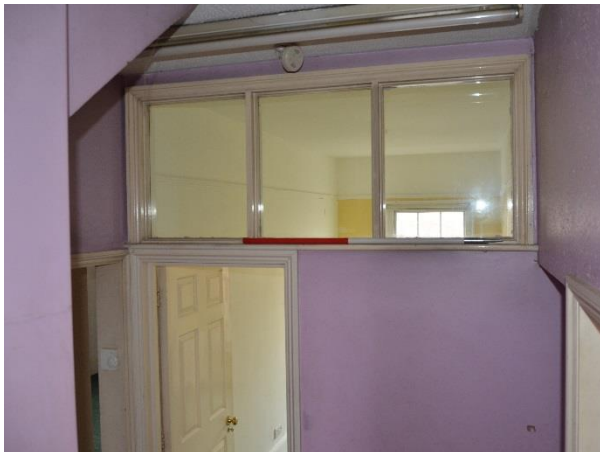
A narrow room in the centre front bay has a sash window to the front elevation (again with thin timber glazing bars) and a picture rail. The upper portion of the north wall of this room is glazed in three panes to provide additional illumination to the landing (F1) (ILLUS 14).

*ILLUS 14: Additional window to provide illumination to the lobby area*

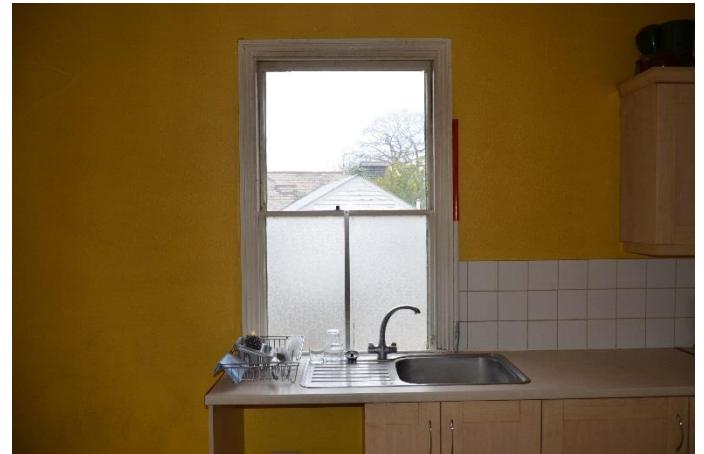
The rear room of the upper floor currently functions as a kitchen. There is a large sash window with etched glass in the rear elevation suggesting that the room may have originally functioned as a bathroom (ILLUS 15). A small casement window of two panes over two panes with scrolled catch and timber glazing bars in the left elevation (ILLUS 16). The blocked door in the rear of the cupboard in F6 is apparent in the north facing elevation.

*ILLUS 15: Original window with etched glass*

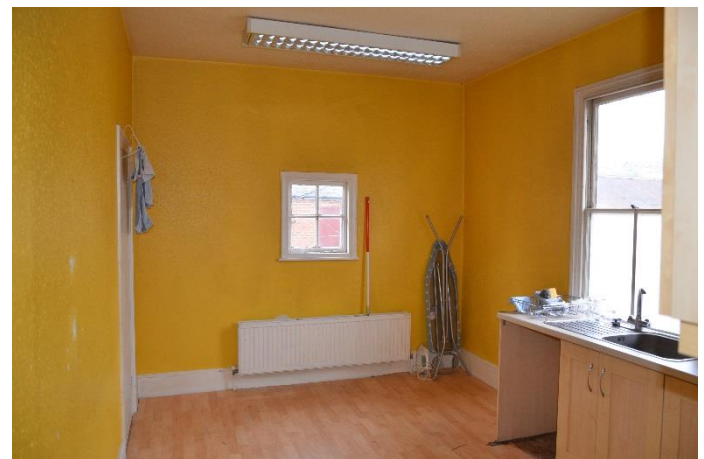
*ILLUS 16: Single side opening casement window set in single skin wall*

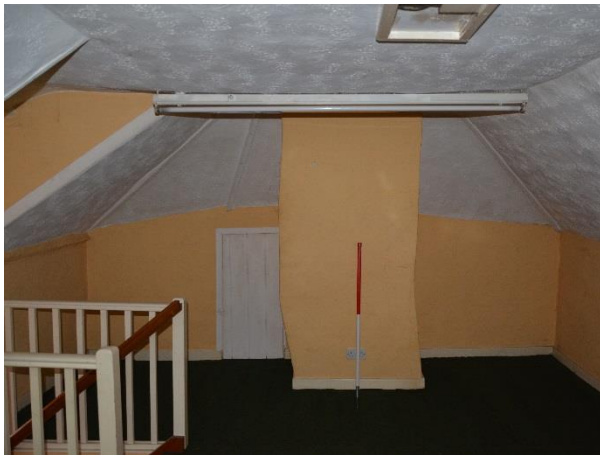
The attic is plastered and painted and contains two chimney breasts (ILLUS 17). There is a small cupboard with a plank and batten door built into the wall of the right elevation providing access to the roof space.

ILLUS 17: Internal arrangement of the Attic room

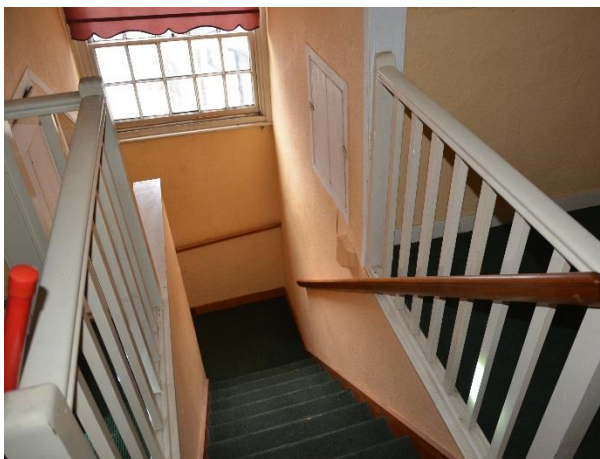
The formation of the attic room is a later addition to the property, the construction of the staircase necessitated in the formation of the flat roofed dormer window in order to provide the additional head room needed for the staircase. The stair case cuts the main ceiling joists, the stubs of which have been left projecting into the stairwell (ILLUS 18).

ILLUS 18: Cut main joist for the insertion of the staircase

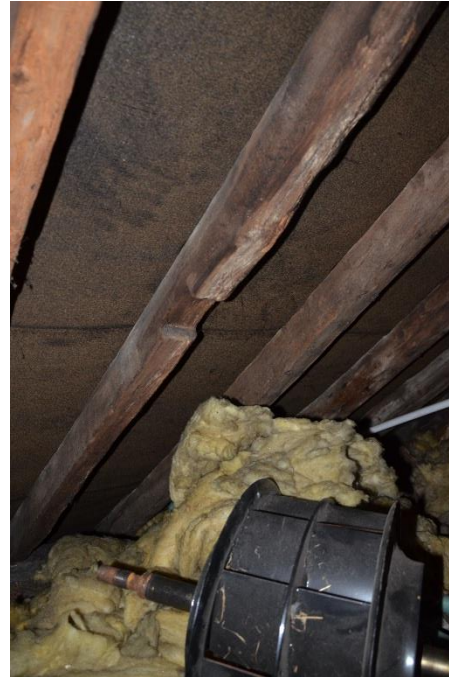
The construction of the roof is concealed by the attic room, however a series of small openings within the eaves provide limited access to the roof fabric. The roof is constructed of machine sawn timbers ( $0.09m \times 0.09m$ ), centred at  $0.32m$ , evidence of the former roof construction prior to the formation of the attic room is indicated through a series of open joints within the common rafters (ILLUS 19).

ILLUS 19: Cut common rafters

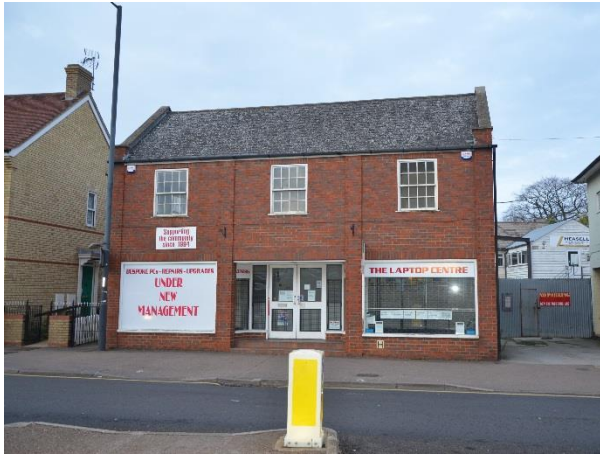
Buildings B and D are constructed of modern red brick built building, laid in a running bond ( $0.21m \times 0.10m \times 0.065m$  x). The building is aligned east west in relation to the street frontage and replaces a single rectangular structure identified in the map regression. It has lately been used as a computer shop.

ILLUS 20: The main façade of Building B

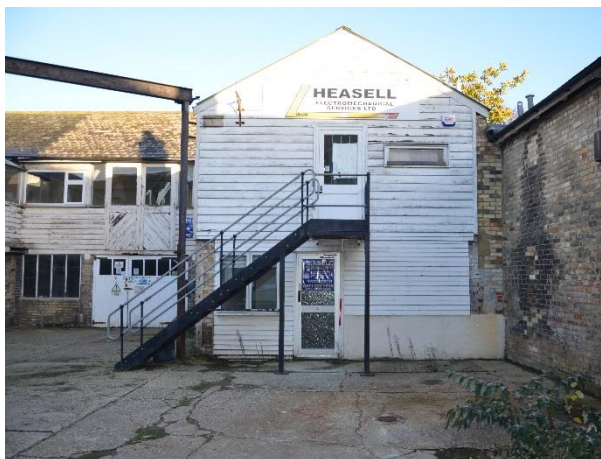
Building C forms a brick built square structure of two storeys with an external galvanised steel staircase providing access to the first floor. Constructed from London stock brick, laid (0.22m x 0.10m x 0.065m) in a Flemish bond with timber weatherboard cladding to the south facing elevation and upper levels (ILLUS 21).

*ILLUS 21: South facing elevation, Building C*

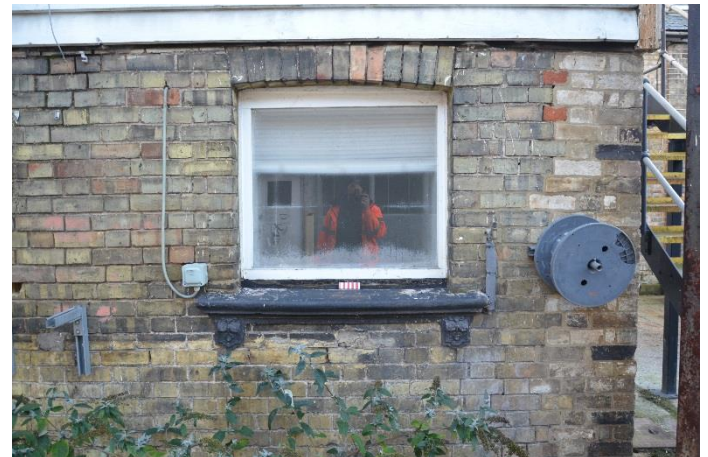
Within the west facing elevation two cast iron windowsills with decorative brackets were positioned at ground floor level. The window furniture had been replaced with modern metal casement window units (ILLUS 22).

*ILLUS 22: Detail showing cast iron window sill and decorative brackets*

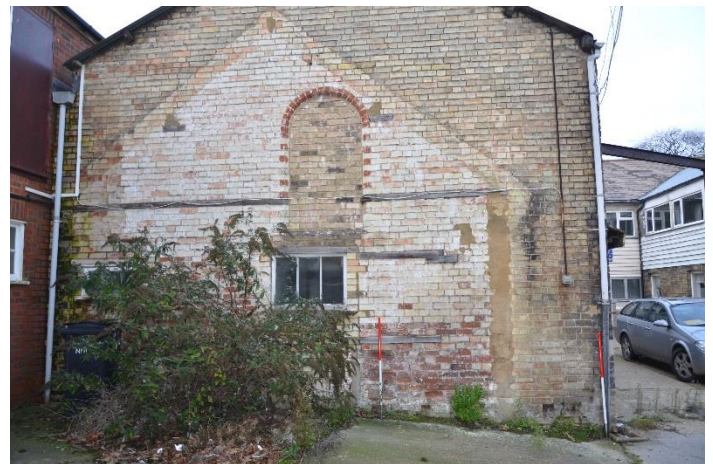
A former roof line is indicated through a painted area and may corresponding with buildings shown on maps between 1897 and 1971.

This gable also contains an inserted window of four vertical panes beneath the blocked arched opening, the lower inserted window is positioned within a former blocked doorway that is obscured, internally by a modern inserted staircase. (ILLUS 23).

*ILLUS 23: Blocked doorway and window opening with building scar*

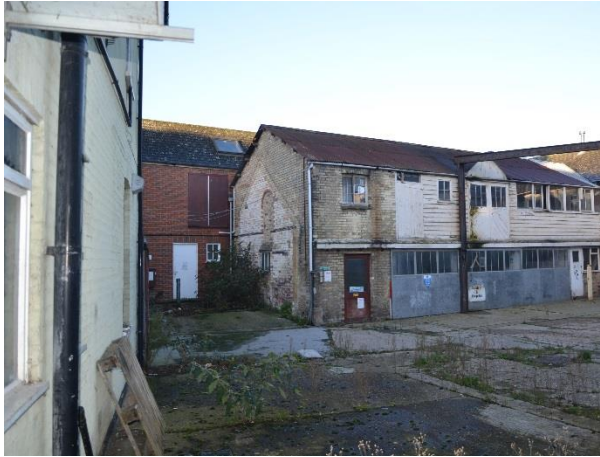
*ILLUS 24: East facing elevation showing loading bay door*

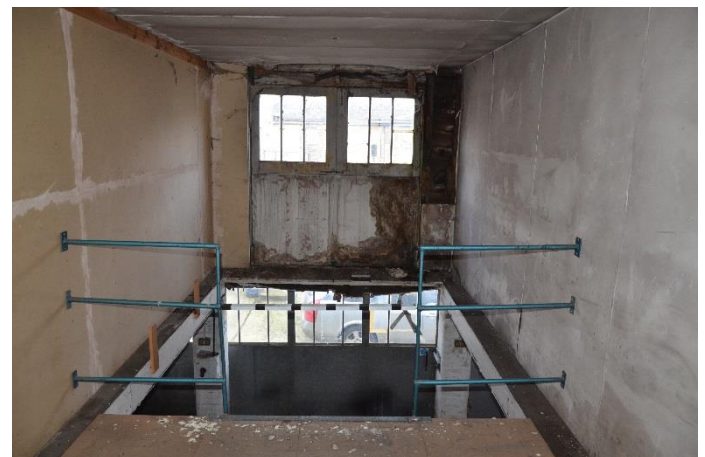
This room has a floor only in the west half, the eastern edge being open to G1-E below and secured with a metal rail (ILLUS 25). A pair of wooden doors, with upper glazed parts formed of three panes in timber glazing bars, occupies most of the east elevation. There is a blocked window within the west elevation. modern doors set in a plywood partition walls lead into rooms F1-E and F3-E.

*ILLUS 25: Removed floor within F2-E*

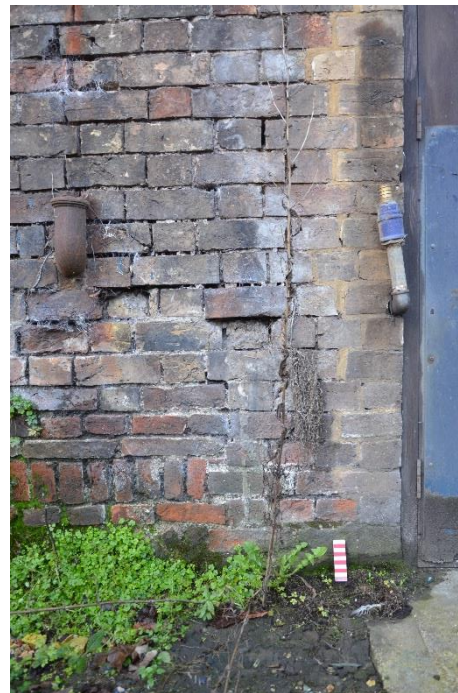
The east facing elevation is constructed of London stock brick (0.22m x 0.11m x 0.07m) laid in a Flemish bond set above a 0.45m high coursed of handmade red brick (0.23m x 0.11m x 0.05m) laid in an ornate pattern. The change in brickwork at the lower level may indicate that the building shares the footing of a previous building (ILLUS 26).

*ILLUS 26: Coursing of handmade bricks and construction break between buildings G and H*

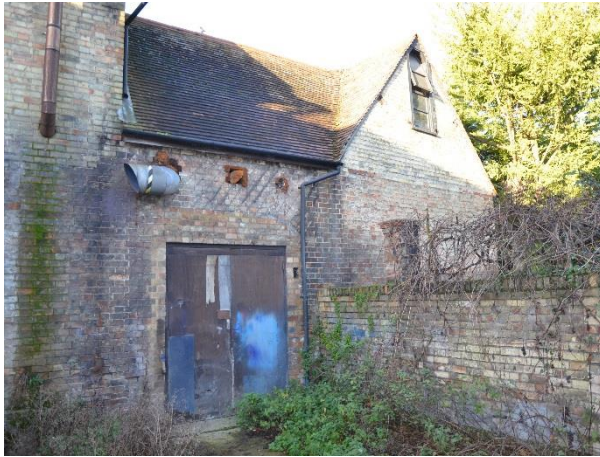
Building H forms an extension to west, north-south range, the building is constructed from London stock brick, laid in a Flemish bond with a creamy yellow mortar, the building roof line forms a "T" shaped range with full height gables containing inserted windows at the apex's (ILLUS 27).

ILLUS 27: East facing elevation of Building H

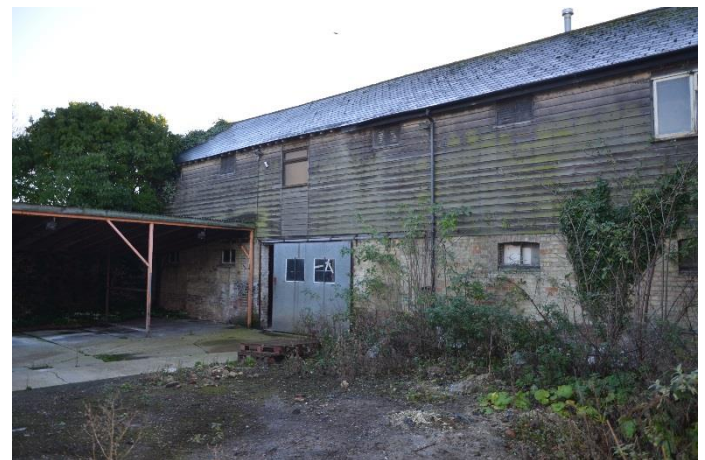
Constructed in a mixture of red brick (0.21m x 0.065m x 0.10m) and London stock brick (0.21m x 0.065m x 0.10m) and laid in a Flemish bond. The first floor level is timber framed with wooden infilled panels and external weatherboard cladding and the building is roofed in modern materials (ILLUS 28).

ILLUS 28: North facing elevation of Building I

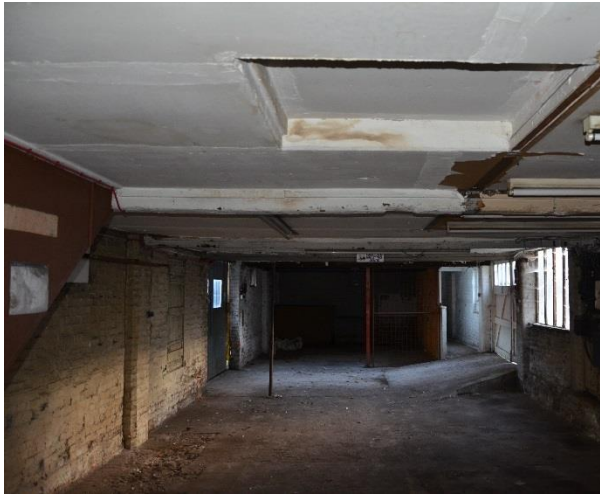
The ground floor room occupies the whole of the northeast-southwest aligned range (apart from the subdivision forming corridor G2-I). It is comprised of six undivided bays (1 to 6, numbered east to west) marked by small chamfered brick buttresses with brick infilled panels, the floor is of modern cast concrete and the walls are painted with various colours indicating changes of use. The ceiling is carried on timber beams two of which are supported by "Acrow" type props. A change in ground level between the main yard and the northern part of the site is overcome by an internal concrete ramp (ILLUS 29).

*ILLUS 29: General view of the ground floor of Building I showing the loading hatch in the ceiling*

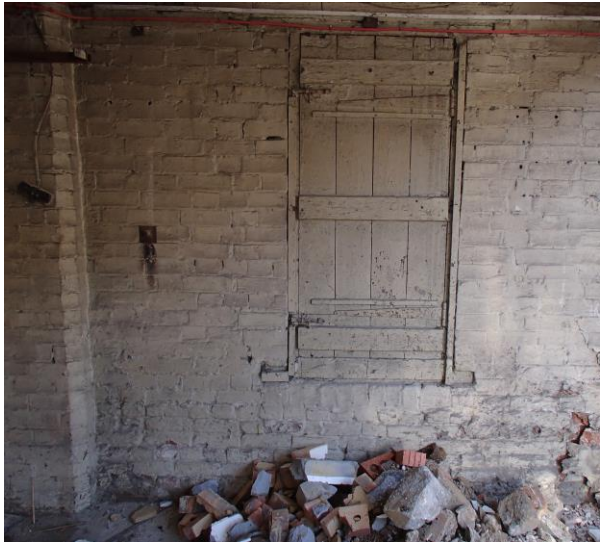
Regular site monitoring was carried out during the course of the demolition works, between 29<sup>th</sup> January and 19<sup>th</sup> February 2016. The demolition was generally carried out by hand, to retain the maximum reusable bricks. 1 feature was discovered which was not previously visible. A door was exposed at the northern end of building E, on the ground floor in room G3 (see ILLUS 28).

ILLUS 30: Exposed doorway in G3-E
