**FARM BUILDINGS AT COLVILLE HALL  
CHELMSFORD ROAD  
WHITE RODING  
ESSEX**

**HISTORIC BUILDING RECORD**

January 2013

**FAU Project No.:** 2632

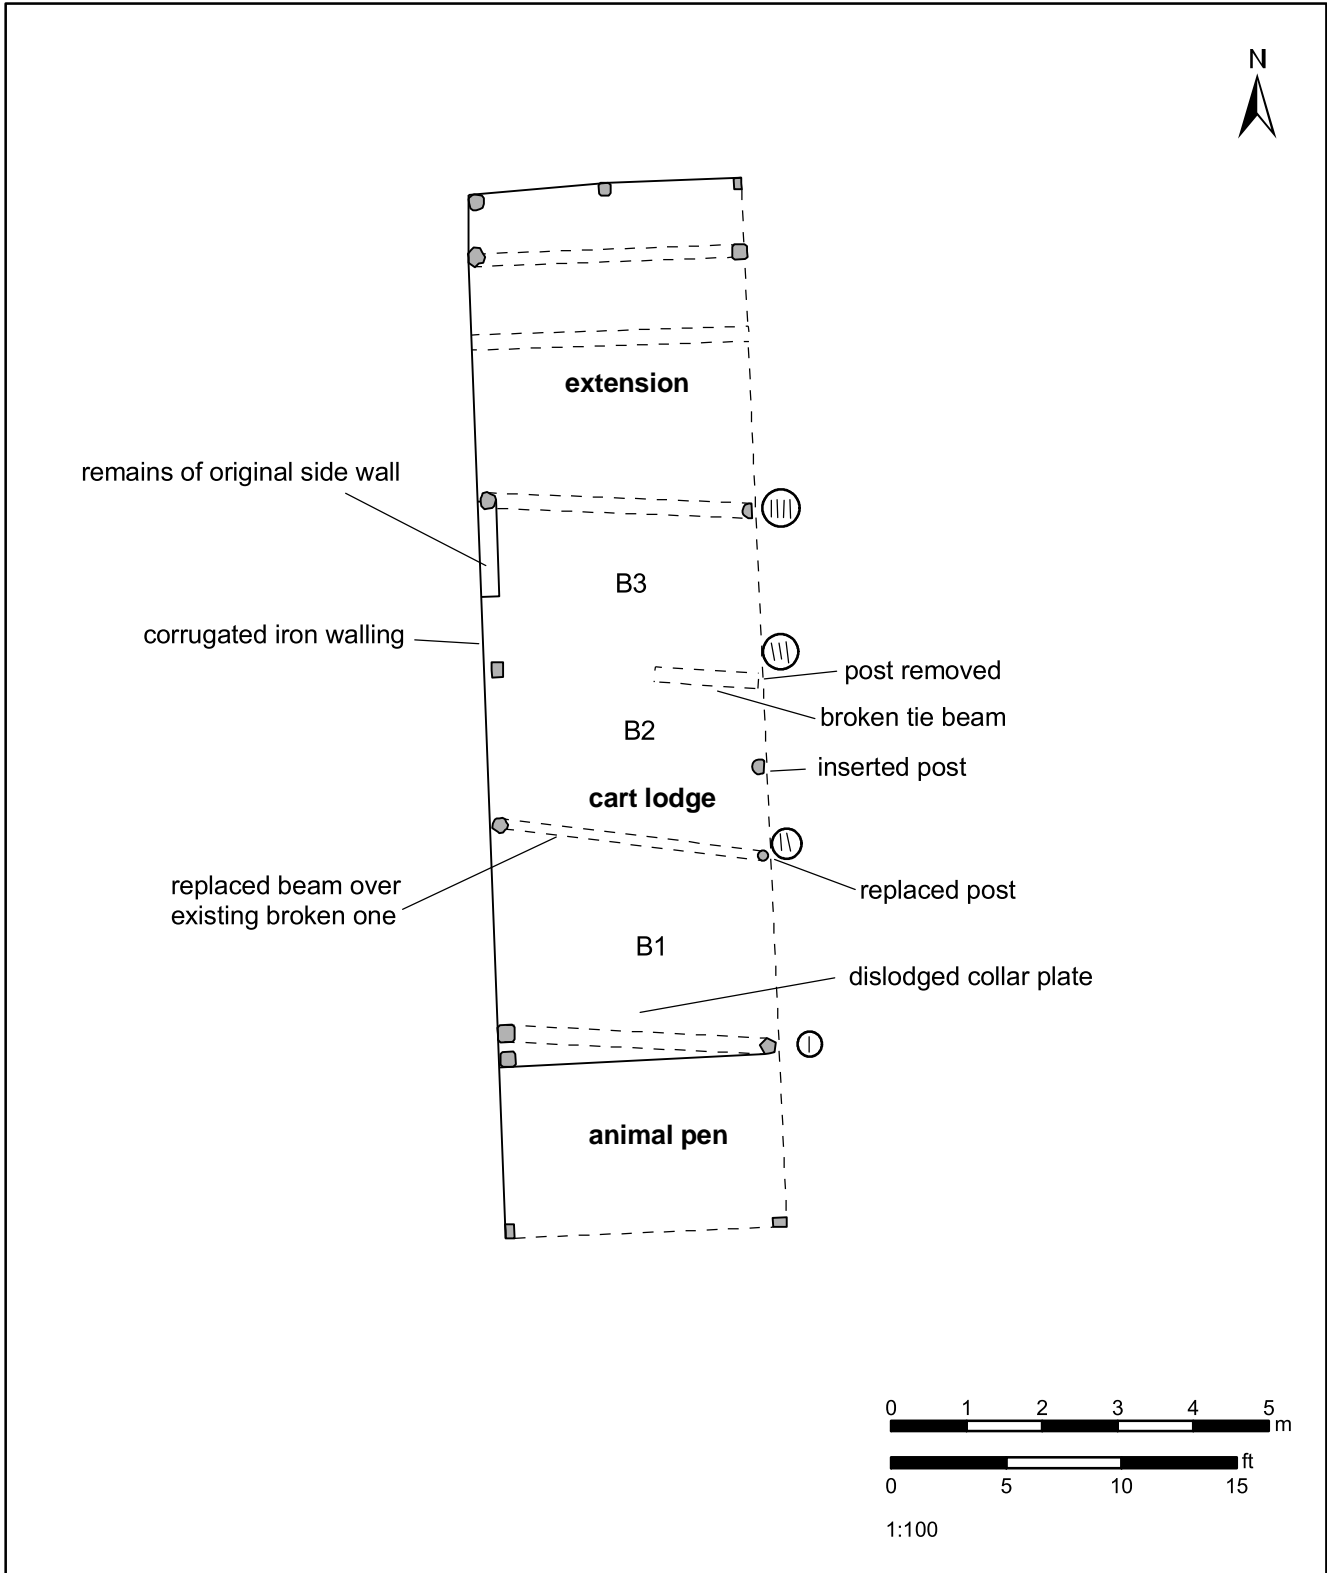
Fig.11. Floor plan of cart lodge

Tie beams with c.16cm<sup>2</sup> dimensions have failed between bays 1 and 2 and 2 and 3 (plate 21), and the only existing complete tie beam to remain is contemporary with the roof rebuild (fig. 11). The later beams are lapped rather than dovetailed onto the posts.

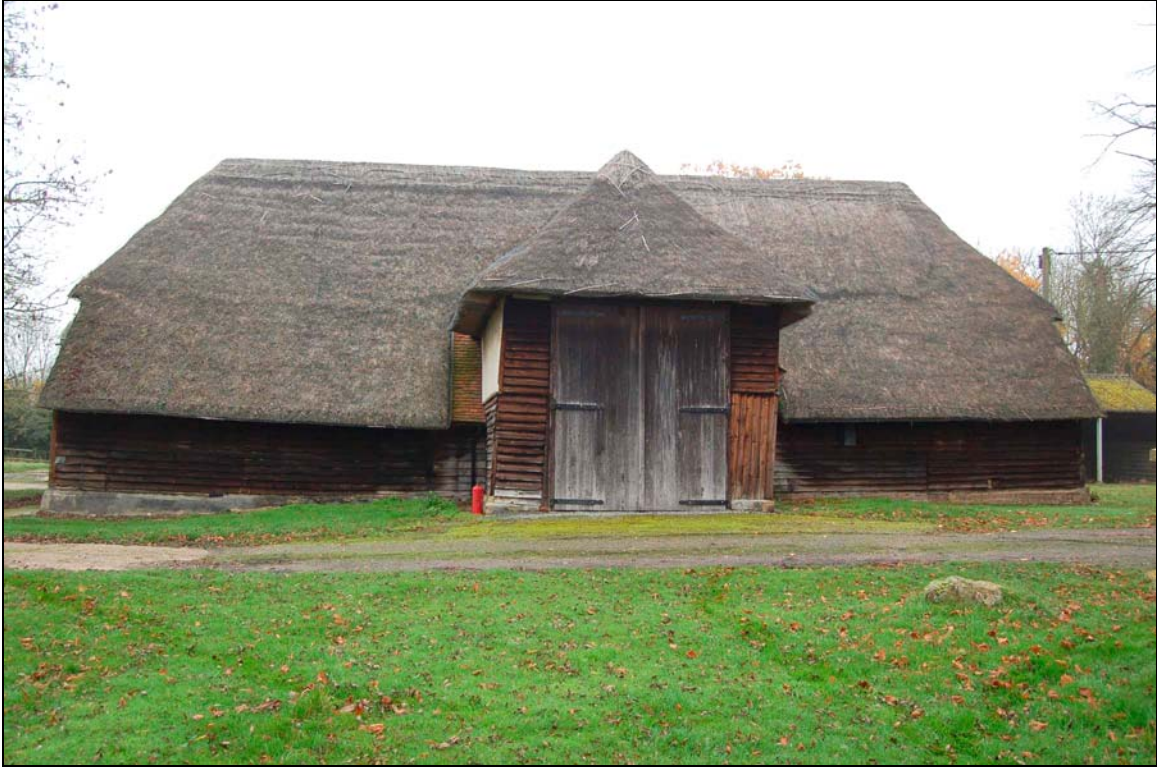
Plate 1 South elevation of barn

The main elevation (plate 1) facing onto the farmstead has the porch located on the central bay and contains historic strap-hinged cart doors, which have been refurbished inside. On the east side of the doors the lower weatherboarding has been laid vertically rather than horizontally in the refurbishment. Either side of the porch is historic lath and plaster (KPT 2012). The long thatched roof extends over the low eaves of the south aisle and the low walls show few details apart from the small window east of the porch (fig. 4 & plates 1 & 2) that may represent a former vent. The wall west of the porch bows out slightly (fig. 6). Plain tiles have been built into the valleys around the porch roof for greater damp-proofing. The side walls of the porch are half-timbered and on the east side is an early ledged and braced plank door with old fittings including a wooden lock (plate 2).

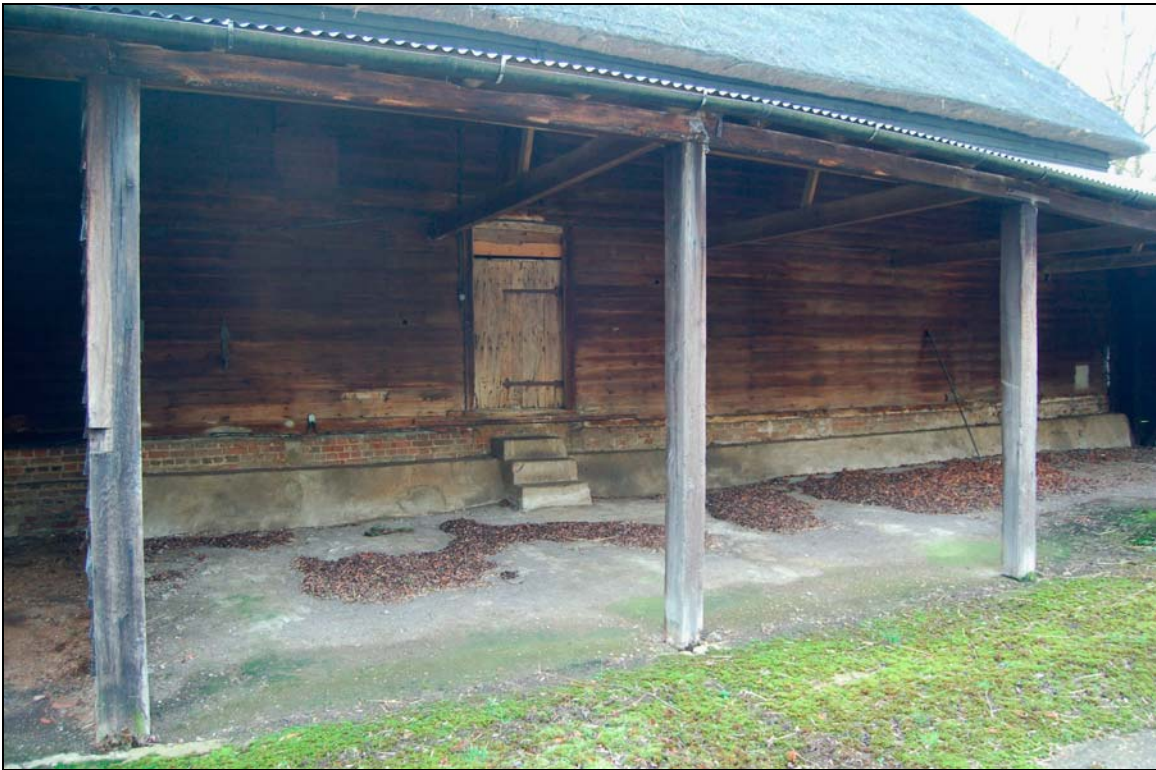
Plate 4 North elevation of barn within modern shed

The north wall of the historic barn is viewed from the interior of the extension (plate 4). On this side the plinth is higher to counteract the natural slope of the ground down to the mill pond. The main feature is an old door located centrally and accessed by concrete steps, providing pedestrian entry into the barn. The door has a ledged and braced plank form and good hand-forged strap hinges of likely 17th century date (plate 5) and simple looped cast iron latches. Above it is a narrow pitching hatch, contemporary in date and presumably leading to a former hay loft inside.

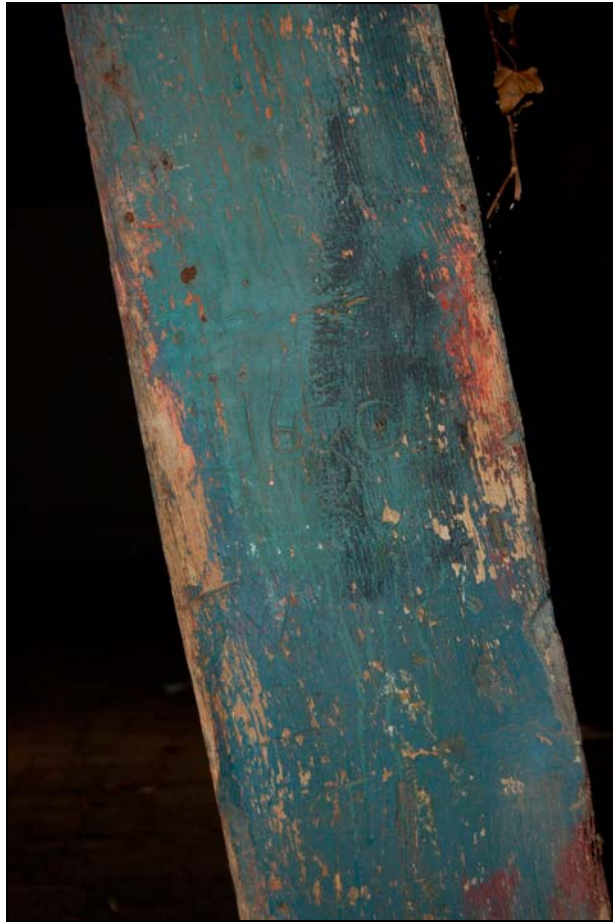
Plate 11 Carved initials and date on T4 southern bay post

The perceived construction date of 1630 and initials 'I.B.' is carved on the west side of the south-east midstrey post (fig. 4 & plate 11). Below the graffiti are some criss-cross marks and other initials that are harder to decipher.

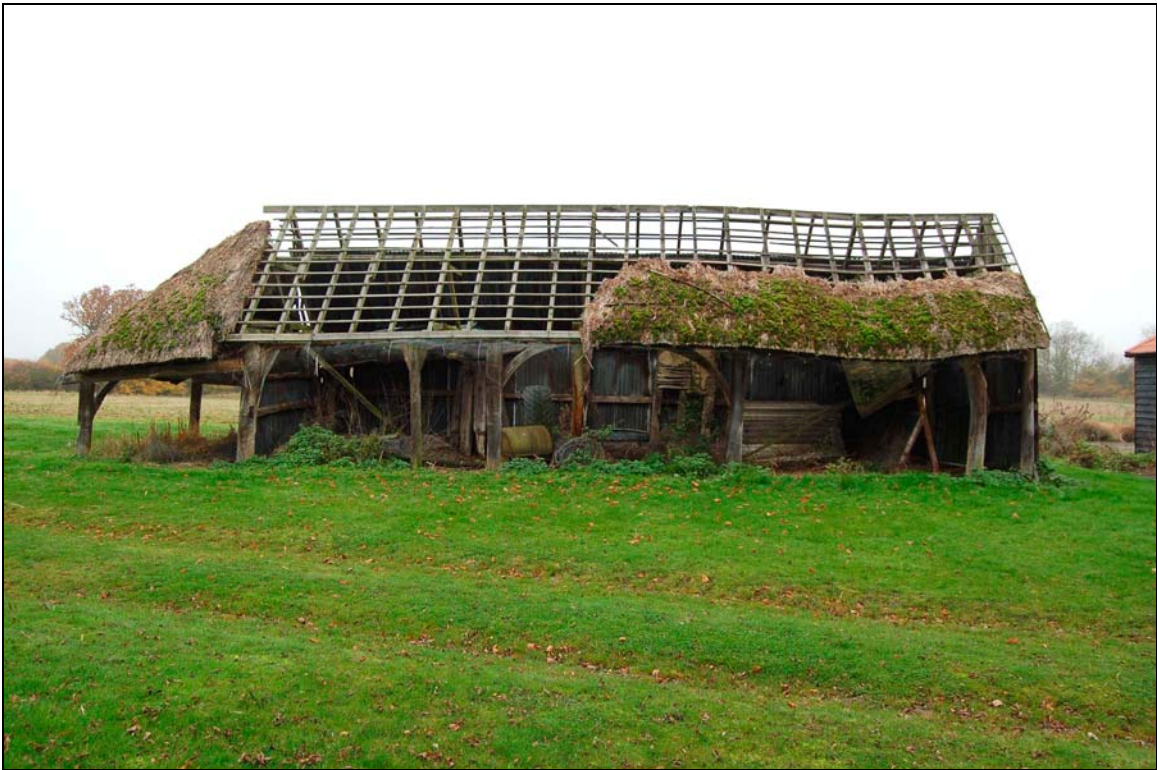
Plate 18 East elevation of cart lodge

The main east elevation (plate 18) is open-sided, representing the three modern bays rather than the original layout. The posts at the two ends along are original, the northern-most of which retains its curved brace, which has been replaced by a bolted knee brace at the opposite end. This replacement is likely to have been part of the 19th century phase and includes another such post dividing bays 1 and 2, which is narrower than the others (fig. 11). A post of similar dimensions to the main ones has also been inserted along the centre of the original second bay (B2 in fig. 11). Evidence for wooden rails exist at the front of bays 1 and 3. The central bay (B2) may have been railed or gated but there are no original posts to verify this. All the posts on the east side have scribed carpenter's marks at their top from 1 to 4, indicating a direction of build from south to north (fig. 11).

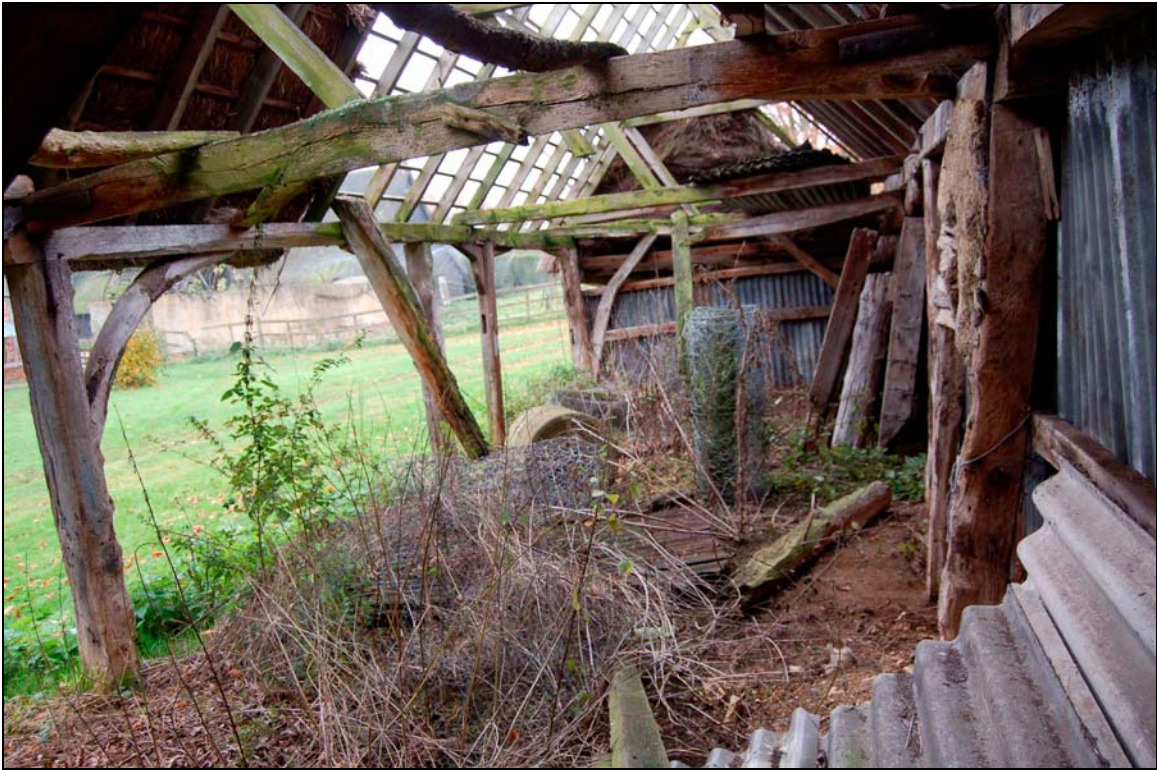
Plate 21 Interior of cart lodge viewed to south

The cart lodge bays are defined by stout 20cm-wide oak posts that support double-pegged c.16cm<sup>2</sup> wall plates (plate 21). On the east, the wall plate consists mainly of one length of timber joined to a shorter length by a rather rotten 4-pegged face-halved and bladed scarf joint above the replaced post (fig. 11). On the opposing west side the wall plate has failed and been replaced midway along by a new plate that has been lapped over the existing one. Diagonal braces are lapped over the side plates and pegged into the wall plates in the four corners (fig. 11 & plate 22).

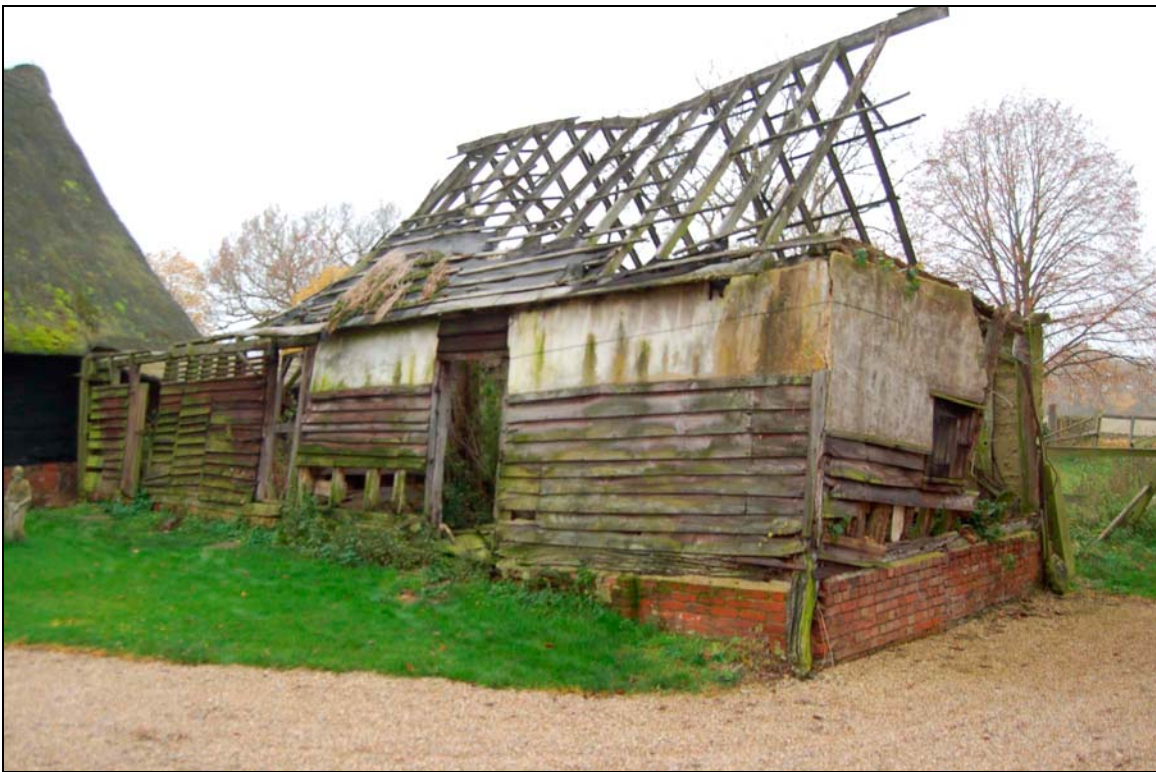
Plate 24 Byre viewed to south-west

Traditionally the byre (plate 24) was used for keeping cows or perhaps oxen in the early days before they were replaced by horses. By the 1960s it was used as a 'hay, coal and wood house' (SALE/B5370). According to the list description it is one of the oldest buildings of the farm but unfortunately it was left to deteriorate for a long time before the present owners bought the site. The main structure is still standing but much of the roof has collapsed or is on the verge of collapsing and the interior was completely overgrown at the time of the survey. In view of this, only the southern half was entered and the rest was recorded externally or by photograph through existing apertures. Given the conditions, some plates in this report are included from the Structural Survey by The Morton Partnership, which was carried out in early March 2012 when there was no vegetation and the north wall, which has now partly collapsed, was still standing.

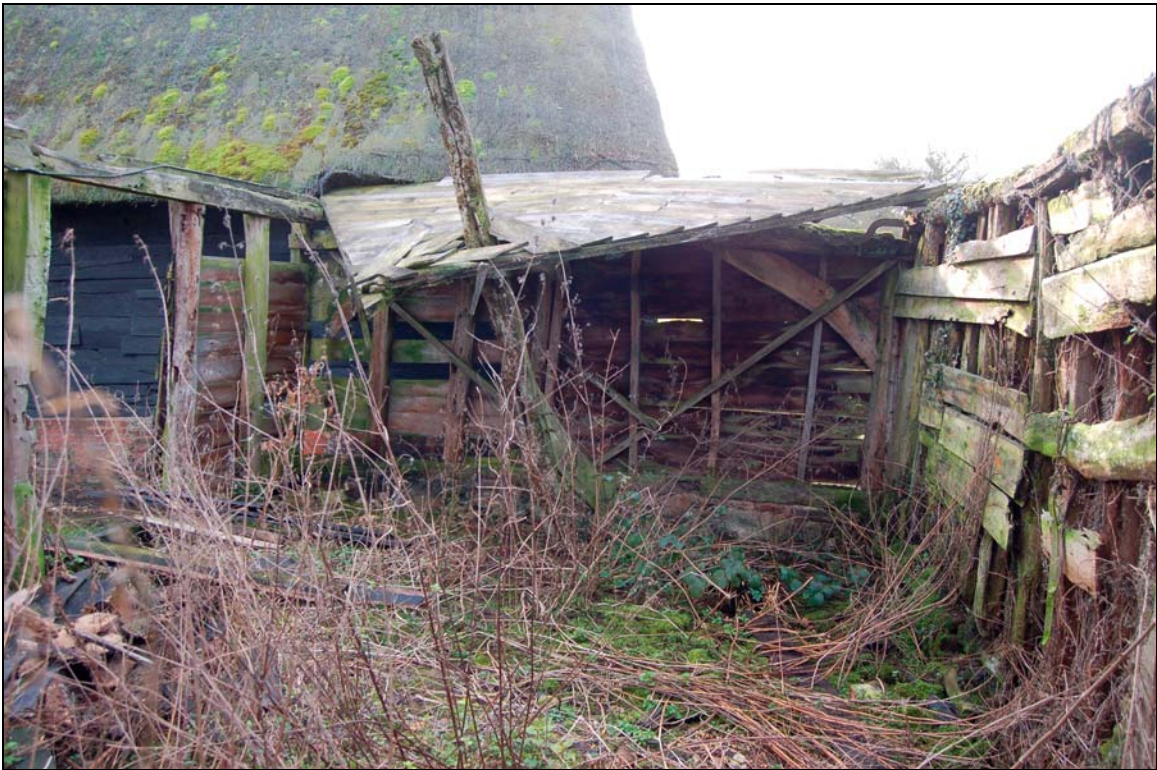
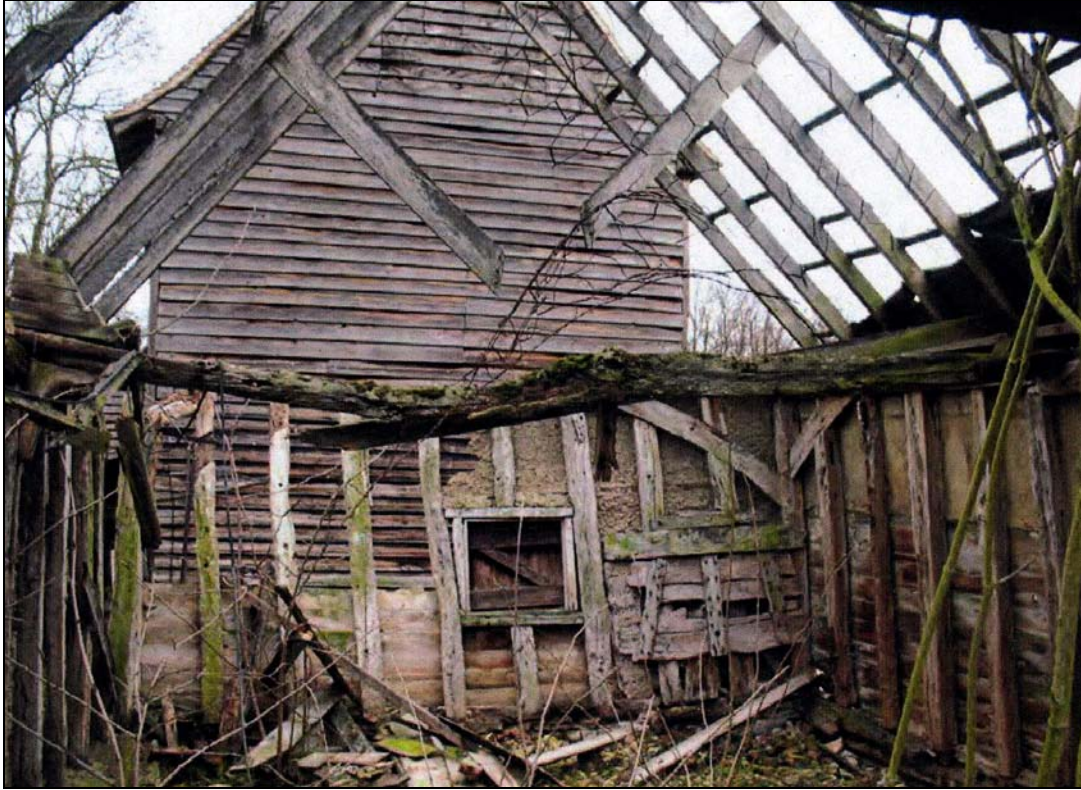
The interior is divided into two two-bay areas by a timber partition (fig. 12 & plates 26 & 27). The southern bays vary in size from 2.7 to 3.7m but the north bays are consistently 3m-wide. A brick floor survives amongst the vegetation in the southern half, but any similar flooring in the north bay was not apparent. Both sides have boarded internal walls suitable for keeping heavy animals. Access during the survey was hampered by the large amount of vegetation and the unsafe condition of the roof, particularly in the north side. There are no visible remains of mullion windows or other early features.
