BAMBURGH RESEARCH PROJECT

FENWICK STEAD, BELFORD NORTHUMBERLAND

HISTORIC BUILDING RECORDING REPORT

BRP 14/06b

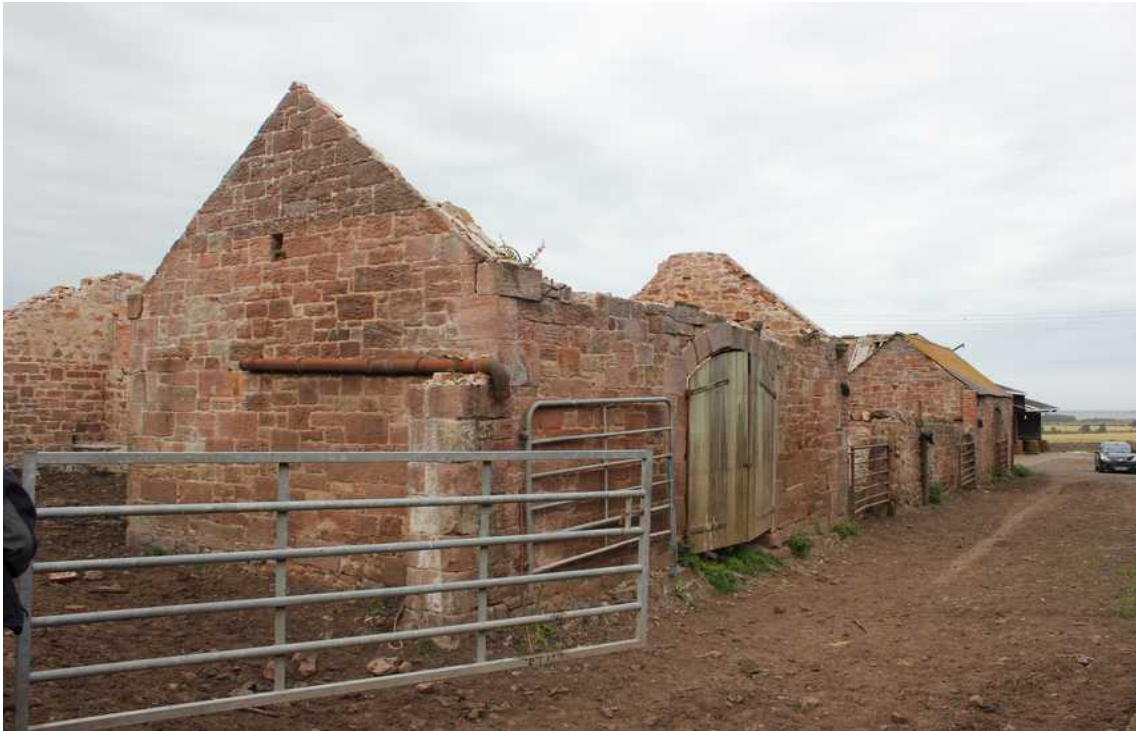
Plate 1: South side of range, facing east, north-east, Building B, foreground

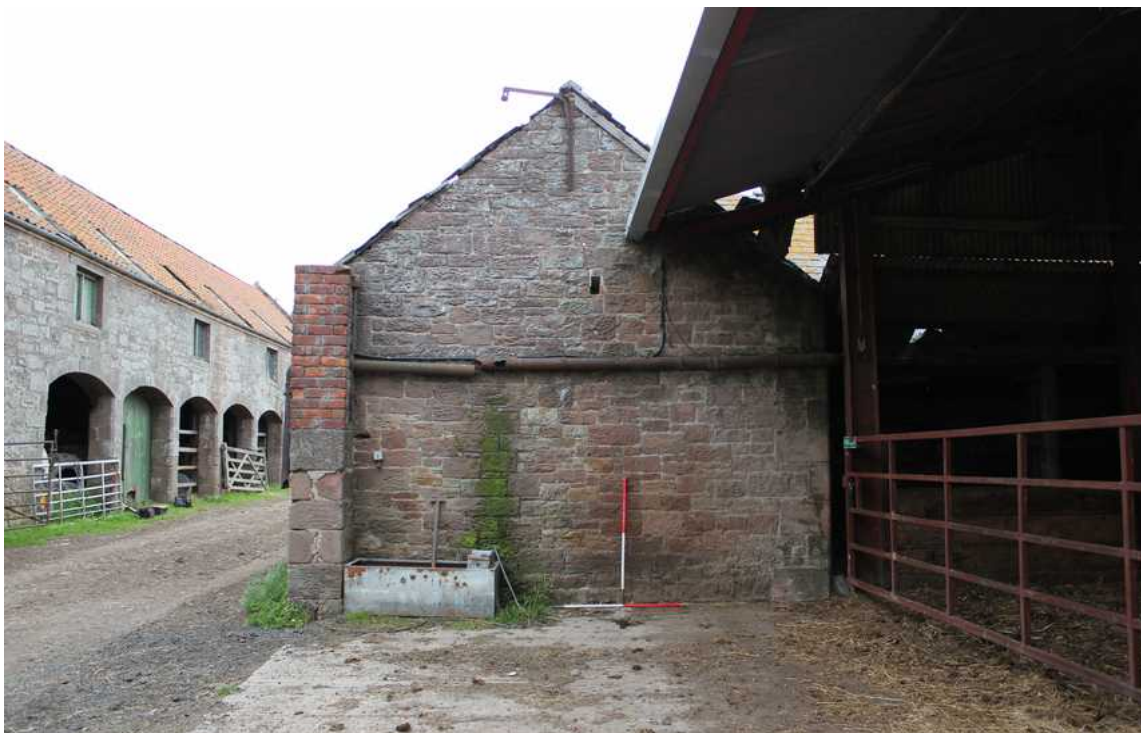
Plate 2: East side of Building A, listed building's in the background

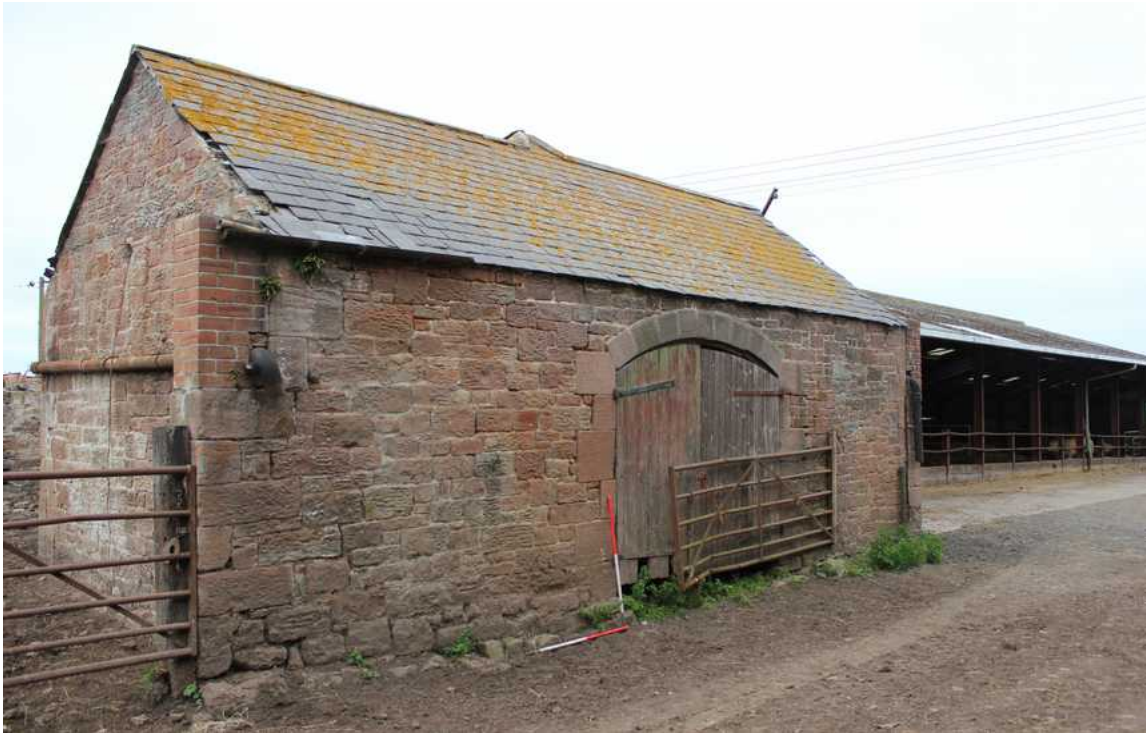
4.2.1 Building A is a simple rectangular structure that measures 9m east to west by 4.8m north to south. It is constructed from roughly squared, irregularly coursed, sandstone blocks as a single build. The corner quoins and door surrounds represent larger, more regularly squared masonry blocks, though with a similar pecked finish. It has two entrances, one in the south wall that measures 2.55m wide, and is closed by a timber double door and a second more normal sized door, 1.09m wide, in the rear, north wall. It is the only building in the range where the roof survives, being covered by a simple pitched roof that carries slates. It shows evidence of a repair in the upper south-west corner by late 19th to early 20th century red brick.

Plate 3: Building A, facing north-east, showing double door and later brick repair.

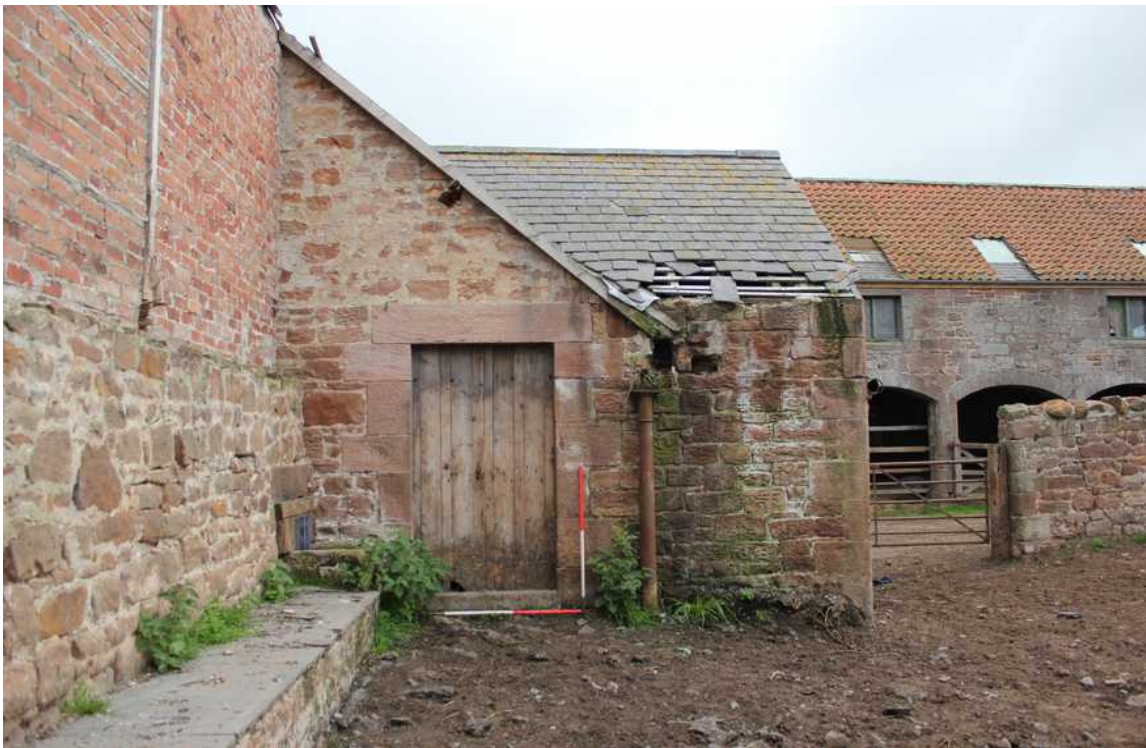
Plate 4: Rear, north side, of Building A, from within Courtyard B

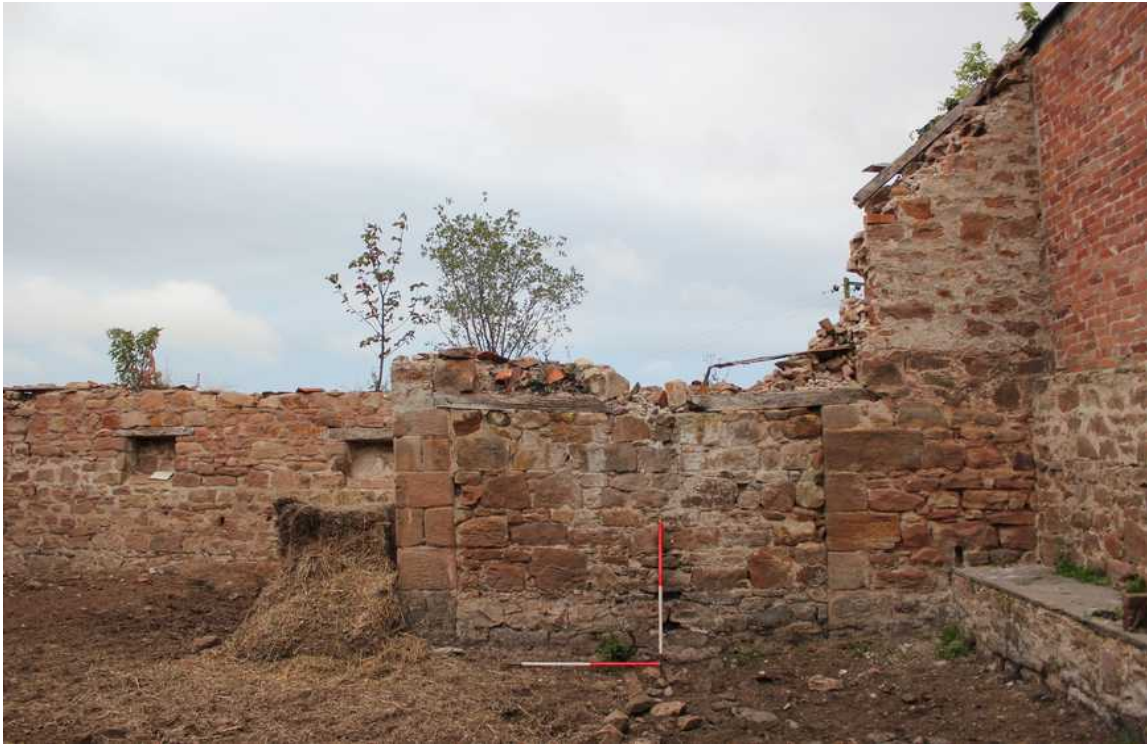
Plate 5: Blocked entrance in stub wall at the rear of Courtyard B, facing north

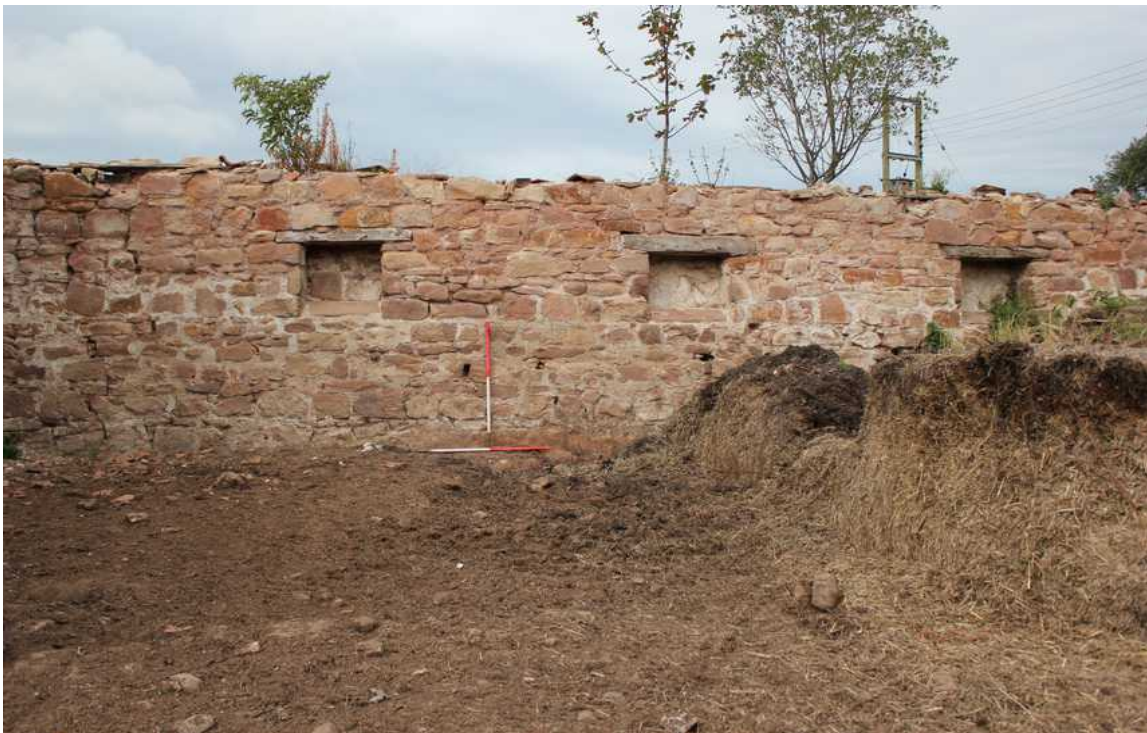
Plate 6: Blocked windows in the south facing wall of Courtyard B

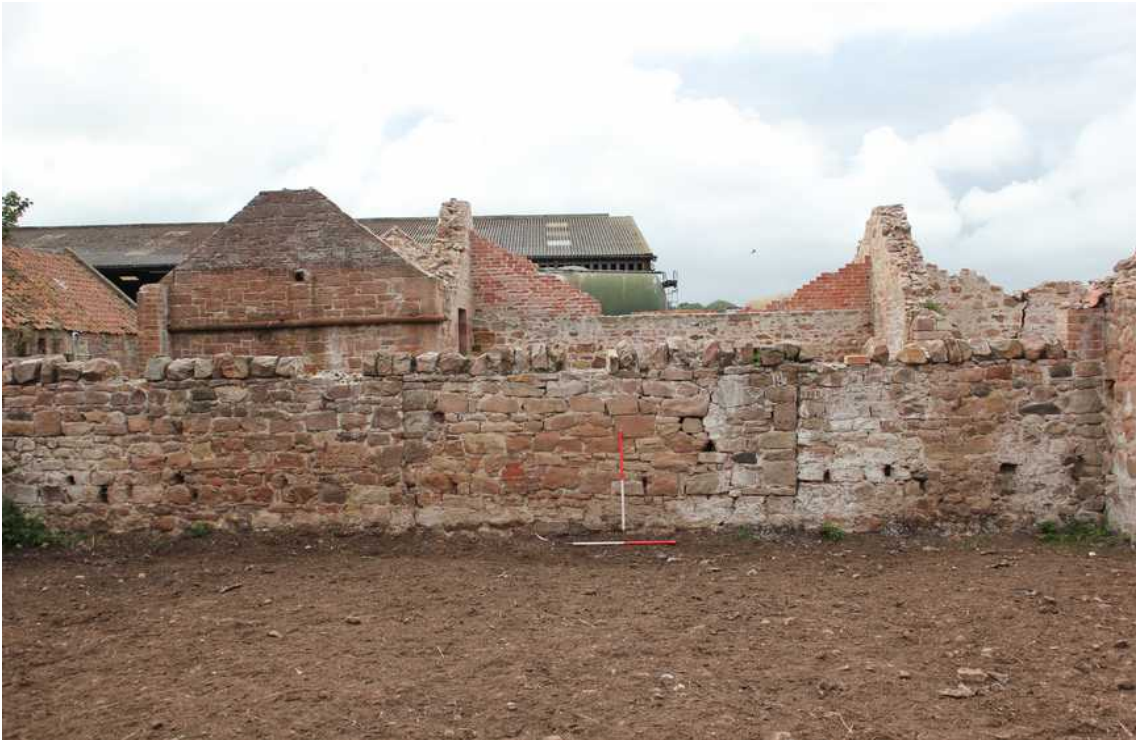
4.4.1 Courtyard C measures some 10.5m east to west by 17m north to south and was joined to Courtyard B by a gap in their shared east wall some 3.94m wide, that is now filled by a crude sandstone rubble and mortar. A further entrance, 3.11m wide, was present in the south wall. The rectangular Building D, extends between Courtyards C and E, taking up the south-west corner of Courtyard C. The northern end of the courtyard shows two stub walls extending from the east and west sides, in a manner similar to that seen in Courtyard B. Suggesting that this end of the courtyard contained a roofed shed of the same style as that seen to the east. It is clear that the east end of the west stub wall had been either extended or repaired by a later masonry build that comprised more regular squared blocks. This aside all indications are that the shed would have stood open on its south side for 5.8m, the same as that seen in the shed at the north end of Courtyard B. A similar series of three small blocked windows were also present in the north wall. A stone bench extended along the west wall from the shed to Building D. As with that seen in Courtyard B, a metal trough was set into its south end. In this case extending through the wall into Courtyard E. It can be assumed that this area was also formerly roofed.

Plate 7: Blocked entrance between Courtyards B and C, facing west

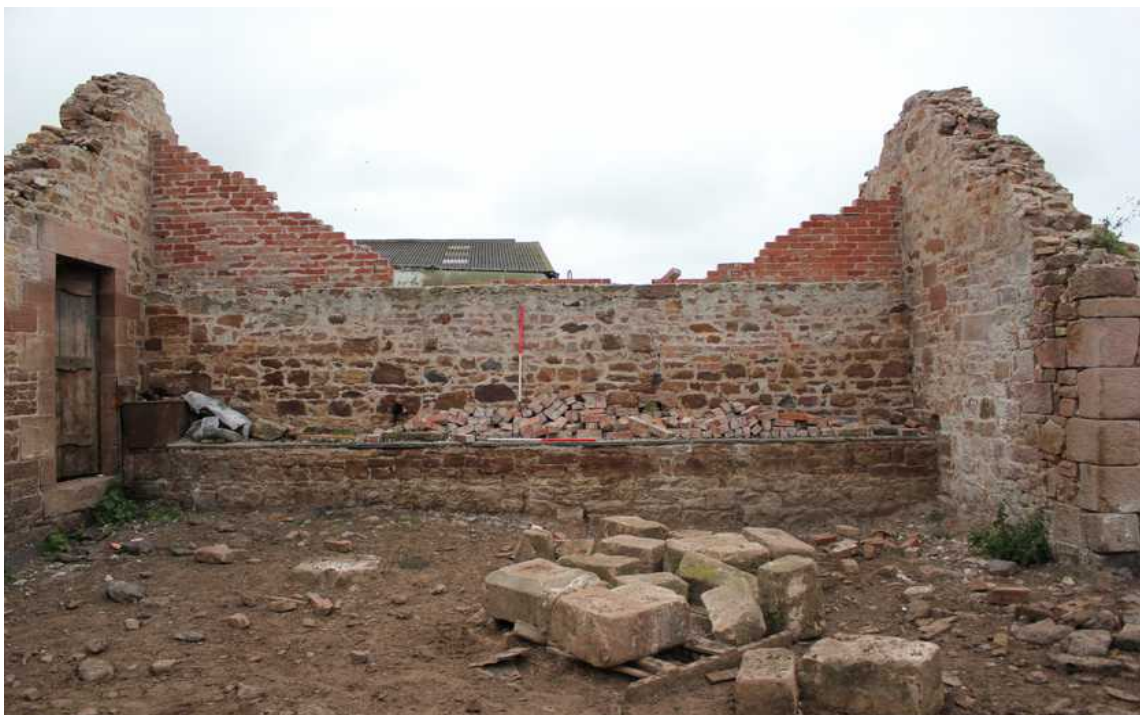
Plate 8: Platform and trough on the west side of Courtyard C, and door into Building D

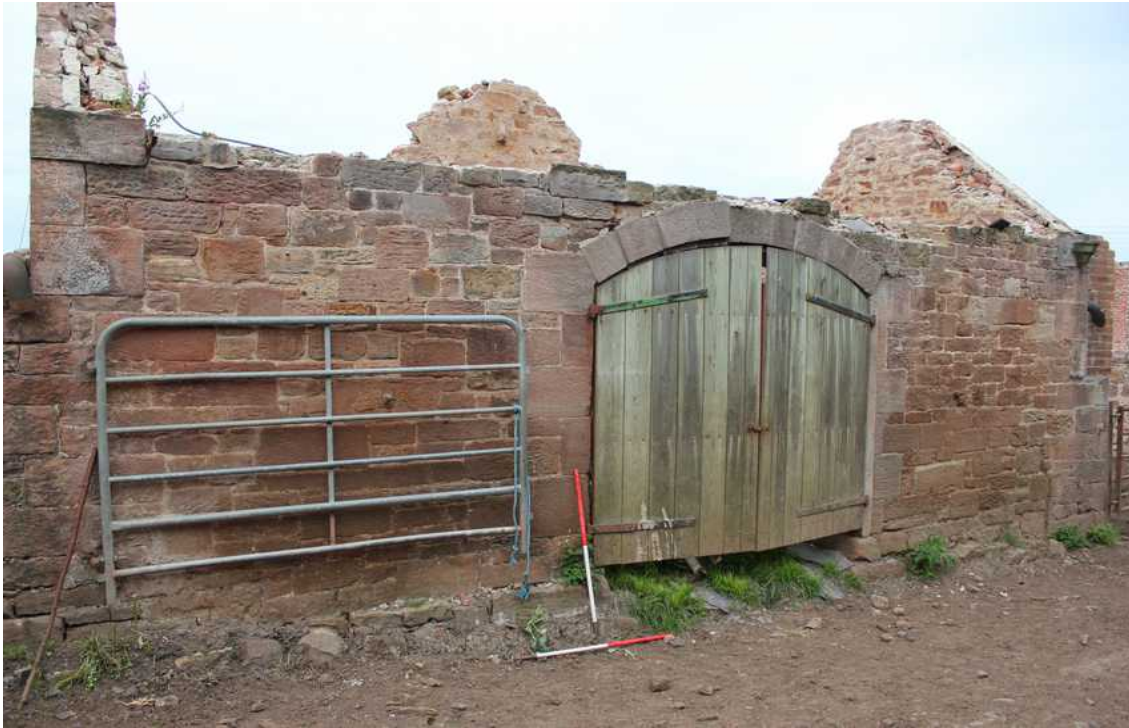
4.5.1 The building was very similar in form and size to Building A, being 9m east to west by 5m north to south. A, 2.55m wide, entrance lay centrally in its south wall, closed by a pair of double wooden doors. Unlike building A, there were two doors in the north wall, each 1.09m wide and opening into the two courtyards C and E. As was also the case with Building A the structure was constructed from squared masonry blocks, but keyed into the more crudely built courtyards to its north. The roof did not survive but it was clear that a simple pitched roof had formerly covered the building.

Plate 9: South face of Building D, showing double door and missing roof

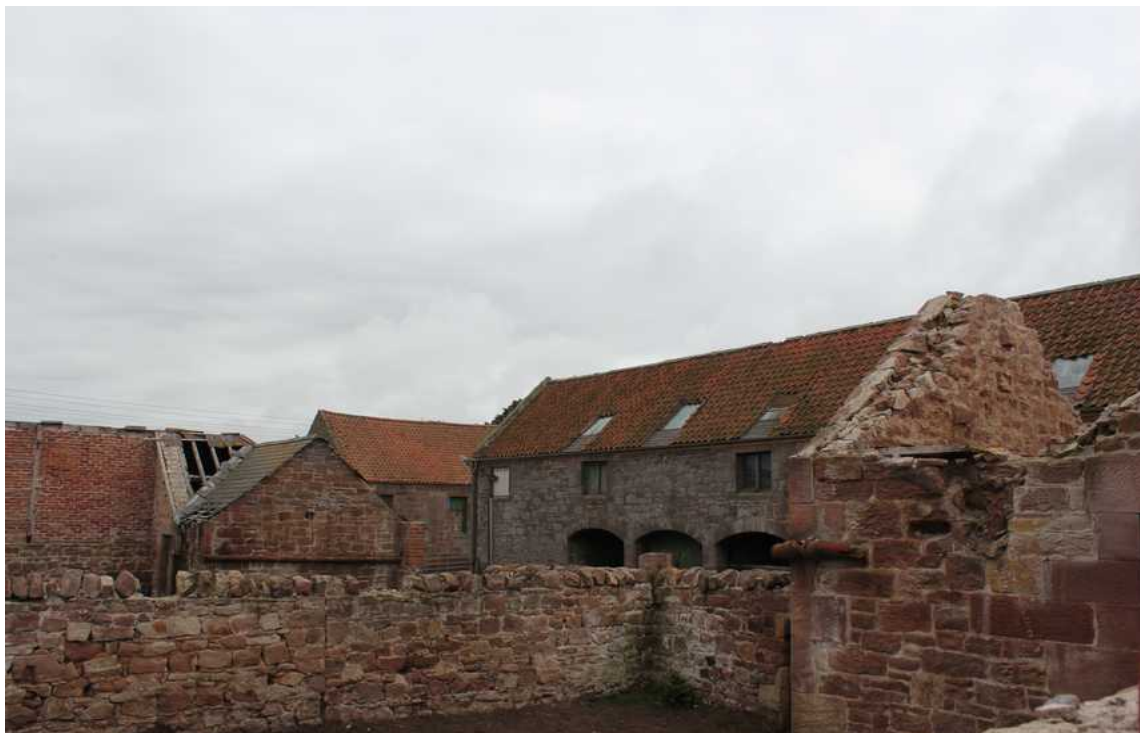
Plate 10: The building range from Courtyard E, facing south-east, showing proximity to listed buildings
