An Archaeological Building Recording at Bay Tree Farmhouse, Rodsley, Derbyshire

ARS Ltd Report 2010/11
February 2010
Oasis I.D. archaeol5 – 72283

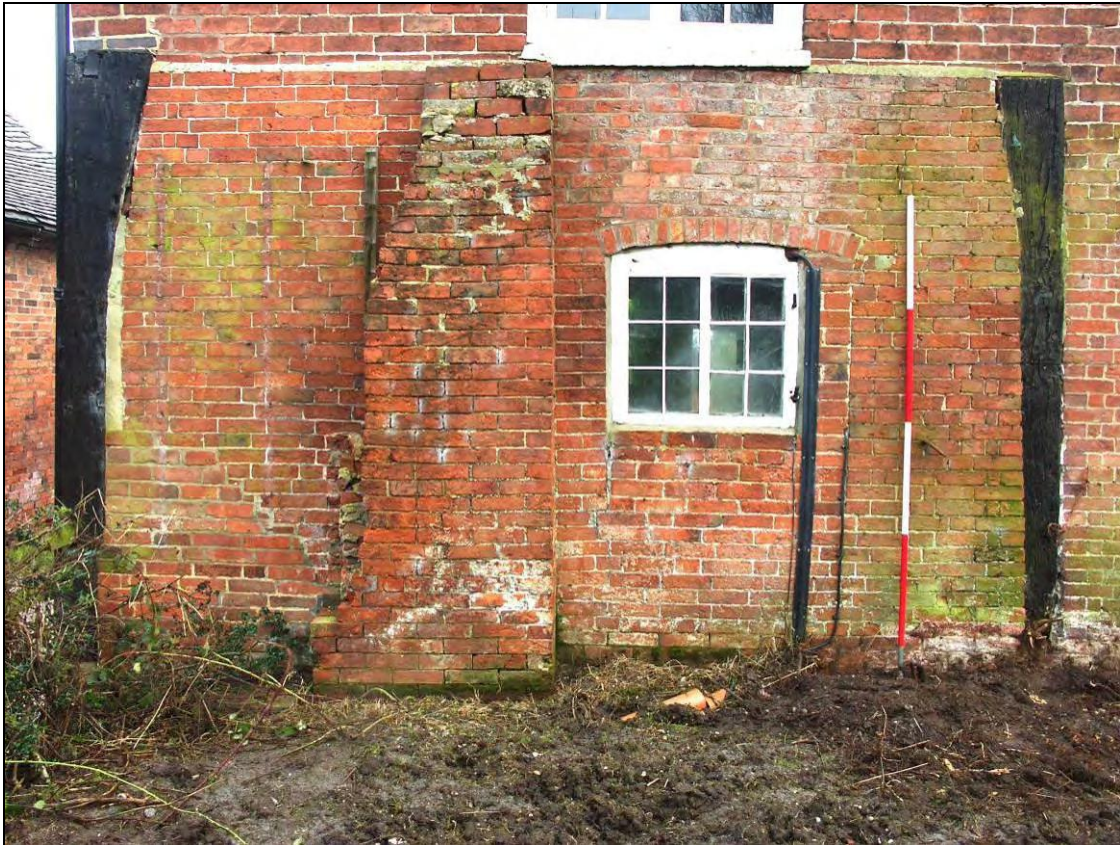
structure (Fig. 4). This bay has two *in-situ* timber posts with flared jowls. The posts are in good state of preservation although the southern post has moderate wet rot damage at the bottom and the top has been slightly truncated. The posts have matching peg holes for the attachment of former braces and a central rail which would have been integral to the timber-framed structure (Fig. 5). This confirms that the current brick infill is a later addition which replaced the original frame. The construction of the brick infill or nogging is very irregular although it seems to be mainly built with orange hand-made bricks (9" x 4" x 2½") bonded with flush, white, medium-coarse lime mortar (up to 10mm thick) and laid mostly to Flemish Garden bond. The base of the northern end of the building has been re-built with concrete which is supporting the timber post. This post has been slightly disfigured with the insertion of three slots carved within it which are supporting the present garden fence (Fig. 6).

Figure 4: Northern bay with the remains of a timber-framed building (scale 2m)

- 5.25 The remains of the timber-framed structure should be preserved and areas of advanced wet-rot decay restored. The only surviving wall panel on the ground floor between rooms G-1/G-2 and G-3 should also be retained without any alterations. However, the current plaster covering this wall in room G-3 may be causing damp problems to the timber and thus its preservation may be improved with the removal of the plaster and conservation treatment to the timber-framing. This would entail the exposure of the only internal surviving Post-Medieval timber-framed wall which would provide significant historical value and character to the house. The removal of the plaster could also be undertaken inside rooms G-1 and G-2, although the latter

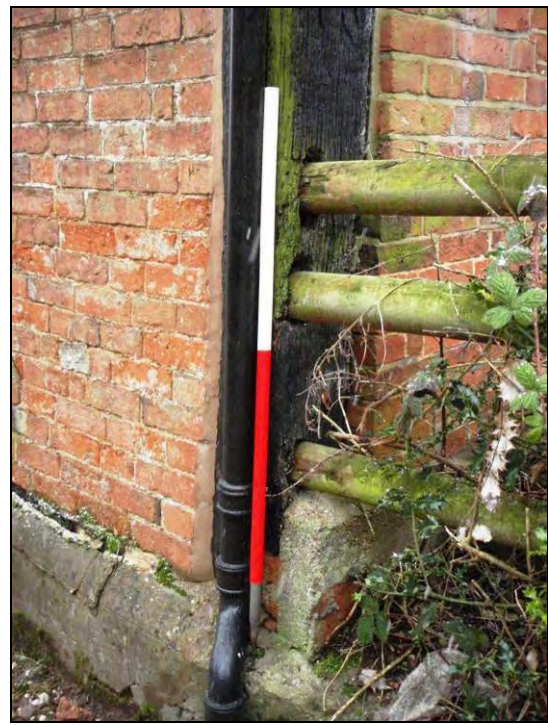
Figure 6: Slots in northern post for the present fence

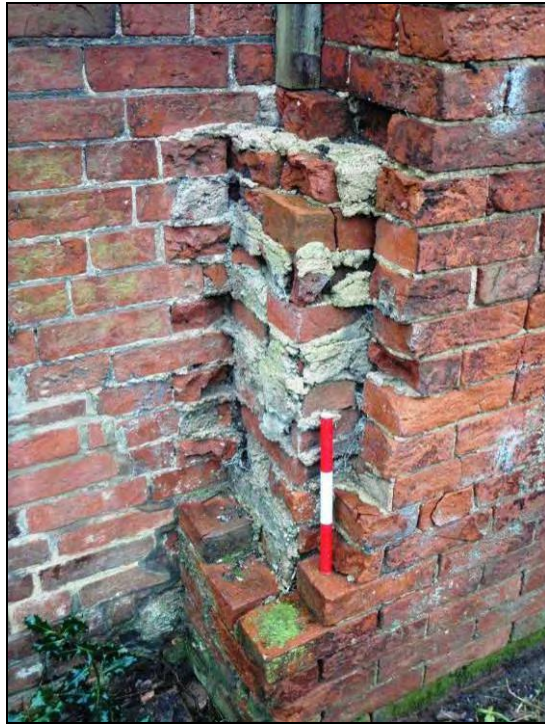
- 4.6 The remains of a projecting brick chimney stack can be seen against the wall. It is built with orange hand-made bricks (9" x 4" x 2½") bonded with flush thin coarse mortar and laid to stretcher bond. A dismantled section enables to view the current state of the fire place's cavity which is blocked with secondary bricks (9" x 4¼" x 2½") (Fig. 7). The upper four brick courses of the stack are a later replacement.

Figure 7: Brick infill inside the former fire place (scale 300mm)

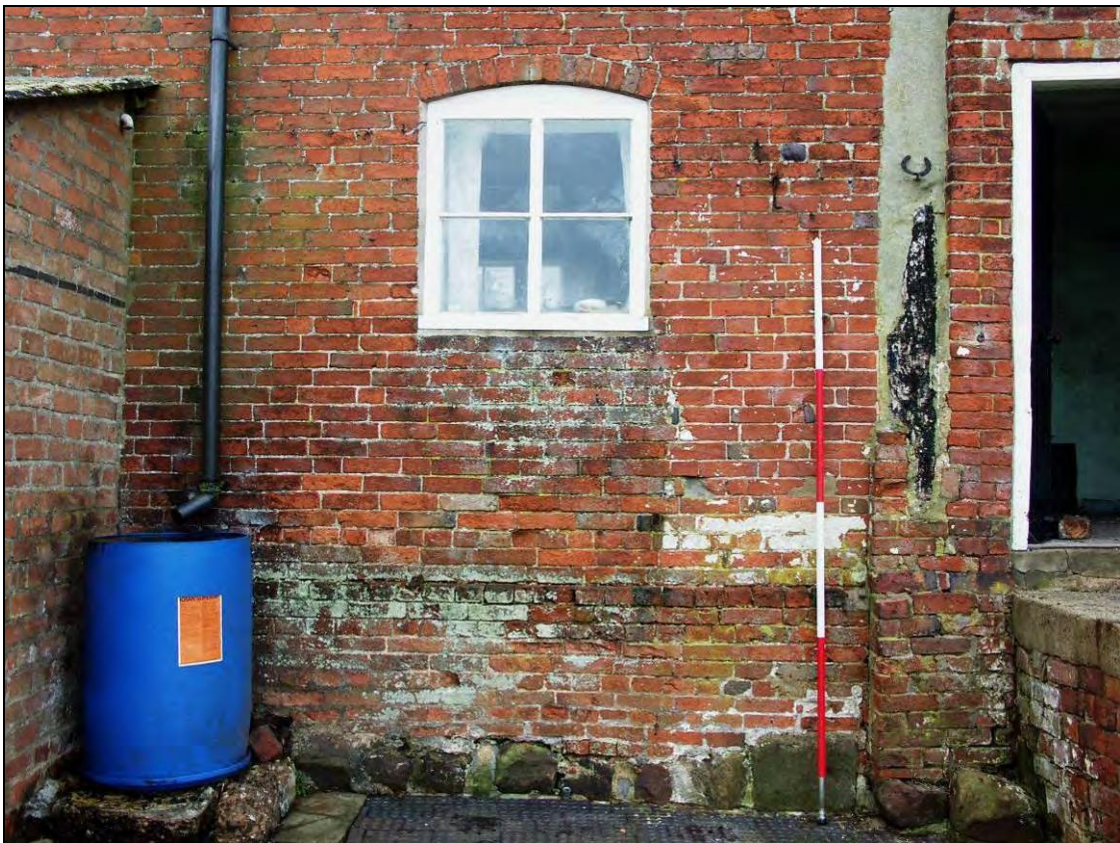
- 4.12 The lower section of the entire elevation has a continuous brick plinth supported by stone foundation which is partially exposed on the northern side of the elevation as the ground appears to have been slightly reduced from its original level (Fig. 17).

Figure 17: Exposed rubble stone foundation supporting a brick plinth (scale 2m)

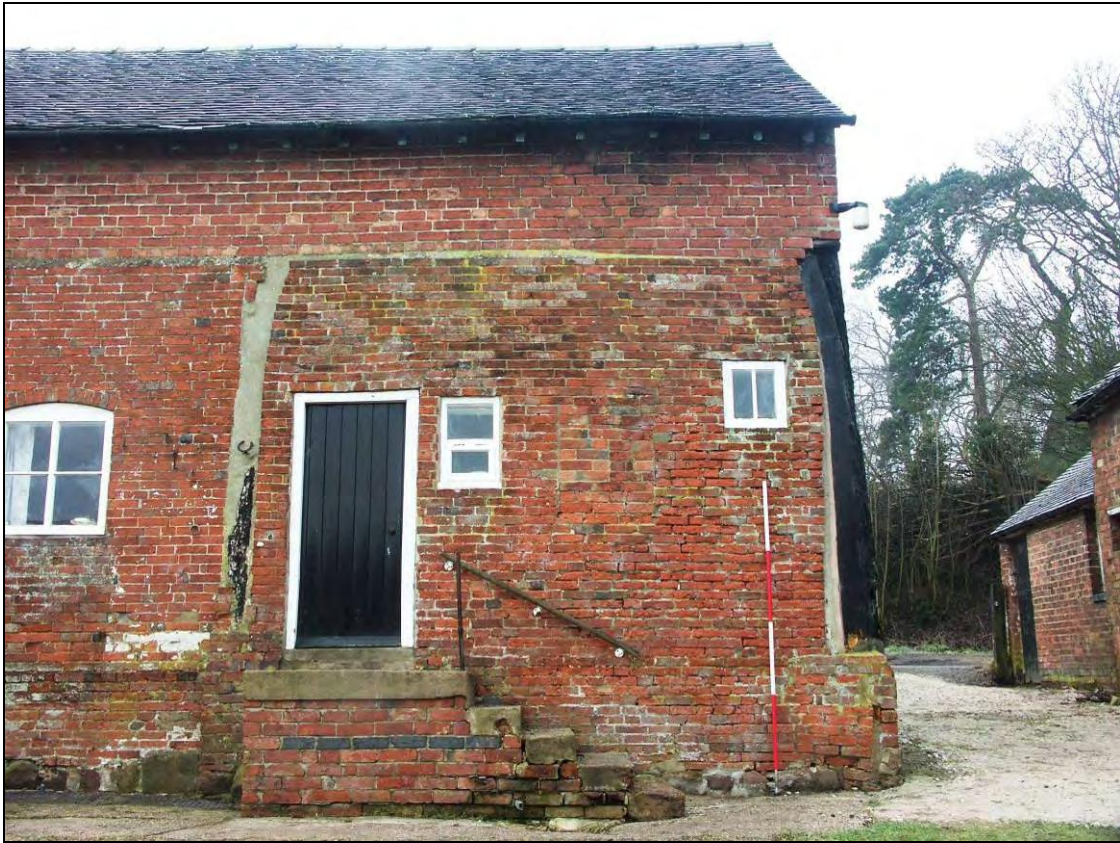
- 4.13 The northern bay contains the remains of the earlier timber-framed structure consisting of two principal posts which are in moderate condition with wet rot at the base of the posts (Fig. 18). The southern post is mostly covered with cement and the northern is also covered with a soft-wood timber plank attempting to protect the original post from wet rot. However, the plank is slightly rotten and may be causing further damage to the post.
- 4.14 There are two small plain windows within the nogged brick wall and a larger window opening in the middle which is now blocked with bricks. There is a timber door which is accessed from the external staircase made of brick and concrete (Fig. 18).

Figure 18: Northern bay with remains of timber-framed building (scale 2m)

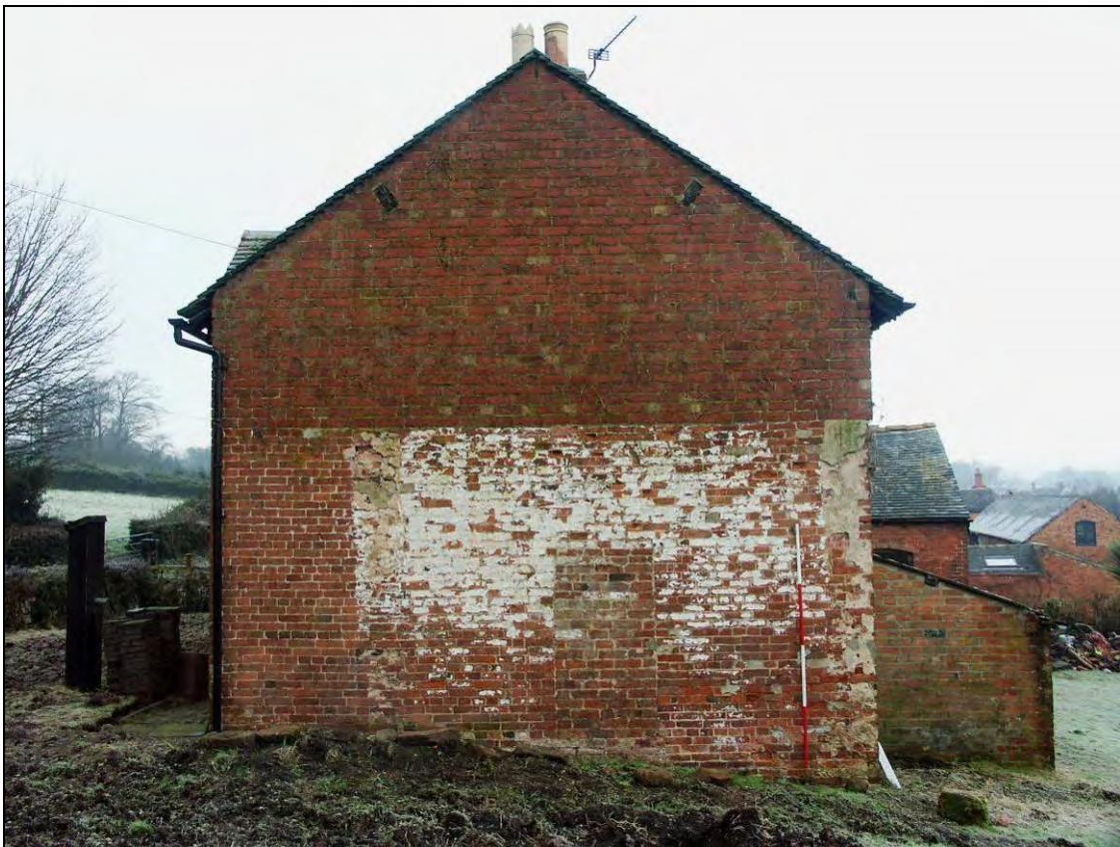
- 4.15 The south elevation is rather plain with a central doorway blocked with bricks which would have connected room G-4 with a brick structure abutting this wall of which brick scars are still perceivable (Figs 19 and 20). The former structure is also highlighted with the remains of lime wash in the brick wall. There is no sign of the former structure's roof as the top section of the current wall and gable were added later once the former structure was dismantled.

Figure 20: South elevation showing a blocked doorway and scars of a demolished structure (scale 2m)

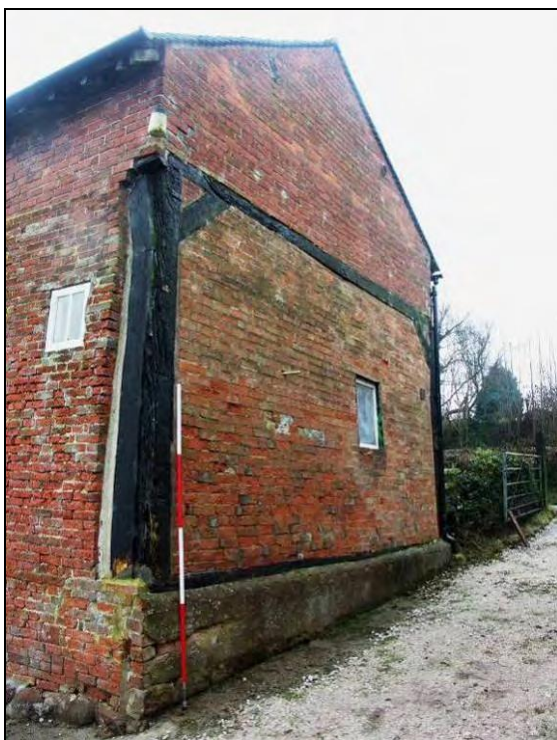
- 4.16 The north elevation is also fairly plain however; it has further *in situ* elements of the original timber-framed house. These consist of the principal posts tenoned in a wall sill, which is highly rotten, and supporting a wall plate reinforced with two straight up braces and two small iron braces (Figs 21 – 23). Both posts have empty peg's holes for a former rail. The wall plate and braces also have peg holes for studs which had been removed and replaced by the current nogged brickwork which is consistent with the side walls of the northern bay. There is a small fixed window within the nogged brick wall.

Figure 21: North elevation with timber frame

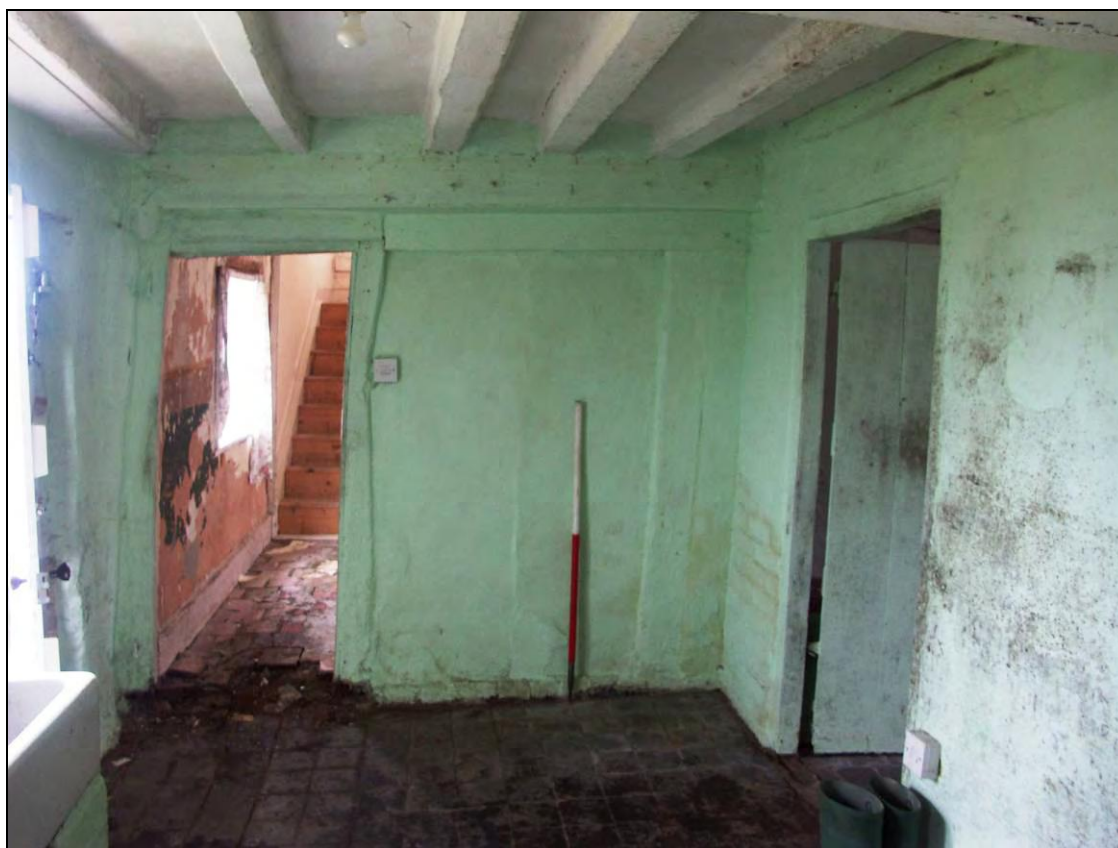
- 4.22 The southern wall has surviving elements of the original timber-framed house consisting of the wall rail and studs which are covered with paint (Fig. 26). The sill is missing and has been replaced with bricks. There is a doorway which leads to room G-3 on the southern wall and another doorway in the partition to room G-2.
- 4.23 Removed peg holes filled with cement can be seen on top of the south-east principal post (Fig. 27). The peg holes might have been the joint of a brace which had been removed. The post is in good condition however it is inclined due to earlier structural movements (Fig. 28).

Figure 26: Eastern wall of room G-1 with surviving timber stud and rail (scale 1m)

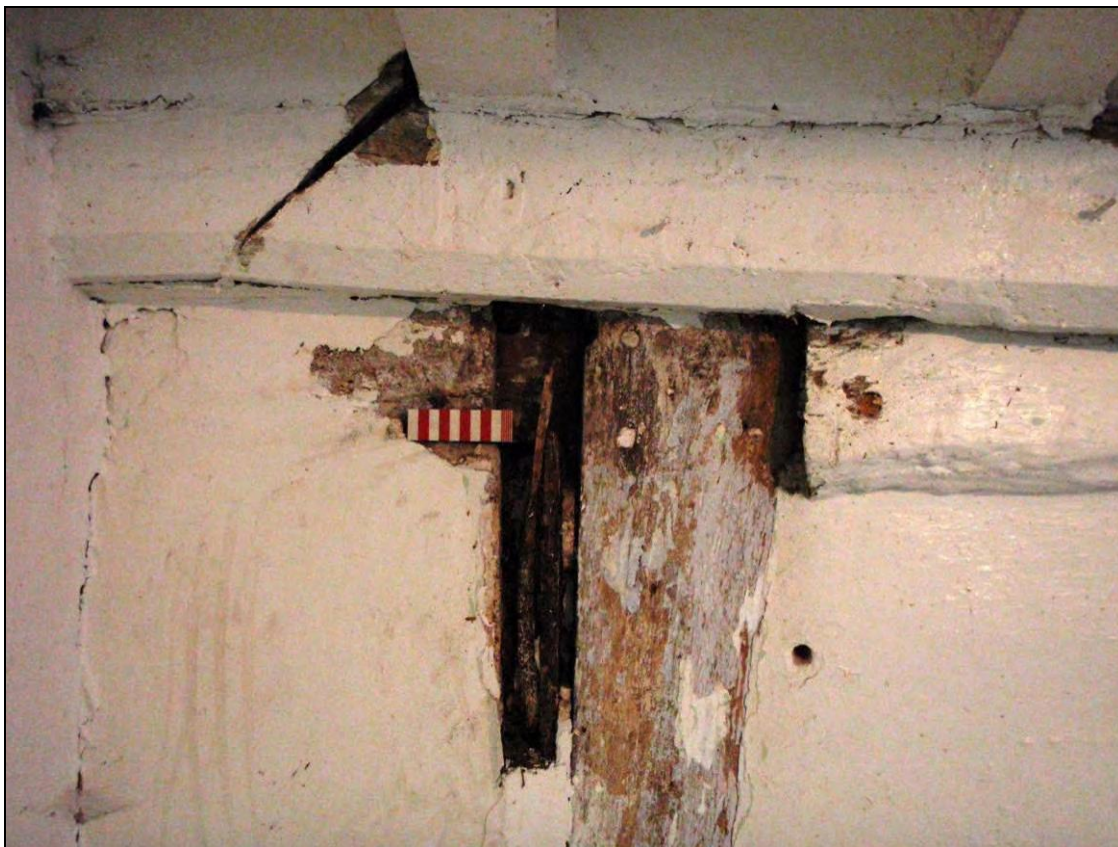
Figure 30: Detail of stud detached from rail with later cement infill, looking south (scale 100mm)

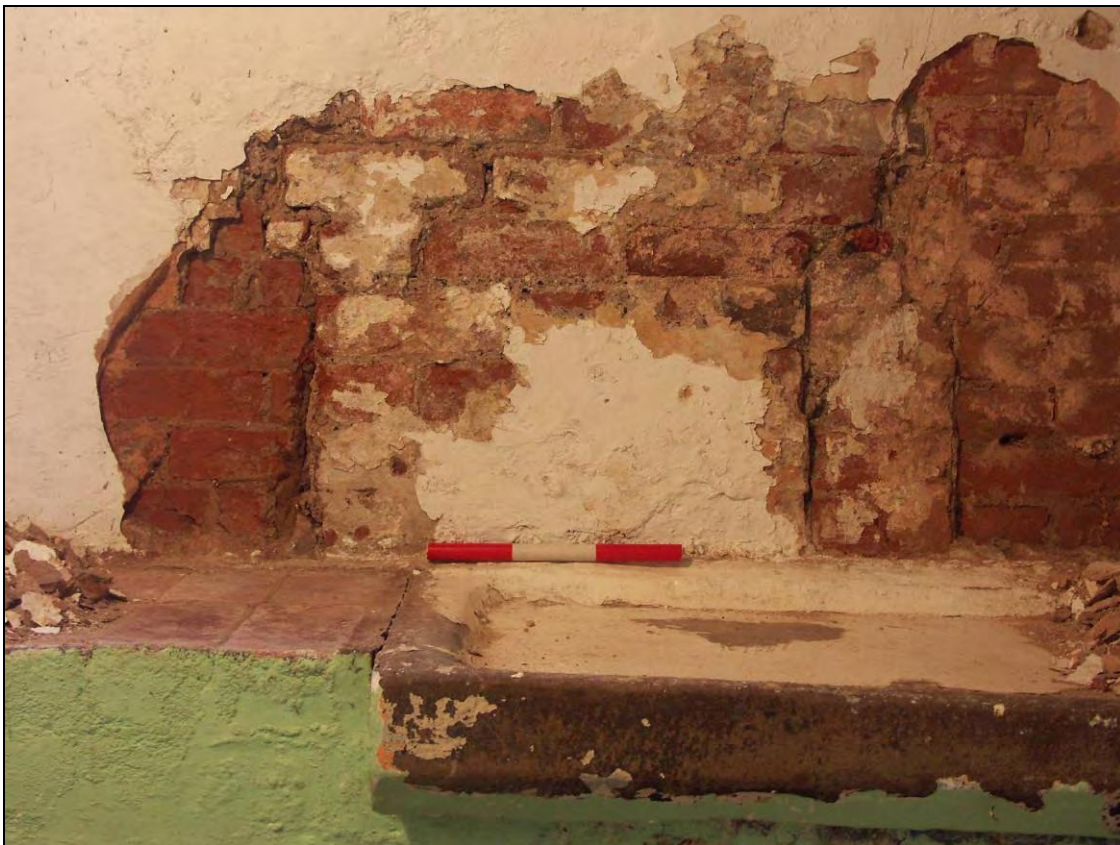
- 4.28 The remains of a fire place associated with the external obsolete chimney stack were observed behind a partially decayed plasterwork adjacent to the salting trough (Fig. 33).

Figure 33: Former fire place next to salting trough, looking west (scale 300mm)

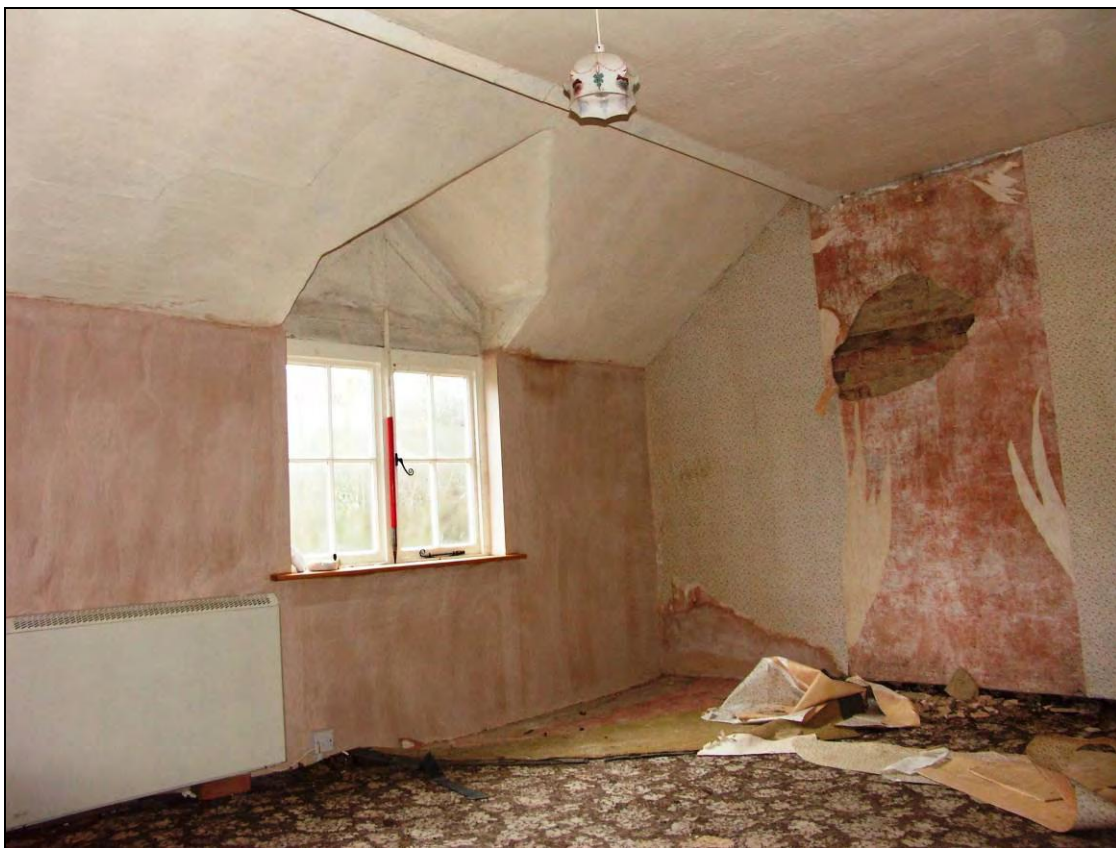
Figure 57: Western wall with repaired plaster work (scale 1m)

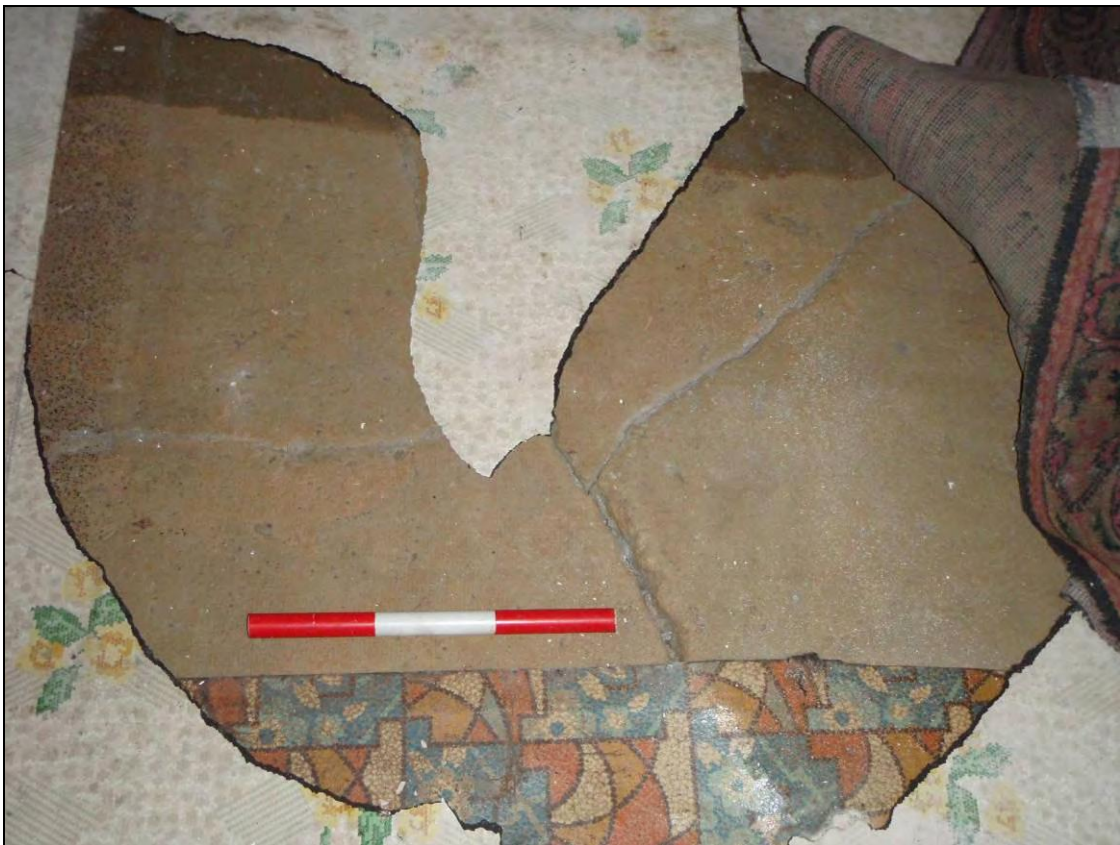
Figure 61: Fissures on the screed floor (scale 300mm)
