Stretton Mill Farm, Stretton
Archaeological Building Recording

Stretton Mill

ARS Ltd Report No. 2013/54
July 2013

Archaeological Building Recording

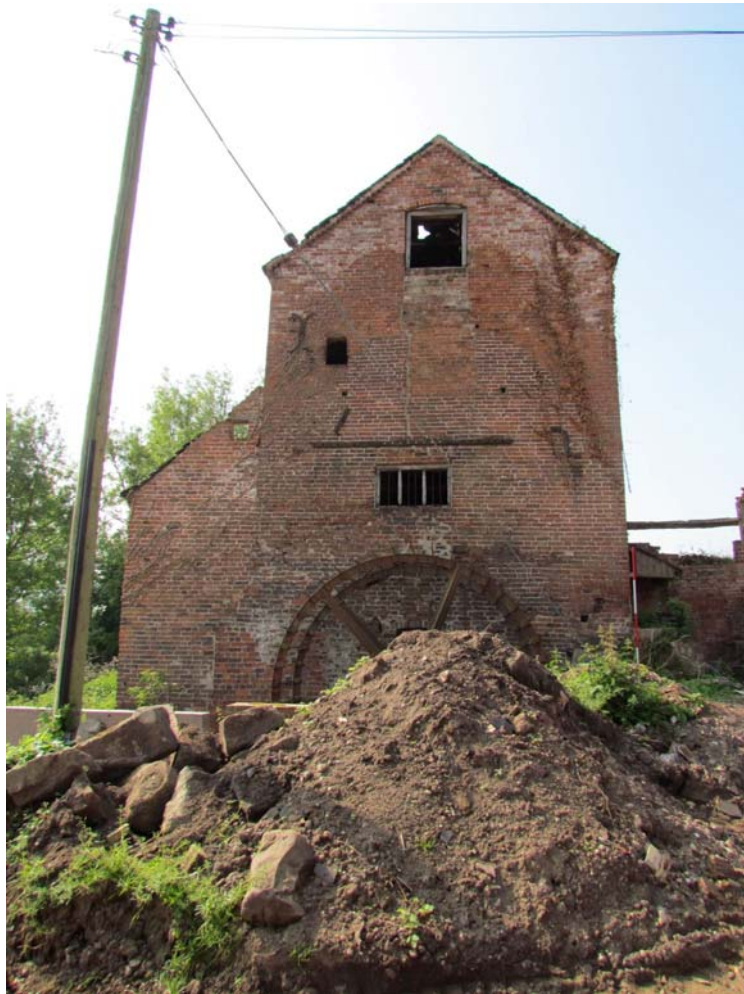
Figure 15: North Elevation of Mill, Looking South-east (scale = 2m).

and stone kerbs to the wheel pit. Above this is a rectangular mullioned window with a timber surround and a timber tie, with a cast-iron tie further up. Two changes in the brickwork can be discerned above this level, showing where additional storeys have been constructed and infills in the brickwork may indicate changes in the position of windows. There are further alterations in the brickwork visible at the lower part of the join with the extension to the west. A square window in the gable has a timber surround and the gable itself has a toothed verge and eaves. The two-storey office building to the west is plain apart from an infilled doorway. The western extension had a pitched roof although this has collapsed.

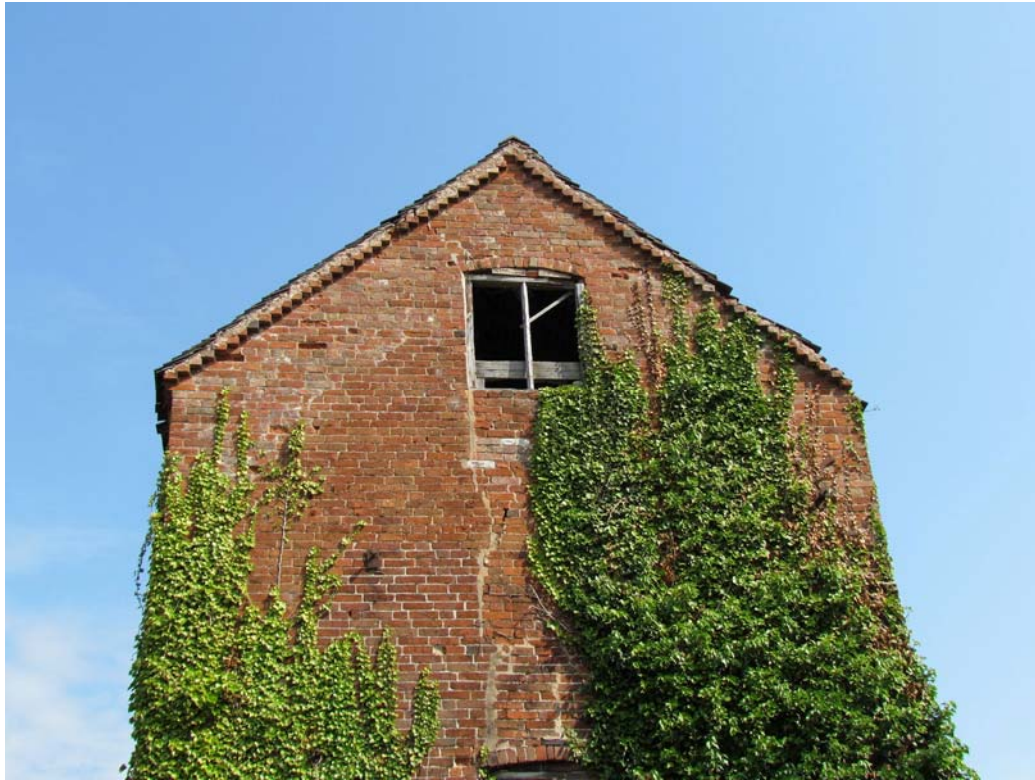
Figure 20: Detail of Upper Section Showing Changes in Brickwork.

Further up is a timber-framed mullioned window with a segmental arched brick head. Similar changes in the brickwork are visible above this height, although somewhat obscured by ivy growth. There is a similar window in the gable and lines in the mortar may indicate previous alterations in the position of other windows as the height of the mill was altered. The eaves are stepped under the gable.

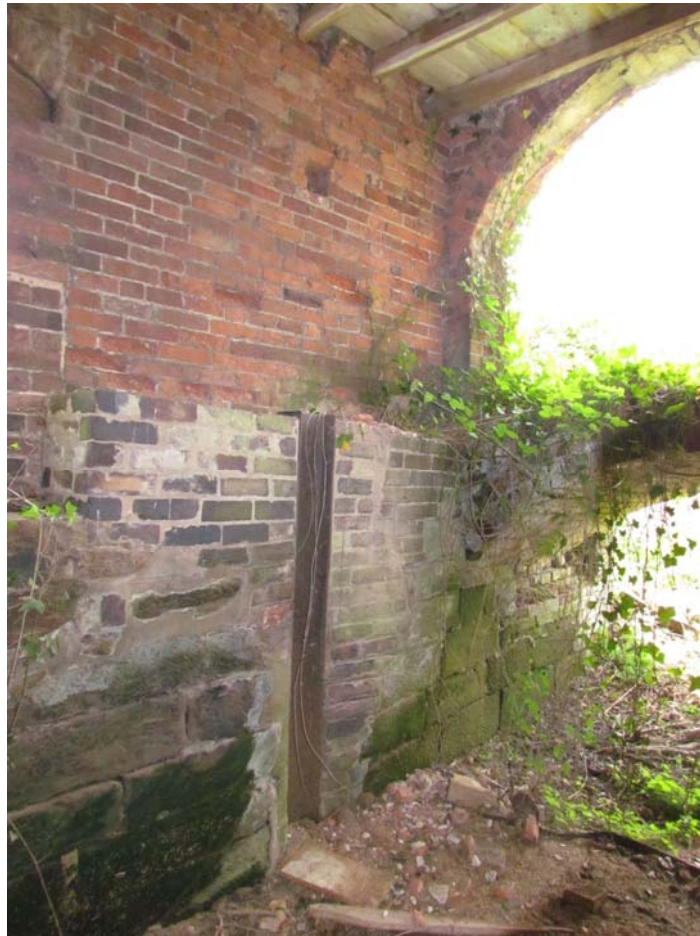
Figure 26: Detail of Southern Wheelpit, Looking South.

of the stone floor, an infilled opening and more recent repairs to the pit with modern brick and a steel joist.

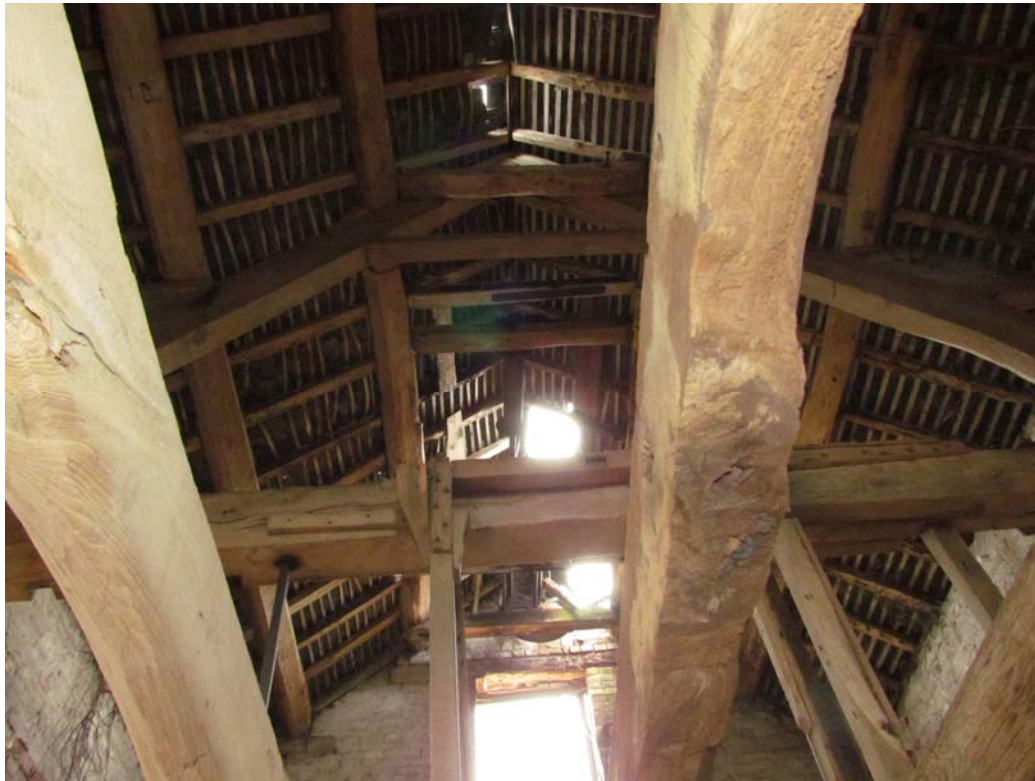
Figure 32: View of Roof Structure from Stone Floor, Looking North.

The upper floors were accessed by stairs which have now been removed. The bin floor provided storage in timber bins but, at the time of survey these and the floor had collapsed. However, a view into these levels could be obtained from the stone floor. The walls retain evidence of whitewashing. The roof structure incorporates a pair of crucks, probably re-used from an earlier roof, into the trusses with a tie-beam. There are two hand-finished purlins on each side with lap-joints entrenched into the principal rafters. A rectangular structure is incorporated at the ridge to support the sack hoist.

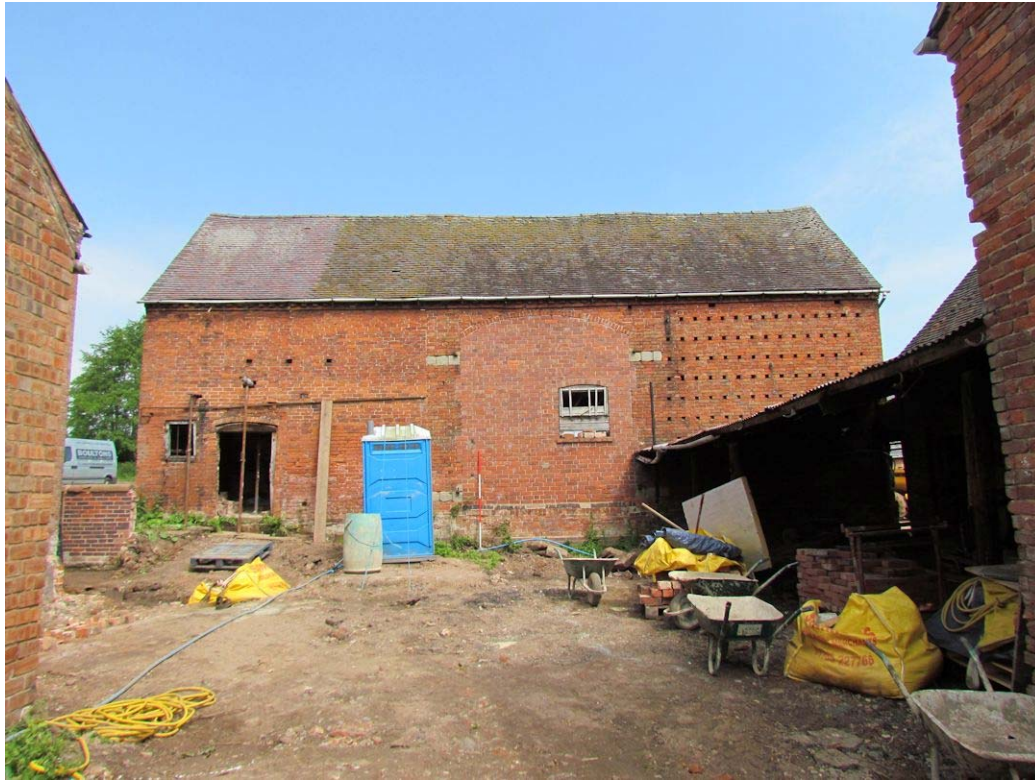
Figure 34: South-east Elevation of Barn 1, Looking North-west (Scale = 2m).

This longitudinal, four bay building is two storeys in height and constructed of red brick in a variation of a Flemish bond of a row of stretchers and a row of two stretchers and two headers. There is a brick plinth but modern brick underpinning has been introduced. The building has a pitched roof covered in blue clay tiles, the south-west section of which appears to have been replaced and there are dentilled eaves. The south-east elevation originally had a full-height cart entry in what is now bay 3, with four stone door hinge pads which survive, but the opening has been infilled and a window inserted to the new wall. Bay 4 has regular lines of ventilation holes and marks the threshing floor. A line in the mortar between bays 1 and 2 and bay 3 indicates where the side of the building was built up in the later 19th century to create a stable on the ground floor with hay storage above. The stable has a doorway with a timber surround and a cut-brick head and a window, also with a timber surround. At the time of survey, access to the first floor was not possible due to the poor condition of the ladder and floor and of the external steps.

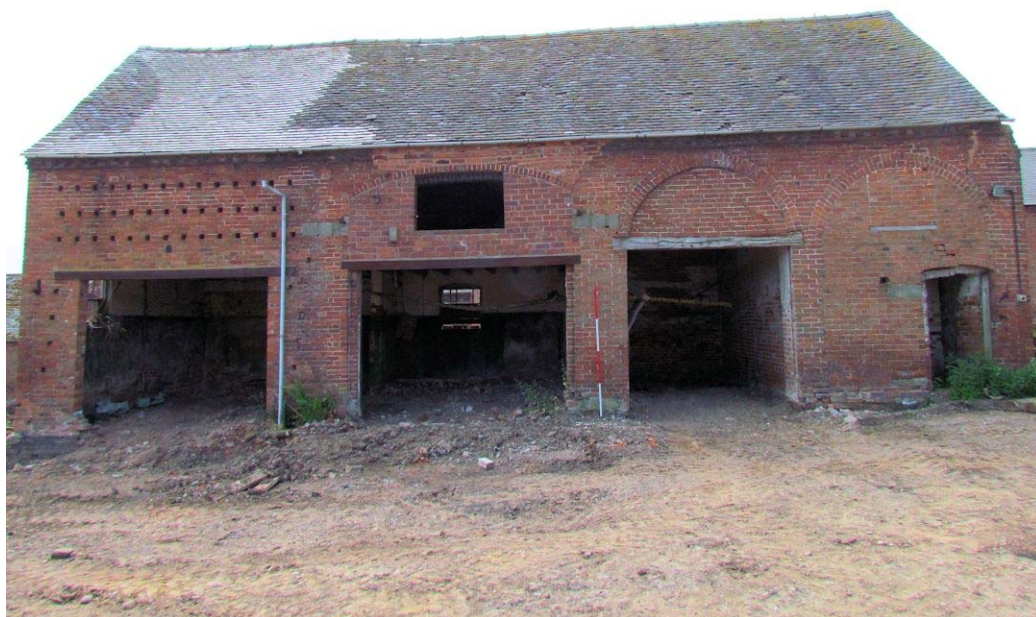
Figure 35: North-west Elevation, Looking South-east (Scale = 2m).

The former cart entry on this elevation had a segmental brick arched head and has also been infilled with a steel joist forming the lower opening and a window above but retains three stone hinges. Repair work appears to have been carried out to the brickwork here. The wall in the former threshing floor in bay 1 has been partially removed, also with a steel joist inserted. Bays 1 and 2 are marked by round arches each formed of a double row of headers. The arch in Bay 1 was infilled in the late 19th century to form the stable and a door with a part-timber surround and a window with a timber sill inserted. Two stone hinges were inserted by the door surround and the window has subsequently been infilled. The northern part of the roof on this elevation appears to have been repaired.

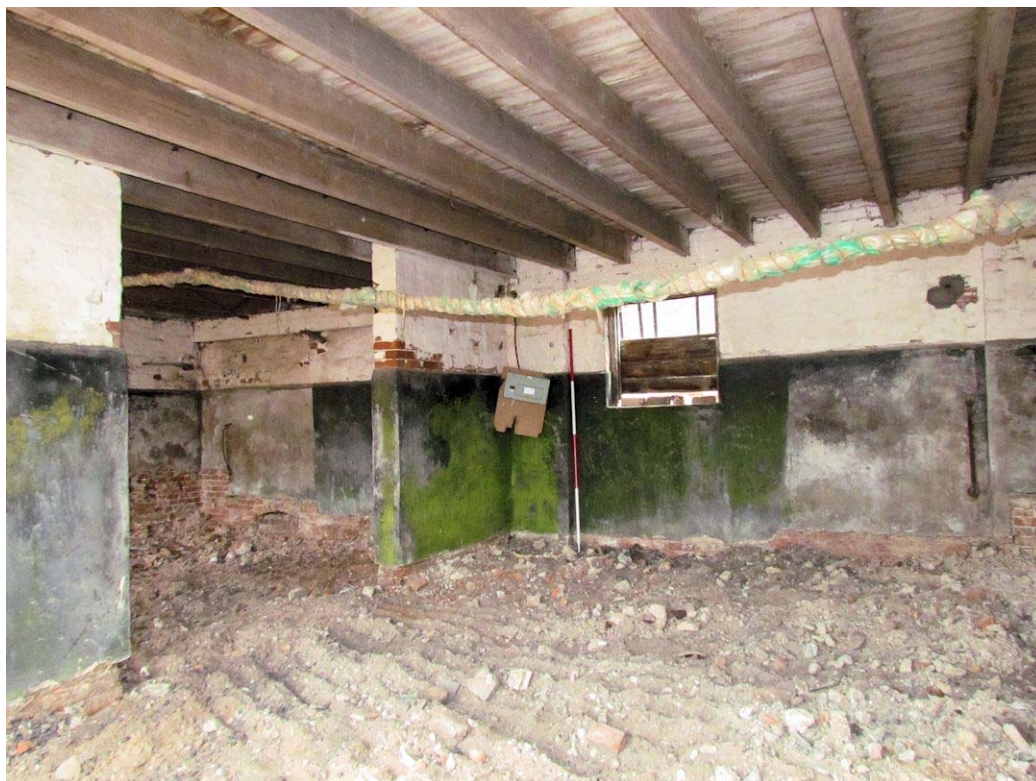
Figure 40: Interior of Bay 3, Looking East (Scale = 2m).

Bay 3 has been completely altered from its former function as a cart entry, with the end walls infilled. It appears to have been used most recently for housing cattle as the walls are surfaced with a thick concrete screed at lower level and painted white above. A timber floor has been inserted above and the floor removed at the time of survey. The slot in the partition wall in bay 2 allows a view into the upper floor in bay 3 and reveals a similar roof structure continuing the length of the building.

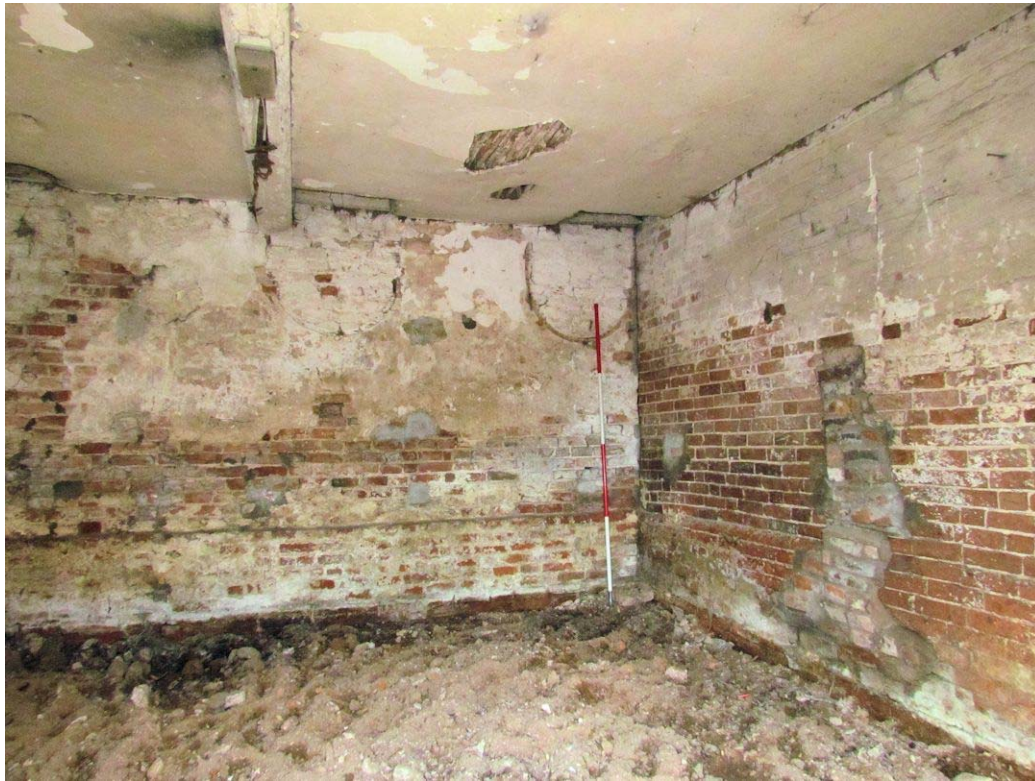
Figure 52: Bay 1, Looking North (Scale = 2m).

There are signs of hay byres on the north wall which indicate this has been used as a stable. There is an infilled opening on the east wall. Openings in the ceiling allow a view of the roof which has a modern lining and has presumably been replaced. At the time of survey, the floor had been removed.

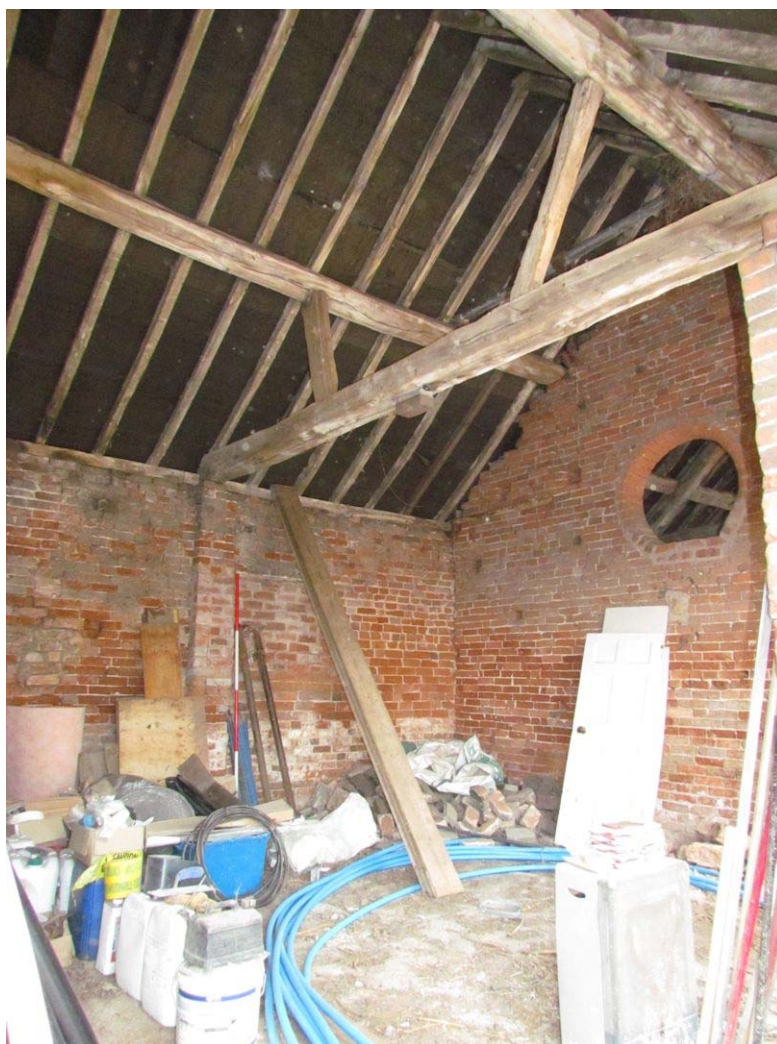
Figure 54: Bay 3, Looking North (Scale = 2m).

This bay has a good view of the truss, formed of a tie-beam supported by a brick pier and two struts supporting the two purlins. The roof here has a modern lining and has presumably been replaced. There is a round pitching eye in the north-east wall which may have been inserted as there is evidence of fragments in the brickwork around it. The floor is concrete screed.
