An Archaeological Watching Brief at The Friarage, Hartlepool

ARS Ltd Report No. 2013/105 November 2013

In November 2013 Archaeological Research Services Ltd was commissioned by Galliford Try to undertake an archaeological watching brief at The Friarage, Hartlepool, during geotechnical works in advance of the redevelopment of land surrounding The Friarage building. The work involved monitoring the excavation of a series of geotechnical test pits and boreholes

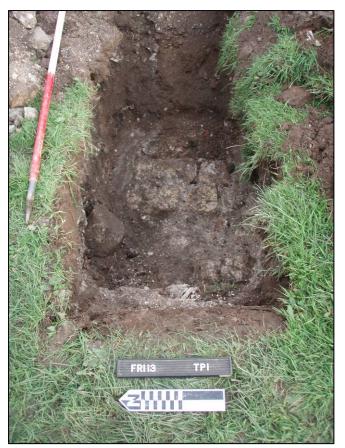
- 5.1.2. A sandstone wall was discovered within the layer of made ground (005). Initial investigation of the wall revealed blocks of un-bonded sandstone rubble. Further excavation found that the wall had survived much better at a lower level, however. The wall was running from north to south and was constructed of roughly faced sandstone blocks bonded with lime mortar. It appeared that the wall consisted of two rows of bonded sandstone blocks running parallel to each other. It is possible that the void in between would have originally been in-filled with rubble. The blocks of sandstone had an average size of 0.2m x 0.17m. Due to the limited size of the test pit it was not possible to determine anything more about the wall, such as form or function. No finds were recovered from the vicinity of the wall. A thin layer of concrete was found lying directly above the wall in the northern side of the trench. Further excavation of the trench revealed that the concrete was encasing another ceramic pipe (006). It appears that the wall had been partially demolished in order to lay the two ceramic pipes and this would account both for the rubble that was encountered during initial investigations and the lime mortar dust that was seen within the made ground (005). The wall had been built into the natural yellow sand (014) that sat beneath the made ground. The foundations were quite deep and substantial but unfortunately, due to the depth of the trench, further investigations were deemed too unsafe.

Figure 3: Test Pit 1 showing stone wall. Scale = 1m

- 6.1. It is possible that the short length of stone wall encountered in Test Pit 1 is associated with the 17th century mansion that still stands on the site. However not enough of the structure was revealed to determine its form or function.
- 6.2. The brick foundations found in Test Pit 2 appear to relate to the 19th century hospital that once stood in the southwest part of the site. Again, however, due to the narrow width of the trench no more can be said about the remains. The made ground encountered across the site has been interpreted as demolition waste that was produced when the 19th century hospital was demolished.

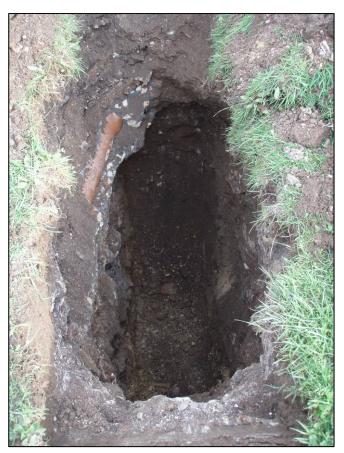
- 5.1.3. The test pit was dug through the natural sand (014) and excavation was terminated when the bedrock (012) was reached. At this point the trench had an overall depth of approximately 2.5m.

Figure 4: Test Pit 1 after excavation.

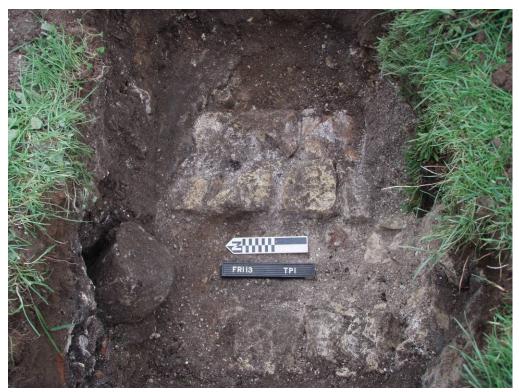
Figure 5: Test Pit 1 showing detail of wall. Scale = 0.25m.

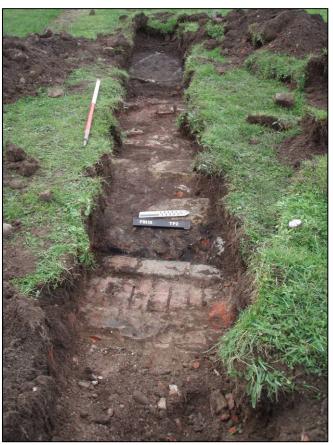
5.2.1. Test Pit 2 was dug towards the southwest corner of the site. The pit was excavated through the modern turf and topsoil (001). Directly beneath the topsoil, a large concrete slab (007) was encountered. The trench was moved slightly to the east, in order to avoid the concrete slab, where three lines of brick foundations (008, 009 and 010) were uncovered. The brick foundations were within a layer of made ground (005) which consisted of grey-brown sandy silt with crushed sandstone. The foundations were running in a southwest-northeast direction and each was constructed of typically Victorian 9-inch, unfrogged, red engineering bricks measuring 0.11m x 0.23m x 0.07m and bonded with a cement mortar. Once the foundations had been recorded, an attempt was made to remove them using the mechanical digger. This was unsuccessful, however, so excavation of the trench was abandoned.

Figure 6: Test Pit 2 showing the brick foundations. Scale = 1m.

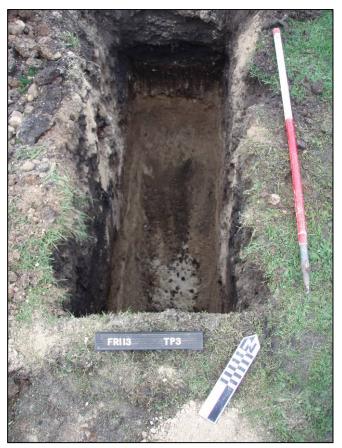
5.3.1. Test Pit 3 was dug towards the centre of the development site. The pit was dug through the modern turf and topsoil (001) and down through made ground (002) that was 0.13m deep and consisted of dark brown, finely textured clayey silt containing brick and stone rubble. Beneath the made ground was a layer of very dark material consisting of ash, clinker and slag (011). This has been interpreted as a dump of industrial waste material. Beneath this layer was the natural yellow sand (014) sitting above the bedrock (012). No archaeological finds or features were found within this pit.

Figure 7: Test Pit 3 after excavation. Scale = 1m.

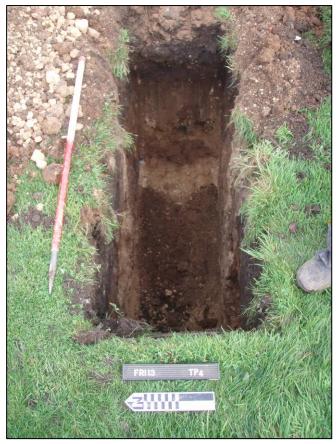
5.4.1. Test Pit 4 was located towards the southern extent of the site. The pit was dug through the modern turf and topsoil (001) and down through made ground (002) that was 0.13m deep and consisted of dark brown, finely textured clayey silt containing brick and stone rubble. Beneath the made ground was a layer of very dark material consisting of ash, clinker and slag (011). This has been interpreted as a dump of industrial waste material. Beneath the very dark layer was a layer of red/brown clay (013) that had a depth of 0.15m. The red/brown clay was sitting directly on top of the natural yellow sand (014) which in turn was sat on top of the bedrock (012).

Figure 8: Test Pit 4 after excavation. Scale = 1m.

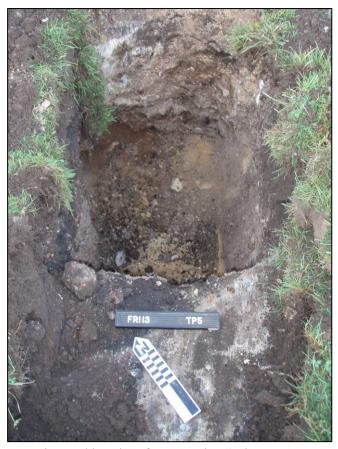
5.5.1. Test Pit 5 was located slightly to the east of the Friarage building. The test pit was dug through topsoil and turf (001) which was overlying a thin layer of dark material consisting of ash, clinker and slag (011). Beneath this was a layer of made ground (005) containing crushed sandstone with a depth of 1m. Amongst the made ground were two sections of concrete (016 and 017) which, it was presumed, encased ceramic drains. The test pit was only extended down to the bedrock in between the two blocks of concrete. Beneath the made ground was the natural sand which was sitting directly on top of the bedrock.

Figure 9: Test Pit 5 after excavation. Scale = 0.25m.
