## An Archaeological Watching Brief at The Friarage, Hartlepool

**ARS Ltd Report No. 2014/105**  
March 2014

# An Archaeological Watching Brief at The Friarage, Hartlepool

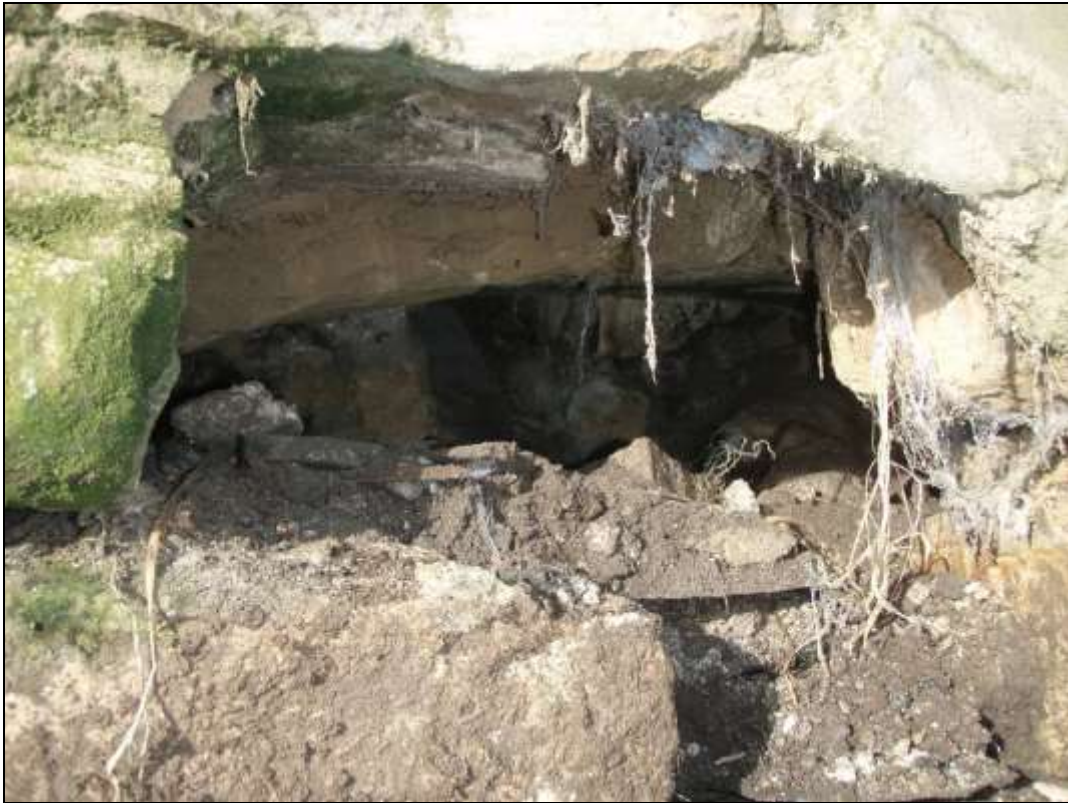
5.2.3 The stonework in the blocked-up doorway was very loose and poorly constructed and some of the stones became dislodged during excavation. When some of the stones were removed they revealed that the wall was constructed with an inner and an outer leaf of faced sandstone blocks with a lime mortar core. The interior of the door was topped by a segmented arch constructed of carved sandstone blocks. The arch could be seen springing from the inner leaf of the left door jamb.

5.2.4 The basement beyond the door had been backfilled with modern rubble and demolition debris although there was a gap of approximately 0.2m between the top of the backfill and the ceiling.

Figure 3: Looking through the blocked opening to the arch beyond.

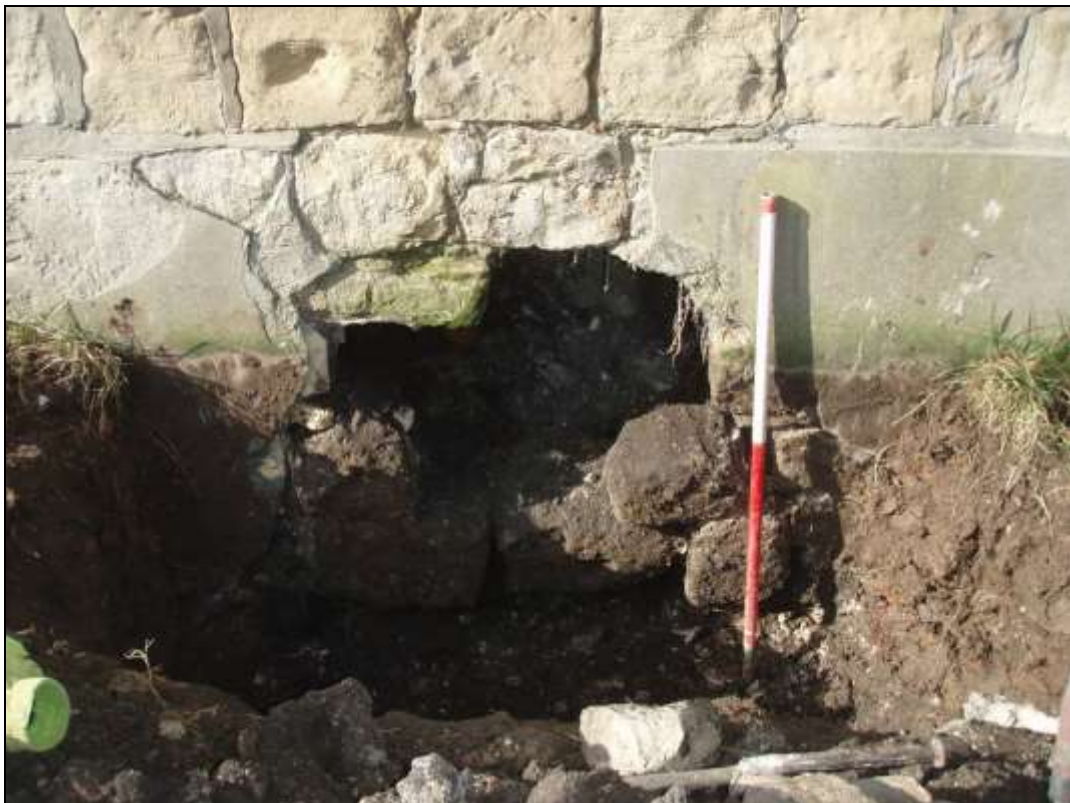
5.2.2 In recent years a layer of render had been applied to the outer face of the building from approximately 0.45m above ground level to approximately 0.5m below. This render had chipped off in some places and investigation of the stonework of the building revealed a doorway that had been blocked up with re-used faced sandstone blocks bonded with lime mortar. Due to the shallow depth of the trench only the top 0.6m of the doorway was revealed. The left jamb of the doorway was visible but the right jamb was beyond the limits of the pit. There was no sign of a lintel along the top of the doorway.

Figure 4: Test Pit 1 showing the blocked doorway.

- 6.1. The lack of a lintel across the top of the blocked doorway is unusual and may indicate that it was originally a window that was later opened up and made in to a door before subsequently being blocked up when the hospital closed. If this is the case then the only access into the basement would have been from inside the building. Although the stonework beneath the other two windows was not investigated it is assumed that a further two blocked-up mullioned windows would be present.

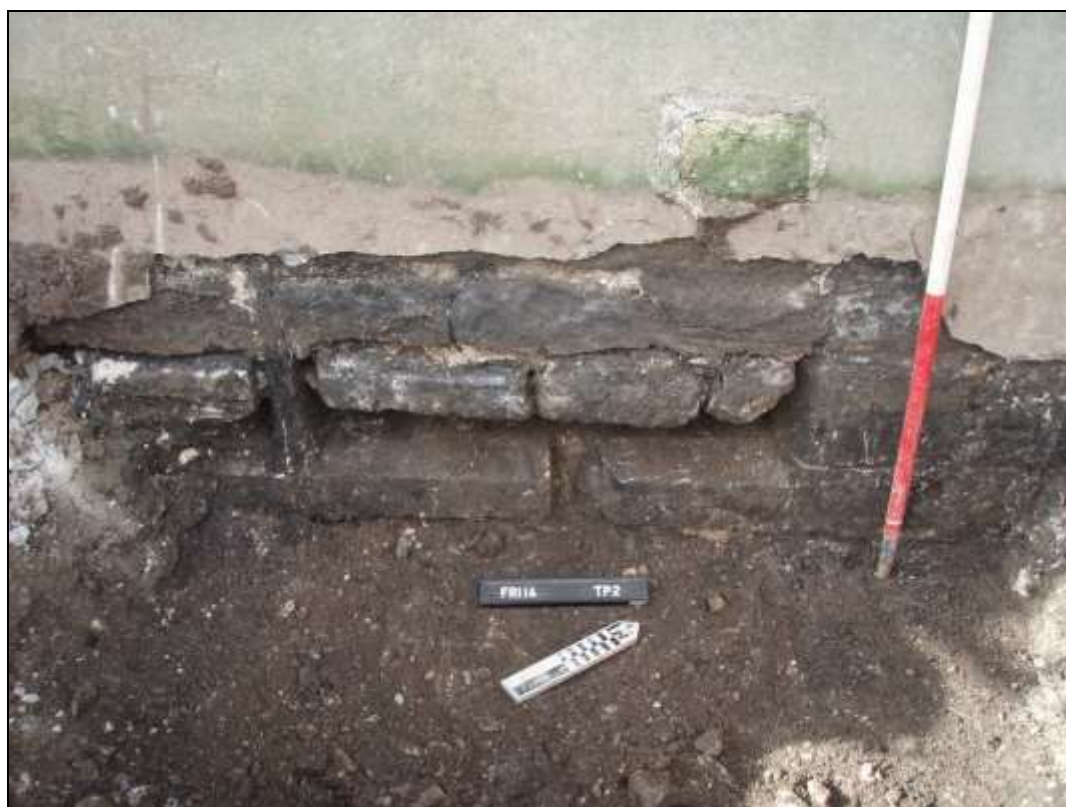
- 5.3.2 At a depth of approximately 0.6m a stone window sill was discovered. Cleaning the stonework revealed the lower right hand side of a window with a single surviving stone mullion. There was a scar on the sill where another mullion would have originally been. The window had been blocked up with sandstone blocks bonded with lime mortar. The render on the outside of the building covered the top portion of the window although some of this was loose and became dislodge during excavation which revealed more of the window.

Figure 5: Test Pit 2 showing the stone window sill with surviving mullion. Scale = 1m

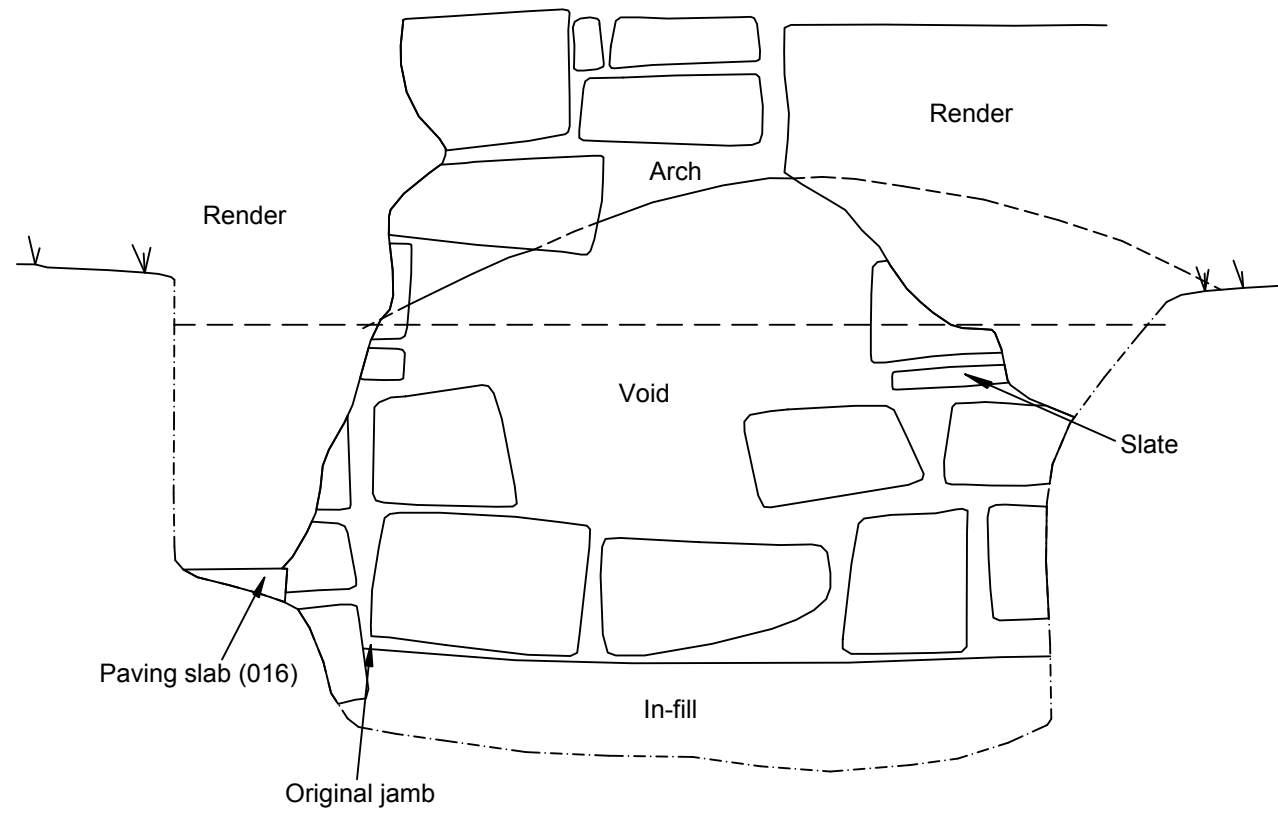
Test Pit 1

Sections of Test Pits 1 and 2 showing door and window detail
