**Ivy House barns and stable complex,  
Biggin-by-Hartington, Newhaven,  
Derbyshire**

**Built Heritage Assessment**

**ARS Ltd Report 2011/111**  
November 2011  
OASIS ID: archaeo15-175378

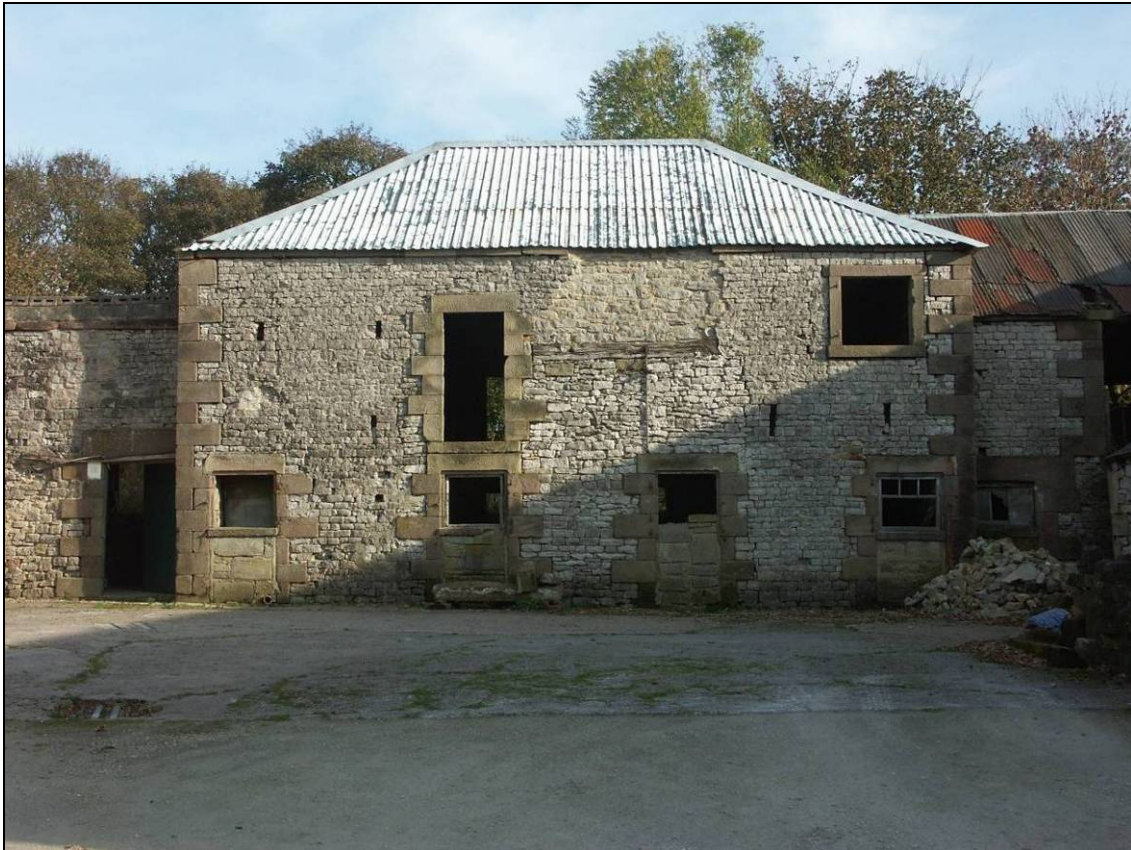
4.3 The eastern wing is composed of a central and slightly taller and wider range of four-bays and two storeys with a hipped roof (Block 2), which is flanked by smaller projections (Blocks 1 and 3) of which the northern one has lost its upper storey and has now a shallow mono-pitched metal roof. The west elevation of Block 2 had been altered with the insertion of a large central opening with a timber lintel (Fig. 3). The opening is currently blocked with roughly hewn coursed limestone rubble and contains a stable doorway equivalent to the remainder doorcases of the ground floor. Above the lintel there is a poorly repaired/rebuilt masonry section. The lower section of the stable doorways are blocked up, modifying them into window openings instead. There are several ventilation slots.

Figure 3: West elevation of the eastern wing with the central range (Block 2)

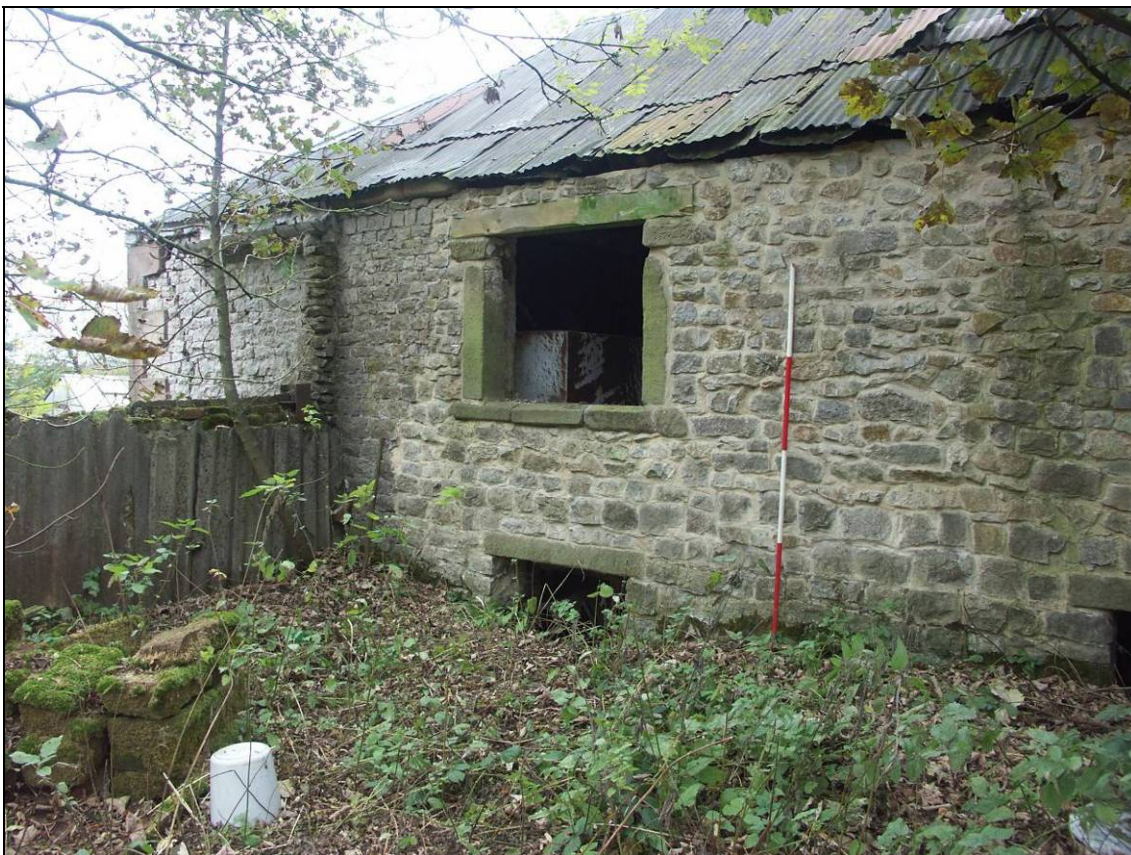
4.5 The upper section of the east elevation of Block 3 also has a large area which might have recently been rebuilt (Fig. 4). There is a considerable crack along the southern quoins and a quoin block slightly misplaced as the result of having been knocked over. The east elevation of Block 2 also contains an equivalent large opening with a timber lintel and several ventilation slots (Fig. 5). It is suggested that the central range (Block 2) was altered into a threshing barn containing a central threshing floor with opposing doors for winnowing. Subsequently, the function of this range changed and the large doorways were blocked up.

Figure 4: Detail of rebuilt area within the east elevation of the eastern wing (Block 3)

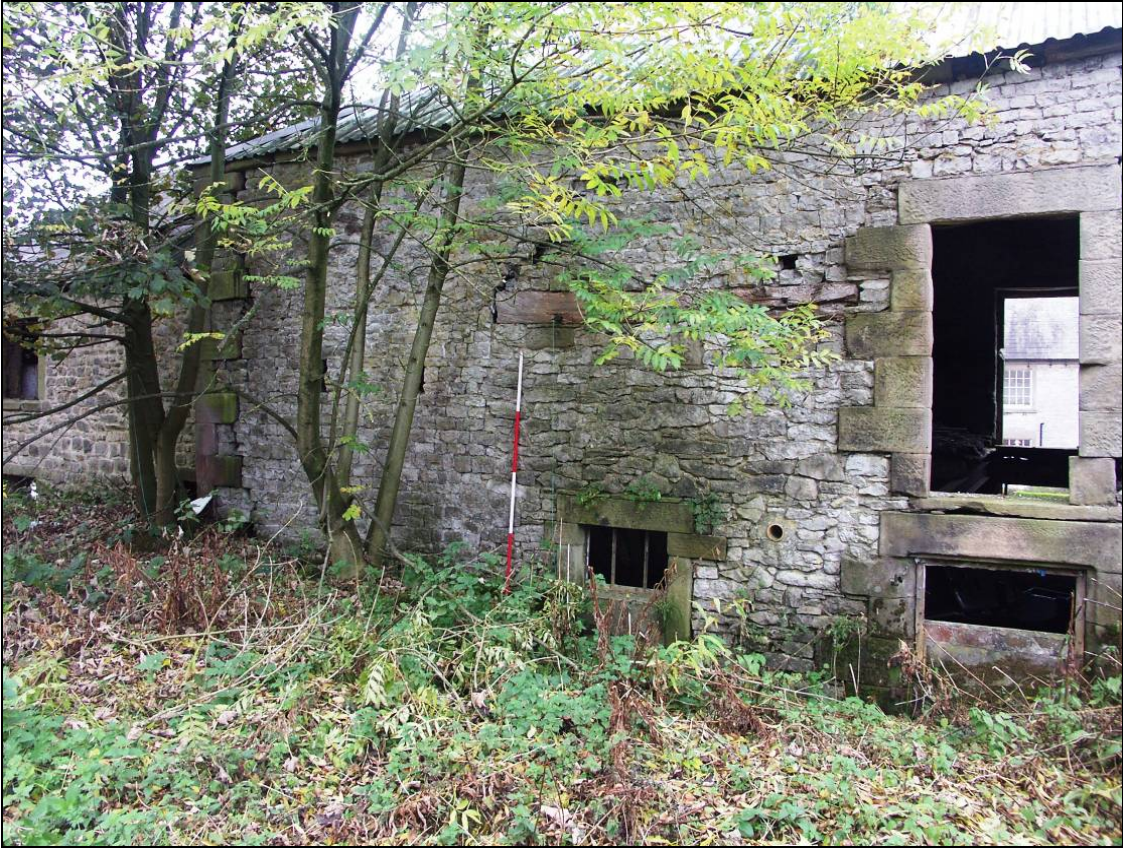
4.4 The rear ground level has been considerably raised (*c.* 1 to 1.50m in height) with a made-ground deposit which partially blocks the original opening within the entire east elevation of Blocks 1, 2 and 3 (Figs 4 – 7). Therefore, the reduction of this later made-ground deposit would re-establish its primary appearance and function.

Figure 5: Central area of the east elevation of the eastern wing (Block 2)

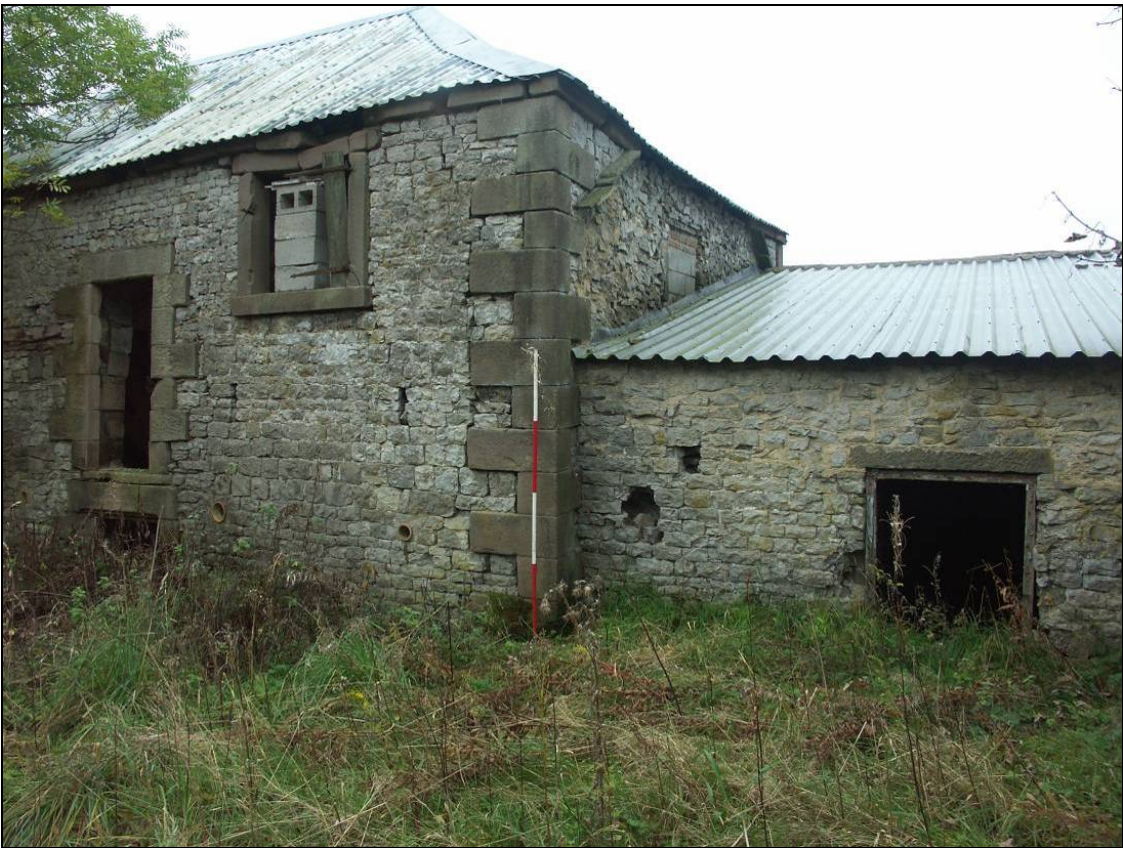
4.6 The northern projection (Block 1) has suffered severe alterations as its upper storey no longer exists. Traces of its original pitched stone flashing can be seen within the northern wall of the central range (Fig. 6).

Figure 6: Detail of quoins and northernmost section of the eastern wing (Block 2)

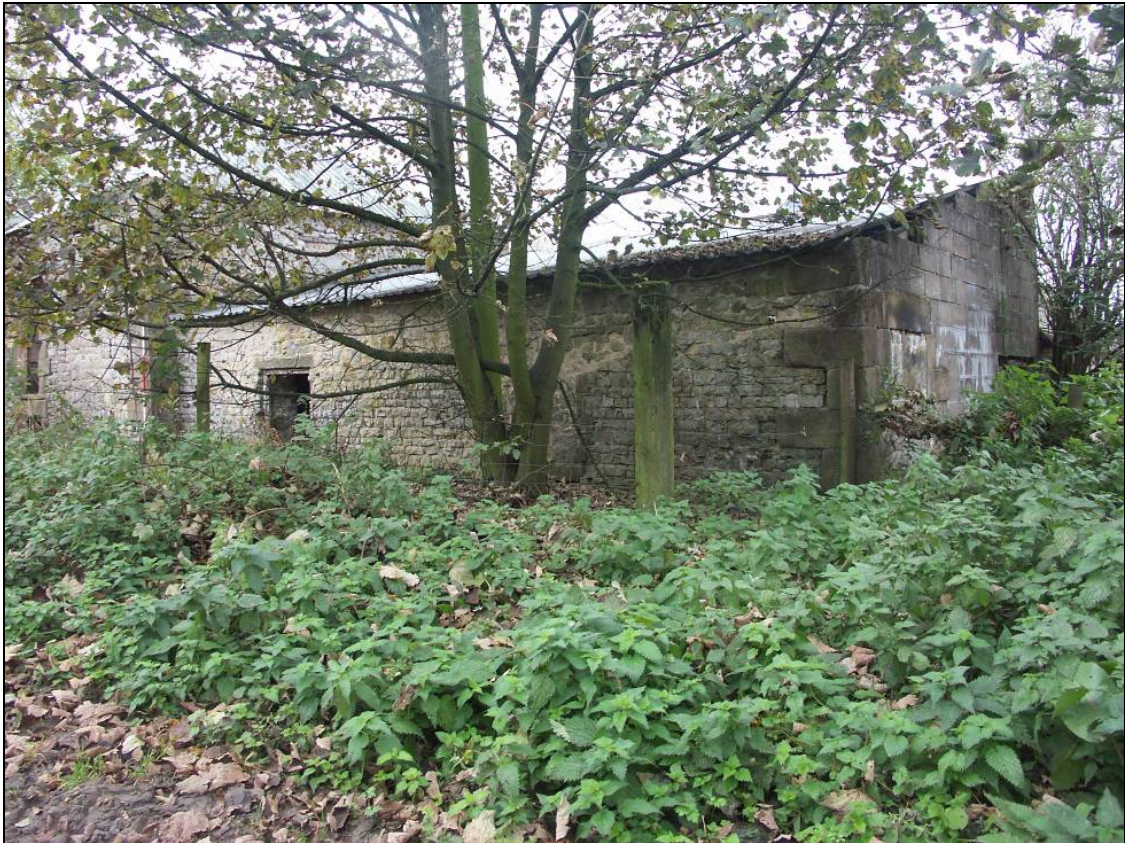
4.8 Further alterations within Block 1 include the insertion of concrete blocks forming the present northern elevation of the wing (Fig. 7).

Figure 7: Modern alterations within the north section of the eastern wing (Block 1)

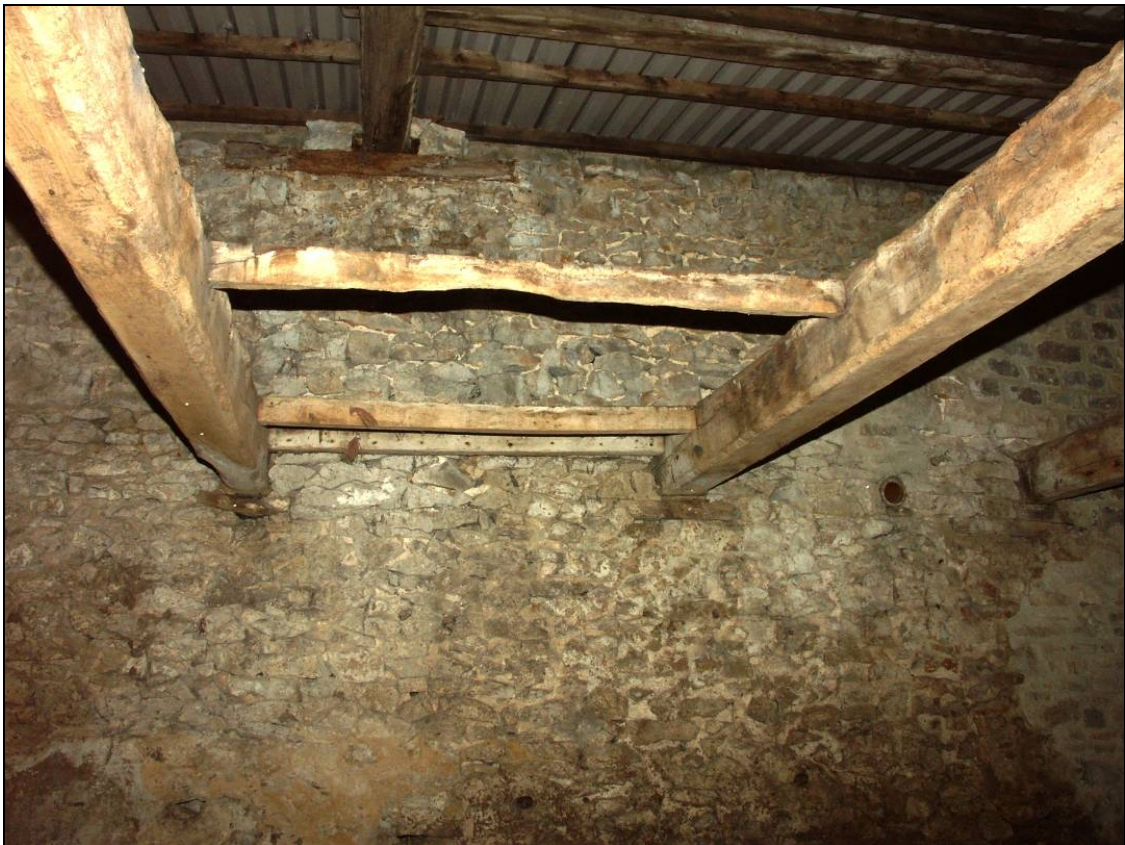
4.9 Internally, the masonry consists of random uncoursed roughly hewn limestone rubble throughout the entire blocks. Block 1 contains three large timber bridging beams. It is unknown whether these are set within their original location as they are supported by timber pads along the western wall (Fig. 8) but are devoid of them within the eastern wall (Fig. 9). It is suggested that these beams might have been associated with the present modified lean-to roof, instead of being the original bridging beams.

Figure 8: Bridging beams supported by timber pads within the northern section of Block 1

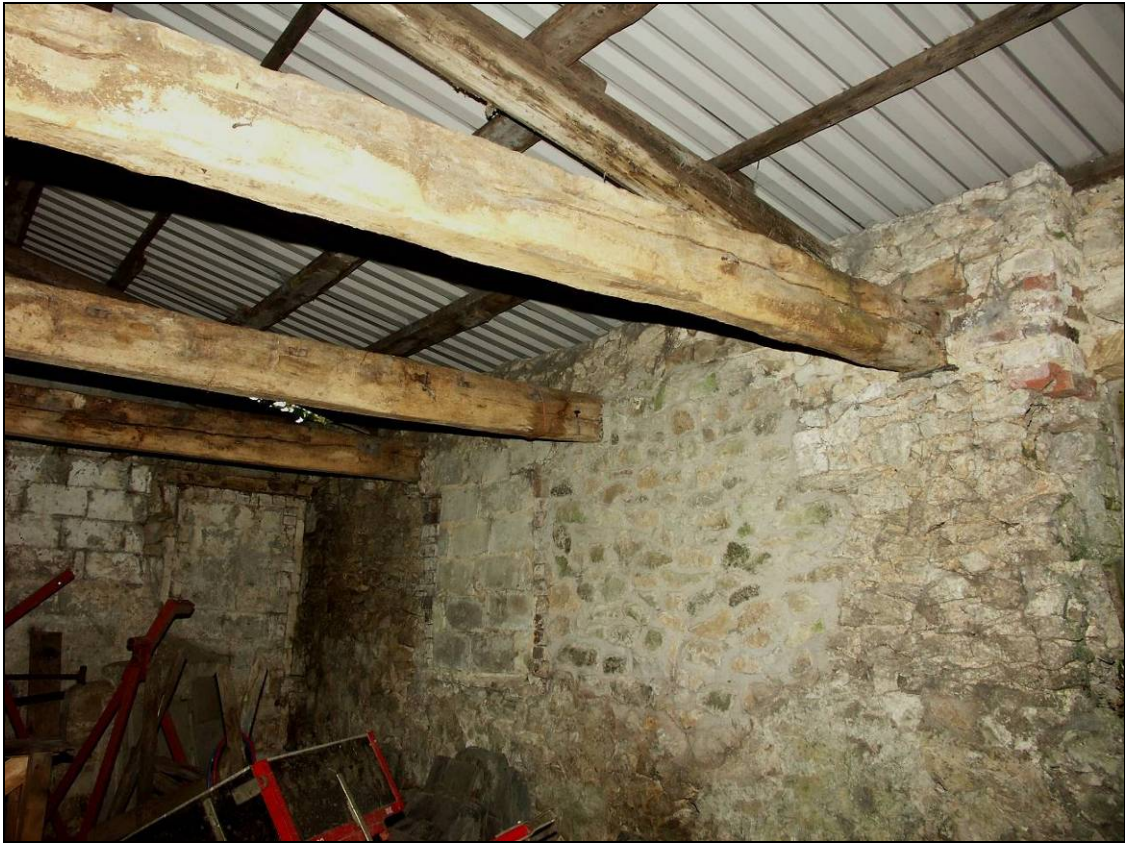
Figure 9: Opposite side of the bridging beams without support pads (Block 1)

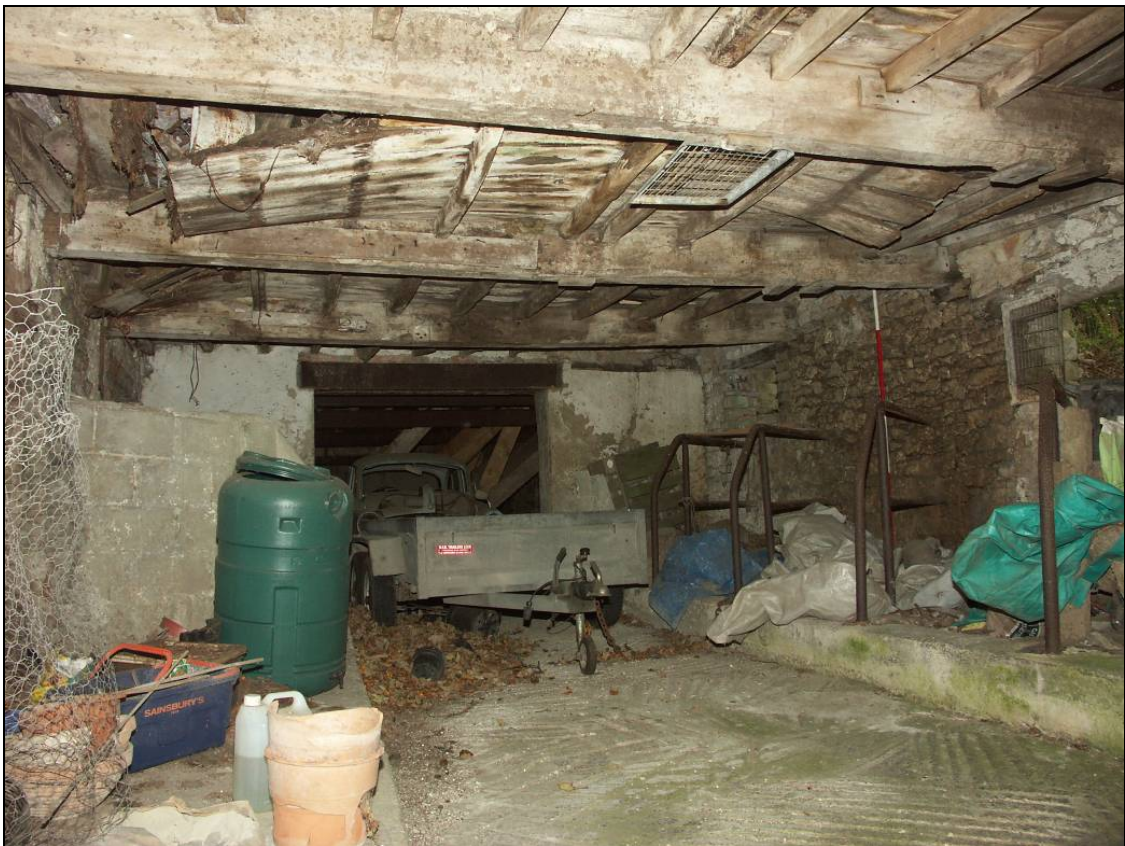
4.10 The southern projection (Block 3) has suffered substantial alterations including the insertion of raised concrete platforms for livestock on the ground floor. It has four original timber bridging beams supporting the floor above (Fig. 10). It is suggested that the existing floor arrangement would have been equivalent within Block 1 prior to its substantial alteration involving the insertion of the current roof.

Figure 10: Southern ground floor of the eastern wing (Block 3)

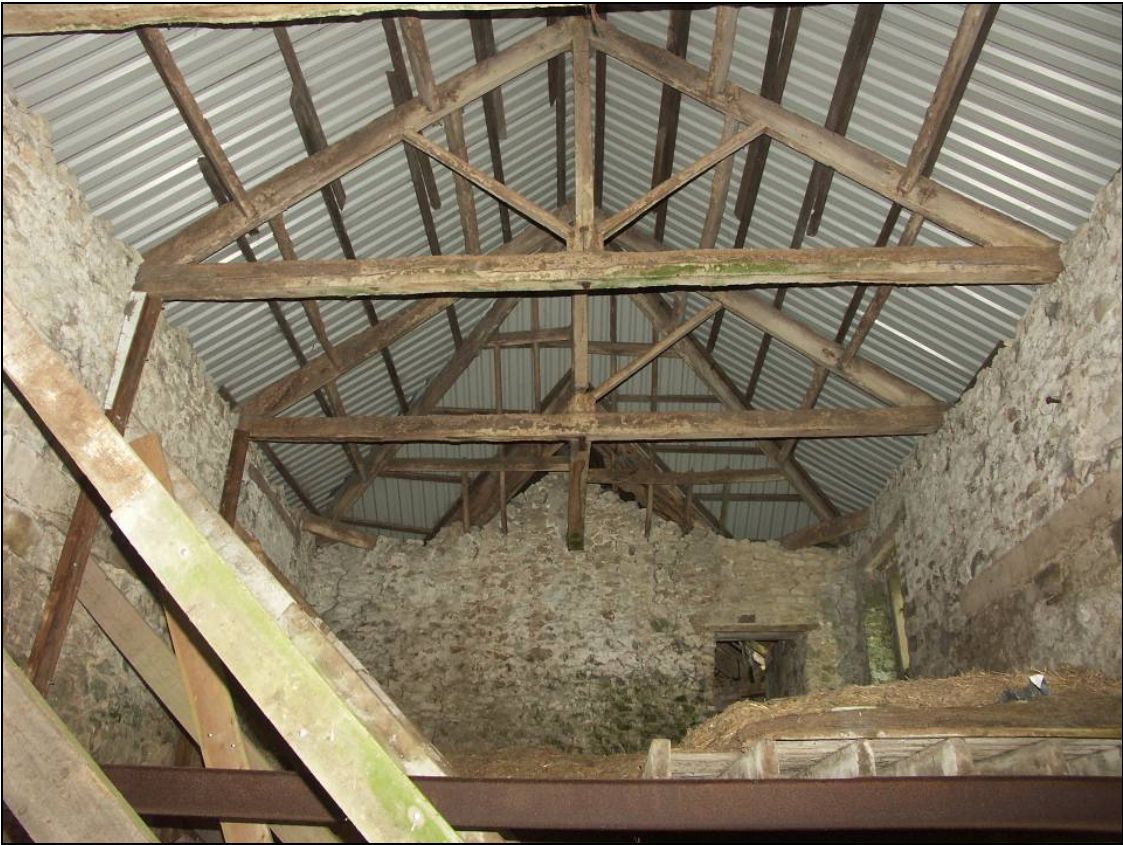
4.11 Block 2 contains several inserted RSJ girders creating floor spaces. The eastern wall is currently propped up with several timber planks. The original roof structure consists of king-post trusses, bolted to the tie-beams, carrying six tiers of staggered trenched side purlins (Fig. 11). The structure is in good to moderate state of preservation. However, the upper floor structures are currently unsafe due to previous rain water penetration.

Figure 11: General view of the central roof structure of Block 2

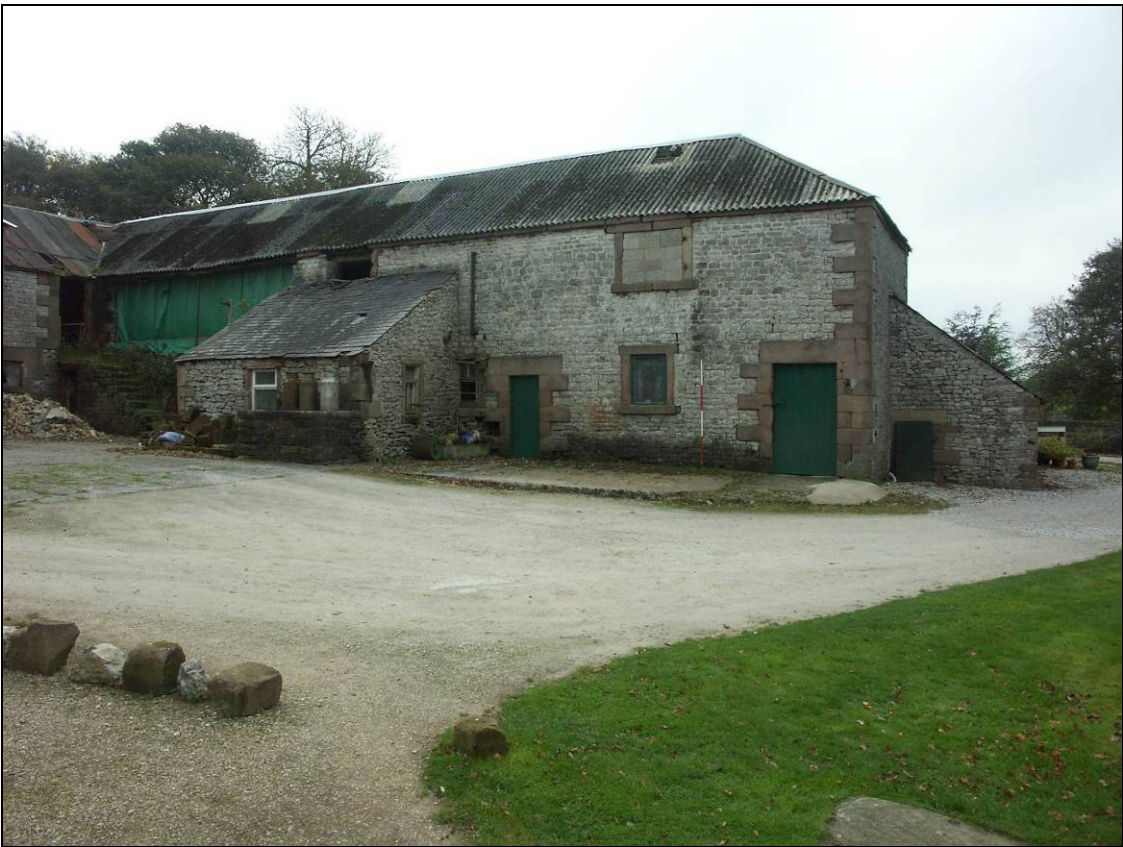
4.12 The southern wing (Blocks 4 and 5) is comparable to the eastern counterpart although is somewhat plainer (Fig. 12). The north elevation is severely damaged and part of the upper wall of Block 4 has collapsed (Fig. 13). This would have occurred recently as a

Figure 12: North elevation of Block 5

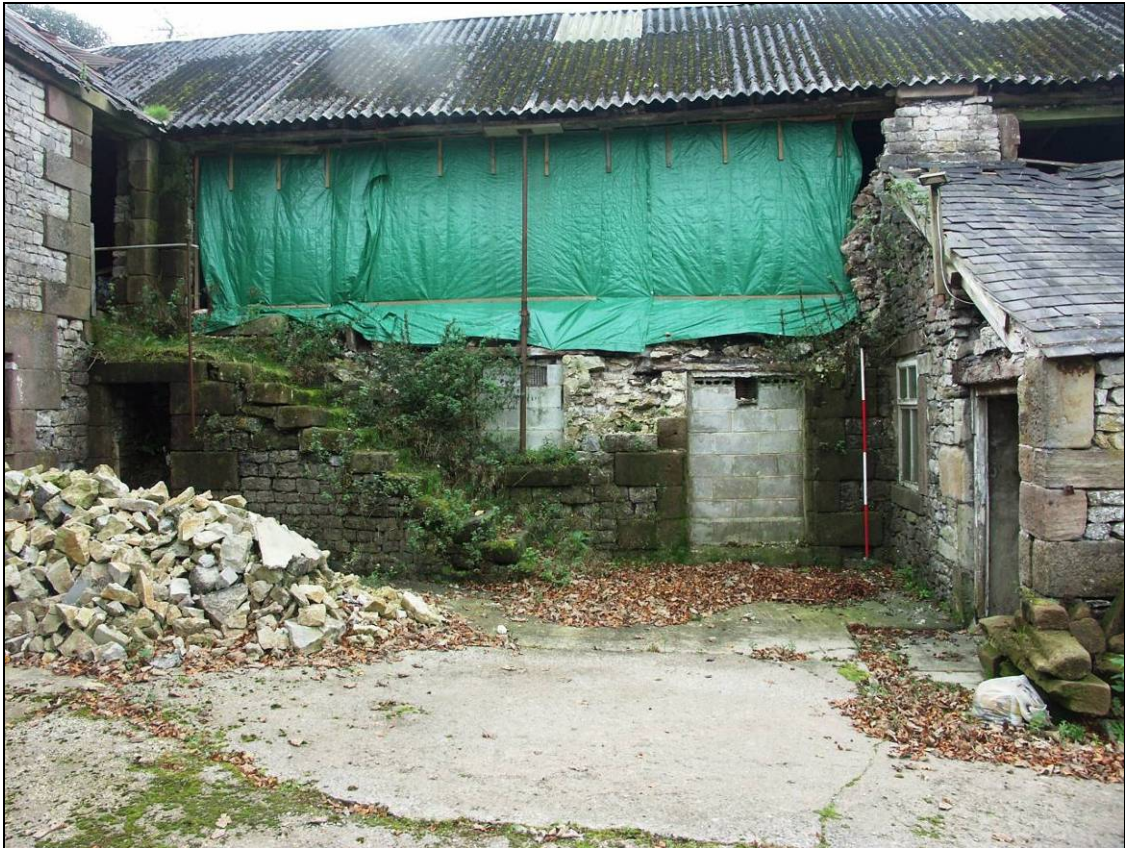
photograph taken in 2003, as part of the Images of England project, shows the entire wall standing (see Appendix I).

Figure 13: Detail of collapsed wall within the north elevation of the southern wing (Block 4)

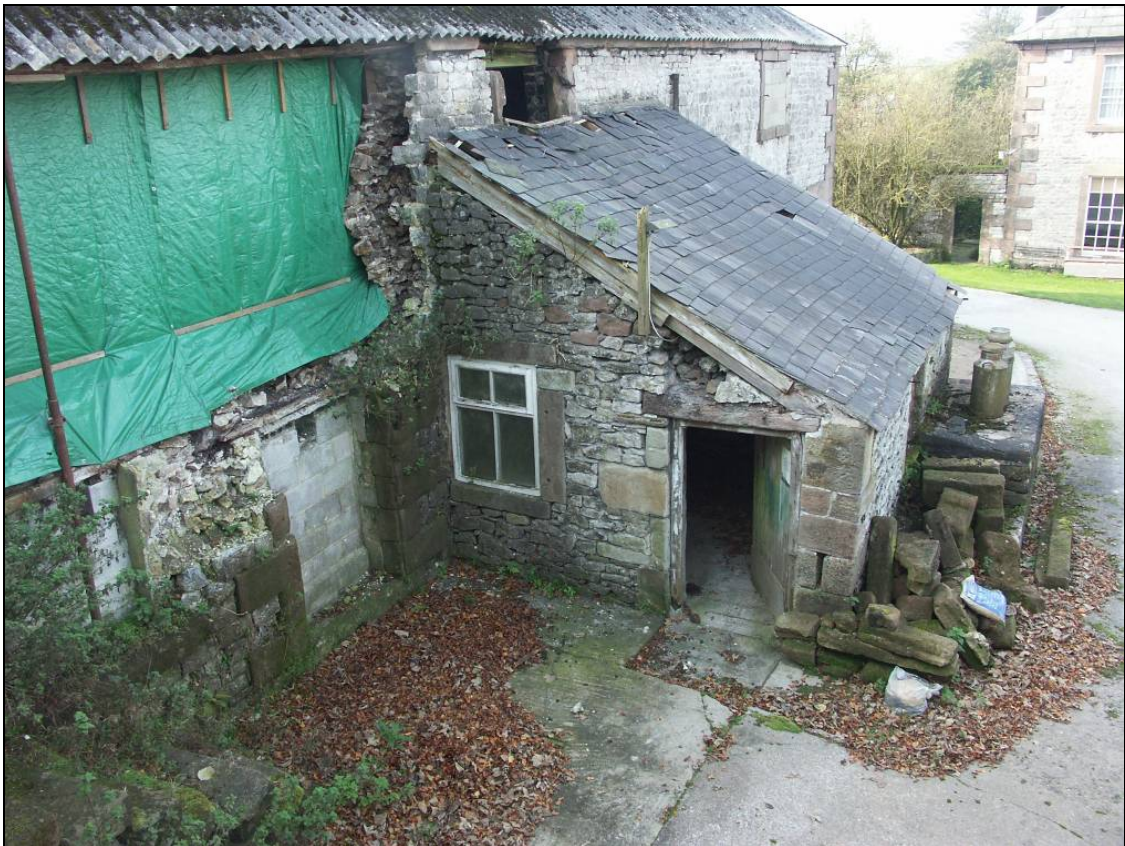
4.13 There is a small lean-to (Block 6) abutting the north elevation (Fig. 14) which is connected to the adjacent milking parlour (Block 4). The lean-to appears depicted from the first edition of the Ordnance Survey map issued in *c.* 1880s. However, its mono-pitched roof might have been modified at a later period as it partially obscures an original window opening above and furthermore, the present slated roof appears to be a modern replacement (Fig. 15).

Figure 14: Small lean-to (Block 6) abutting the north elevation of the southern wing (Block 4)

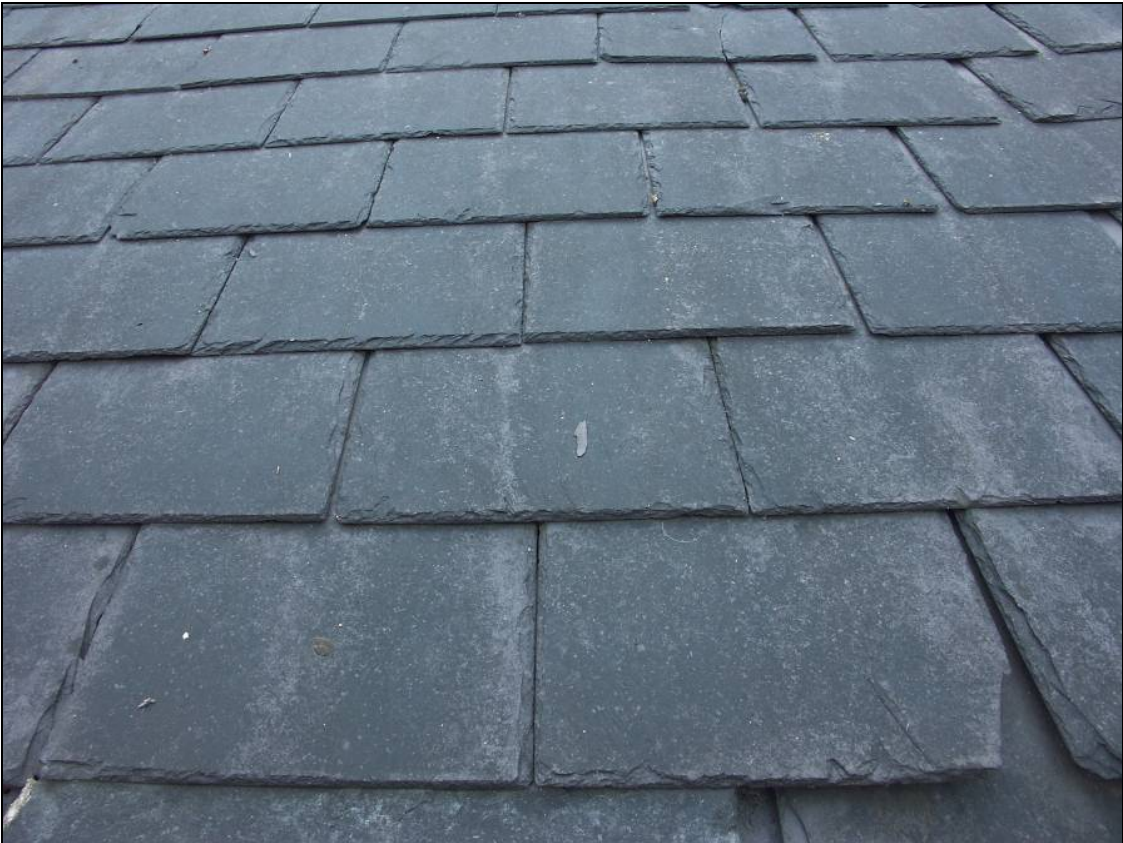
Figure 15: Detail of the slated roof of the small lean-to structure (Block 6)

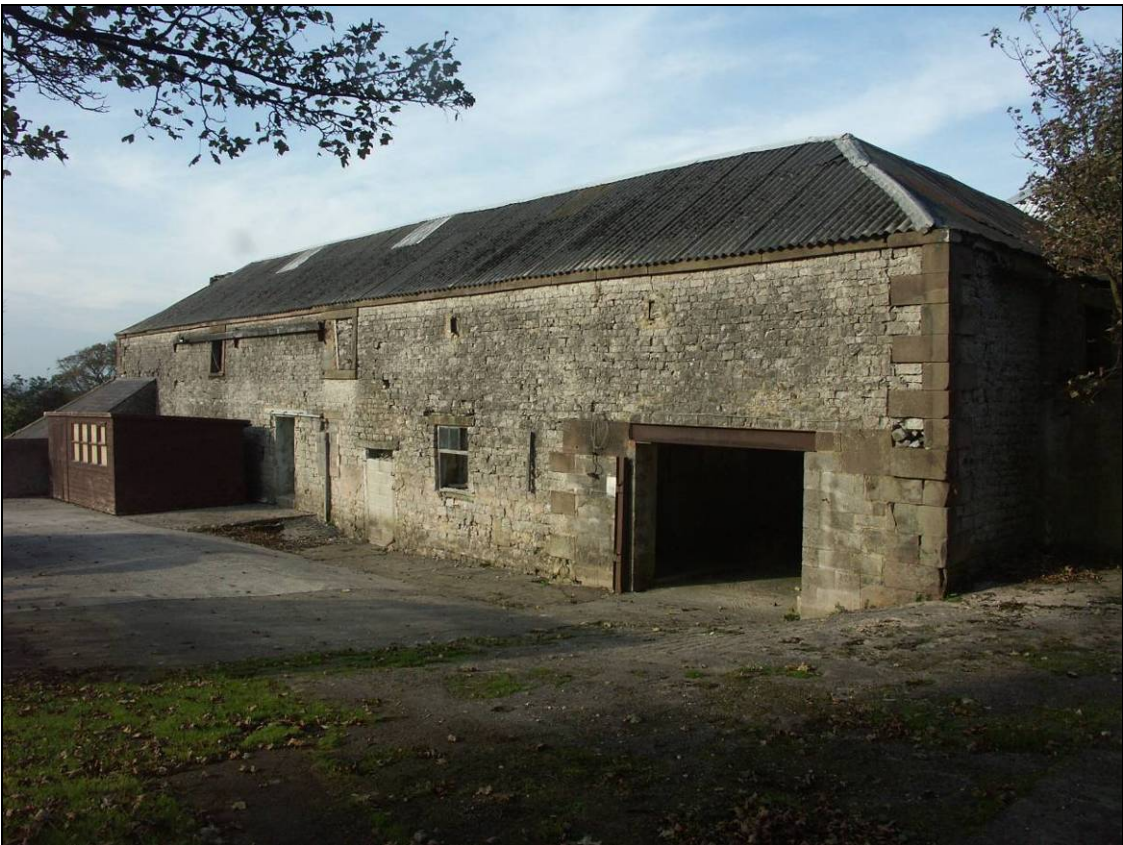
4.14 The south elevation of the southern wing (Blocks 4 and 5) has been modified with several later insertions, including several doorways, and blocking original window openings. Below the eaves, there are a series of RSJ girders cut flush with the wall which would have been part of a later steel abutment (Fig. 16). This elevation contains several cracks within the masonry. There is a short lean-to (Block 7) which appears to have been used as a pig sty. Block 7 would have originally extended eastwards as indicated by the cartographic records aforementioned (see section 3), and by a series of scars within the wall including several sockets for timber beams and a partially incised window sill which would have accommodated the apex of the lean-to extension (Fig. 17). Furthermore, the original lean-to can be seen in the historic photograph available from The Kings at Ivy House's website <<http://www.thekingsativyhouse.co.uk/ivy-house-location.html#>> prior to its alteration. The re-development work proposed to construct similar pens, to provide discrete enclosures for the individual cottage holiday lets, which would restore its original appearance.

Figure 16: General view of the southern wing

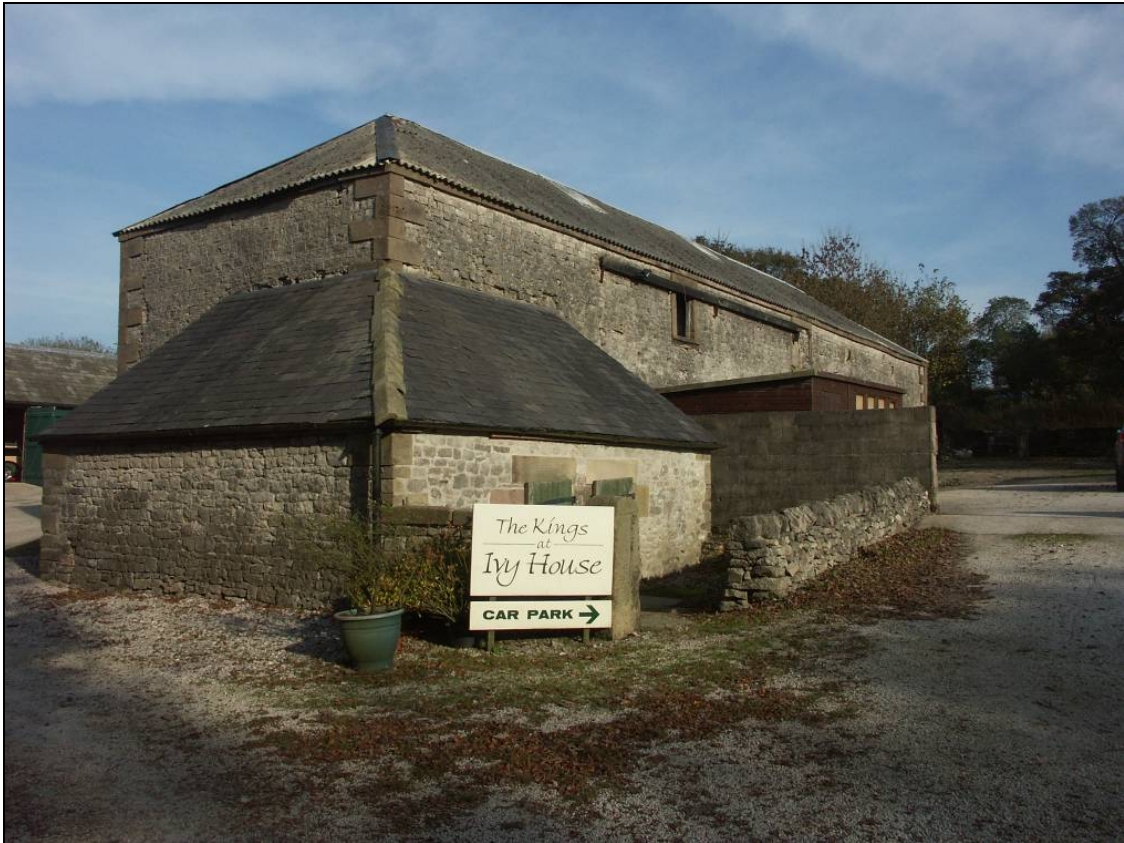
Figure 17: Southern wing with lean-to structure (Block 7) abutting the west and south elevations

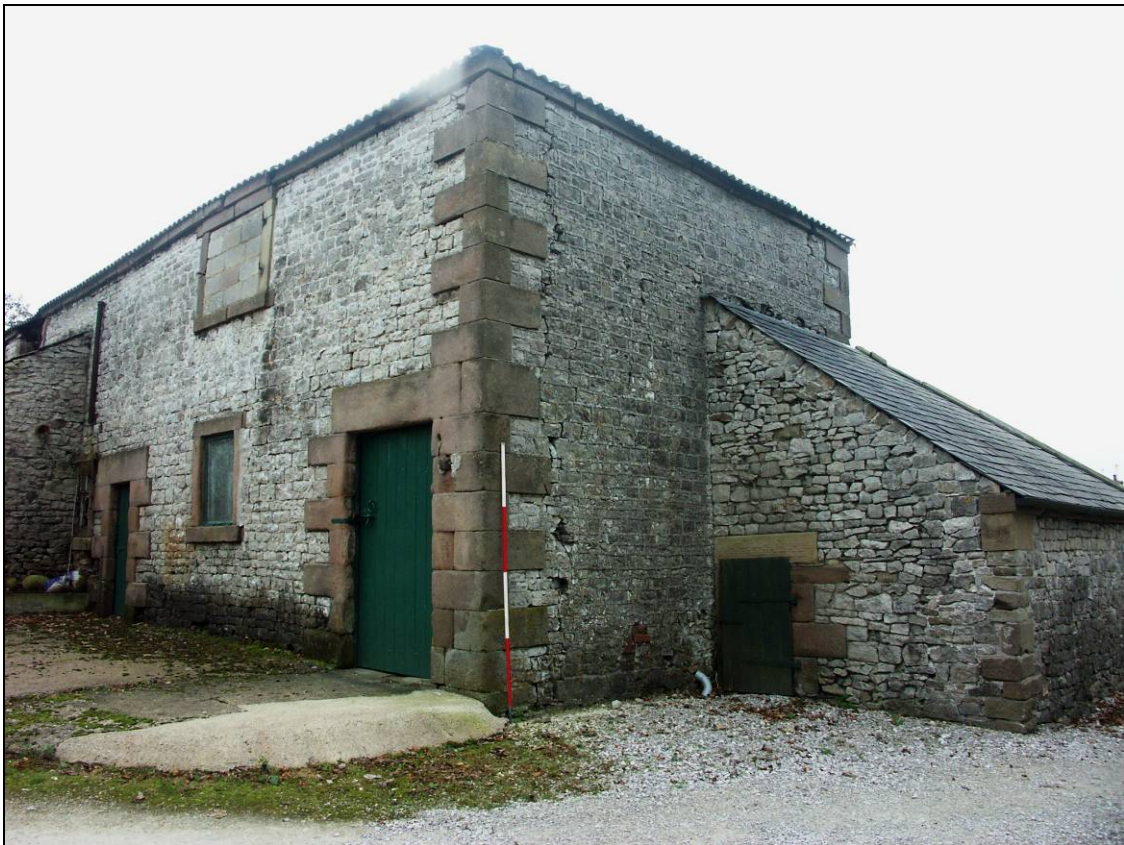
4.15 The west elevation of the southern wing (Block 5) is currently 'ribbon' pointed which is a later unsightly alteration (Fig. 18). The hard lines of raised ribbon pointing serve no purpose of benefit to the stone and have a rather aggressive appearance. In very poor random rubble masonry it is difficult to avoid buttering mortar over some areas of face but it is not good practice and can trap moisture behind mortar and damage the stone. The most pleasing results can be achieved by pointing the joints flush and then after the initial set stippling the surface so that it is slightly recessed.

Figure 18: Detail of the west elevation of the southern wing (Block 5)

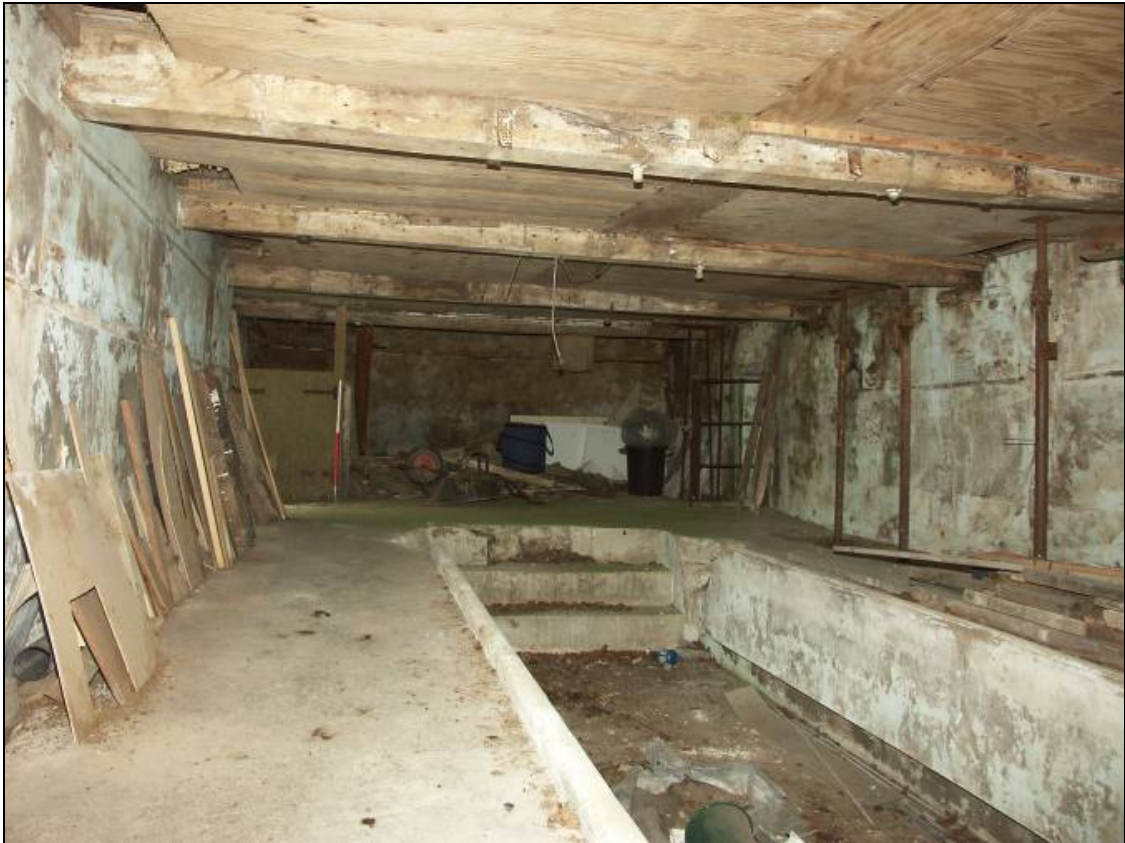
4.16 The interior of Block 4 has been substantially modified into a milking parlour with several insertions including a large concreted pit (Fig. 19). The southern wall has an additional veneer of brickwork which might have been constructed in order to support the rotten beam ends of the above floor. The upper floor is structurally unsound and the roof structure is comparable to the eastern wing although with two side purlins as it is narrower (Fig. 20).

Figure 19: Internal view of the milking parlour (Block 4)

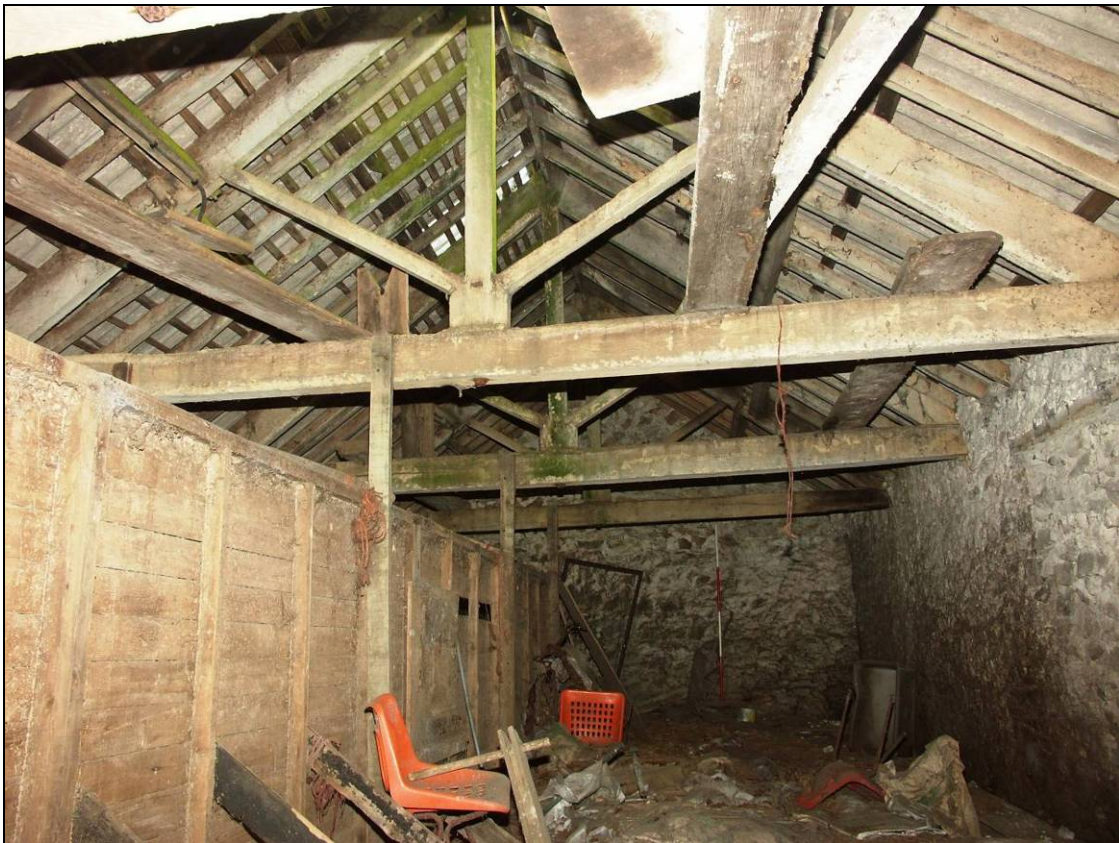
Figure 20: Roof structure of the southern wing (Block 4)
