## The former Jubilee Pool, Newcastle-under-Lyme, Staffordshire

# Archaeological building recording and palaeo-environmental analysis

#### ARS Ltd Report 2015/114

July 2015

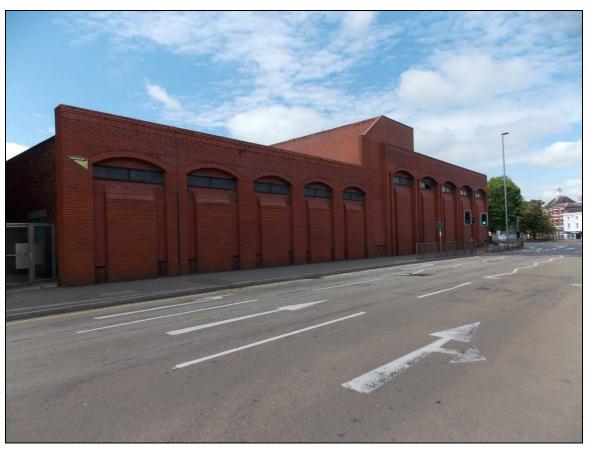
Plate 1: General view of the north elevation along Brunswick Road, looking south-west.

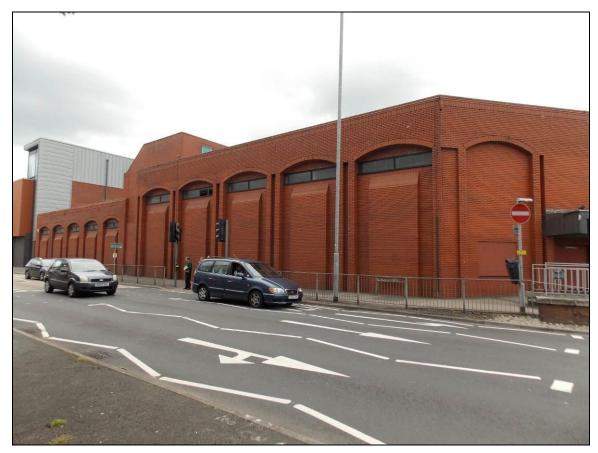
Plate 2: Western end of the north elevation and contiguous canted wall, looking south-east.

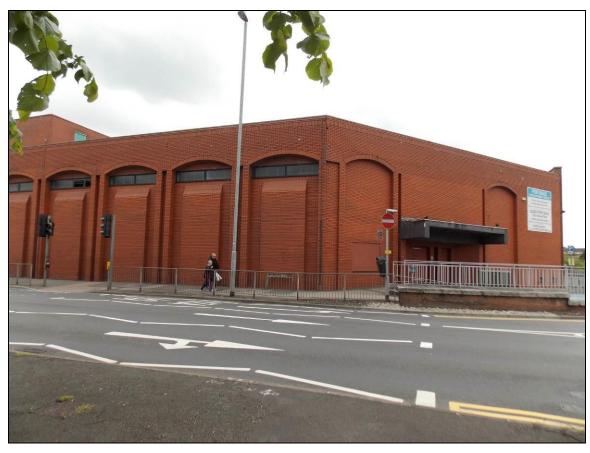
Plate 3: General view of the canted wall and western end of the north elevation, looking south.

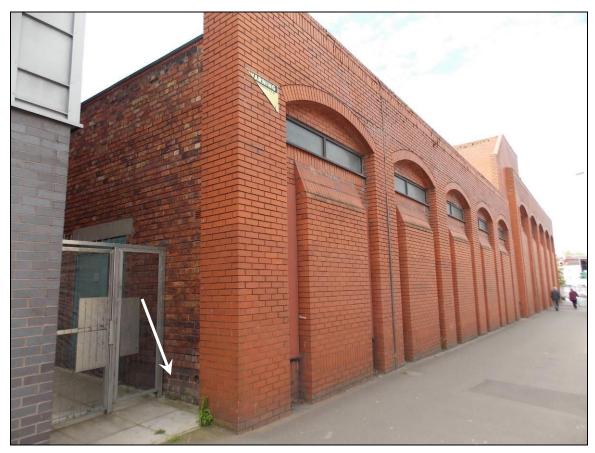
- 5.1.3 The eastern end abuts an earlier brick wall that forms the east elevation which was partially inspected due to access restrictions. This wall appears to contain an earlier phase of construction than the primary bath house, consisting of up to five courses of hand-made dark reddish-brown bricks within the lower courses (Plate 4). Only a short section of this masonry was visible from Brunswick Street. The lower brickwork of the west wall of the pool complex appears to be the remains of a late 19<sup>th</sup> century boundary wall of a former Methodist Chapel as indicated by cartographic records. The chapel was situated immediately to the east of the former Jubilee Pool.

Plate 4: Eastern end abutting a brick wall with earlier lower masonry (arrow), looking west.

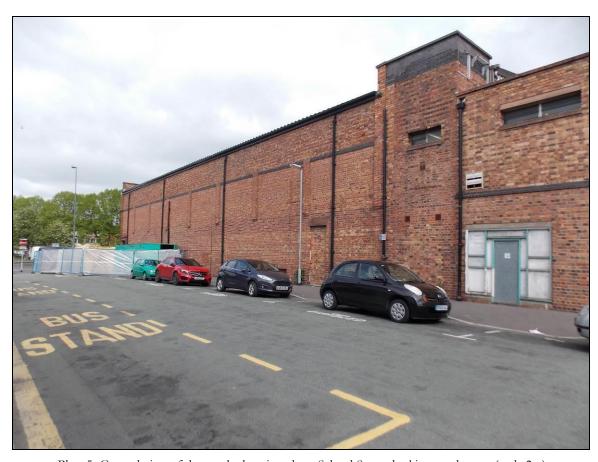
Plate 5: General view of the south elevation along School Street, looking north-west (scale 2m).

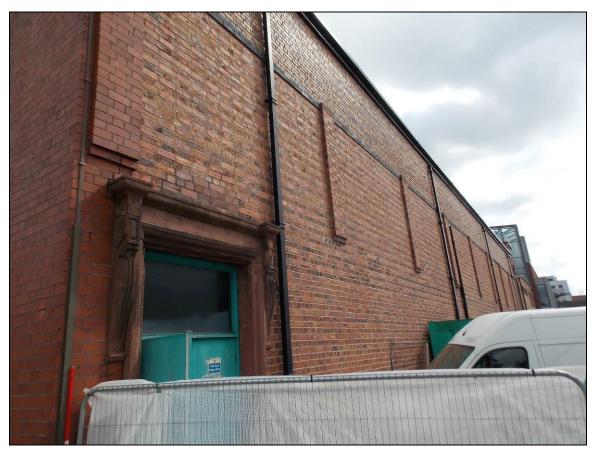
- 5.1.6 Within the westernmost bay there is another doorway with an elegant sandstone moulded entablature supported by side brackets. The decorated entablature is partially damaged and the uppermost moulded hood is a later replacement made from artificial stone. The door appears to be a later replacement with an upper fixed plain light (Plates 7 and 8).

Plate 7: Western end with doorway, looking north-east (scale 50mm).

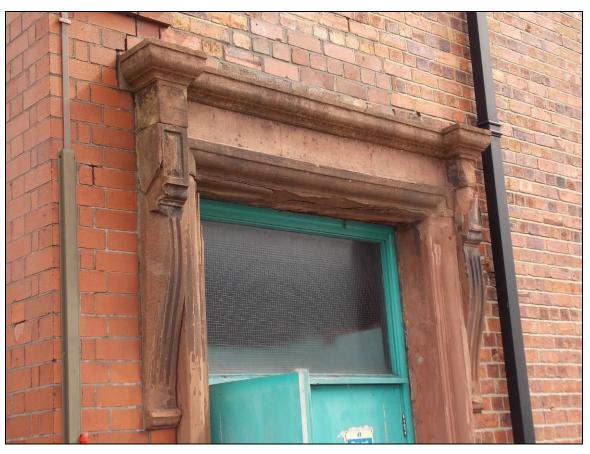
Plate 8: Detail of sandstone entablature, looking north.

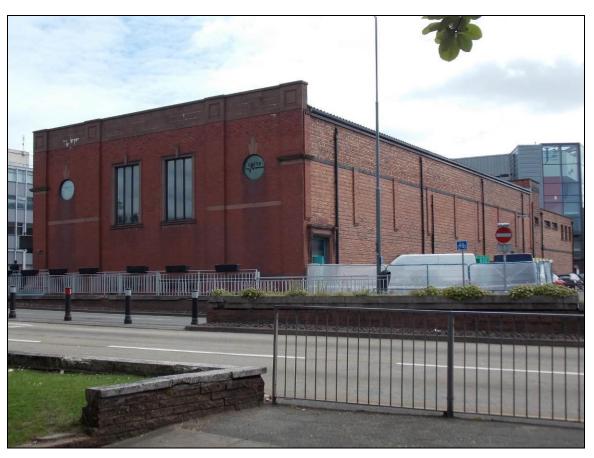
Plate 9: General view of the west and south elevations, looking north-east.

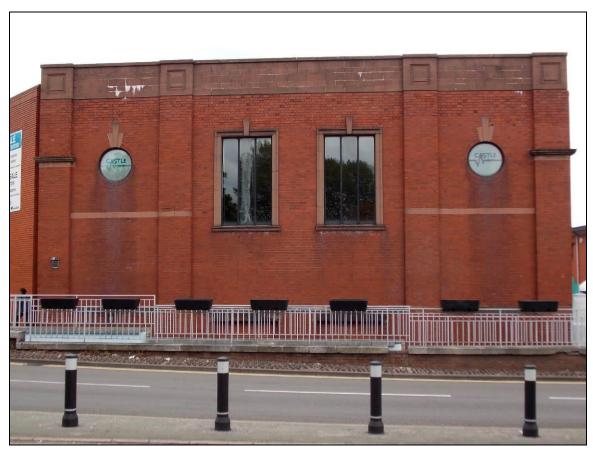
Plate 10: West elevation along Barracks Road.

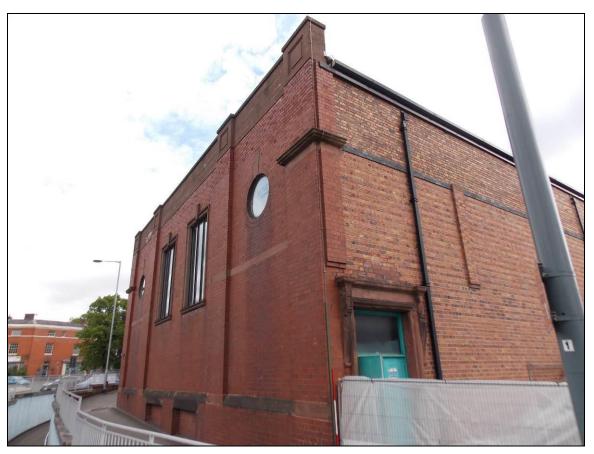
Plate 11: West elevation, looking north (scale 2m).

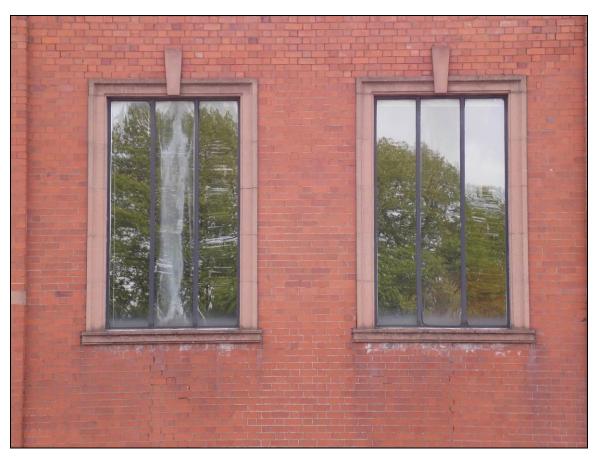
Plate 13: Detail of central window openings.

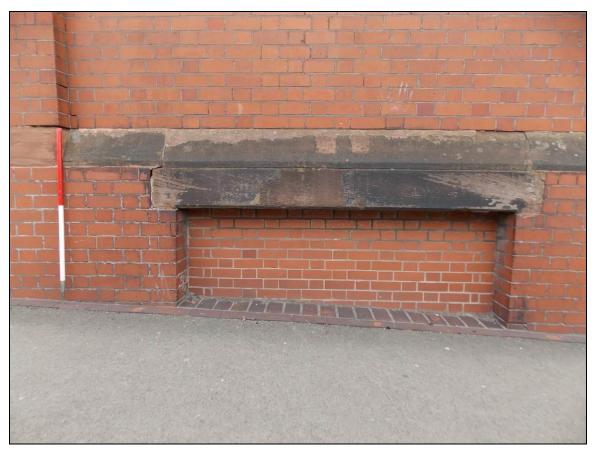
Plate 15: Detail of bricked-up opening, looking east (scale 1m).

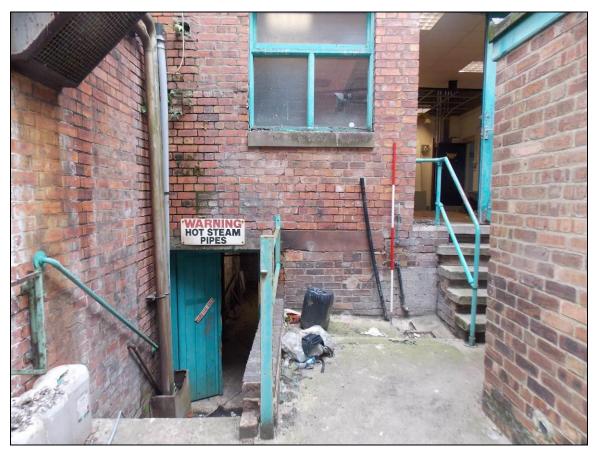
Plate 17: East elevation with doorways to a cellar and a laundry room, looking west (scale 2m).

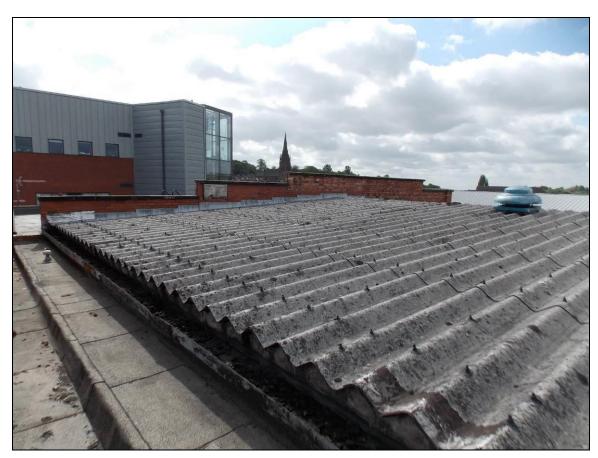
Plate 18: Roof of the large pool area, looking east.

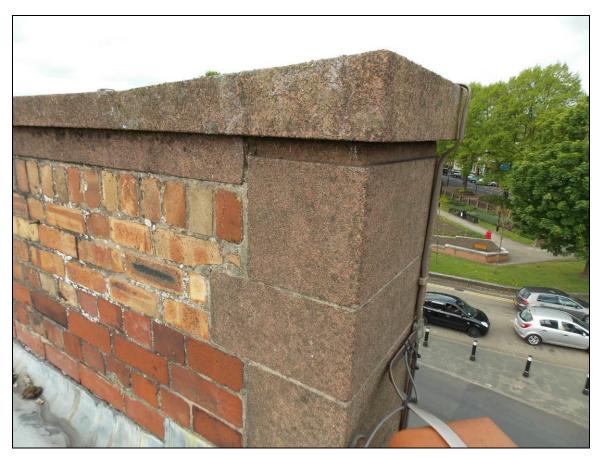
- 5.1.8 Although the uppermost parapet is made of artificial stone resembling the sandstone fabric present within the original masonry, the inserted brickwork between the parapet and the window heads is comparable to the original reddish bricks within this elevation. It is likely that the inserted brickwork might have been reused from the upper area of a former Dutch gable that was dismantled during the 1970s re-development of the Jubilee Pool.

Plate 21: Parapet of west elevation with artificial stone blocks, looking south-west.

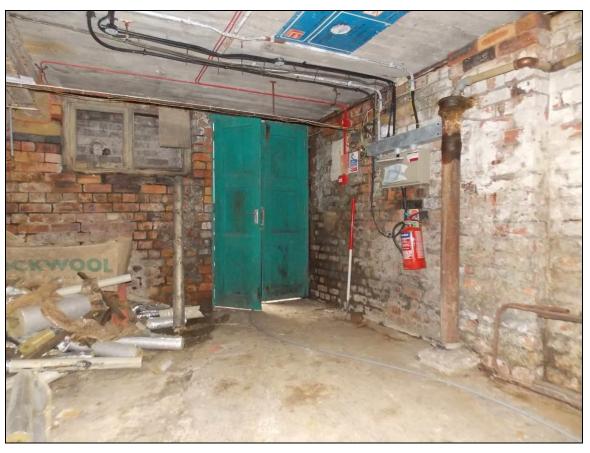
Plate 22: Doorway of the cellar, looking east (scale 2m).

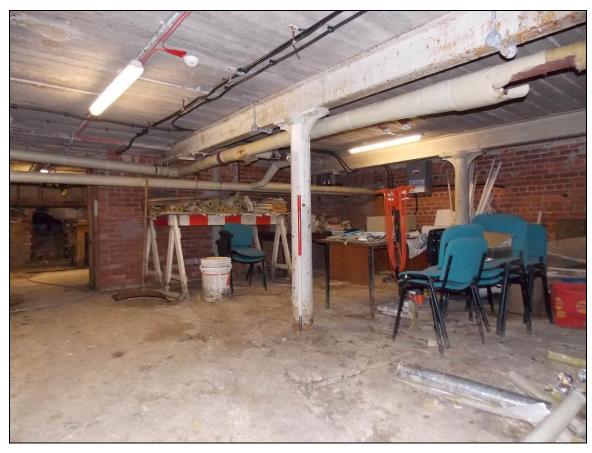
5.1.13 There is a small cellar which is accessed from a yard and through a straight staircase which leads to a doorway within the east wall of the pool complex. The doorway contains a double panelled timber door. In close proximity to the doorway there is a blocked-up light well (Plate 22). The cellar consists of two rooms of which the eastern one contains two castiron columns with stiffeners supporting RSJ girders which in turn carry concrete ceiling joists. The floor is also built with concrete and the walls consists of original orangey standard bricks laid in English bond, although there are large areas refaced or rebuilt with modern bricks (Plates 23 and 24).

Plate 24: Detail of cast-iron column, looking west (scale 1m).

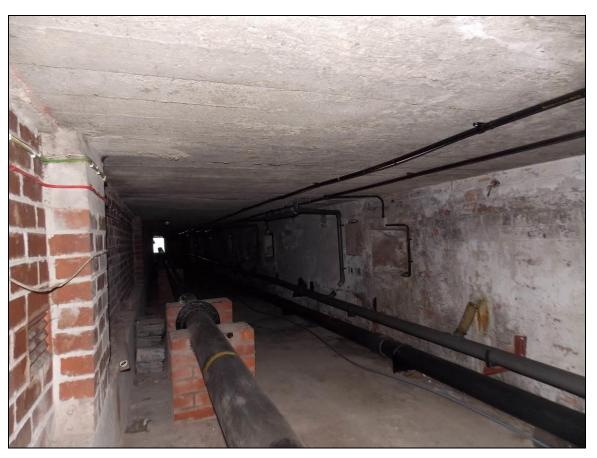
Plate 26: Large pool's gallery with primary brickwork, looking west.

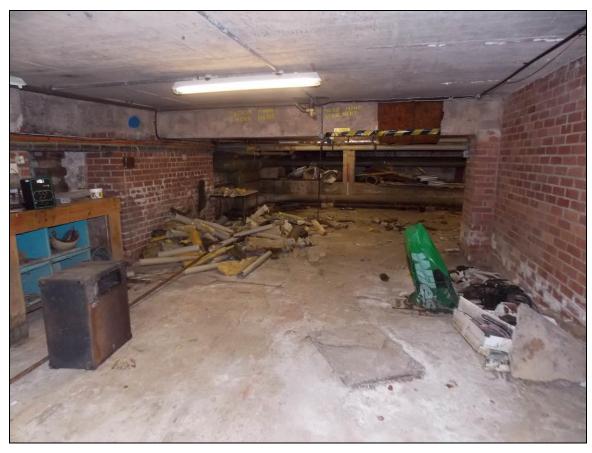
5.1.14 The western room is a larger L-shaped area with comparable fabrics to the eastern room although it is devoid of cast-iron columns. Instead, it contains concrete pillars supporting large concrete beams. Within the western wall there is a small aperture which leads to an underground gallery which extends throughout a large swimming pool within the southwestern area of the complex (Plate 25). The construction of the swimming pool appears to consist of its primary brickwork although the opposed walls of the gallery had suffered significant repair/rebuilt (Plate 26). Scars of primary partition walls were observed within the concrete floor and the west wall of the large western room (Plate 27). Towards the northern area the concrete structure leads to another underground gallery around the small swimming pool which also retains the original brickwork (Plates 28 – 30).

Plate 28: Western room of the cellar, looking north (scale 1m).

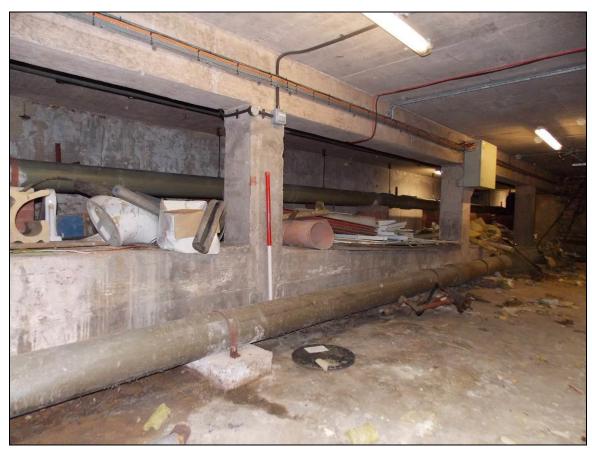
Plate 29: Concrete structure around the small pool chamber, looking north-east (scale 1m).

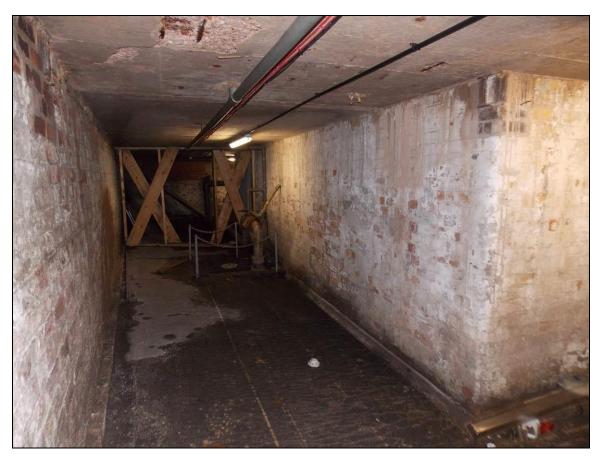
Plate 30: Eastern underground gallery of the small pool, looking north.

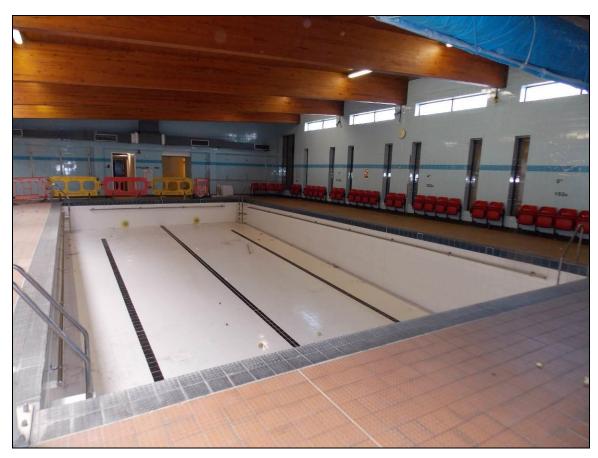
- 5.1.16 The small pool is situated within the north-eastern area of the complex and consists of a modern refurbished structure (Plates 41 and 42), although the pool itself retains its original masonry as identified within the underground gallery.

Plate 41: Small pool, looking north-west.

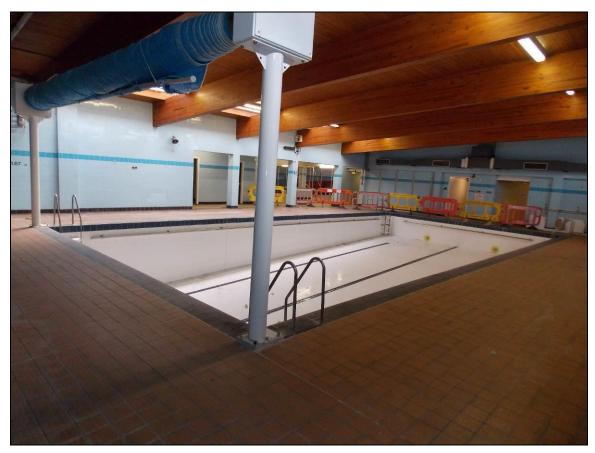
Plate 42: Small pool, looking south-west.

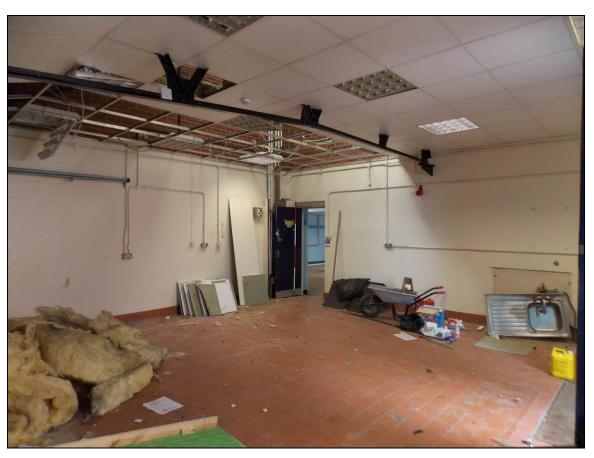
- 5.1.17 The south-eastern corner of the complex consists of a small room which had been used as a laundry. Although the outer wall appears to be a primary construction, the internal partition walls creating this room consists of modern brickwork, concrete floor and an RSJ roof structure with a suspended false ceiling. The room contains a doorway with a double ledged door which provide access to the external yard. It also has an inserted doorway to the adjacent Boiler House (Plates 43 45).

Plate 43: Laundry, looking north-west (scale 2m).

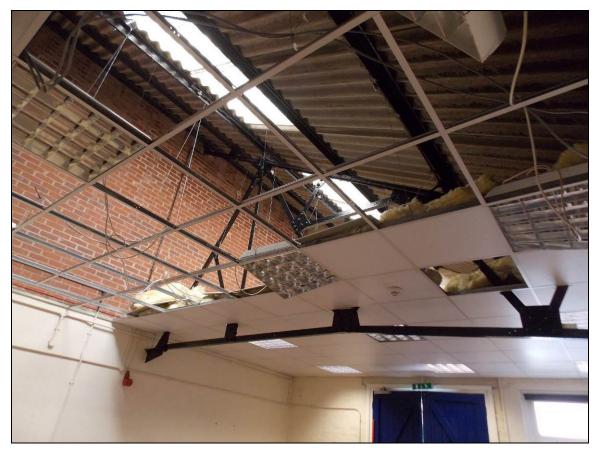
Plate 45: Roof structure within the laundry, looking north-east.

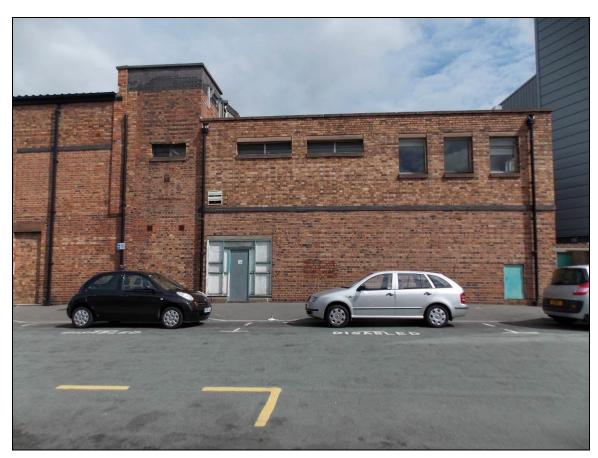
Plate 57: South elevation of the Boiler House, looking north (scale 2m).

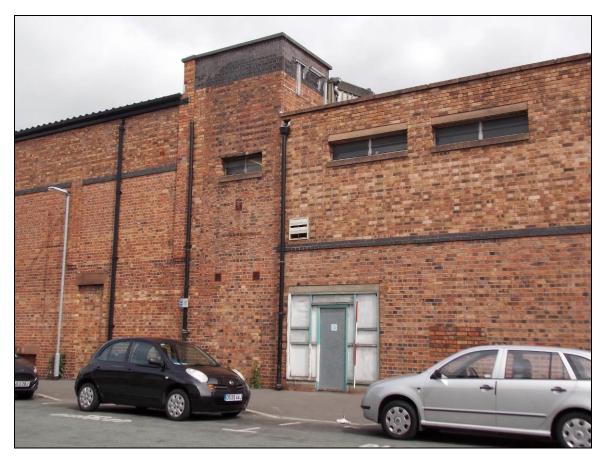
Plate 58: Detail of base of former chimney stack, looking north-west (scale 2m).

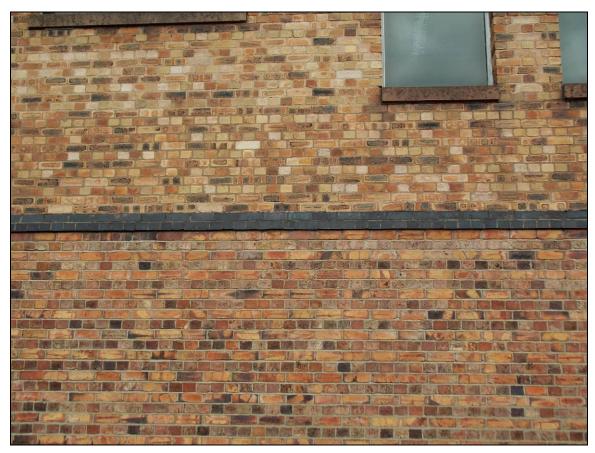
Plate 59: Different type of brickwork between the ground and first floors, looking north.

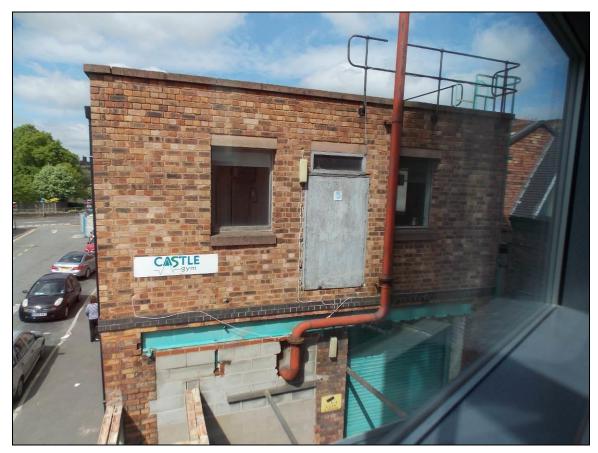
northern one contains a roller shutter. The upper floor contains three symmetrically arranged window openings with sandstone lintels and projecting sills that are equivalent to the larger openings within the south elevation. The central window opening has been modified into a fire exit doorway (Plates 60 and 61).

Plate 61: East elevation of the Boiler House.

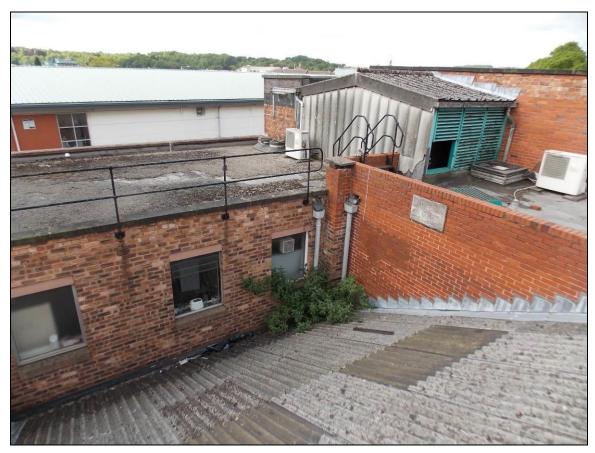
5.2.4 The north elevation was viewed from the roof although only the upper level was examined as the ground floor is obscured by the roof of the laundry room of the main complex. It is composed of five bays demarcated by window openings equivalent to the ones within the first floor of the east elevation. The easternmost had been modified into a fire exit doorway (Plate 62). The flat roof is covered with felt and contains a plant structure made of corrugated asbestos sheeting which is adjacent to a tank area within the uppermost area of the remains of the former chimney stack which had been truncated and modified with later engineering bricks and a new coping (Plates 63 and 64).

Plate 63: Flat roof of the Boiler House, looking south-west.

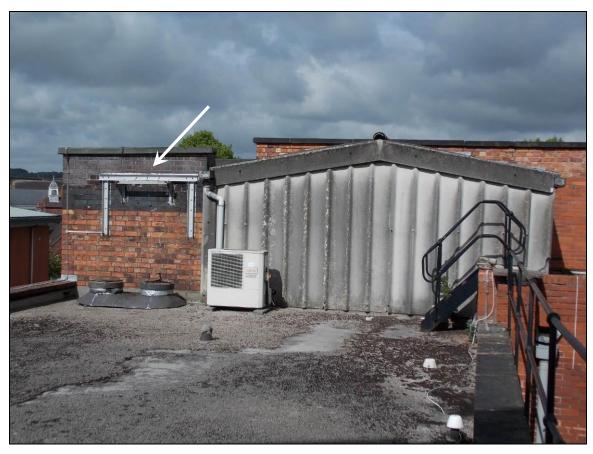
Plate 64: Roof of the Boiler House with remnants of the chimney stack (arrow), looking west.

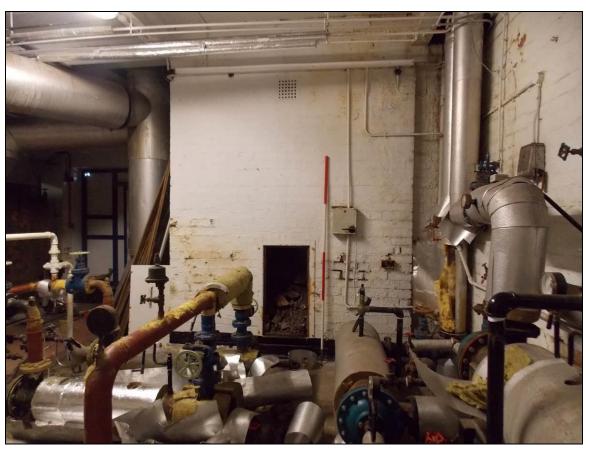
- 5.2.6 The Boiler House is currently used as an electrical switch board and contains also two gas boilers which would have replaced a former steam plant. As the first floor was added in 1974, the ceiling is a later insertion built with concrete and RSJ girders. The outer walls are original built with standard orangey bricks laid to English Garden Wall bond, and contains pilasters along the side walls establishing five bays across the interior. Within the southwestern corner the remains of the former chimney stack are extant with a flue opening (Plates 65-69).

Plate 69: Former chimney stack with flue opening, looking south (scale 2m).

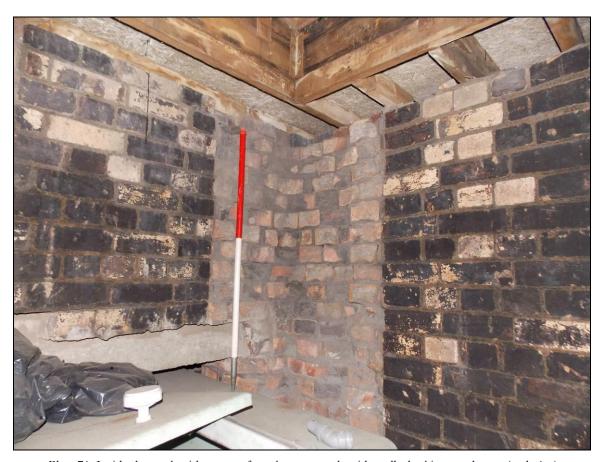
Plate 71: Inside the stack with traces of smoke soot on the side walls, looking south-east (scale 1m).

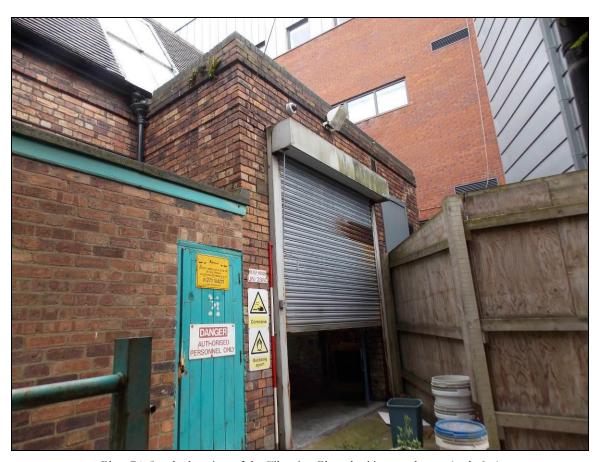
- 5.3.2 This brickwork consists of standard yellowish bricks laid in English bond which abuts the masonry of the former Jubilee Pool as indicted by a vertical construction joint within the westernmost end of the south wall (Plate 78). Indeed, this structure appears to have been constructed sometimes between the 1920s 1950s as indicated by cartographic records.

Plate 74: South elevation of the Filtration Plant, looking north-east (scale 2m).

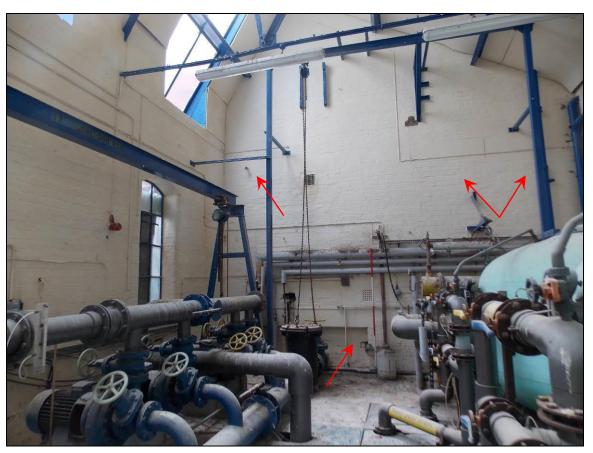
Plate 80: Western wall with blocked-up window openings (arrows), looking west (scale 2m).

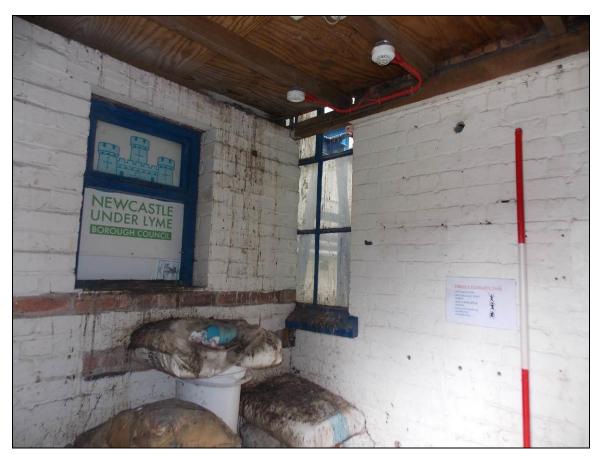
Plate 82: Internal view of the extension against an original window, looking north-west (scale 2m).
