# Yockings Gate Farm, Whitchurch, Shropshire

## Historic Building Assessment

**ARS Ltd Report 2016/76**

May 2016

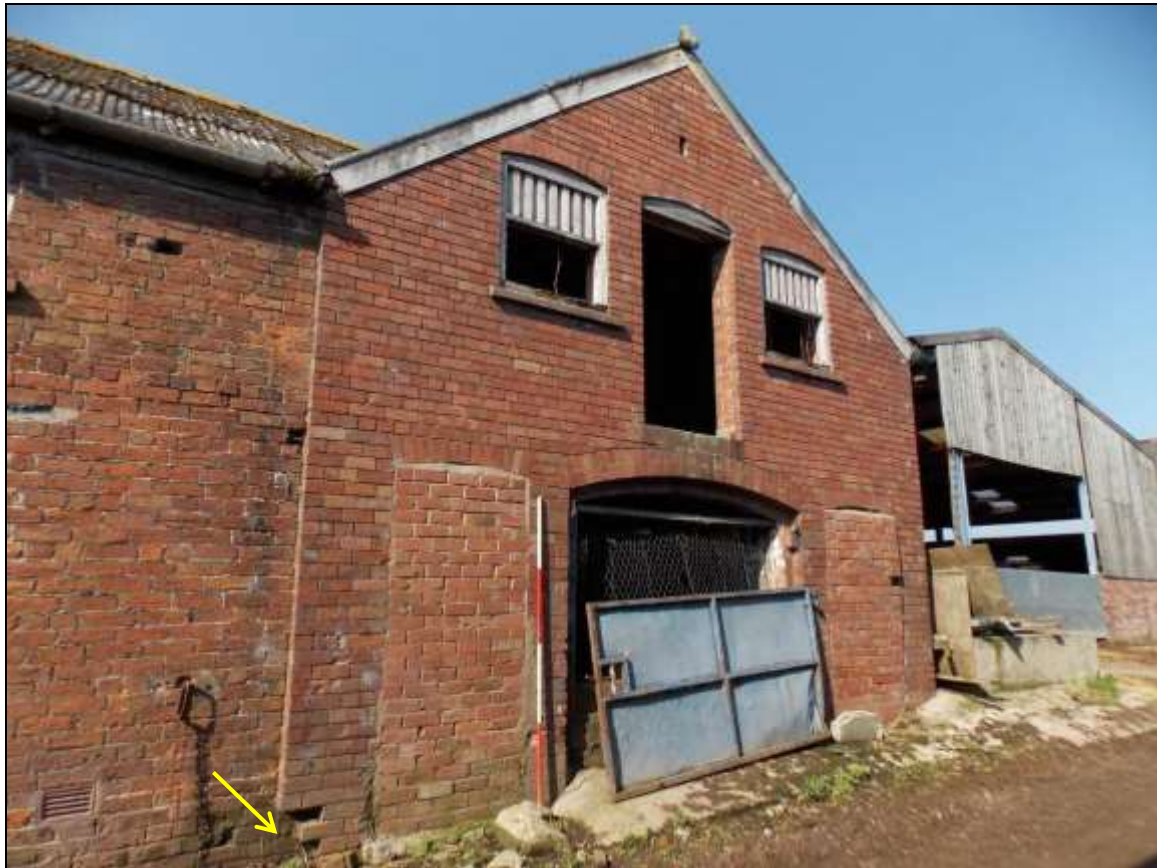
Plate 4: Front elevation of Building A covering earlier brickwork (arrow), looking north-west (scale 2m).

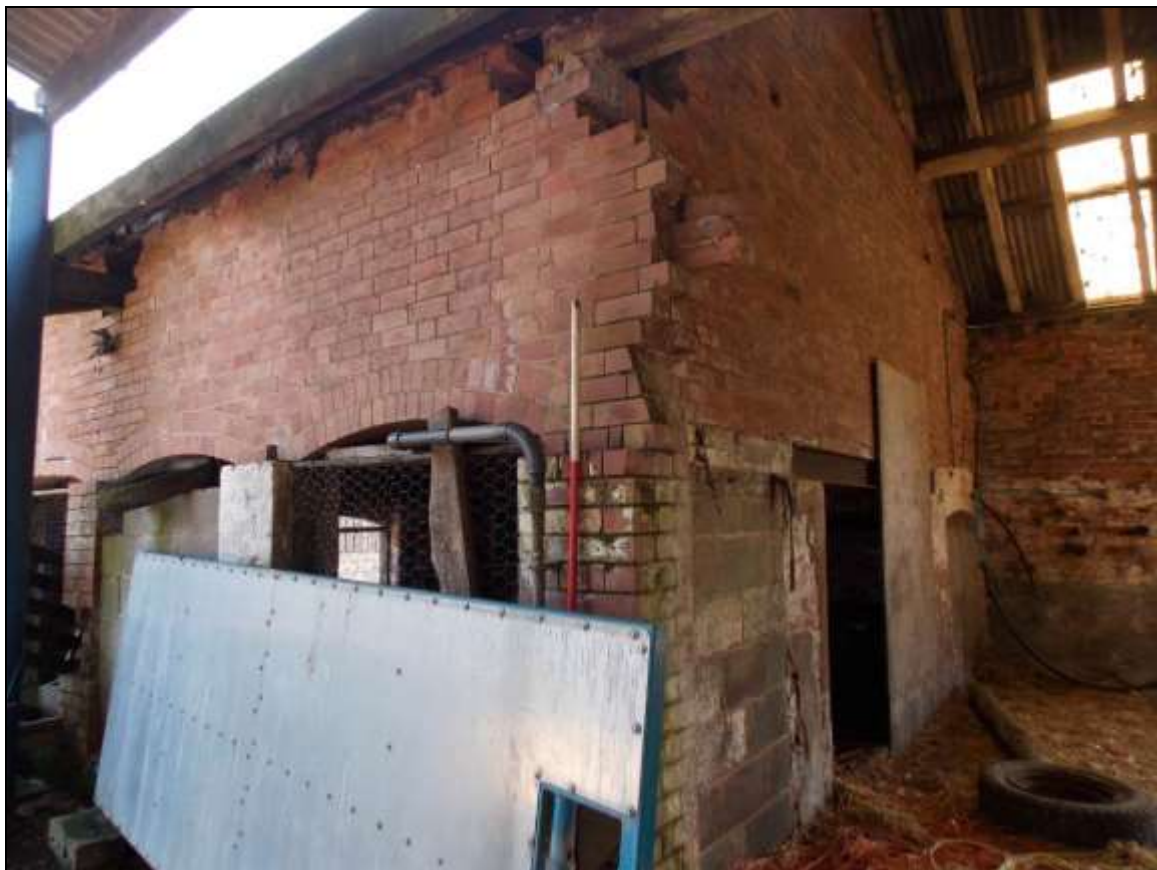
Plate 7: Detail of truncated arcade, looking north-east (scale 2m).

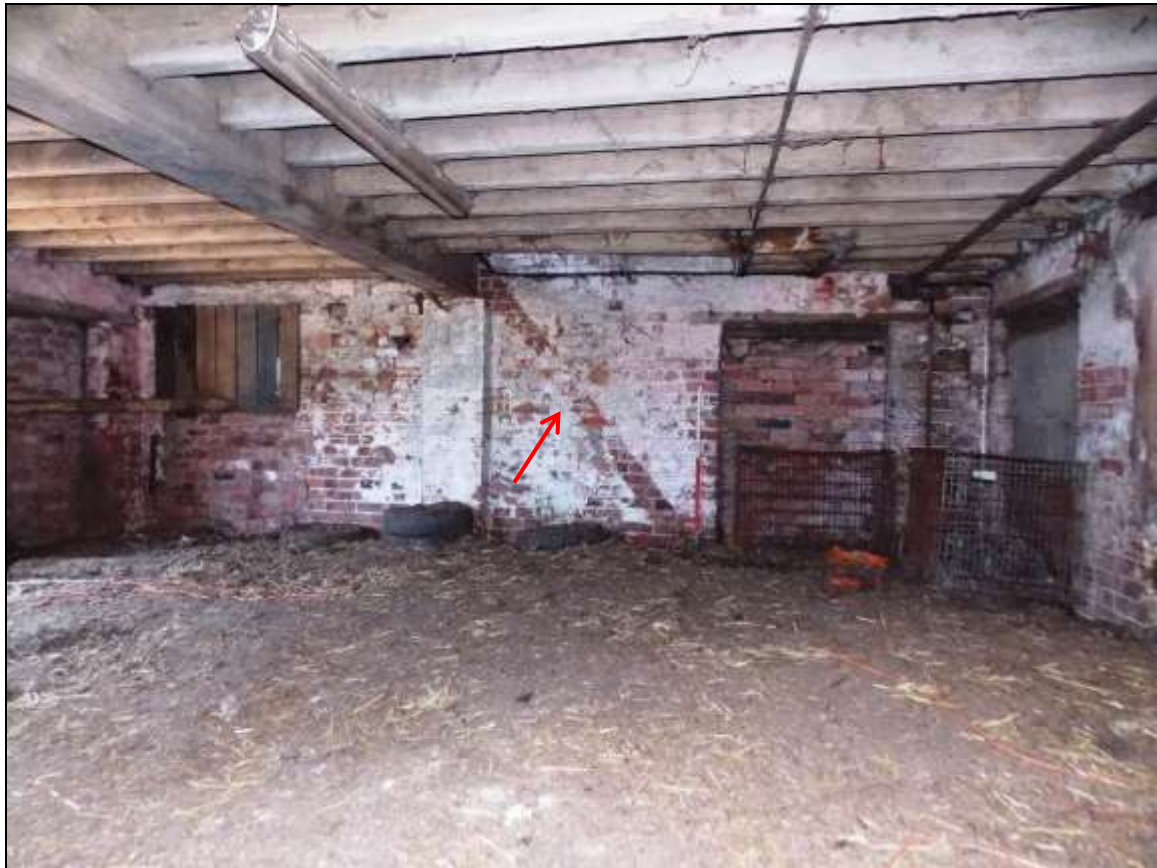
Plate 10: Scar of former staircase (arrow) against the south-eastern wall, looking north-east (scale 1m).

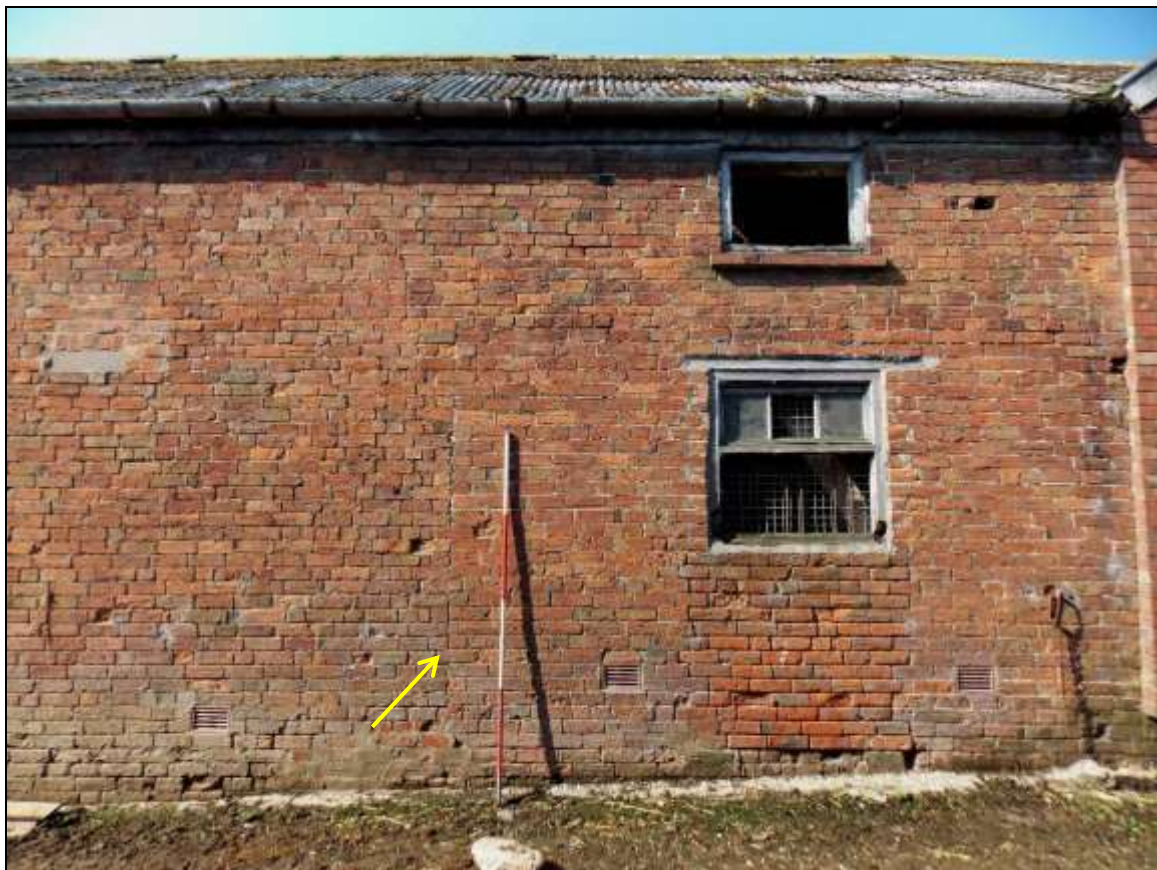
Plate 17: Vertical construction joint (arrow) between Buildings B and C, looking south-west (scale 2m).

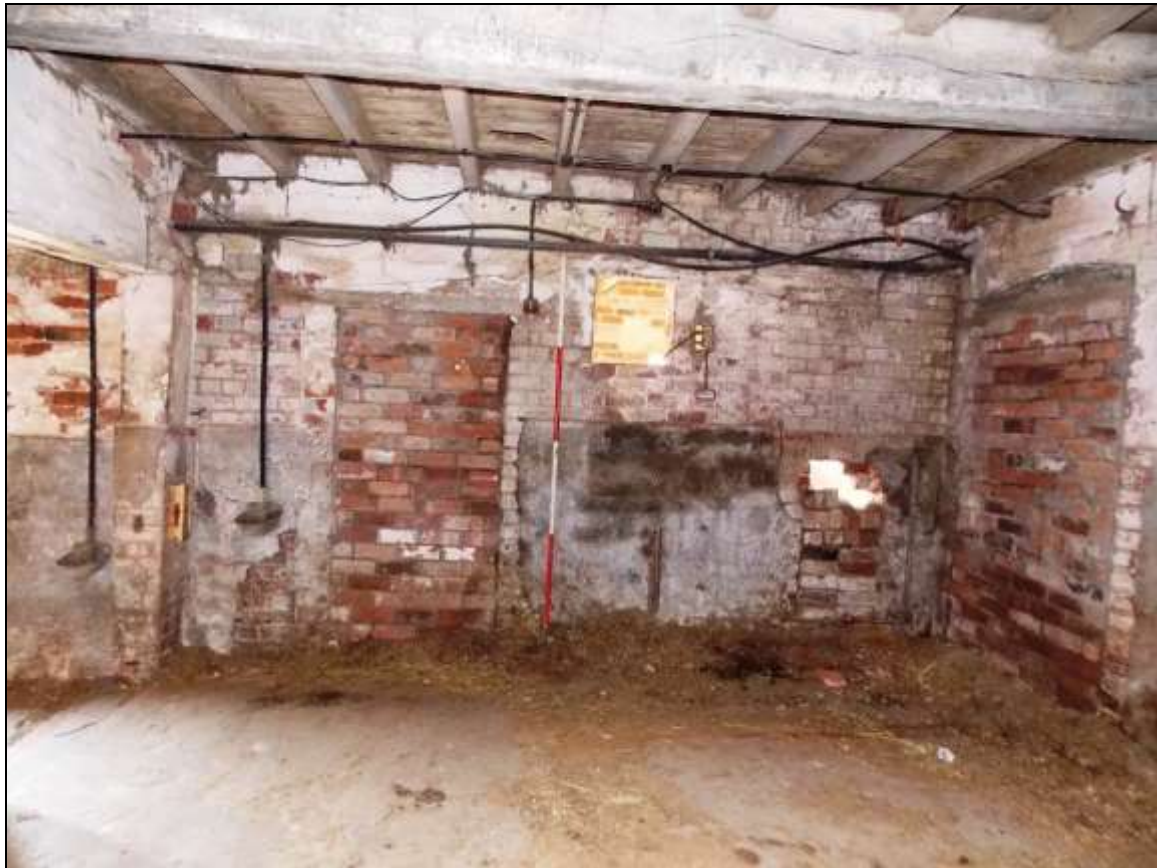
Plate 21: South-western wall with blocked-up openings (scale 2m).

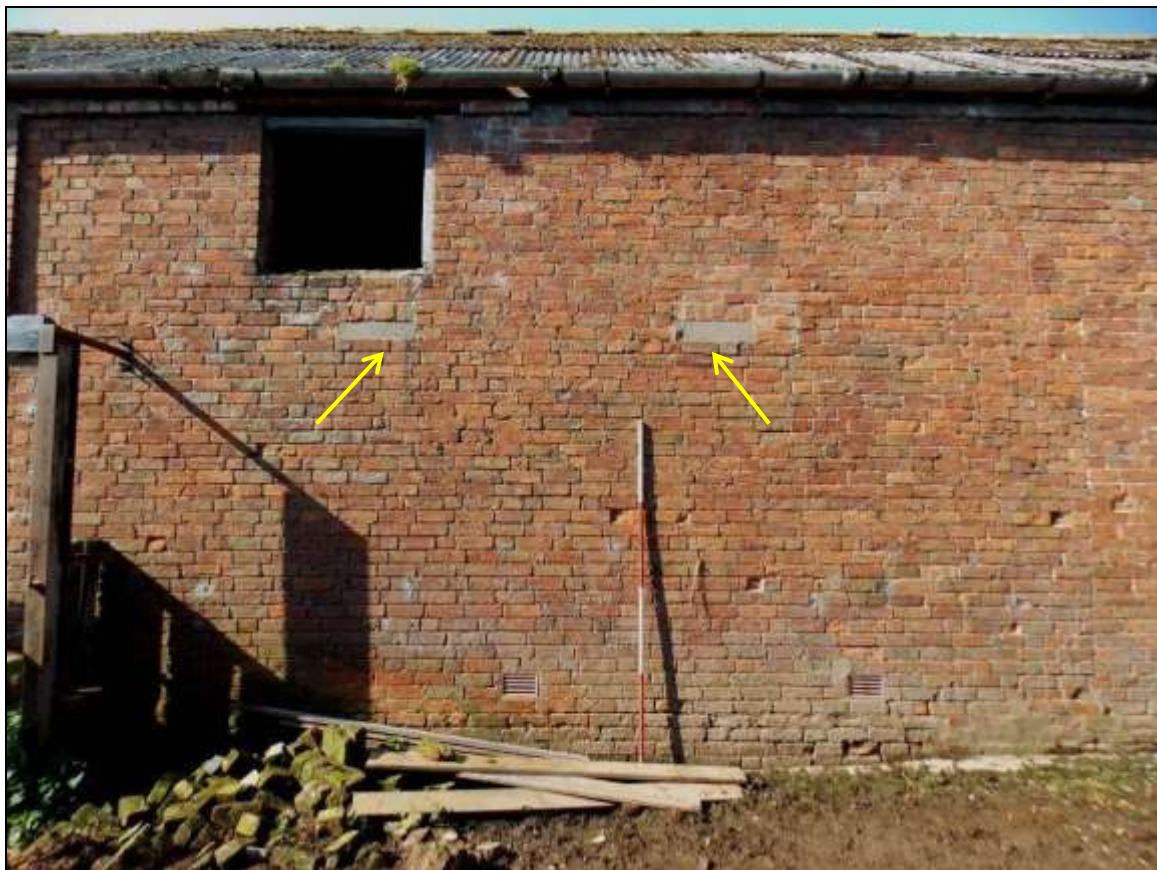
Plate 27: Detail of north-eastern wall with inserted concrete pads (arrows) for internal RSJ (scale 2m).

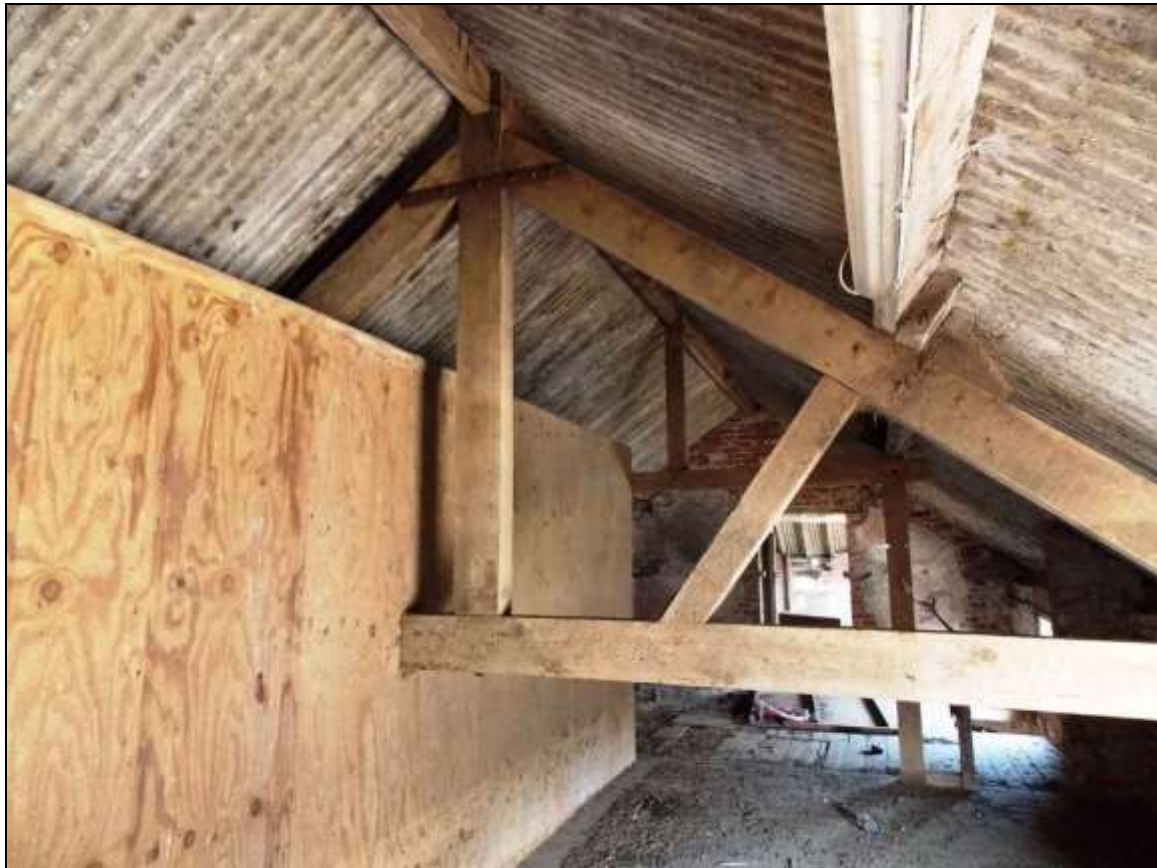
6.3.3 The loft contains a bolted king-post truss which appears to have been a later repair/rebuilt (Plate 35). Equivalent trusses are also present in the adjacent Building D. The south-eastern end comprises a gable wall with diamond-shaped vents and an inserted doorway which enables access to the loft of Building D through a step 350mm down. Although the gable wall has suffered minor alterations to accommodate the present roof structure, it can be discerned that the face of the brickwork (somewhat crudely finished and with sections of horizontal timber) corresponds to an internal side. (Plate 36). Indeed, the opposite side of this wall which faces onto the loft of Building D is more even and properly finished corresponding to a former external face of the wall (Plate 37). The entire masonry appears to be an integral construction thus the adjoining Building D would have been built against it.

Plate 35: Loft storey of Building C with bolted king-post truss, looking north-west.

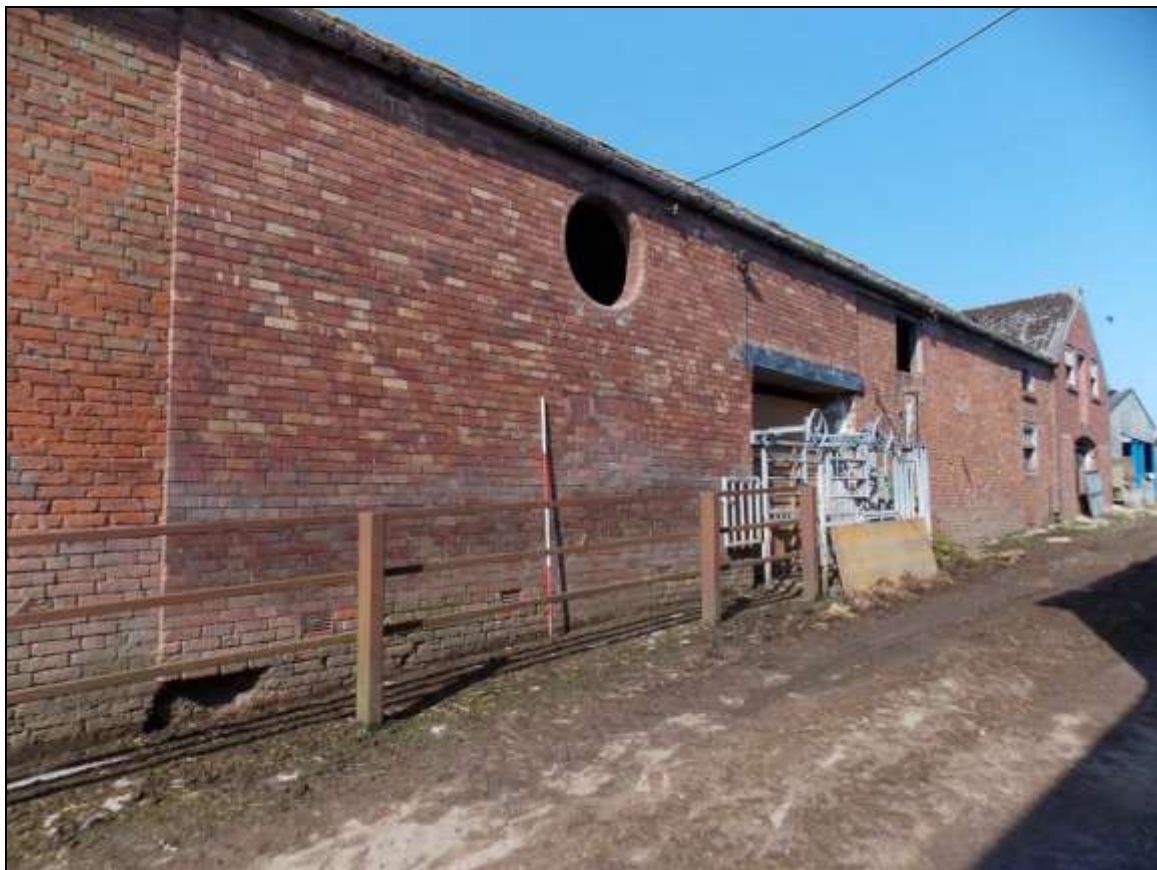
Plate 43: Refaced brickwork within the north-west side of the north-eastern elevation (scale 2m).

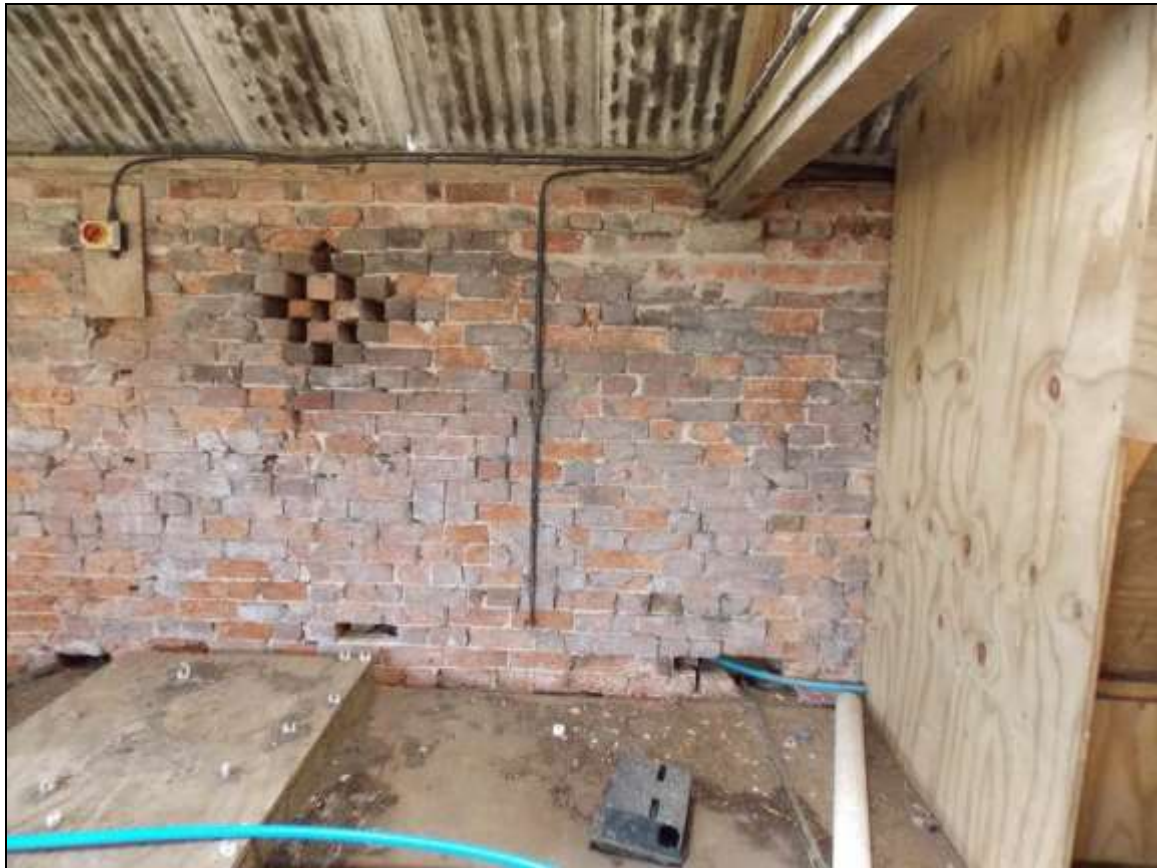
Plate 55: Detail of primary brickwork with vent and later bricks supporting the roof structure.

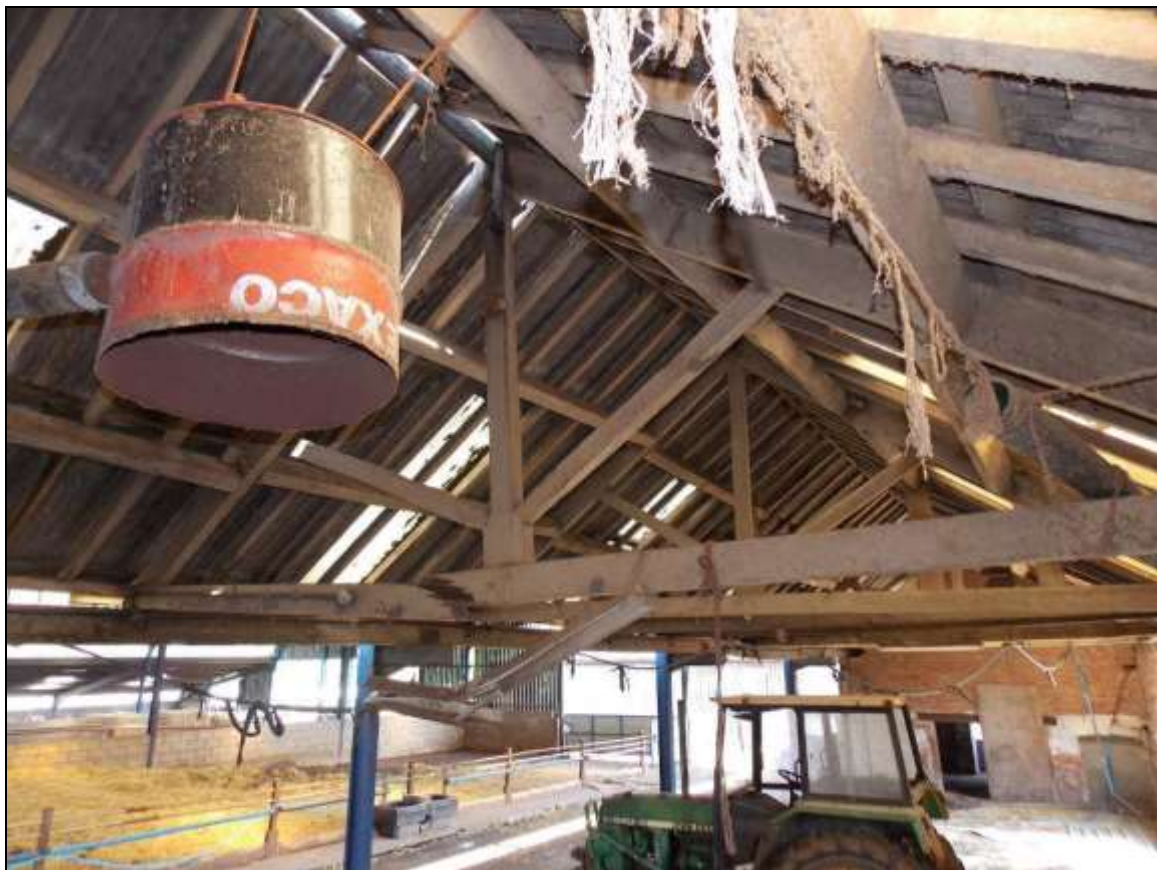
Plate 67: South-western truss with cracked tie-beam, looking north-east.

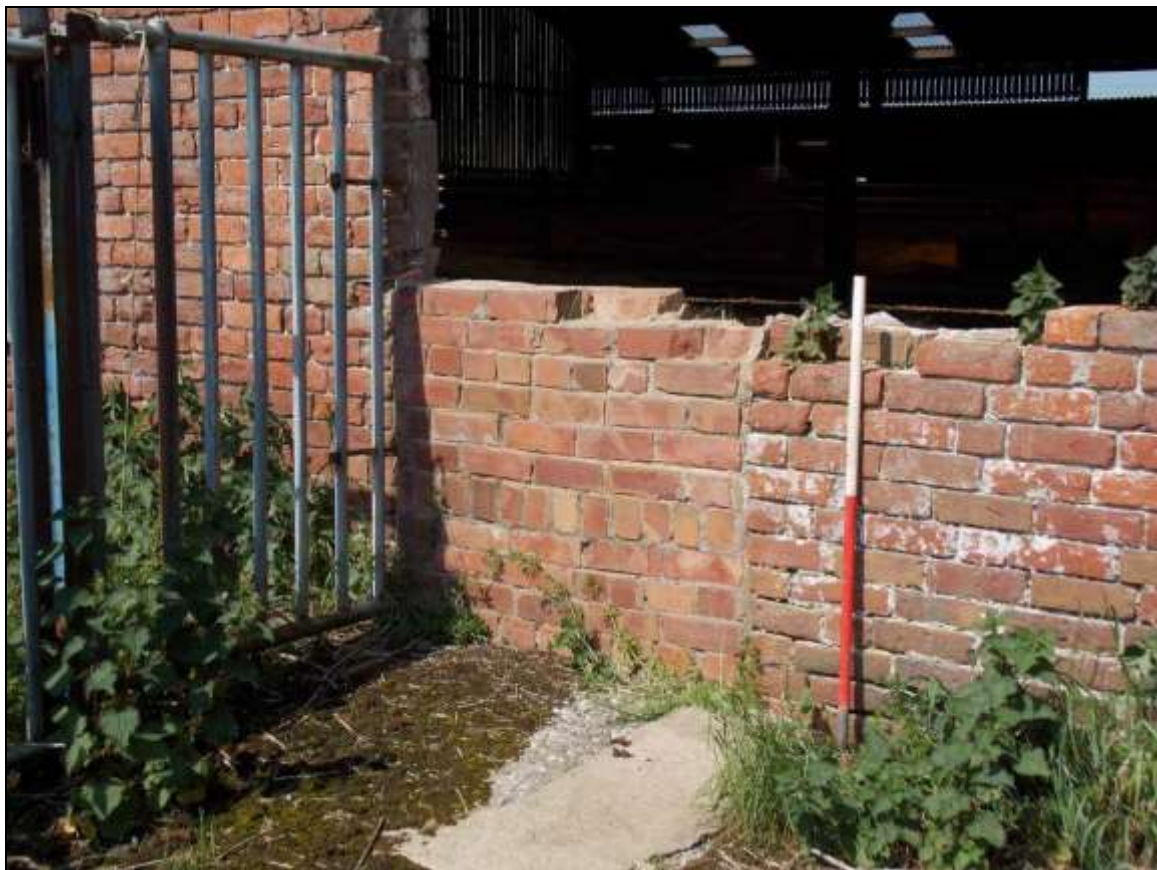
Plate 72: Detail of the remains of a blocked-up doorway, looking north-west (scale 1m).
