**An Archaeological Watching Brief at
Robin Hood's Stoop, Hathersage,
Derbyshire**

ARS Ltd Report 2008/47
June 2008

An Archaeological Watching Brief at Robin Hood's Stoop, Hathersage, Derbyshire.

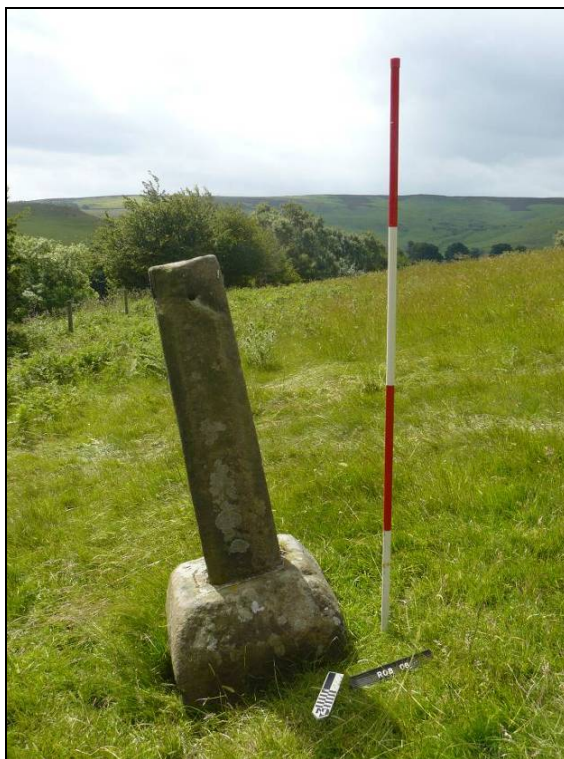
Fig. 3: Position of the cross before re-alignment. Facing south

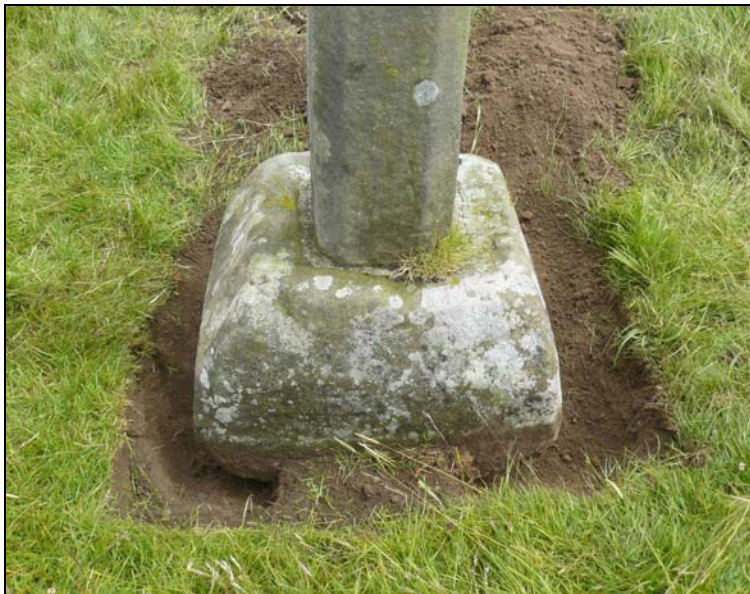
- 3.1 The cross base measured approximately 0.7m square and therefore, an area of 1m² was measured out for excavation. Turf was removed from around the base which revealed coarse sandy topsoil context (001) which had accumulated around the base over time. Topsoil was initially removed by hand from around the monument to enable the positioning of lifting straps below the base to support its removal (Fig. 4). At the western edge topsoil was removed to a depth of 0.07m exposing a sandy clay (002) located beneath the base.

Fig. 4: Excavation around the base to enable lifting. Facing east.

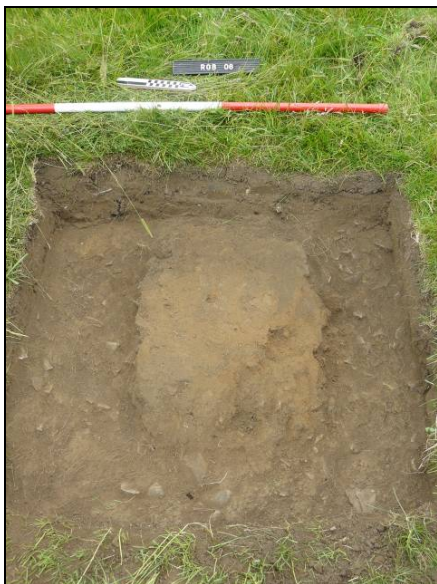
- 3.2 The sandy clay (002) overlay a subsoil horizon (003) (Fig. 5). Context (002) was interpreted as a bedding/levelling layer for the base of the cross and had a depth of 40mm. Examination of (002) displayed the slope which had developed over time and was found to have an angle of 12 ° (Fig. 6).

Fig. 5: Context (002) overlying (003).
Facing west.

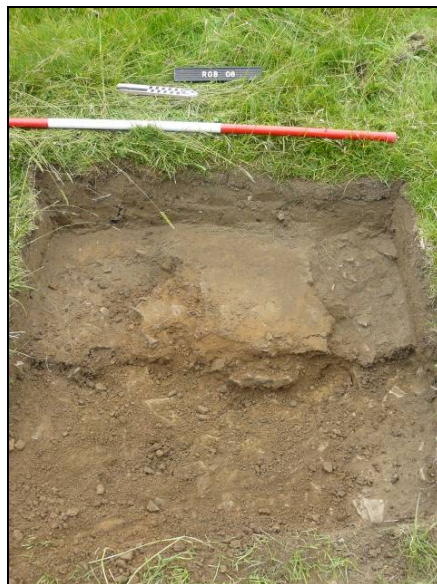
Fig. 6: Section of (002). Facing west

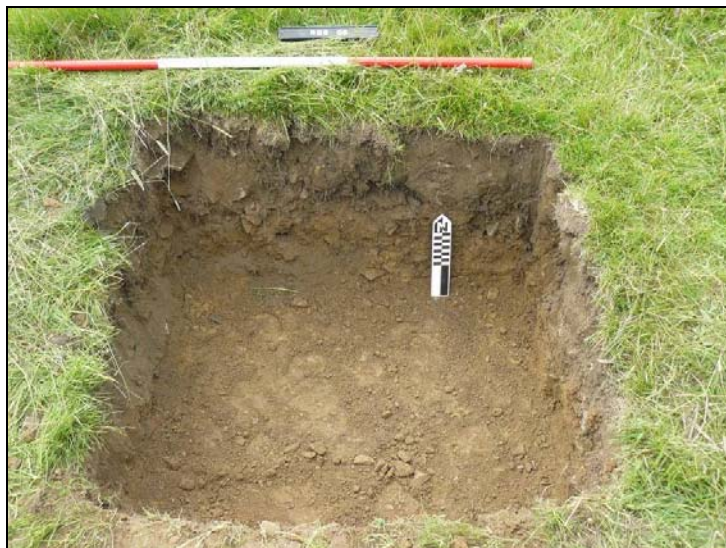
- 3.2 The stoney subsoil (003) was excavated by hand and the natural substrata (004) of sandstone and clay was revealed 0.1m below the eastern edge. The natural substrata was levelled to 0.2m below the eastern edge and 0.55m below the western edge (Fig. 7).

Fig. 7: 1m² pit levelled into the hillside

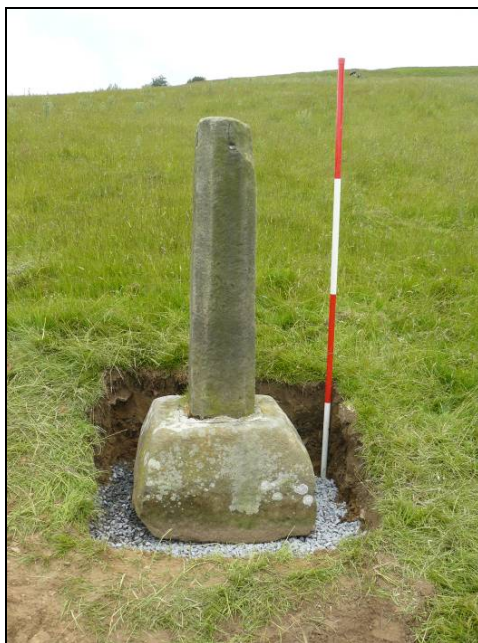
Fig. 8: Cross shaft and base repositioned. Facing west

- 3.3 Following excavation of the pit a level sub-base layer was created within the pit using blue gritstone chippings to a depth of approximately 0.2m and compacted by the bucket of the JCB. The cross shaft and base were lifted back into position

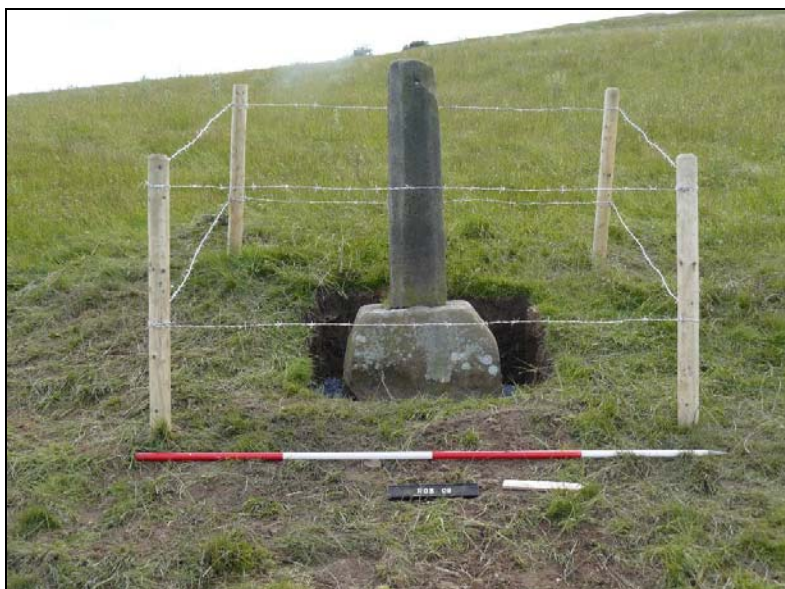
Fig. 9: Perimeter fence around the cross. Facing west.

(Fig. 8) and a 2m square perimeter fence erected around the cross (Fig. 9). The area surrounding the cross base was re-turfed at a later date to protect and stabilise the cross (Fig. 10).

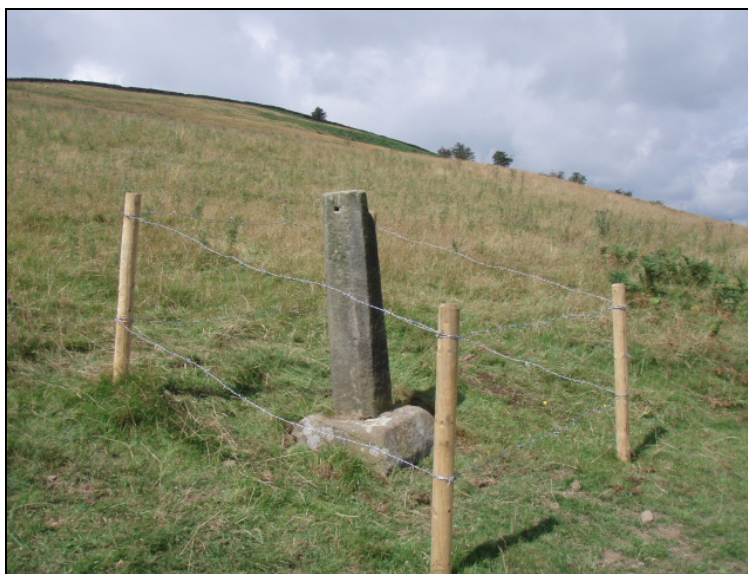
Fig. 10 Robin Hood's Stoop after re-turfing. Facing north-west
