The Round Tower, Alverton Lodge, Alton Towers Survey and Watching Brief

ARS Ltd Report No. 2008/24 February 2008

ARS Ltd Report 2008/24

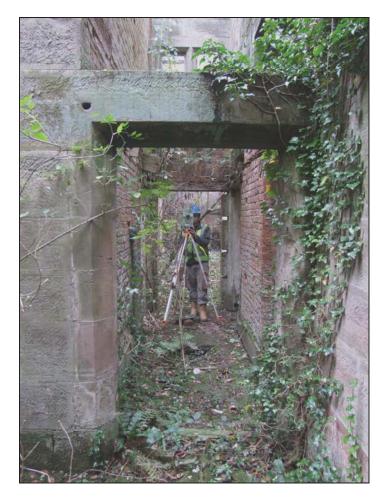
Fig. 3 Restricted recording conditions on the south side of the Tower

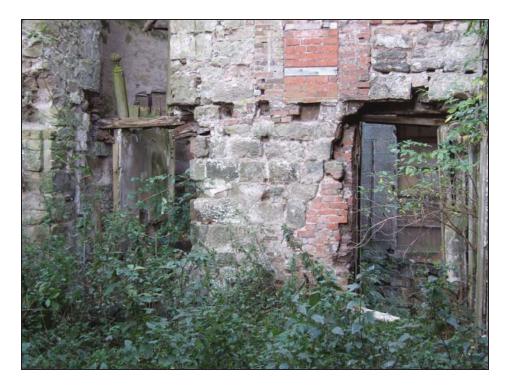
On the lowest floor two doorways survived, that to the south (Fig. 23; A) giving access to the interior of the Round Tower with the surviving opening measuring at least 2.14m high and 1.27m wide, and that to the north (Fig. 23; B) opening into a large room on the north of the Round Tower with the opening measuring at least 2.33m high and 0.94m wide. Timber lintels survived in both doorways, but the jambs only survived in the northern door. The northern door had also been extensively rebuilt on its southern side with brickwork of no discernible bonding pattern (Fig. 23; C). A small area of plaster still survived on the north side of the northern door frame (Fig. 23; D). Mortice holes to support the joists were visible between the lowest and central floor levels (Fig. 23; E).

Fig. 4 Lowest storey on east elevation showing doorways to Round Tower on left, mortice holes for original joists and brickwork infilling/repair

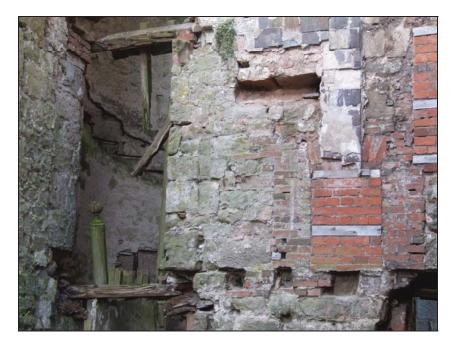
The central floor level featured a doorway to its south (Fig. 23; F), which gave access to the Round Tower interior and, as with the doorway at the lowest floor level, only the lintel survived. The opening measured 2.22m high and 1.00m wide. In the centre of this floor level an infilled, arched brick window measuring 0.96m high by 0.66m wide and comprising two distinct phases of brickwork (Fig. 23; G). Too little of the first phase of brickwork survived to be able to discern the bonding style, however the second phase of brickwork was of an English Bond. Both phases were partly obscured by and area of lath-and-plaster/tiles (Fig. 23; H), and indicates that at least three phases of remodelling of the structure have occurred in this area. This comprises: Phase 1 – original sandstone construction; Phase 2 – outer brickwork construction of window; Phase 3 – infilling of window and plastering. Above and to the north of this window was a second larger window, also infilled with brick in an English Bond, measuring 1.1m high and 1.3m wide (Fig. 23X; I).

Fig. 5 Central storey of east elevation showing doorway to Round Tower and phases of brickwork infilling and remodelling

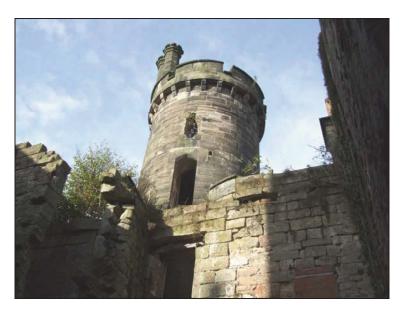
Fig. 6 Upper storeys of east elevation

The lowest level contains a high, narrow doorway (Fig. 23; K) measuring 1.9m high by 0.55m wide surmounted by a large arched lintel cut from one sandstone block. A low wall measuring 0.57m high (Fig. 23; L) is situated above the northern side of the lower three storeys and continues in a straight line as it runs from north to south, before curving to the west at point L on Fig. 23 to abut the Round Tower 0.32m to the north of the doorway to the Tower. The central level contains one window, a badly eroded "arrow slit", (Fig. 23; M) of which better examples survive on the north and south sides. The slit measures 1.24m high but has eroded out to 0.35m wide and is constructed of carved sandstone jambs, a lintel and a sill. The uppermost level consists of a slightly projecting decorative battlement 1.14m high with narrow crenellations measuring 0.5m high and 0.2m wide (Fig. 23; N), surmounted by two octagonal chimneys measuring 2.05m high at the south-east quadrant (Fig. 23; O).

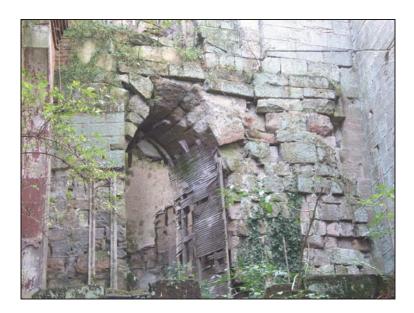
The lowest floor level, measuring at least 5.9m high and 6m wide was dominated by a large, badly eroded archway to its centre (Fig. 24; A) which measured at least 4.35m high by 1.78m wide. The lowest parts of this elevation were covered with vegetation and the floor had collapsed in this area making access impossible

Fig 7 Lower of north elevation showing large central archway

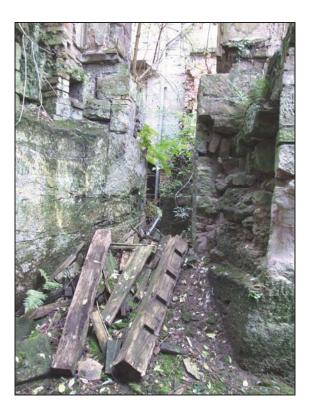
Fig. 8 Collapsed floor causing restricted access to north elevation

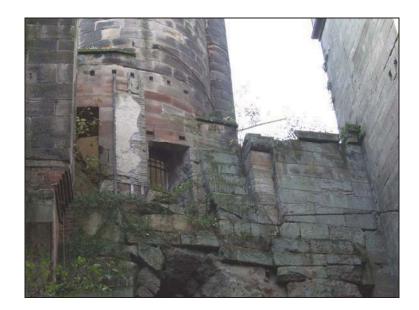
Fig. 9 Central section of north elevation

lower level continues (Fig. 24; E). In the centre, a small buttress (Fig. 24; F) ascends to abut the Round Tower, below a steel handrail that curves around and down the tower to the east (Fig. 24; G). To the west of the buttress a recessed window covered with a steel grille (Fig. 24; H) measuring 1.25m high by 0.85m wide is located with two mortice holes for joists immediately above it. Immediately west of this window an area of lath-and-plaster 2.26m high by 0.65m wide is still fixed to the sandstone (Fig. 24; I). A second window (Fig. 24; J) measuring 1.19m high by 0.62m wide is situated at the western edge of this elevation. The window is overgrown with vegetation.

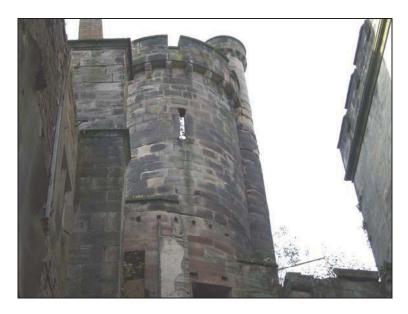
The upper level of this elevation consists of the cylinder of the Round Tower with a protruding chimney to the west (Fig. 24; K). It measures 5.7m from base to top of crenellations and the diameter of the Tower is 3.8m in diameter with the chimney projecting a further 0.4m out from the side of the Tower and 2.25m above the top of the battlements. The elevation contains one window, an "arrow slit", (Fig. 24; L). The slit measures 1.24m high and 0.22m wide and is constructed of carved sandstone jambs, a lintel and a sill. The uppermost level consists of a slightly projecting decorative battlement 1.14m high with narrow crenellations measuring 0.5m high and 0.2m wide (Fig. 24; M).

Fig. 10 Upper section of north elevation showing protruding chimney to west

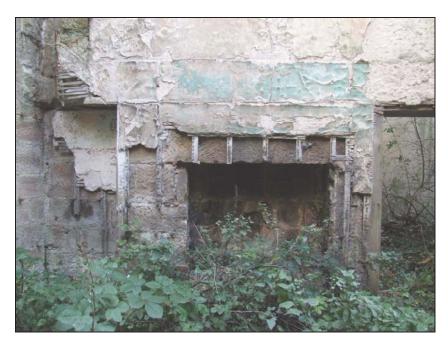
and 0.70m wide is situated, and to the south a doorway (Fig. 25; C) measuring at least 2.05m high and 1.10m wide survives with timber lintel and jambs. Lath-and plaster (Fig. 25; D) covers much of the elevation on this storey and, above the fireplace, a turquoise paint can still be seen.

Fig. 11 Lower storey of west elevation showing fireplace, surviving plaster and turquoise paint

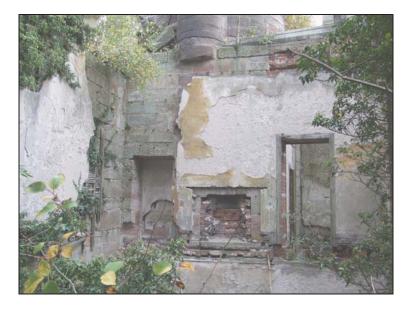
The second storey is very similar to the lowest storey measures 4.88m high and 5.33m wide, although the southern part is partly obscured by vegetation. A central fireplace (Fig. 25; E), built of sandstone with brickwork interior, measures 1.05m wide and 1.10m high with an alcove to the north (Fig. 26; F) measuring 2.23m high and 0.91m wide and partly infilled with brick work at its base (Fig. 25; G). To the south of the fireplace a door way (Fig. 25; H) measuring 2.4m high and 1.06m wide still retains its wooden lintel and jambs. A large area of plaster (Fig. 25; I) still survives across most of this elevation, although it does not reach to the full height of the wall. This suggests that originally the room was around 3.9m high. Above the plasterwork the elevation appears to have been built of brick on its south side (Fig. 25; J), which could represent a rebuilding episode.

Fig.12 Second storey of west elevation

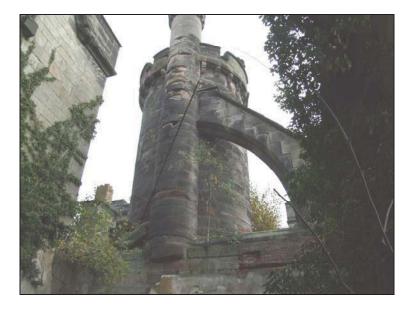
The upper storeys of this elevation consist of the Round Tower with projecting chimney (Fig. 25; K) and a flying buttress (Fig. 25; L). The Round Tower measures 6.68m high and 3.8m in diameter, with the projecting chimney located centrally to the western face. The decorative battlement at the top of the tower measures 1.14m high with narrow crenellations measuring 0.5m high and 0.2m wide (Fig. 25; M). The chimney measures 1.23m wide and 8.92m high and is built of sandstone blocks and surmounted by a small projecting decorative battlement measuring 0.56m high (Fig. 25; N). The flying buttress, built of sandstone blocks springs from the south side of the tops of the lower storeys of the elevation and abuts the chimney stack on its southern side, midway up the Tower.

Fig. 13 Upper storeys of west elevation showing protruding chimney and flying buttress

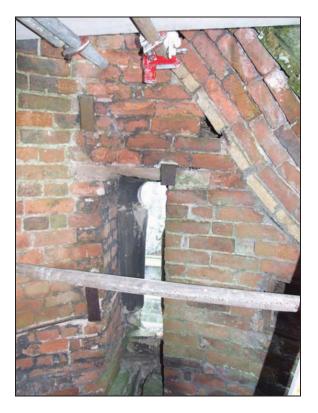
4.6.1 The key observation evident from the interior photography is that parts of the upper portion of the tower (the lower parts towards the centre and base of the barrel) are brick construction with exterior stone cladding (Fig. 14). This occurs at the interface between the two construction materials, directly below a diagonal brick-constructed flue that 'snakes' up the tower in a similar direction to the spiral staircase evident in the walls in the floor below (Fig. 14).

Fig. 14 Interior brick construction with stone cladding visible through the window. The diagonal brick flue can be seen in the top right of shot with a row of heat-retardant bricks at its base.

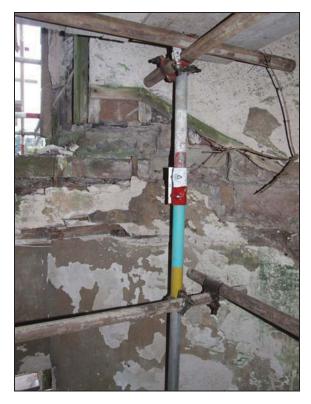
- 4.6.2 The principal reason for the recording in the tower's interior was to record the lath and plaster rendering which is visible across the Alverton Lodge site in patches. It was noted that this was in a poor state of repair and could communicate little further information concerning the original interior decoration.
- 4.6.3 The other major feature of note evident on the interior of the tower was the 'ghost' of the spiral staircase in the lower levels (Fig. 15) As shown in the figure below, the staircase ran upwards anticlockwise, different to that of medieval defensive spiral staircases which ran upwards clockwise in order to hinder the sword arm of a potential attacker. The (Fig. 15 below) also shows that the staircase was an original feature which predated the lath and plaster rendering, as the rendering fits around the 'ghost' of the staircase.

Fig. 15 Detail of the 'ghost' of the original interior spiral staircase showing the exposed brickwork behind the lath and plaster rendering.

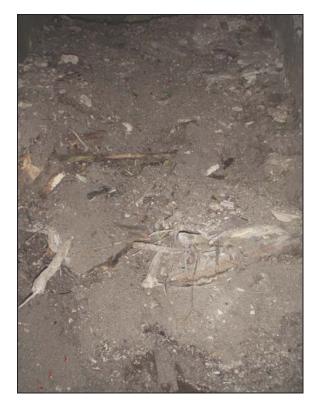
- 4.7.2 The stairwell had a deep fill as can be seen in Fig 17 . This mainly consisted of a wind and rain deposited sediment. Intermingled in this sediment were pieces of decaying wood, fallen plaster and building rubble in the form of fragmented breeze blocks.
- 4.7.3 The debris was removed by hand, firstly with a shovel then by trowel and brush which revealed the staircase rising upwards and spiralling to the left at the top, as seen in Fig 19. Pieces of wood were collected from within the debris as seen in Fig 20 and can be identified as material used to fabricate a wooden tread plate at the nose of the step (Fig 21).
- 4.7.4 No other archaeological features, deposits or small finds were located within the sediment deposit.

Fig. 17 Stairwell fill viewed from the bottom of the stairs

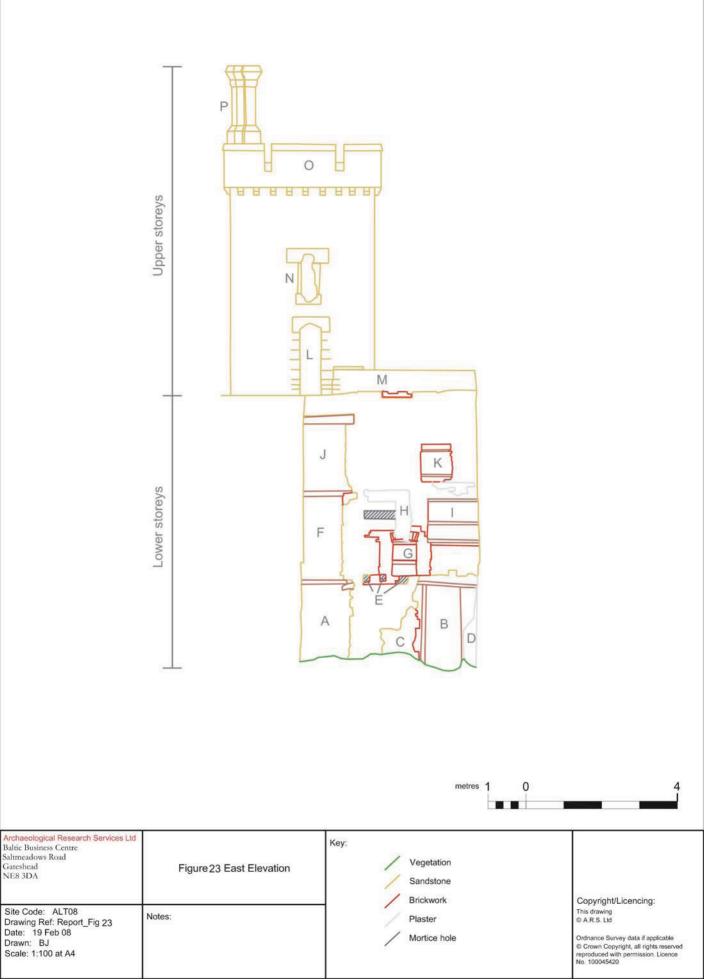
The lower three storeys of this elevation were predominantly built of finely tooled sandstone blocks which had been rendered with a plaster, most of which has subsequently eroded. Brick infills of window and door frames were visible on all three floors. The lower storeys measured at least 8.3m high, although debris and vegetation on the lowest floor made an accurate measurement impossible, and 4.66m north to south. The lowest storey measured at least 3.39m high, whilst the central storey measured 2.36m high and the upper storey measured 2.55m high.

The upper floor level featured a doorway at its southern side which corresponded with those on the lower storeys, measuring 1.77m high by 1.14m wide and comprised a lintel but no jambs and gave access to the interior of the Round Tower. The northern side of the elevation had a small, window measuring 1m high by 0.82m wide (Fig. 23; J), bricked-up with an English Bond.

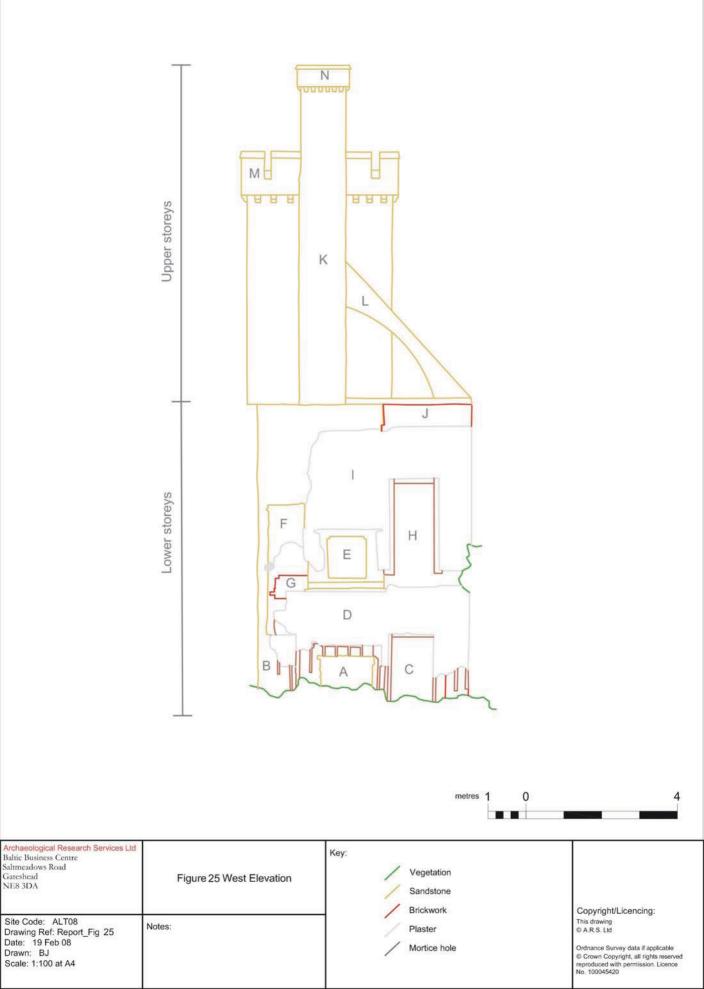
The lower part of the elevation can be divided into two storeys. The lower storey was heavily obscured by vegetation at its base but measured at least 3.22m high and 5.33m wide. A large fireplace (Fig. 25; A) is situated in the centre of the elevation, built of sandstone, and measuring at least 1.58m high and 1.35m wide. To the north of the fireplace an alcove (Fig. 25; B) measuring at least 2.05m high
