**An Archaeological Assessment
and Photographic Building Recording at the
Balmoral Hotel, Newcastle upon Tyne.
Heritage statement.
Part B, Listed Building Appraisal**

Archaeological Research Services Ltd Report No. 2008/57
July 2008

**Heritage statement.
Planning application.
Part B, Listed Building Appraisal.**

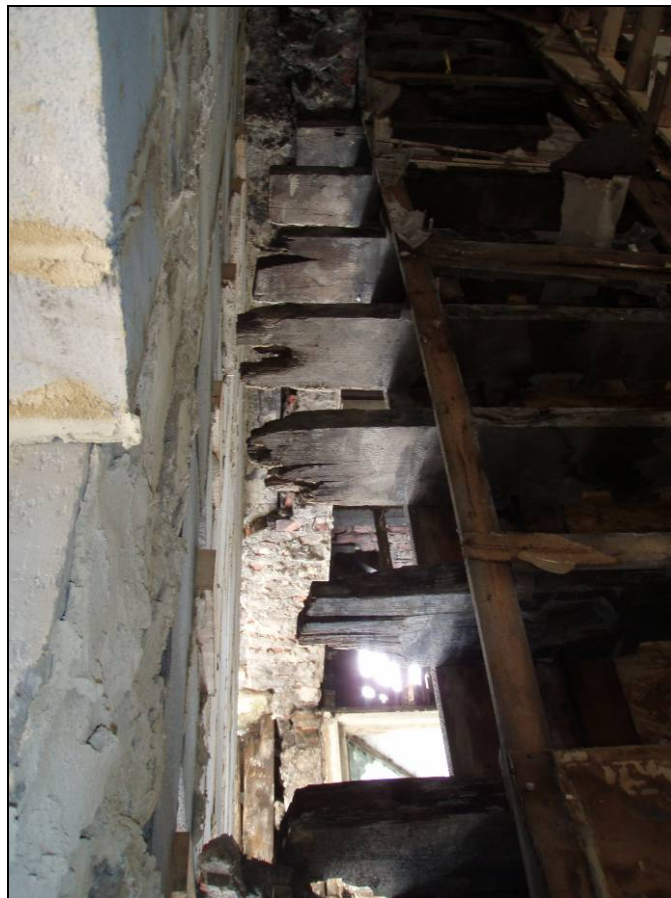
2.1.2. The first floor roof support joists are rotten and dangerous (figs. 2 & 3). They are all to be replaced and have been subject to archaeological photographic recording. They do not in any case contribute materially to the historic character of the property

Fig. 2 Rotten joists, looking down from first floor

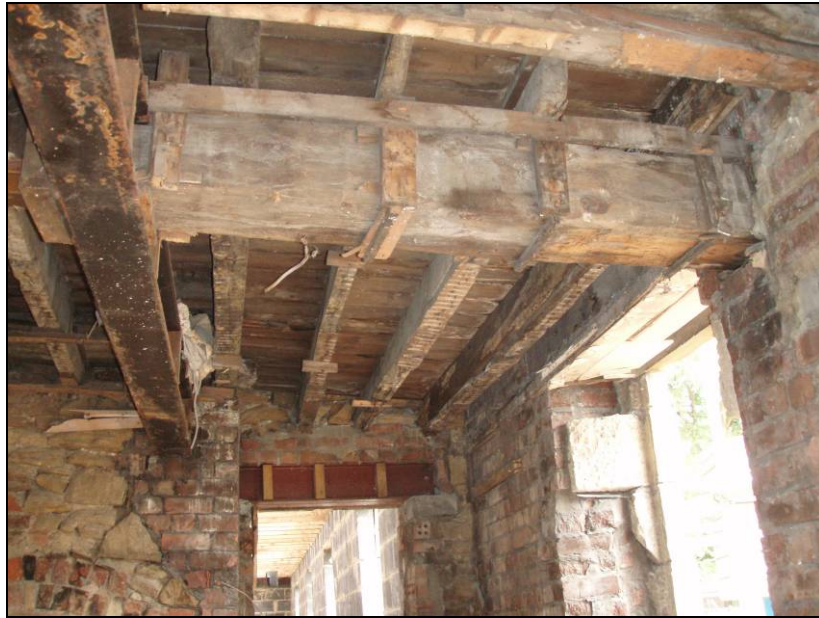
Fig. 3 Dangerous roof joists looking up from ground floor.

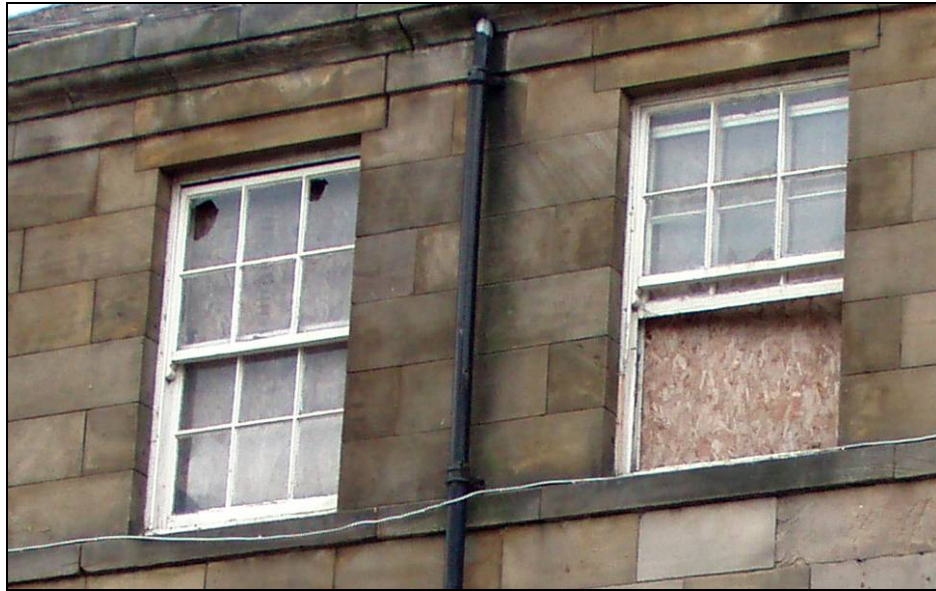
The windows to the east elevation of the Balmoral exist on 3 floors. The windows on this elevation are important to both the character of the building and its setting. The 2nd floor consists of 5 sash windows (fig. 4). The windows consist of 12 lights, separated by wooden transom and mullion bars. The windows are wooden framed. Built into the structure of the hotel are narrow sandstone lintels, the cills are not only associated with the windows but are part of a sandstone string course which runs the length of the building. The sash windows are of mid to late Victorian design as is evident from their recession into the walls. Also the lack of an internal sash box (concealing the rope pulleys for the window) may indicate a mid to late Victorian date.

Fig. 4 2nd floor sash windows

- 2.4.A. ***'Remove and replace all existing windows and window cills with new softwood single glazed painted sliding sash windows to match exactly those removed except that all new mullion and transoms bars must all be 19mm max thickness all as shown on architects detailed drawing 1472DT.'***

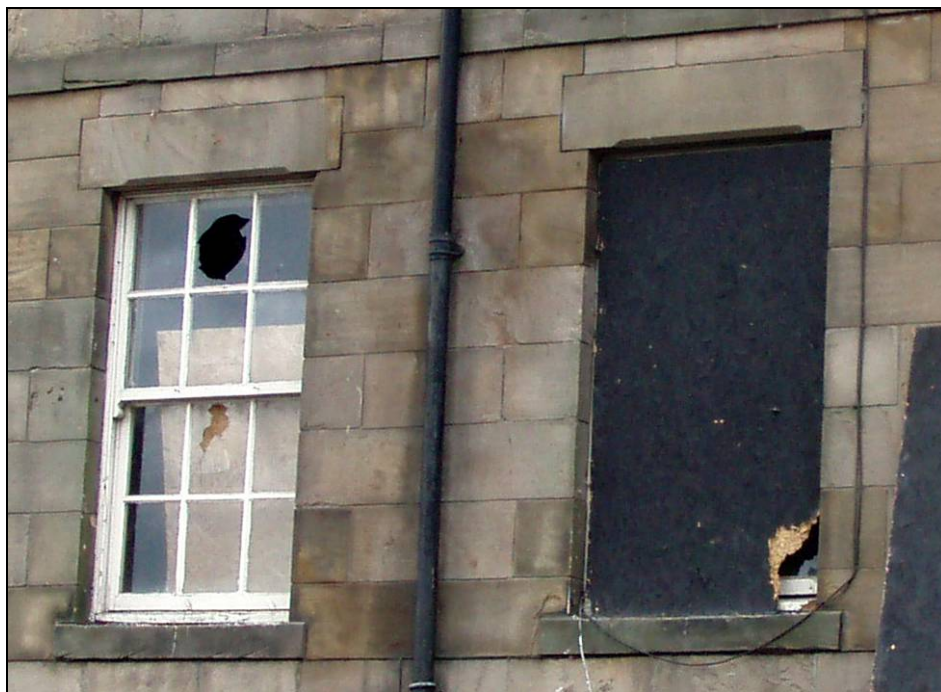
2.4.2. The 1st floor windows (figs. 5 & 6) are of the same design as the 2nd. 12 lights are housed within the mullions and transoms with a wooden frame. The window lintels take two slightly different forms. Towards the north side of the east elevation (fig. 5), the lintels have a form of stopped chamfer across their base. This is not present on the windows to the south.

Fig. 5 East elevation, first floor windows with mouldings.

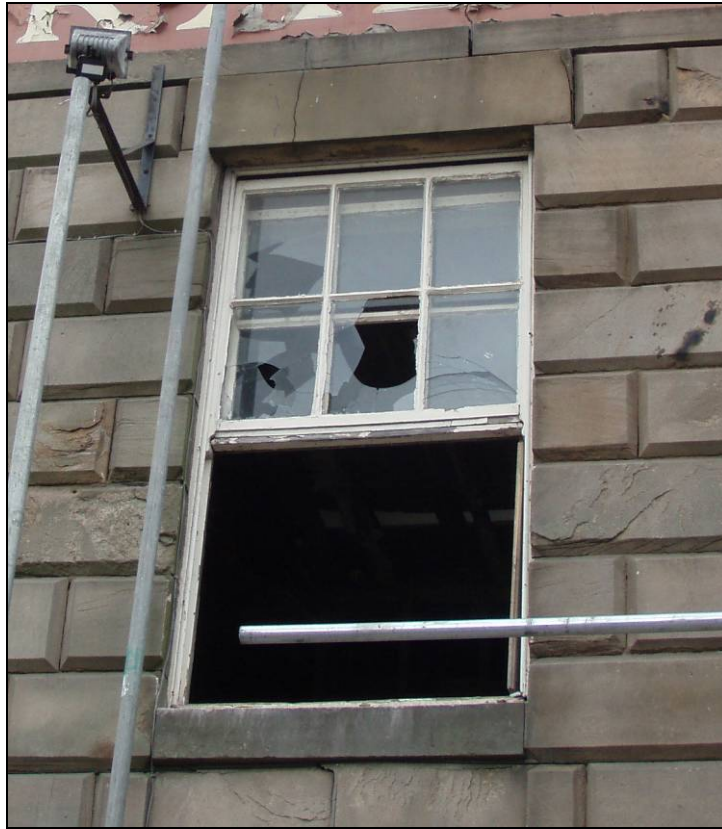
Fig. 6 East elevation, first floor window without moulding

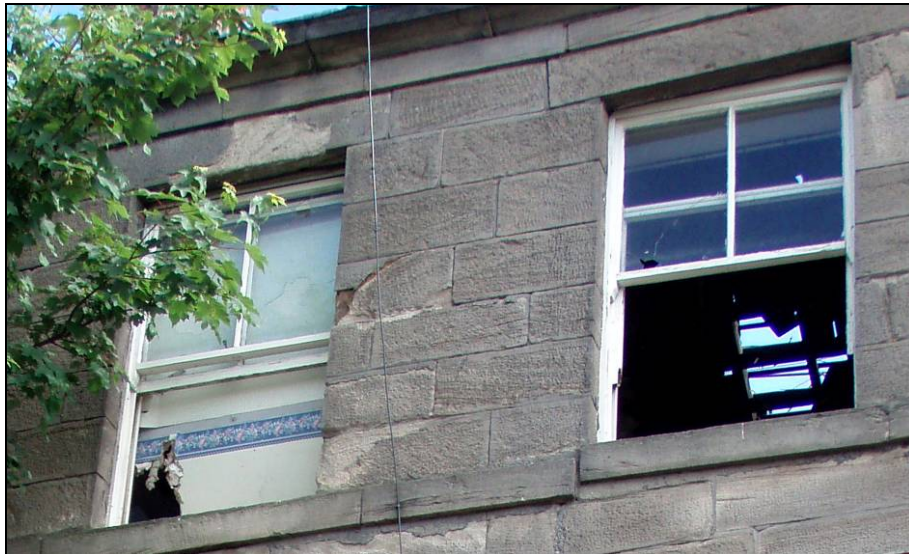
The windows to the south elevation (fig. 1) are present on 3 floors. The 2nd floor windows are again of the sash design. To the western side of this elevation the windows differ from the rest as these windows only contain 4 panes of glass (fig. 7). This is a later developed technique which indicates a Victorian date as at this time glass manufacture became more proficient allowing for larger panes to be used. To the eastern side of this south elevation the single window (fig. 8) is of the same design as the eastern elevation. 12 lights, separated by wooden transom and mullion bars. The window is wooden framed. Narrow sandstone lintels are built into the structure of the hotel. The cills are not only associated with the windows but are part of the string course which runs the length of the building.

Fig. 7 South elevation Windows to the west side

- 2.4.6. All windows are to be replaced as they are rotten and badly damaged. Replacements are all to be sash, in wood, highly sympathetic to the existing as per the architect's drawings and the schedule of works.

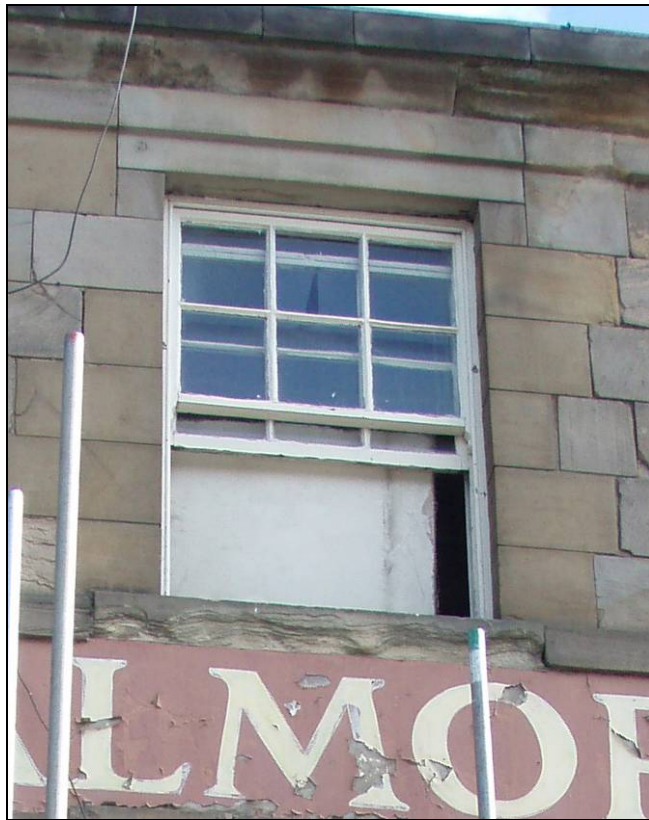
2.4.4. There are two windows on the first floor. To the west there is the bay window (fig. 9). The bay window is of wooden construction. Its front consists of 4 large lights (separated by wooden mullions and transoms) with sliding sash frames. To either side of the bay front, a pair of sliding sash windows each holds 2 lights. An attractive addition to the hotel although not original, it dates to the first half of the 20th century. The whole is in poor condition but the development proposal will contribute to the historic character of this frontage by replacing this in identical style. The bay window has been subject to full preservation by record with large-scale drawings (1:20) and detailed photographic record. To the east of this elevation there is a single window in the style of those of the east elevation, 2 lights, separated by wooden transom and mullion bars. The window is constructed of wooden frames.

Fig. 8 First floor south elevation window to the eastern side.

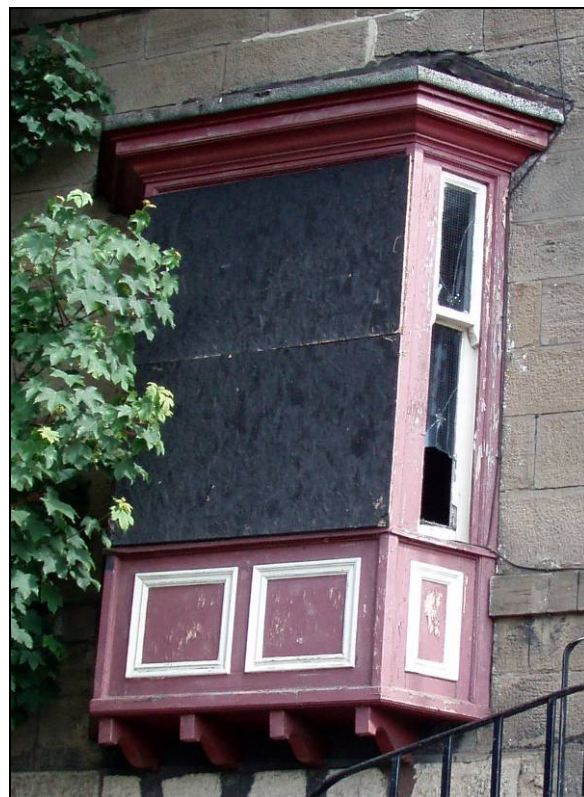
Fig. 9 South elevation bay window

- 6.3. The bay window to the west of the south front is not original but dates to the earlier part of the twentieth century. This is attractive and well constructed and, although not original, does enhance the historic character of the building. It is however in a poor state of repair. For this reason it has been subject to full historic fabric investigation (see scheme of works discussion section 2 of this report) and preservation by record by photographs and large-scale drawings (see figures and appendix I in this report) and its removal is proposed. It is to be replaced in an identical style (as laid out in schedule of works), thus enhancing the historic character of the east front. The door to the south front is attractive and perhaps of earlier twentieth century date (shown on plans of 1952). However, to judge by the relatively poor workmanship of the wood panelling, quite unlike the work in the adjacent bay window, this may be a replacement to an earlier door in similar style. This is in a poor state of repair and has also been subject to historic fabric investigation (see scheme of works discussion section 2 of this report) and full preservation by record by photographs and large-scale drawings (see figures and appendix I in this report). It is proposed to remove this and replace it with an identical, though better quality, wood-panelled door in Victorian style, thus also enhancing the historic character of the south front.

- B. *'Rebuild rotten damaged bay window frame and replace window on south elevation with new lead covered roof.'***

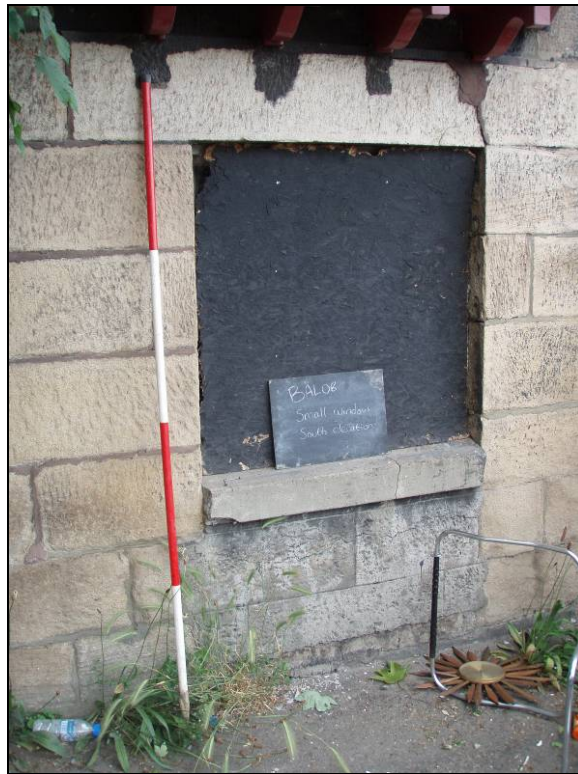
- 2.4.5. To the ground floor there are two more windows. The window to the west (fig 10) is not in keeping with the other designs. It is square with 4 large lights, the upper two being slightly smaller and having a 'push to open' mechanism. It is clear on examination that the opening occupied by this window has been modified (in-filled) in the past to change it from rectangular to square. A sandstone lintel has been inserted mid way up to form the new opening, with in-filled lower half being crudely rendered over. To the east side there is a window of different style to the rest (Fig. 11). It is a ridged, non opening window with 20 small lights separated by wooden mullions and transoms. This window is of an earlier design and is likely to be original. Internally this has ornate wooden moulded surrounds. This is badly damaged/ rotted and is to be sympathetically replaced as per the schedule of works.

Fig. 10 South elevation, ground floor window

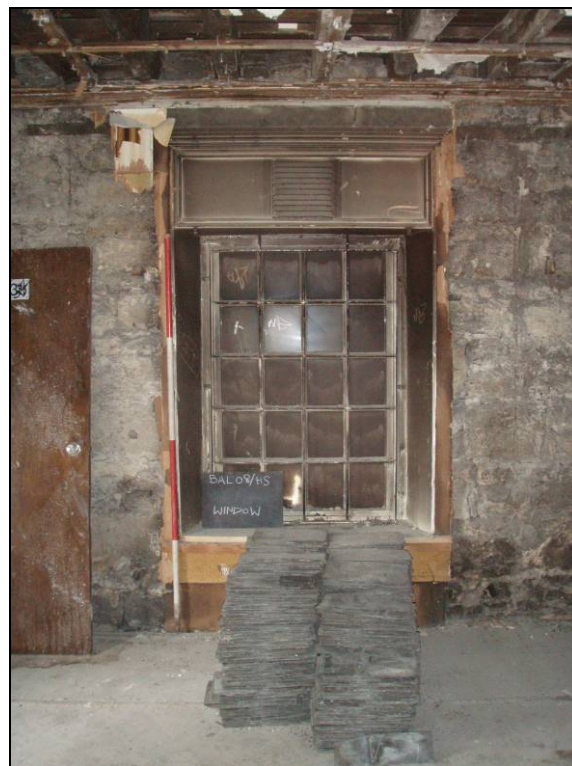
Fig. 11 South elevation ground floor window (internal)

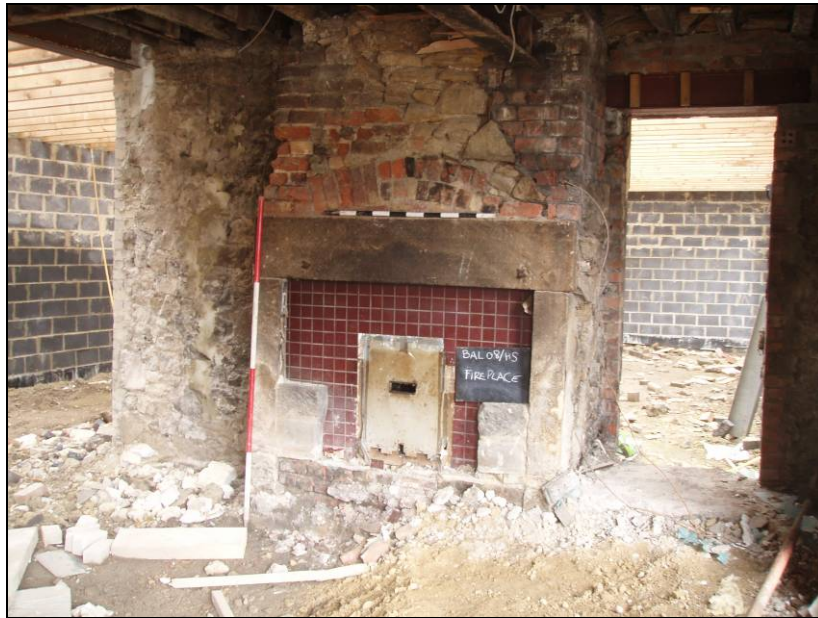
3.5.1. Internally to the north elevation of the historic property are the remains of a fire. Some of the original masonry exists, especially on the west side (fig. 12). The structure however has been seriously altered with rough modern brick infill, and cannot be retained as an RSJ has been inserted into this part of the structure in the 1970's supporting the entire upper stories of the building on the chimney breast. This is extremely unsafe and needs to be removed. The whole structure has been subject to a detailed photographic record.

Fig. 12 Fire place with rough brick infill

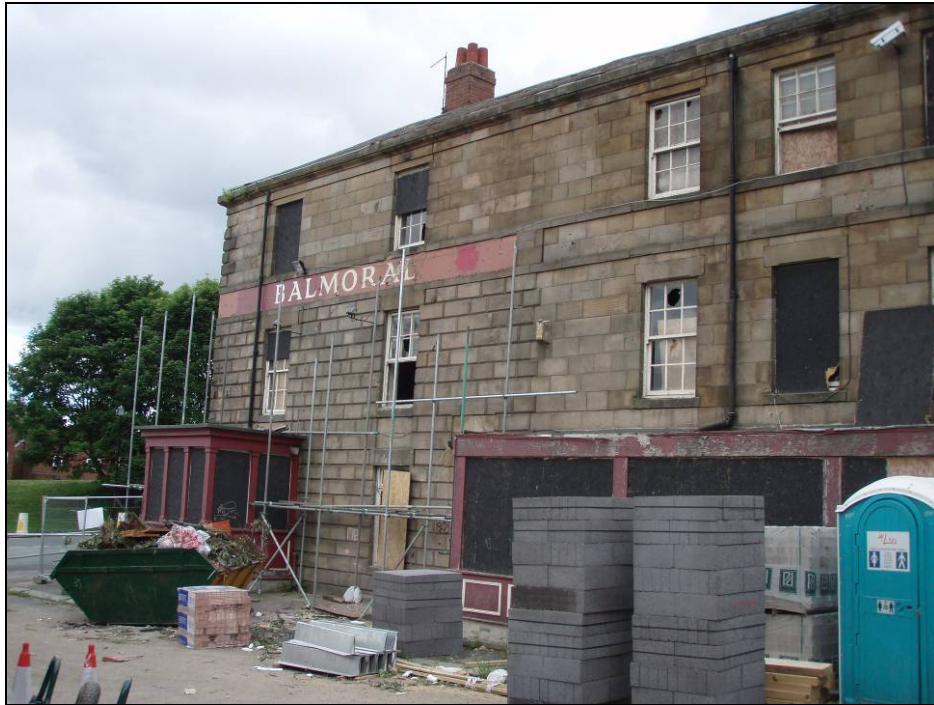
The sandstone Ashlar wall (fig. 13) contains 11 sash windows. A relatively new entrance porch to the south is of wood construction, as is the modern 'conservatory' to the north. The centre of the wall on the ground floor has a blocked up door (fig. 14) way which has also been clad over so that now only its lintel is visible (Amat & Hewitt 2008). The 'Balmoral Hotel' sign is visible on this elevation, constructed of a wooden bored and painted lettering.

Fig. 13 East elevation showing Ashlar wall and cladding.

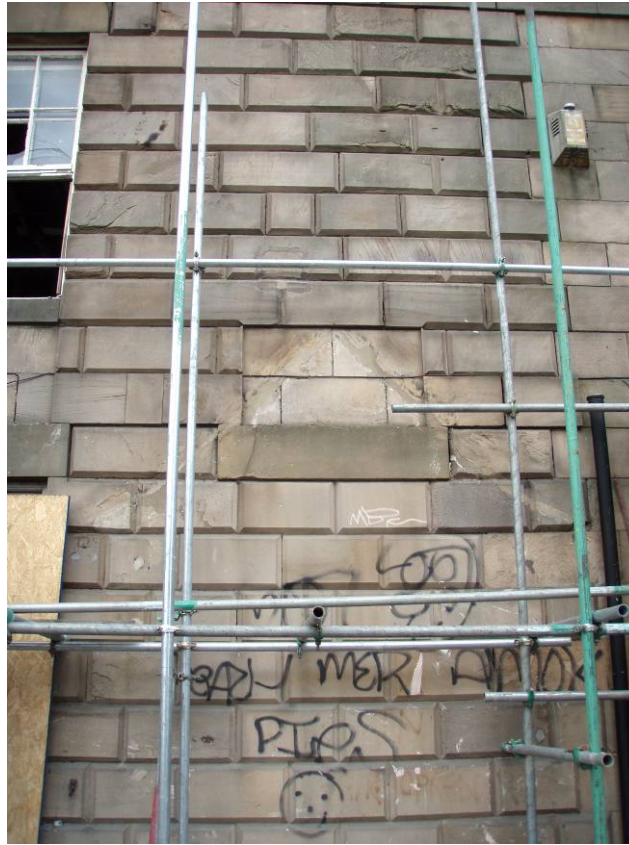
Fig. 14 East elevation 'blocked up door' with lintel

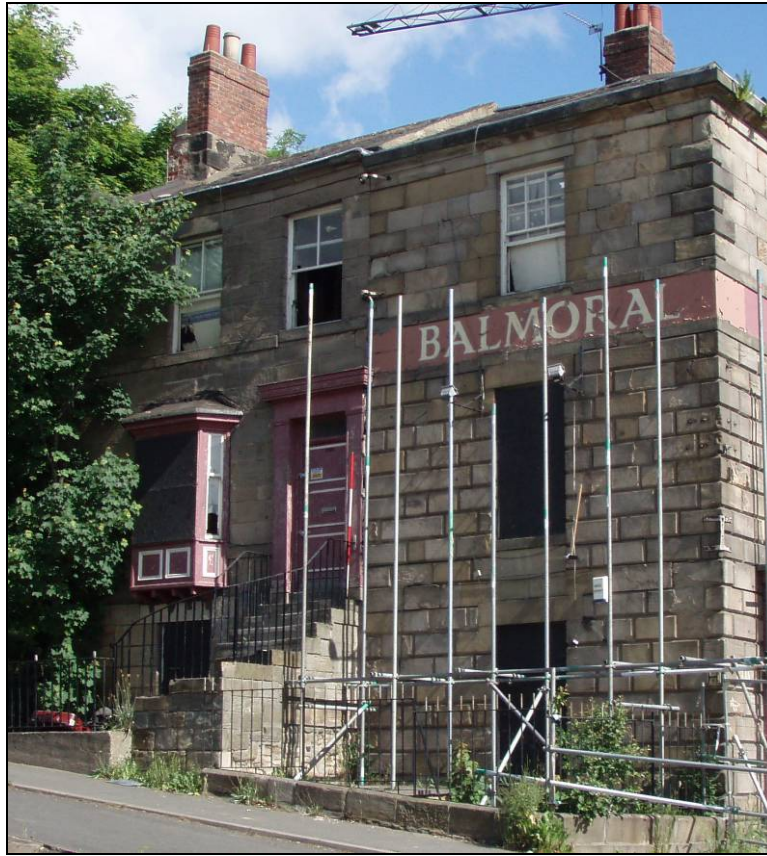
As with the east elevation, the south elevation (fig. 15) is in Ashlar and partially sandstone clad. The wall has cladding to the east side but not to the west. The wall houses 7 windows one of which being a bay, as well as a door. From this perspective, the difference between what were 2 individual buildings is more apparent as the cladding stops in a vertical line up the centre of the building (to the right of the door).

3.7.3. Some slight bowing to the Ashlar walls of the south elevation particularly on the western side can be seen. These are structurally unsound and will be carefully dismantled and rebuilt in identical style as per the schedule of works. This is essential work which can only enhance the property by prolonging its life. Care should be taken to rebuild like for like thus ensuring the character of this mid nineteenth century house is retained.

Fig. 15 South elevation wall

3.7. *'Take down and rebuild as necessary all Ashlar Stonework on south façade on second floor which has moved due to subsidence. Replace cracked lintel over ground floor window.'*

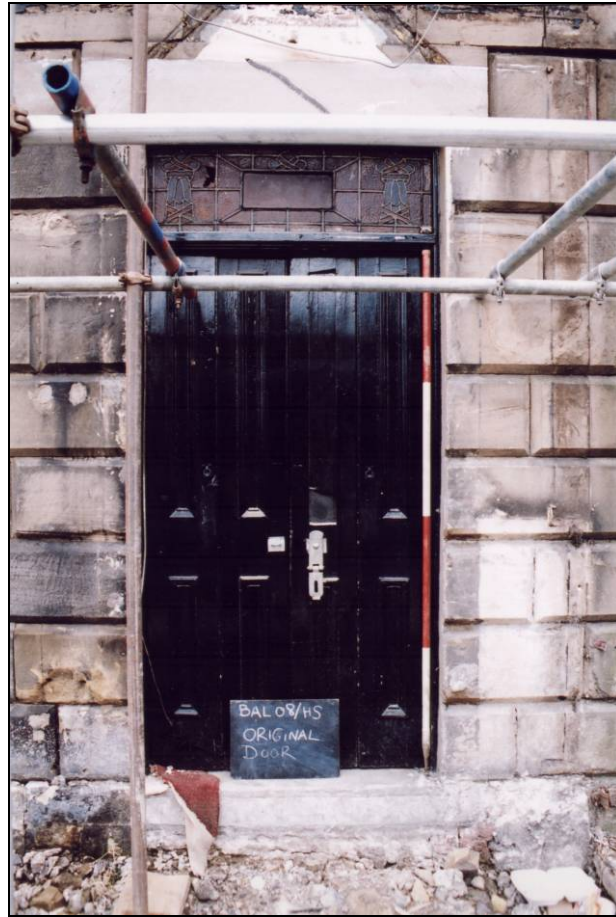
- 3.8.1. The original entrance (fig. 16) into the bar area of the Balmoral exists on the east elevation. It was uncovered by the removal of the modern 20th century porch. The original door, which is thickly painted, is preserved. The door has 4 panels, each panel hinged in two parts & opens inward. It is well preserved to the inside, outside and within the door alcove. A stained glass window (fig. 17) which is likely no earlier than 1880 in date, probably a replacement to the original light, is situated above the door, though this is in slight disrepair as one small panel is smashed. This feature is an unusual survival and the development proposes to enhance the historic character of the existing front by preserving this in-situ (see Schedule of works).

Fig. 16 Original wooden door to the east elevation

3.8. *Remove existing entrance porch in order to expose and retain the original entrance door and stained glass window.*

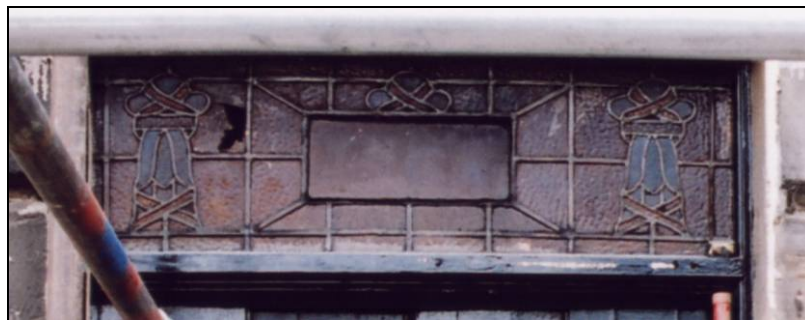
Fig. 17 Stained glass window above east elevation door.

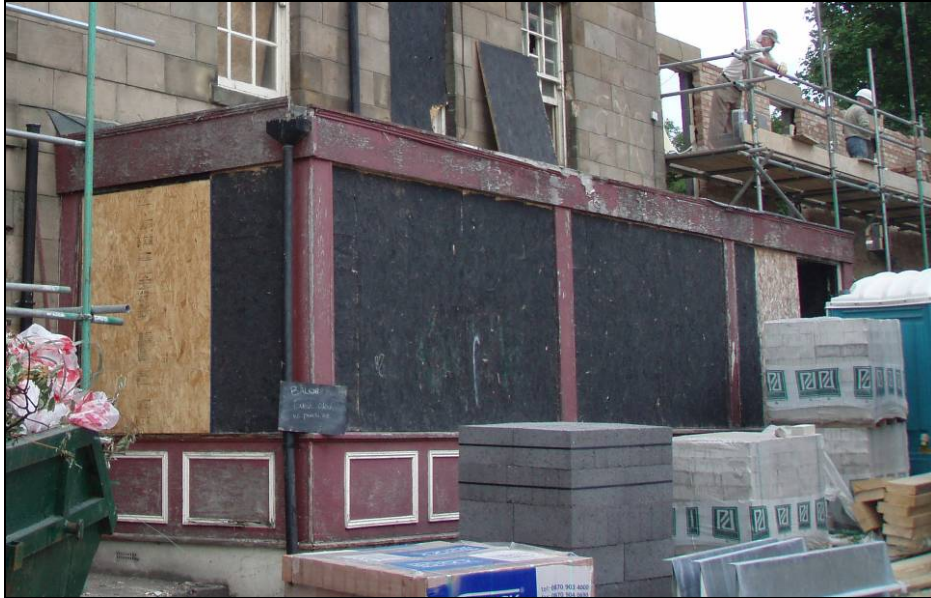
- 3.9.1. The conservatory on the east elevation (fig. 18) is of later 20th century design. It blocks what were 3 east facing windows. From analysis of the building control plans (Amat & Hewitt 2008), the construction likely took place around the same time that the central entrance was blocked. The structure is built of wood in a style matching the entrance porch and south elevation bay window. 5 large lights

are separated by wooden mullions. A new conservatory is to be constructed as per the schedule of works but no modification will be made to original masonry behind. As the existing conservatory is a relatively modern feature and in a bad state of disrepair, the construction of a new conservatory, sympathetic to the original could only help to enhance the building and its setting.

Fig. 18 East elevation conservatory.

6.2. Though superficially interesting and of pleasant appearance, the wooden porch and conservatory to the east front of modern date (post 1950), they are rotten and split, obscure original historic details, and detract from the historic character of the property. Their proposed removal will return lost character to this

3.9. *‘Remove existing conservatory and replace with new one with double glazed lights full floor to ceilings in height all as detailed.’*

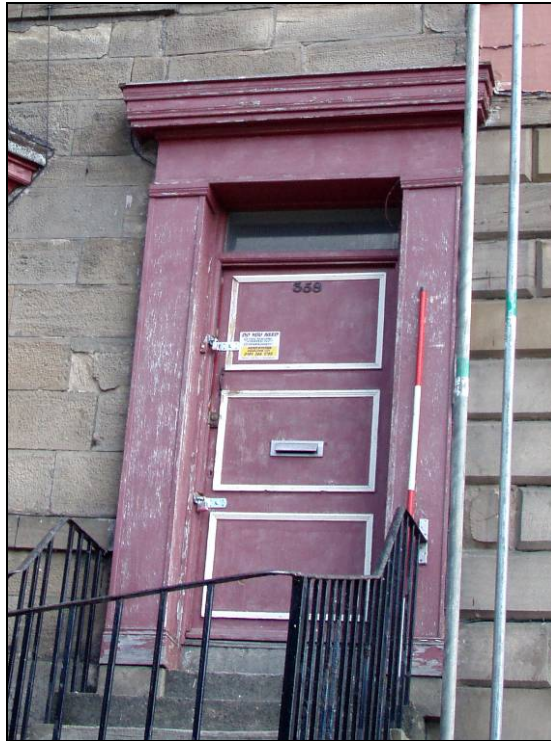
- 4.1.1. The entrance of the south elevation is to the first floor, the door is of wooden construction, with a glass panel over (fig. 19). Superficially similar in style to bay window but in cheaper materials (plywood panels), it is of poor craftsmanship and a state of disrepair and will benefit from the proposed high quality replacement in the same style (see the schedule of works).

Fig. 19 South elevation entrance.

4 ***‘Fit new 6 panel “Victorian” style doors with appropriated ironmongery and door frames and architraves to match original to new and existing door openings.’***
