An Archaeological Building Recording at Cliff Ash Farm, Cliffash Lane, Idridgehay, Derbyshire

Farmhouse and Barn

Archaeological Research Services Ltd Report No. 2008/66 August 2008

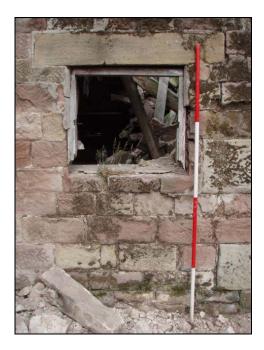
Fig. 16 Window on the ground floor of the south-west elevation of the barn

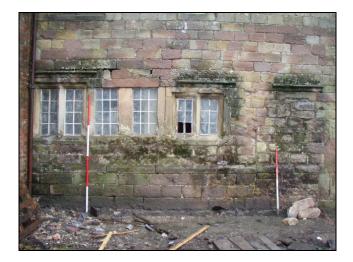
The south-east elevation comprised of two sections; the original wall of the farmhouse and the wall of the extension to the farmhouse. The red brick extension known as Area Three was built onto the south-east wall of the original farmhouse. The south-east elevation of the original farmhouse originally contained three windows on the ground floor, indicated by the three projecting door-heads still in existence (Fig. 33). After this date, the window on the right hand side of Figure 33 was sealed and three new windows were inserted. This is clear as the mullions are constructed of cleaner sandstone than the blocks used to construct the elevation. It is possible the smaller window of these three was inserted earlier than the other two as the stile on the right hand side of the window and the lintel appear to be re-used. The date of the insertion of the new windows is unknown.

Fig. 33 Lower windows in south-east elevation of original farmhouse.

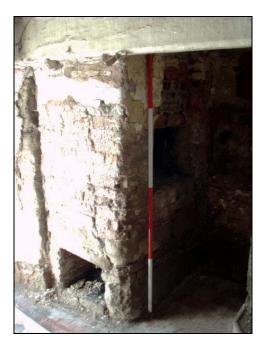
Fig. 53 Red brick bread oven in Room 3

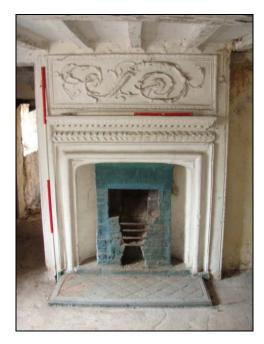
Room 8 was a plastered room larger in size than Room 7 and contained an ornate fireplace with plaster decorations located along the north-east wall (Fig. 59). A small room, possibly originally a walk-in wardrobe, was situated within the north-east wall of this room (Fig. 60). A short passageway led from Room 8 to Room 9 and extended eastwards behind the fireplace forming a small storage area

Fig. 59 Fireplace within Room 8

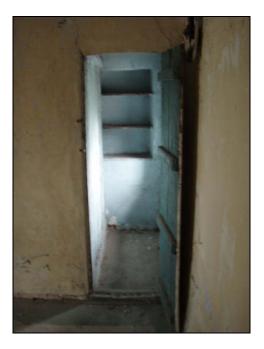
Fig. 60 Storage room off Room 8

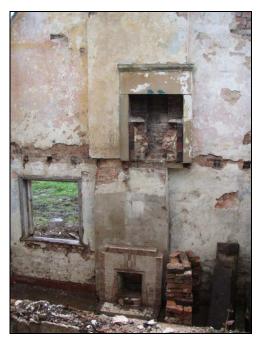
Fig. 62 Interior of Area Three showing the two fireplaces and the position of the first floor

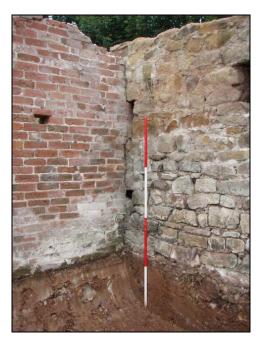
Fig. 64 Red brick wall separating the two rooms of the outbuilding

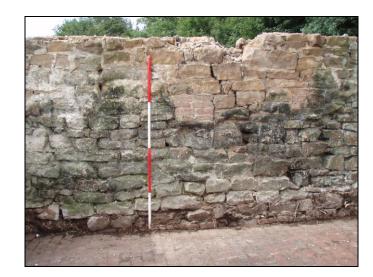
The south-west elevation contained one window which had been blocked with red bricks and a slate tile (Fig. 65).

Fig. 65 South-west elevation with sealed window in centre of photograph

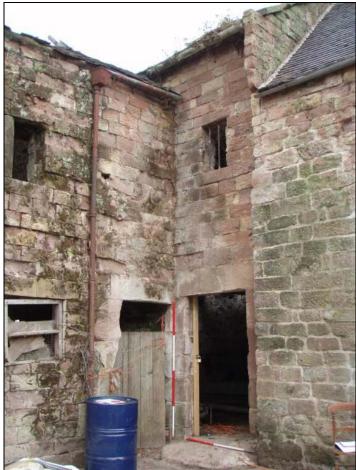
PLATE 1: AREA CONJOINING BARN WITH FARMHOUSE

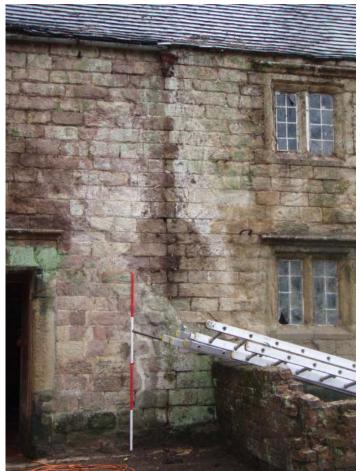
PLATE 2: BOND IN NORTH-WEST WALL SHOWING EXTENSION OF FARMHOUSE

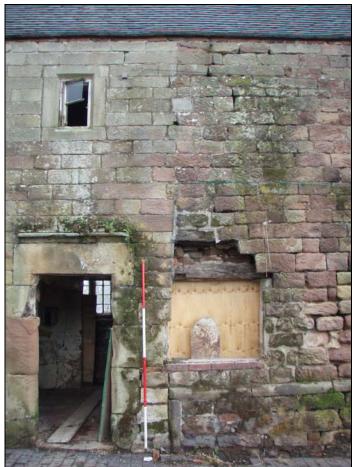
PLATE 3: BOND IN SOUTH-WEST WALL SHOWING EXTENSION OF FARMHOUSE

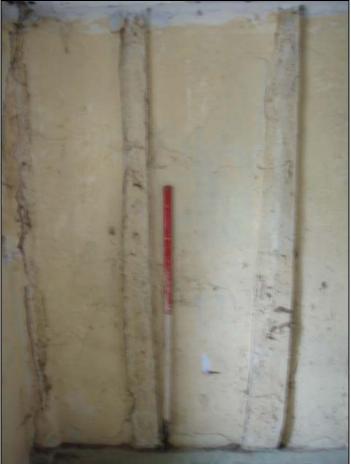
PLATE 4: WATTLE AND DAUB WALL IN ROOM 7 OF FARMHOUSE

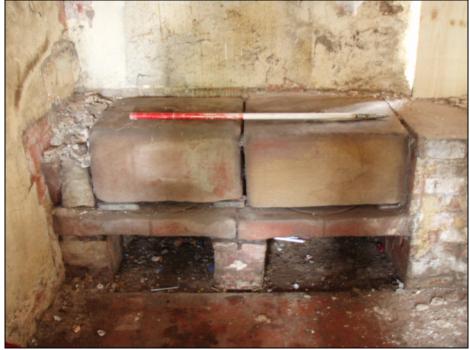
6.8.3 Two cheese presses were positioned along the south-east wall of the room. The two sandstone blocks, measuring 0.66m and 0.77m in width respectively and 0.34m in height remained in their original locations. Below the blocks was a narrow gap for excess water to run off. The press was built upon a layer of sandstone blocks 0.38m in length over two red brick footings 0.3m high. The press was edged by a red brick wall to the right hand side of Figure 54. The mechanism consisting of a vertical pole attached to a wheel which would be turned to lift or depress the two stone blocks had been removed after the cheese presses were no longer used. The cheese presses are an original feature of the farmhouse and will be kept *in situ* during the conversion of the buildings.

PLATE 5: CHEESE PRESSES IN ROOM 3 OF FARMHOUSE
