Robin Hood's Stoop

ARS Ltd Report 2008/47
June 2008

An Archaeological Watching Brief at Robin Hood's Stoop, Hathersage, Derbyshire.

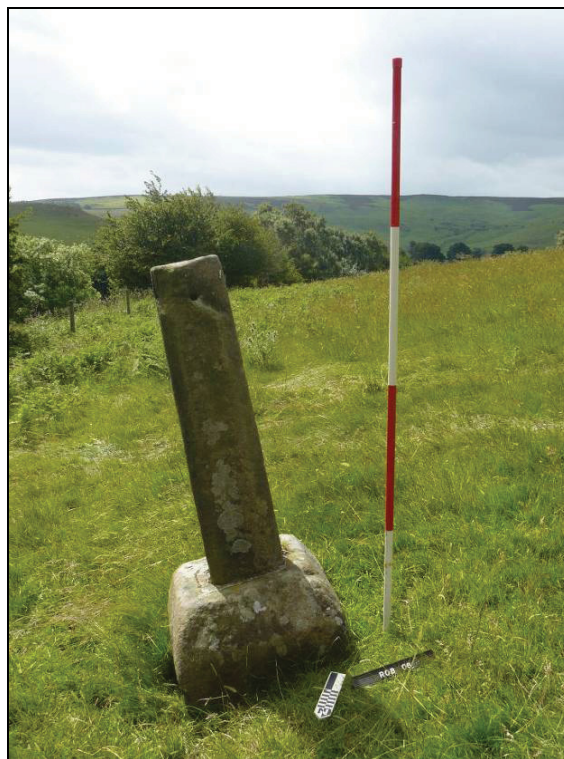
Fig. 3: Position of the cross before re-alignment. Facing south

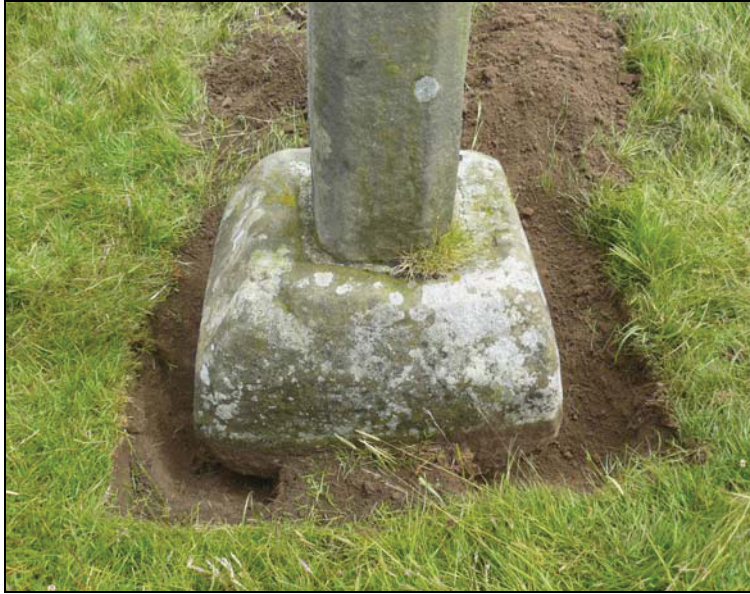
- 3.1 The cross base measured approximately 0.7m square and therefore, an area of 1m² was measured out for excavation. Turf was removed from around the base which revealed coarse sandy topsoil context (001) which had accumulated around the base over time. Topsoil was initially removed by hand from around the monument to enable the positioning of lifting straps below the base to support its removal (Fig. 4). At the western edge topsoil was removed to a depth of 0.07m exposing a sandy clay (002) located beneath the base.

Fig. 4: Excavation around the base to enable lifting. Facing east.

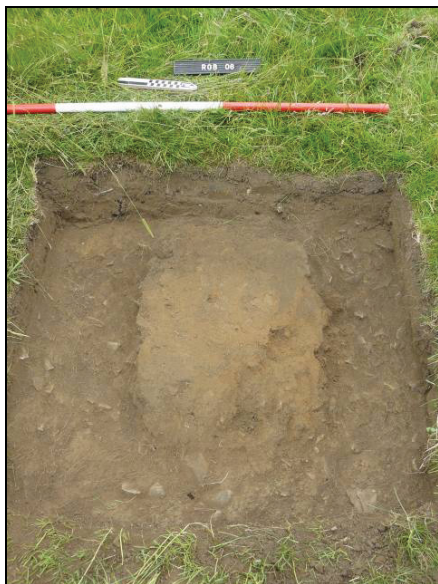
- 3.2 The sandy clay (002) overlay a subsoil horizon (003) (Fig. 5). Context (002) was interpreted as a bedding/levelling layer for the base of the cross and had a depth of 40mm. Examination of (002) displayed the slope which had developed over time and was found to have an angle of 12 ° (Fig. 6).

Fig. 5: Context (002) overlying (003).
Facing west.

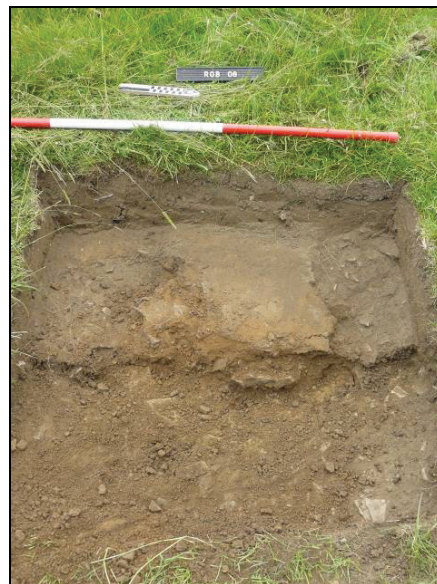
Fig. 6: Section of (002). Facing west

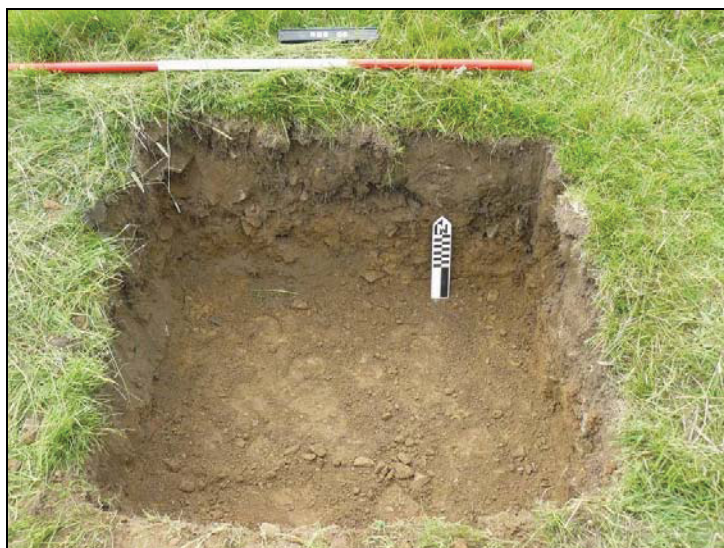
- 3.2 The stoney subsoil (003) was excavated by hand and the natural substrata (004) of sandstone and clay was revealed 0.1m below the eastern edge. The natural substrata was levelled to 0.2m below the eastern edge and 0.55m below the western edge (Fig. 7).

Fig. 7: 1m² pit levelled into the hillside

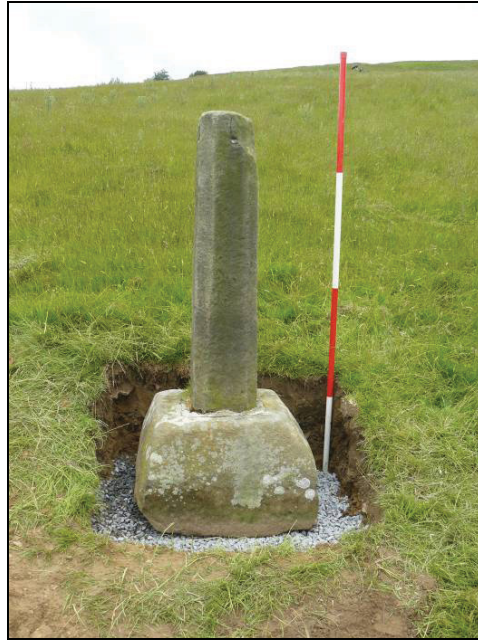
Fig. 8: Cross shaft and base repositioned. Facing west

- 3.3 Following excavation of the pit a level sub-base layer was created within the pit using blue gritstone chippings to a depth of approximately 0.2m and compacted by the bucket of the JCB. The cross shaft and base were lifted back into position

(Fig. 8) and a 2m square perimeter fence erected around the cross (Fig. 9). The area surrounding the cross base was re-turfed at a later date to protect and stabilise the cross (Fig. 10).

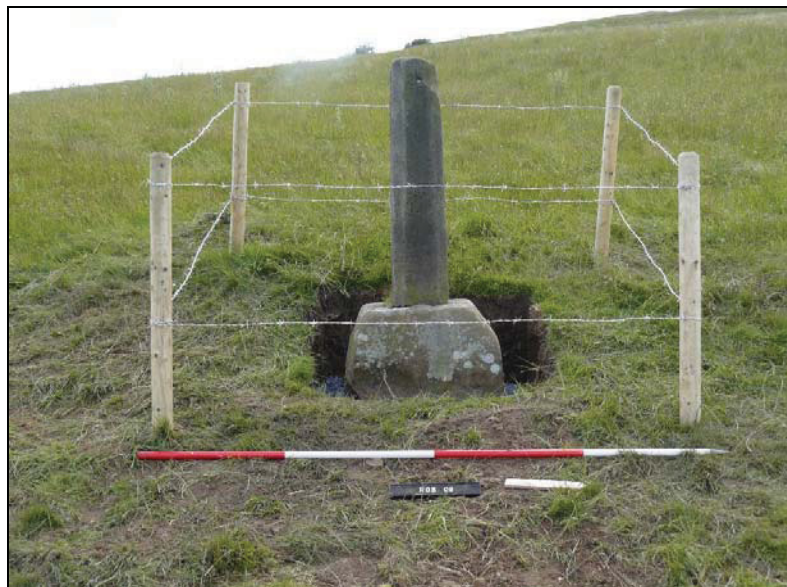
Fig. 9: Perimeter fence around the cross. Facing west.

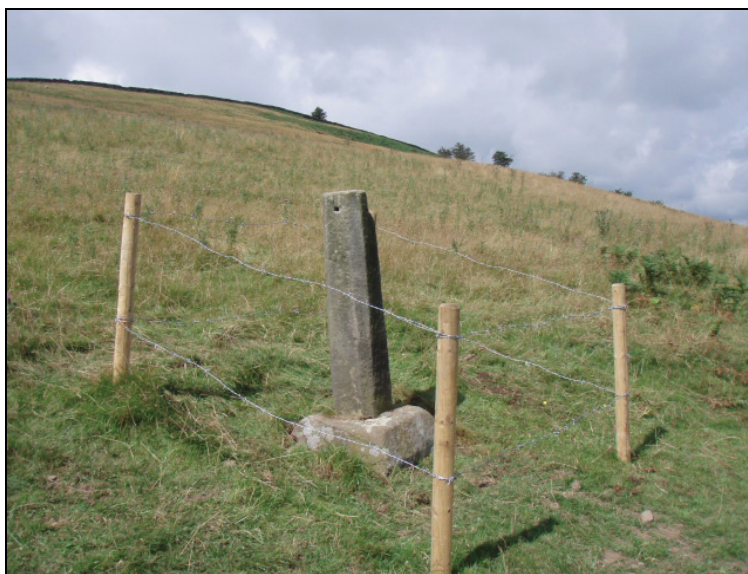
Fig. 10 Robin Hood's Stoop after re-turfing. Facing north-west
