## Alport Mill, Harthill, Derbyshire

### Report on a Watching Brief.

**ARS Ltd Report No. 2009/4/159**  
March 2009

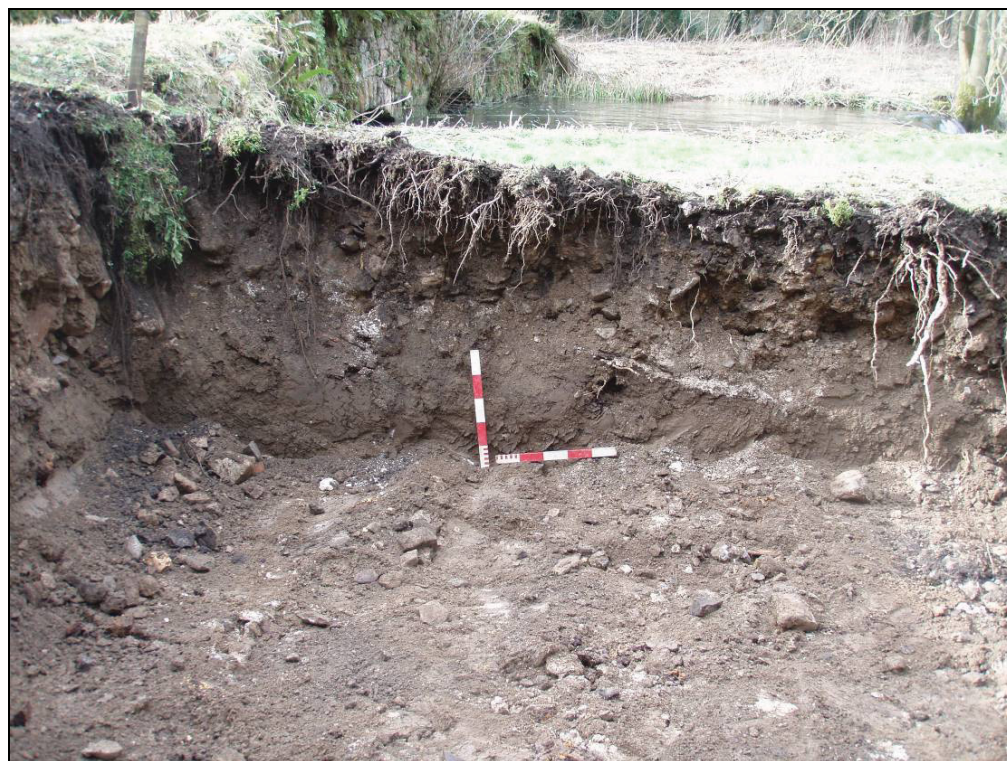
- 6.1.4 Below the made ground layer were a series of natural deposits including sandstone bedrock and accumulations of tufa. Initial excavations reached a depth of approximately 1.4m below the upper most level of the current ground surface and the base of the pit levelled off (Fig. 6).

Fig. 6 The east facing section of the turbine pit before excavation of the sump.

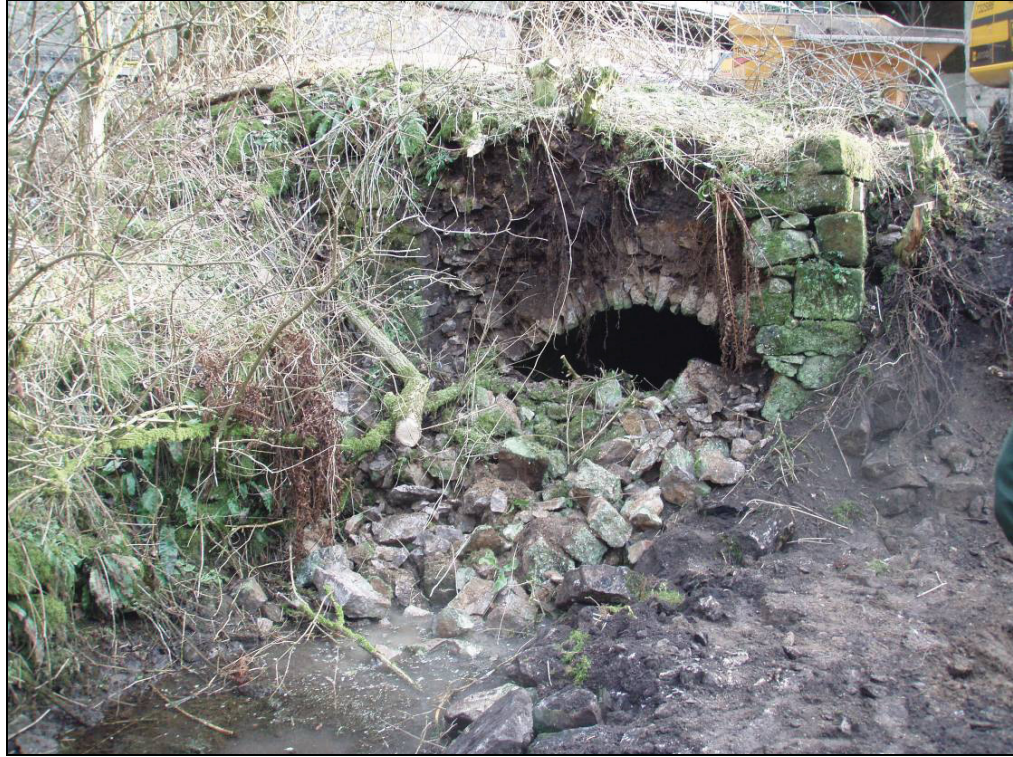
- 6.1.5 Excavation of the turbine pit initially retained a spit of ground approximately 0.5m wide extending north from the western edge of the covered mill race. It was deemed necessary to remove this spit in order to facilitate the re-instatement of the mill race to function as the outlet of the turbine. Removal of this spit was undertaken with due care so as not to disturb the upstanding front of the covered mill race and the western retaining wall edge. It was found to contain a quantity of sandstone blocks that obviously related to a section of collapsed wall. A significant amount of root penetration from removed foliage was also observed and as a consequence excavations were halted due to fear that these roots may penetrate into the structure of the covered mill race and their removal result in a dislodgment and possible collapse of any upstanding features. However, removal of the material in front of the covered mill race must have reduced the supporting pressure on the structure as a short while later debris was observed to be falling from a central point in the race arch. The front of the mill race then suffered a collapse as the arch collapsed at the centre. This revealed the extent of the root penetration from previous coverage of the covered race which had obviously destabilised the structure to the point of collapse (Fig. 7).

Fig. 7 Collapse of the mill race front showing evidence of extensive root penetration.

- 6.1.6 The western retaining wall of the covered mill race remained intact to its full height, however, the instability of the structure meant that it was subsequently demolished due to concerns of health and safety.

- 6.1.7 With the permission of the Listed Historic Buildings Officer for The Peak National Park Haddon Estates has reconstructed and consolidated the front of the mill race using like for like materials.

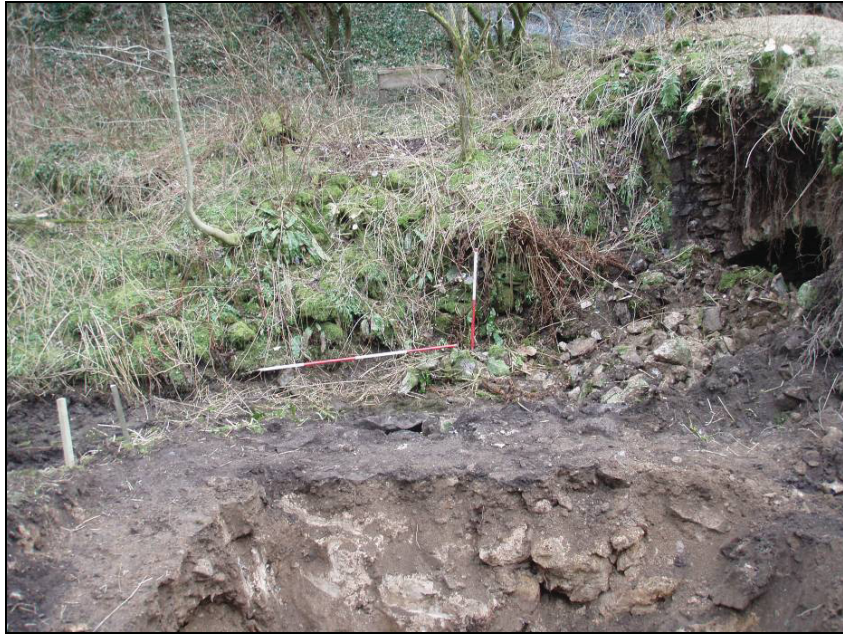
- 6.1.10 A visual examination of the race revealed a much dilapidated retaining wall to exist along its eastern edge and to extend from the outlet of the covered section for approximately 40m north in various states of disrepair (Fig. 8). The most intact section of this wall was found to occur approximately 20m

Fig. 8. A dilapidated section of the eastern mill race wall near the covered outlet, post collapse.

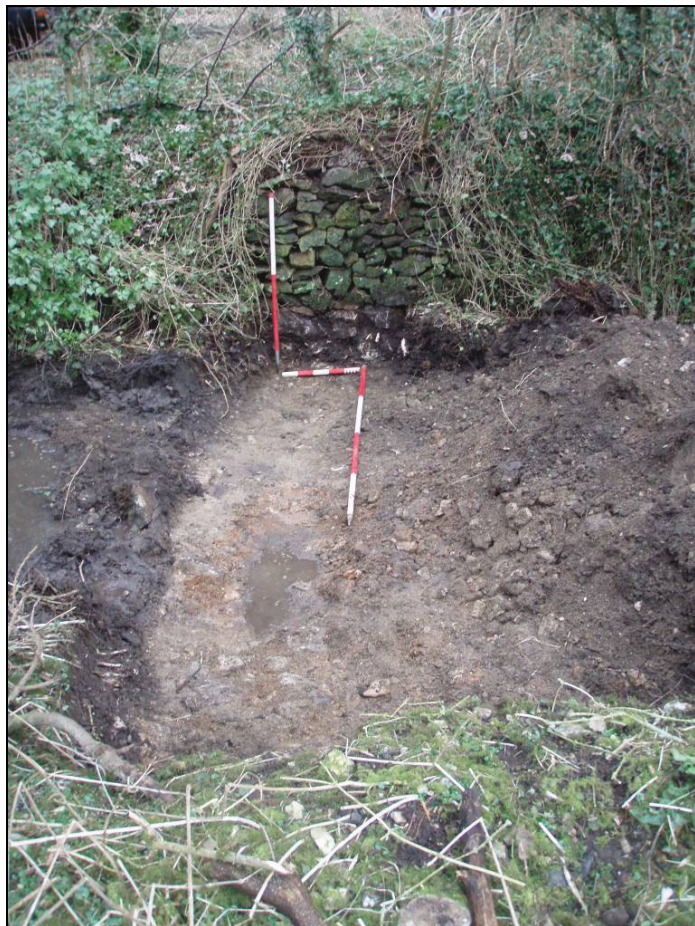
Fig.9 An intact section of the eastern mill race wall.

north of the covered exit and consisted of a section of dry stone wall approximately 1.45m high with up to fifteen courses of roughly hewn and irregularly sized blocks. (Fig. 9). Further north of this section the wall appeared to have largely collapsed but also to have probably reduced in height as it approached the outlet of the race into the River Lathkill.

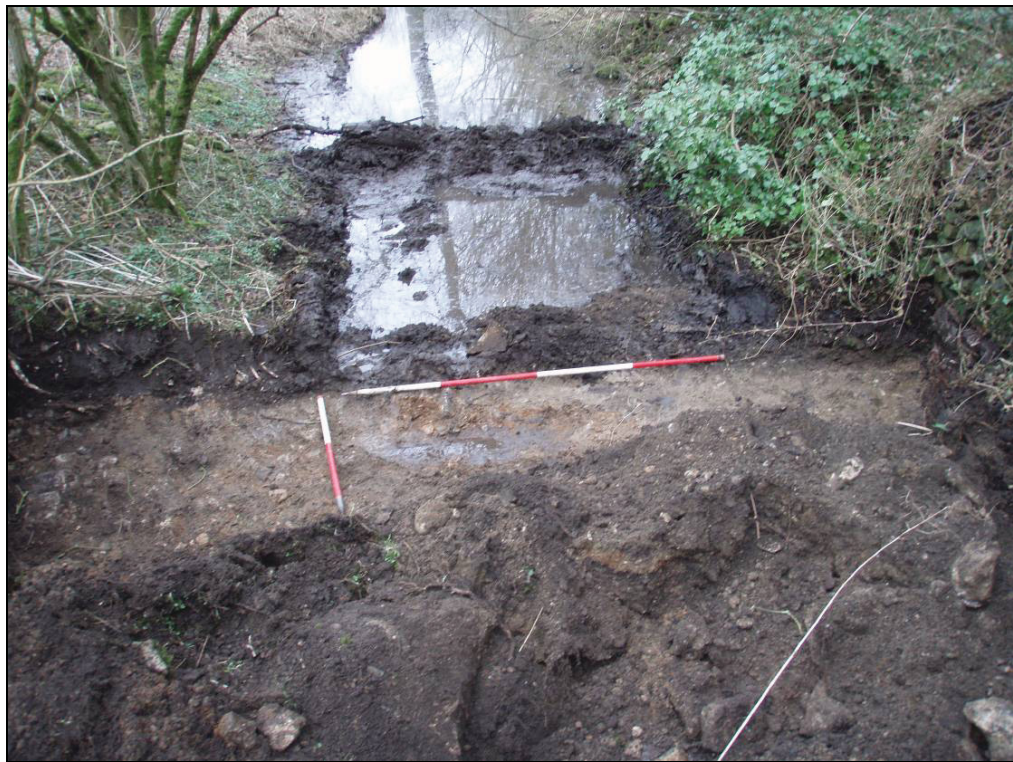
6.1.12 The section also revealed the silts of the mill race to be extremely shallow, with a depth of less than 0.1m at the centre increasing in height up to 0.4m in against the eastern wall and western bank. The base of the race was formed by a natural sandstone derived deposit (Fig.10).

Fig.10 South facing section through the mill race.

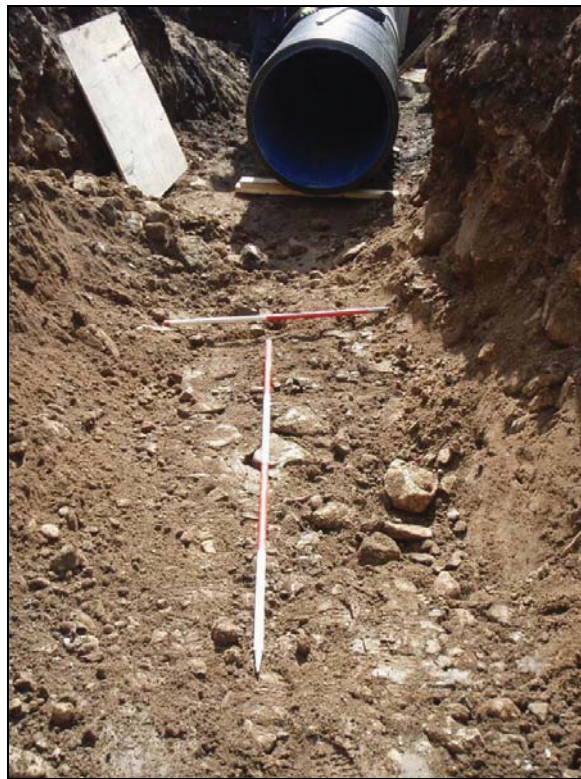
- 6.3.4 The tufa outcrop continued for 10m north almost to the northern extent of the mill. To the north of the mill the surface cover had been tracked over and a loose hardcore laid down.
- 6.3.5 Underlying the hardcore surface was made ground, 2.4m north of the mill this deposit contained fine black smelly humic organic deposit containing hewn sandstone blocks of approximately 0.6m x 0.3m x 0.2m. Below this layer a concrete base 0.15m thick was encountered and removed, local knowledge identified this area as the location of a modern fish pond.
- 6.3.6 The concrete base extended for approximately 3m to the north and overlay a light brown sandy soil containing sub angular pebbles and cobbles, probable redeposited natural ground; this was the limit of excavation (Figure 14).

Fig. 14. Redeposited natural deposit within the pipe trench. Facing south.

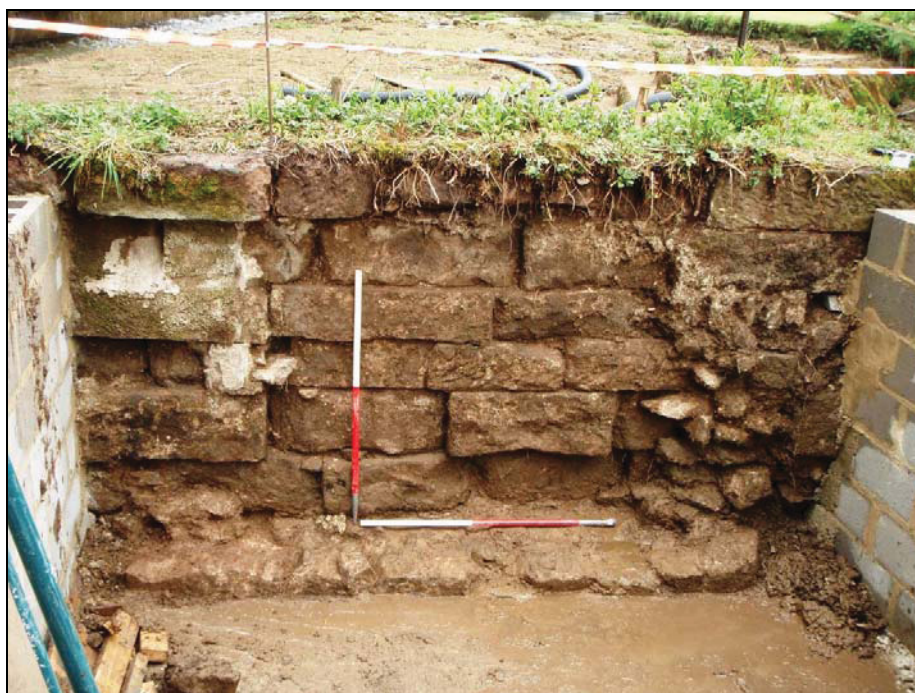
- 6.4.1 Within the confines of the breeze block constructed intake house a north facing section of the reservoir wall was revealed. The wall measured 3.4m in length, 1.8m high and 0.35m to 0.4m in width, with the surface of the upper course covered by coarse vegetation which had developed over the banked up ground previously abutting the wall (Fig. 15).
- 6.4.2 The section of the wall recorded was constructed with six courses of irregular sized worked sandstone blocks ranging in size from 0.22m x 0.2m to 0.89m x 0.25m, bonded by a clay matrix. The majority of the blocks had been roughly hewn with the exception of four blocks which displayed evidence of chisel marks (Fig.16). The face of the wall is mainly flush, with the exception of three blocks on the top course which protrude up to 0.15m and several blocks recessed up to 0.1m (Figs 15 & 16).

Fig. 15. North facing section of reservoir wall within the intake house. Scale 2 x 1m

- 6.4.6 The six courses off the upstanding wall are constructed on top of a wider course of sandstone blocks whose depths are unknown due to the construction of a concrete pad which butts up against them and reveals 0.1m (figure 15). Extending north by 0.5m and presumably extending below the courses of wall above it can be interpreted as either a substantial foundation or the footprint of an earlier structure.

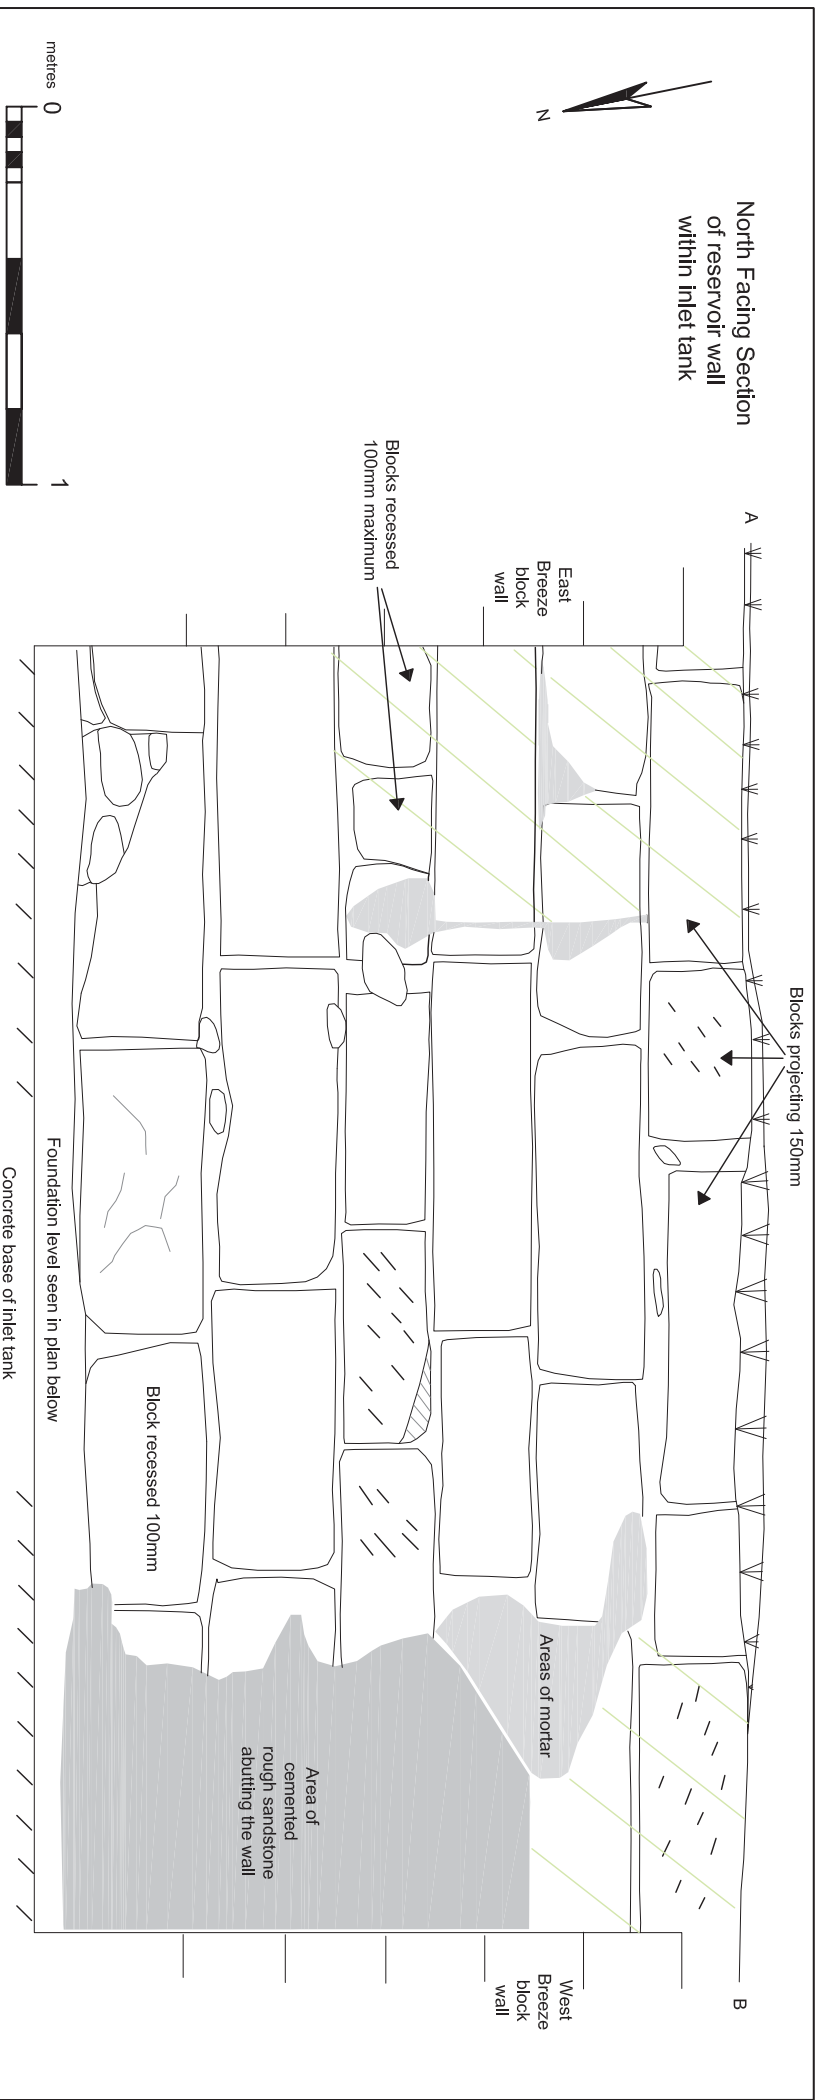
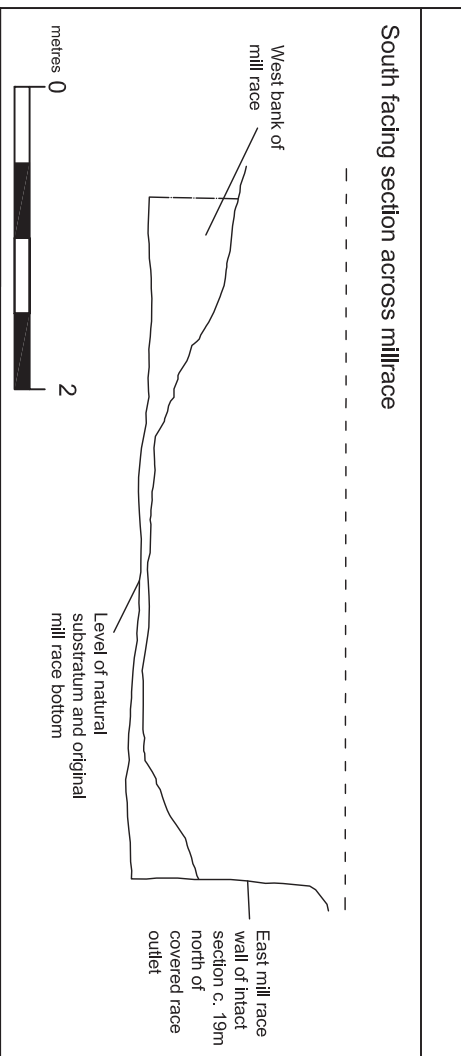
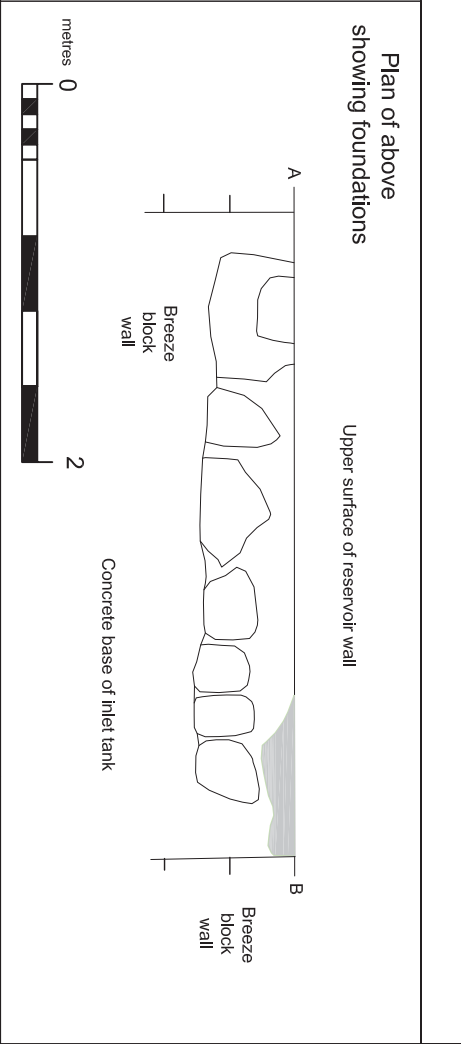
- 6.4.3 0.7m west of the eastern breeze block wall an area of mortar bonded to the sandstone blocks suggested the construction of a structure abutting this wall. A greenish discolouration of the blocks to the east of this mortar and the existence of a water tank relating to a fishfarm intake constructed in the 1970s approximately 3m east, confirmed the presence of another fishfarm intake (Figs 17 and 18).
- 6.4.5 An area extending approximately 0.8m in length and 1.2 high was bounded by the western breeze block wall (Fig. 16). This area displayed the remains of small irregular shaped pieces of sandstones rubble which were bonded by lime mortar and a clay matrix to the face of the reservoir wall. Extending north of the wall by 0.15m this may also represent a previous structure abutting the

Archaeological Research Services Ltd Angel House Portland Square Bakewell Derbyshire DE45 1HB	<b>Site Code:</b> Alp 09 <b>Drawing Ref:</b> 30-04-2009 <b>Date:</b> BM <b>Drawn:</b> 1:20, 1:40, 1:50 at A4 <b>Scale:</b>	<b>Figure 16</b> Section and plan of reservoir wall contained within intake tank and south facing section of mill race
<b>Copyright/Licensing:</b> This drawing © A.R.S. Ltd Ordnance Survey data if applicable © Crown Copyright, all rights reserved reproduced with permission, Licence No. 100045420

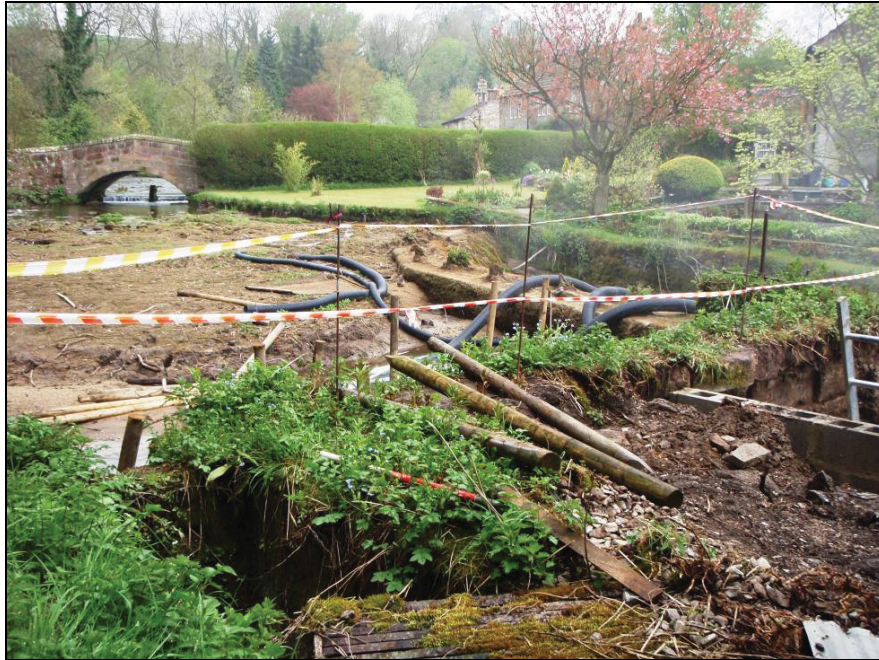
reservoir wall. Evidence of the greenish discolouration seen previously was also evident in this location suggesting the possibility again of another water tank.

Fig. 17. Shot shows the relationship of water tank with area of intake tank. Facing west.
