An Archaeological Watching Brief at the Old Coach House, Belper.

ARS Ltd Report 2009/28

An archaeological watching brief was undertaken by Archaeological Research Services Ltd for Central Networks (E.ON UK Trading Ltd).

The watching brief was carried out between the 23rd and 26th of March 2009 and consisted of the observation of groundworks to excavate a trench for a new electricity supply to the Old Coach House. These groundworks formed part of the final phase of renovation work at the Old Coach House.

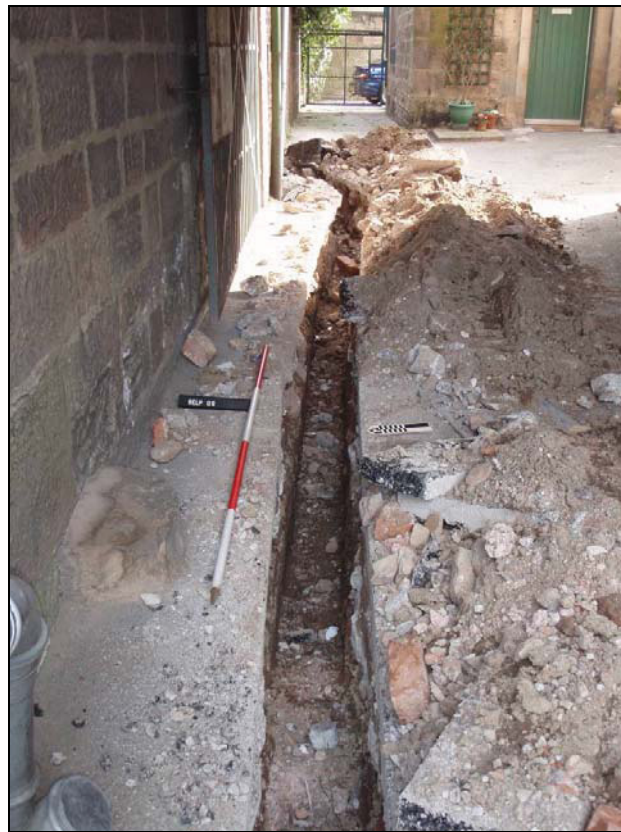
Fig. 3 Trench shown running below the archway, looking east. (Scale: 2m)

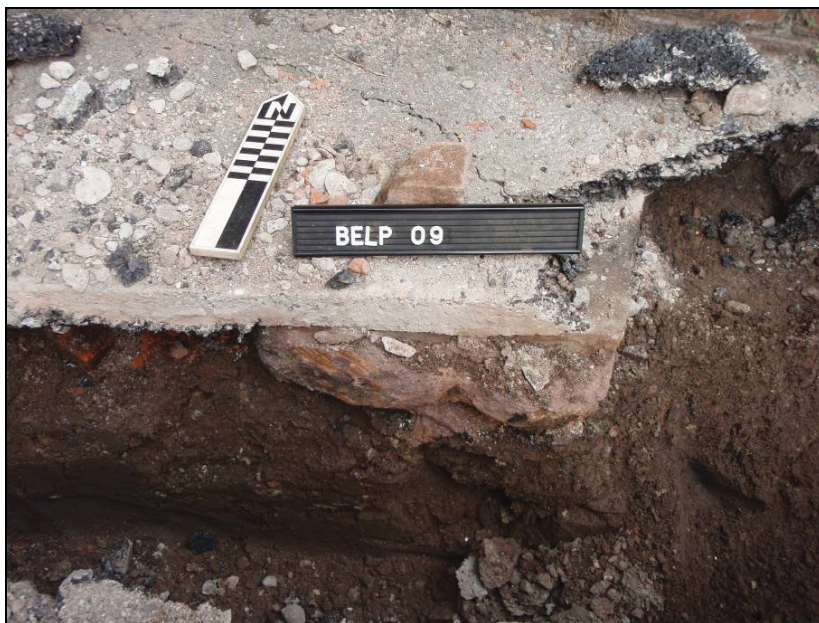
- 4.1 The current ground surface was tarmac (1001) below which a layer of concrete (1002), up to 0.3m in depth, was found to exist in places. Removal of the concrete required a breaker. Below the concrete intermittent areas of sandstone (1003) survived which were probably flags relating to a previous floor level (Figs. 4 and 5). Beneath the sandstone flags was made ground (1004) which contained red bricks and some 19th century pottery.

Fig. 4 Sandstone flag (1003) found to exist below the tarmac. Also showing depth of the made ground (1004) below, looking north. (Scale: 0.25m)

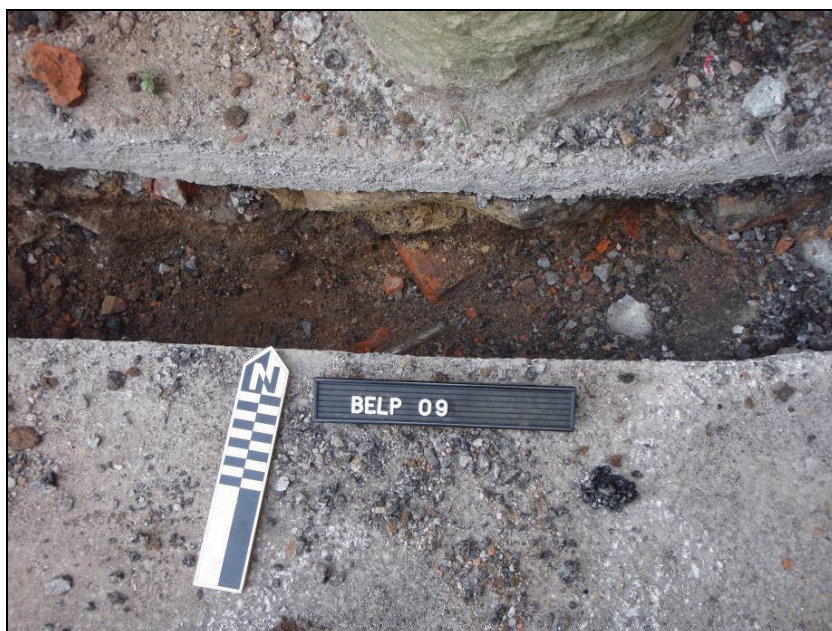
Fig. 5 Sandstone flag (1003) shown above a red brick within the made ground (1004), looking north. (Scale: 0.25m)

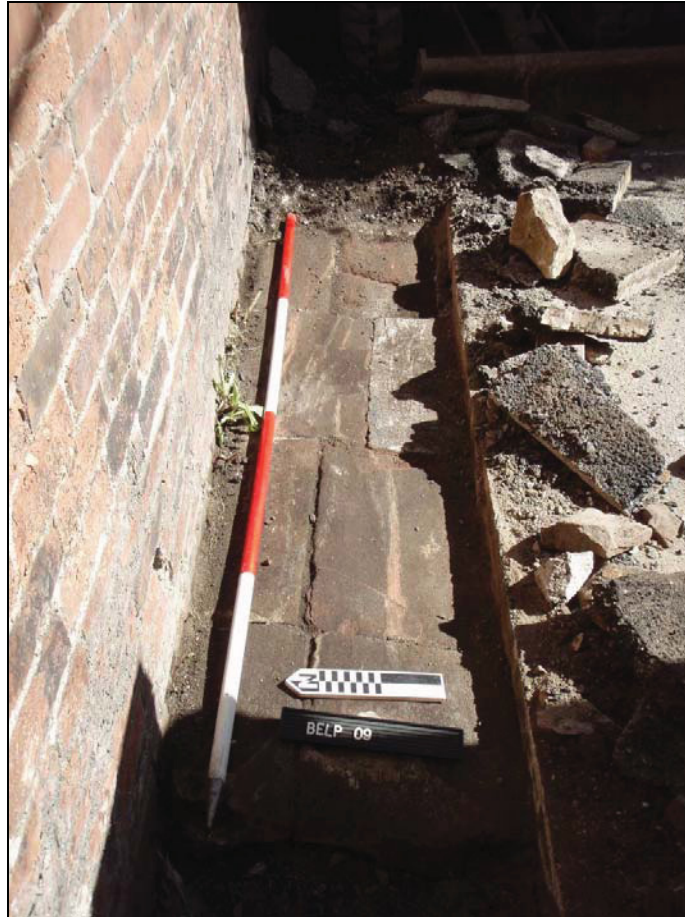
- 4.2 The tarmac was less compacted close to the 'Timekeepers' cottage beneath which was more intact area of stone flagging. In this area the sandstone flagging was fully revealed and recorded (Fig. 6). The area of flags measured approximately 2m by 0.5m. The flags were on average 0.15 - 0.2m deep and measured between 0.3 x 0.2m. The flags abutted the brick wall to the north and overlay the made ground (1004) identified earlier. The flagged area, although small, gives a good indication of the original floor surface.

Fig. 6 View of the flagged floor level found below the tarmac close to the Timekeepers cottage, looking east. (Scale: 2m)

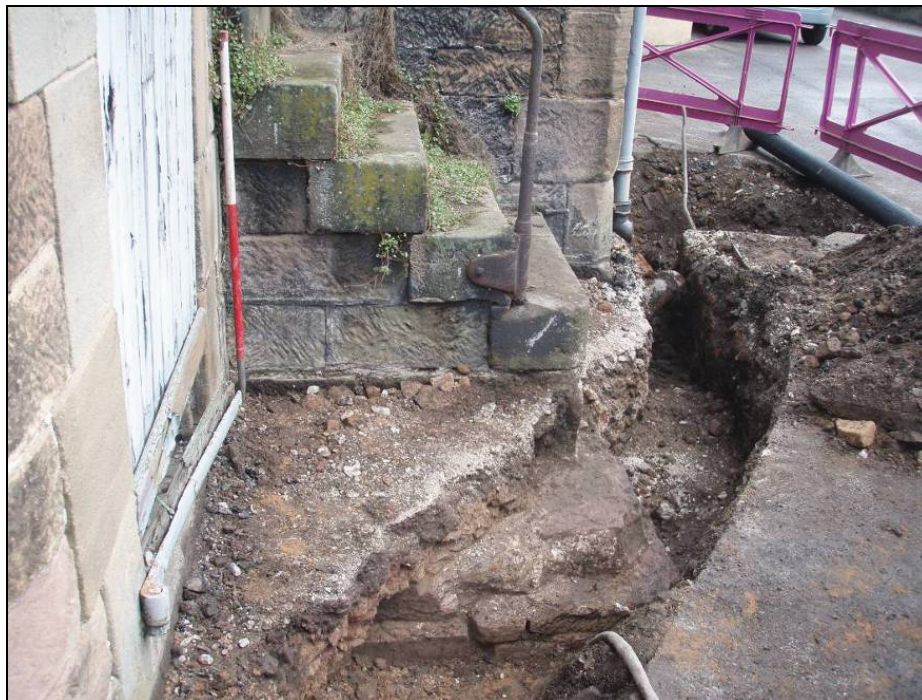
- 4.3 Foundations relating to the southern corner of a sandstone building were found below the modern tarmac surface close to the substation within the funeral parlour car park (Figs. 7 and 10). The building appears to be contemporary to the mill as it has been constructed from the same sandstone and may have acted as a store house. The foundations were exposed to a depth of 0.36m within the excavation limit and 0.3m below the current ground level. The foundations appear to have been roughly constructed with varying sizes of sandstone blocks and slabs measuring 0.09m x 0.1m x unknown to 0.46m x 0.3m x 0.09m. A coarse, sandy lime mortar (1007) had been used as the bonding agent. The mortar was found to

- 4.6 It is likely that the remains represent the substantial sandstone foundations of the building above. The set of exterior steps attached to the building overlay the top stone of the foundation level demonstrating that the two were clearly associated (Fig. 8). The alignment of the foundations also corresponds to that of the above building and both appear to have been constructed from the same type of sandstone (Fig. 7).

Fig. 7 View of sandstone foundation corner (106) showing the proximity to the steps and building above (Scale: 2m)

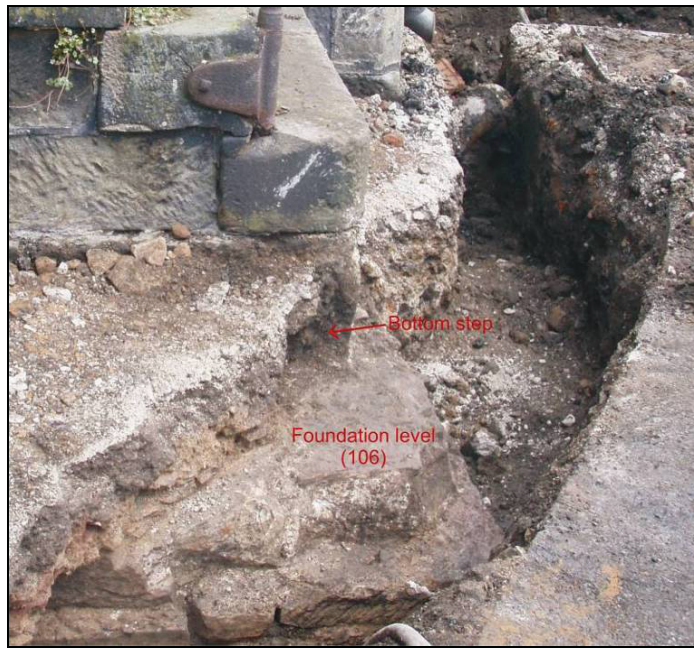
Fig. 8 Image showing how the sandstone steps overlaid the foundation level (106).

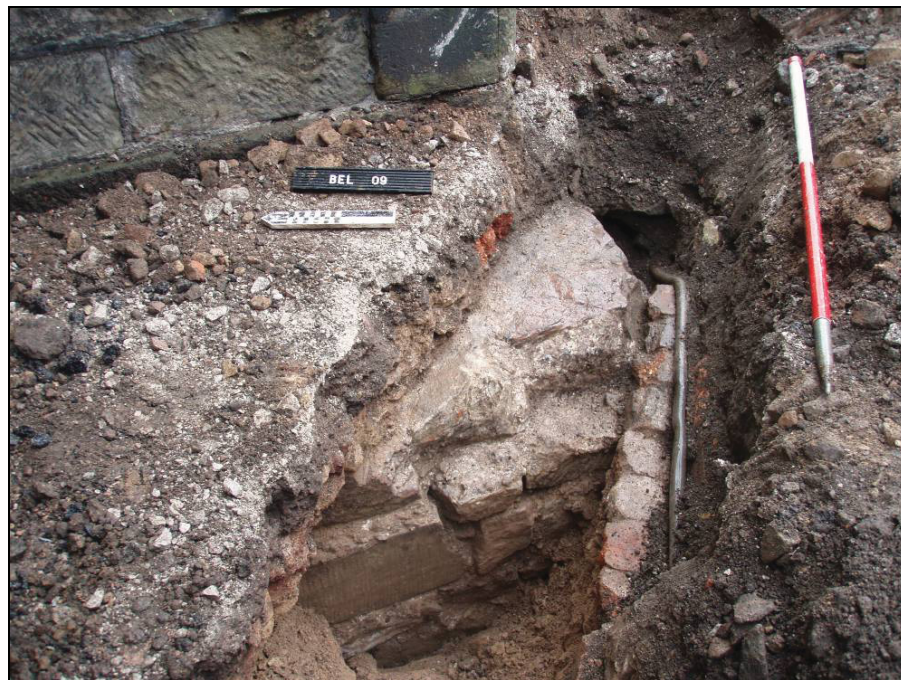
- 4.5 A lead pipe service, bedded on hand made red bricks, was found to run over the southern corner of the foundation level (Fig. 9). The pipe and bricks were removed during the excavation but the sandstone foundation was left *in situ* by diverting the electricity cable around the southern corner of the foundation.

Fig. 9 View showing the depth of the foundation level, looking east.
(Scale: 2m)
