# An Archaeological Desk-Based Assessment at Chowdean Lodge, Low Fell, Gateshead

Archaeological Research Services Ltd  
Report No. 2009/21  
March 2009

# **An Archaeological Desk-Based Assessment at Chowdean Lodge, Low Fell, Gateshead.**

**Archaeological Research Services Ltd Report 2009/21**

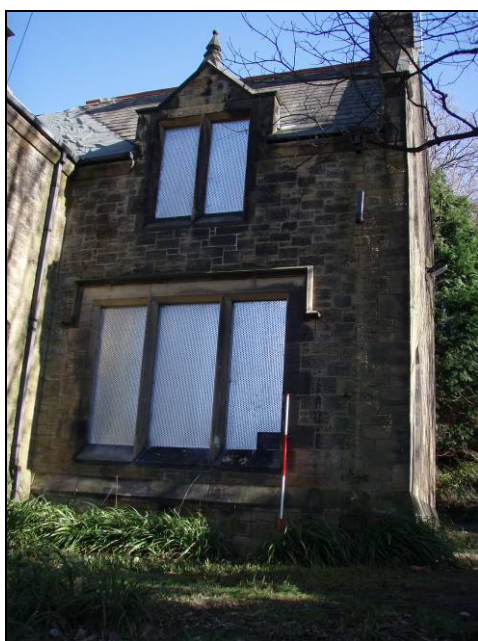
The southern section of the western elevation (Fig. 16) consists of two storeys of sandstone walls. The ground floor has three large windows framed by sandstone with an ornate moulded lintel. The first floor consists of two smaller windows again framed in sandstone. The slate roof is visible from this elevation and the damage caused by the removal of the leading is evident.

Fig. 16 Exterior west elevation, south section.

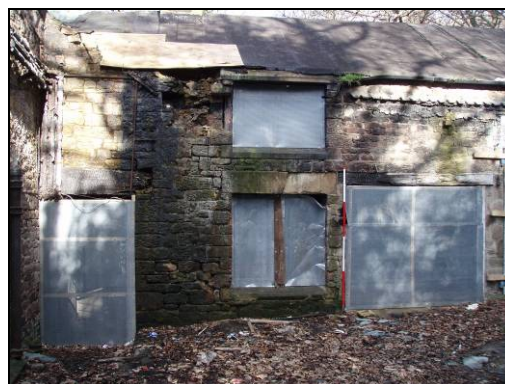
5.1.5. The southern elevation of the stable block (Fig. 22) is in disrepair. To its west there is a remnant of fire damage to a roof which is no longer extant. There are 3 windows on this elevation, two to the ground floor and one to the first floor, each having large sandstone lintels and cills. There are two large double doorways constructed of wood to the centre and two single doorways to the east and west. The sandstone used in the construction of the stable block was undressed unlike that of the main building. To the west of the elevation there is clear masonry joint which corresponds with the map regression showing them once to have been separate buildings.

Fig. 22 External south elevation of stable block.

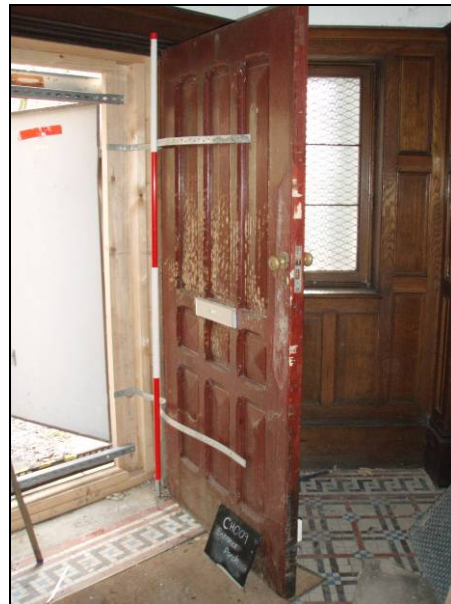
The porch (Fig. 26) consisted of a large wood panelled door (Fig. 12) which is original to the property. The door has been modified in recent years with the replacement of the door lock section. The porch interior maintains the original wood panelling covering its walls (Figs 13 & 27). The panels are not in prime condition, the majority of them having been damaged (including the wall behind) by damp and rot. The flooring (Fig. 28) consists of a geometric tiled floor which continues throughout the porch, Room1 and Room7.

Fig. 26 Internal porch doorway.

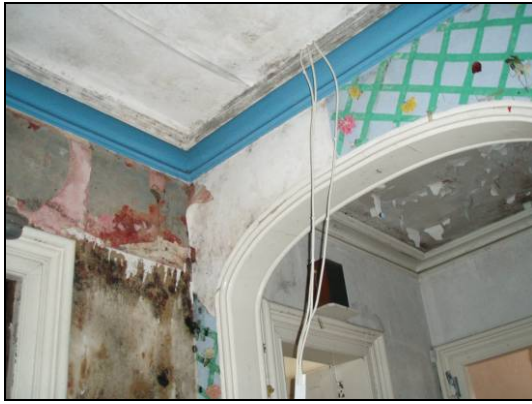
present in this room, the original sash cord still visible in the frame work. The walls contain a moulded dado rail and skirting (Fig. 15) which are in a style which is consistent in every room in the house. The ceiling has a deep moulded design which is also present throughout the house. Heavy damp and rot have damaged the walls in this room including the dado rail, skirting and coving (Fig. 29).

Fig. 29 Room 1, damage to ceiling.

- 6.2. As mentioned above, the interior has suffered some unsympathetic modern renovations. However, there are however a number of original features still extant and worth retaining. The skirting, dado rails and coving, present in many of the rooms, are original to the property and, although not spectacular in design, do give aesthetic appeal and character to the building. It is recommended that these features be retained in any future work unless poor condition through rot prevents this, in which case they should be replaced in a sympathetic style.

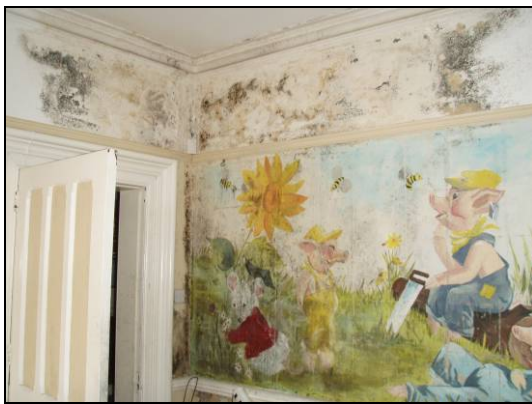
The walls of this room are also suffering the effects of damp and rot (Fig. 31). The walls consist of the same dado rails, skirting and coving as in Room 1. A modern mural covers the eastern wall and is covered with fungus caused by the damp. There are three large sash windows (Figs. 11 & 30) on the western elevation and a single modern replacement window on the southern elevation. The southern elevation also has a fireplace which has been damaged by vandals. The room has a large wood panelled door.

Fig. 31 Damp in Room 2.

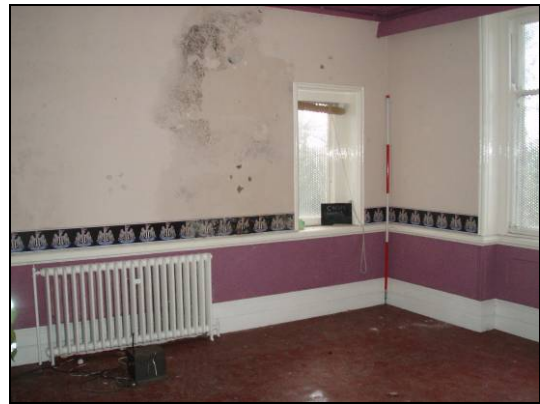
This room has the same architectural details as rooms 1 & 2. Three large sash windows are present on the western elevation with a modern replacement window on the southern elevation (Fig. 32). A modern fireplace is present on the northern elevation with damp clearly visible on the wall (Fig. 33). The room has a large wood panelled door.

Fig. 32 Small window in Room 3.

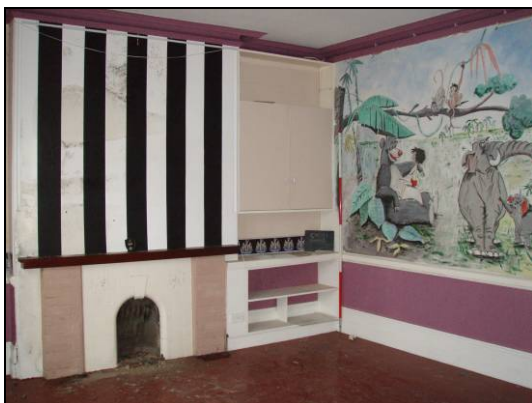
Fig. 33 Fireplace and mural in Room 3

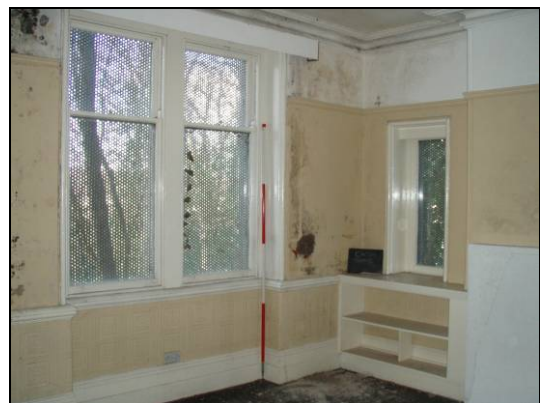
Fig. 34 Sash window and wall rot in Room 4.

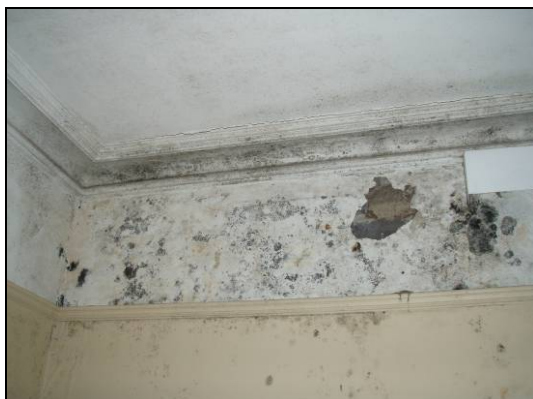
This room shows many signs of water damage. All walls have evidence of rot and damp which has affected the architectural details (Fig. 35). This room has two large sash windows (Fig. 11) on the western elevation and one narrow modern replacement window on the northern elevation (Fig. 34). A fireplace has been boxed in on the northern elevation and it is possible that original details may survive behind this boxing. The room has a large wood panelled door.

Fig. 35 Ceiling coving and rot in Room 4

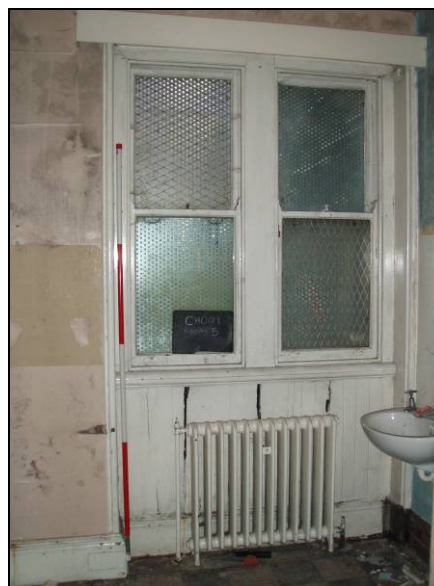
Room 5 is particularly dark due to the positioning of its two sash windows (Fig. 36) to the eastern elevation. Modern cupboards have been constructed unsympathetically to the northern elevation removing the coving, dado rail and skirting. This room is also stricken with damp which has damaged the walls and ceiling. The room has a large wood panelled door.

Fig. 36 Sash windows of Room 5

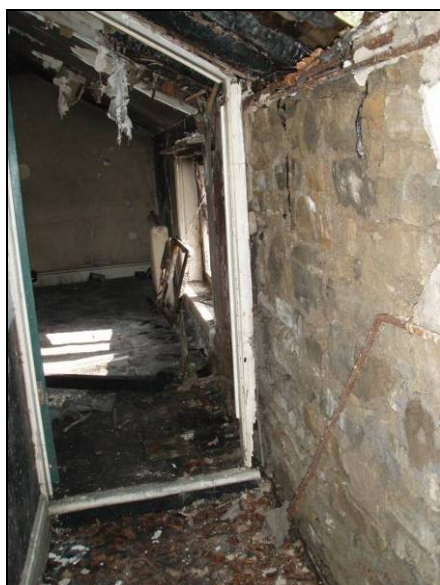
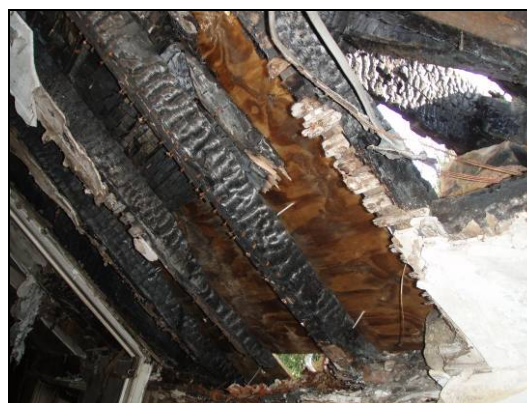
There are two large sash windows on the northern elevation of this room, although the glass has been replaced by a modern re-enforced glass. There are three doorways in this room, one leading to Room 5, one to a small cupboard/larder and a third leading to a flight of stairs into the stable block. The stable block could not be accessed internally due to health and safety. From the stair case it is evident that the stable block and rooms associated with it are in a very poor state of repair and have been fire damaged at some point (Figs. 37 & 38).

Fig. 37 Poor condition of Stable Block

Fig. 38 Fire damage to roof of Stable Block

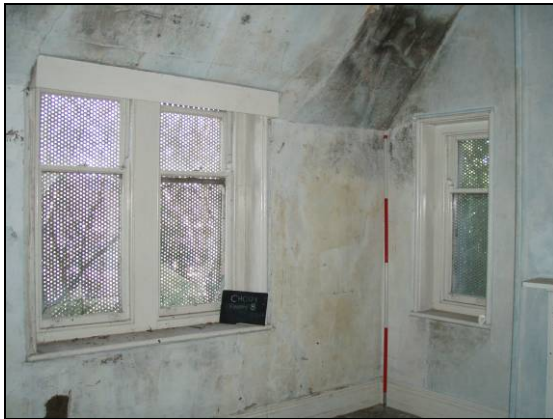
This room has the same skirting as the other rooms but no coving or dado rail. A fire place and surround are present with a tiled hearth. There are two sash windows (Fig. 41) on the western elevation and a single sash window to the north (Fig. 40). The walls in this room were badly damaged through the leaking roof. Damp and rot are evident and have made the plaster come away from the walls. The flooring has also suffered through the damp damaging the skirting and floor boards. The room has a large wood panelled door

Fig. 41 Sash windows and water damage to Room 8.

- 6.3. The doors of the property are all of the same six panelled style and original to the property. It is recommended that they be retained. The majority of the windows of the property (apart from the small replacement windows on the ground floor (as mentioned above) are the original sash windows. It is recommended that these windows should be retained, and if they are not structurally sound, should be replaced in a sympathetic style.

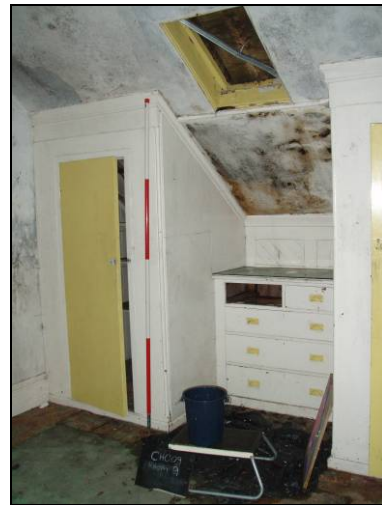
This room has also been damaged through damp. The ceiling and walls all show signs of rot and mould. Two sash windows are present on the eastern elevation and a damaged ceiling light is present on the roof of the northern elevation (Fig. 42). This window has allowed a lot of water to get in and damage the surround walls and flooring. There are modern cupboards to the northern elevation and a modern fireplace to the south (Fig. 43). The room has a large wood panelled door

Fig. 42 Modern cupboards in Room 9.

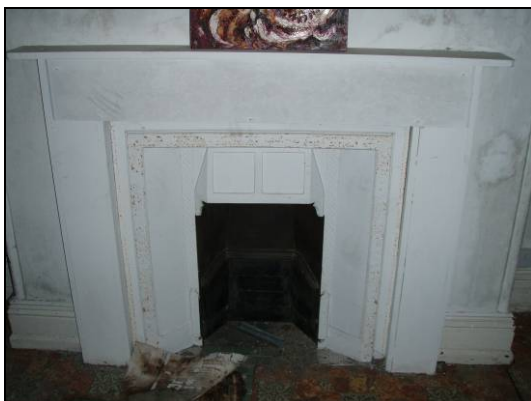
Fig. 43 Fireplace in Room 9.

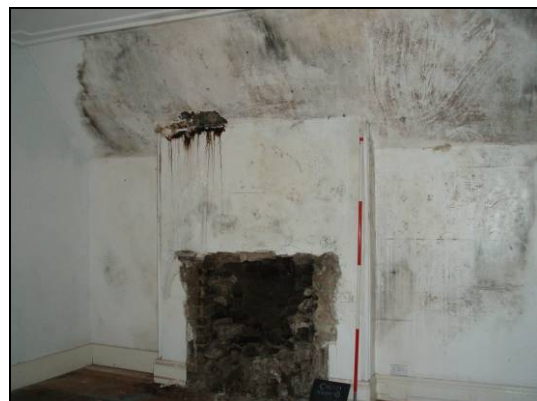
Room 10 has also been damaged through damp. The wall plaster has been damaged as well as the ceiling and flooring. Vandals have removed the fireplace, destroying the chimney breast in the process (Fig. 44). Sections of the skirting have been cut away and/ or damaged. There are two sash windows to the western elevation and a serving hatch (leading to Room 11) on the southern elevation. This room has a simple roof moulding instead of the ornately moulded coving found on the ground floor. The room has a large wood panelled door.

Fig. 44 Damaged chimney breast in Room 10

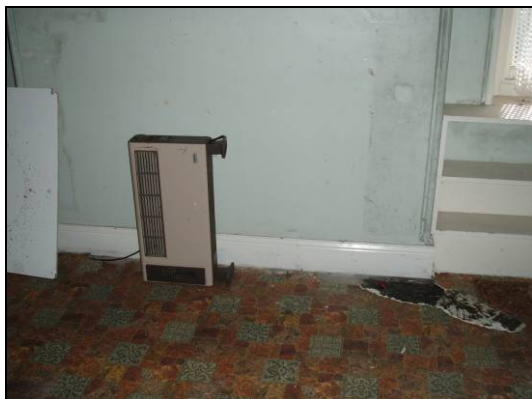
Like the other rooms Room 11 has heavy damp and rot. Two sash windows are present on the western elevation and one narrow sash window to the south (mirroring Room 8). The fireplace in this room has been plastered over and a replacement skirting board placed along it (Fig. 45). It is possible that some remnants of the original fireplace may exist behind the plaster. The serving hatch from Room 10 is evident of the northern elevation but boarded shut. The room has a large wood panelled door.

Fig. 45 Covered fireplace in Room 11

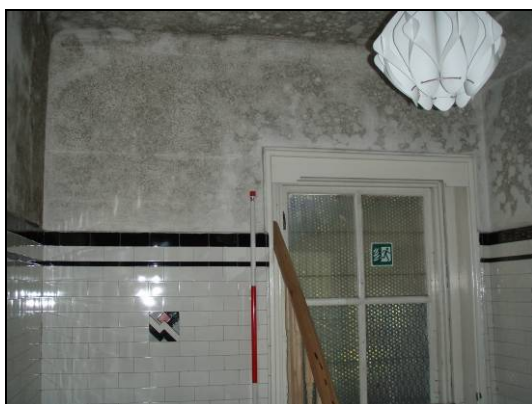
Room 13 has a large porcelain bath on the northern elevation and a square window on the eastern elevation. This is a modern window converted into a fire escape. The walls are tiled 2/3 of the way up with visible damp and rot above, covering the ceiling.

Fig. 47 Water damage to Room 13.

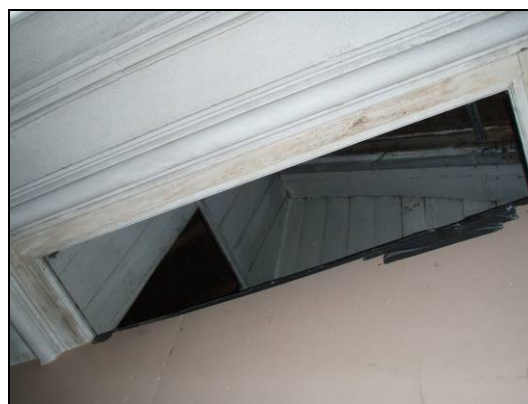
Fig. 48 Partition wall blocking Light in Room 14.

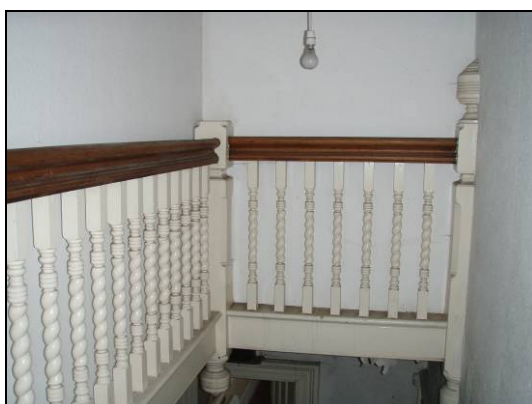
Fig. 49 Partition wall behind balustrade in Room 14.
