**An Archaeological Building Recording  
of Trinity House and 1, 2, 3 Trinity Chare, Broad  
Chare, Newcastle Upon Tyne.**

**Archaeological Research Services Ltd Report No. 2009/52**  
August 2009

**An Archaeological Building Recording  
of Trinity House and 1, 2, 3 Trinity Chare, Broad Chare, Newcastle  
Upon Tyne.**

**Archaeological Research Services Ltd Report 2009/52**

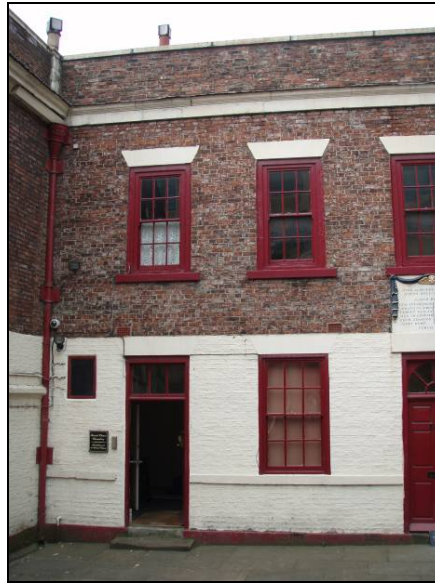
- 4.3.1. In the southern corner of this elevation there is an ornamental drain pipe running from the roof, with the attached date 1787 (Fig. 11).

Fig. 11 Ornate drain pipe of the North West facing elevation

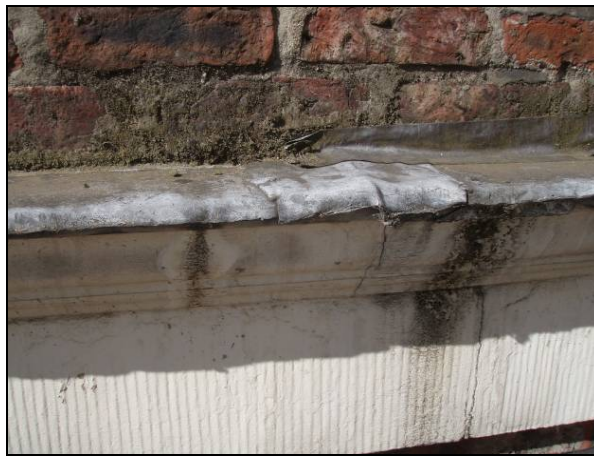
- 4.4.1. The first floor of this elevation has five windows across its length each of the same design as those on the ground floor. This elevation also has a lead topped cill running its length (Figs. 23 and 24)

Fig. 23 First floor North East facing elevation of Trinity Chare

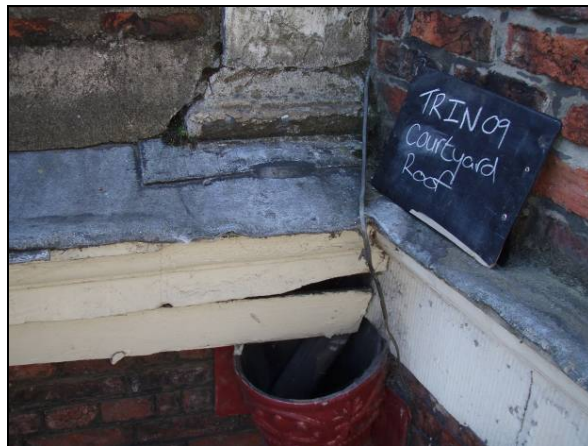
Fig. 24 Lead plated cill

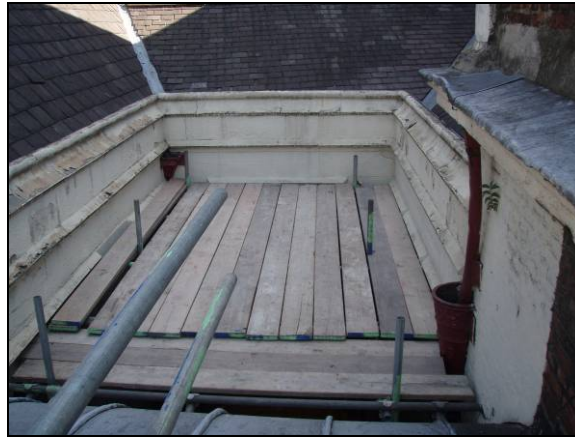
This wing of Trinity house is constructed from brick. The ground floor has been rendered and painted white to match the portions of building constructed of sandstone, with exposed brickwork on the first floor. The ground floor has two small windows, one of which is blocked off; the other has a replacement light within the wooden frame and a moulded sandstone surround. The ground floor of this elevation also has a tunnel leading through to the rear of the building. The first floor has five large sash windows (Fig. 10), each containing 24 smaller lights with wooden transoms and mullions and decorative stone surrounds. A cill topped with lead runs the length of this elevation (Fig. 25) acting as a 'drip strip', or water run off. This cill is in a poor state of.

Fig. 25 Lead plated cill above drain

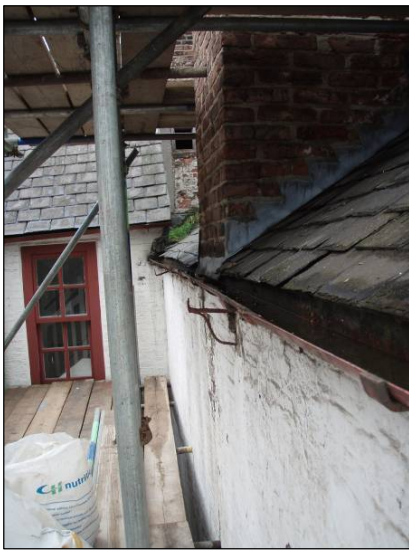
- 4.2.1. The first floor of this elevation includes the arched walkway (Fig. 7) which has three sash windows and a sloped, lead-lined roof. Within the gap between the two archways, ornate windows are positioned facing each other on the south east and north west elevations (Fig. 8). These windows comprise of stained-glass lights with leading, and moulded sandstone surrounds. The guttering of the roof (first floor) is moulded from lead and is in a state of poor repair. (Fig. 26)

Fig. 26 guttering and cills

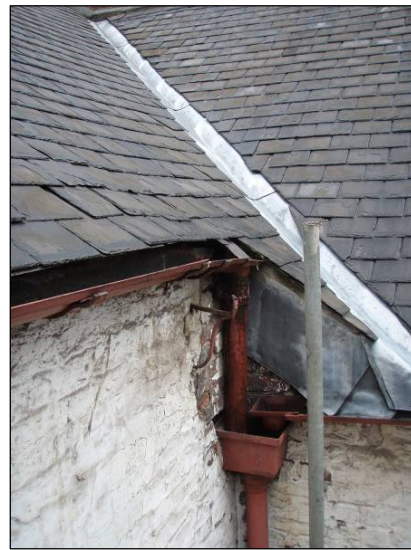
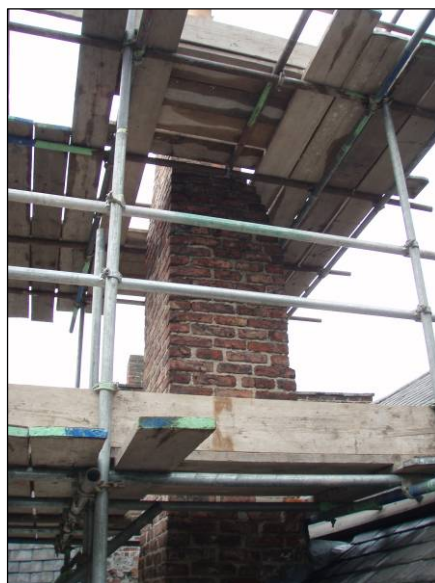
- 4.6.1. The first floor roof of this alleyway is of the same construction as the inner courtyard. The guttering is of a thin lead, semi-circular design (Figs 27 and 28) and in a poor state repair, having come away from the wall in places. A brick-built chimney (Fig. 29) rises from this section of the roof. It is approximately 0.60m by 0.60m at its base tapering to 0.30m by 0.30m at its top. The pointing of the chimney is badly eroded.

Fig. 27 Guttering of access passage

Fig. 28 Guttering of access passage
