An Archaeological Building Recording at Bay Tree Farmhouse, Rodsley, Derbyshire

ARS Ltd Report 2010/11
February 2010
Oasis I.D. archaeol5 – 72283

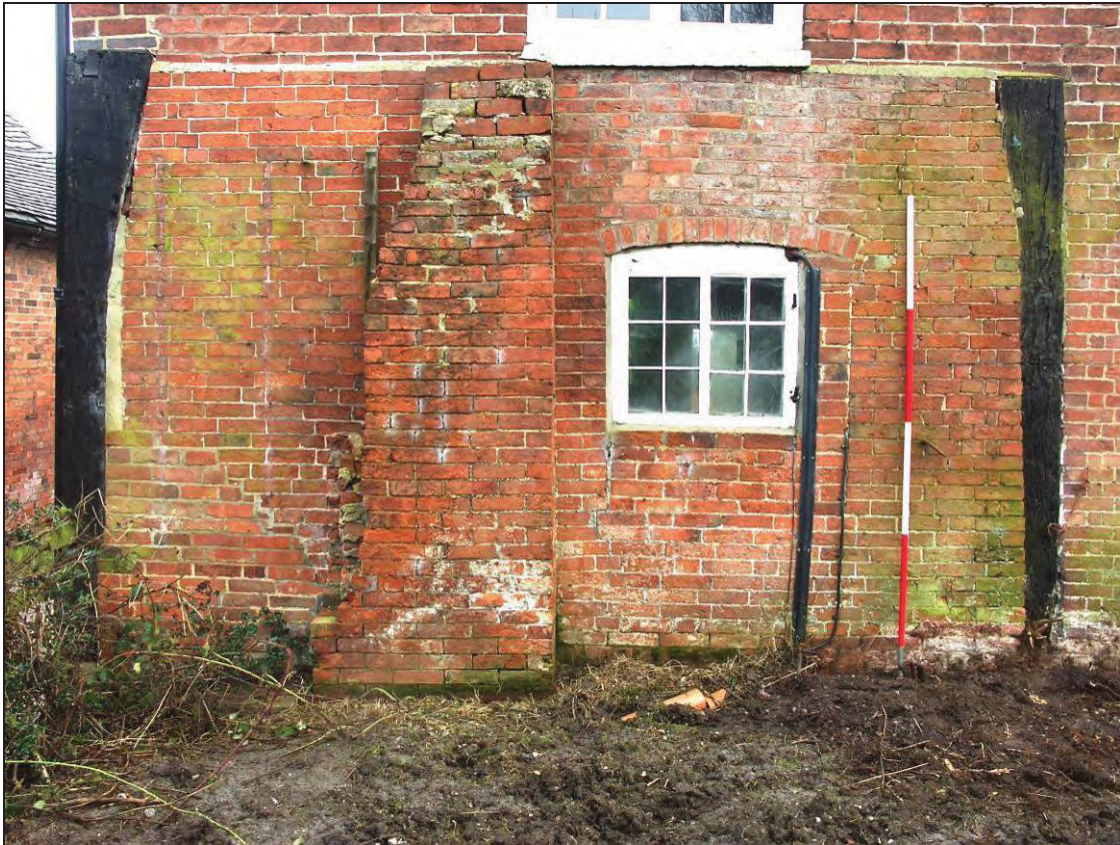
structure (Fig. 4). This bay has two *in-situ* timber posts with flared jowls. The posts are in good state of preservation although the southern post has moderate wet rot damage at the bottom and the top has been slightly truncated. The posts have matching peg holes for the attachment of former braces and a central rail which would have been integral to the timber-framed structure (Fig. 5). This confirms that the current brick infill is a later addition which replaced the original frame. The construction of the brick infill or nogging is very irregular although it seems to be mainly built with orange hand-made bricks (9" x 4" x 2½") bonded with flush, white, medium-coarse lime mortar (up to 10mm thick) and laid mostly to Flemish Garden bond. The base of the northern end of the building has been re-built with concrete which is supporting the timber post. This post has been slightly disfigured with the insertion of three slots carved within it which are supporting the present garden fence (Fig. 6).

Figure 4: Northern bay with the remains of a timber-framed building (scale 2m)

- 5.25 The remains of the timber-framed structure should be preserved and areas of advanced wet-rot decay restored. The only surviving wall panel on the ground floor between rooms G-1/G-2 and G-3 should also be retained without any alterations. However, the current plaster covering this wall in room G-3 may be causing damp problems to the timber and thus its preservation may be improved with the removal of the plaster and conservation treatment to the timber-framing. This would entail the exposure of the only internal surviving Post-Medieval timber-framed wall which would provide significant historical value and character to the house. The removal of the plaster could also be undertaken inside rooms G-1 and G-2, although the latter

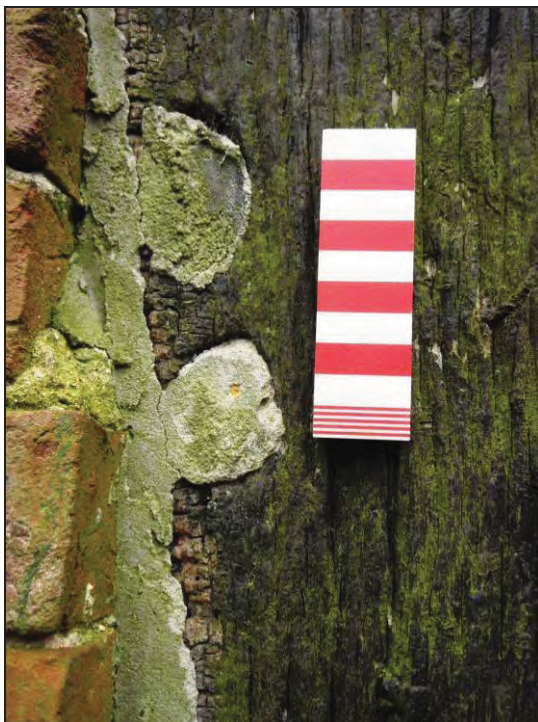
Figure 5: Detail of removed pegs (scale 100mm)

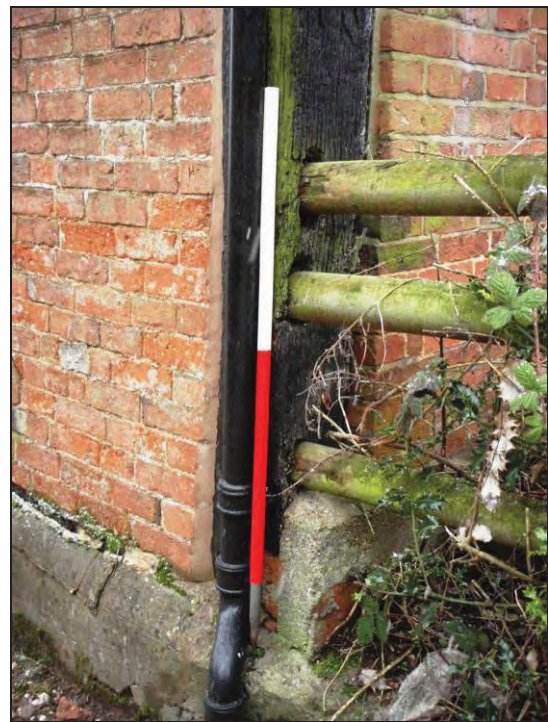
Figure 6: Slots in northern post for the present fence

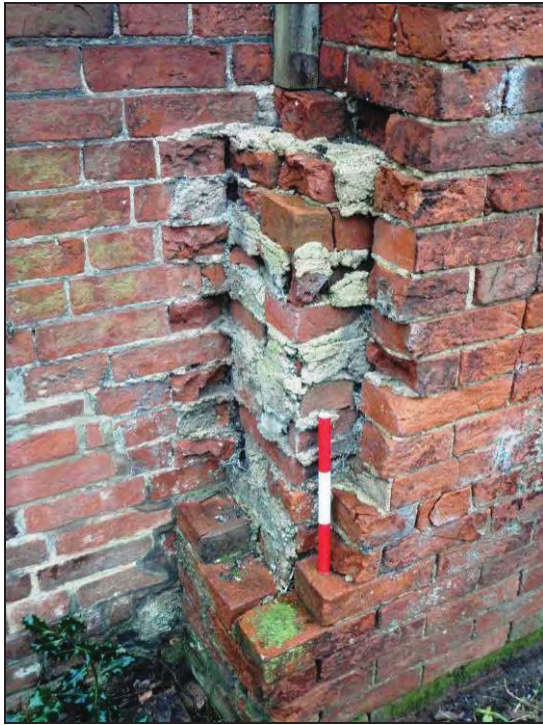
- 4.6 The remains of a projecting brick chimney stack can be seen against the wall. It is built with orange hand-made bricks (9" x 4" x 2½") bonded with flush thin coarse mortar and laid to stretcher bond. A dismantled section enables to view the current state of the fire place's cavity which is blocked with secondary bricks (9" x 4¼" x 2½") (Fig. 7). The upper four brick courses of the stack are a later replacement.

Figure 7: Brick infill inside the former fire place (scale 300mm)

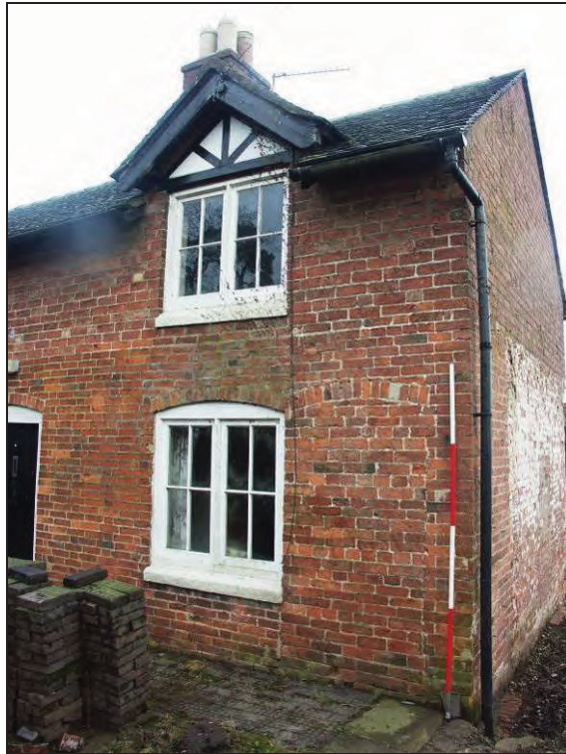
Figure 10: Former doorway blocked-up (scale 2m)

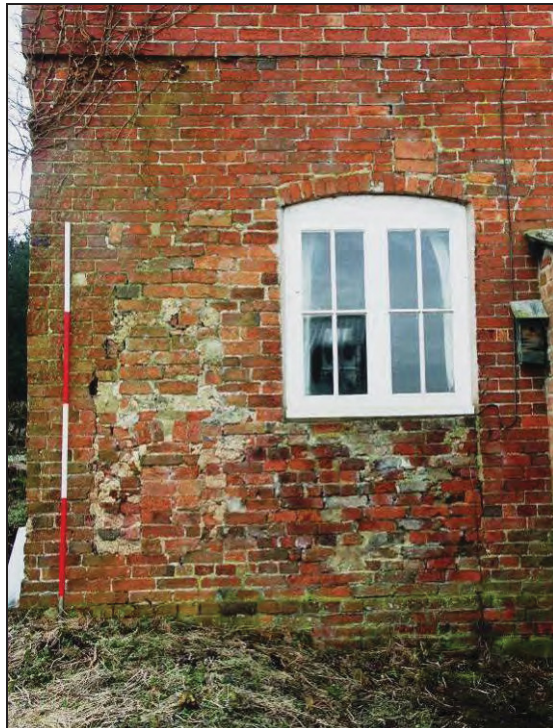
Figure 14: Southern bay with bricked-up oven

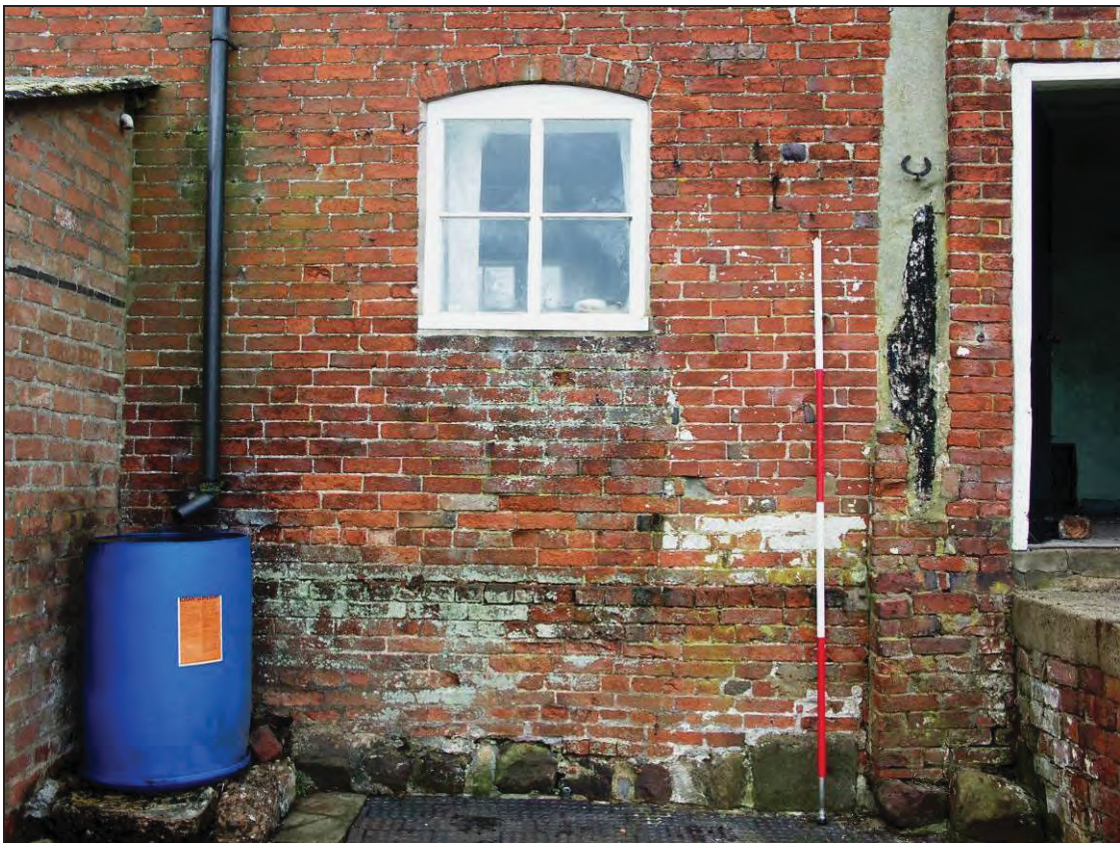
- 4.12 The lower section of the entire elevation has a continuous brick plinth supported by stone foundation which is partially exposed on the northern side of the elevation as the ground appears to have been slightly reduced from its original level (Fig. 17).

Figure 17: Exposed rubble stone foundation supporting a brick plinth (scale 2m)

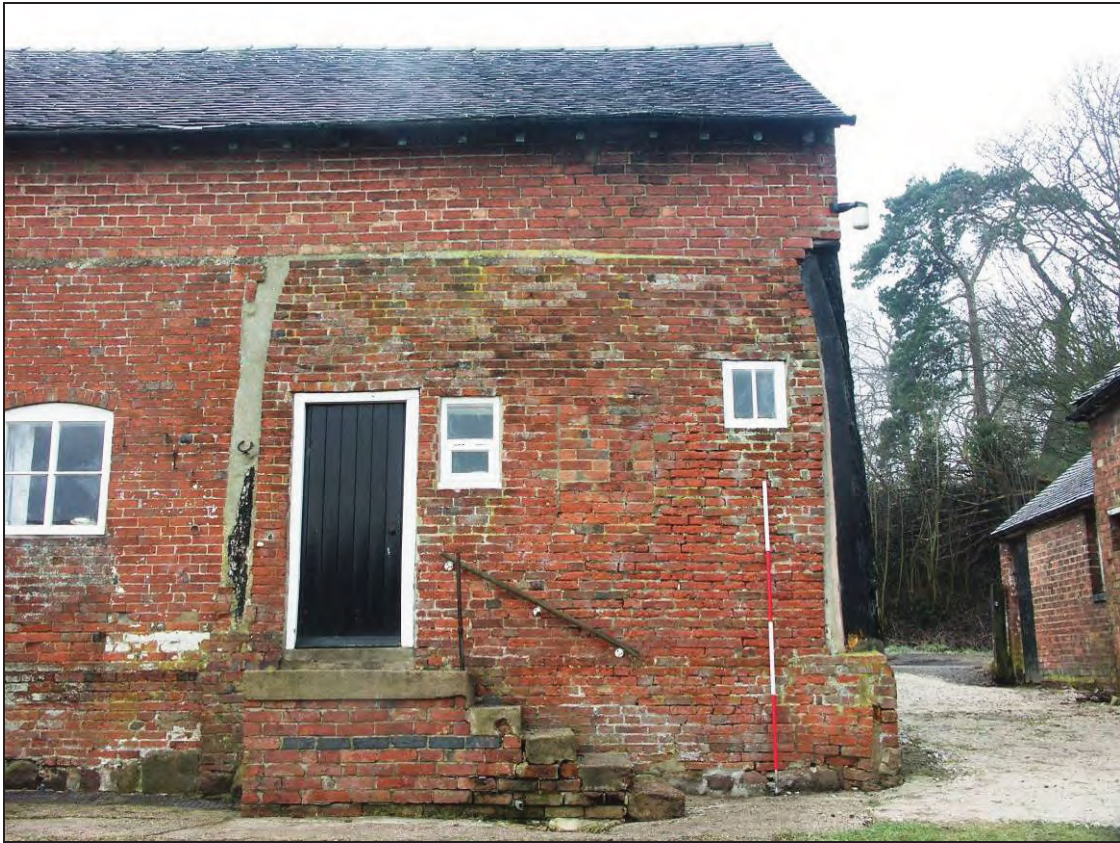
- 4.13 The northern bay contains the remains of the earlier timber-framed structure consisting of two principal posts which are in moderate condition with wet rot at the base of the posts (Fig. 18). The southern post is mostly covered with cement and the northern is also covered with a soft-wood timber plank attempting to protect the original post from wet rot. However, the plank is slightly rotten and may be causing further damage to the post.
- 4.14 There are two small plain windows within the nogged brick wall and a larger window opening in the middle which is now blocked with bricks. There is a timber door which is accessed from the external staircase made of brick and concrete (Fig. 18).

Figure 18: Northern bay with remains of timber-framed building (scale 2m)

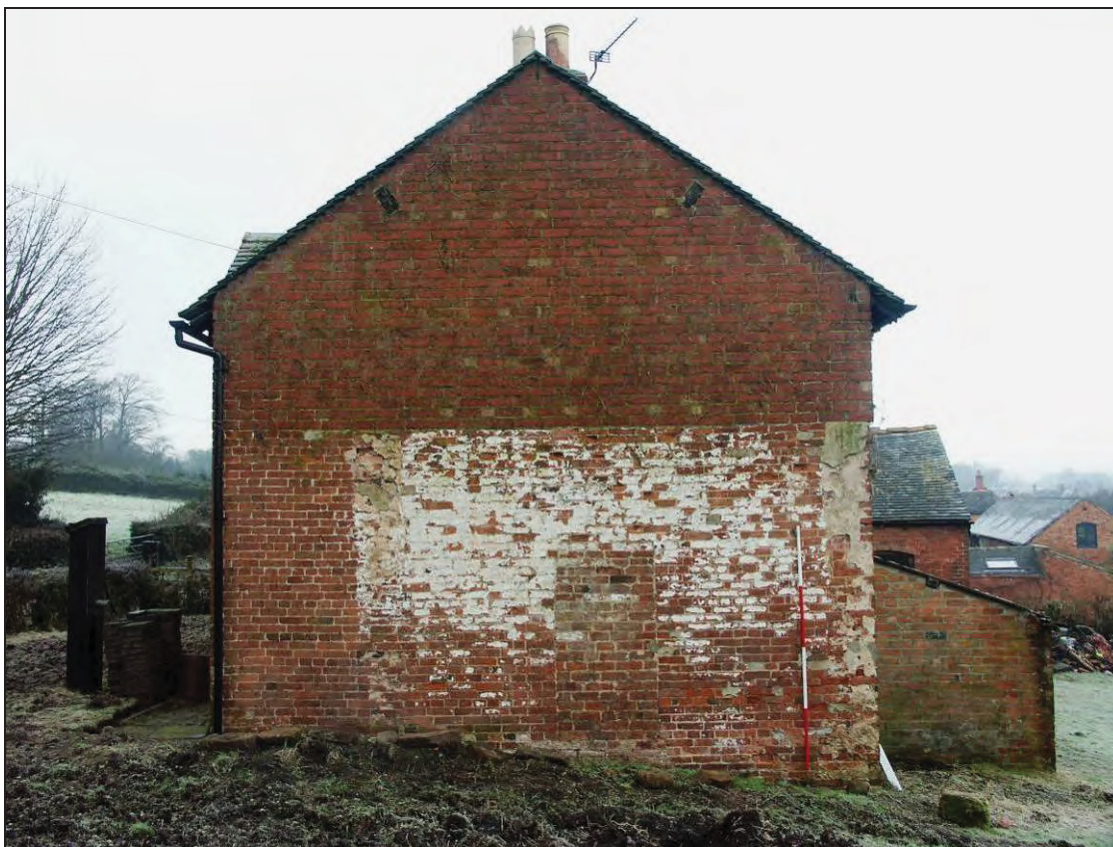
- 4.15 The south elevation is rather plain with a central doorway blocked with bricks which would have connected room G-4 with a brick structure abutting this wall of which brick scars are still perceivable (Figs 19 and 20). The former structure is also highlighted with the remains of lime wash in the brick wall. There is no sign of the former structure's roof as the top section of the current wall and gable were added later once the former structure was dismantled.

Figure 20: South elevation showing a blocked doorway and scars of a demolished structure (scale 2m)

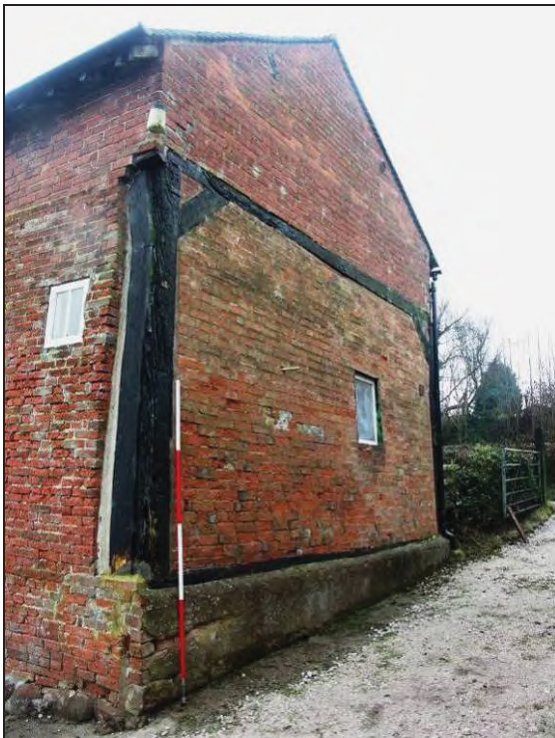
- 4.16 The north elevation is also fairly plain however; it has further *in situ* elements of the original timber-framed house. These consist of the principal posts tenoned in a wall sill, which is highly rotten, and supporting a wall plate reinforced with two straight up braces and two small iron braces (Figs 21 – 23). Both posts have empty peg's holes for a former rail. The wall plate and braces also have peg holes for studs which had been removed and replaced by the current nogged brickwork which is consistent with the side walls of the northern bay. There is a small fixed window within the nogged brick wall.

Figure 21: North elevation with timber frame

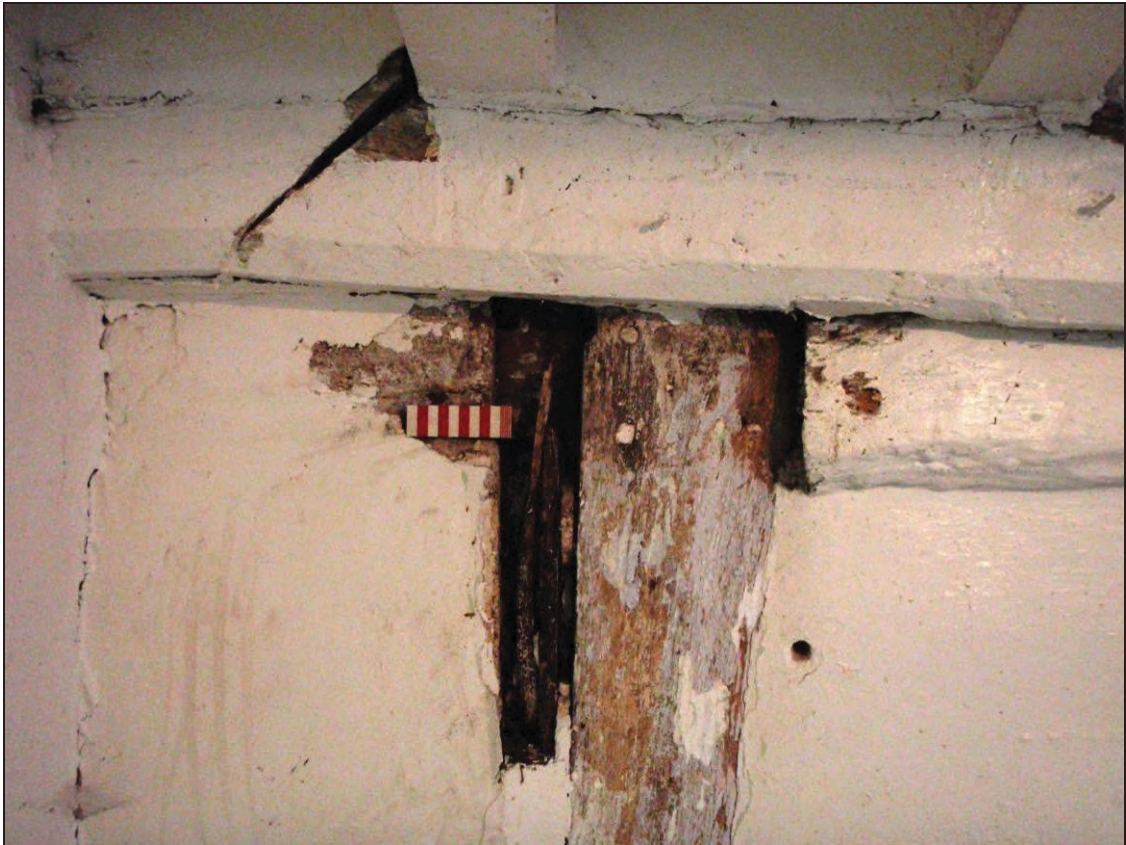
Figure 30: Detail of stud detached from rail with later cement infill, looking south (scale 100mm)

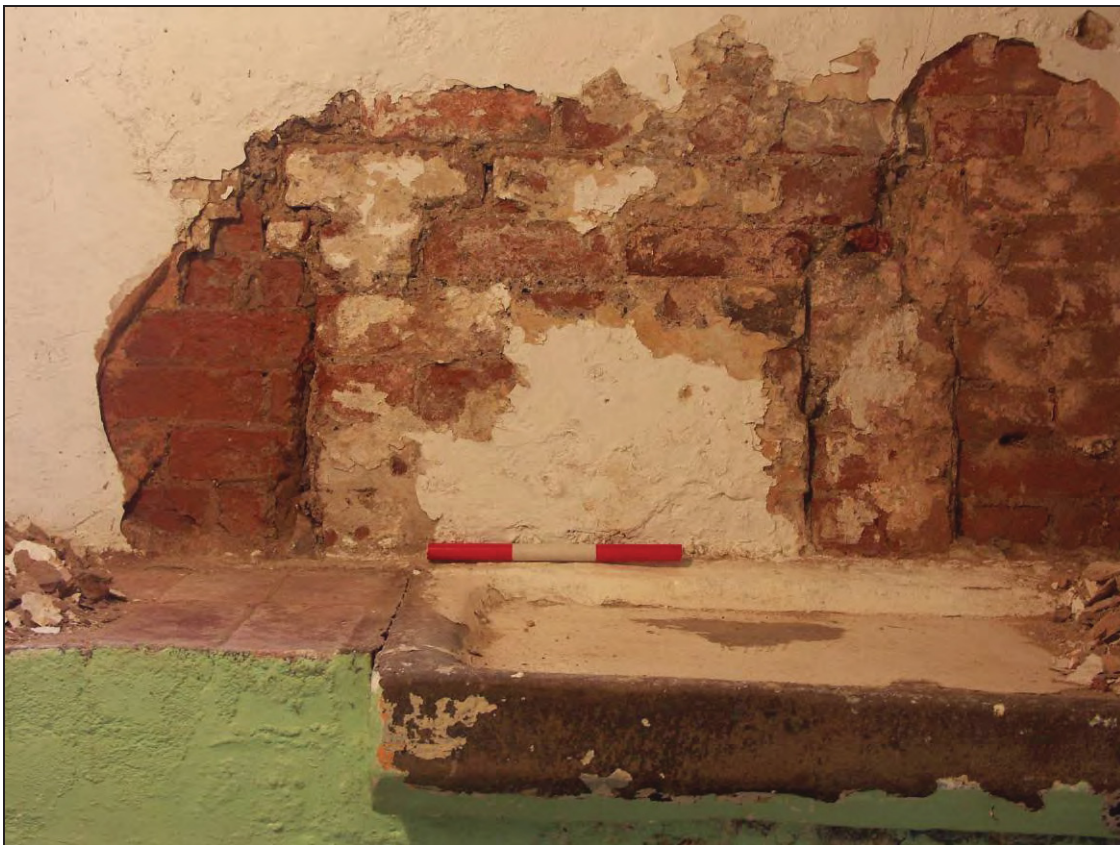
- 4.28 The remains of a fire place associated with the external obsolete chimney stack were observed behind a partially decayed plasterwork adjacent to the salting trough (Fig. 33).

Figure 33: Former fire place next to salting trough, looking west (scale 300mm)

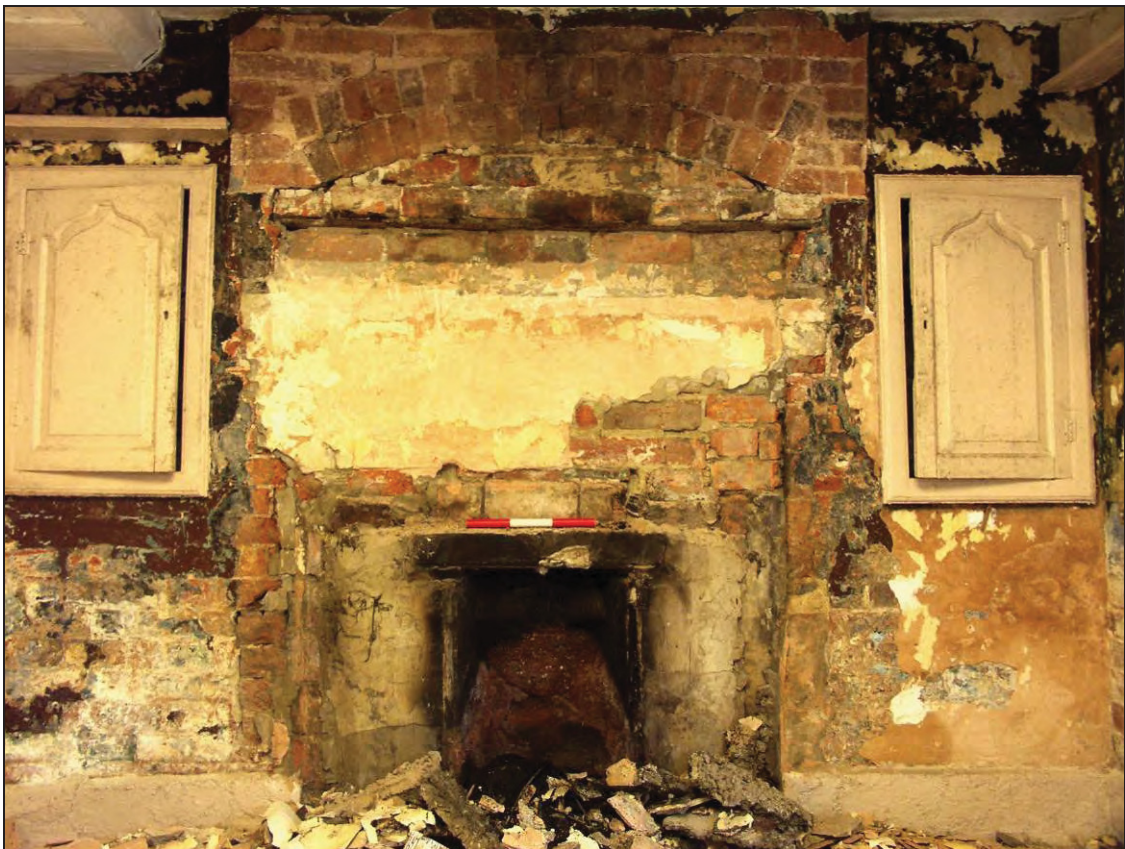
Figure 37: Detail of the fire place inserted in a larger blocked-up opening of a kitchen range (scale 300mm)

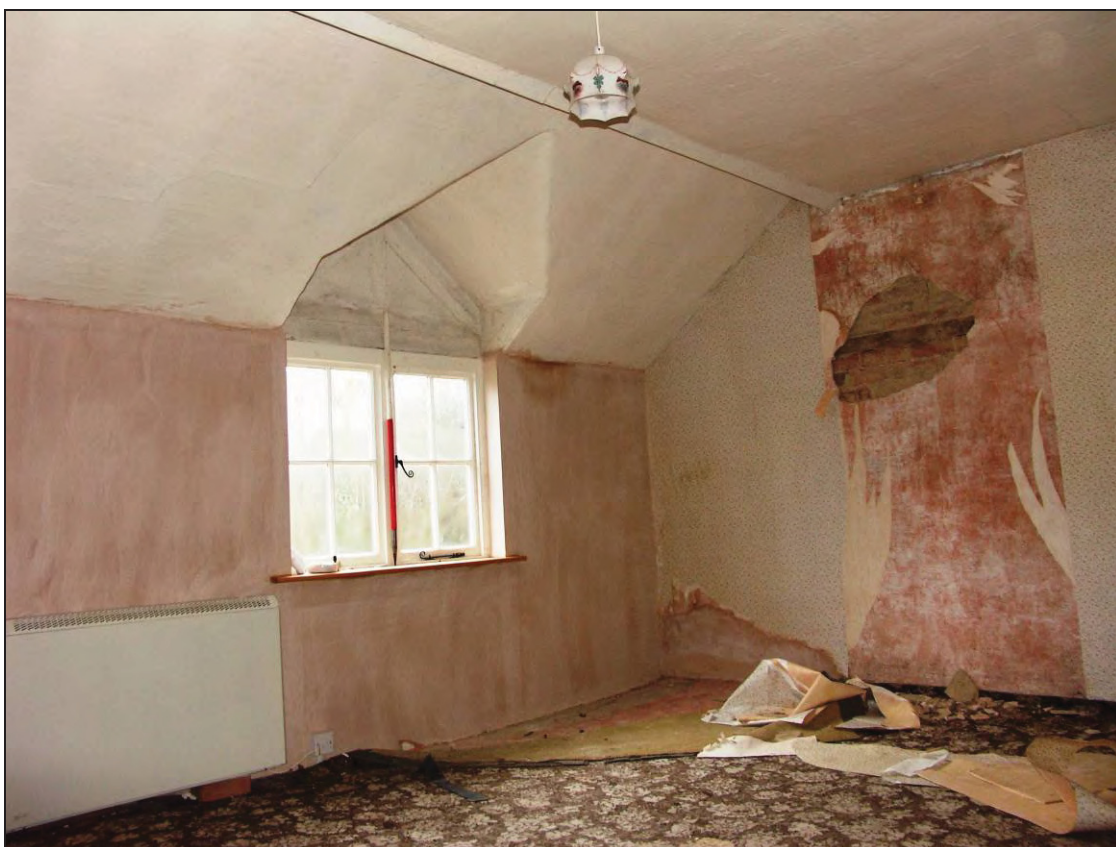
Figure 57: Western wall with repaired plaster work (scale 1m)

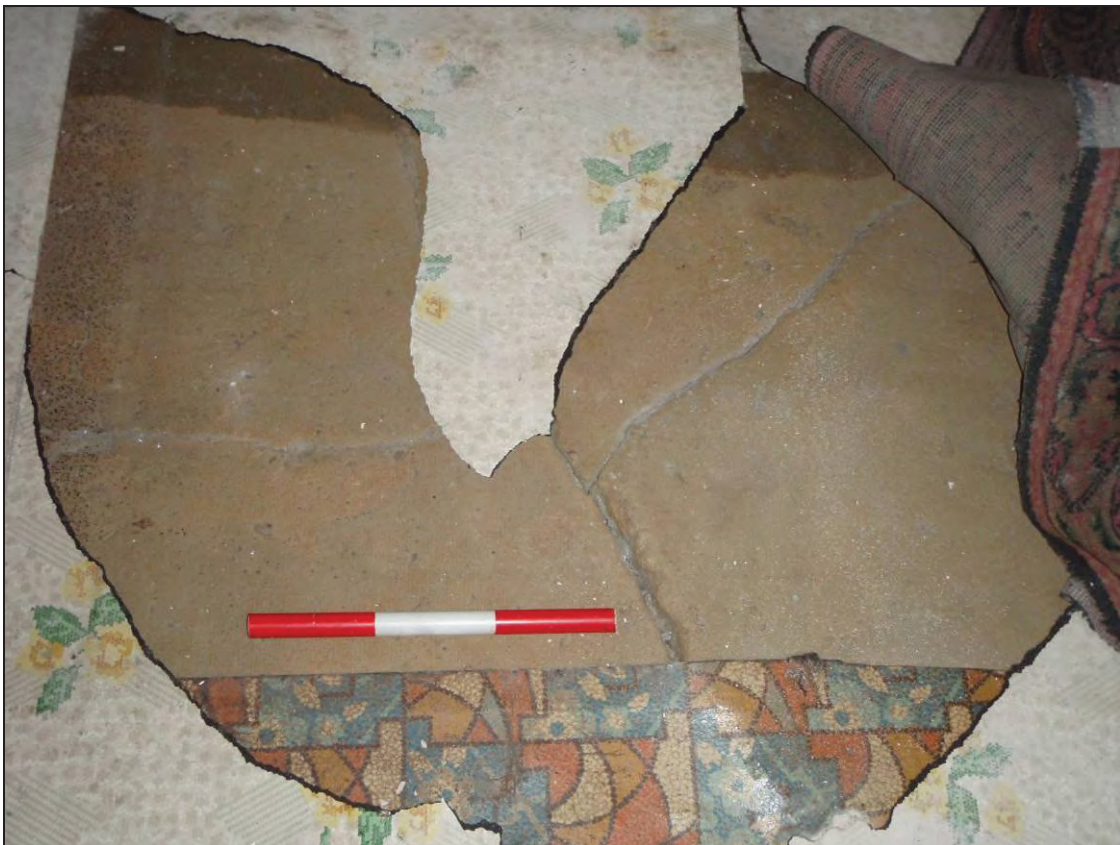
Figure 61: Fissures on the screed floor (scale 300mm)
