## Culvert Repairs, Darley Abbey, Derbyshire

## Report on an Archaeological Watching Brief

ARS Ltd Report 2010/25 February 2010

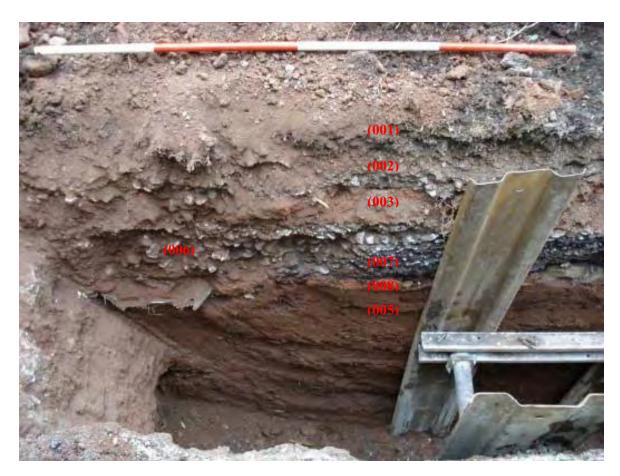
Fig. 3 East facing section of Trench 1 (scale = 2m)

- 4.2. Immediately below context 012 (250mm from surface level) was a layer of orangey brown sandy clay with modern brick demolition debris inclusions (003). This layer extended to a depth of 600mm from surface level where, in the south facing and east facing sections of the trench, a 300mm thick layer of compacted dark ashy material (007) was encountered. This layer has been interpreted as the original surface level of the path. In the southern end of the east facing section this context was cut by a deposit of made ground consisting of grey clinker-like stones (006). In the south facing section beneath context 007 was a red marl clay natural substratum (005).

- 4.3. Context 007 was not evident in the west facing section of Trench 1, where between 680mm and 850mm below surface level a sandy stone matrix (**004**) similar to that of 002 was encountered. Immediately beneath context 004 was the natural substratum (**005**). In the east facing section of the trench a single line of bricks 1m in length (**008**) was evident immediately beneath 007. The origin of this short length of bricks is unclear; however it is possible that they represented a former surface level that has been almost completely destroyed by the construction and subsequent reconstruction of the path including the deposition of context 006. Immediately beneath this context is the natural substratum (**005**).

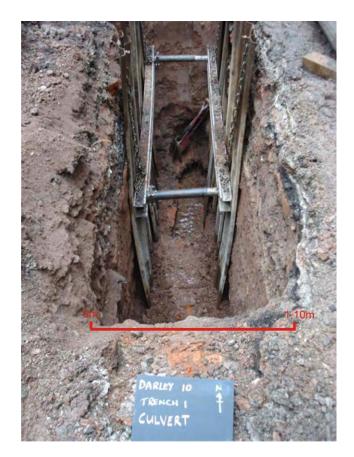
Fig. 4 Trench 1with Culvert in bottom

- 4.1. Trench 1 was positioned 92m along a path which runs parallel to the River Derwent at the junction of Old Lane and Haslam's Lane in order to identify a suspected blockage caused by the damaged culvert. The surface level comprised a layer of compacted yellowy-grey hardcore (001) which ran along the length of the path. This layer continued for approximately 50mm before it merged with a bedding layer of compacted grey stones (002). 150mm below surface level a horizon of a black coarse-grained matrix with stone inclusions (012) was encountered. This context has been interpreted as semi degraded former tarmac surface of the path and had a thickness of 100mm.
