An Archaeological Building Recording at Stublach Grange Farm, Stublach, Cheshire

ARS Ltd Report 2010/44July 2010

In July 2010 Archaeological Research Services Ltd were commissioned by Storengy UK to undertake an Archaeological Building Recording at Stublach Grange Farm near Lach Dennis, Cheshire, prior to the proposed demolition of the building.

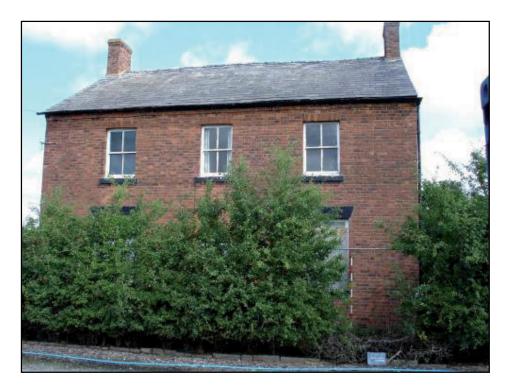
Figure 9- South Facing Elevation

The south facing elevation contains five windows and one doorway. Two large windows are situated either side of a central doorway on the ground floor. The windows are both sash design, probably original to the building. Each window opening has a sandstone lintel and cill, although the first floor openings contain brick heads instead. The doorway has a semi-circular arched head built with rubbed bricks and a recessed door jambs and arch *intrados* containing a glazed fanlight of three lights. To the west of this elevation there is the garage extension. Unlike the house this has a corrugated metal roof. This elevation is constructed from large, red sandstone blocks.

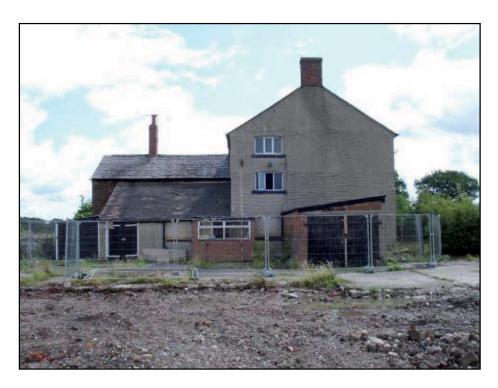
Fig 12- West Facing Elevation

Unlike the south facing elevation, the walls are rendered with grey mortar. The main farmhouse (southern extent of the buildings running east-west) has four windows, two on the ground floor, one on the first floor and another on the second floor. On the ground floor of this elevation a garage extension is located centrally with its roof sloping down to the north. To the south of the garage is a small window with four glass panes. To the north of the garage (between the garage and porch entrance) there is another small sash window. This window opening has a segmental arched head and sandstone cill. The first floor has one window with three glass panes and a sandstone cill. The second floor also has a single window in the same stile as the first floor. Located centrally on the west facing elevation is a modern entrance porch which leads into the internal kitchen area. The porch is brick built with two large windows, to the north of this is another wood framed window. Further north there is a large wooden double door to an area used as a storage shed. At the very north of this elevation another garage has been added onto the building and consists of a corrugated metal roof and large wooden double doors.

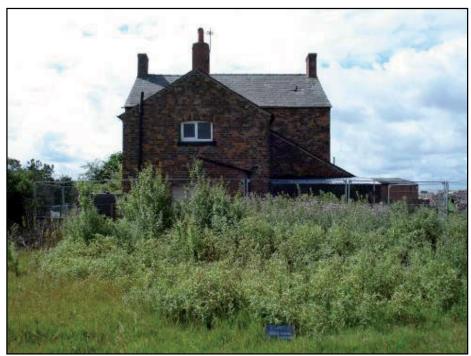
Fig- 13 North Facing Elevation

This elevation mainly consists of the north-south extension with the exception of the ground floor garage extension. The ground floor consists of one window in the same style as those on the west facing elevation. Above this on the first floor there is another window in the same style.

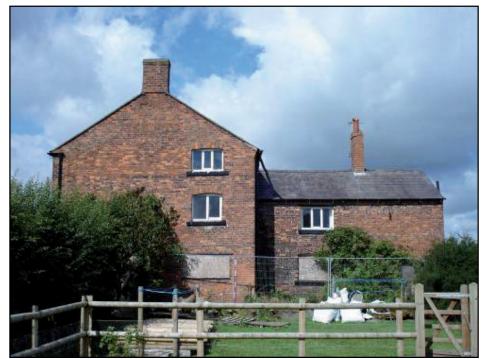
Fig- 14 East Facing Elevation

The main farmhouse (southern extent of the buildings running east-west) has three windows, one to each floor. The ground floor window is a long wooden framed window with three glass panes. The first floor has a window in the same style as those to the west and north, with two glass panes. The window to the second floor, again in the same style, has 3 glass panes. The extension to the south (running north-south) has two windows, one to the ground floor and one to the first floor. Both are the same in style to the other elevation having three glass panes each.

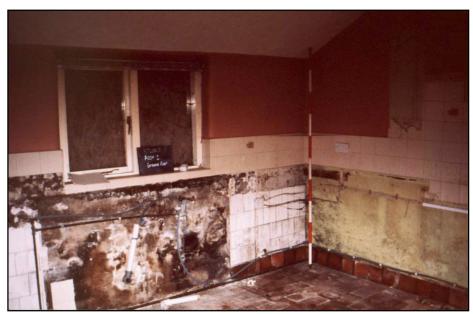
Fig- 15 Room 1

This room (formally used as a kitchen) has been re-plastered and remodelled when turning it into a modern kitchen, as such any interesting architectural features it may have had are not present. The original window and frame are still extant but the room has no features of historical or architectural significance.

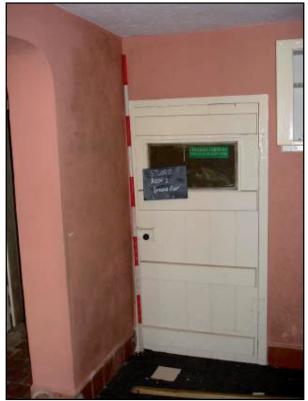
Fig- 16 Room 2

This room, likely used as a scullery, retains the original window frame and small wooden door leading through to the main hallway (Room 7). This room is accessed through an archway from the kitchen.

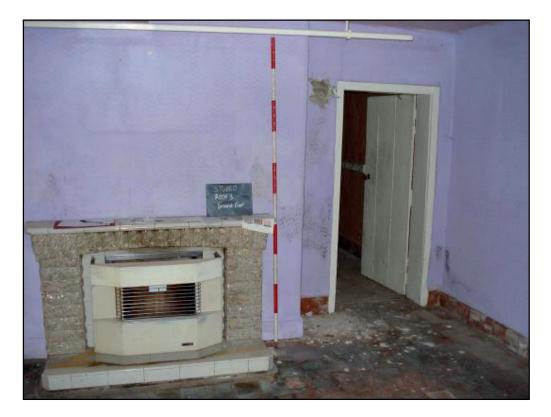
Fig- 17 Room 3

Like the previous two rooms this room has mainly modern features to it. The original fireplace has been replaced with a gas heater with modern surround. This room gives access to Rooms 4, 5 and 7. Room 5 is accessed through an archway.

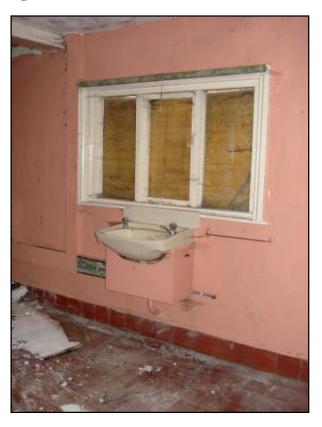
Fig- 18 Room 4

This room was has a window boarded up. Much like rooms 1-3 this room appears to have been modernised to make a toilet room. It has no features of historical or architectural significance.

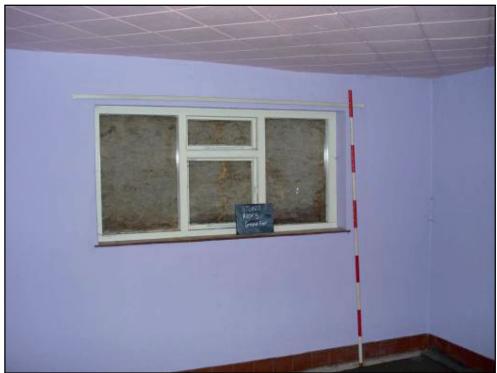
Fig -19 Room 5

This room contains no features of historical or architectural significance. The wooden framed window to the eastern elevation is not in keeping with the style of the other windows on the ground floor which would imply that it is a later replacement.

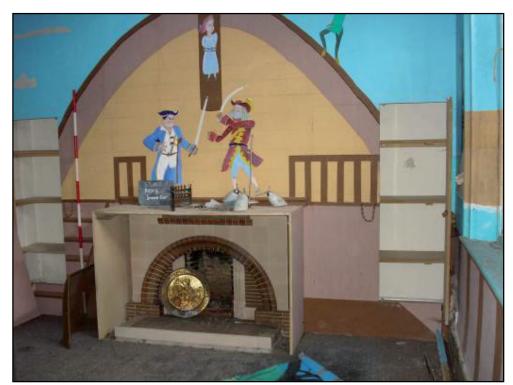
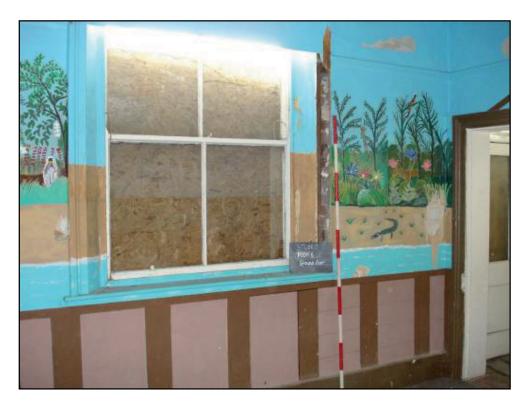
Room 6 is accessed through the main hallway (Room 7). This room has been previously used as a children's play room. What is likely to have been the original fireplace is currently boarded up behind a ply-wood screen probably for health and safety purposes. The flooring is covered by carpet. The room retains the original sash windows and frames on the southern extension.

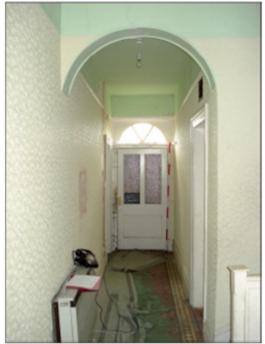
Fig- 22 Room 7

This is the main hallway/ corridor of the house and gives access to Rooms 2, 3, 6 and 8 as well as containing the staircase to the first floor. Although the flooring has been covered by carpet, the carpet has been pulled away from the wall to reveal the original tiled floor beneath. Although the fanlight of the doorway appears to be original, the door itself is probably a modern replacement.

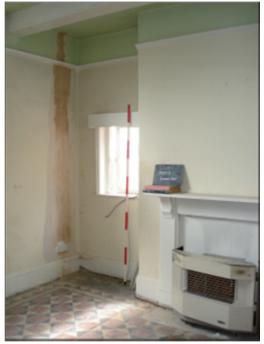
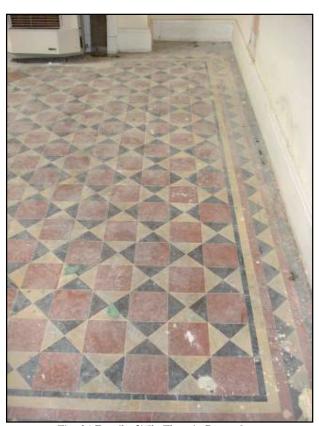
Fig- 23 Room 8

Room 8 continues with the original tile flooring found in Room 7. There is an original sash window on the southern extension (as with Room 6) and a smaller wooden framed window on the western elevation. The central fireplace has been removed (evidence of the original hearth can be seen in the missing tiles around that area) and replaced with a gas fire. This room retains the original skirting boards, picture rails, and ceiling beam.

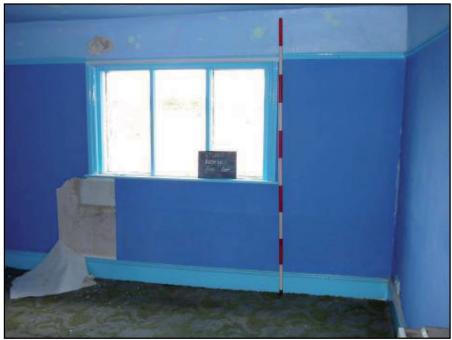
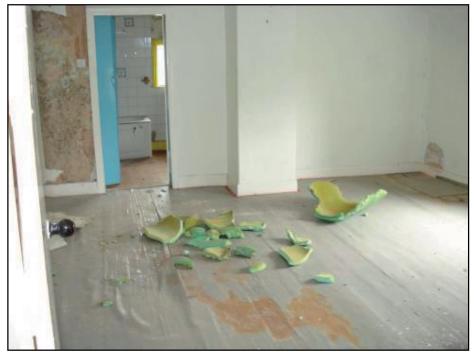
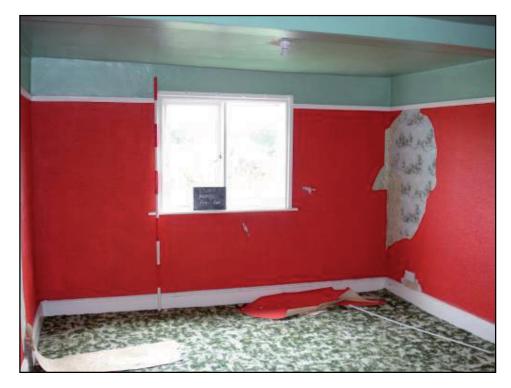
Room 10 has a wooden framed window and original skirting boards. The floor boards have become rotten due to water leakage from the adjacent boiler system in room 12. It was deemed unsafe to fully enter these rooms but an initial viewing from the doorway revealed that the rooms contained no features of historical or architectural significance. Room 13 is slightly larger that Room 10 but has a smaller wood framed window. Original skirting boards, picture rails and ceiling beams are present within these rooms.

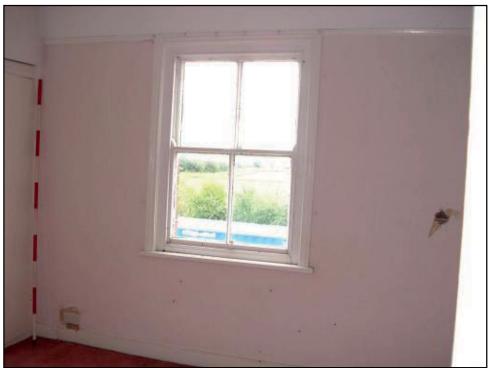
Fig- 29 Room 14

This room has had fitted wardrobes installed either side of the fireplace, which has itself been blocked up. The room retains the original sash windows but the original skirting boards have been replaced.

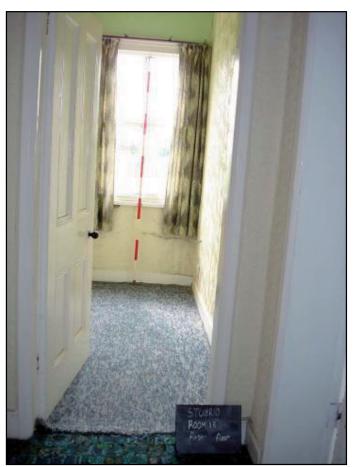
Fig- 30 Room 15

This narrow room is no wider than the original sash window within. A loft hatch in the ceiling provides access to the roof cavity.

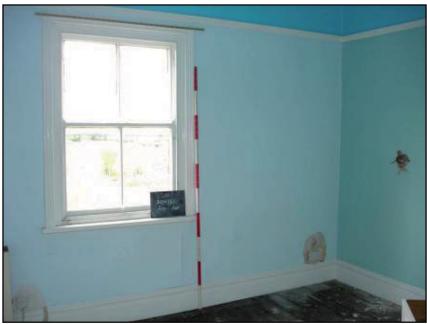
Fig- 31 Room 16

This room is comparable to Room 14, without the fitted wardrobes. This room however also retains the original skirting boards and picture rail.

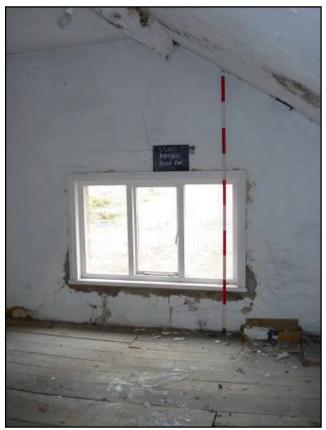
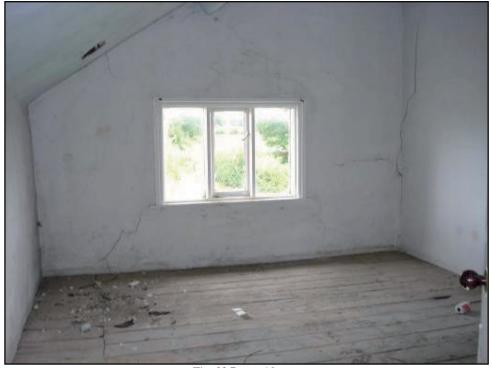
These rooms are identical to each other. The only exception being the window in Room 17 is slightly lower than in 18. Each room has low sloping ceilings caused by the roof angle. Both rooms are in a very poor state of repair.
