**An Archaeological Building Recording of
Thorburn's Yard, South Street, Seahouses,
Northumberland.**

Archaeological Research Services Ltd
Report No. 2011/5
January 2011

An Archaeological Building Recording of Thorburn's Yard, South Street, Seahouses, Northumberland.

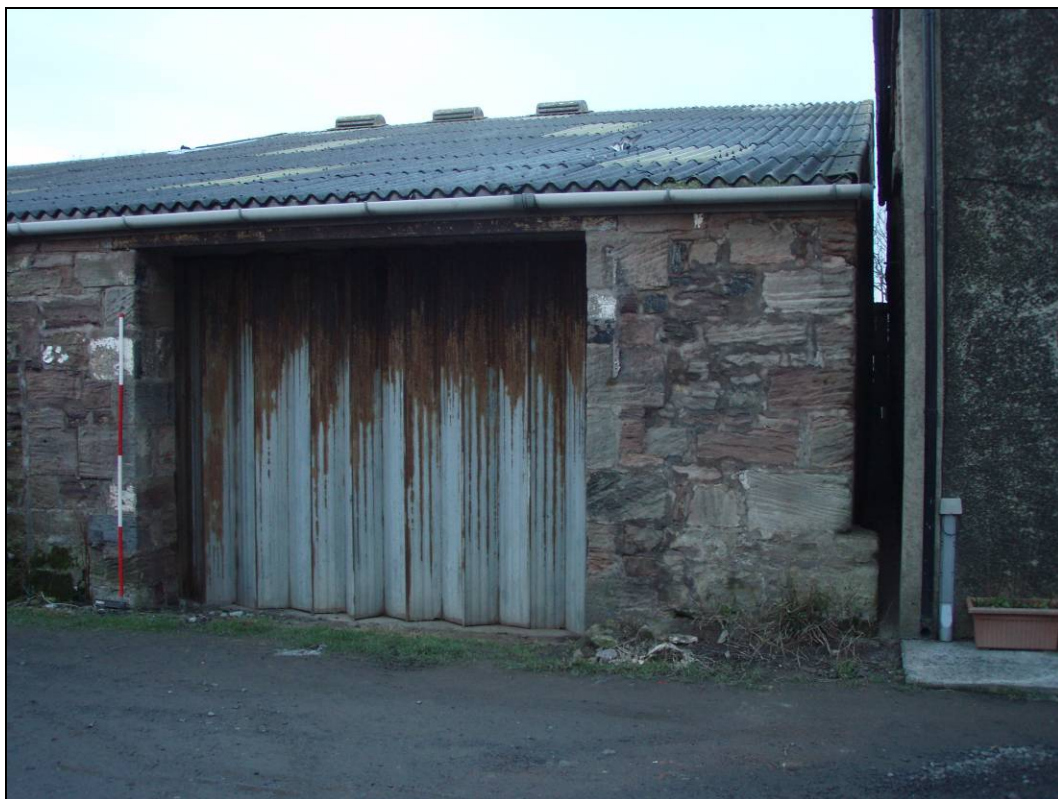
- 3.2. Wall 1 (Figs 3 - 11) runs northeast – southwest along South Street. The northwest facing elevation is a construction of sandstone beach stones (probably locally sourced) in various sizes. The wall is in a state of disrepair and has various blocked off openings along its frontage. Several doorways and windows have been blocked off (Figs 4, 5, 8) using the same locally sourced sandstone as the rest of the wall. The doorways and windows each have a large sandstone lintel with the exception of a more modern doorway (Fig 7), which has been cut into the wall, and since blocked off in more modern times. Toward the northeast section are two small holes cut into the wall (Fig. 9), with a lintel above. This is another blocked off entrance, and local opinion is that the holes were created in order to facilitate the filling of a diesel tank, which used to be situated on the southwest facing elevation, during the sites use as Thorburn's Yard.

Figure 3. Wall 1 northwest facing elevation

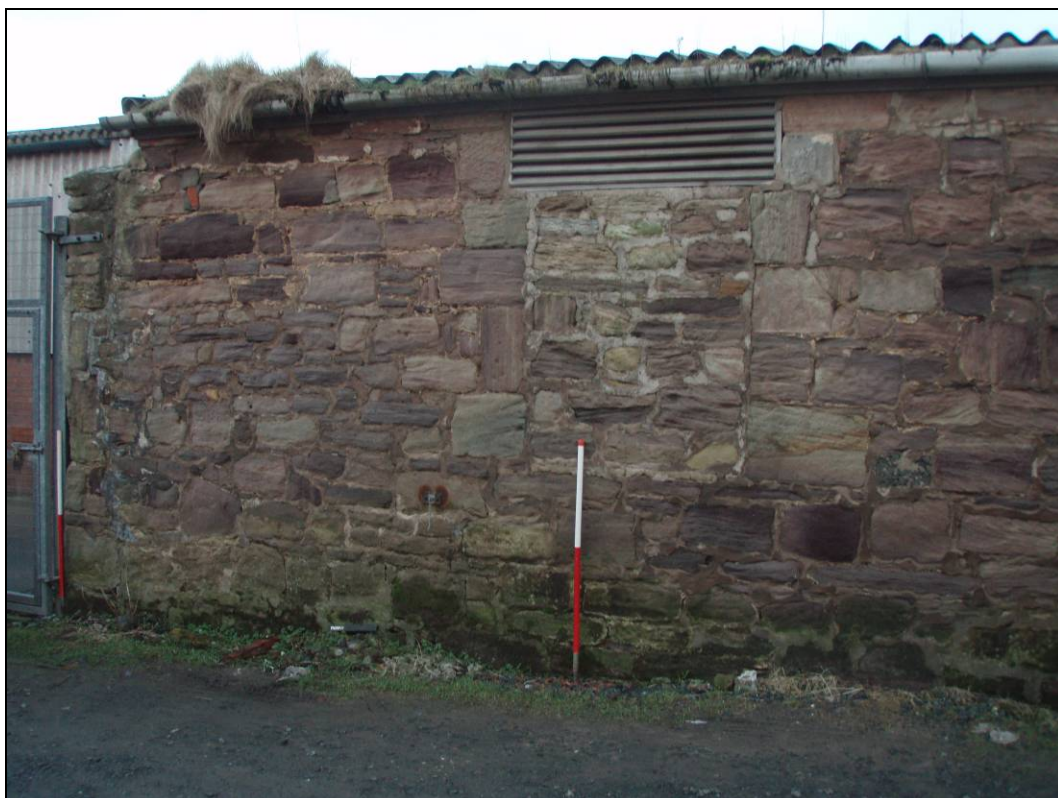
Figure 4. Wall 1 northwest facing elevation, blocked off door

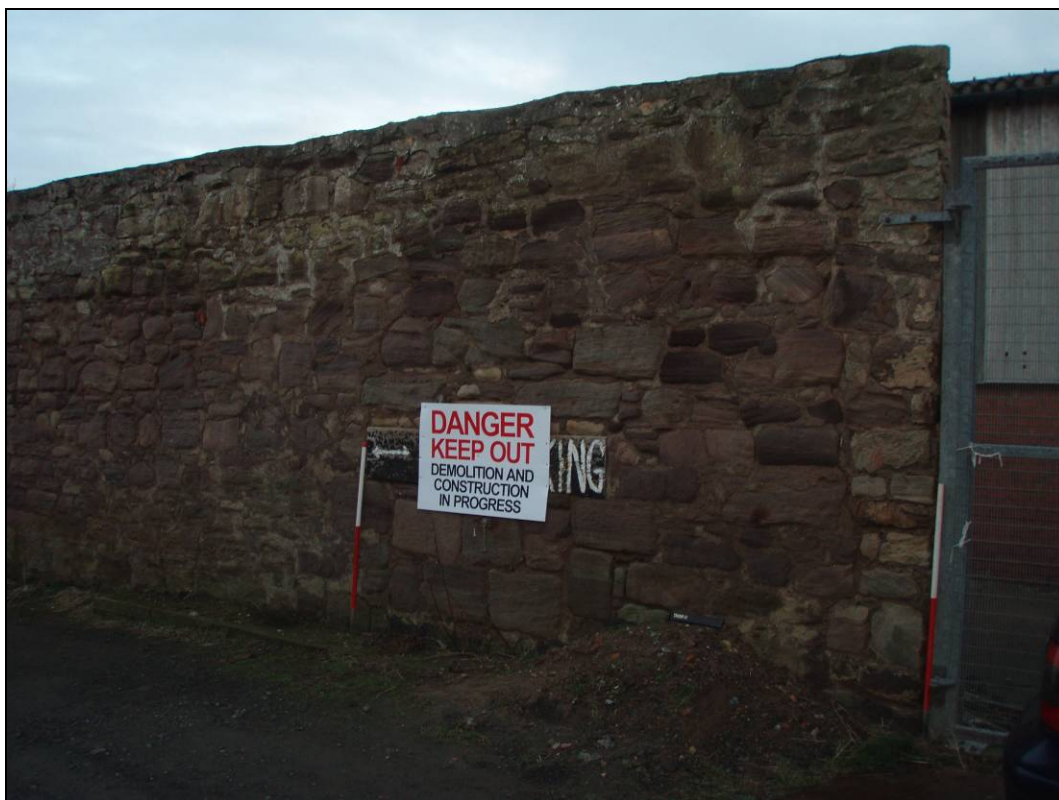
Figure 5. Wall 1 northwest facing elevation, blocked off opening

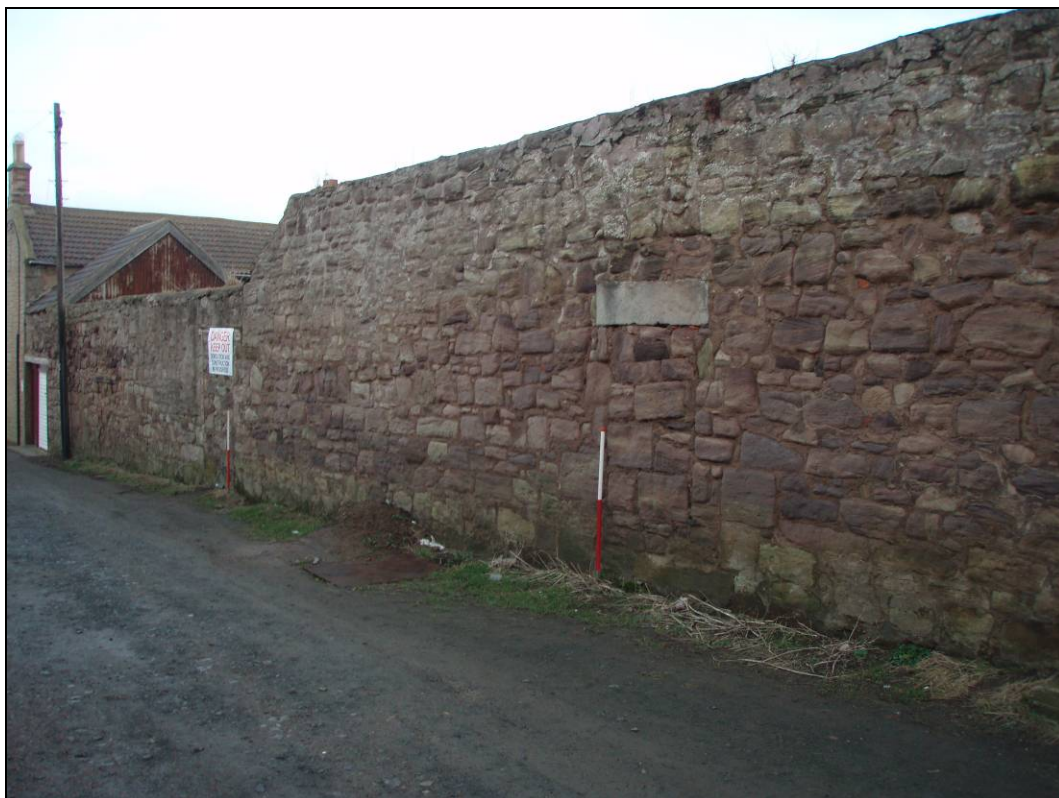
Figure 6. Wall 1 northwest facing elevation

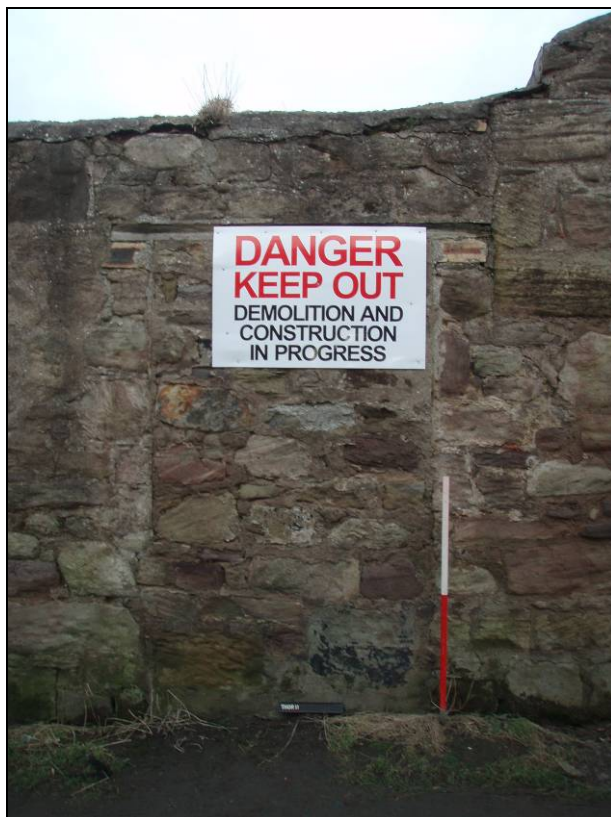
Figure 7. Wall 1 northwest facing elevation, more recent doorway

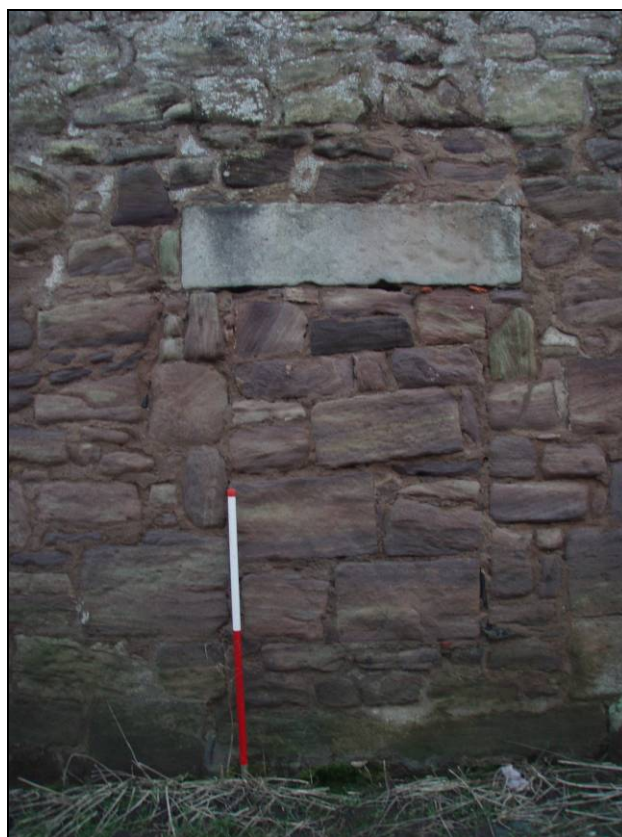
Figure 8. Wall 1 northwest facing elevation, blocked off opening.

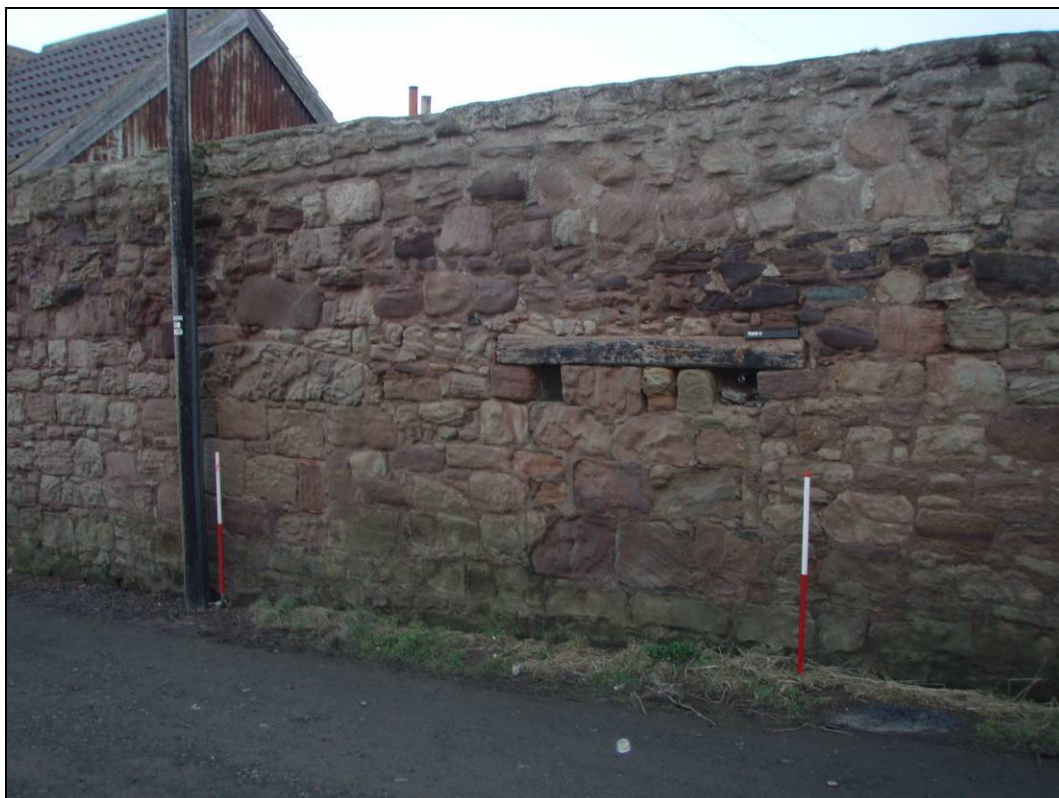
Figure 9. Wall 1 northwest facing elevation, with blocked off opening and utility holes

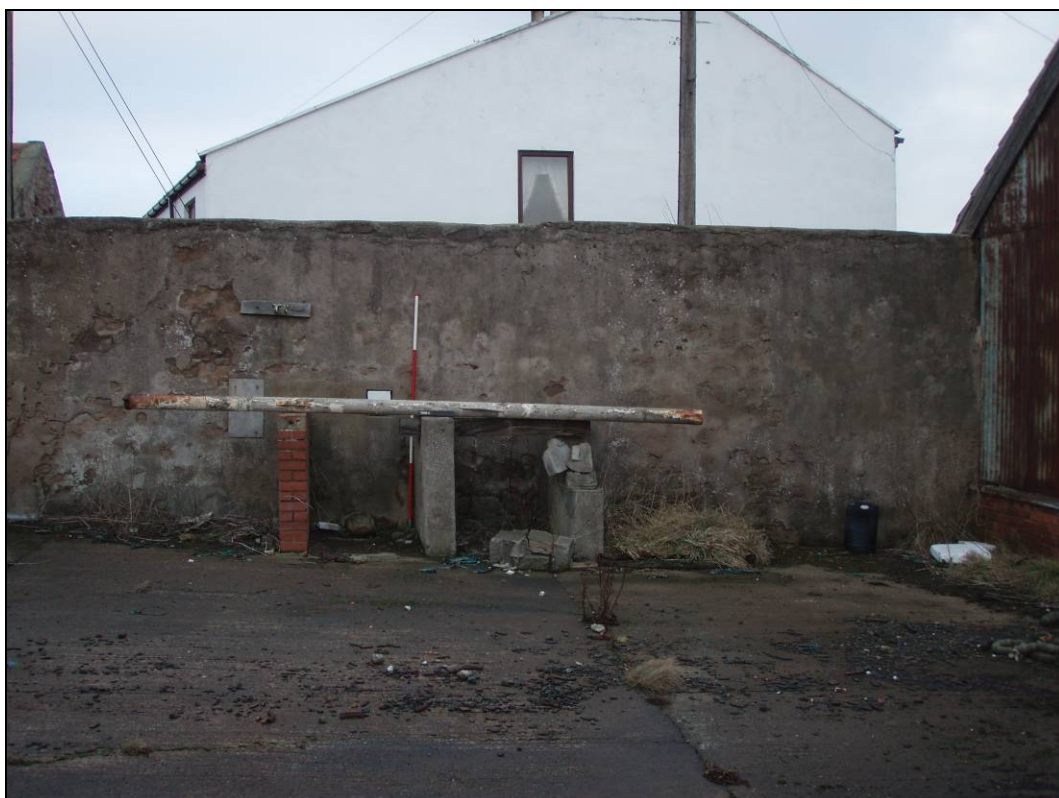
- 3.3. The southeast facing elevation (Figs 10, 11) of Wall 1 has been clad with a gray mortar and so the sandstone construction of this elevation cannot be seen.

Figure 10 Wall 1 southeast facing elevation

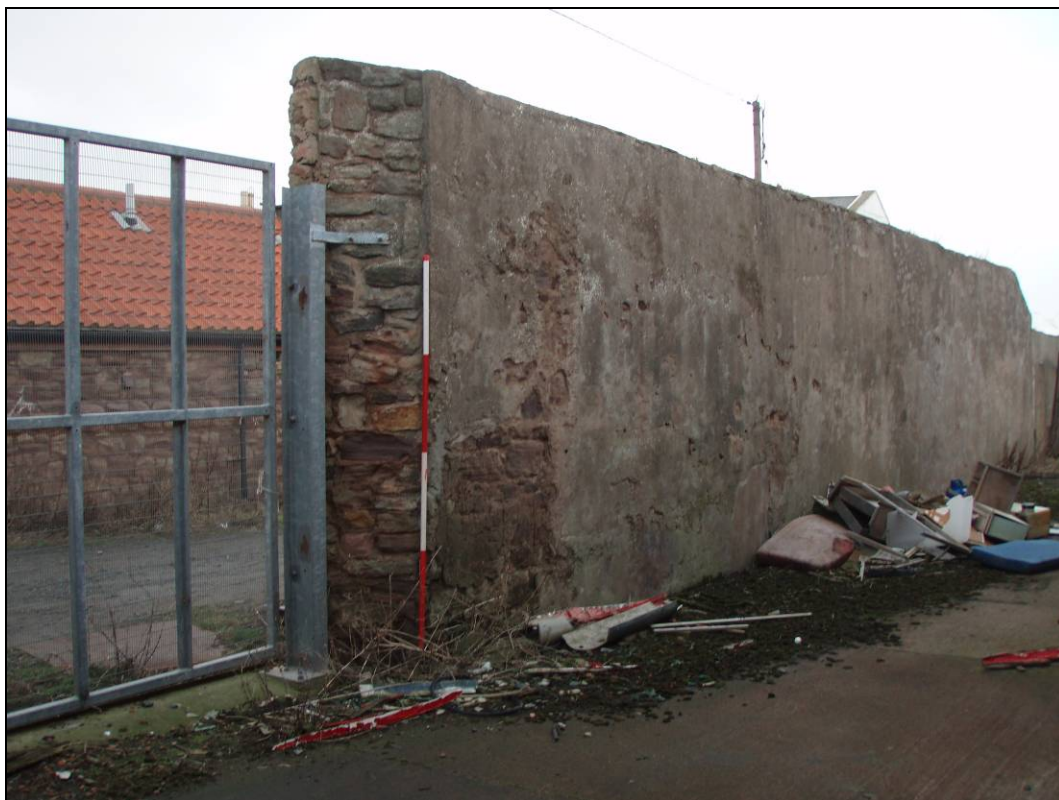
Figure 11. Wall 1 southeast facing elevation

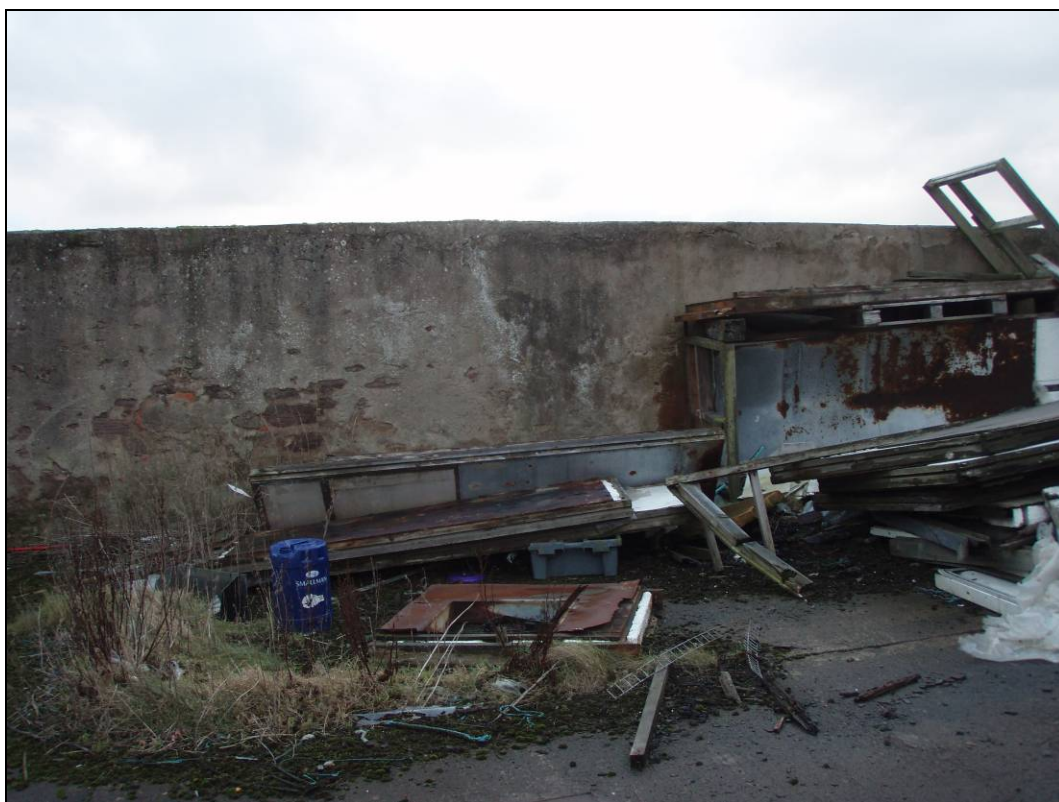
- 3.4. Wall 2 (Figs 12 - 15) is of a lower construction than Wall 1. The northwest facing elevation has been clad in the same grey mortar as Wall 1. The southeast facing elevation is of the same construction as Wall 1, but is heavily weathered and in a poor state of repair.

Figure 12. Wall 2 northeast facing elevation

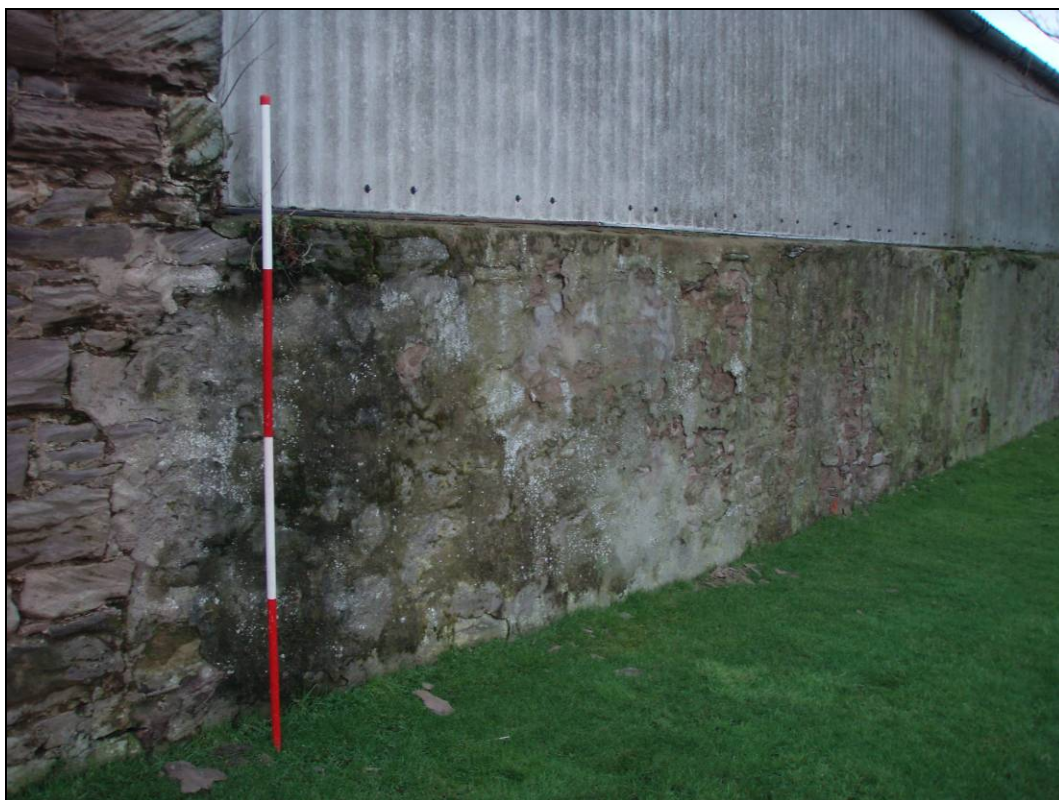
Figure 13. Wall 2 southeast facing elevation

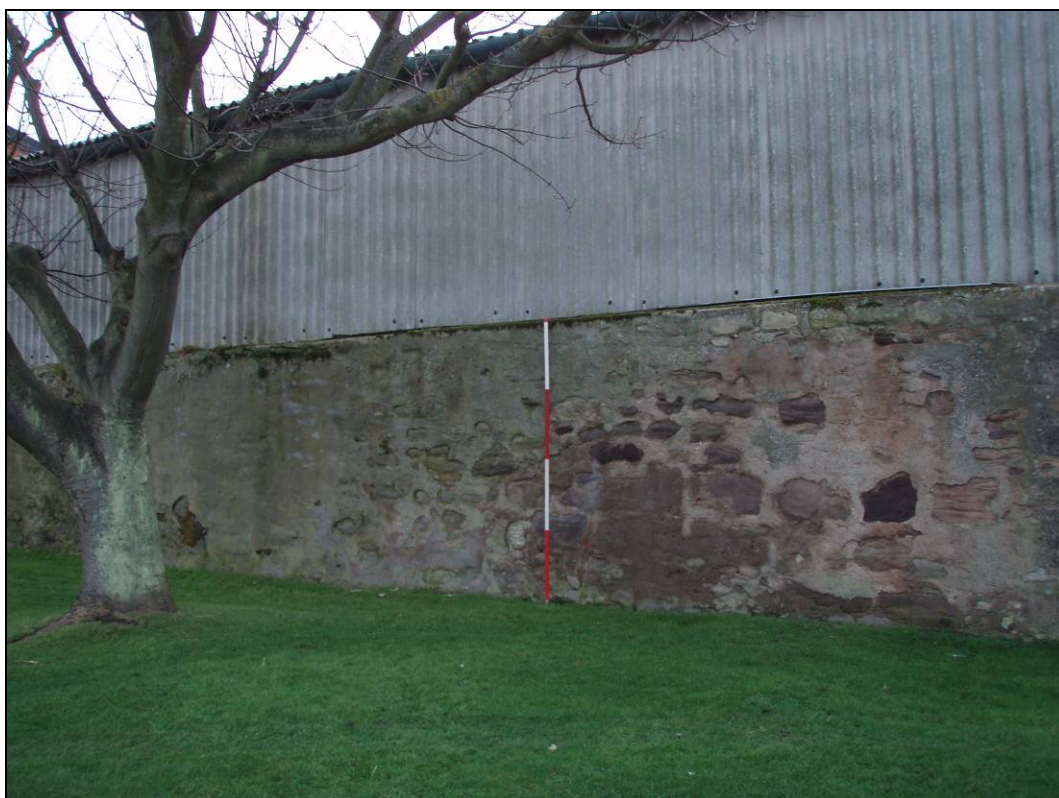
Figure 14. Wall 2 southeast facing elevation

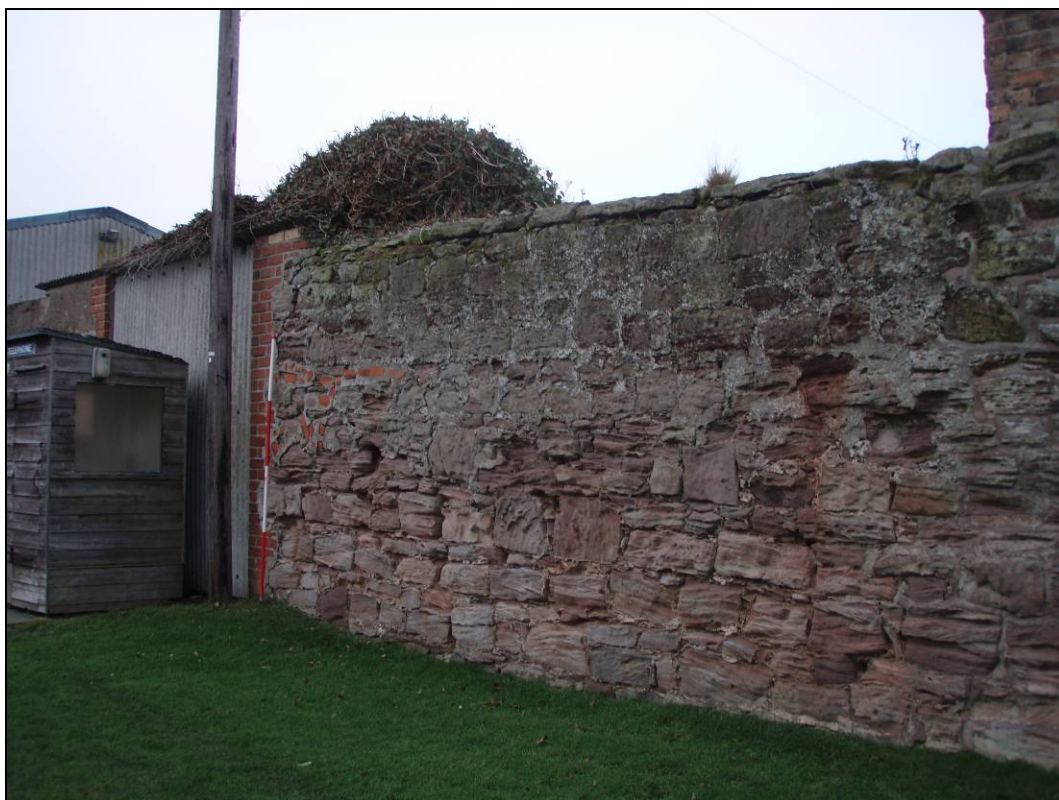
Figure 15. Wall 2 southeast facing elevation, showing heavy erosion.
