River Avon Restoration, Structures at Upavon, Wiltshire

Archaeological Watching Brief

Ref: 101461.02
March 2015

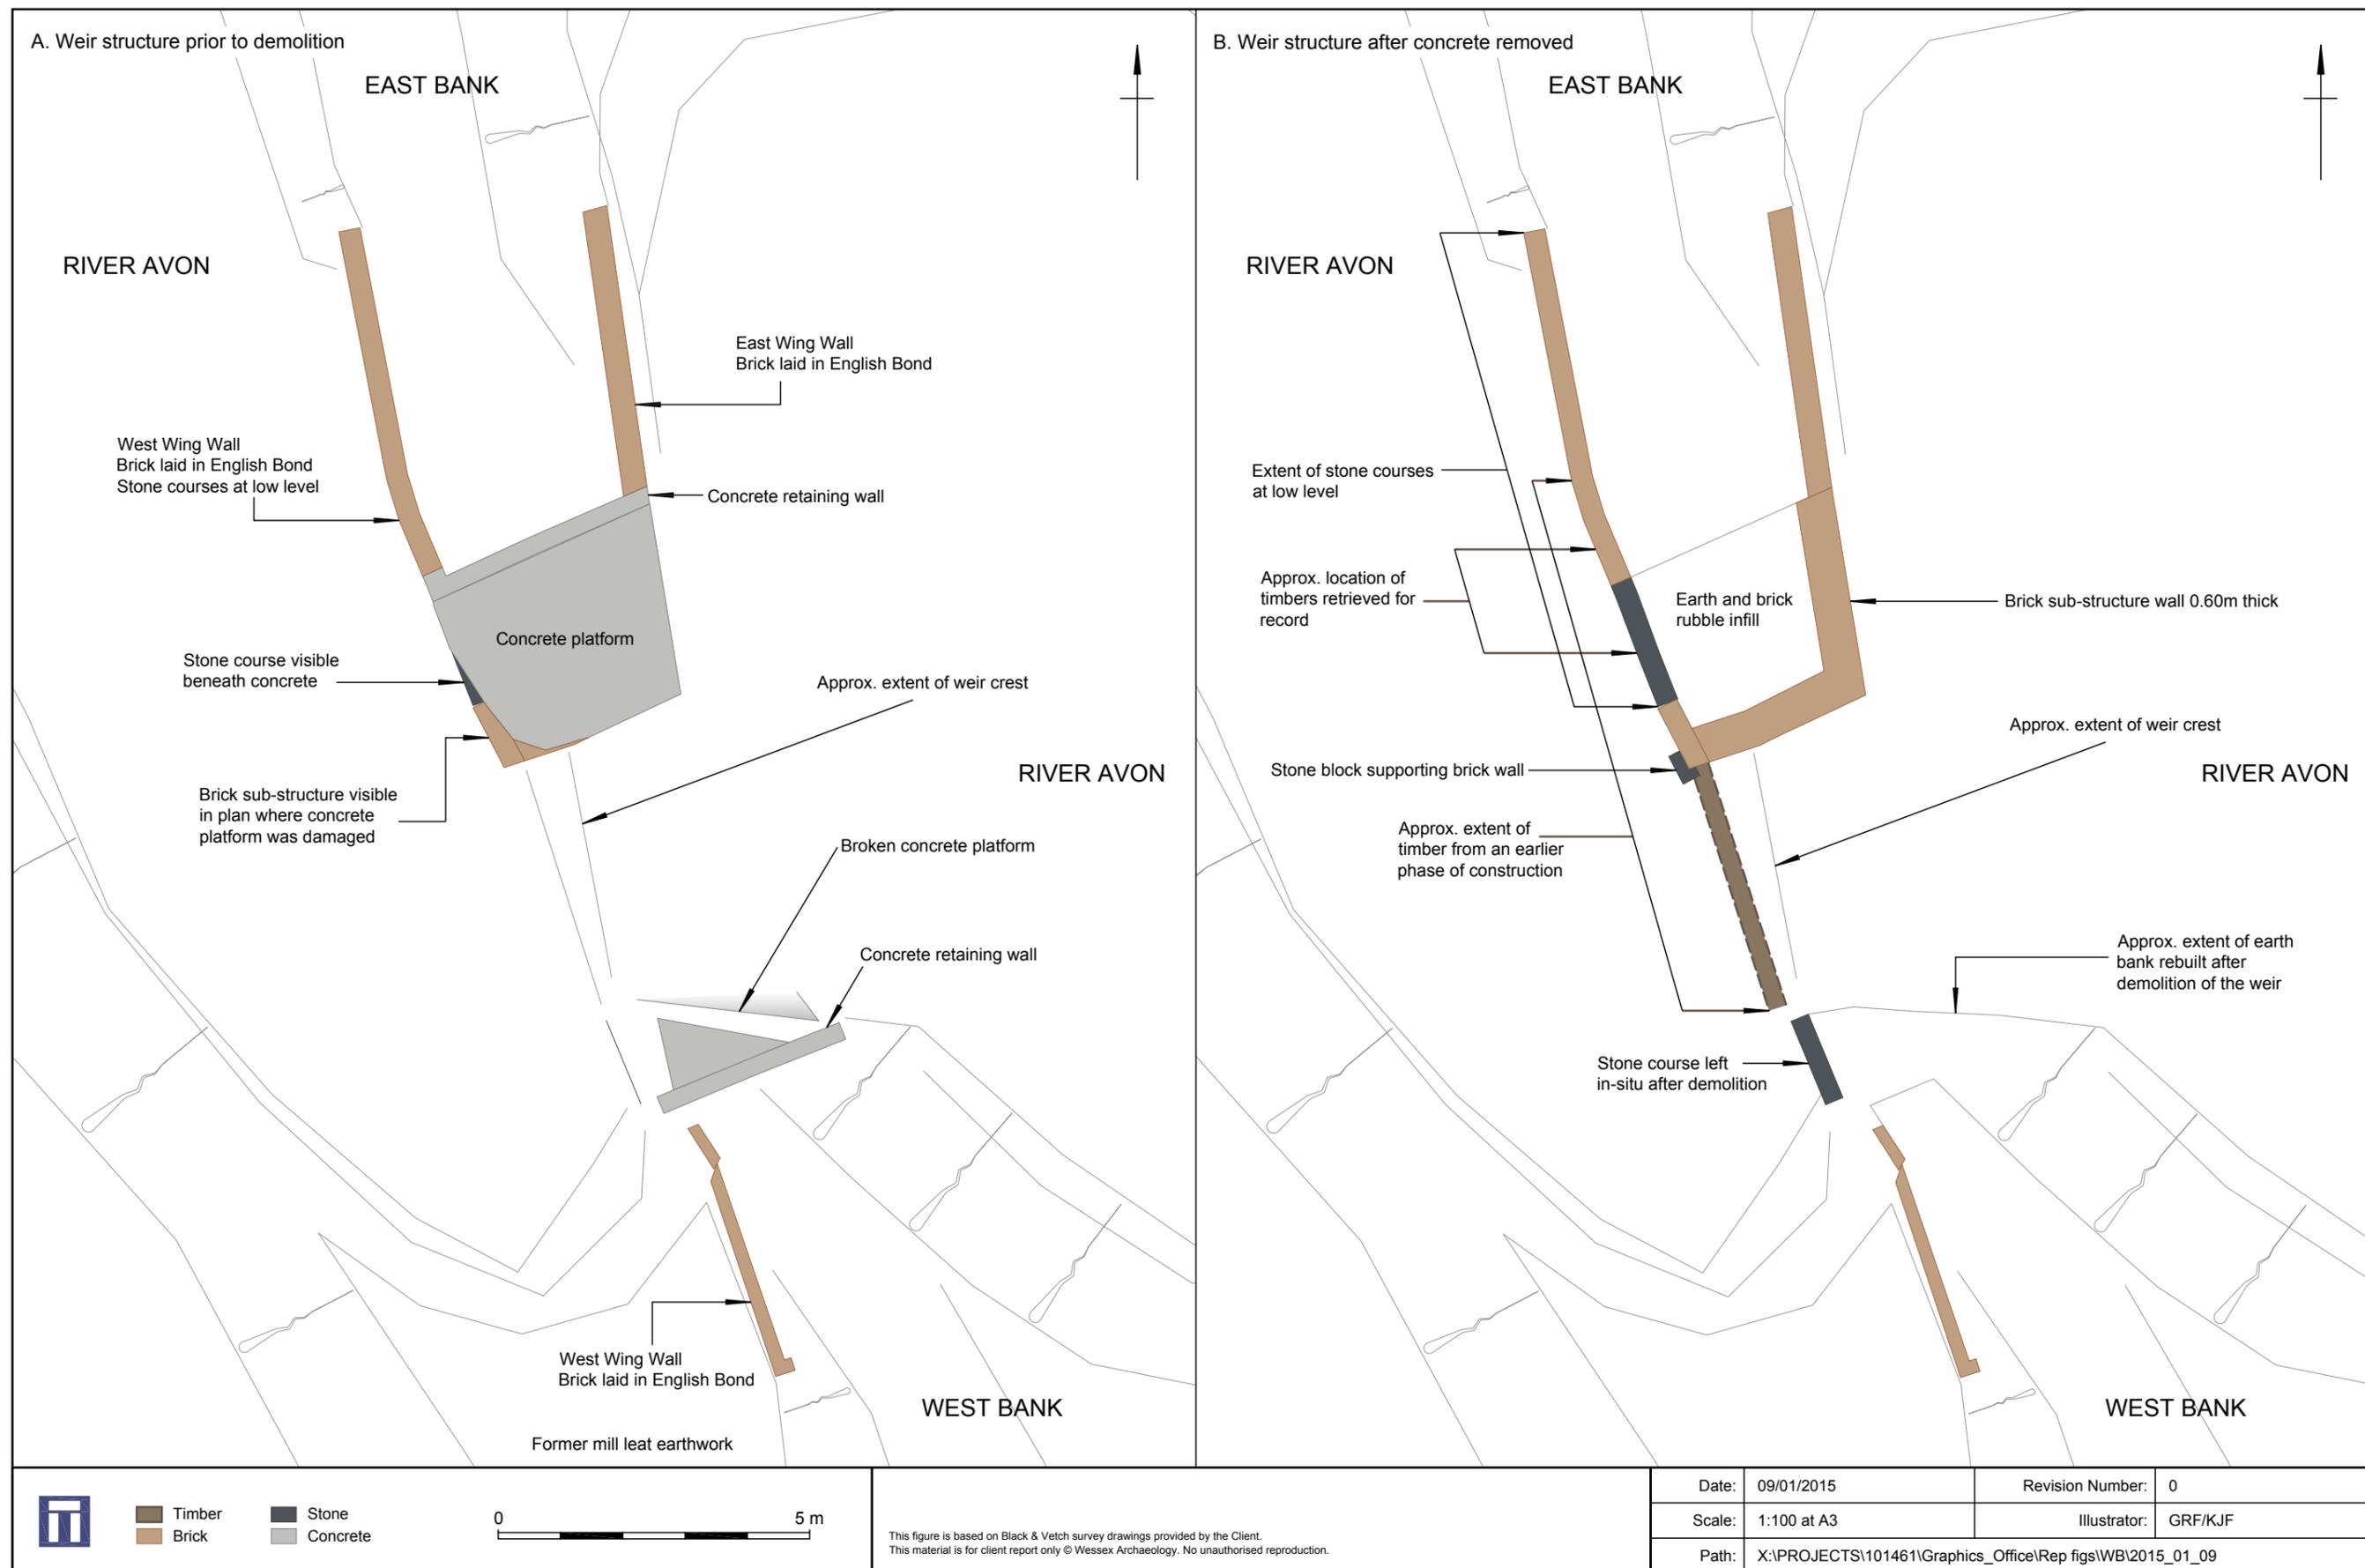
Figure 2

Plan of the weir structure prior to and after removal of the concrete fabric

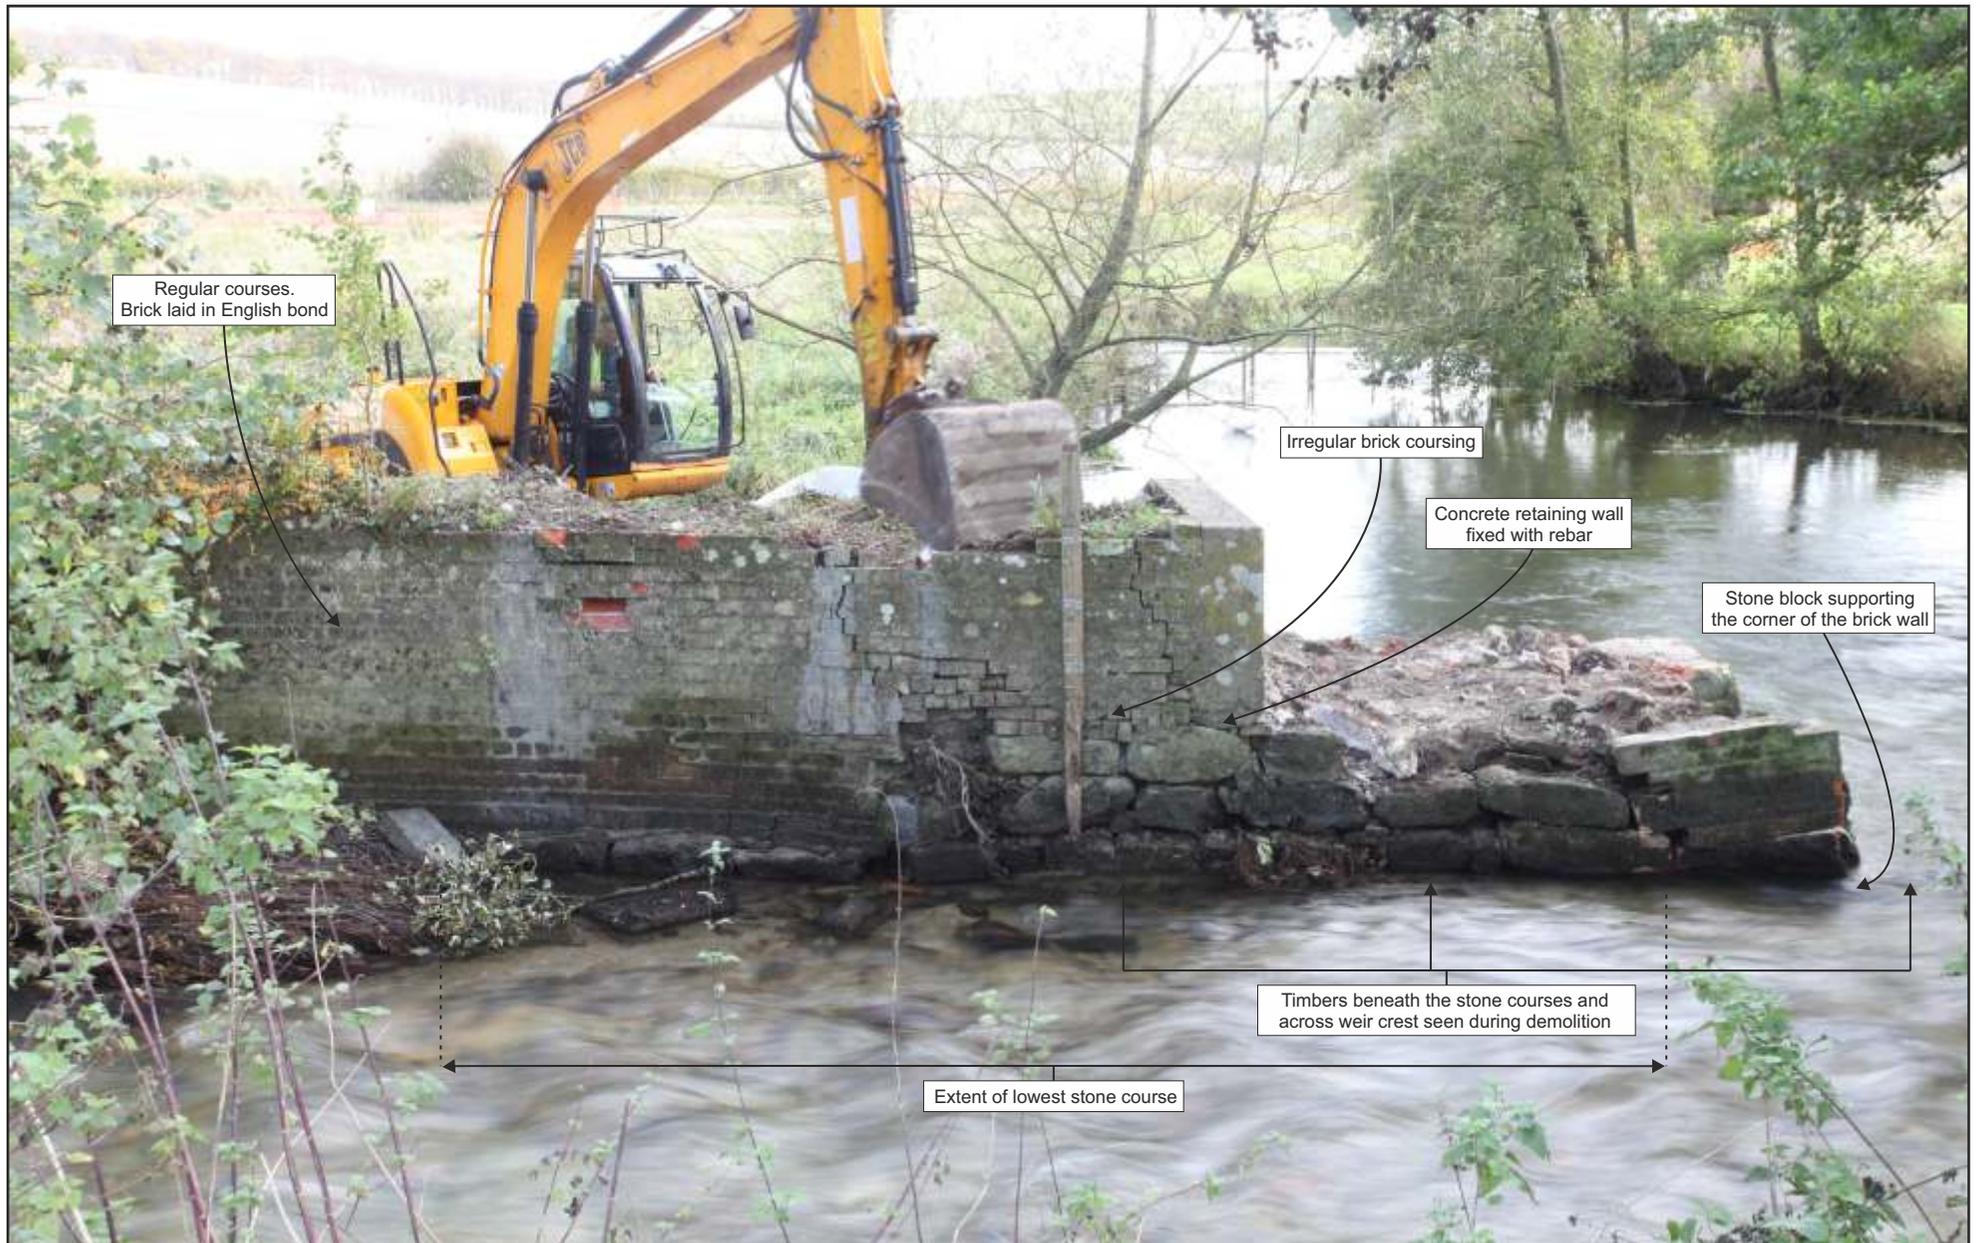
Figure 3

The east bank, west wall during demolition

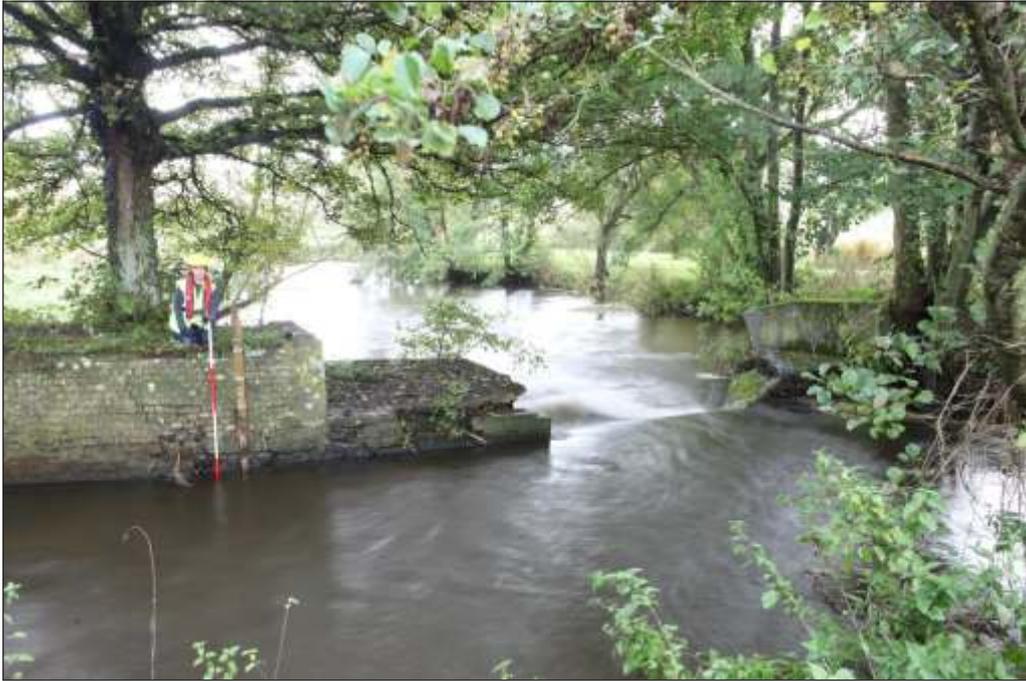
- 4.1.2 The remains of the structure was positioned on both side of the River Avon on a north-south axis between the east and west banks. The river curves from its typical north-south alignment to an east-west alignment at this point, therefore the north end of the weir structure was on the east bank and the south end on the west bank. When recorded the structure was in poor condition with collapsing wing walls and broken platforms attached to either bank and disarticulated remnants visible on the river bed. **Plates 1 to 5** show the structure prior to its demolition.

Plate 1: The weir structure viewed from the north-west prior to demolition

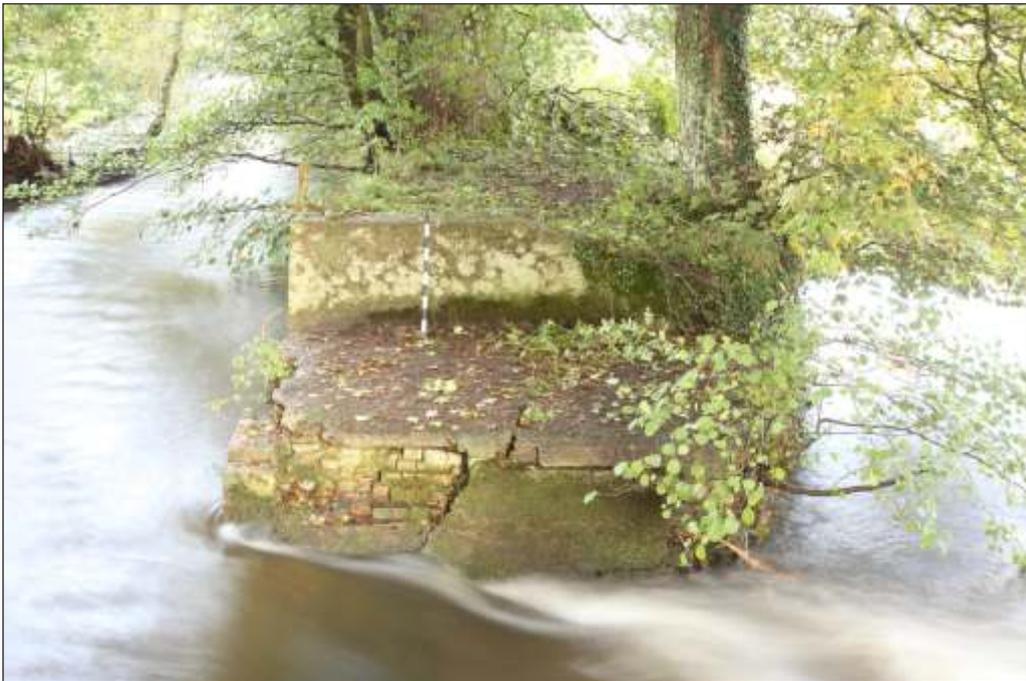
Plate 2: The east bank of the weir structure prior to demolition

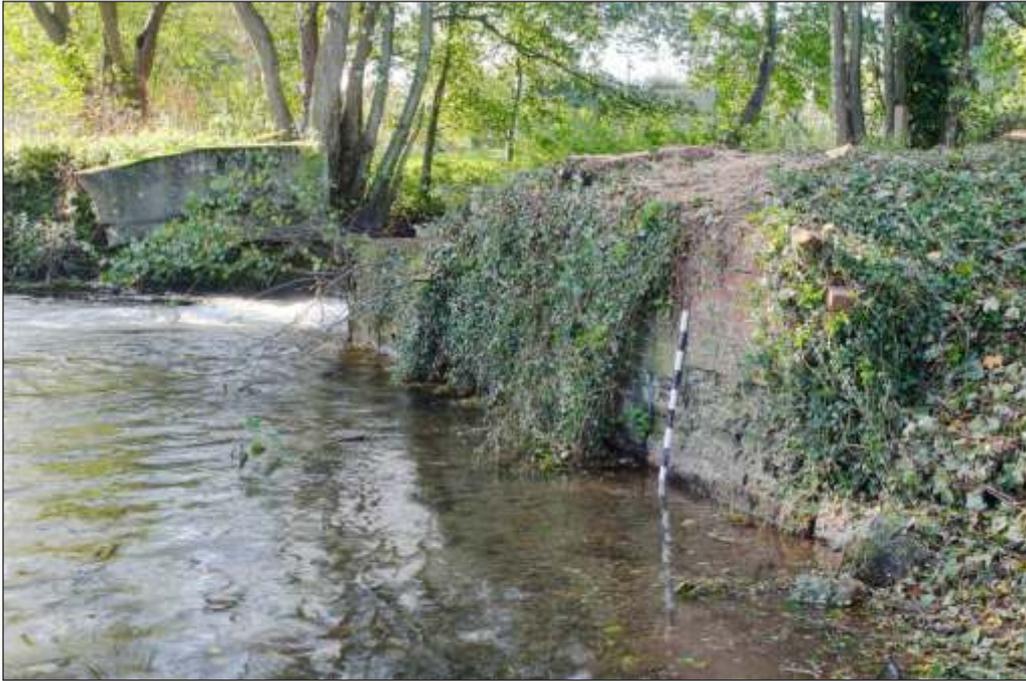
- 4.1.5 The brick wing walls of the weir structure are for the most part regularly coursed and laid in an English bond pattern (**Plates 1, 3 and 7**). The exception is an area of brickwork in the east bank's west wing wall adjacent to the concrete retaining wall and directly above the upper course of stone. In this area the bricks are laid irregularly with a combination of headers and rowlocks because the stone blocks below do not form a level surface so the bricks must fill an irregular space (**Plate 1, Figure 3**). The bricks used were machine-cut, unfrogged type measuring 22.5cm x 11cm x 7cm. The bricks were bonded with pale hydraulic lime mortar.

Plate 3: The east bank, east wall (foreground) and west bank (background) of the weir structure prior to demolition

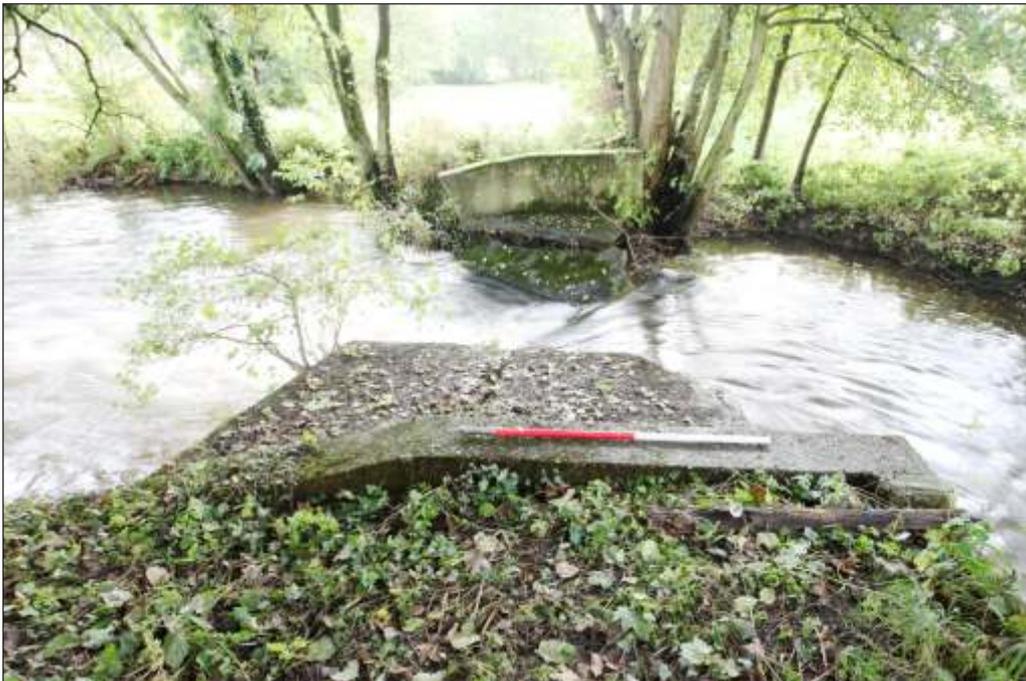
Plate 4: The weir structure viewed from the east to the west bank prior to demolition

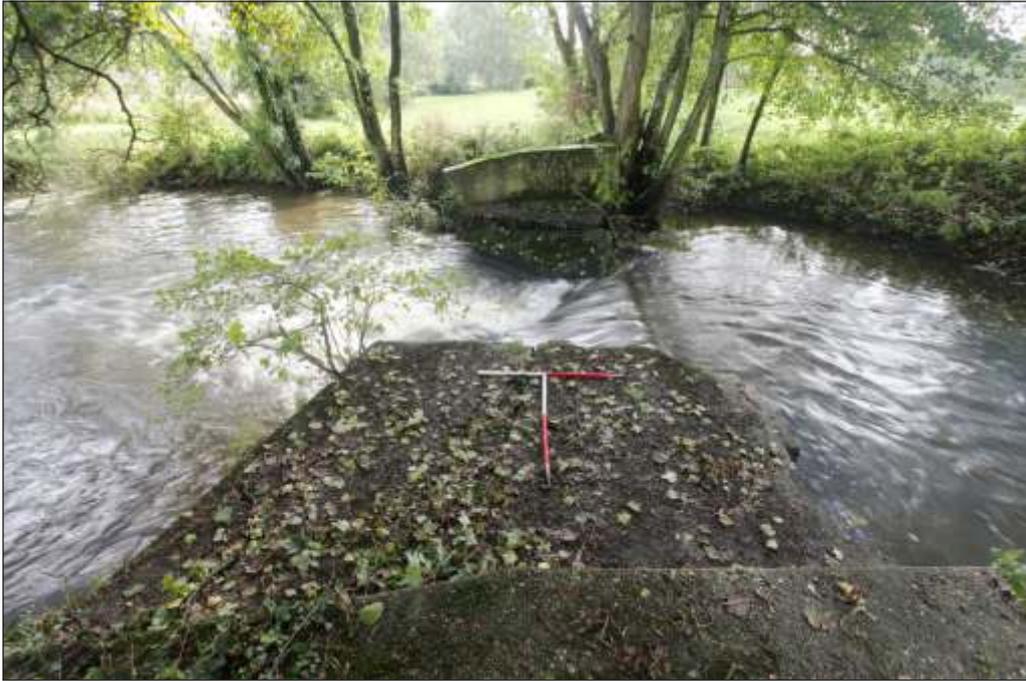
Plate 5: The weir structure viewed from the east to the west bank prior to demolition. The photo shows the east bank concrete platform

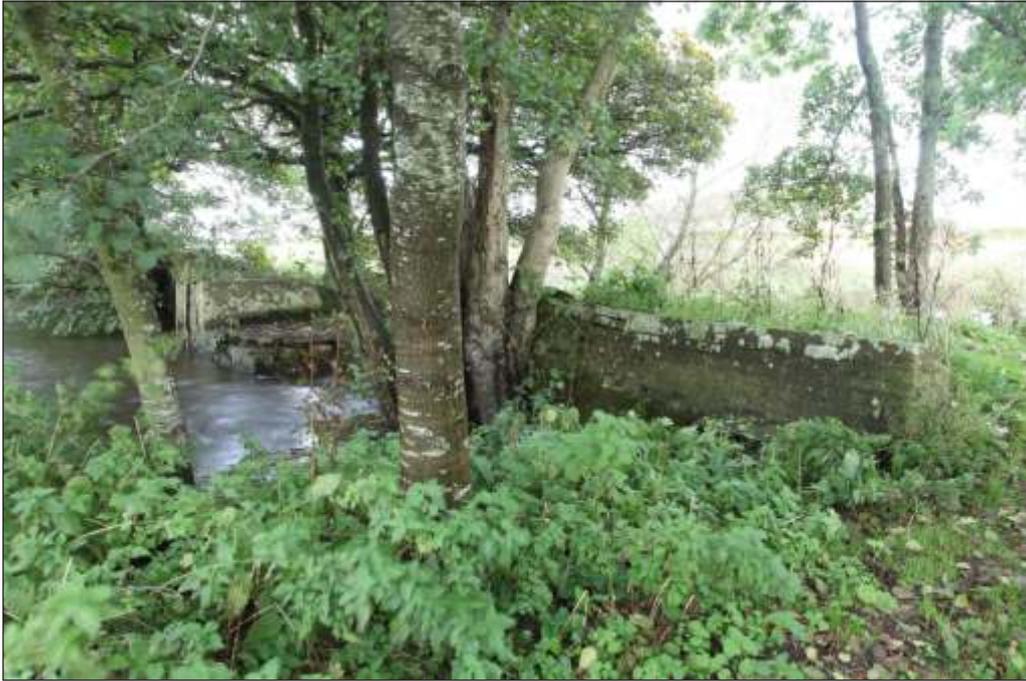
- 4.1.6 On the west bank, the brick wing wall was left intact (**Plate 7**), only the concrete fabric and earth and brick rubble material beneath the platform was removed.

Plate 7: The weir structure prior to demolition showing a detail of the west bank, west wall

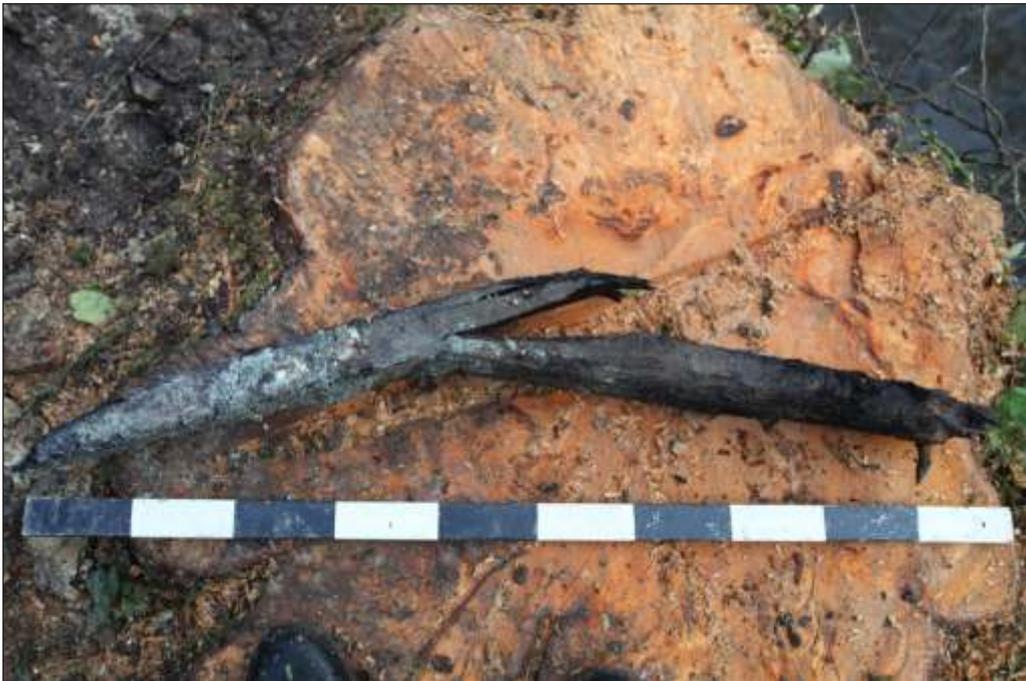
- 4.1.9 A timber was recovered from the demolition of the weir slope (Timber 4, **Plate 8**). This timber was squared in section and tapered to a point at each end although one end appeared broken. It measured 1m in length and 0.13m in width tapering to 0.03m at one end and 0.08m at the broken end. The timber was split and bent at its centre but would have originally been straight. It had an iron nail with its point protruding from close to the broken end of the timber and there was a similar nail attached to a fragment of timber found in the spoil from the weir slope. It is possible that this timber formed part of an earlier timber hatch that existed before the 19th century phase brick and stone structure.

Plate 8: Timber recovered from the demolition of the weir slope.

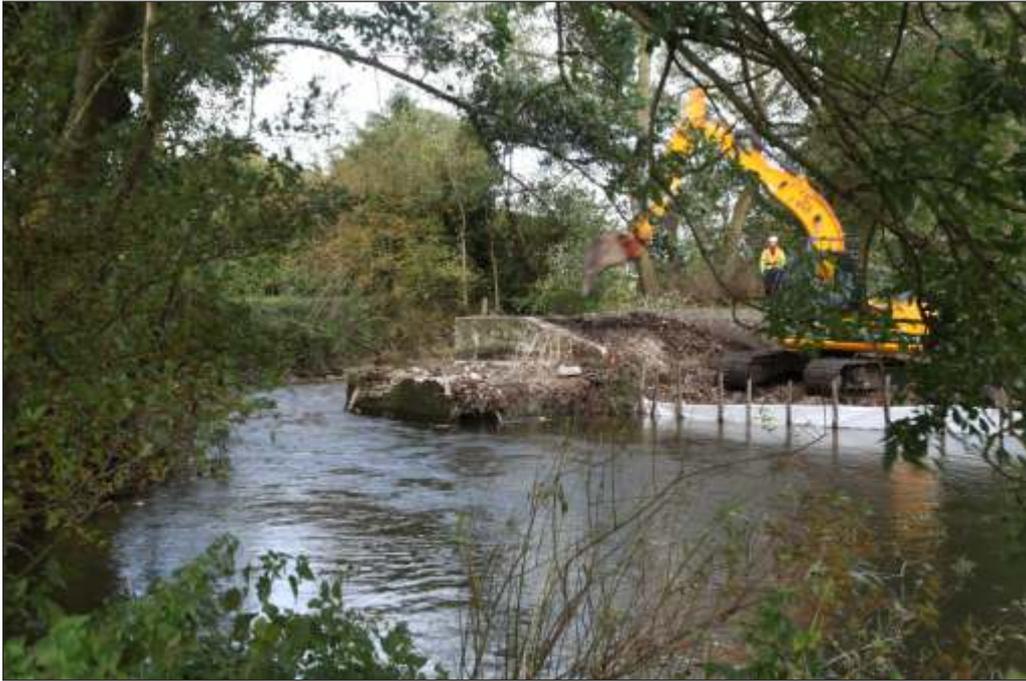
Plate 9: The weir structure on the east bank after the concrete platform was removed

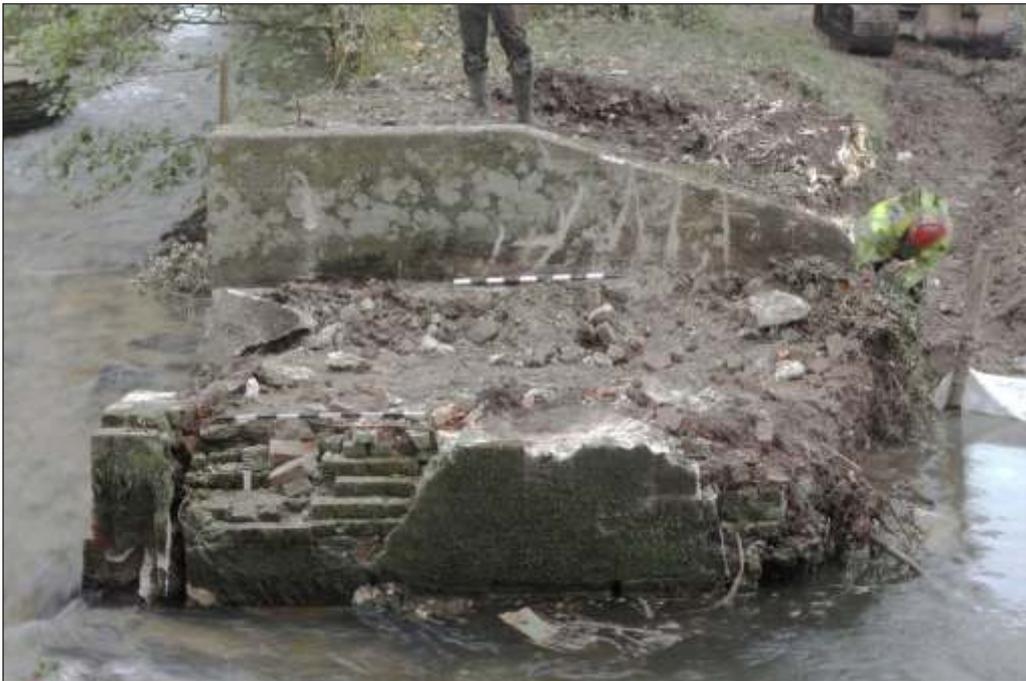
Plate 10: The weir structure on the east bank after the concrete platform was removed. The photo shows the brick sub-structure and earth and rubble infill

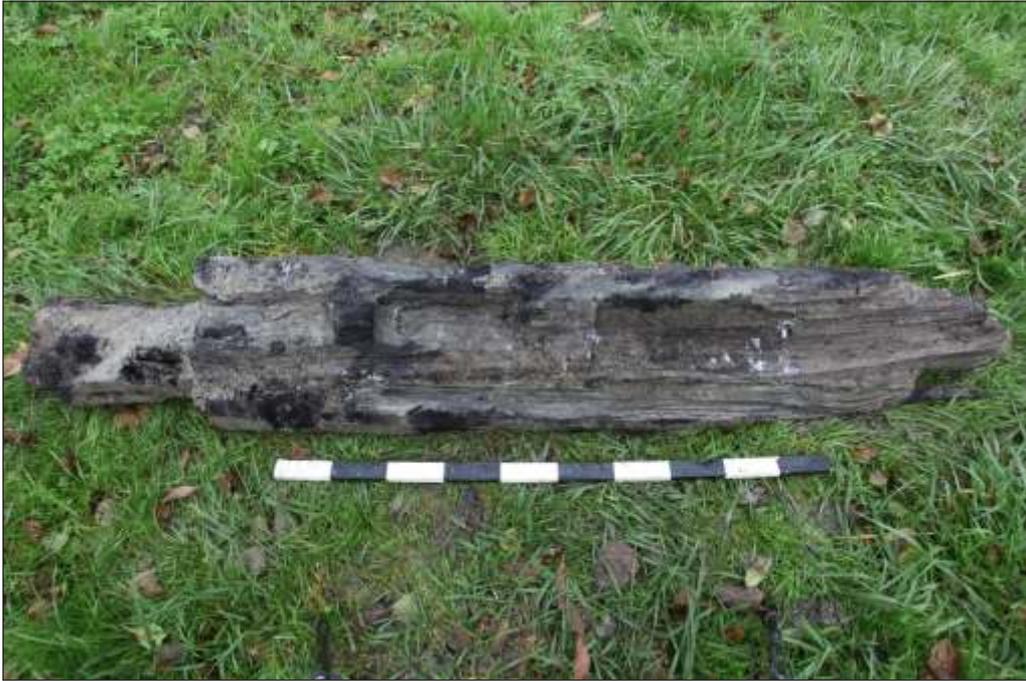
- 4.1.13 Timber 1 was recovered from underneath the east bank west wall under what was the concrete platform. It measured a maximum of 1.81m x 0.18m x 0.28m. It is broken at one end which has a mortise 0.18m and a broken tenon 0.04m x 0.02m x 0.18m. At the opposite end is a more substantial tenon 0.18m x 0.14m x 0.34m. One side of the timber is cut with a series of three mortises 0.23 x 0.08m, 0.22m x 0.08m and the third is 0.80m x 0.07m; all are 0.08m deep. This side also has a shallow groove cut 0.02m wide and at least 1m in length (**Plate 11**). There is another groove on the opposing face of the timber. The groove measured 0.08m wide and 0.05m deep and crossed the face of the timber diagonally (**Plate 12**).

Plate 11: Timber 1 recovered from beneath the east bank, west wall of the weir structure with several carpentry joints including mortises and tenons and a groove along its length

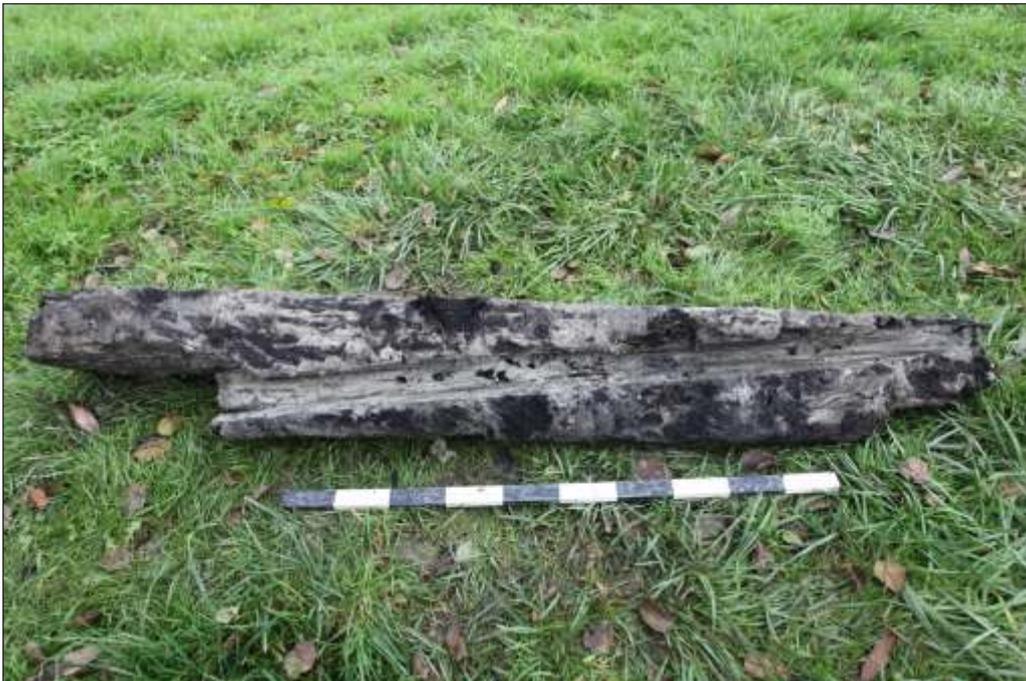
Plate 12: Timber 1. The opposing face to that shown in Plate 11. It has a diagonal groove along its length

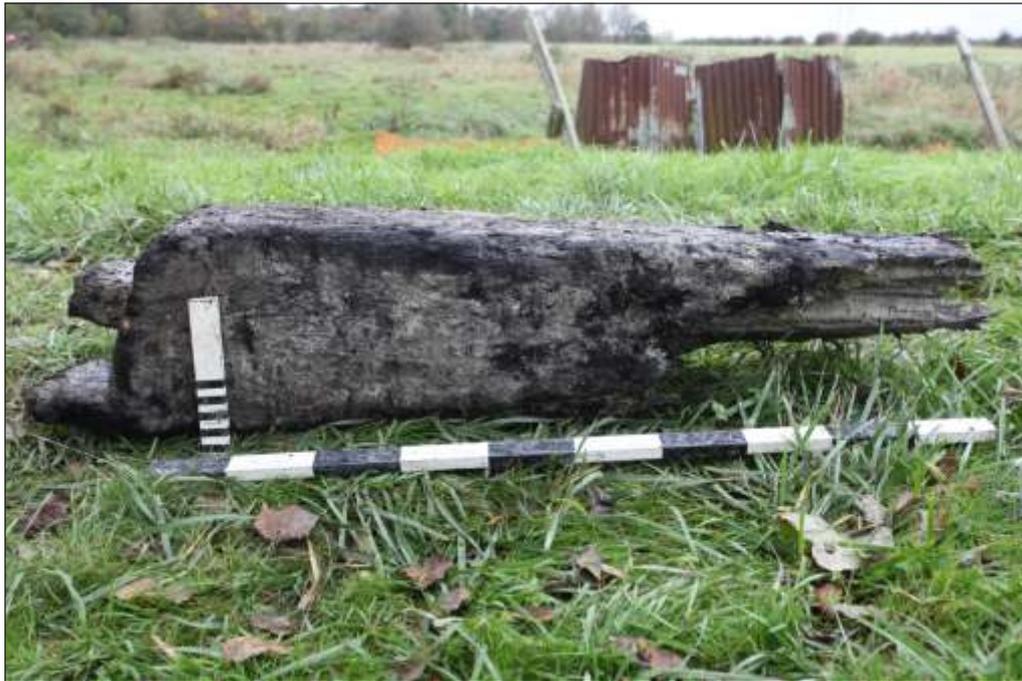
- 4.1.14 Timber 2 (**Plates 13-14**) was also recovered from underneath the east bank west wing wall, positioned approximately beneath the concrete retaining wall. It measured 1.34m in length and is tapered so ranges from 0.23m x 0.25m to 0.12m x 0.13m at each end. The smaller end appears to be broken and has lost some fabric which may account for its lesser dimensions. This broken end has three broken tenons visible arranged at three of its four corners, the longest measures 0.12m. The timber narrows from 0.25m wide to 0.11m at a point 0.8m from its intact end and then tapers in a series of broken steps towards the damaged end. The intact end of the timber has two large tenons that extend from a sloping face. One is 0.03m x 0.19m x 0.11m and the other measures 0.06 x 0.20 x 0.10. Neither measures the full width of the timber and they are slightly offset to each other. It is possible there were some more grooves cut into the broken end of the timber, however these were ephemeral and may be due to lost fabric due to damage rather than specific cuts.

Plate 13: Timber 2 recovered from beneath the east bank, west wall of the weir structure

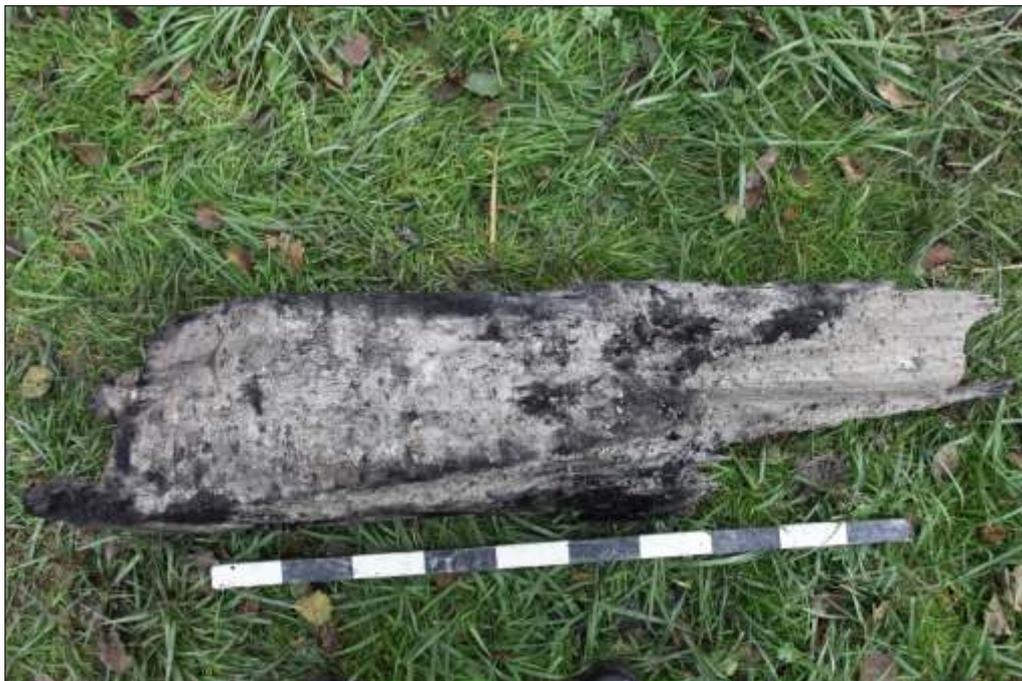
Plate 14: Timber 2 showing details of the groove along its length and damaged areas at one end

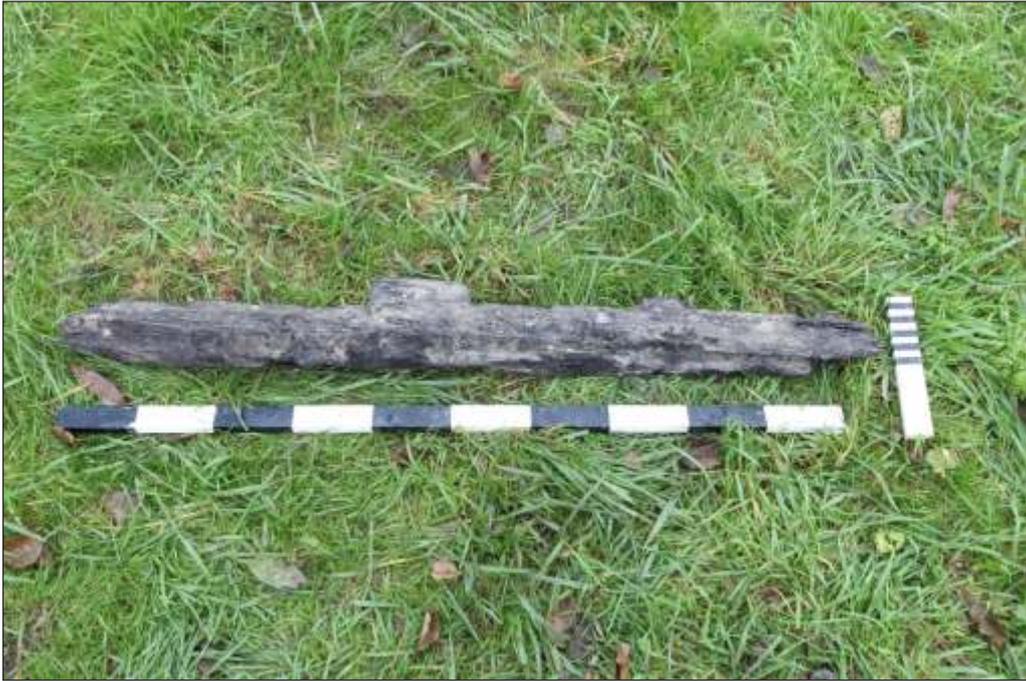
- 4.1.15 Timber 3 (**Plate 15**) was located in the same area as Timber 1. It is the smallest of the timbers retrieved from beneath the east bank west wall and measures 1.05m x 0.11m x 0.10m (max) but is broken at both ends. It has a diagonal groove 0.07m wide on one side with a concave profile 0.02m deep. On the opposing face are two tenons. One is 0.38m from the end of the timber and measures 0.13m x 0.03m in length and extends 0.065m from the face of the timber. The other is 0.21m from the opposite end of the timber, it measures 0.05m x 0.07m and extends 0.02m from the timber surface. There is a gap of 0.23m between the two tenons.

Plate 15: Timber 3 recovered from beneath the east bank, west wall of the weir structure. The two tenons along the length of the timber are clearly visible

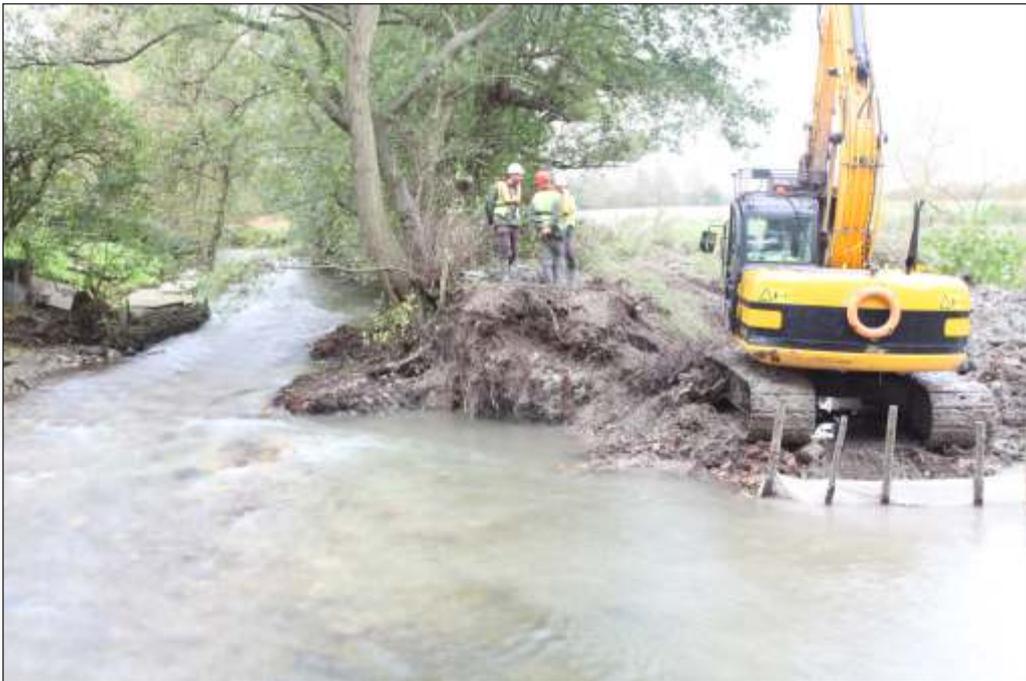
Plate 16: The east bank after the complete demolition of the weir structure but prior to the final re-grading of the bank

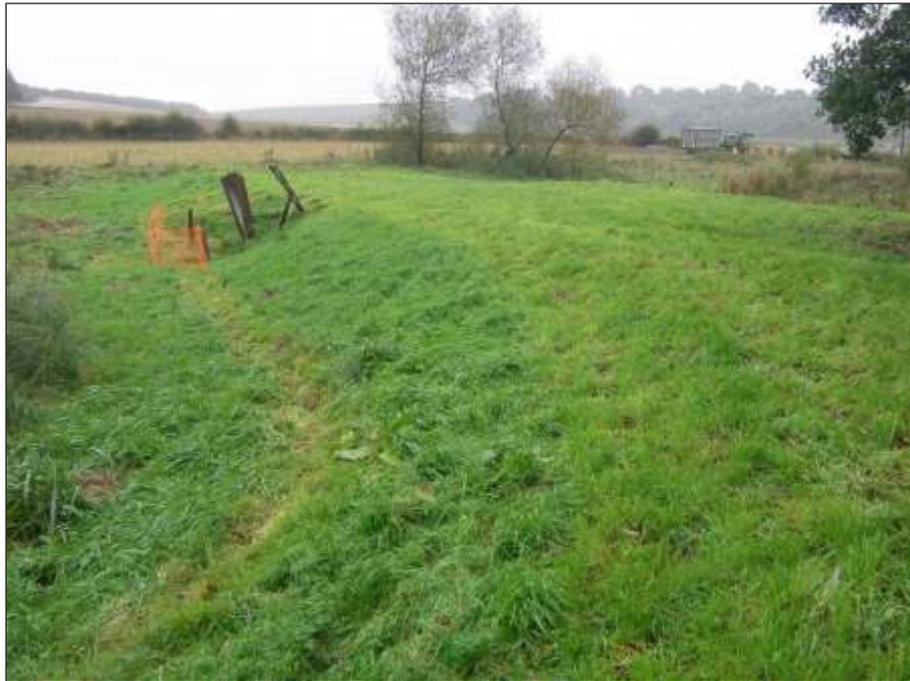
river bank and a small water channel, which was linked via a 1.4m wide brick-lined culvert **Figure 1**. When first viewed in October 2014 the levee and culvert appeared to be in good condition and functioning (**Plates 17-18**). A photograph taken by the Environment Agency on the 29/10/14 (**Plate 19**), shows the interior of the culvert partially filled with water. A deposit of soil/material on the left side of the culvert suggests that the brick vault may have partially failed in this area.

Plate 17: Entrance of culvert viewed from the south

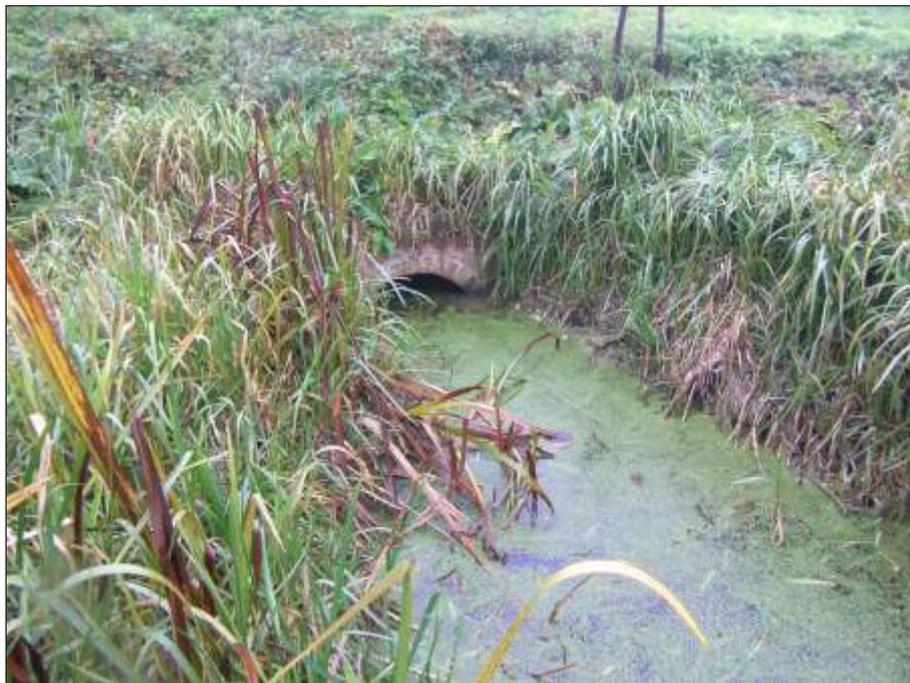
- 4.2.5 With the exception of its length and width (approximately 15m x 1.4m) details of the culvert construction and profile could not be recorded *in-situ* due to the flooded conditions at the time of works (**Plate 22**), however, the earlier interior photographs (**Plates 18-19**) indicate that top of the culvert was barrel vaulted.

Plate 18: Southeast end of culvert (submerged, view from the north-west) unmonitored landscaping works in the background

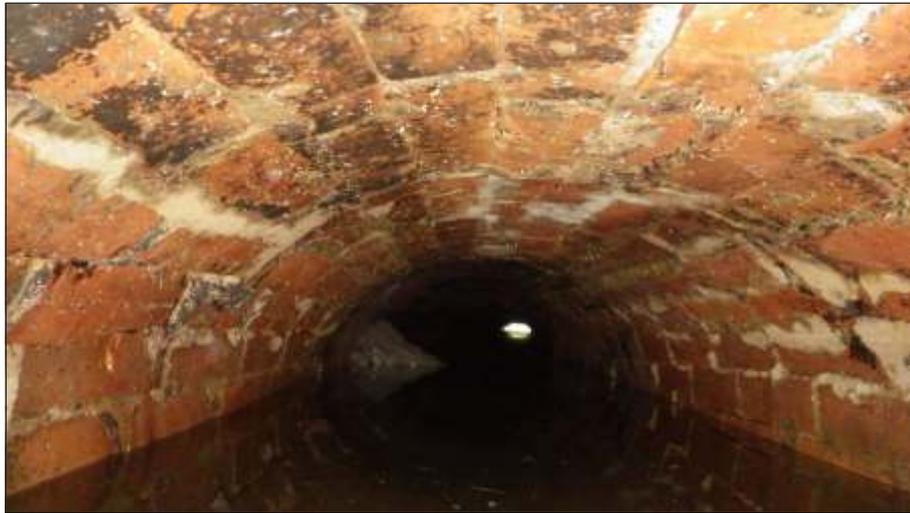
Plate 19: Interior of the culvert showing brick vault

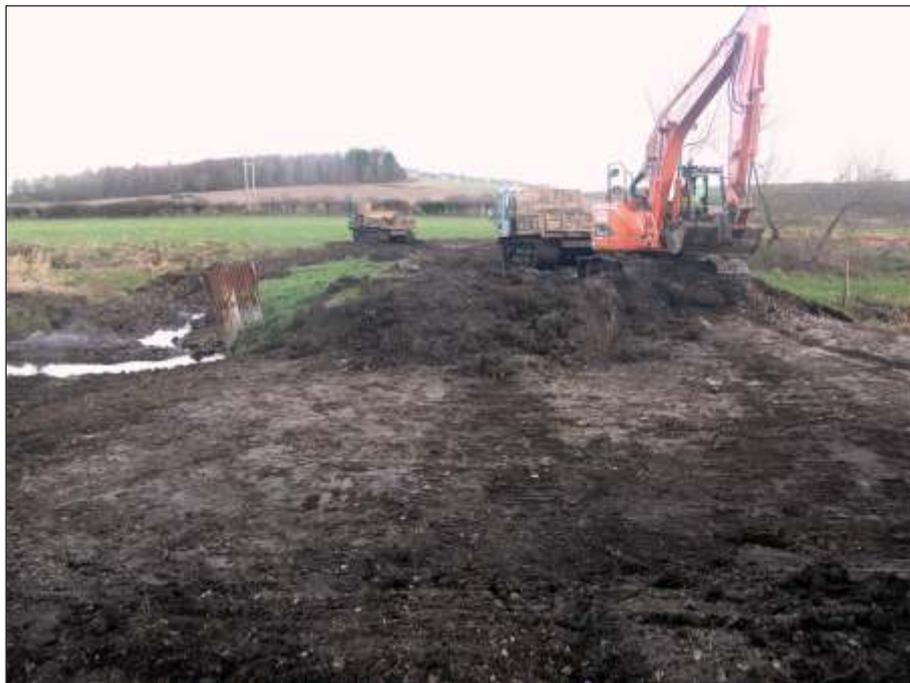
Plate 20: Levee construction material revealed after topsoil strip, (viewed from the southwest) with rubble made ground material on the edge to the left and chalk made ground material on the edge to the right

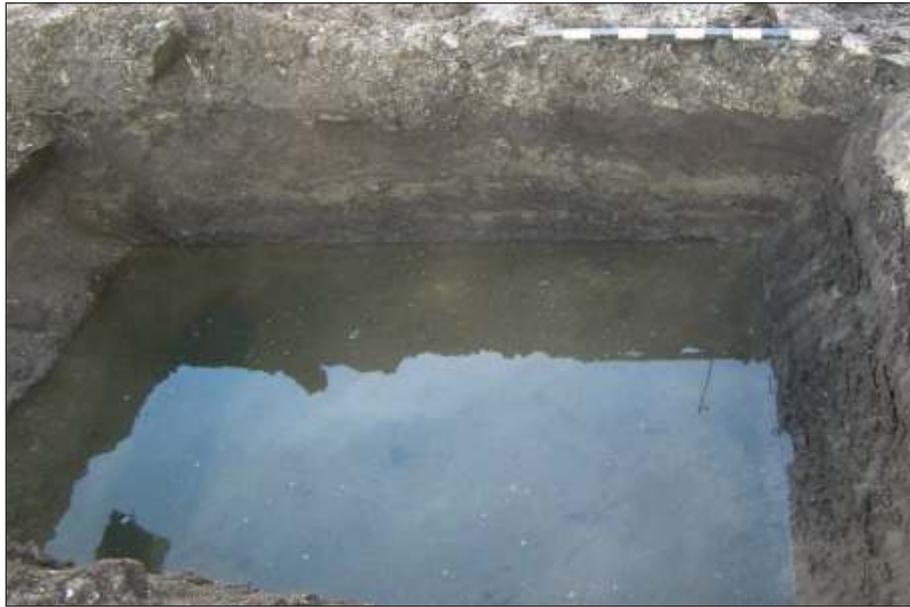
Plate 21: Representative levee construction section trench with submerged culvert to the left

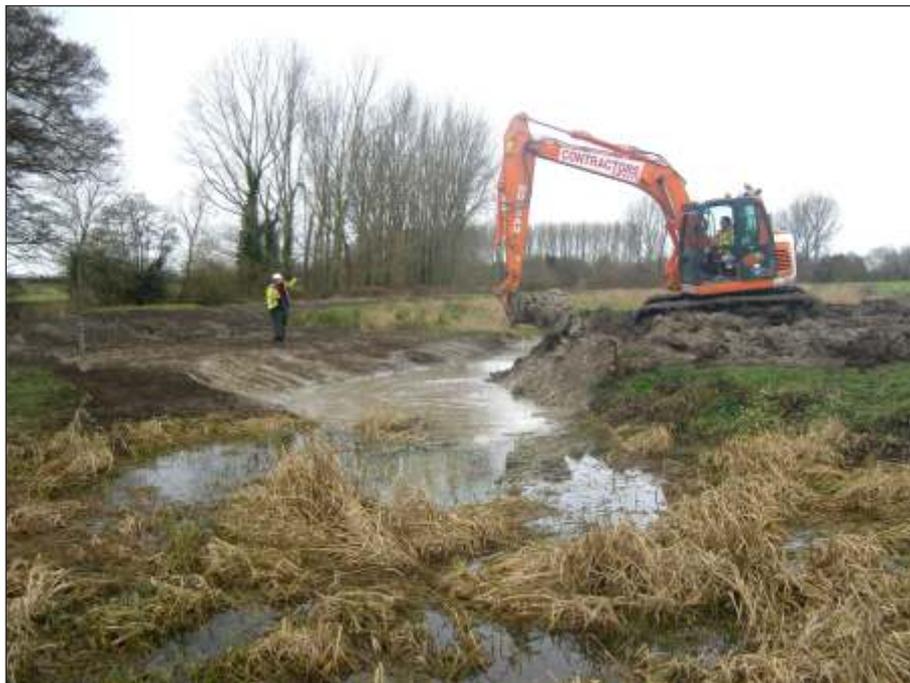
Plate 22: Removal of levee material works prior to culvert removal. View from the south-east

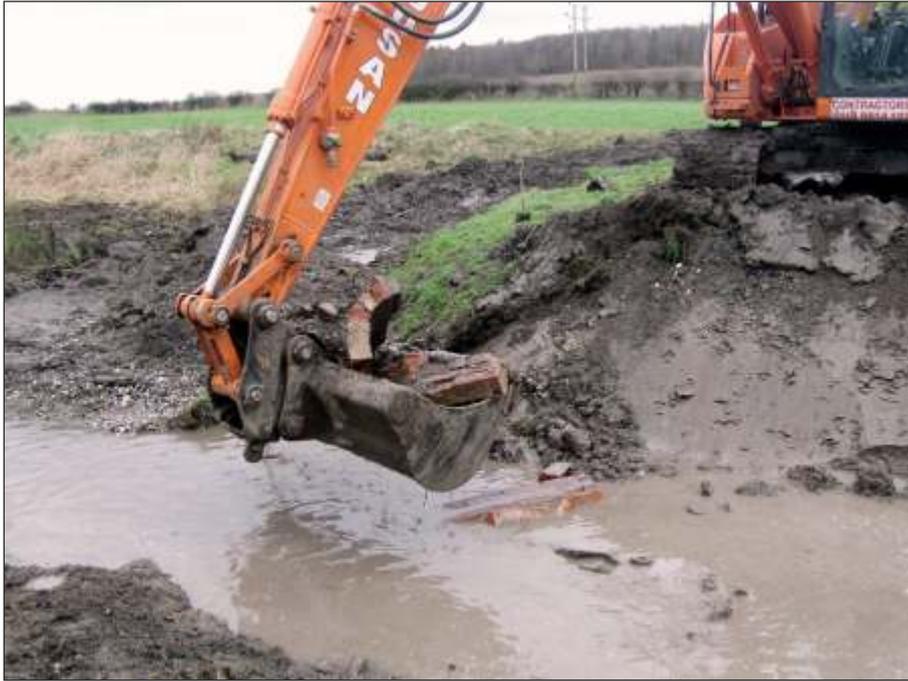
- 4.2.6 The demolition of the culvert was monitored (**Plate 23**) and a representative sample of brick and mortar and possible stone foundation material was retrieved for analysis. This comprised of hard, un-frogged red bricks measuring 23cm x 11cm x 8cm bonded by a pale, coarse, cementitious mortar containing sub-angular inclusions. It appears from the brick and mortar analysis that the brick is likely to be of late 19th – 20th century date. It is not known if the fragment of rubble limestone is related to the structure.

Plate 23: Culvert removal in progress and brick construction detail
