**BRITNED PROTOCOL IMPLEMENTATION**

**Archaeological Evaluation of a Previously Unreported Wreck at KP~121.910**

**Report Ref: 64496.03**

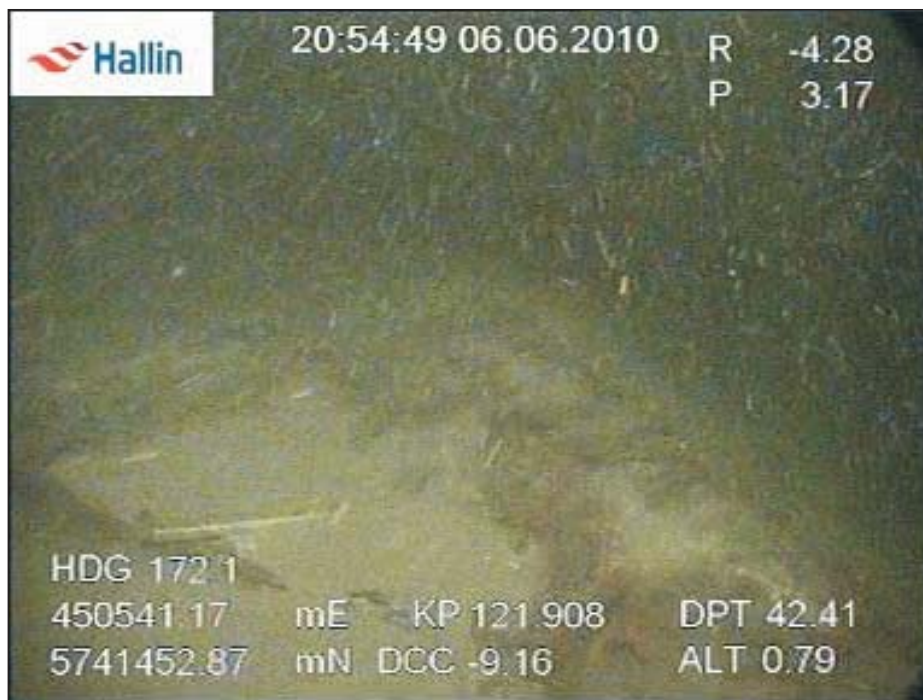
- 4.2.6 Although both ends of the wreck are obscured, making it difficult to determine which end is the bow, the north-western end of the wreck appears to be formed by a gradual tapering of the port and starboard sides, and the rounded-point at the tip, although covered by a mound of sand, suggests that this is the bow. The port side of the bow was obscured by sand, nets and marine growth, making the exact shape of the bow indistinct. There are no clear video stills that illustrate the NW tip or the mound of sediment, however, **Plate 1** illustrates a view from the bow looking south-east over the starboard side of the wreck, and demonstrates its V-shape and suggests the curvature of the hull.

Plate 1: The bow – at the NW end of wreck

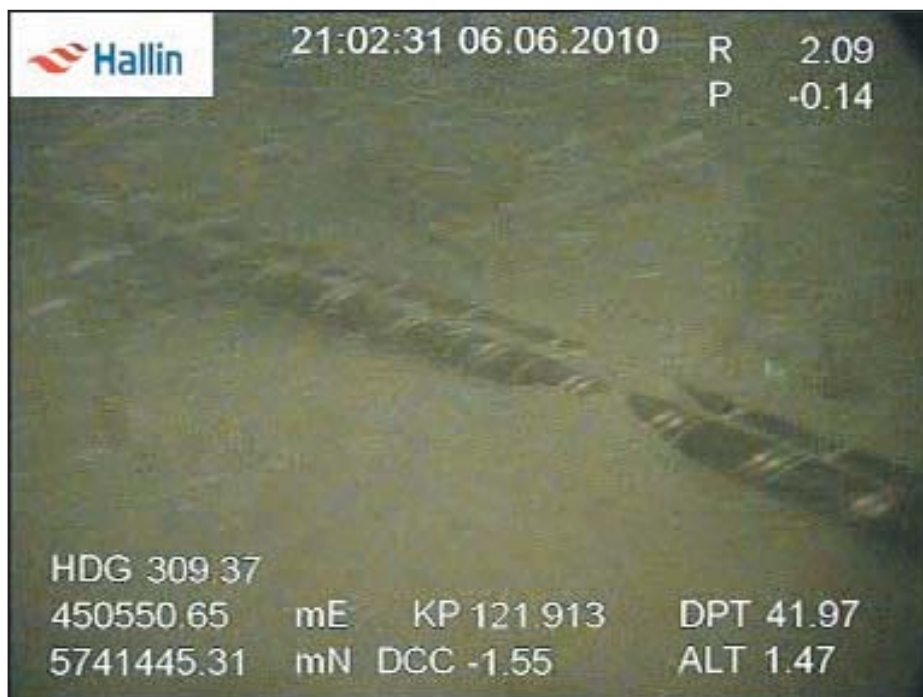
- 4.2.7 The south-eastern end of the wreck, probably the stern, is illustrated in **Plate 2**. On the starboard side, the side of the hull is broken outwards – and the broken end terminates to the north of the cable. On the port side of the wreck, the side of the hull continues under the cable, but is obscured by sediment. Although the wreck could continue for some distance under the sediment, the two ends appear to be tapering towards each other, suggesting that the cable crosses relatively near the south-eastern end of the wreck. There is not enough information to determine the shape of the stern – it could have formed a rounded point similar to the shape of the bow, or the vessel could have had a transom stern.

Plate 2: The stern – at the SE end of the wreck – note hull sides tapering together

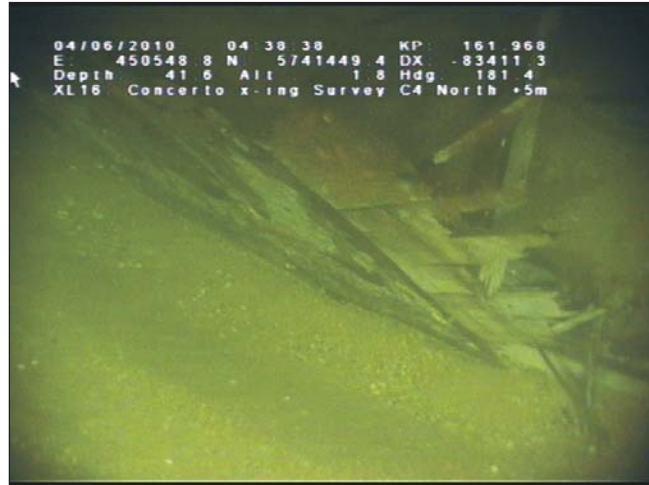
- 4.2.12 It is possible that iron/metal fittings were used as supports or knees, as they appear to be visible in **Plates 3** and **6**.
- 4.2.13 **Plates 7** to **10** show the starboard side of the hull, to the north-west of the area of upstanding structure (**Plates 4** to **6**). In addition to illustrating the damaged nature of the hull, these photographs appear to show protective sheathing, or possibly paint, separating from the timber.

Plate 3: Debris at KP 121.906-05 (from Island Pioneer) - section of hull - probably on the north side of the wreck

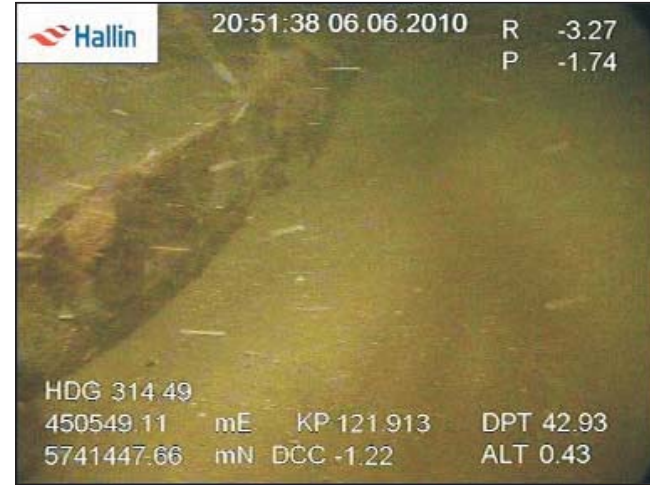
Plate 4: View of starboard side of hull, facing NW (from outside of the wreck)

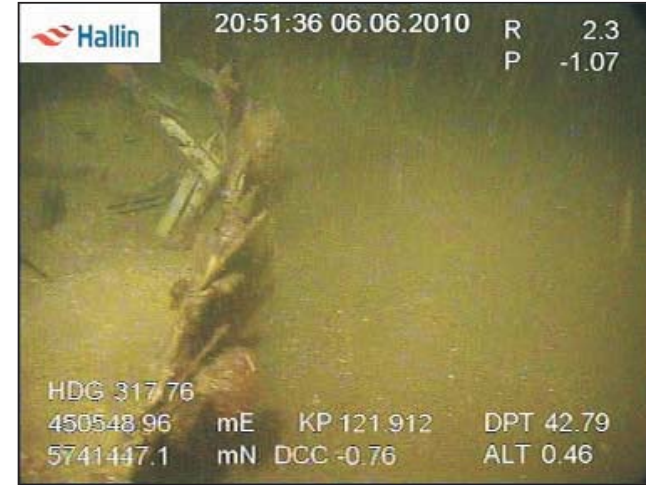
Plate 5: View of starboard side of hull - facing NW - note light build

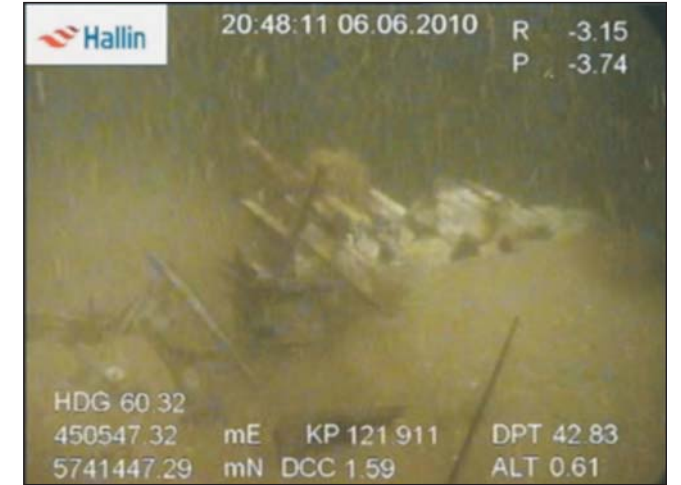
Plate 6: View of starboard side of hull from the inside of the wreck, facing NE

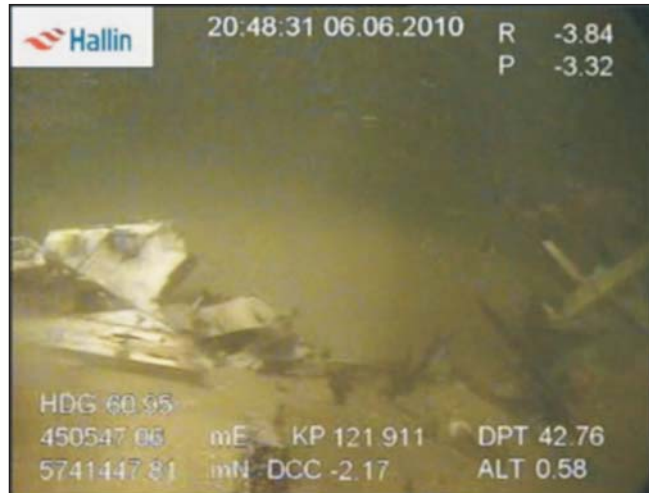
Plate 7: Immediately NW of Plate 6 - view of starboard side of hull, facing NE

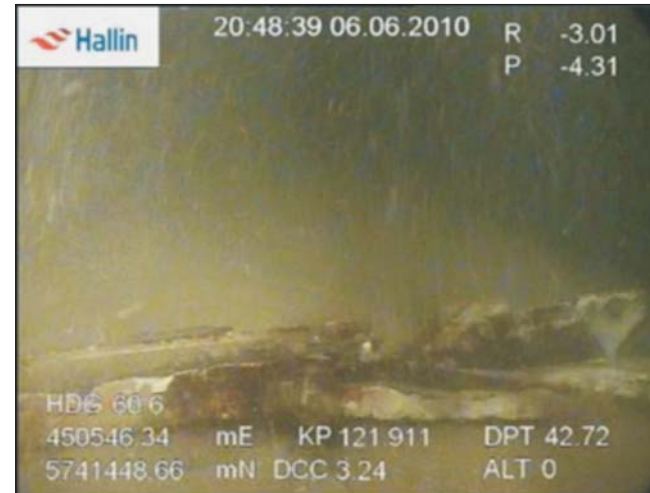
Plate 8: Immediately NW of Plate 7 - view of starboard side of hull, facing NE - note sheathing

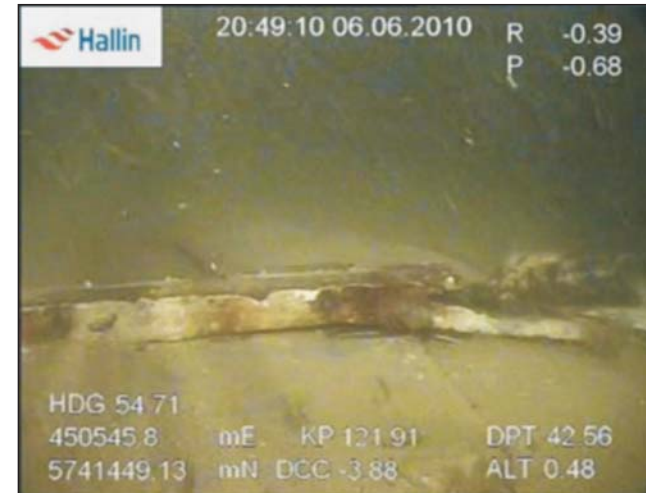
Plate 9: Immediately NW of Plate 8 - view of starboard side of hull, facing NE

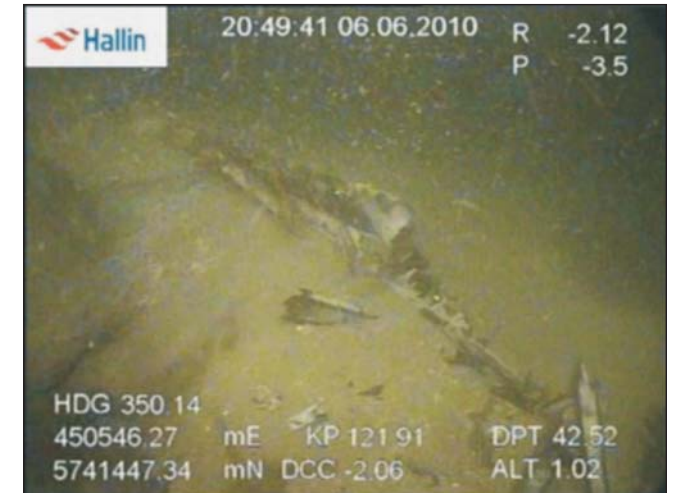
Plate 10: View looking NNW at starboard side of hull

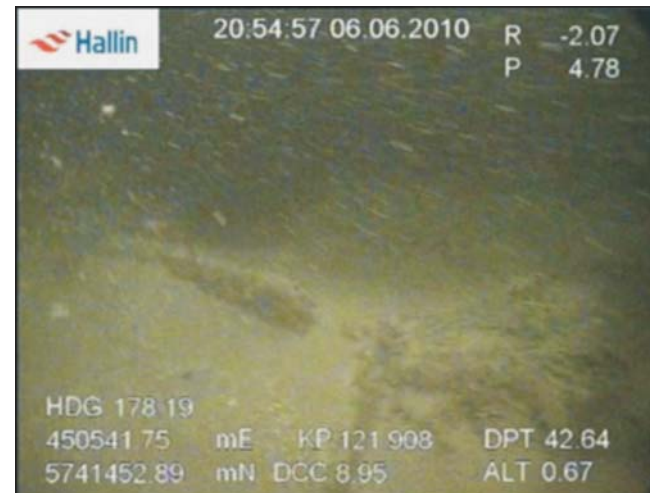
- 4.2.15 The starboard side of the vessel near the bow is illustrated by **Plates 11** and **12**, taken facing south-east. In addition to showing the line of the hull, they illustrate where sections of the hull are dislocated, with timbers laying at different angles to the hull.

Plate 11: View of starboard side of hull, facing south

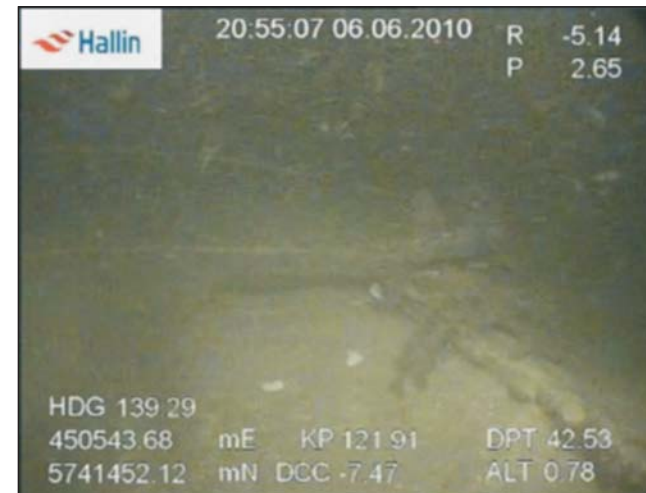
Plate 12: View of starboard side of hull - near NW end - facing SE - note dislocated timber extending from side of wreck

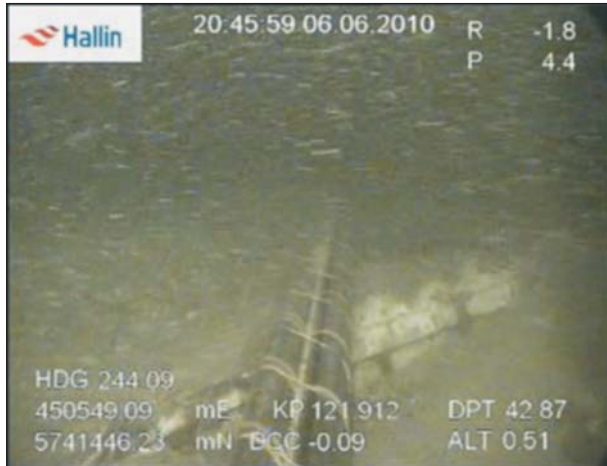
Plate 13: View of port side of hull, facing WSW

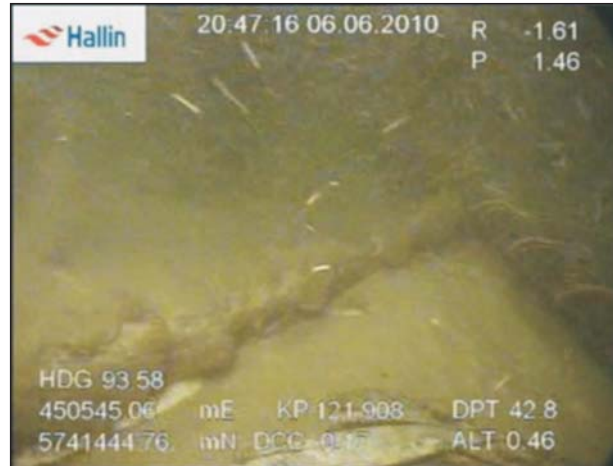
Plate 14: View of port side of hull, facing east (back side of Plate 13 – note light build)

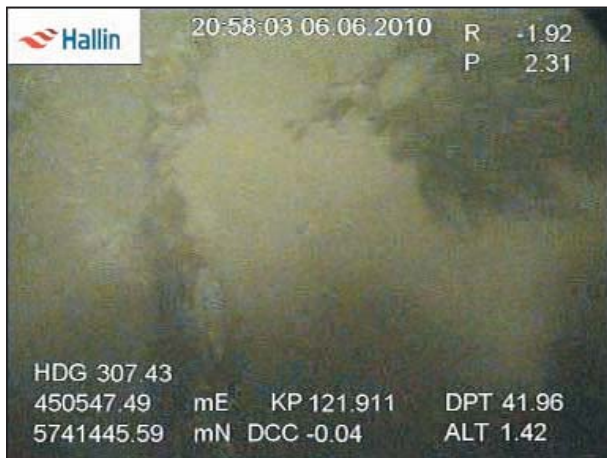
Plate 15: View of port side of hull (NW of Plate 13), facing NW

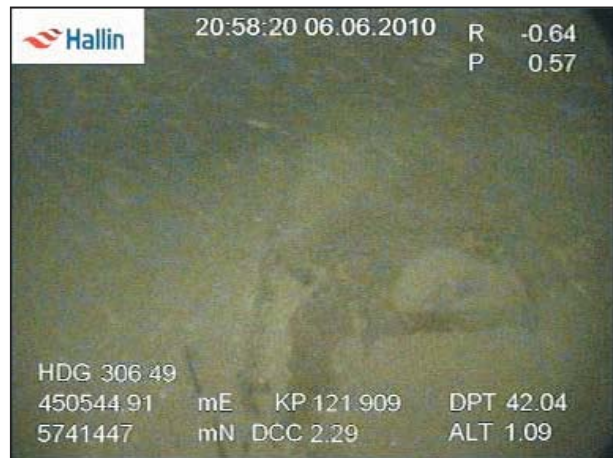
Plate 16: View of port side of hull (NW of Plate 15), facing NW

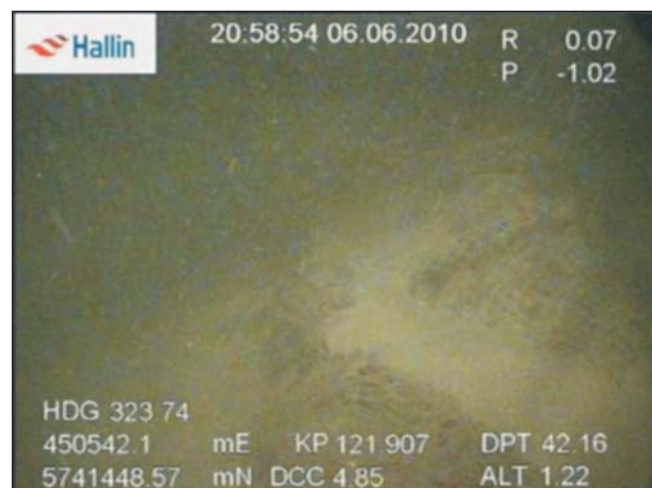
Plate 17: Example of nets covering wreck

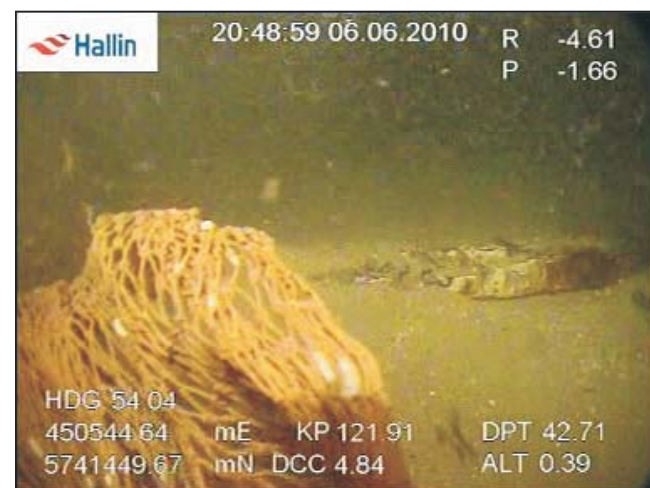
Plate 18: Modern nets covering wreck

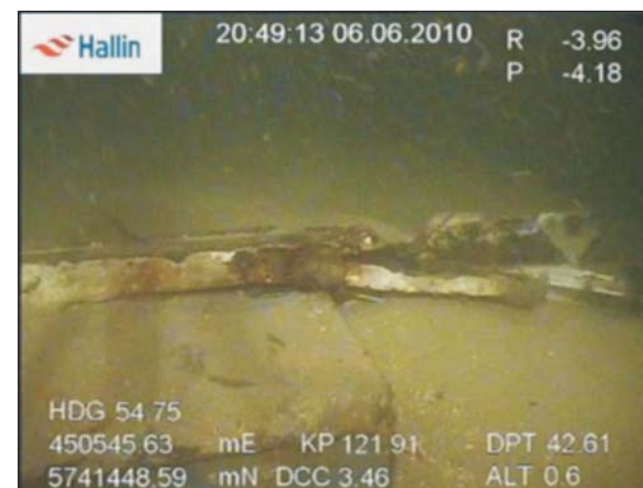
- 4.2.20 A box or chest was located inside the wreck, against the north (starboard) side of the hull (**Plate 19** and **20**). It is unknown what the box was made of. Although it could be a made of metal, its pitted appearance suggests stone or concrete, whereas the rounded edges might suggest it was made of wood. The box measured approximately 1m long (north-west/south-east) by at least 50-70cm wide, and at least 20-40cm tall. The purpose of the box is unknown, and although possible explanations for using a stone or concrete box in a boat of this size would be for balance or to set the engine in, this type of box or weight would usually be positioned along the keel line, not butted up against the side of the hull.

Plate 19: Box or chest on north side of wreck

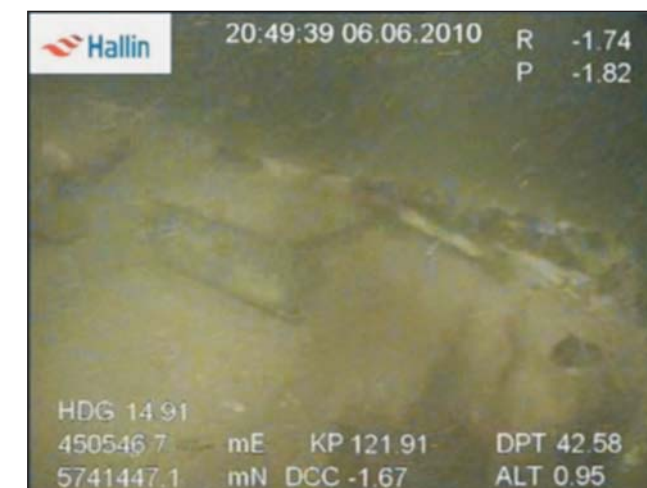
Plate 20: Second view of metal or stone box on north side of wreck

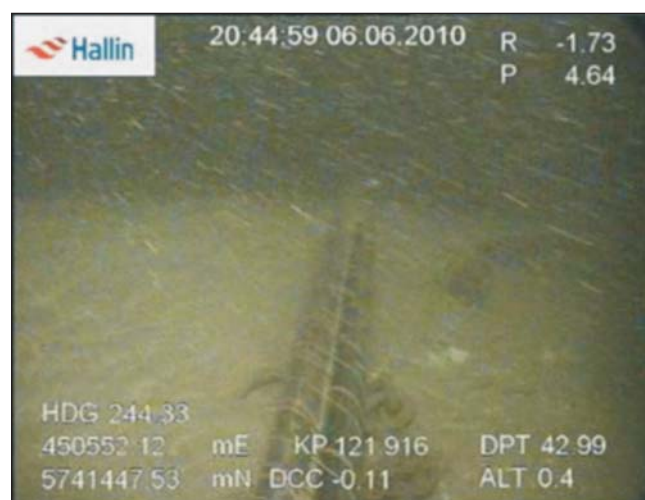
- 4.2.22 A small section of chain that appeared to be fairly modern was located to the east of the stern (**Plate 21**).
- 4.2.23 Photographs from the 4 June 2010 TSV *Island Pioneer* survey show an area of metal debris and possible ship fittings (**Plate 22**). The positioning details of the photograph locate the material immediately to the north-west of the box, however this material was not re-discovered during the 6 June 2010 survey, possibly suggesting that it was obscured by nets or rope. It was not possible to identify the material from the photograph, although it appeared to be relatively modern.
- 4.2.24 Additional modern material was identified during the 6 June 2010 survey, and it was located near the stern of the vessel (**Plate 23**). It appears to consist of possibly rubber or metal hoses/cables/tubing and associated metal, rope and net debris.

Plate 21: Chain under cable

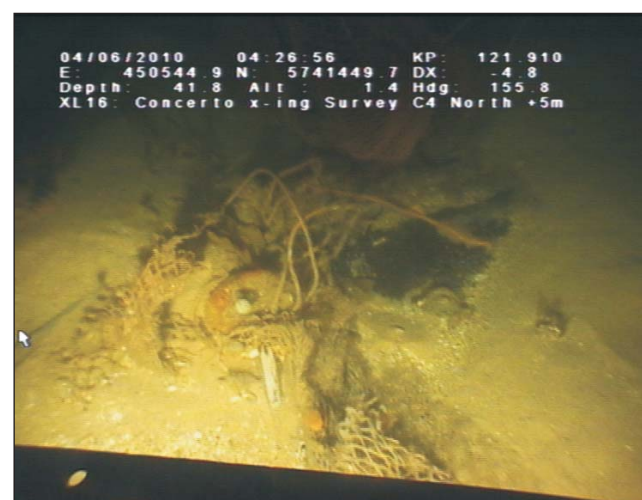
Plate 22: Debris at KP 121.906-02 (from Island Pioneer) – possible fittings or fastenings

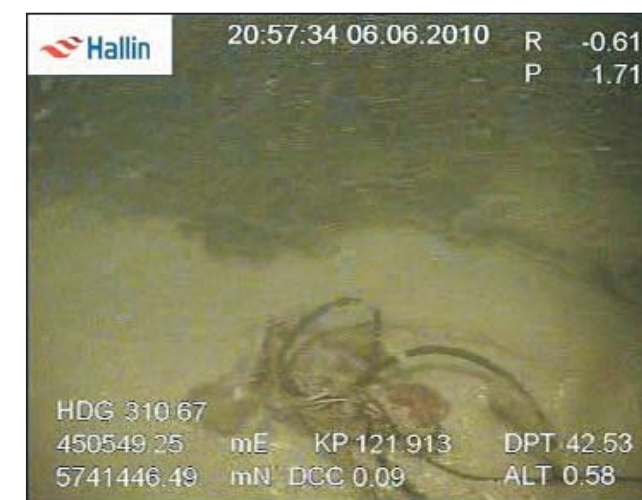
Plate 23: Debris within wreck – possible metal or rubber tubing, rope and netting
