# NURSERY STREET, SHEFFIELD, SOUTH YORKSHIRE

Archaeological Watching Brief

Ref: 73254.03 October 2012

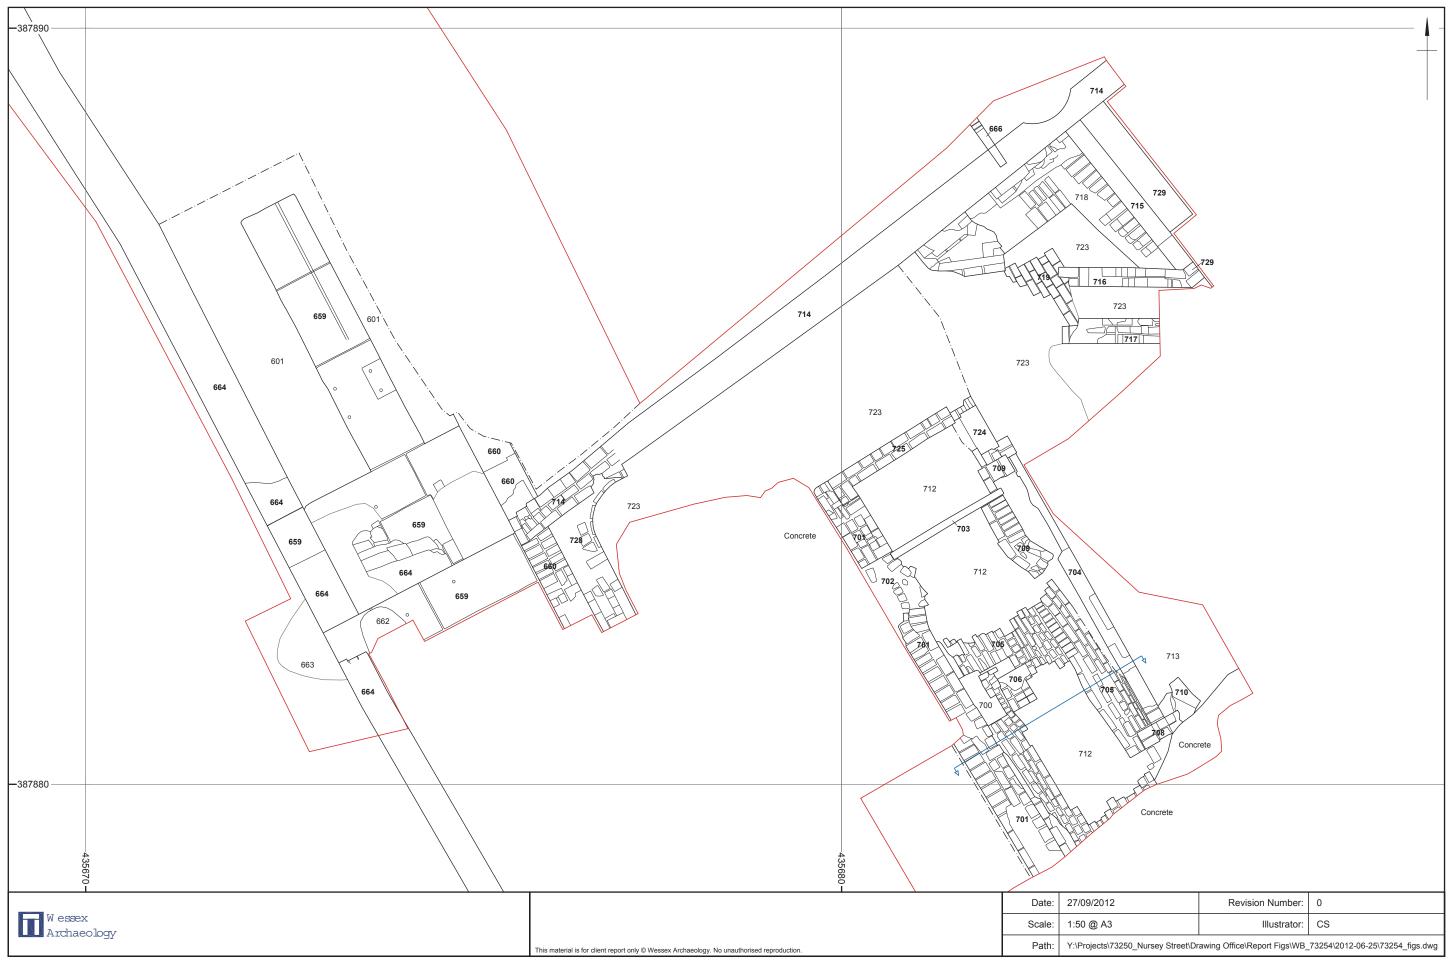
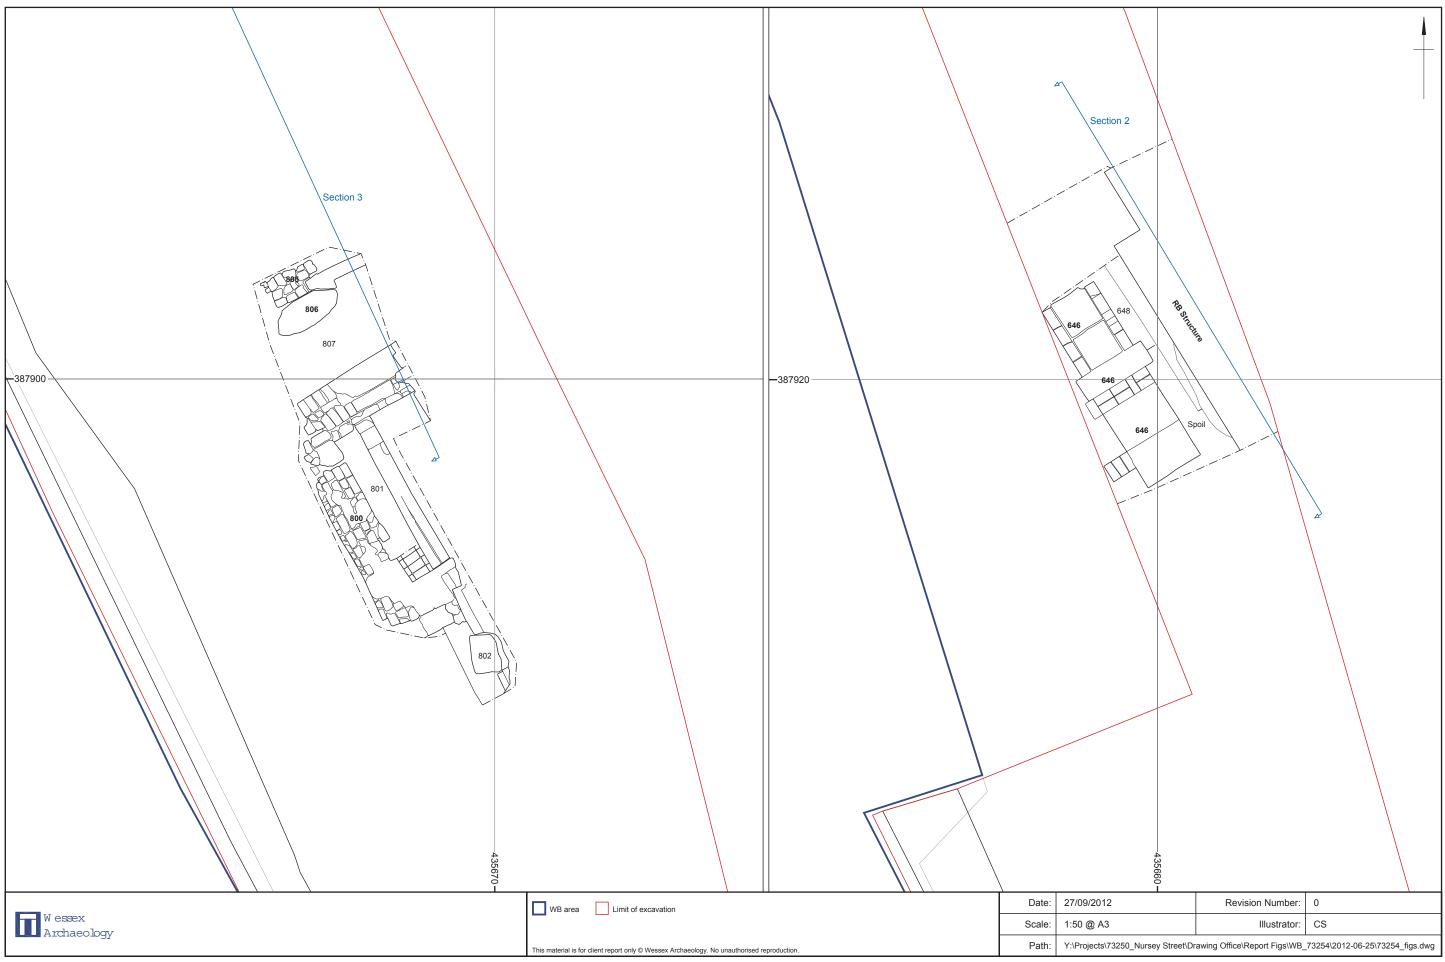
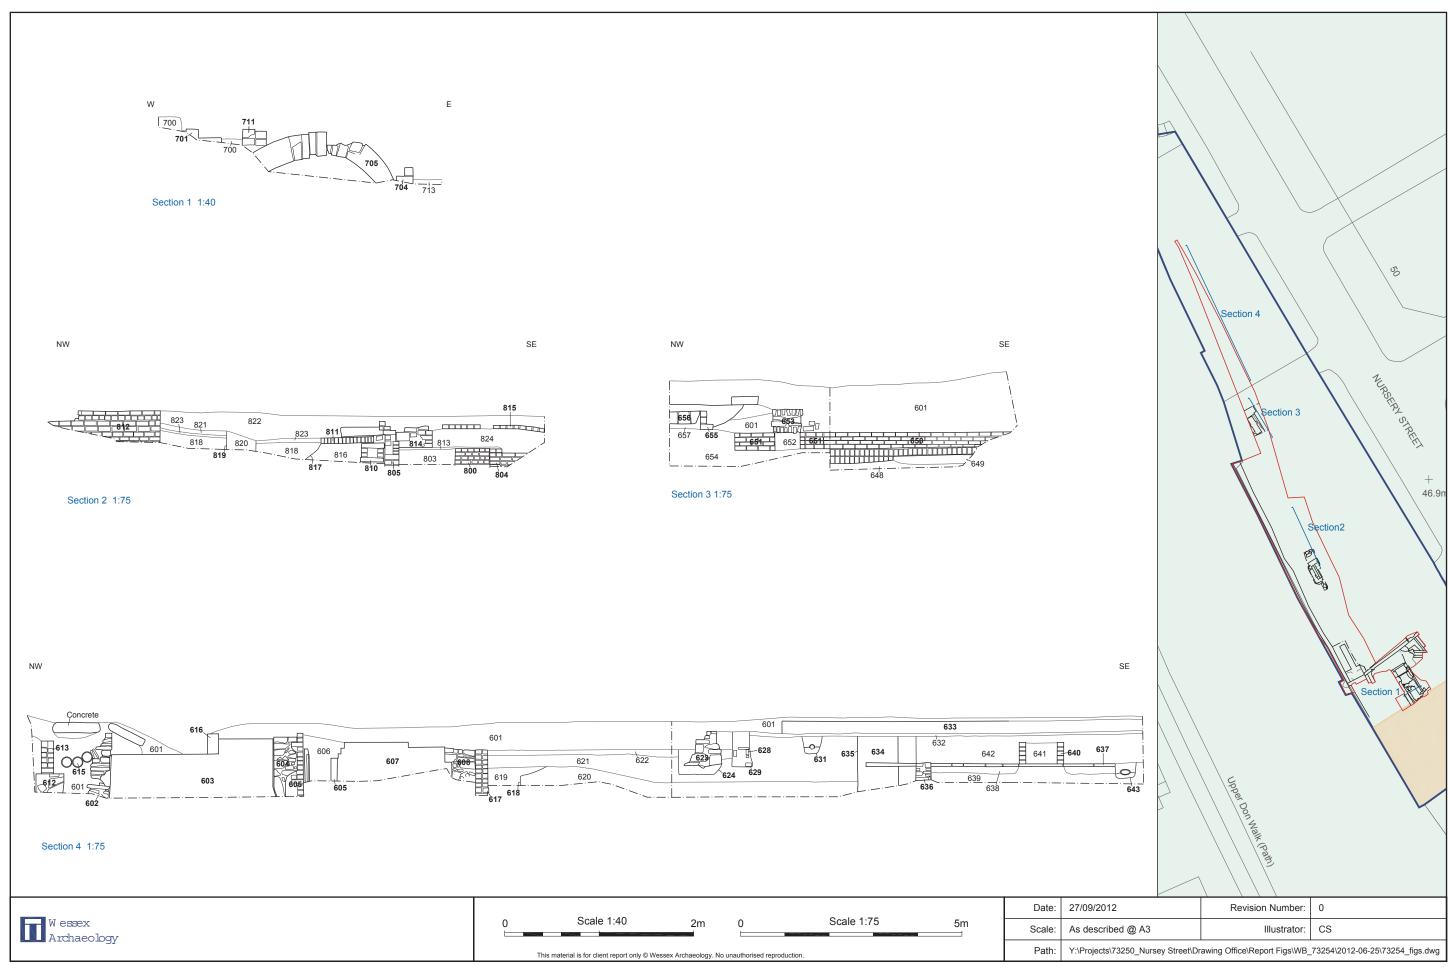
Sections Figure 6

- 4.4.6 Immediately east of this, a number of brick structures were seen in section (Figure 6, Plate 11). These included two northwest to southeast running walls (650 and 651) constructed in handmade brick and bonded with a sandy lime mortar. An opening 652 in wall 651, possibly a drain or a flue, was covered with a loose sandstone and redbrick structure 653. Remnants of sandstone set floor surface 656 were observed in section.

- 4.5.1 A number of walls were identified in section approximately 4m east of the riverbank at the northern end of site (**Figure 6**). The southern part of this section corresponded with the previously excavated Evaluation Trench 5, and the northern part of this section with the previously excavated Evaluation Trench 4 (**Figure 1**).

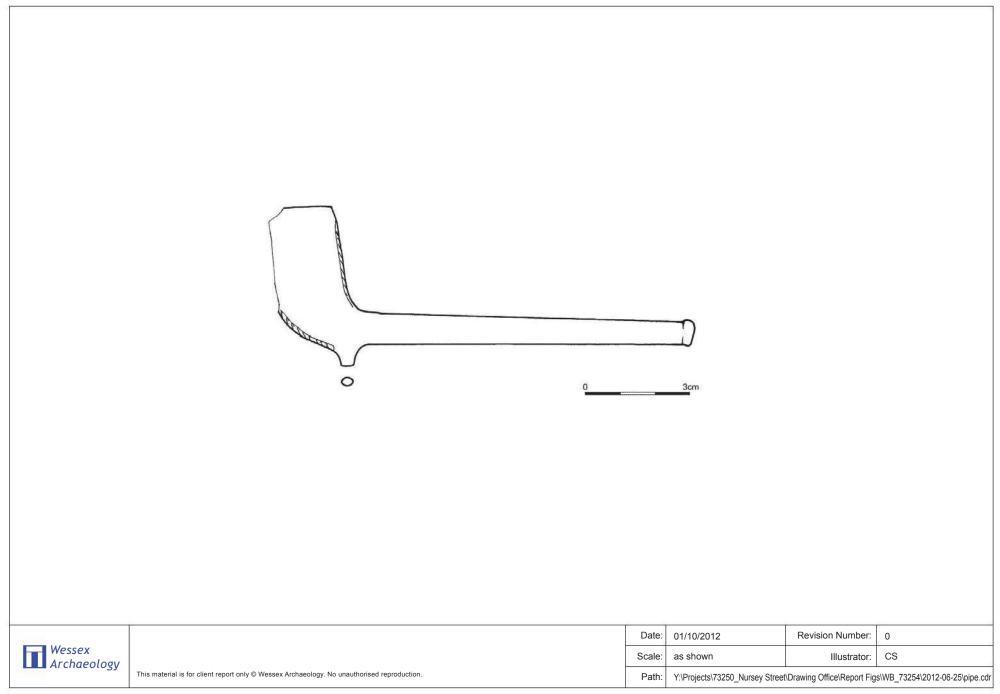
- 5.2.1 A single clay tobacco 'cutty' pipe was recovered from context **714** (**Figure 7**).
- 5.2.2 The 19<sup>th</sup> century witnessed a shift from the longer stemmed pipes of the first half of the century to the shorter stemmed "cutty" pipes with a nipple mouthpiece that because popular from about 1850. This particular pipe is a typical cutty style pipe with a plain spur, nipple mouthpiece, cut rim with a simple ribbon decoration on both seams. This style of ribbon decoration was a feature of the later nineteenth century and would place the pipe within the date range of 1870-1920.

- 5.2.4 The pipe from Nursery Street is a good example of a standard cutty style pipe that would have been in common production and usage at the end of the 19<sup>th</sup> or early 20<sup>th</sup> century.

Clay Pipe recovered from **714**.

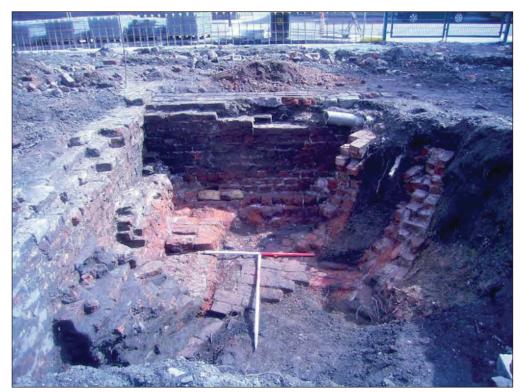
4.3.1 The southern area was dominated by a large basement area encompassing a flue (**Plate 1**; **Figure 4**), vaulted basement passage (**Plate 2**) and steam engine boiler base (**Plate 3**) northwest of the area of known crucible cellars. The cellared area is shaded yellow on the 1896 Goad Fire Insurance plan (**Figures 2 and 3**) and the structures identified correlate well with those marked on the Goad plan.

- 4.3.3 The original construction appears to have included the eastern section of wall **714** and wall **715**, which abutted it. These sections were constructed of lime mortared handmade red bricks. Within wall **714** was an almost complete clay tobacco pipe dating to 1870-1920 (see Section 5.2 below; **Figure 7**). Later the western section of **714** and **660** appear to have been repaired or replaced in black ash mortar brick.

Plate 1: Northeast corner **714/745**, lasouthern area, looking east.

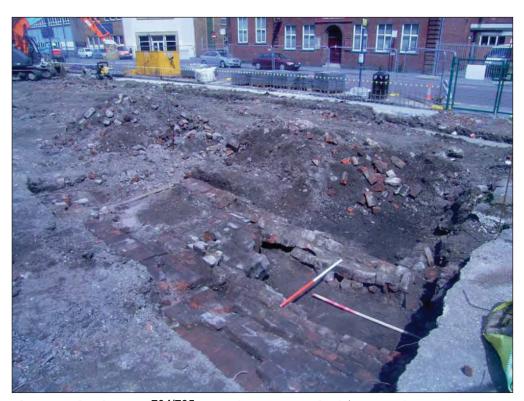
- 4.3.7 A vaulted red brick structure **704/705** was encountered northwest of the known area of crucible cellars (**Figures 4, Plate 2**). The vaulted structure is in the same position as basement annotated 'Bast.' within the Nursery Wire Works on the 1896 Goad Fire Insurance Plan, between a chimney to the northeast and a steam engine boiler to the southwest (**Figures 2** and **3**). It seems likely that the basement formed a passage between the furnace cellars and the steam engine and chimney base.

- 4.3.8 At least three phases of construction were observed in the vaulted structure. The original structure ran northwest to southeast and was constructed of handmade lime mortared bricks. A parallel wall, below the line of the later phase wall **701**, presumably lay 2m to the west and formed the western side of the structure. The vaulted roof **705** (Section 1, **Figure 6**) was extant over a little more than half of the total structure. There were also traces of an east to west wall **708** and a sandstone surface **710** at the south end of **704** although these were truncated by a modern drain.

Plate 2auTted Struc704605, southern area, looking northeast.

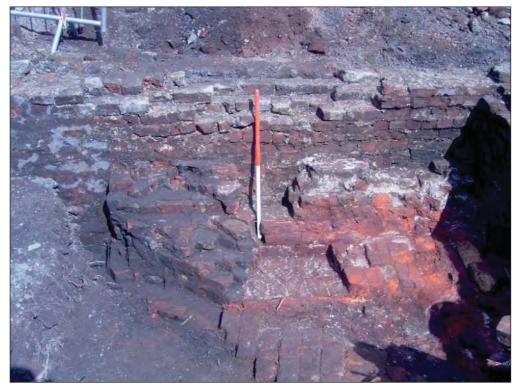
- 4.3.6 A black ash mortar alteration **720** was observed in the southern side of wall **714** and west of **718** (**Plate 3**). The alteration appears to have been part of major structural alterations along probably associated with repair of the flue where exhaust gasses were being channelled from the southwest along wall **714**.

Plate 3: Black ash mortar **320**ersbitchern area, looking northwest.

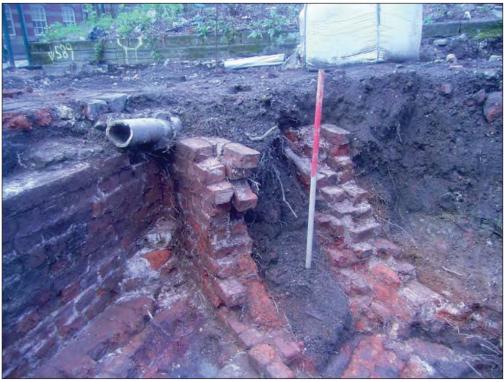
- 4.3.5 Foundation **718** and external wall **715** were truncated by a flue **716/717** running east to west (**Plate 3**) through **715**. The position of the flue, if not its alignment, corresponds to a feature annotated 'Flue' on the Goad plan (**Figure 2**) and probably carried hot exhaust gases from the steam engine boiler to the southwest, to the chimney to the northeast. The flue was constructed of two parallel lime-mortared, handmade red brick walls, identical in materials and bonding agent to walls **714** and **715**. The walls were heat damaged with discoloured mortar and degraded bricks. A red brick surface (**719**) formed the floor of the cellared area.

Plate 4: Detail 716/717 within cellbooking southeast.

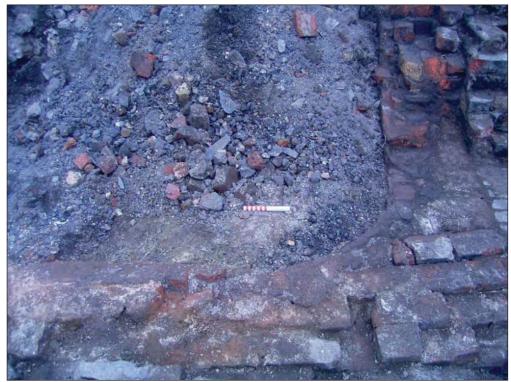
4.3.11 Immediately southeast of the junction of walls 660 and 714 was wall 728, constructed of handmade redbricks and bonded with black ash mortar, similar to 720 to the east. The structure ran parallel to walls 714 and 660, with the inside edge curving through 90° (Plate 5). The wall's position encloses the steam engine boiler shown as a rectangular hatched area on the 1896 Goad plan (Figures 2 and 3). The boiler base lay southwest of the vaulted passage 704/705, and was almost certainly connected to the flue 716/717 to the northeast, along wall 714.

Plate 5: Curve of 28 allooking southeast.

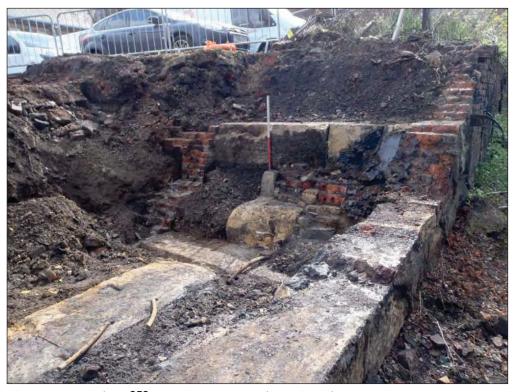
West of the junction of walls 714 and 660, and keyed in to riverside wall 664, 4.3.12 was a substantial sandstone machine base 659 (Figure 4, Plate 6). The location of the machine base lies close to the position of a steam engine, annotated 'ENG', on the 1896 Goad plan (Figures 2 and 3) to the immediate southeast. A number of ferrous pins, presumably for locating overlying machinery, were set into the sandstone blocks. The large rectangular blocks were bonded with a lime mortar. It seems likely that the engine itself would have been powering machinery within the Wire Works and that the machine base was part of the power transfer from the engine into the building to the northeast. A tar-like material (663, Plate 7) was observed on the river bank and on the exterior of the building, adjacent to the machine base. This may represent lubricant or fuel which dripped from the machine during usage. A later repair 661, in black ash mortar, lay immediately west of the junction of walls 714 and 660. This may have been a continuation of wall 714 to the west.

Plate 6: Machine **659** south part of Site, looking southeast.

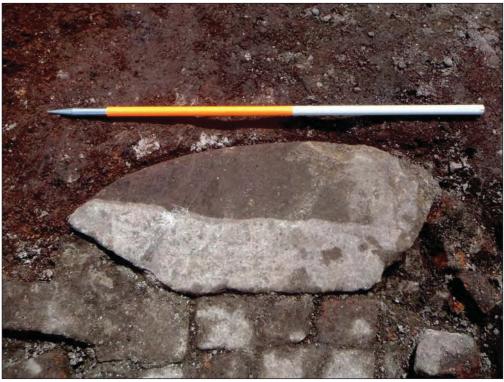
- 4.4.3 North of **800** was northeast to southwest running redbrick wall **805** with a step on the southern side utilising a fragment from a reused grindstone **806** (**Plate 9**). The grindstone would have been approximately 1.5m in diameter when whole. Approximately 4.5m north of **805** was northwest-southeast redbrick wall **812** bonded with black ash mortar. The area between walls **805** and **812** contained northeast to southwest running drain **810**, with sandstone base and capping, and remnants of redbrick floor **811**.

Plate 9: Grindstone reused 806, steptral riverside area.

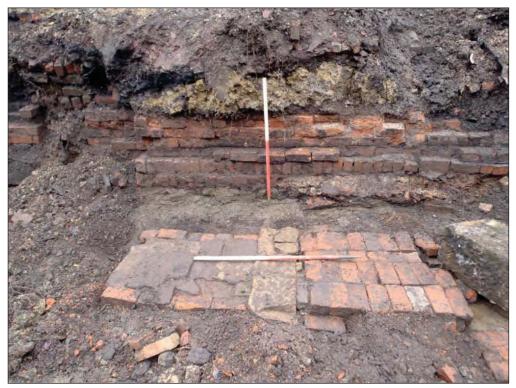
- 4.4.5 Further to the northwest, adjacent to the river and just above water level, a redbrick and sandstone foundation (646) was identified (Plate 10). The foundation was constructed of loose handmade red bricks separated in the middle by a rectangular sandstone block, possibly a step. There appeared to be no mortar within the structure itself, although black ash mortar had been added to the surface of the bricks to the north. The foundation was set on ash bedding deposit 647.

Plate 10: Founda646pn central riverside area, looking northeast.

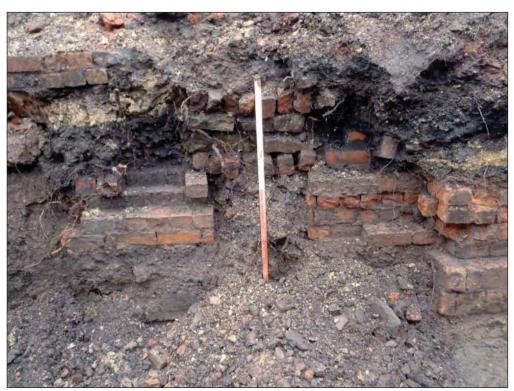
${\tt Plate11~Structures~in~section,~central~riverside~area,~looking~northeast.}$

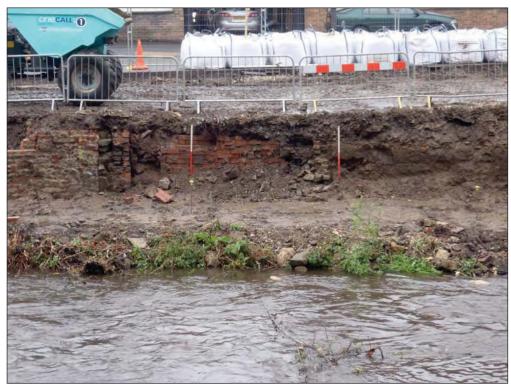
- 4.5.4 At the northern extent of this section were a complex series of sandstone and brick wall foundations, which had been subject to 20th century alterations (Figure 6; Plate 12). The foundations were difficult to interpret with any certainty given the limited area exposed, and all appear to relate to a single large building shown to the northwest of the site on the Goad 1896 plan (Figure 2). Three northeast to southwest sandstone foundations 608. 604 and 602, bonded with lime mortar, were located approximately 3m apart. Wall 602 is likely the end of wall 405/406 recorded in Evaluation Trench 4 (Wessex Archaeology 2010). Walls 608 and 604 were faced with handmade brick 615 and 607 on their southeast sides and most likely relate to walls 413 and 416 in Evaluation Trench 4 (Wessex Archaeology 2010). A deep cutting 617 to the south of 607 was likely related to the construction of the structures in this area. Northwest of wall 602 was a further sandstone foundation 612 with a handmade brick wall 613 above. Between walls 613 and 602 were three salt glazed pipes 615. Beyond wall 617 to the southeast was a layer of mortar 622, probably associated with brickwork 420 seen in this area in Evaluation Trench 4 (Wessex Archaeology 2010).

- 4.5.5 Modern additions/ repairs included two northwest to southeast machine brick foundations 607 and 603/616, abutting walls 608, 604 and 602 respectively. Similar additions were seen to foundations in Evaluation Trench 4 (Wessex Archaeology 2010). A modern manhole 606 was also inserted between walls 607 and 605.

Plate 12 a M 603 - 608 & 617, northern riverside area, boking northeast.

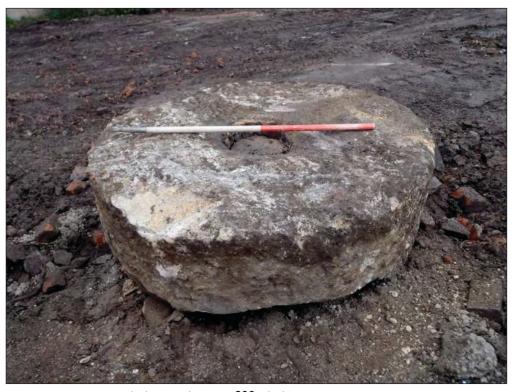
- 5.1.3 From the western part of site, an unstratified glass bottle was recovered by workmen reading "J.W. Wardell/Attercliffe/Sheffield/Trade/Excelsior" and with an image of a flag. Similarly, an unstratified earthenware jug reading "Cheevers/Talbot Mineral Water Works/Montford Road/Sheffield" was noted. A large unstratified 1.5m diameter grindstone, similar in size to re-used stone in step 806, was also recorded (Plate 13). The stone had a circular axle aperture.

Plate 13: Unstratified grindston 206 similar to
