River Avon Restoration Plan, Daslett Farm Hatches

Archaeological Watching Brief Report

**River Avon Restoration Plan
Daslett Farm Hatches
Teffont
Wiltshire**

Archaeological Watching Brief

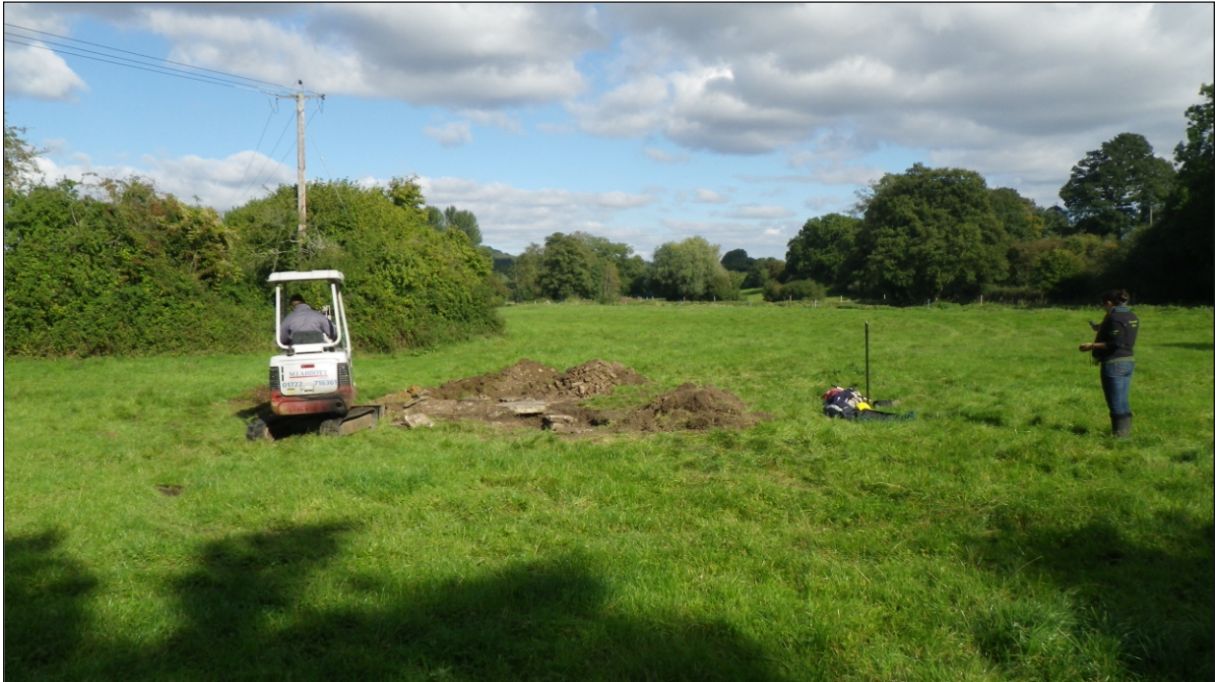
- 4.1.1 The culvert was positioned along the line of the silted up ditch, visible as a slight depression on both sides of the culvert, and on a north-south axis (**Plate 1**). It was constructed from limestone known locally as Teffont rag stone. The British Geological Survey of Great Britain (BGS-on-line) describes the local geology as either the Lulworth Formation or the Durlston Formation. Both are described as sandstone and (subequal/subordinate) Limestone, interbedded. These are sedimentary Bedrock formed in the Cretaceous and Jurassic periods 140 to 151 million BP.

Plate 1: Showing location of culvert in relation to shallow drainage ditch

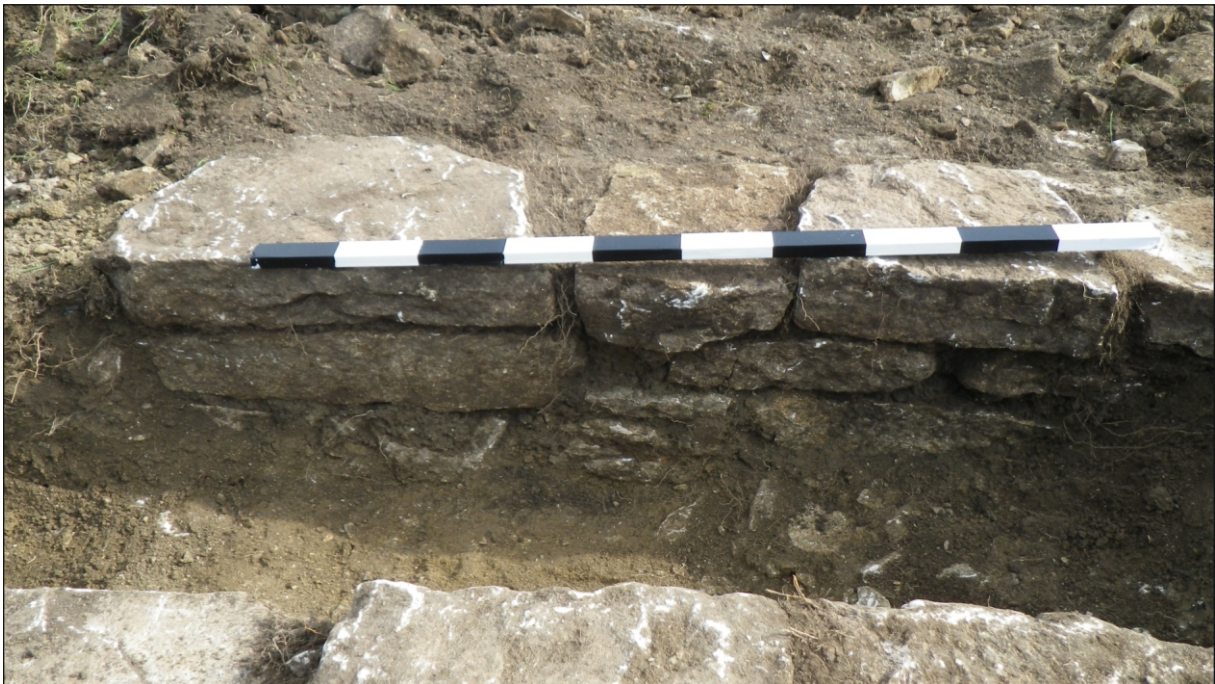
- 4.1.4 The side walls were made of three courses of limestone blocks varying in thickness and laid horizontally (**Plates 2-3**). Some larger blocks appear to have been incorporated, especially at the two ends. The single surviving capping stone was located at the south end of the culvert and was irregular in plan, not squared or tooled. The base of the culvert channel was lined with a single layer of small pieces of limestone. This extended slightly beyond the length of the culvert and is thought to prevent water from under-mining the side walls.

Plate 2: Detail of culvert wall construction. Scale 1m

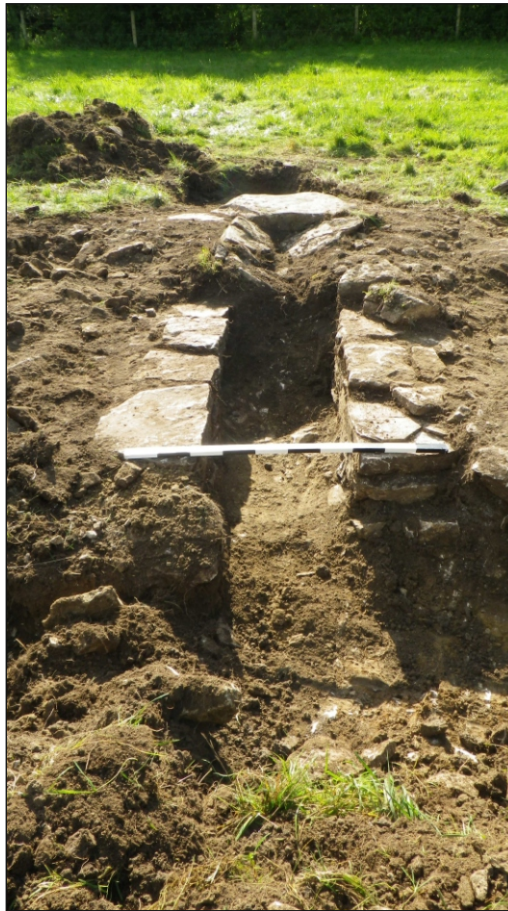
Plate 3: Detail of excavated culvert with capping stones missing. Scale 1m

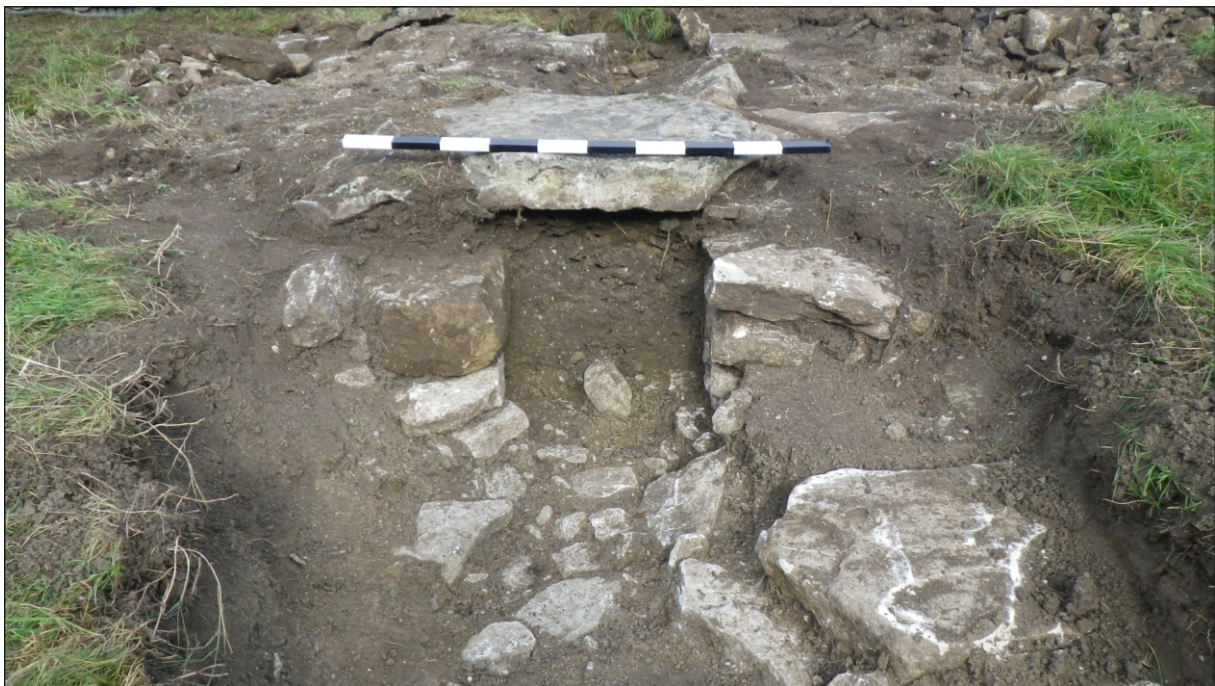
- 4.1.5 A full profile was recorded at the south end (**Plate 4**). From the top of the capping stone to the base of the culvert measured 0.54m. The width of the culvert channel was also 0.54m and the recorded length of the culvert measured 3.67m. It is possible that the culvert originally extended slightly further south as large stones were found to the south-east end of the culvert.

Plate 4: Detail showing culvert profile at south end. Scale 1m

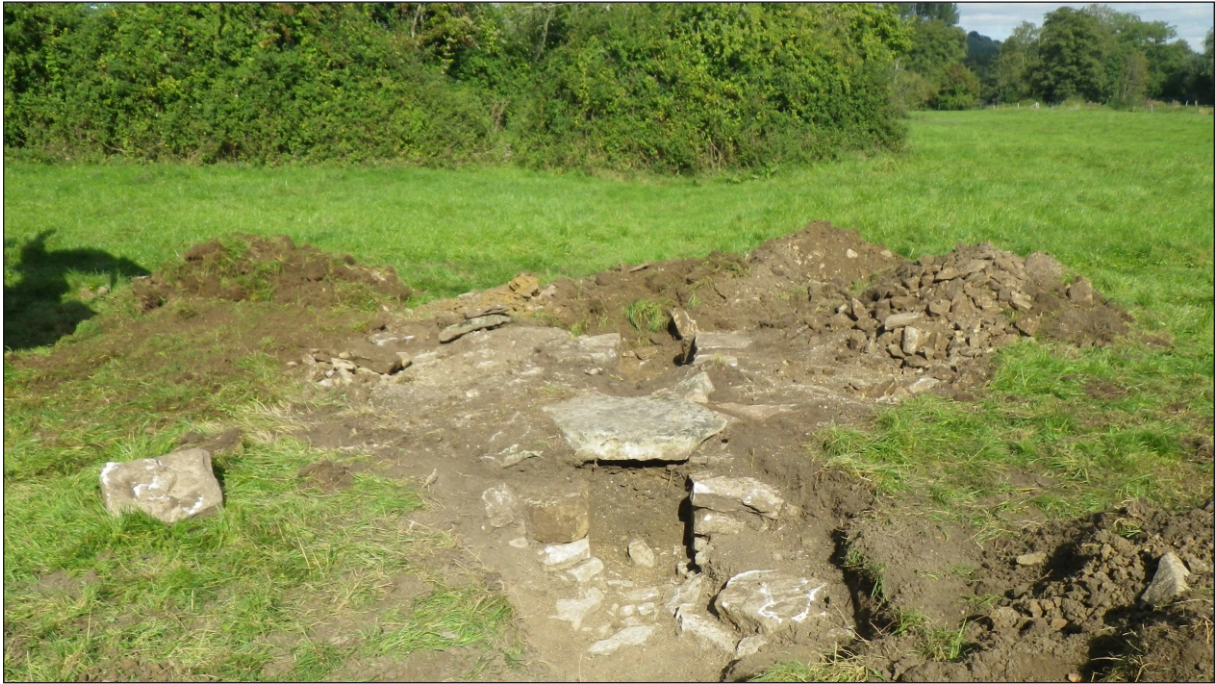
- 4.1.6 To the west and east sides of the capping stones were deposits of broken small pieces of limestone forming metalled surface approaches (**Plate 5**). These deposits are thought to have been placed to protect the flanks of the capping stones and to not erode the sides of the ditch.

Plate 5: Wide angle view from south showing culvert in relation to silted up drainage ditch. Scale 1m
