Bishop's Waltham Palace Bishop's Waltham, Hampshire

Archaeological Watching and Recording Brief

Ref: 108230.02
August 2015

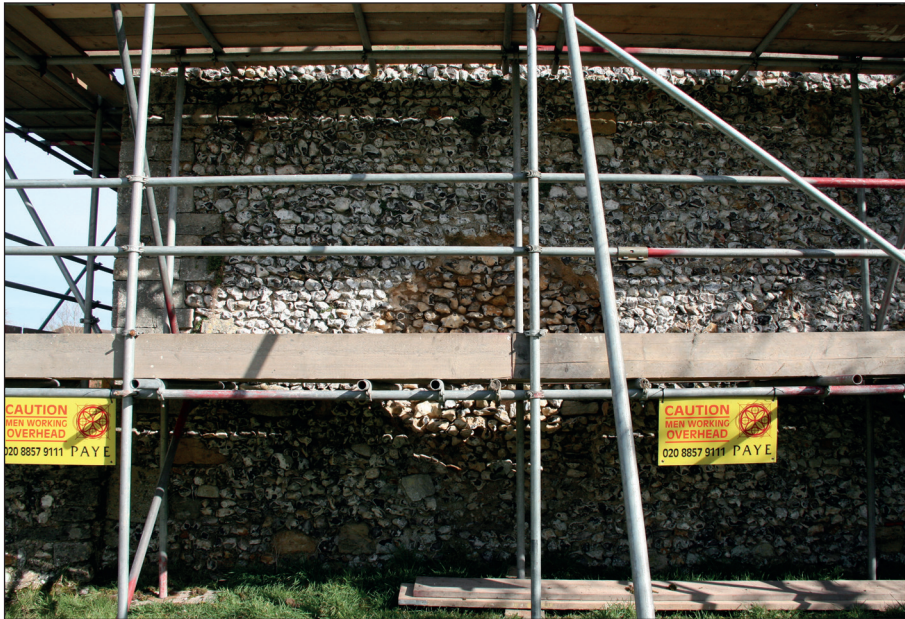
- 3.2.2 **Plate 1** shows the south elevation of the south wall prior to the repair of its facework.
- 3.2.3 On the north elevation, upper storey of the south wall is a brick fireplace that has been pinned and had its open joints repointed because of cracks in the brickwork and loose bricks in the chimney breast (**Plates 2 and 3**). The bricks and flints that form the back of the flue are more stable than those of the breast and have at least two phases of mortar pointing visible on the surface.

Plate 1: View of the southern elevation of the south wall prior to repair

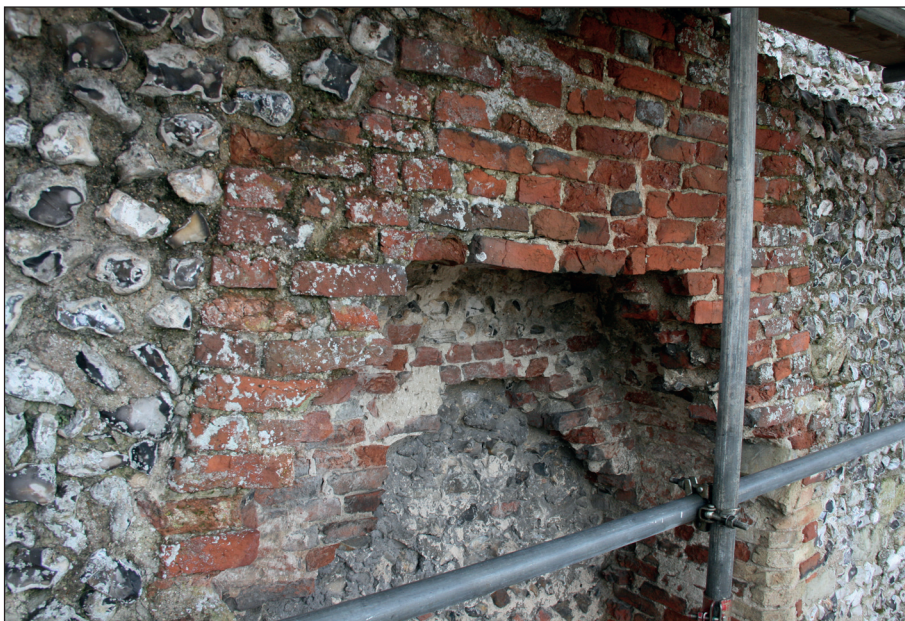
Plate 2: View of the brick fireplace on the northern elevation of the south wall

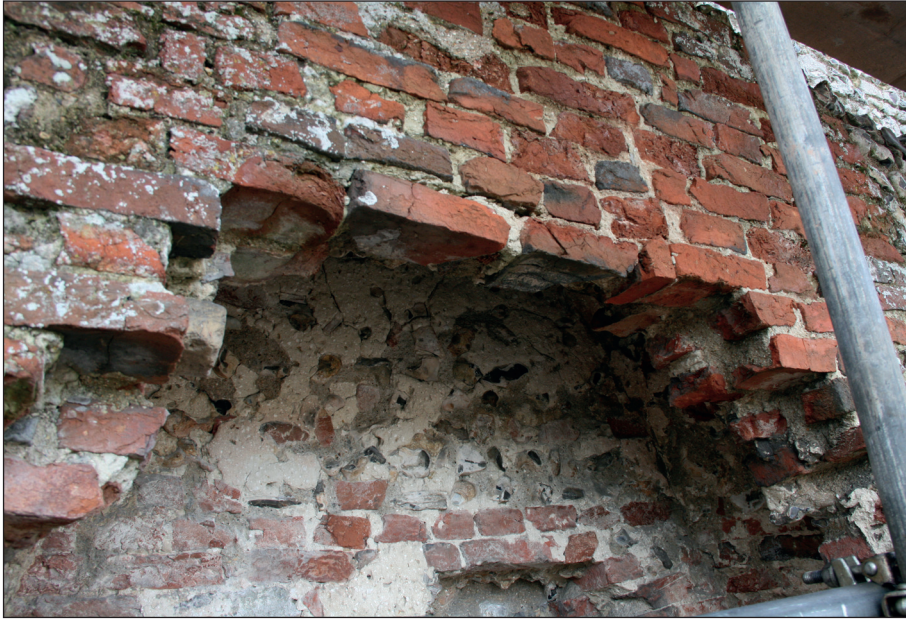
Plate 3: Amplified view of the brick fireplace including the chimney breast and flue

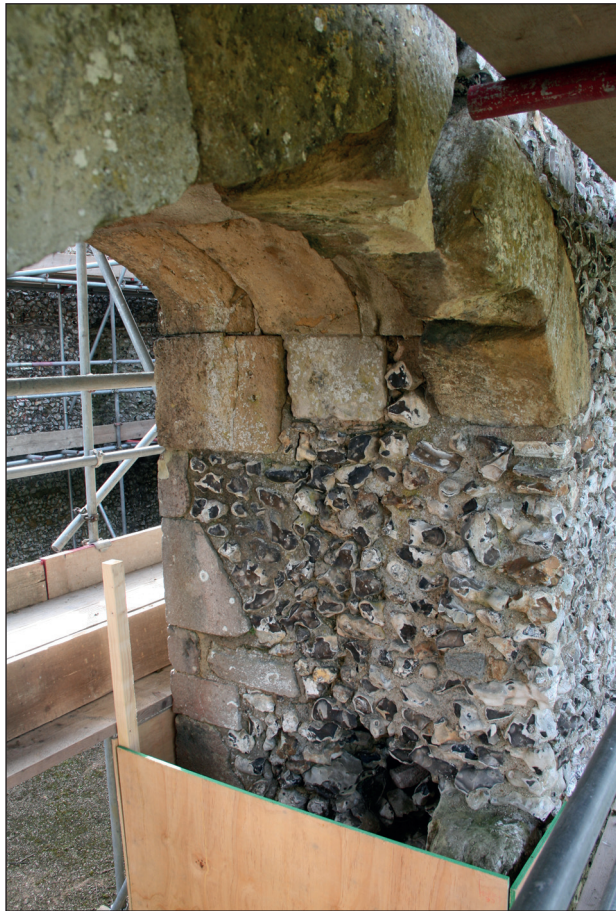
- 3.2.4 The majority of conservation work within the brewhouse/bakery range focussed on the multiple window and door openings. In the west wall, the head of the southwest entrance had some broken masonry that needed replacement where the face had been lost (**Plate 4**) and the door jambs had lost some flint facework, but the latter were boarded over. Similarly the northwest entrance in the west wall had lost some masonry from the head of the opening that was replaced with matching stone as part of the conservation work (**Plate 5**).

Plate 4: The head of the southwest entrance of the west wall showing broken masonry

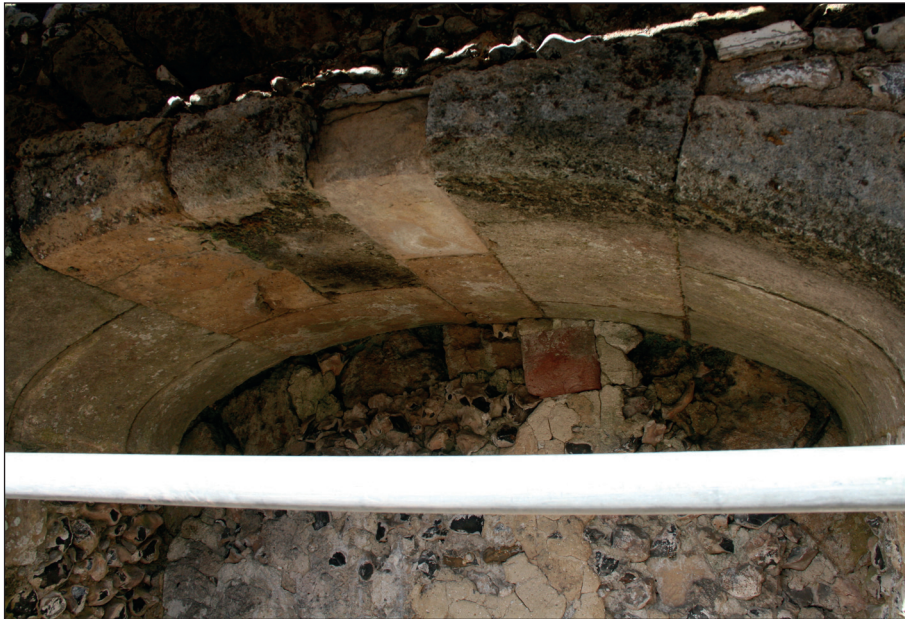
Plate 5: The head of the northwest entrance of the west wall showing replaced masonry

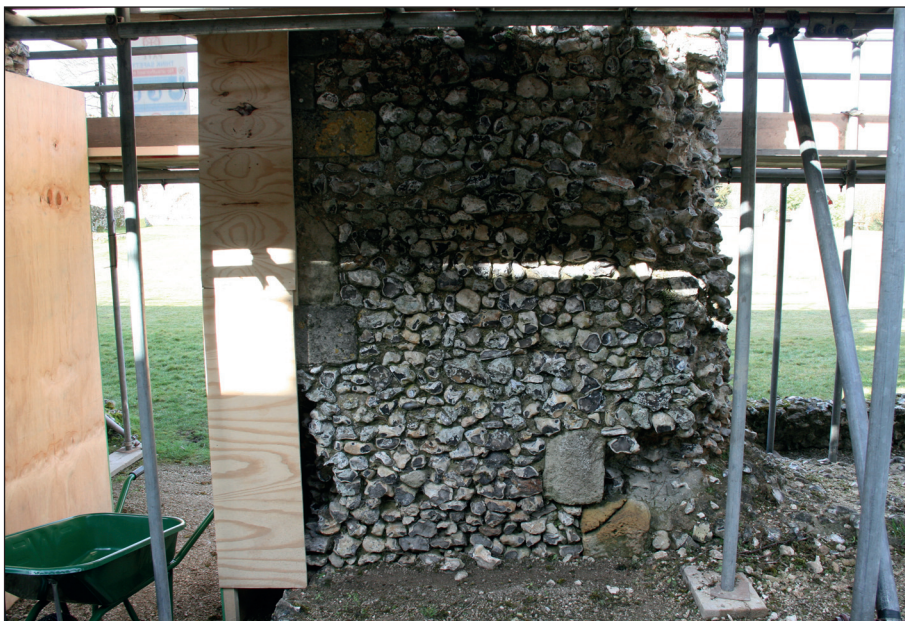
- 3.2.5 The large opening in the centre of the west wall is a breach due to ruination. The south side of the breach had lost some fabric, possibly a masonry block, which exposed the core and needed replacement (**Plate 6**). The north side of the breach is supported by previous brick repair work but this had open joints and required repointing (**Plate 7**).

Plate 6: View from the north-east of the north side of a large breach in the centre of the west wall

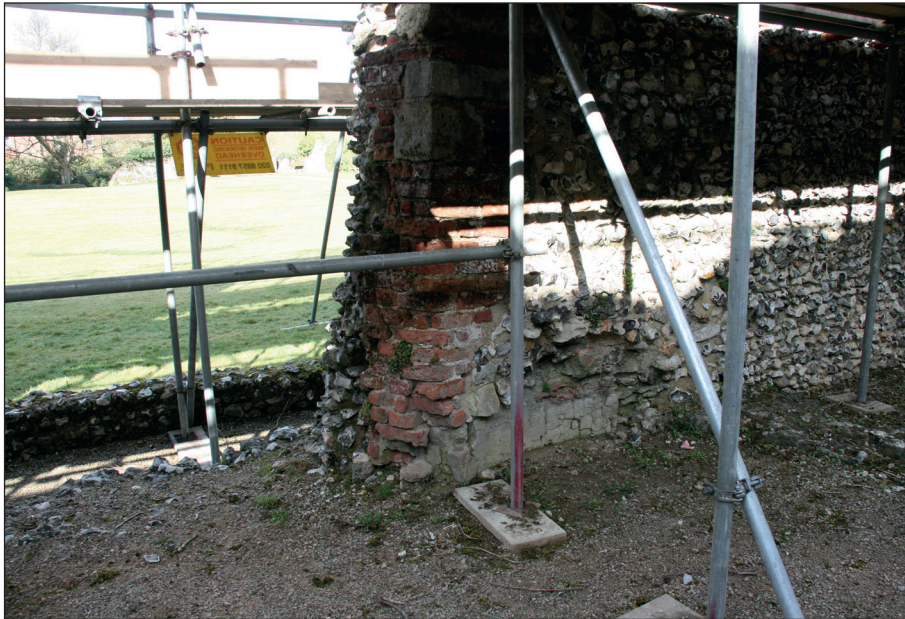
Plate 7: View of the north side of the large breach in the centre of the west wall

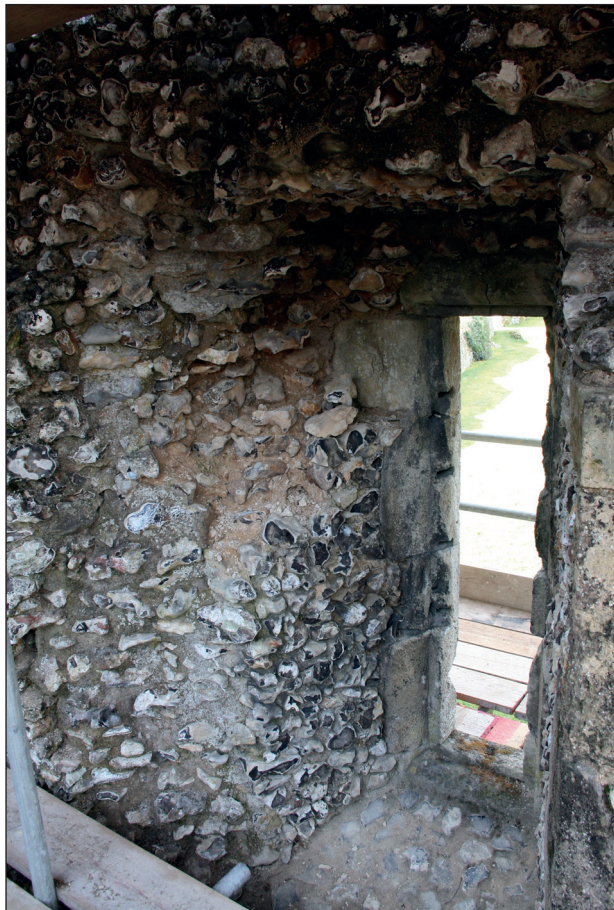
- 3.2.6 Window openings in the west wall of the brewhouse/bakehouse range were also conserved. A first floor window, located at the south end of the wall had a historic crack in the ferramenta within the lintel which requires repair as well as fragmented masonry in the sides of the reveal to be repointed. It was recorded prior to repointing but after vegetation had been removed (**Plates 8**).

Plate 8: View from the east of the south, first floor window in the west wall

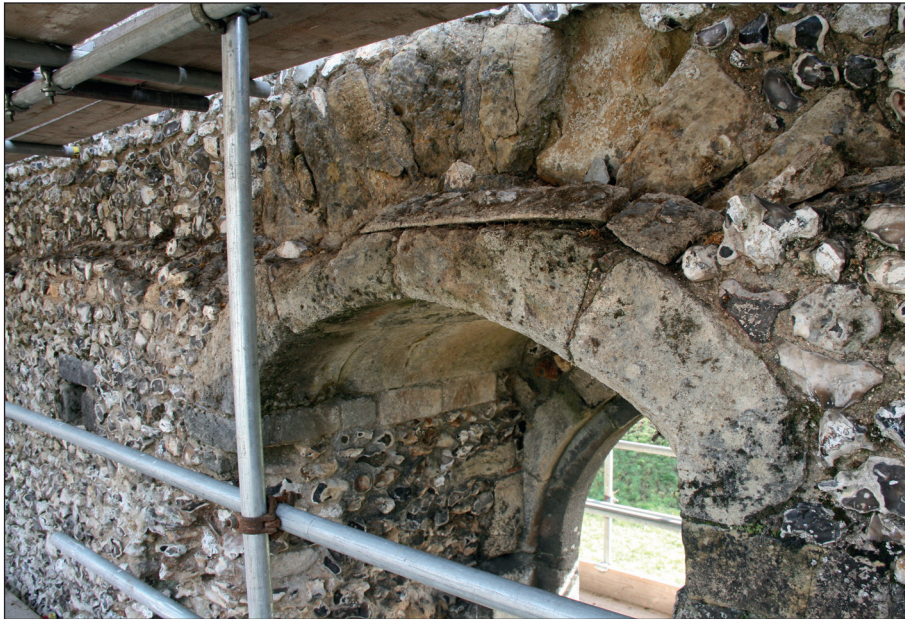
- 3.2.7 The east wall of the range was also subject to conservation. The wall narrows above first floor level and the resultant ledges are capped with concrete over the first floor openings. The removal of vegetation exposed the loose and broken concrete render to view (**Plates 9 and 10**).

Plate 9: Northwest view of the east wall at the point above first floor where it narrows. The image shows the fragmented concrete that caps the ledge of the lower wall

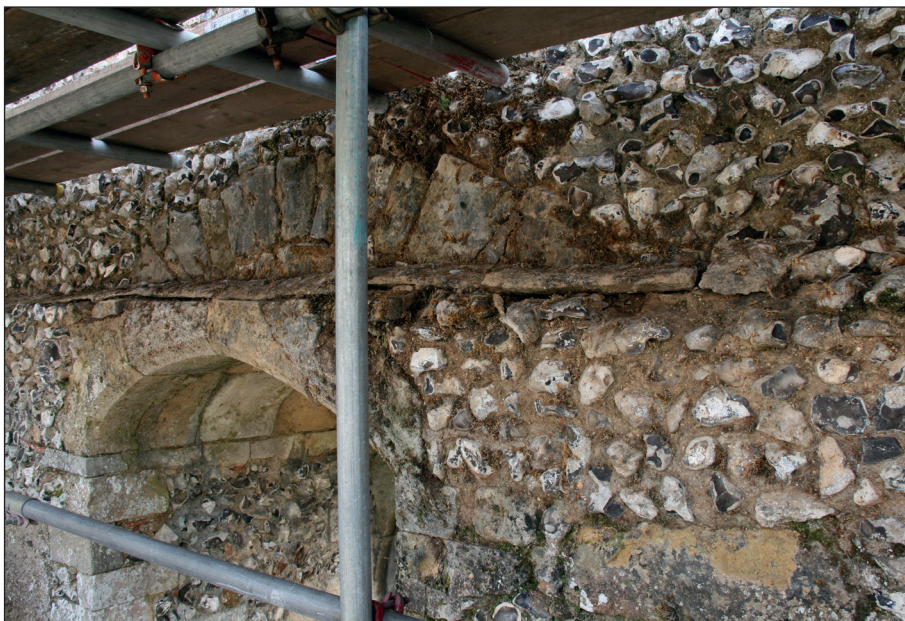
Plate 10: Northwest view of another part of the east wall at the point above first floor where it narrows. The image shows more fragments of the concrete capping prior to conservation.

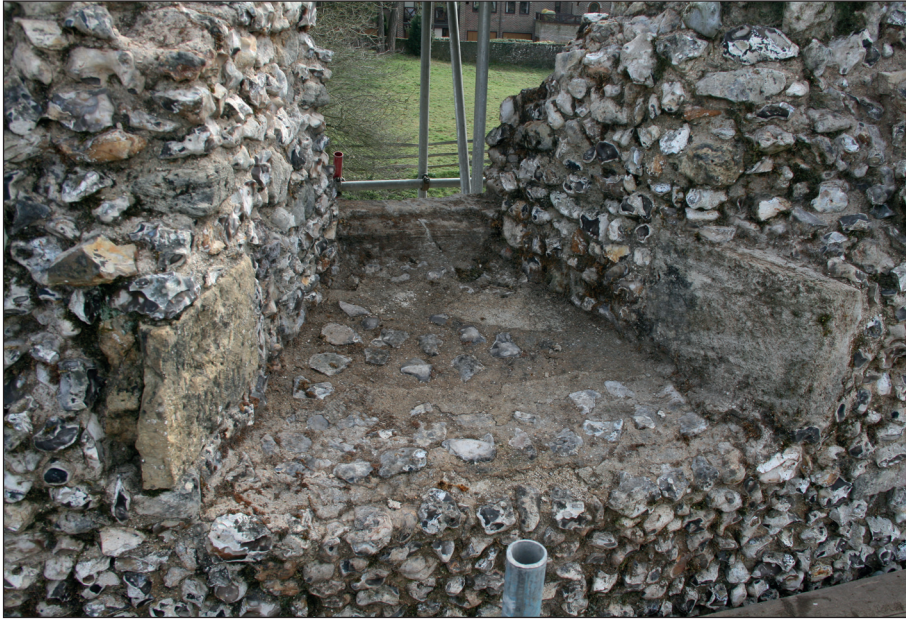
- 3.2.8 The scaffolding allowed for close inspection of the high level openings and features not usually accessible. It was noted that the second floor window (the 2nd one counting north-to south) had previously been repointed across the base of the reveal (**Plate 11**). Unfortunately, the date of this repair is unknown. Also at second floor level, the northernmost window had fallen brickwork to be reinstated (**Plate 12**) in addition to removal of vegetation and repointing of open joints in this wall.

Plate 11: View from the west of a second floor window of the east wall, repointed across the base

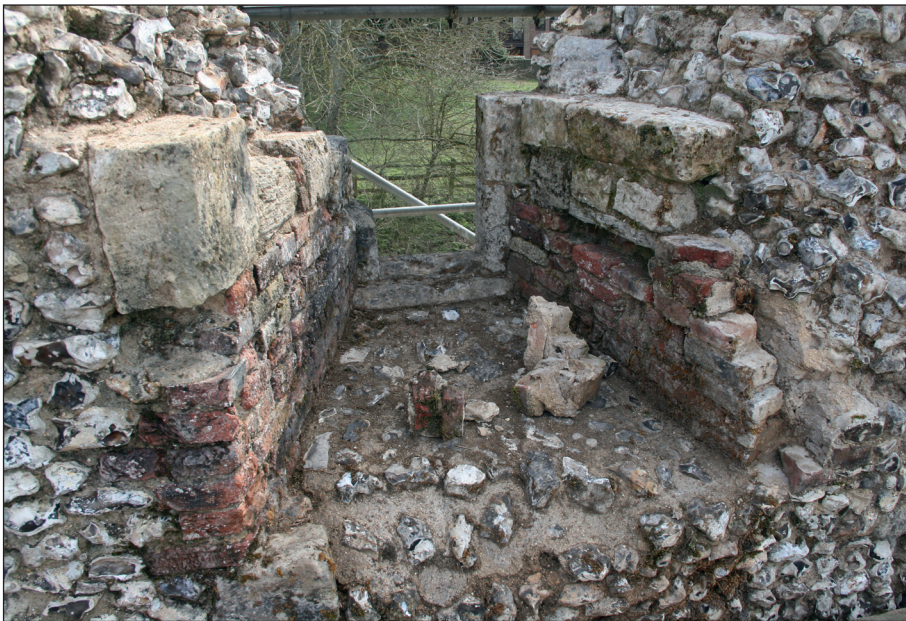
Plate 12: View from the west of a second floor window of the east wall with fragmented brickwork prior to its reinstatement

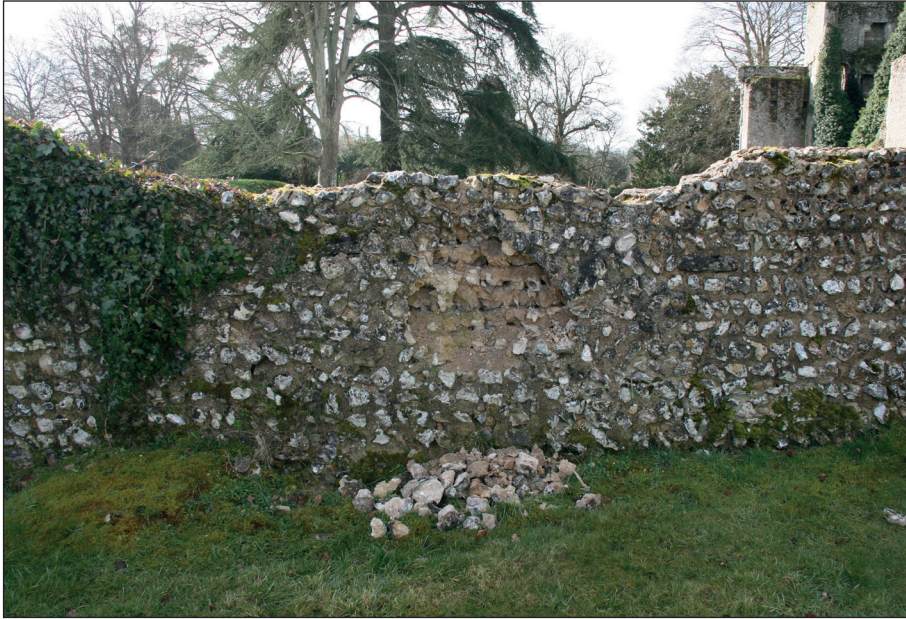
- 3.3 The cross wall**
- 3.3.1 The cross wall does not fall within the scope of this programme of conservation. However, it does have areas of damaged facework much like those under repair in the brewhouse/bakehouse. English Heritage intends to repoint the damaged areas and remove vegetation from the wall using other funds at a later date. Therefore the cross wall was photographed to record its present condition (**Plate 13**).

Plate 13: View from the north of the west end of the cross wall showing damage to stonework

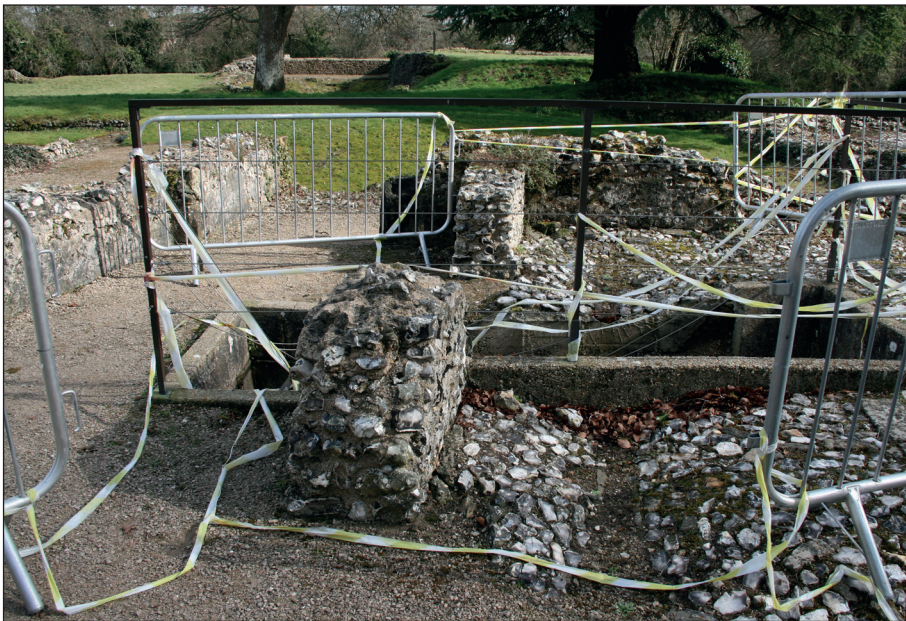
- 3.4 The remains of the 12th century doorway**
- 3.4.1 The 12th century doorway towards the southwest corner of the site is protected by concrete blockwork covering walls and has a railing around it. Unfortunately the railing has been vandalised and broken which has pushed some of the concrete blockwork out of position. This has exposed fabric of the feature that was previously hidden. Therefore it was decided to make a drawn plan (**Figure 2**) in addition to the photographic record of the doorway. The exposed historic fabric is flint as is the surrounding cobbled surface, but the

majority of the stones remain obscured behind the mortar used to bed the cement blocks (Plates 14-16).

Plate 14: View from the northwest of the remains of the 12th century doorway

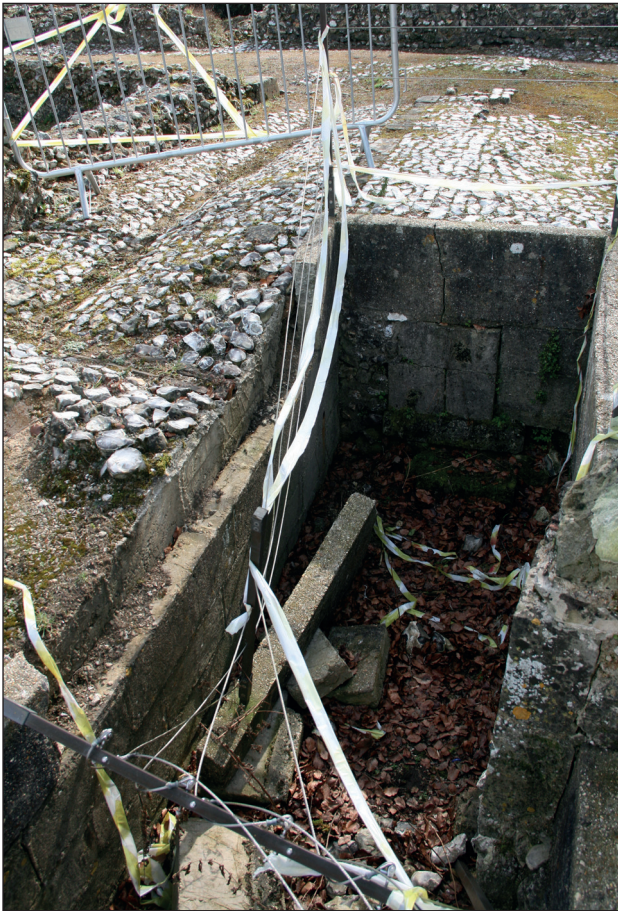
Plate 15: View from the north of the remains of the 12th century doorway and concrete block protection

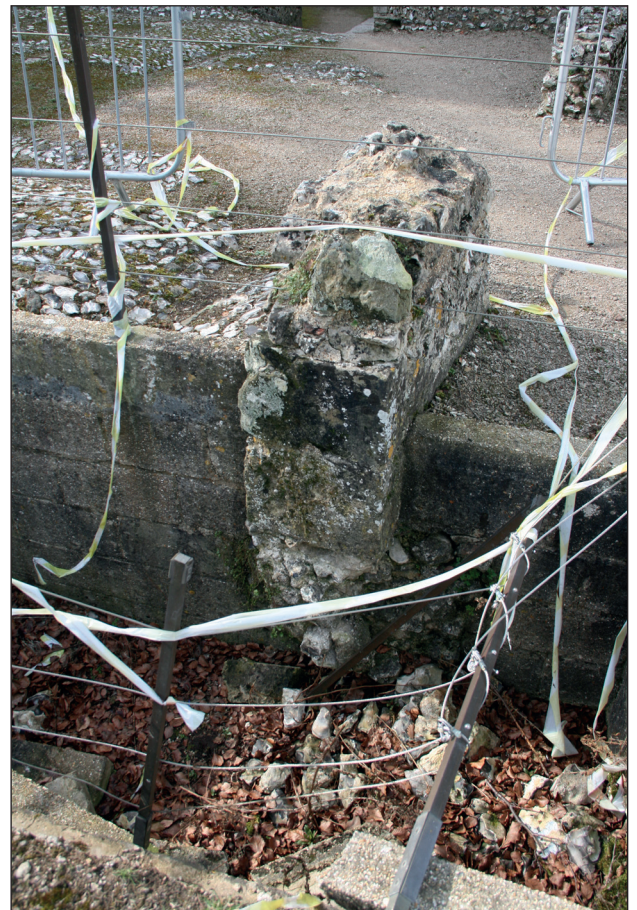
Plate 16: Eastern view of the 12th century doorway showing exposed flint
