Mytholmroyd Flood Alleviation Scheme: Church of St Michael Mytholmroyd, West Yorkshire

Archaeological Watching Brief

Ref: 114020.04
October 2016

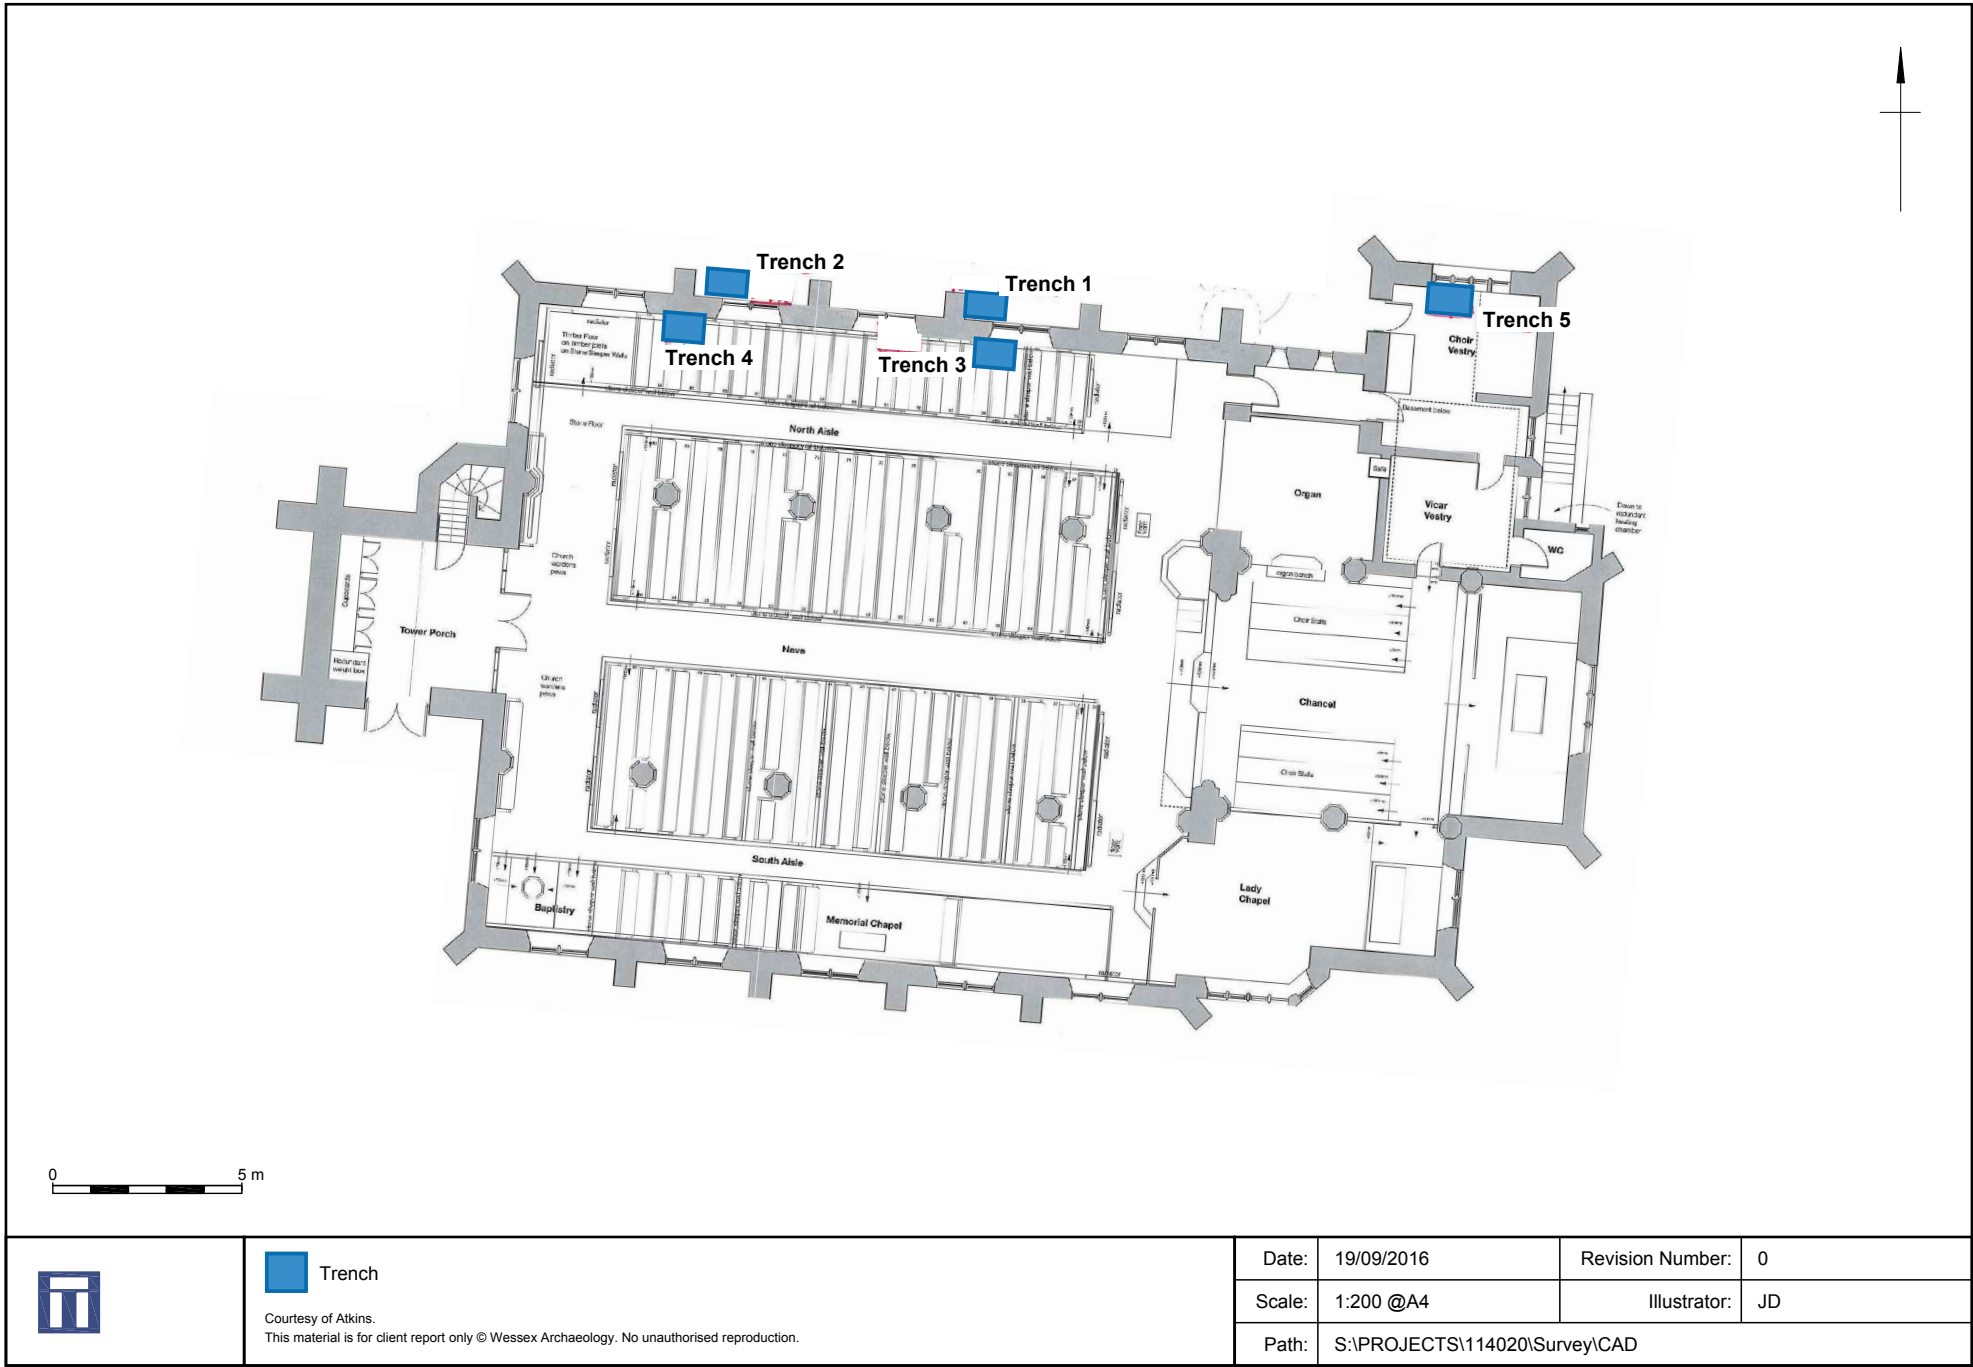
Figure 2

- 4.1.1 Within the Wessex Archaeology WSI (2016) a plan of the Church was produced showing the proposed locations of five test pits, each nominally 1.20 m by 0.80 m in plan (Figure 2). The maximum depth of each pit was not to exceed 1.20 m.

- 4.1.3 Each test pit was given a unique trench number in the following sequence: Trench 1 (TP 104), Trench 2 (TP 102), Trench 3 (TP 103), Trench 4 (TP 101) and Trench 5 (TP 105). It should be noted that for practical reasons the planned positions of some of the test pits were adjusted. Most were moved only slightly but Trench 103, against the inner face of the north wall, was moved from the third bay (from the west) to the fifth bay (Figure 2).

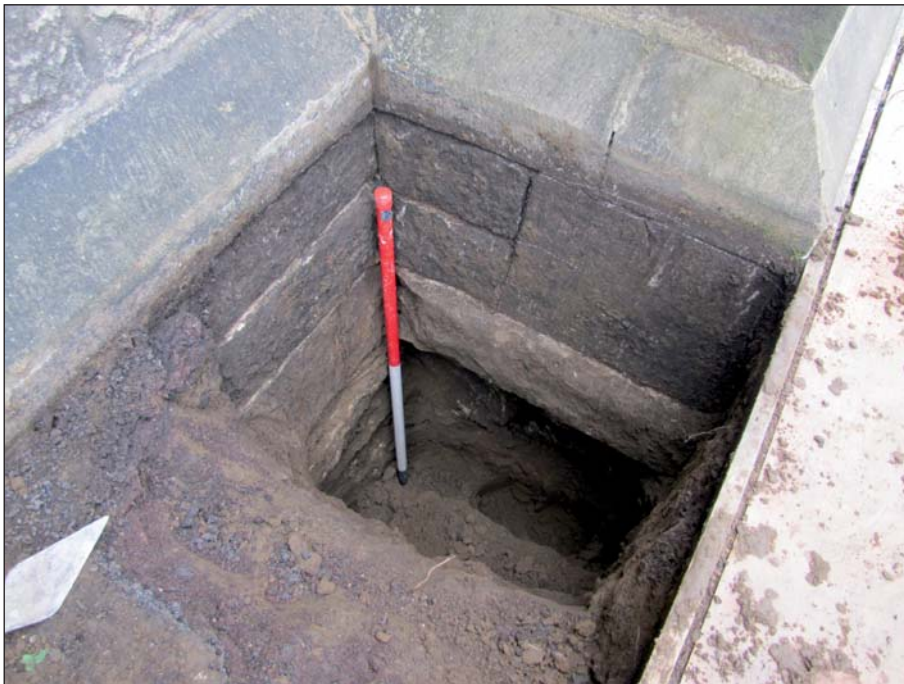
Plate 2: Trench 1 (TP 104) excavated

- 4.1.4 Trench 1 (Plate 2) was located in the corner formed by the eastern face of the buttress and the external face of the north wall in the fourth bay from the west. Excavated dimensions in plan were 0.80 m by 0.60 m, with a depth of 1.30 m. A thin layer of turf and topsoil (101) was removed to reveal a layer of laid ash and clinker (102). Below this was a

deep homogenous deposit (103). There was no clear evidence of a cut for the foundation trench; this may have been off to the north, or the trench may have been located internally. The layer (103) was clearly redeposited (as it would be if foundation trench fill). An inspection of the recovered finds, in particular much of the pottery, showed evidence of severe abrasion, through river washing.

- 4.1.5 The evidence of the abraded pottery, together with the silty nature of the deposit suggests that the layer had been redeposited, possibly the result of river dredging prior to the construction of the Church in 1848. The location of post-church construction finds within the trench indicate the possibility that (103) was re-deposited a second time and may have been foundation trench fill, further disturbed during later building works.

- 4.1.6 In the south face of the trench, part of the north wall of the Church was exposed. This comprised three courses of dressed gritty sandstone below which were a further three courses of slightly projecting unworked sandstone. The base of the foundation was not reached. In the western side of the trench the side of the buttress was revealed. As courses did not align with the north wall of the Church it is possible that the buttress is a later addition.

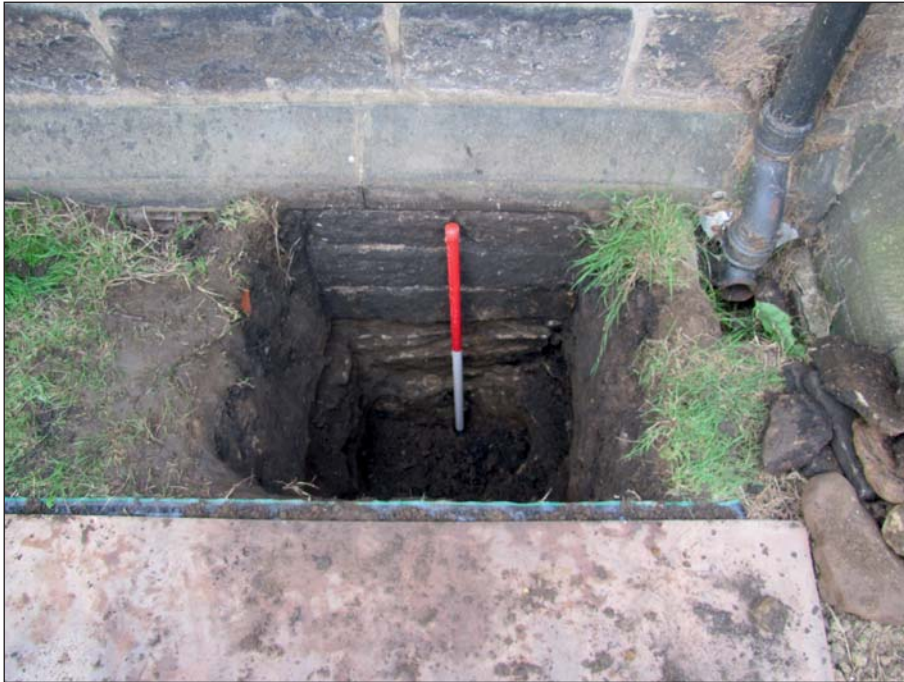
Plate 3: Trench 2 (TP 102) excavated

- 4.1.7 Trench 2 (Plate 3) was located in accordance to the original plan in the eastern half of the second bay from the west, on the outside of the Church adjacent to the face of the north wall. Excavated dimensions in plan were 0.80 m by 0.65 m, with a depth of 1.13 m.

- 4.1.8 A thin layer of turf and topsoil (201) was removed to reveal a layer of ash and clinker (202). Below the ash was a layer (203) which held fragments of building rubble which may have been associated with post-construction repairs. Layers (204) and (205) were of similar appearance to each other, (205) having more river gravel in its makeup.

- 4.1.9 River washed and abraded pottery (and other finds such as glass including window glass) were recovered from layers (204) and (205), but primarily from the lower one. As in Trench 1 this was interpreted as evidence for redeposited river dredged material.

- 4.1.10 Wall foundations were revealed in the south side of the trench. Three courses of dressed sandstone extended to a depth of 0.48 m. These sat on a foundation of four courses of projecting undressed sandstone, extending to a depth of 1.13 m, and continuing beyond.

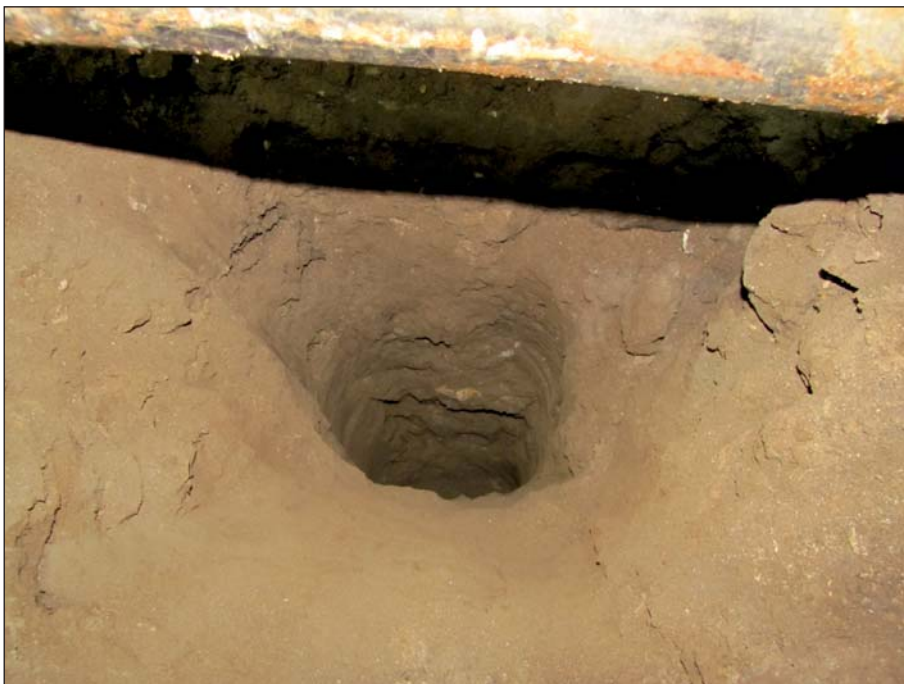
Plate 4: Trench 3 (TP 103) excavated

- 4.11 Trench 3 was located inside the Church, adjacent to the north wall of the North Aisle, in the fifth bay from the west (Plate 4). The trench was re-located following discussions with the architect and the Church Warden to an area to the east that was not covered by wooden pews. Wooden tongue and groove flooring was levered out to reveal a series of joists running west to east that lay over beams which rested on shallow sill walls. The majority of these sill walls (showing in a number of locations in the Church) were of dry laid sandstone. One of the two walls revealed in the opening up process for Trench 3 was of brick. This was due to heating pipes having been laid at a later date within a brick conduit which was used to support a beam.

- 4.1.12 A number of joists were cut out sufficient to allow the excavation of a trench 0.70 m by 0.50 m in plan. The first layer (301) was encountered at a depth of c.0.40 m below the base of the joists. This very dry material held large quantities of stone and brick rubble and was interpreted as the top of a construction layer. Following its removal, the top of

(302) was revealed. This layer was similar to layers (103) and (204-205) on the outside of the Church and was interpreted as redeposited river dredged material.

- 4.1.13 The nature of the lower courses of the north wall of the Aisle matched the external evidence; three courses of dressed sandstone overlaying undressed footings of undetermined depth below.

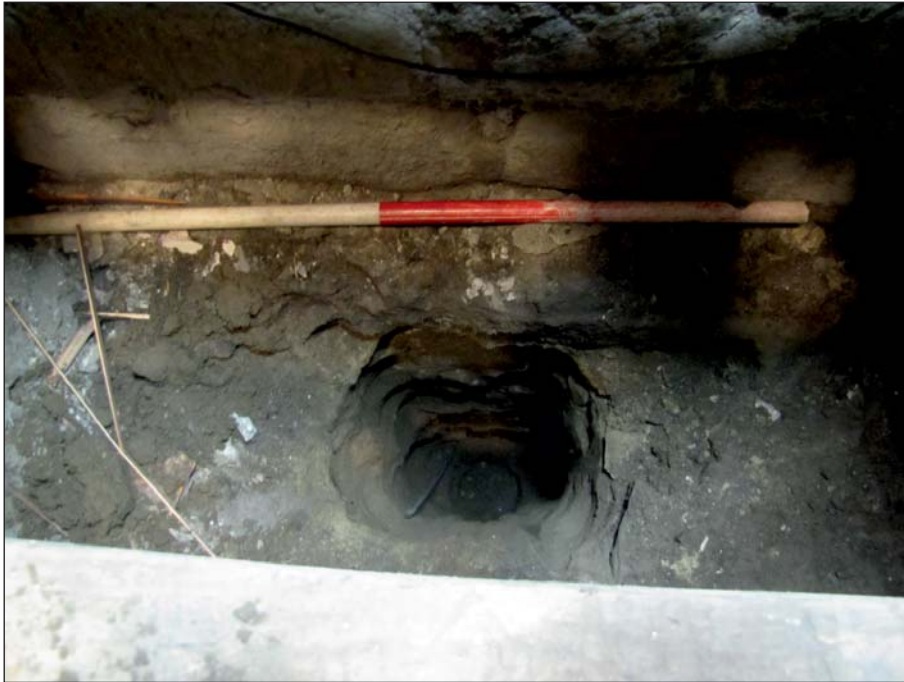
Plate 5: Trench 4 (TP 101) excavated

- 4.1.14 Trench 4 was located within the North Aisle in the western half of the second bay from the west (Figure 2, Plate 5). The original planned location of this trench was compromised slightly by the position of pews. To enable access a pew had to be removed followed by the floor boards on which it stood. It was not possible in this location to remove any of the east-west joists so a small trench was excavated between the joists close to the face of the north wall. The trench, sub-circular in plan, had an approximate diameter of 0.50 m.

- 4.1.15 At a depth of c.0.75 m below the underside of the floorboards, the top of (401) was located. This very dry layer, similar in all respects to (301) was interpreted as construction debris and accumulated material.

- 4.1.16 Located below, and excavated to a depth of 1.27 m, layer (402) was very similar to (302) and was interpreted as redeposited river dredged material.

- 4.1.17 The upper foundations of undressed sandstone (403) revealed in the northern face of the trench were of similar construction to those located in Trench 3. The foundations descended below the limits of excavation.

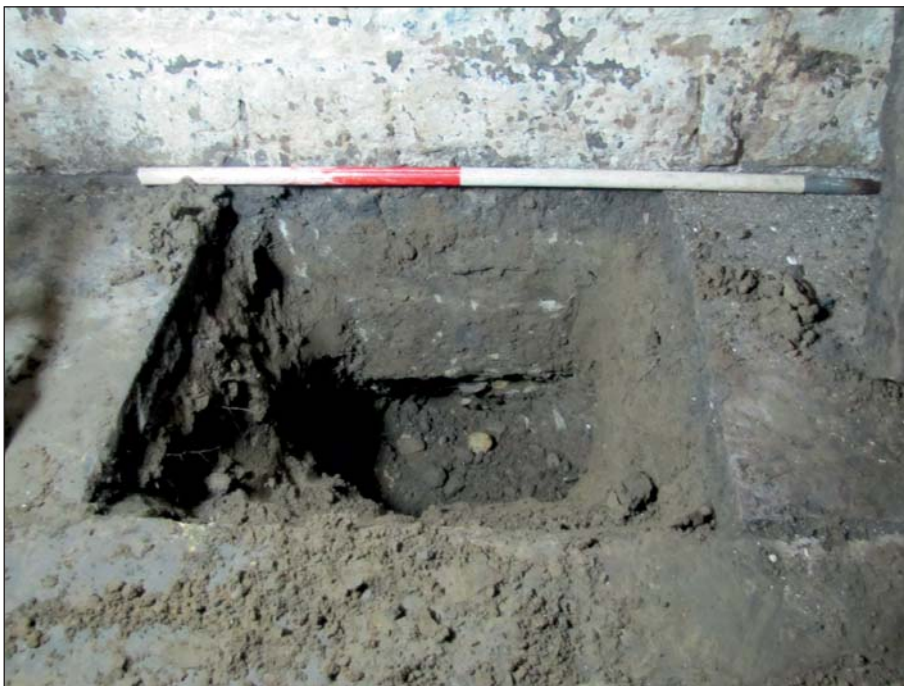
Plate 6: Trench 5 (TP 105) excavated

- 4.1.18 Trench 5 was located in the Choir Vestry basement adjacent to the window in the northern wall (**Plate 6**). The trench measured 0.60 m by 0.50 m and was excavated to a depth of 0.70 m. The floor of the basement was of sandstone flags. One flag was lifted (**501**) to reveal a thin layer of bedding material below (**502**).
- 4.1.19 Layer (503), below (502), was excavated to a depth of 0.70 m. The layer was similar to layers (103) (204-205), (302) and (402) and produced abraded pottery. It was interpreted as redeposited river dredged material.
- 4.1.20 The foundations of the north basement wall revealed in the trench comprised several courses of roughly cut blocks of sandstone in a dirty yellow brown lime mortar (504), with the base of the wall identified at a depth of 0.50 m. Trench 09 (BH 034)

- 4.2.4 Only the base of the north Choir Vestry basement wall was located within Trench 5. The base of the remainder of the north wall foundation was not identified in any other trench. It would seem likely that in 1848, when the plan of the Church was in the process of being laid out, it would have been clear that the site was a plateau of uncompacted made-ground and that any foundations for a building of the size proposed would have to be substantial, notwithstanding the annual risk of flooding.
