# Fielders Farm Shop Wickcroft Farm, Pangbourne Road Theale, Berkshire

Historic Building Record

Planning Ref: 15/00807/FULC Ref: 115150.02 January 2017

Report Ref: 115150.02

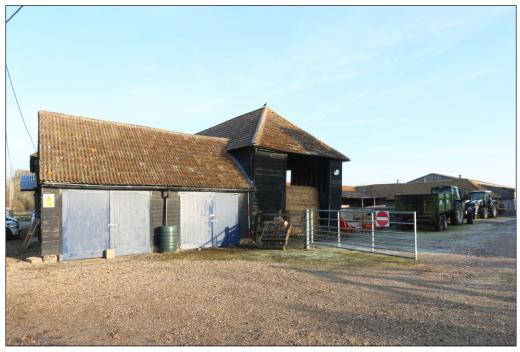
Plate 1: Redundant agricultural buildings viewed from the south-west. Buildings 11 and 1 in the foreground

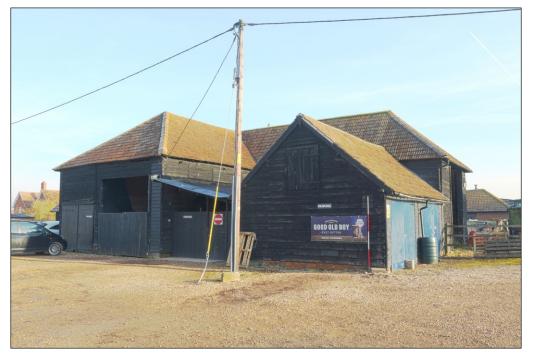
Plate 2: Redundant agricultural buildings viewed from the south-west. Buildings 2, 12 and 11 (left to right) in the foreground and Building 1 behind

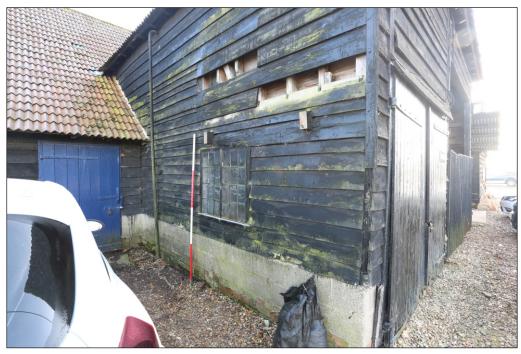
Plate 3: Redundant agricultural buildings viewed from the north-west. Building 10 and 2 are visible (left to right)

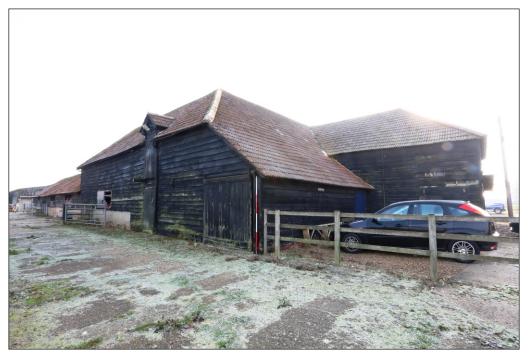
Plate 4: Redundant agricultural buildings viewed from the north-west. Buildings 5, 4, 3, 9, 10 and 2 visible from left to right

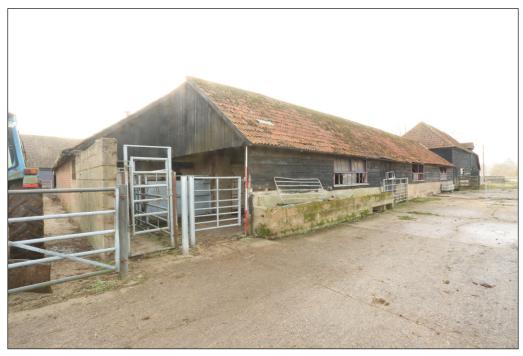
Plate 5: Redundant agricultural buildings viewed from the north-east. Buildings 6 and 5 (left to right) in the foreground

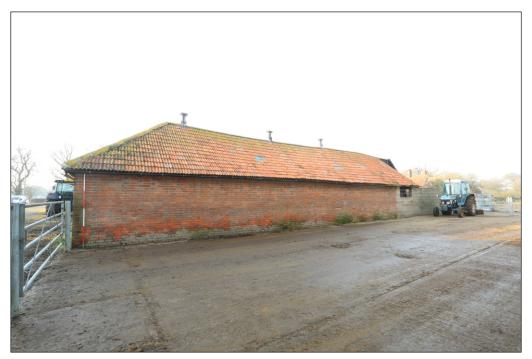
Plate 6: Redundant agricultural buildings viewed from the east showing Buildings 7 and 6 (left to right)

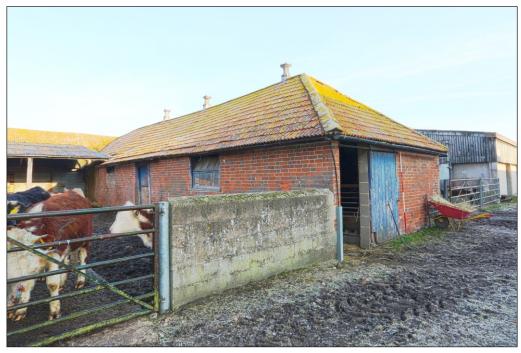
Plate 7: Redundant agricultural buildings viewed from the south-west, specifically Building 7

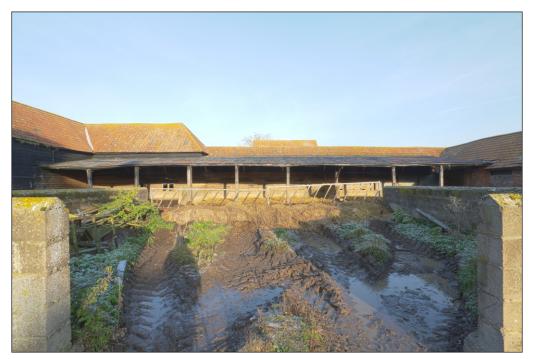
Plate 8: Redundant agricultural buildings viewed from the south showing the central yard and Building 8  $\,$

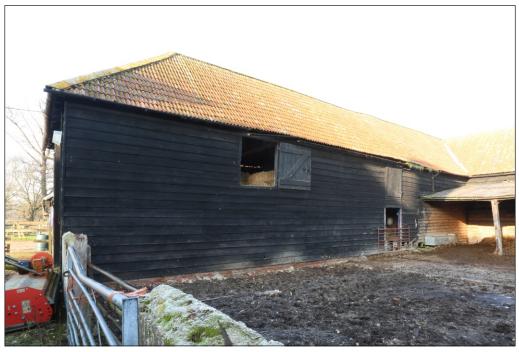
Plate 9: Redundant agricultural buildings viewed from the south-east, specifically the east side of Buildings 1 and 2 (left to right)

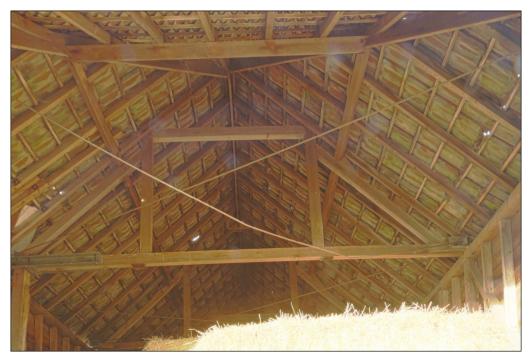
Plate 10: The roof structure within Building 1, viewed from the south

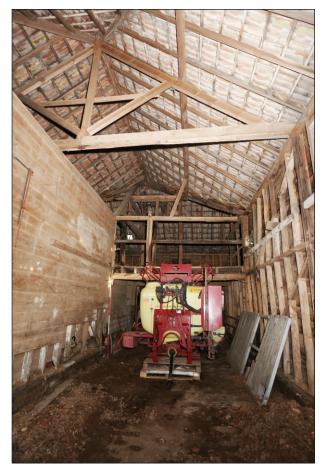
Plate 11: Building 2 large space viewed from the west

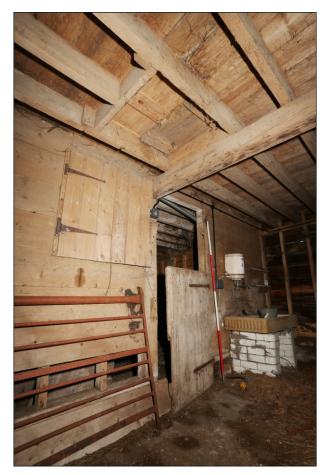
Plate 12: Building 2 door and hatch opening into Building 3 and the overhead hatch to the wheel mechanism on the first floor. Viewed from the south-west

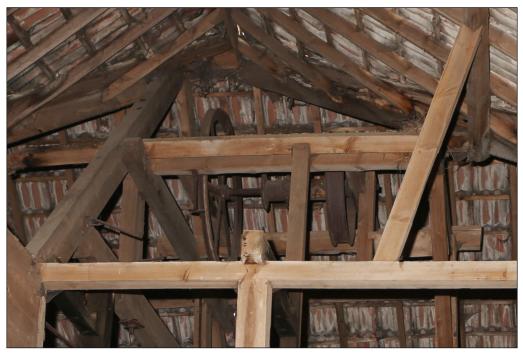
Plate 13: Building 2 wheel mechanism on the first floor viewed from the south

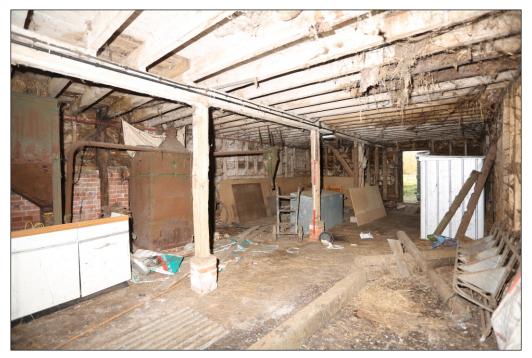
Plate 14: Building 3 ground floor viewed from the south-east. Note the staircase in the far corner and machinery to the left

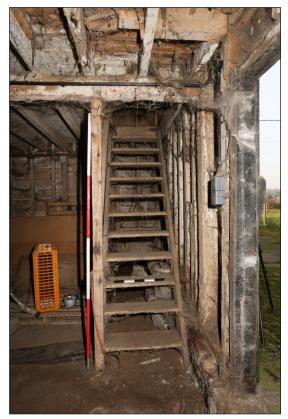
Plate 15: Building 3 staircase viewed from the east

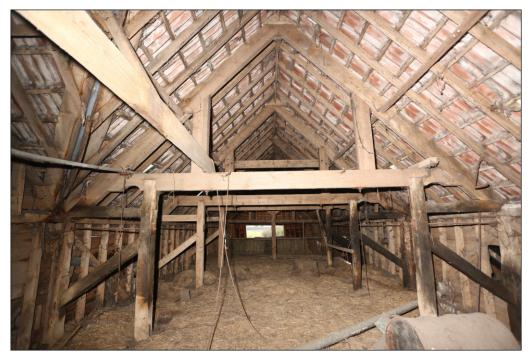
Plate 16: Building 3 first floor viewed from the north. Note the grease stained aisle timbers and holes cut for a line shaft

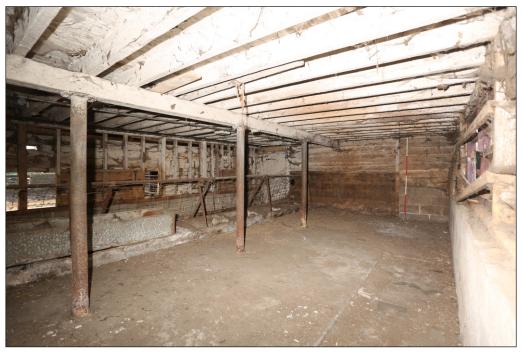
Plate 17: Building 4 ground floor viewed from the north-east

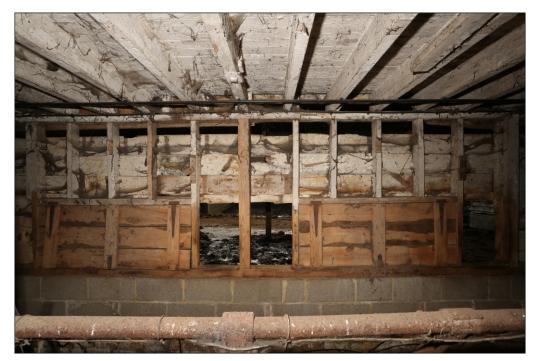
Plate 18: Building 4 inserted hatches in the south wall, viewed from the north

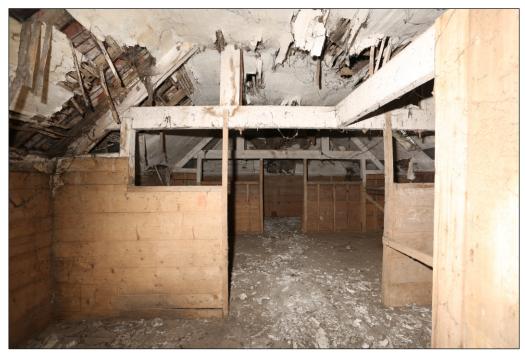
Plate 19: Building 4 first floor viewed from the west

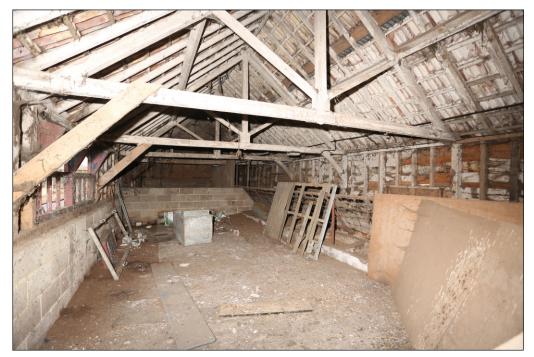
Plate 20: Building 5 ground floor viewed from north-west

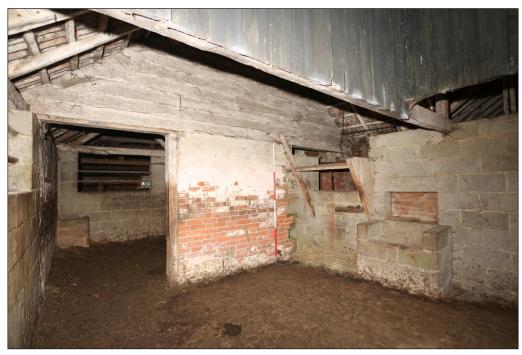
Plate 21: Building 6 south pen viewed from the north-east. The interconnected north pen of Building 7 is partially visible to the left

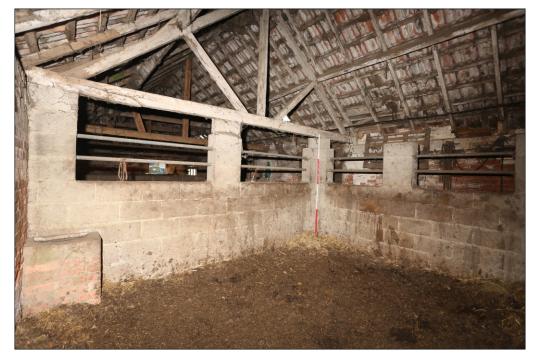
Plate 22: Building 7 north pen viewed from the north-east

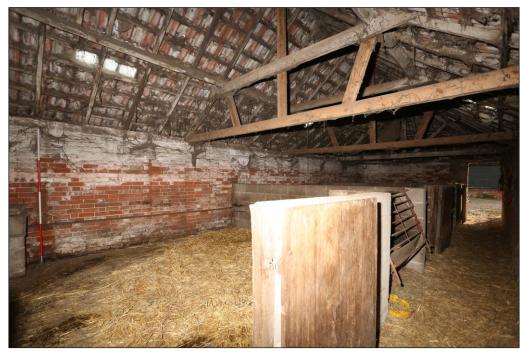
Plate 23: Building 7 pens (except the north one) viewed from the north-west

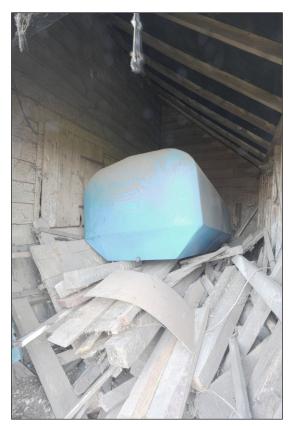
Plate 24: Building 9 viewed from the north-west

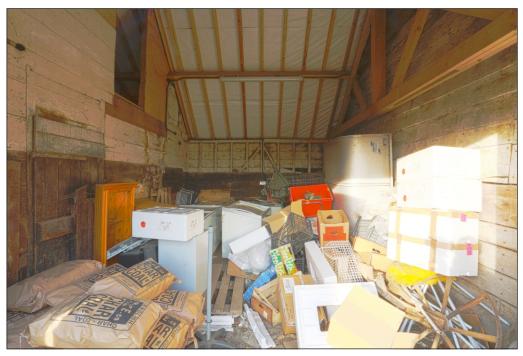
Plate 25: Building 11 east room viewed from the south

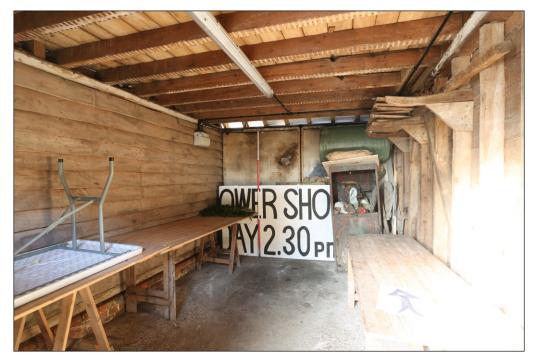
Plate 26: Building 11 west room viewed from the so

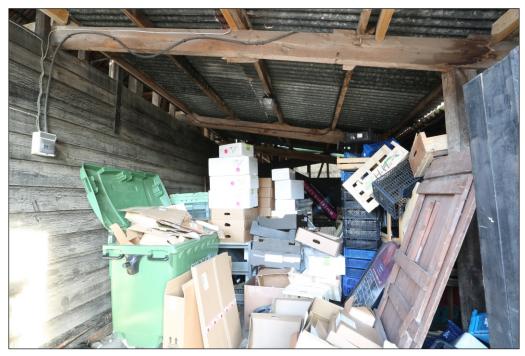
Plate 27: Building 12 viewed from the west
