Rose and Crown Public House Sandridge, Hertfordshire

Historic Building Record

Planning Ref: 5/2017/0333
Ref: 118240.03
October 2017

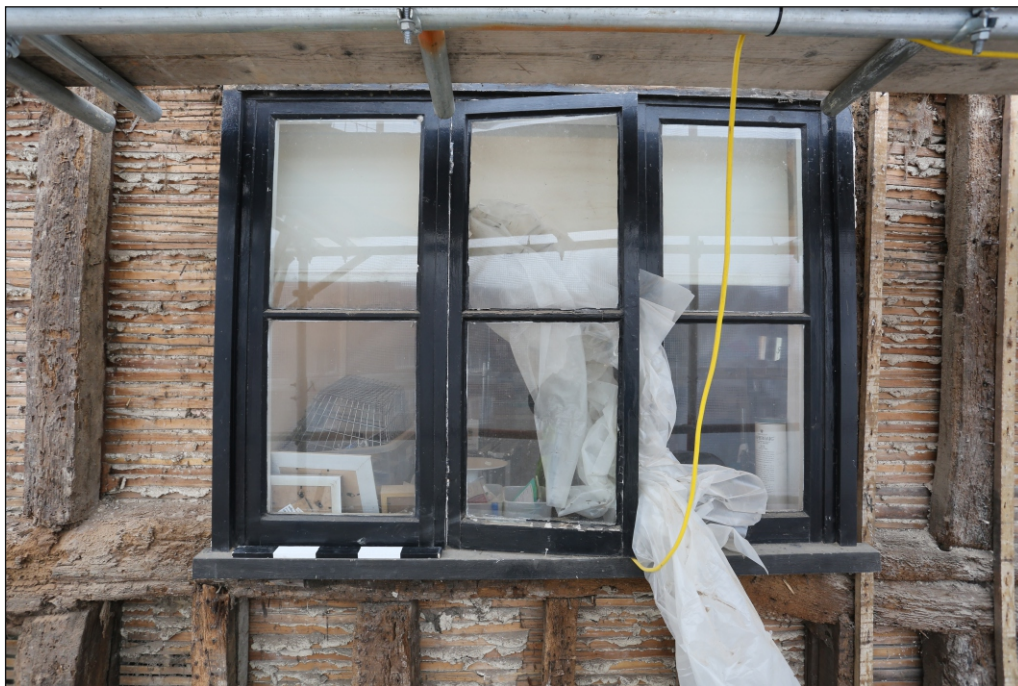
- 4.1.13 The first floor window is cut into the top of the tie-beam (**Plate 10**). It is a three-light casement window, single glazed with two panes per casement and a timber sill. The timber that forms the frame is machine-sawn and neatly finished, more so than the former windows on the ground floor which have a worn appearance.

Plate 10: The north-east elevation first floor window

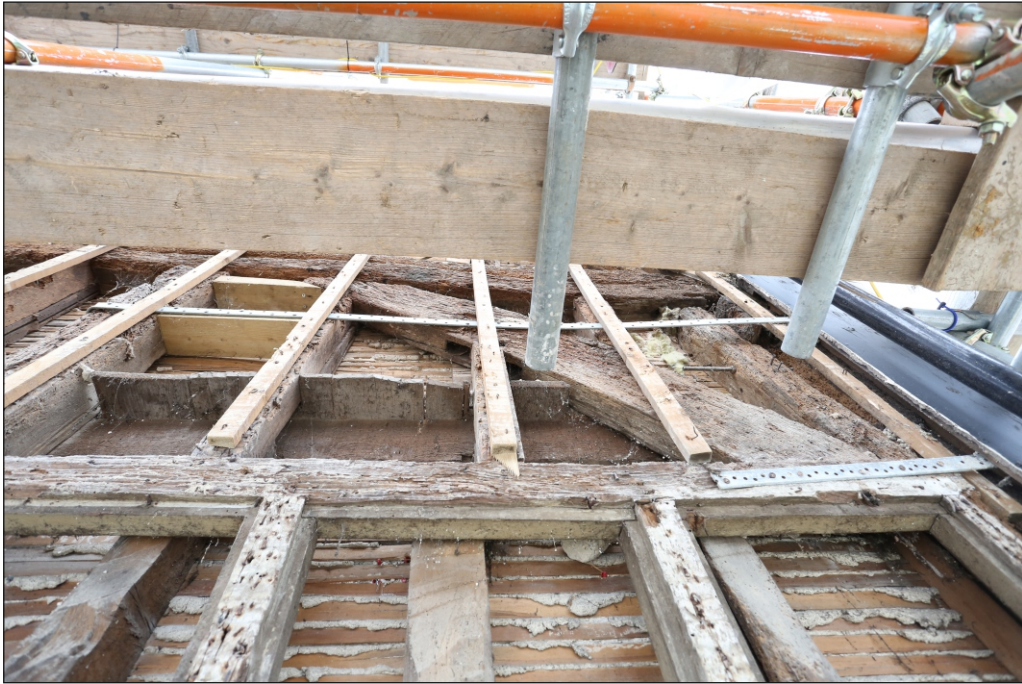
Plate 15: Empty mortise in the north-west up-brace in the north-east elevation

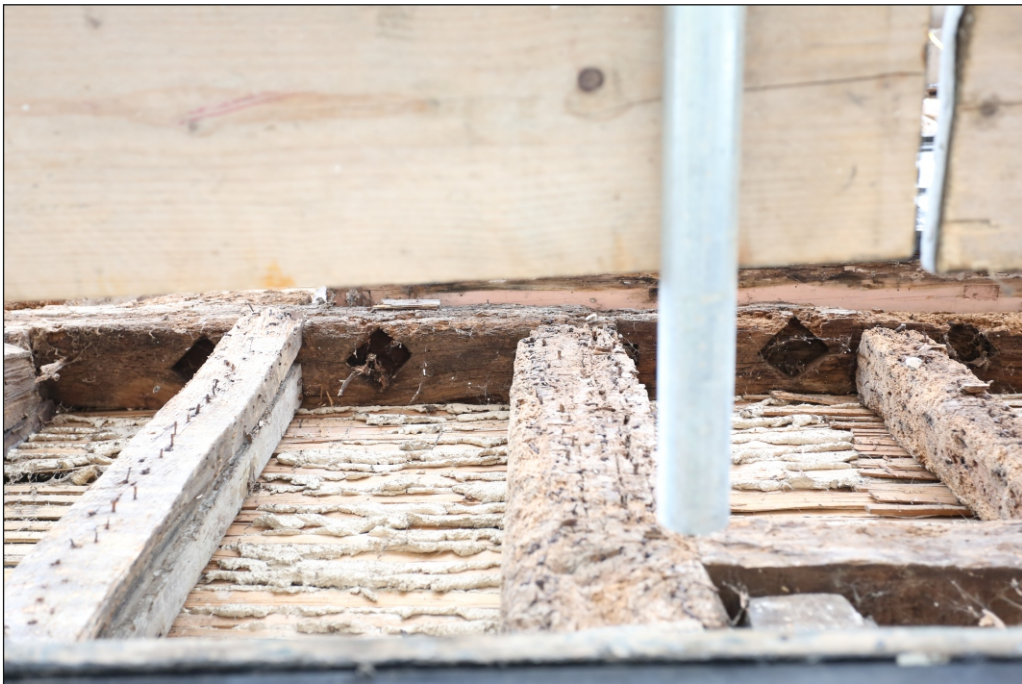
- 4.1.7 The soffit (underside) of the tie-beam and collar both have a series of stave holes and the collar has a worn groove along the top to fit staves above it for a wattle and daub panel, which has subsequently been removed. A similar groove along the tie beam was not visible, however it does have four diamond shaped holes in its soffit, presumably for a diamond mullioned window (**Plate 16**).

Plate 16: Diamond mortises in the soffit of the tie-beam of the north-east elevation. Probably for a diamond mullion window

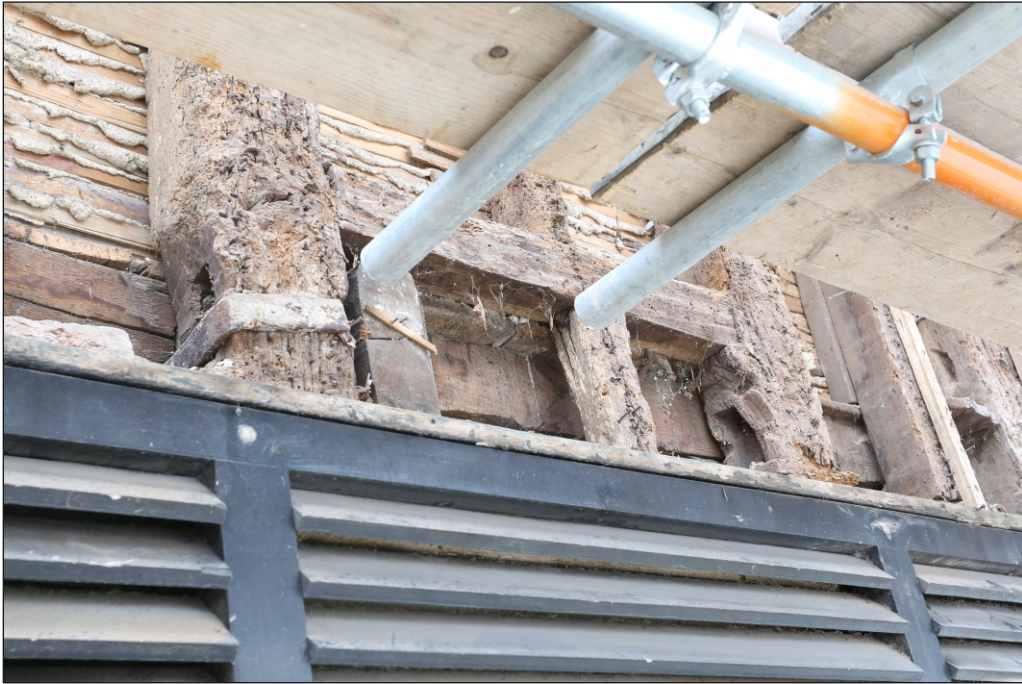
Plate 17: Empty mortices in the studs above the louvre in the north-east elevation. Also note the metal strap.

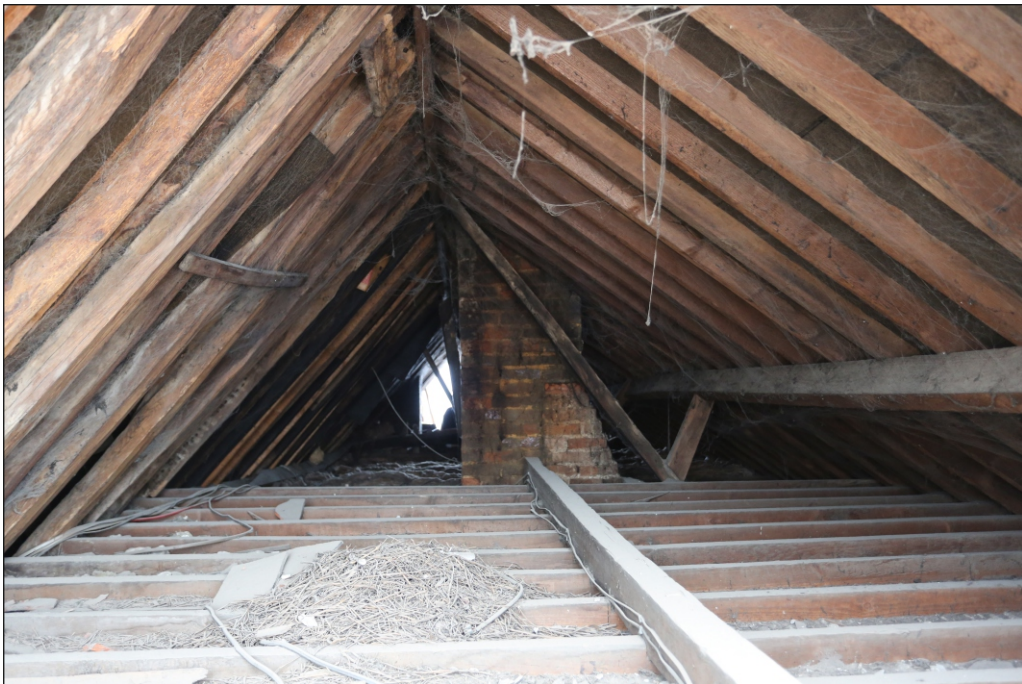
- 4.1.15 The roof of the main range is currently clad in thin slates (**Plate 12**). A brief view inside the roofspace revealed that many of the common rafters have been replaced and several struts and braces have been added (**Plate 18**). However, there does appear to be some earlier timbers left *in-situ* or reused within the roof structure.

Plate 18: The roofspace of the main range viewed from the north-east

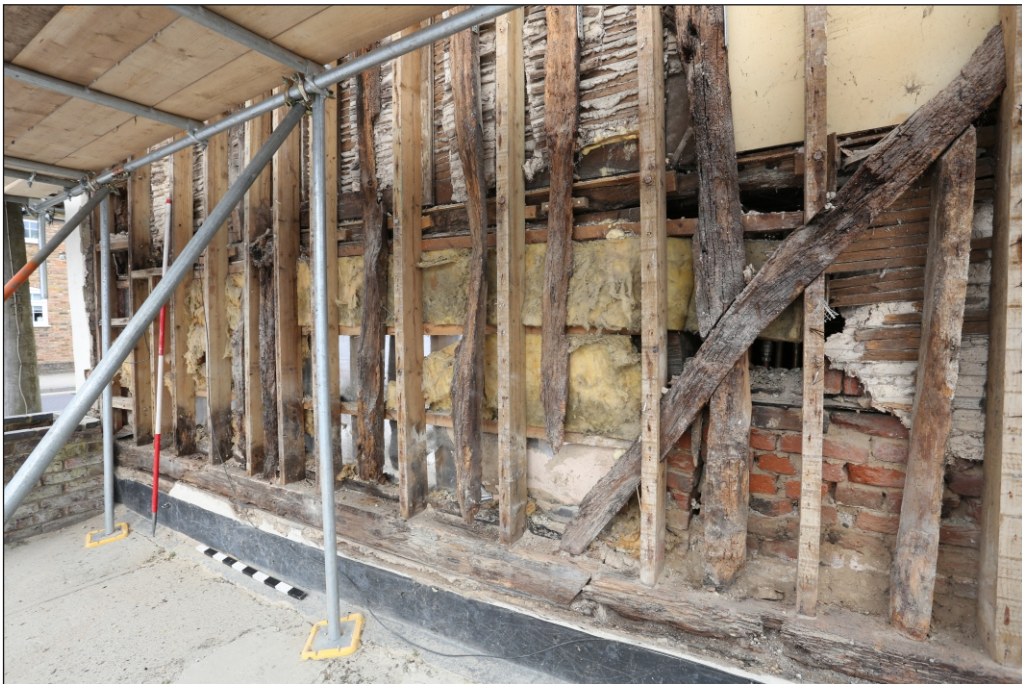
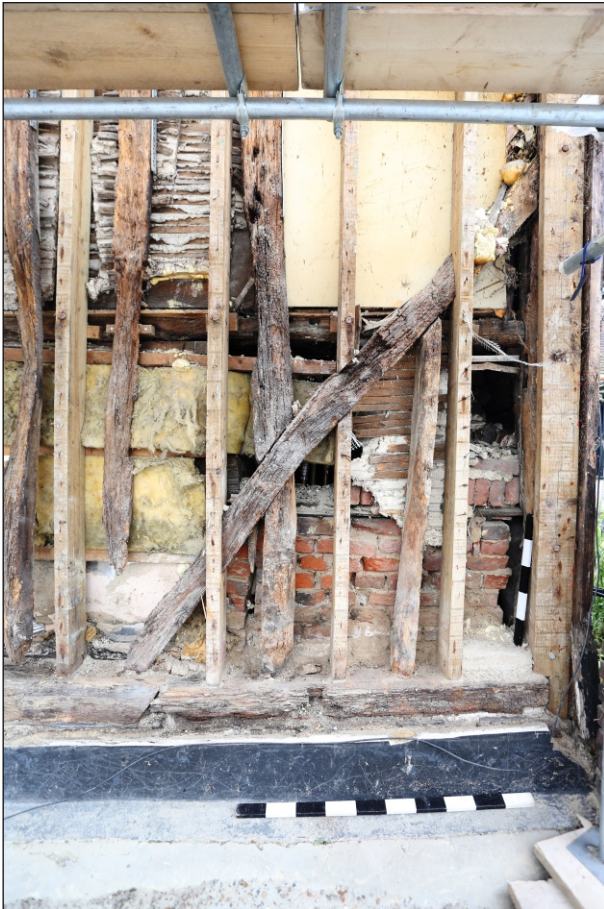
- 4.2.6 The sill beam comprises two timbers of unequal length connected with a scarf joint (**Plate 20** and **25**). The base of the sill beam measures 0.31 m above ground level, it is 0.15 m wide and 5.66 m long in total. The scarf joint is located towards the south-east side of the elevation, 1.36 m from this end of the beam (measured along its top edge). The longer of the two timbers is machine-sawn with a neat finish whereas the shorter timber (**Plate 25**) is heavily weathered with a patina similar to the tie-beam and has two peg holes and a worn mortice joint located towards its base, which suggests it has been rotated and reused.

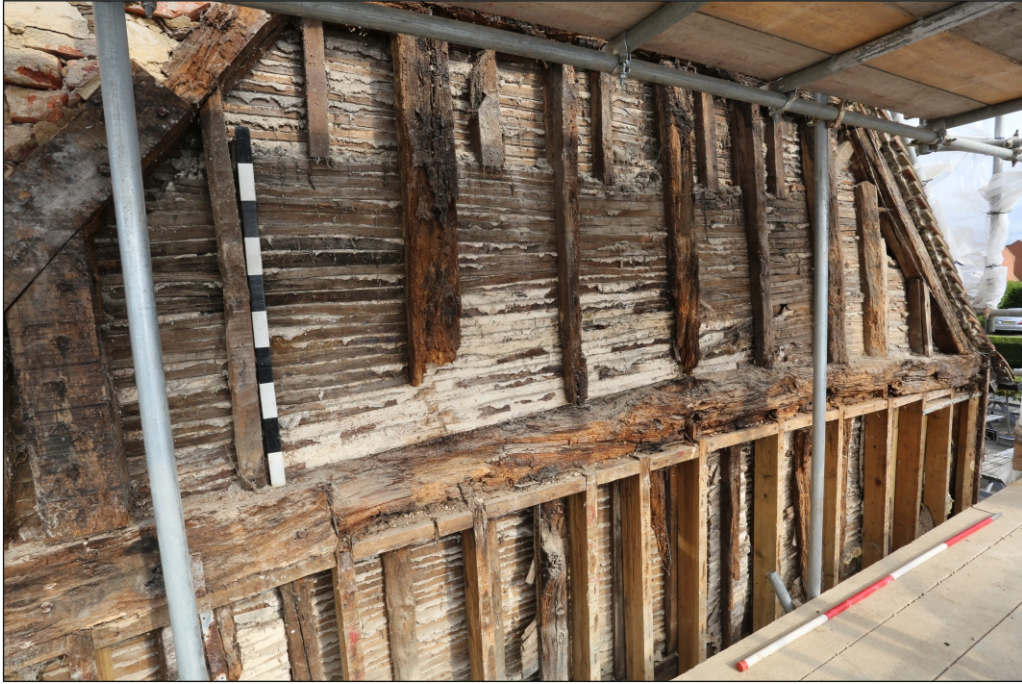
- 4.2.4 The tie-beam measures 0.21 m in width and its base measures 3.04 m above ground level (measured at the mid-point; **Plate 21**). Its face of the timber appeared heavily weathered and degraded. When recorded, the north-west end of the tie beam remained hidden behind render so it is uncertain how it is supported. The south-east end is supported by a modern post. This is bolted to an earlier post behind it. The earlier post is connected to a down brace, which fails to respect two empty mortice and peg holes in the side of the post that may have been a mid-rail and brace that have been removed (**Plate 24**).

Plate 21: The south-west elevation at tie-beam level, viewed from the west

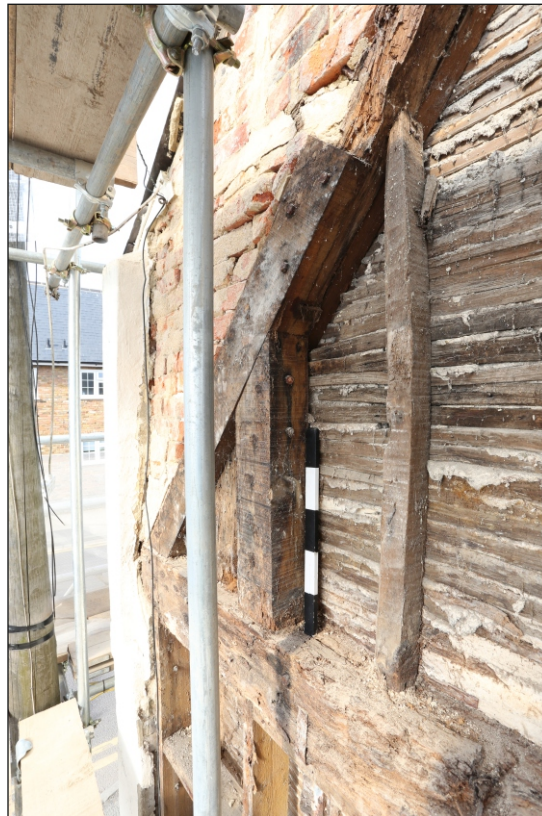
- 4.2.9 The collar measures 4.57 m above ground level (measured to its base) and is 0.15 m wide (**Plate 22**). Like the tie-beam, the face of the collar is heavily worn and degraded. The north-east end appears to be pegged to be principal rafter although the worn state of the timber meant the peg was not obvious (**Plate 27**). Its south-east end rests in a notch cut into the principal rafter. Notches in the top of the collar indicate the position of purlins that have been removed. The south-east purlin has been replaced by another in a slightly higher position (**Plate 28**). A groove along the top of the collar suggests the top of the gable was previously infilled with wattle and daub (**Plate 29**). However, there are no corresponding stave holes in the principal rafters.

Plate 22: The north-east side of the south-west elevation at tie-beam level showing some modern repairs

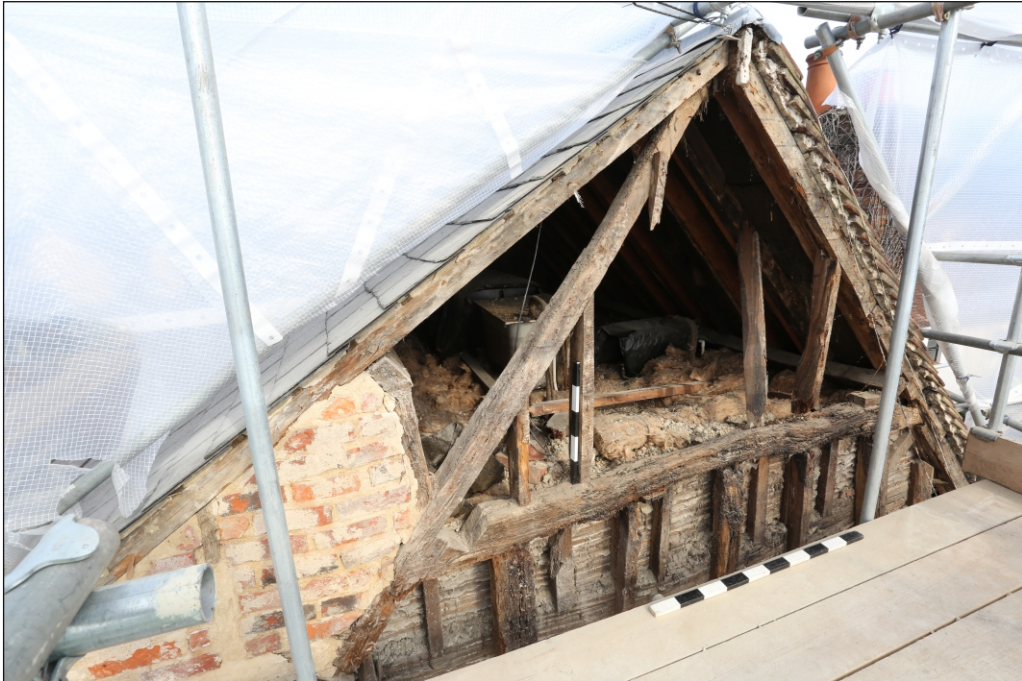
- 4.2.11 The principal rafters of the cross-frame are pegged to the tie-beam and meet a narrow ridge piece at the apex of the roof (**Plate 23**). The lower end of the north-west rafter has been replaced by a modern timber and supported by modern studs bolted together. This rafter narrows above the collar (from 0.2 m to 0.85 m), apparently to accommodate the missing purlin. Conversely, the south-east rafter remains a consistent width (0.15 m visible).

Plate 23: The south-west elevation at collar/roofspace level, viewed from the west

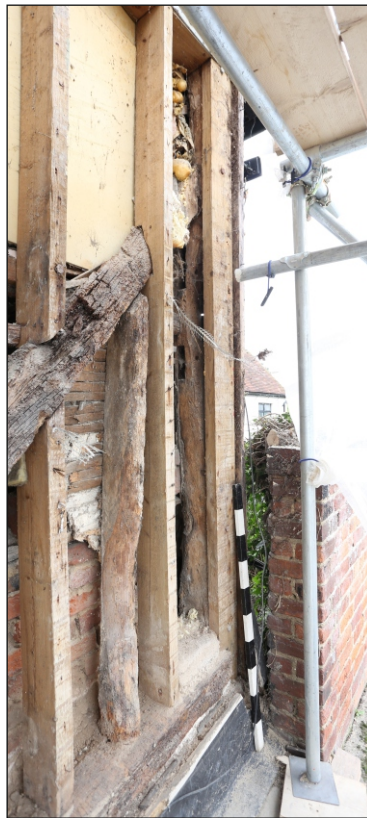
Plate 24: The earlier and modern south-east posts in the south-west elevation. Note the empty mortices

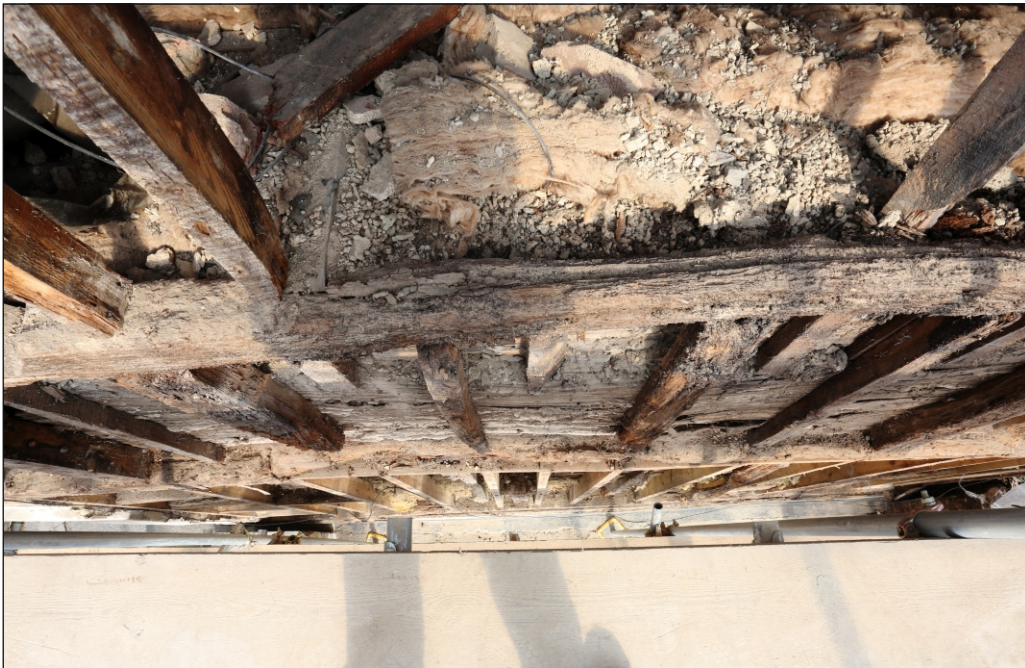
Plate 29: The groove in the top of the collar in the south-west elevation

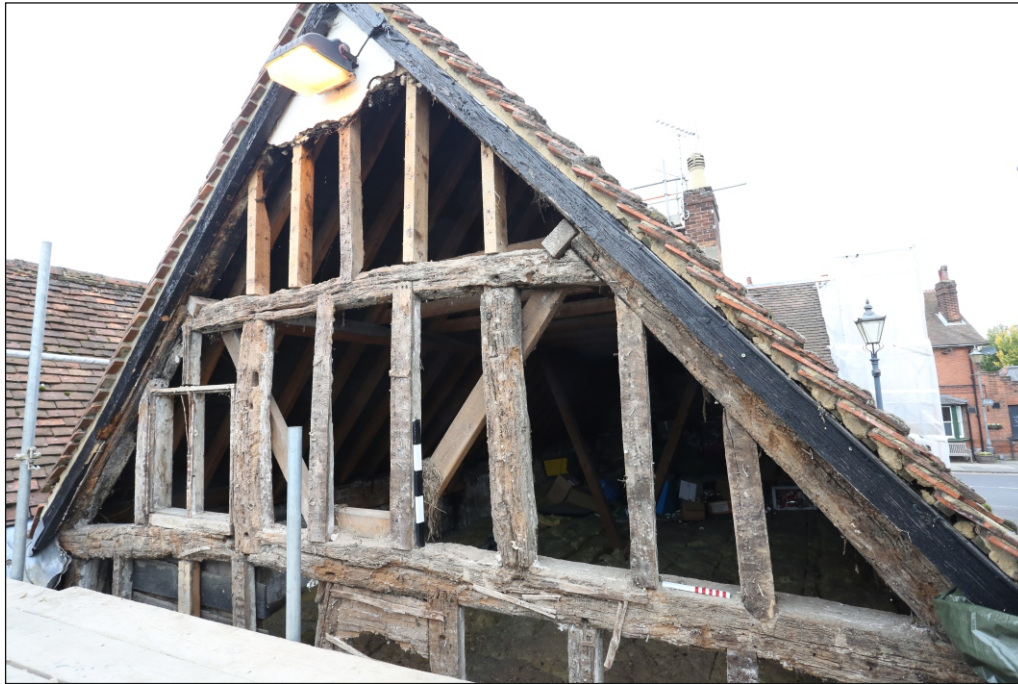
- 4.3.13 The collar measures 4.37 m above ground level (measured from its base) and 0.15 m wide (**Plate 31**). It is pegged to the principal rafters either side and the queen struts below. The top of the collar has a notch at either end to hold a clasped purlin, but the existing purlins are modern replacements. As with the tie-beam the collar soffit has a series of stave holes to take wattle and daub.

Plate 31: The south-east elevation at tie-beam and collar level, viewed from the east

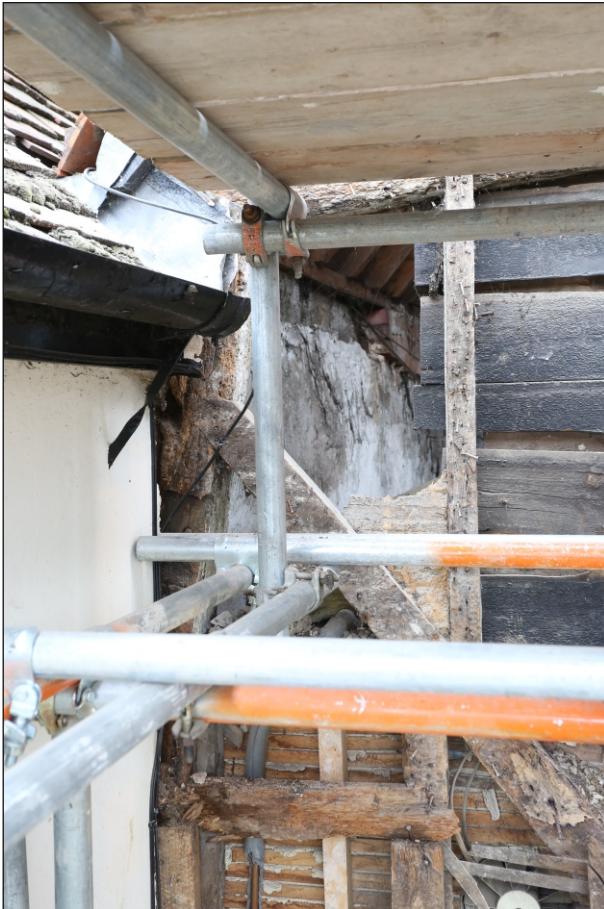
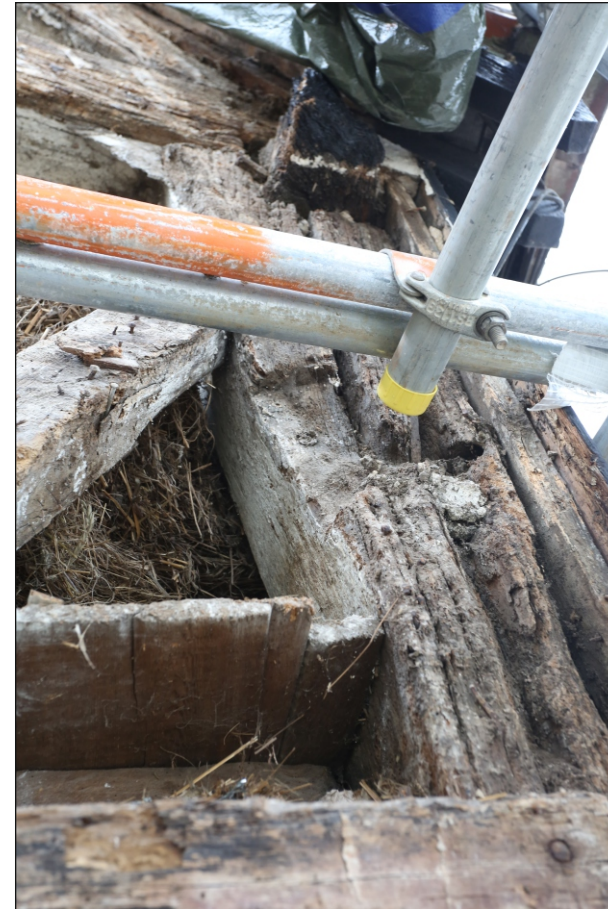
- 4.3.7 The majority of principal timbers within the cross-frame are pegged together and share a similar heavily weathered patina. The sill beam measures 0.17 m thick and its face is heavily worn, revealing the pegged ends of some of the studs above. At either end of the sill beam there are jowled posts which support the cambered tie-beam and wall plates (seen in profile). The width of the posts varies from 0.16 m at the base to 0.3 m at the head. The north-east jowled post sits on the sill beam of the north-east wall of the rear range. Each post has a down-brace nailed into a notch lap and tenoned into the sill beam. Below these existing down-braces, each jowled post has an empty pegged half lap joint angled down as if earlier down-braces have been removed (**Plates 33-34**).

Plate 33: Detail of the south-west jowled post and down brace with an empty half-lap joint in the south-east elevation

Plate 34: Detail of the empty half-lap joint on the north-east jowled post in the south-east elevation

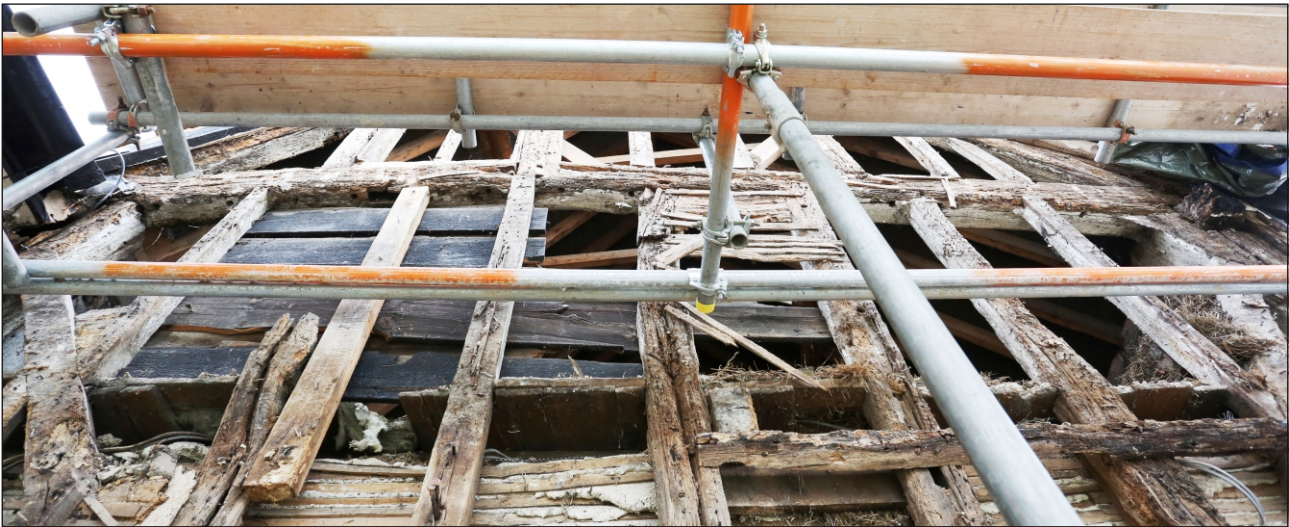
Plate 35: Soffit of the tie-beam in the south-east elevation showing stave holes and empty mortice

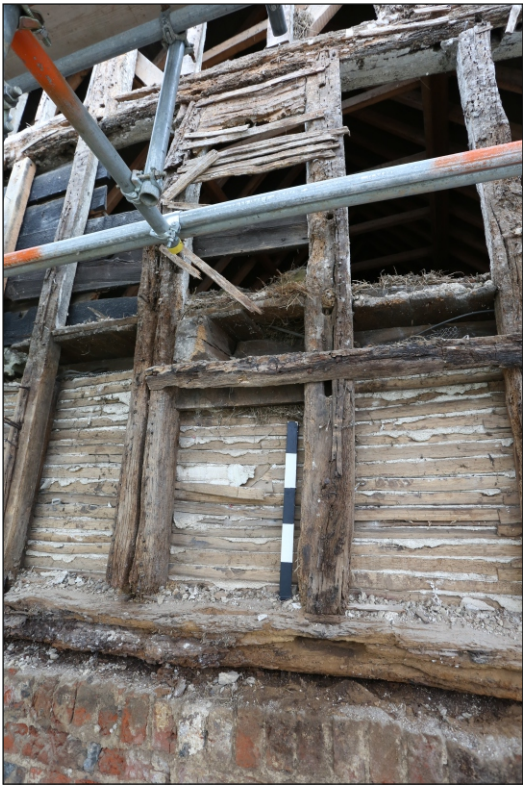
- 4.3.17 There is a patch of surviving lath and plaster immediately beneath the tie-beam (**Plate 36**). Series of nails and broken laths fixed to other studs suggest that the whole wall beneath

Plate 36: Reused timber stud and remnant lath and plaster located towards the centre of the south-east elevation beneath the tie-beam

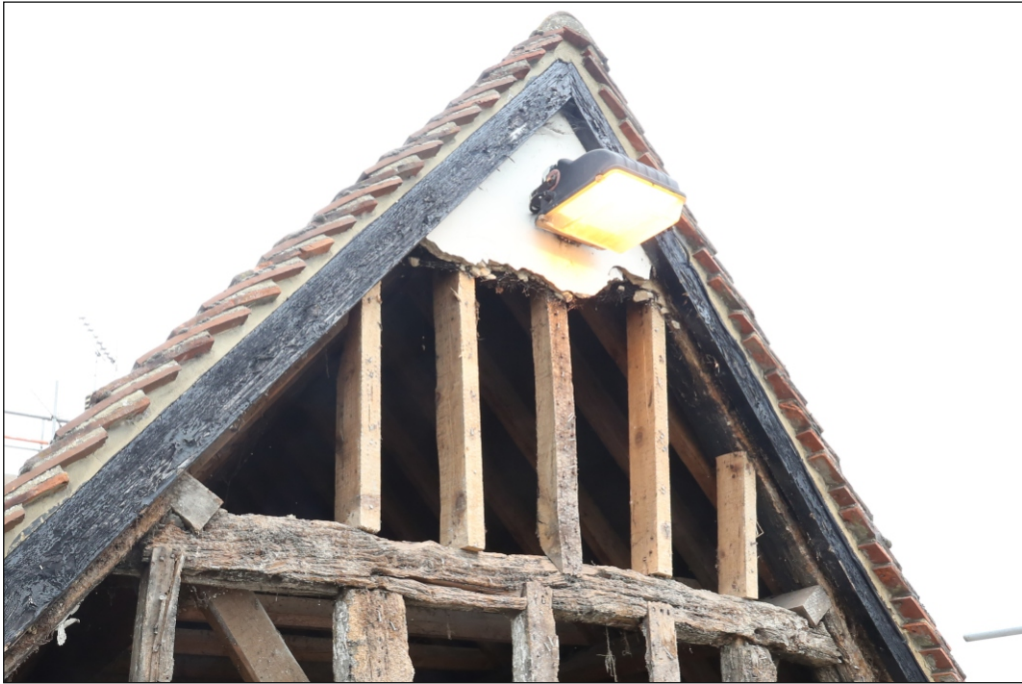
Plate 39: Modern fabric above the collar in the south-east elevation
