# The Royal Oak Public House The Square, Yattendon, Berkshire

Historic Building Record

Planning Ref: 17/01297/FUL and 17/01298/LBC2  
Accession Number: NEBYM:2017.29  
Ref: 116571.02  
August 2018

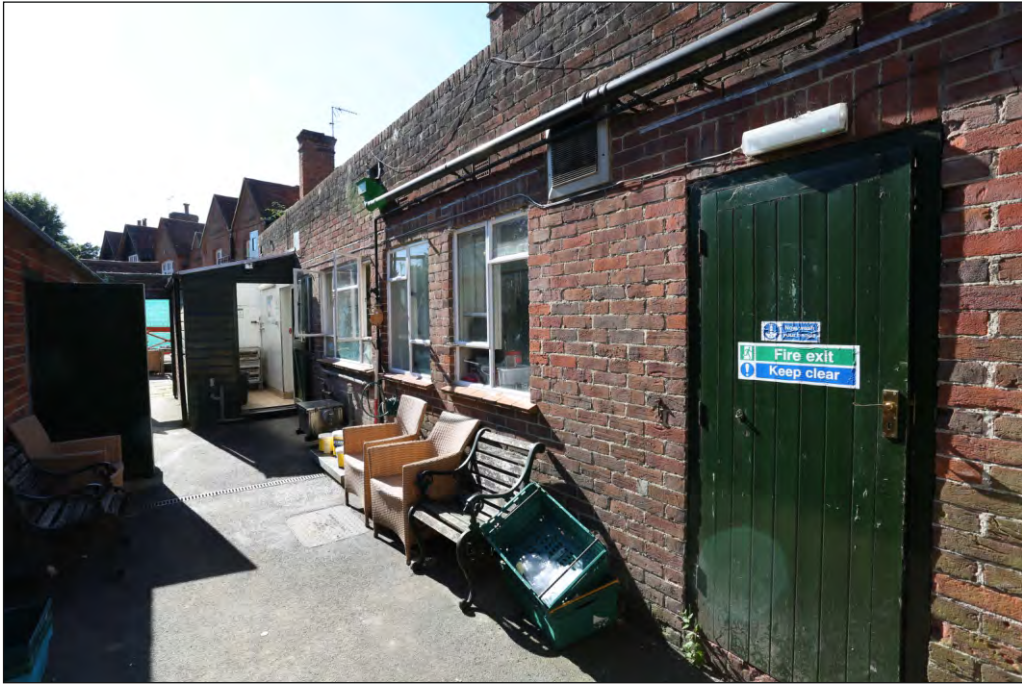
- 4.2.1 This area is located in the existing kitchen at the western end of the building (**Figure 3**) which is set away from the main building possibly as a fire precaution. The kitchen building is constructed in mid-red coloured brick laid in stretcher bond set in a sandy cementitious mortar. It has a flat roof behind a brick parapet topped with a single course of 'brick-on edge' (**Plates 1-2**). Walls are of cavity construction with occasional air bricks at high level and at the base of the parapets to aid in venting the interior. At the base of the wall a slate damp course was noted.

Plate 1: Kitchen building (intervention 1) north wall exterior viewed from west

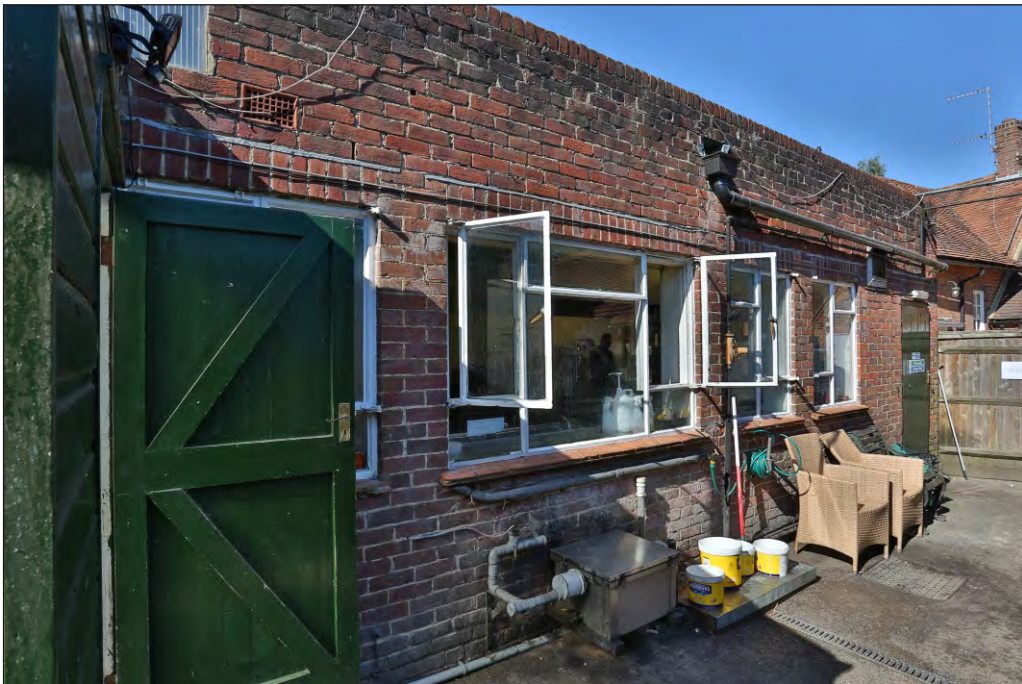
- 4.2.2 Along the north wall of the kitchen there are a series of window openings fitted with a mixture of single and double metal framed casements. This arrangement is asymmetrical at present but may have originally been arranged symmetrically with a large double casement in the centre flanked by pairs of single casements to the east and west. The most easterly opening is now a door (**Figure 3**). Each of the window openings is topped with a three-quarter length soldier course of bricks with evidence of lead drip trays fitted across the internal cavity in the form of thin lead strips visible along the top of the course of bricks. The window sills are formed from a double layer of hard red roof tiles bedded in cementitious mortar.

Plate 2: Kitchen building (intervention 1) north wall exterior viewed from east

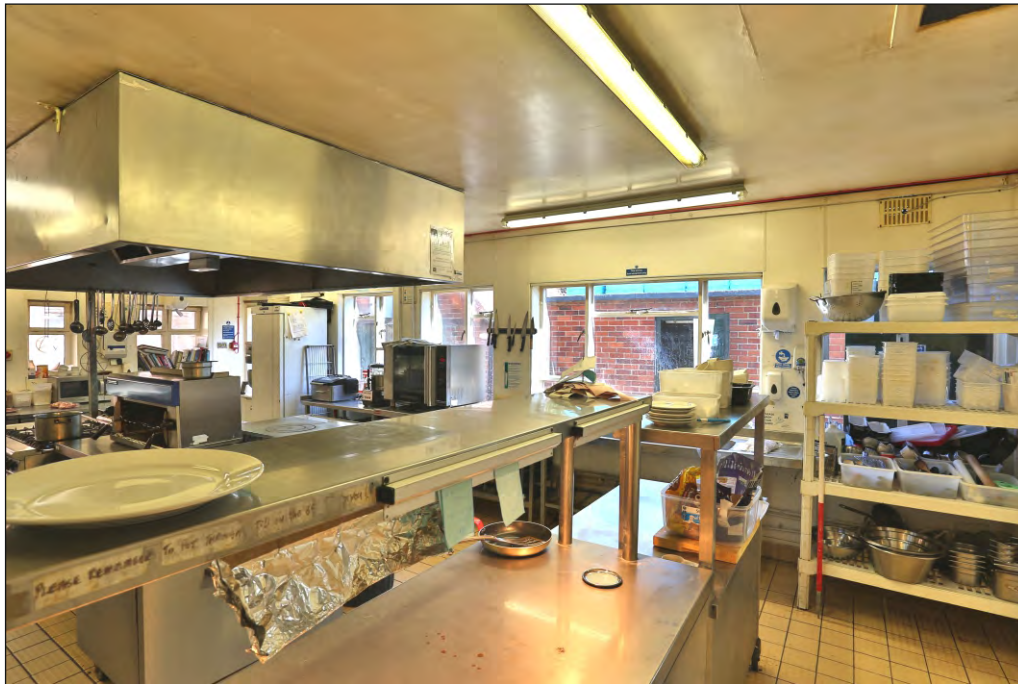
- 4.2.3 At the west end of the room an original wooden door is fitted into an original opening giving access to the small yard on the north side of the kitchen and the storage building to the north. Internally the kitchen is fitted out with modern appliances and modern flooring (**Plate 3**).

Plate 3: Kitchen interior (intervention 1) viewed from south

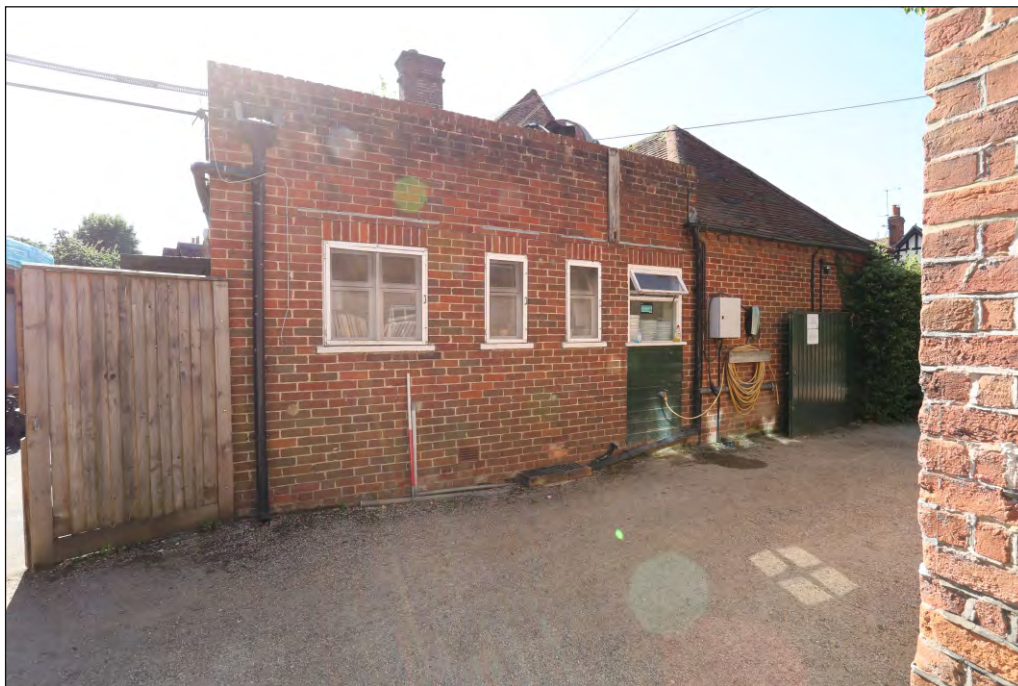
- 4.2.4 The west end of the kitchen is constructed in the same manner with the same bricks and styling and the parapet is continued around from the north wall. (**Plate 4**). There are presently four windows arranged symmetrically with two narrow central openings flanked by a single wider opening to the north and south. The south opening was originally a door but has been blocked to window sill level with horizontal wooden boards.

Plate 4: Kitchen building (intervention 1) west wall exterior viewed from west

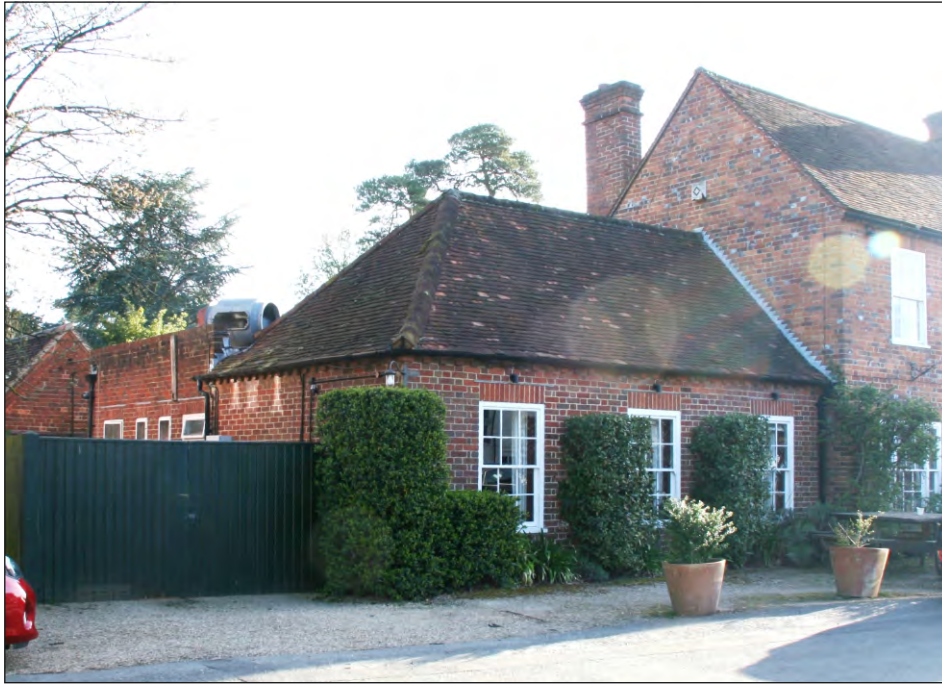
- 4.2.5 The south end of the kitchen wall is bonded into the west wall of the dining room. A comparison of the dining room and kitchen shows that two buildings are almost certainly contemporary. This confirms the information seen on the historic photographs mentioned above. The bricks are the same, the mortar is the same, the bond is the same and, the slate damp proof at the base of the wall is continuous along the west walls of both buildings. The dining room has a hipped roof covered with red clay tiles which hides the

Plate 5: Single-storey west dining room building contemporary with kitchen

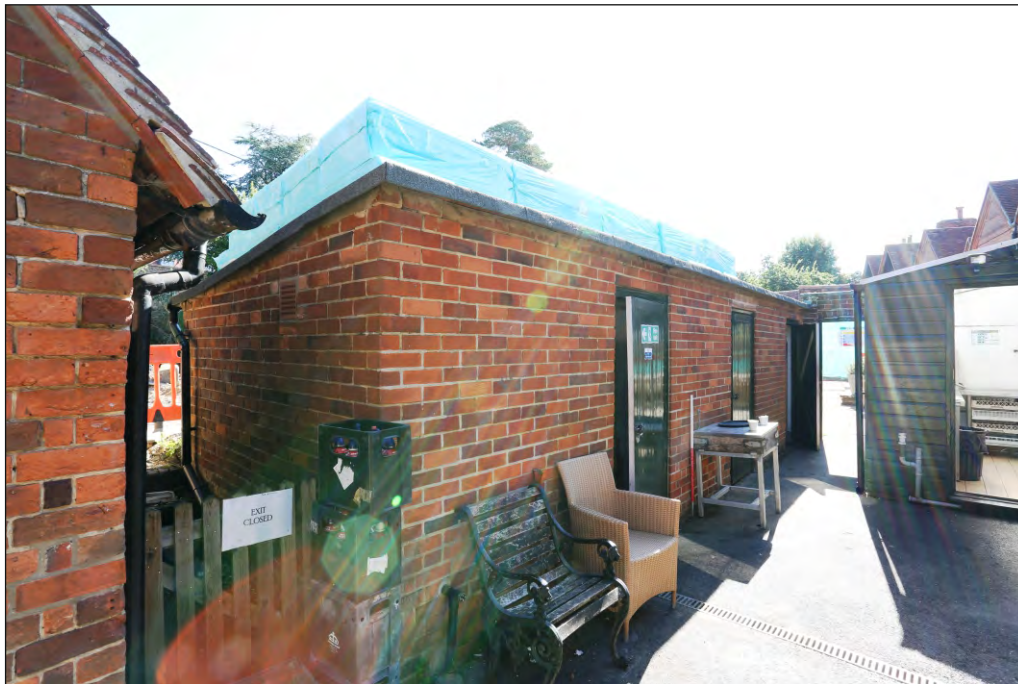
Plate 6: Outbuilding store (intervention 2) south front viewed from south-west

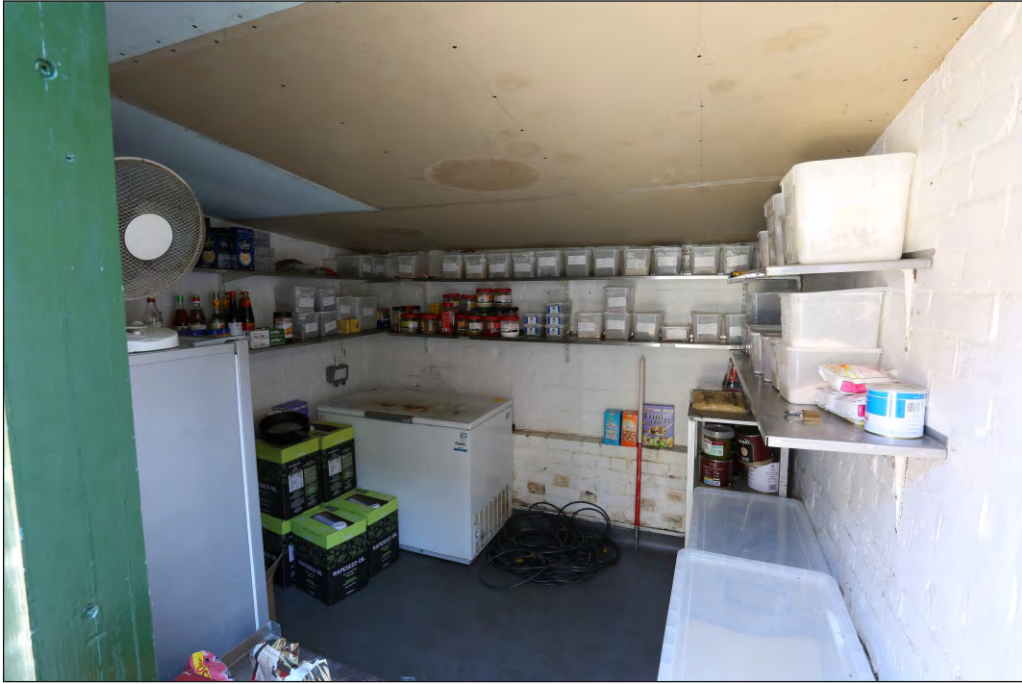
Plate 7: Outbuilding store A interior (intervention 2)

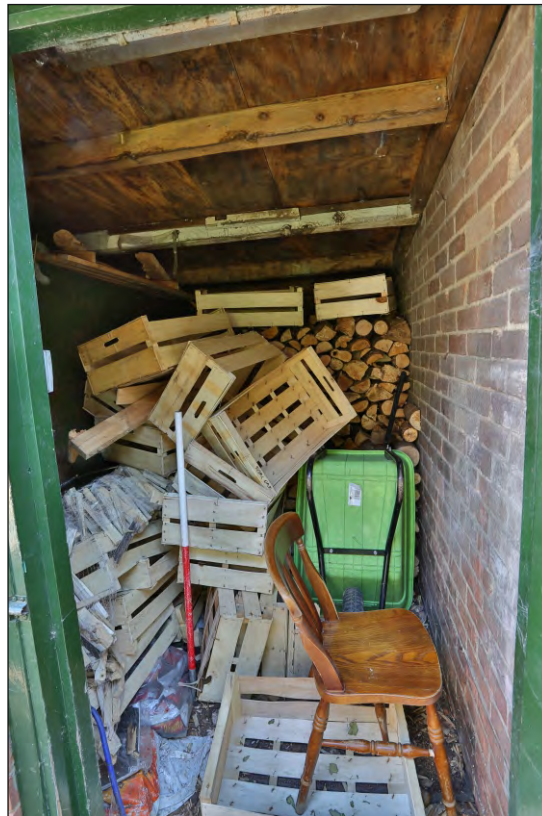
Plate 8: Outbuilding store B interior (intervention 2)

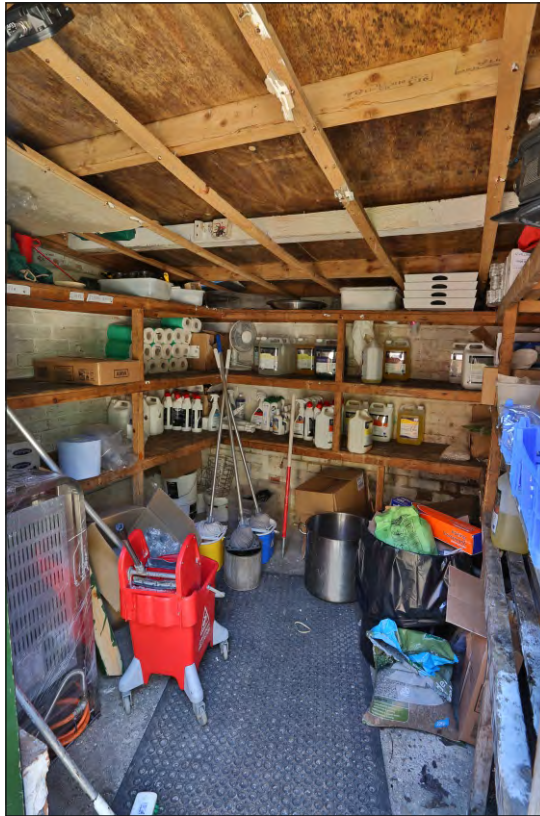
Plate 9: Outbuilding store C interior (intervention 2)

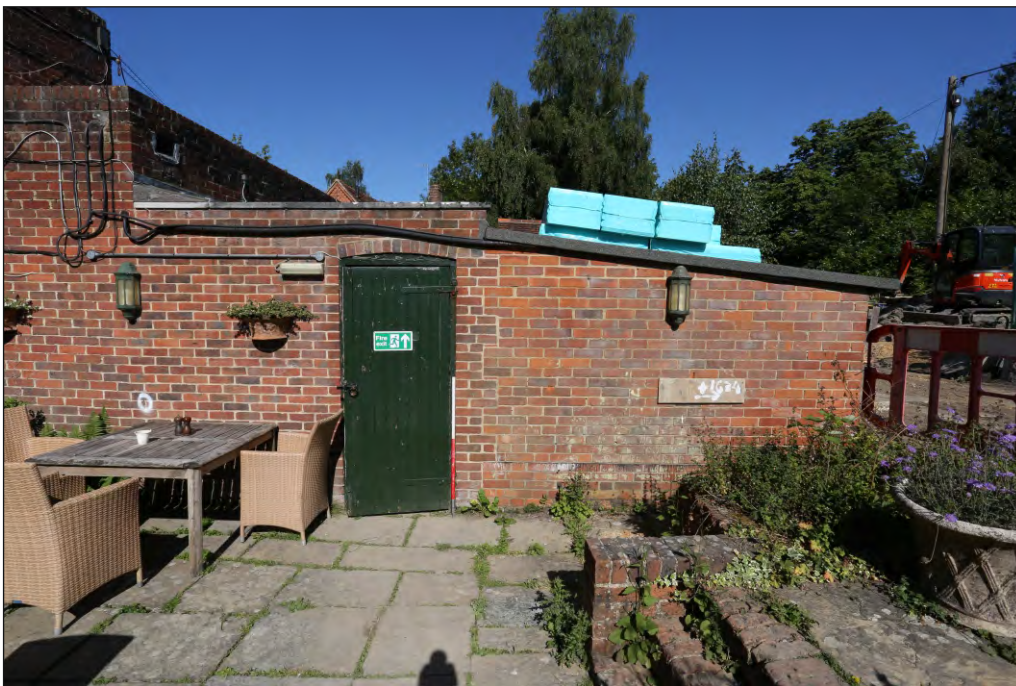
- 4.2.9 The east end wall of the building has been 'block-bonded' into the east end wall of the kitchen building (**Plate 10**). Noted at the base of the east wall was a bitumen damp course. Over time this has melted and run down the exterior brick face of the wall. The north wall has been slightly dug into the existing ground level and remains a plain wall with no distinguishing features. This building also post-dates the 1956 rebuild.

Plate 10: Outbuilding store east wall bonded to kitchen wall (intervention 2)

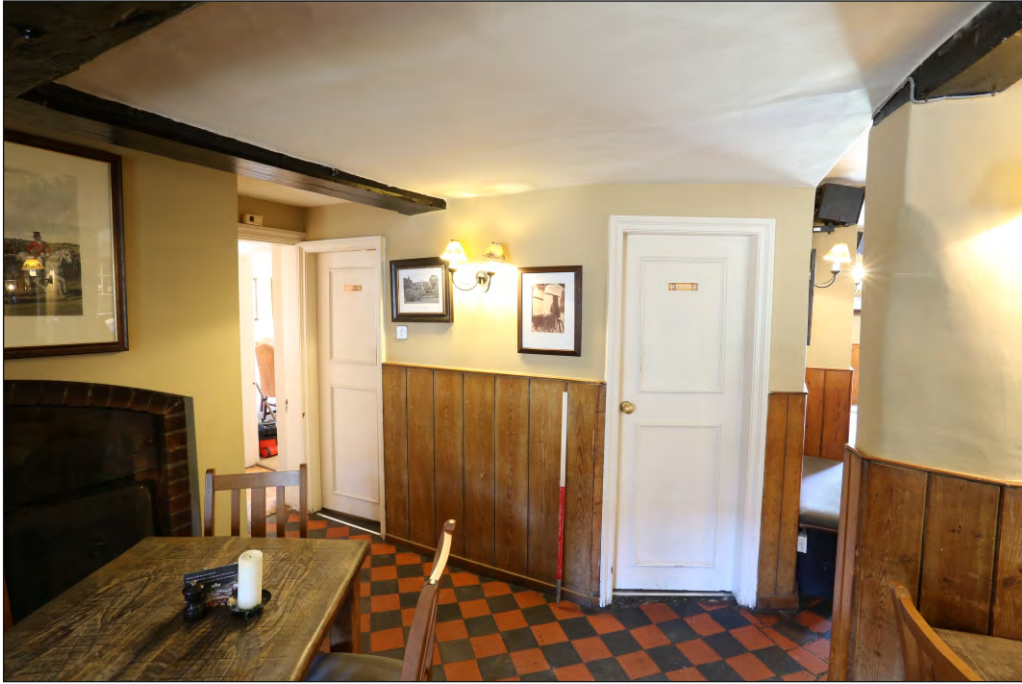
Plate 11: Internal view of current toilets (Intervention 3)

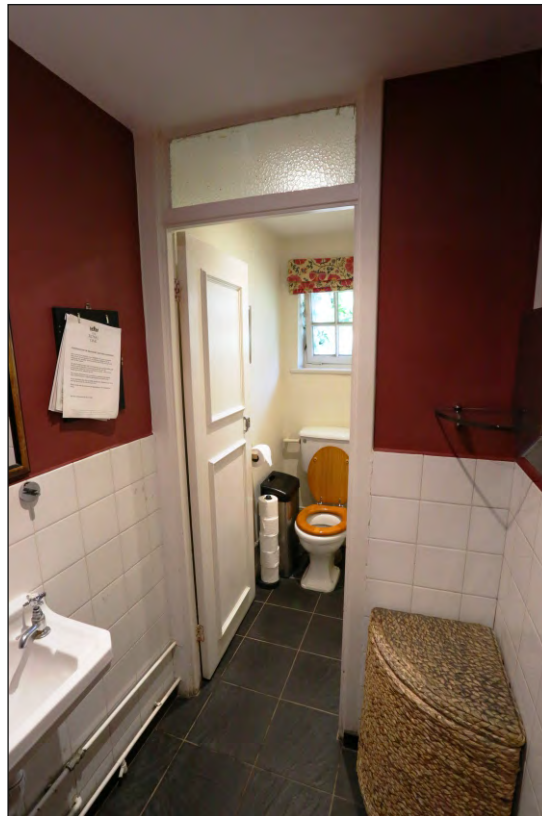
Plate 12: Current female toilet interior (intervention 3)

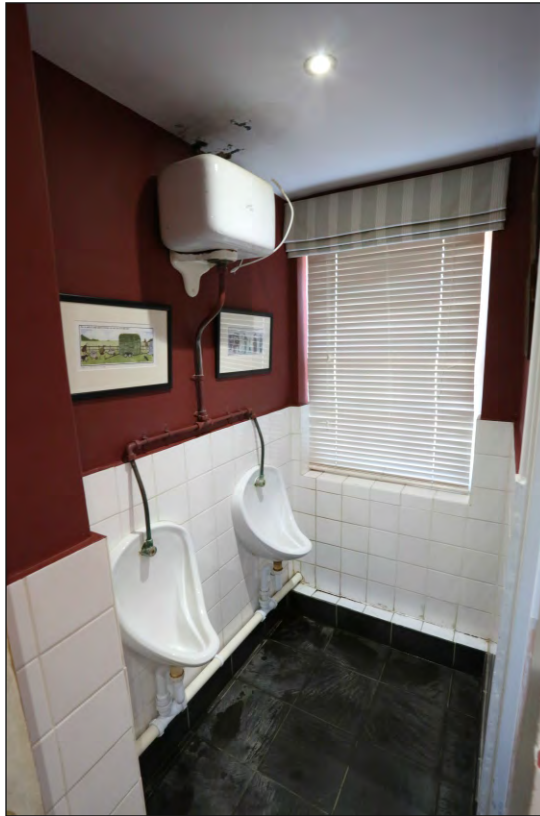
Plate 13: Current male toilet interior (intervention 3)

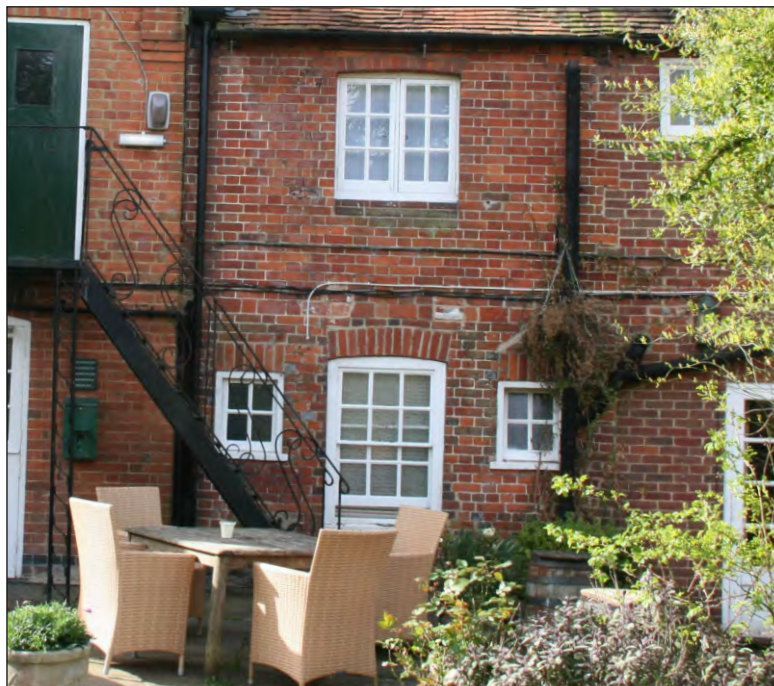
Plate 14: Exterior of ground floor toilets (intervention 3) viewed from north

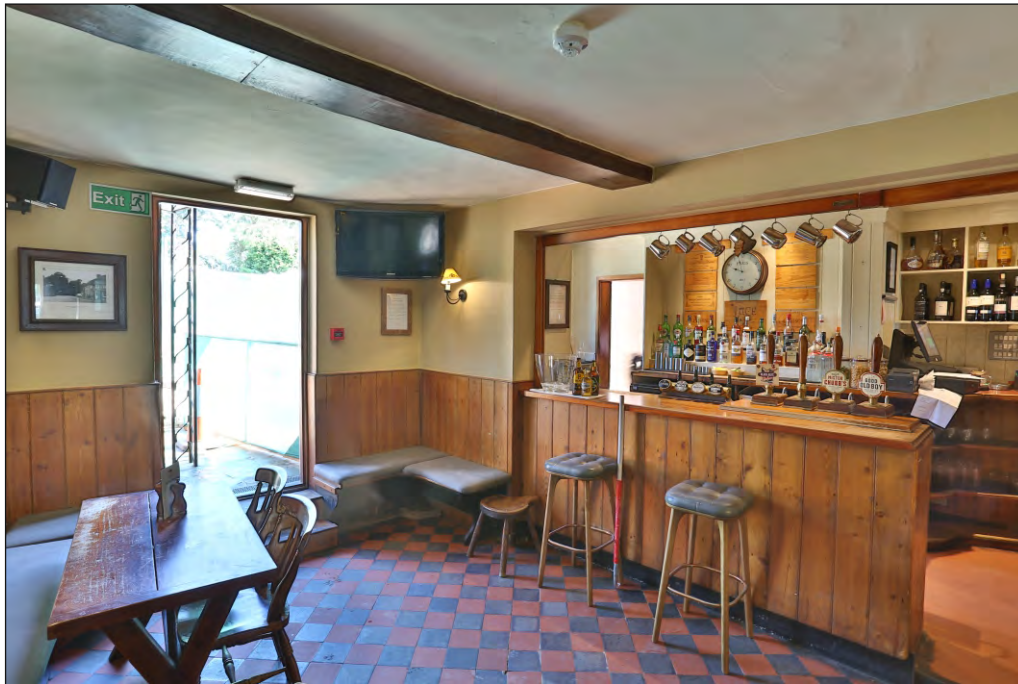
Plate 15: Public bar area (intervention 4)

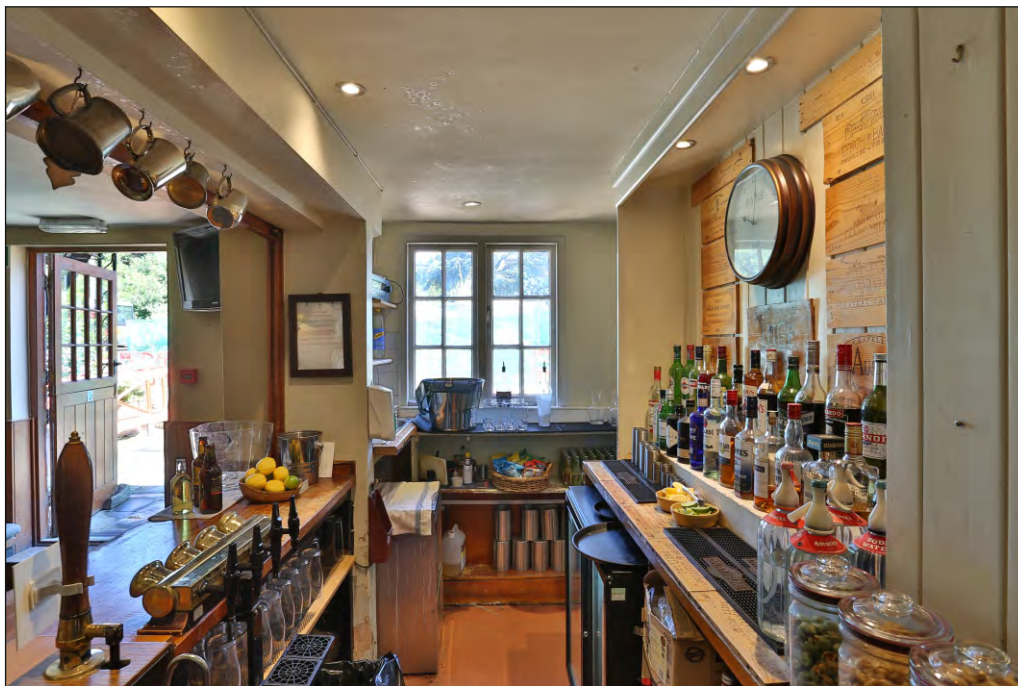
Plate 16: Public bar and window to be removed in north wall (intervention 4)

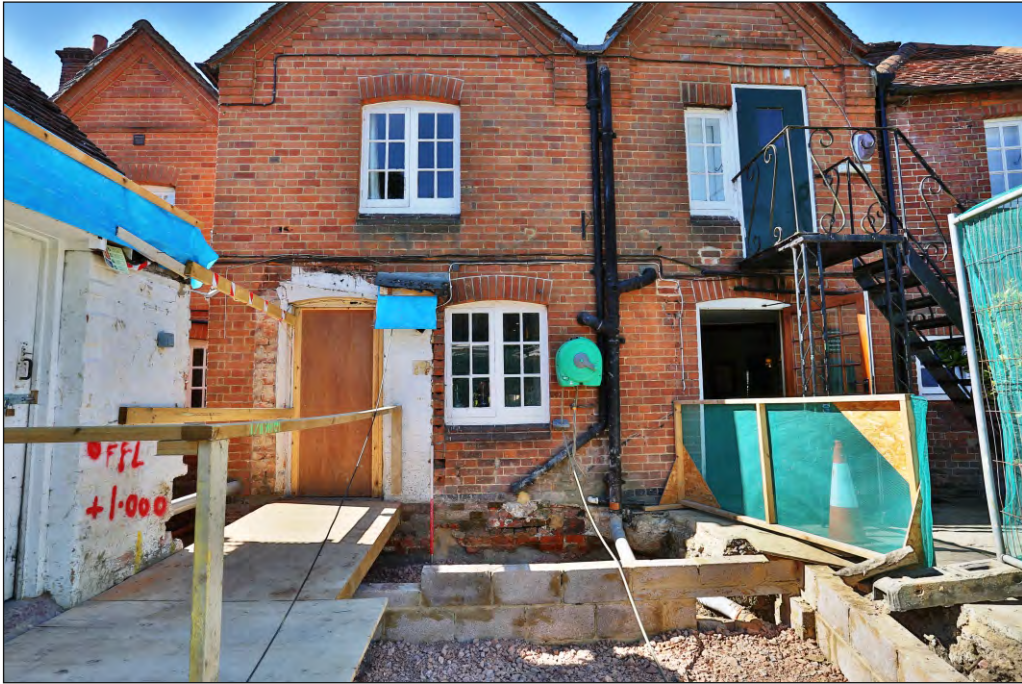
Plate 17: Exterior ground floor wall and openings (intervention 4)

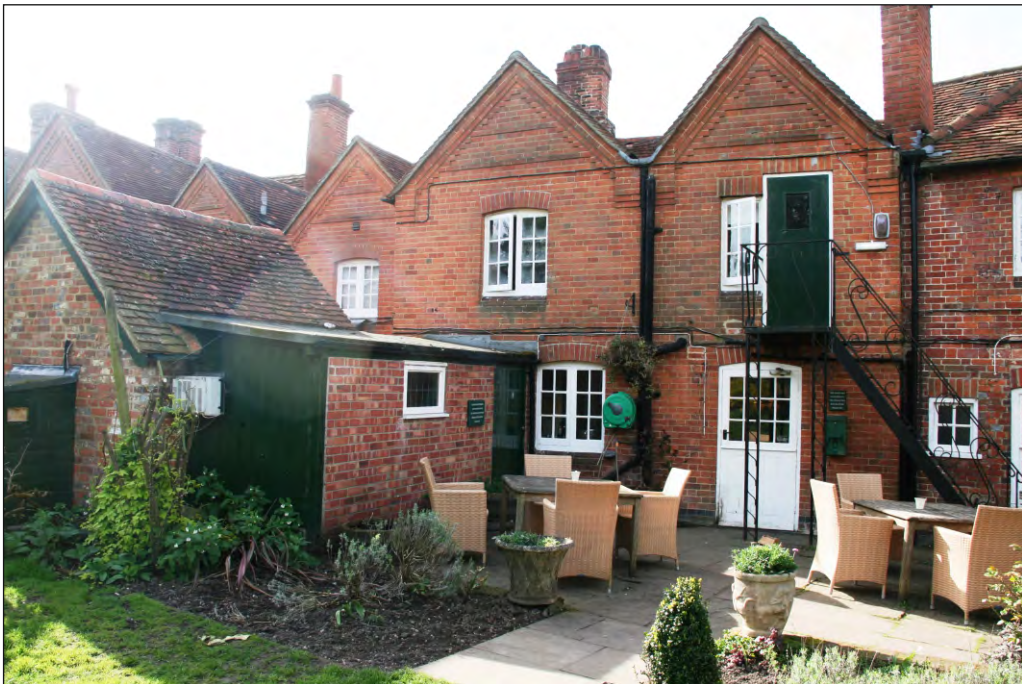
Plate 18: Connecting passage building (intervention 4)

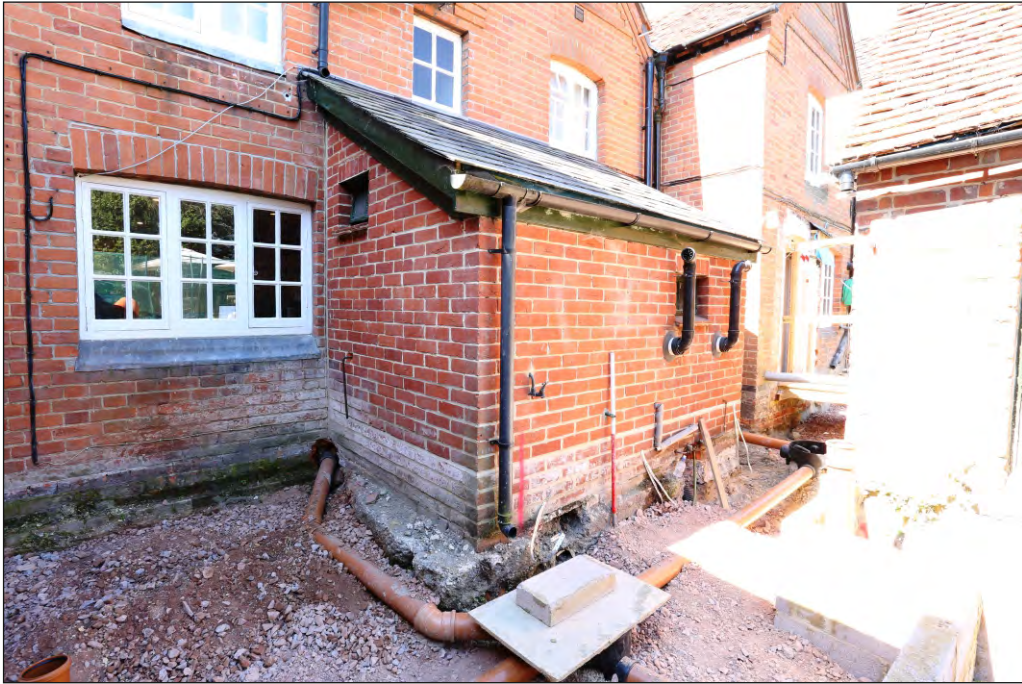
- 4.2.19 The attached outbuilding appears after 1910 and is constructed in red brick laid in stretcher bond set on a concrete foundation (**Plate 19**). It has a mono-pitched roof covered in slate and only two small window openings in the east and north walls. The

Plate 19: Outbuilding viewed from north-east (intervention 5)

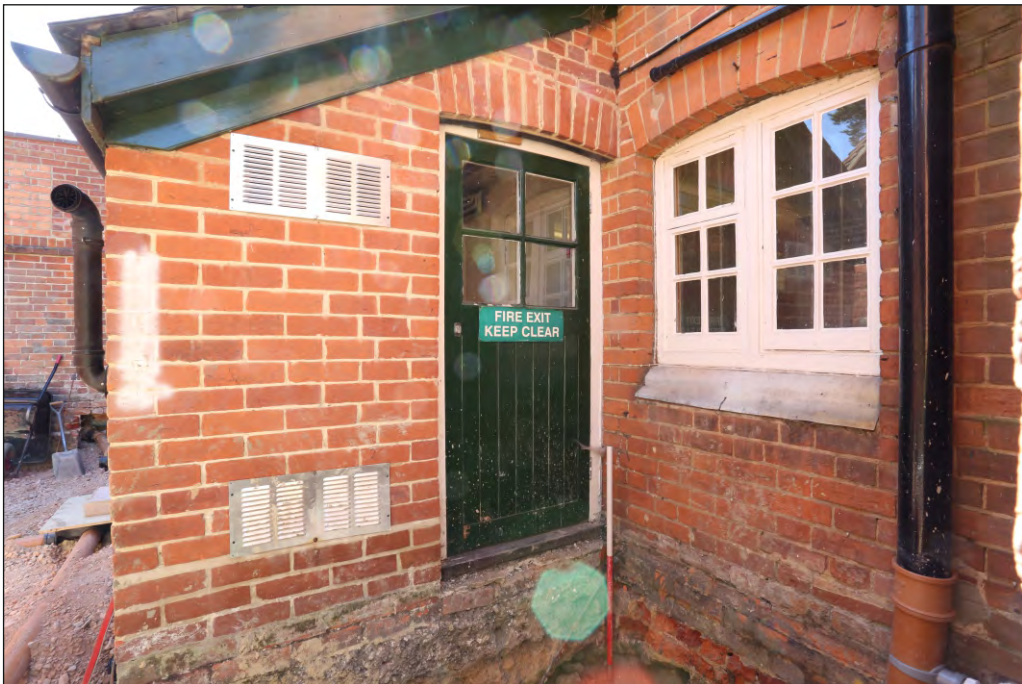
Plate 20: Outbuilding door and rear window (intervention 5)
