HANSON HOUSE  
SNYDALE ROAD  
NORMANTON  
WAKEFIELD  
WEST YORKSHIRE

Historic Building Recording

**Planning Application Ref: 07/00704/FUL & 07/00705/LBC**

74352.02\_BDG\_V0\_3

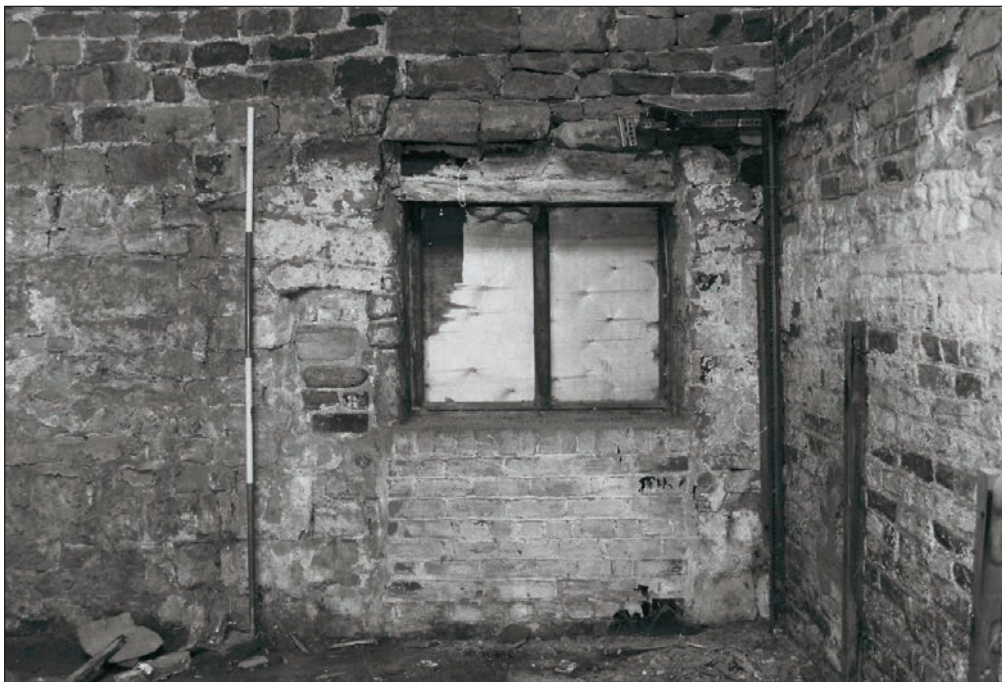
Plate 34: Internal detail of altered door to window and blocked breather slit, west wall of G1, Building 1 (Film 24.03)

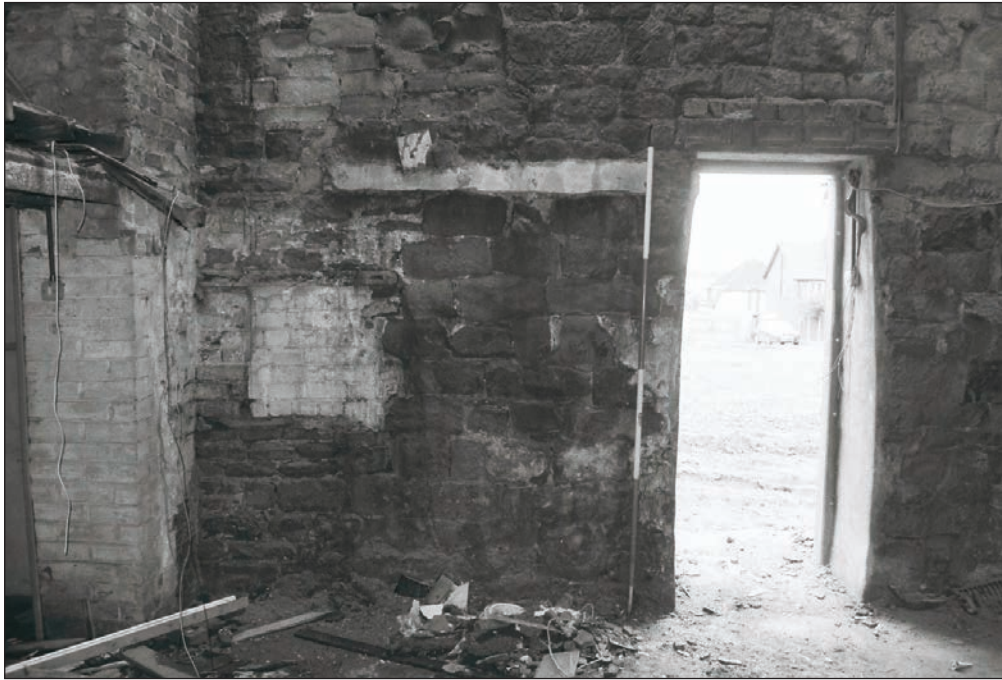
Plate 39: Internal view of the inserted door and blocked window, east wall of G1, Building 1 (Film 24.10)

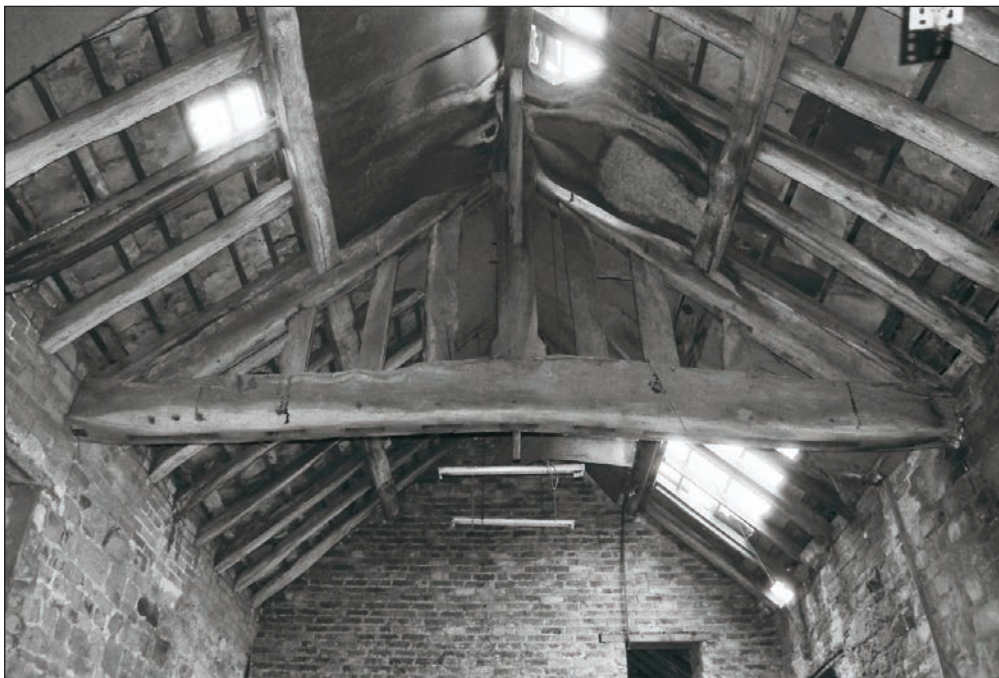
Plate 58: View of the timber truss, showing empty mortice joints on underside of tie beam, F1, Building 1 (Film 24.19)

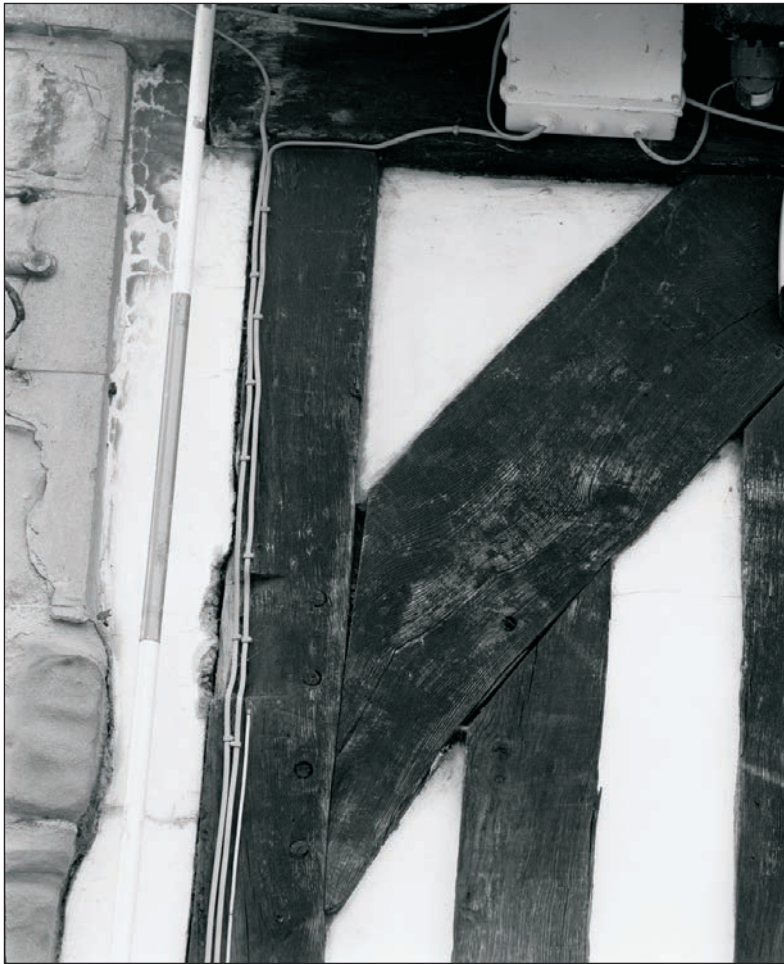
Plate 112: Detail of the eastern post with pegged arched brace, north elevation, Building 2 (note absence of further peg holes on east of upright post) (Film 09.10)

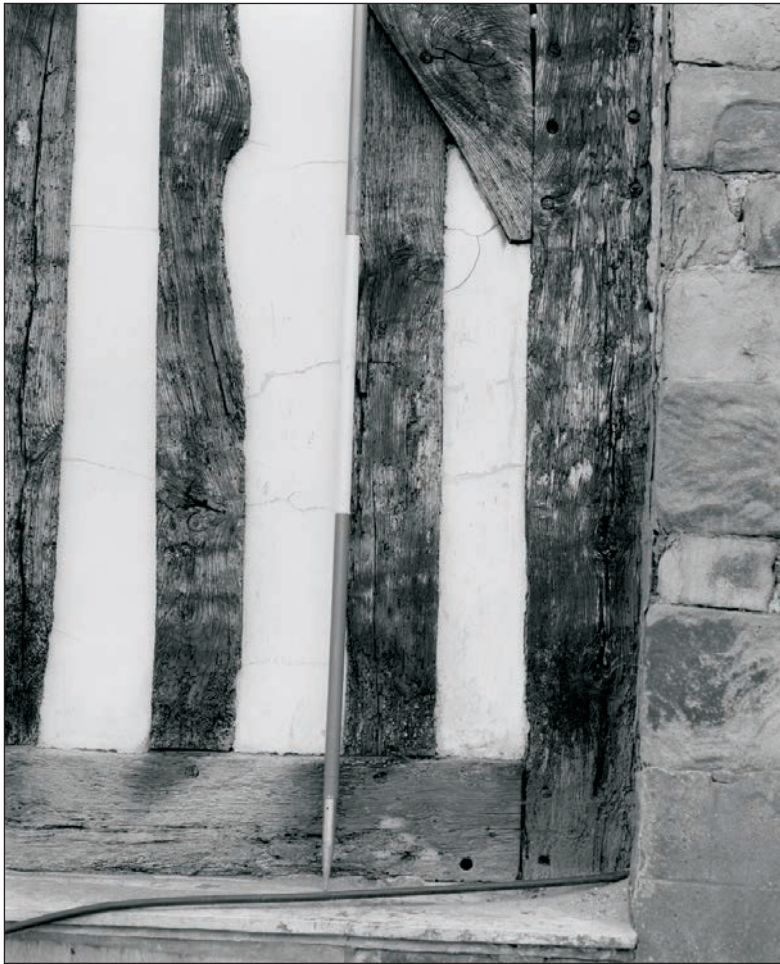
- 5.3.7 At ground floor the elevation was constructed with coursed sandstone. The former close studding below the mid-rail had all been removed and replaced with stone wall. Positioned at the east end was an inserted doorway with flat stone pediment (**Plate 109**). To the west of this was a stone built buttress, an altered or inserted window (blocked) and a small window at the west end in the position of a former doorway, opposing the former doorway within the south elevation (**Plate 107**). Two pairs of peg holes within the mid-rail indicated the position of the former doorway within the timber framed building (**Plate 116**).

Plate 116: Detail of western post showing join with the mid-rail and arched brace, north elevation, Building 2 (note empty peg holes at bottom of post and mid-rail for former doorway, and those within post for a former arched brace to the west) (Film 09.05)

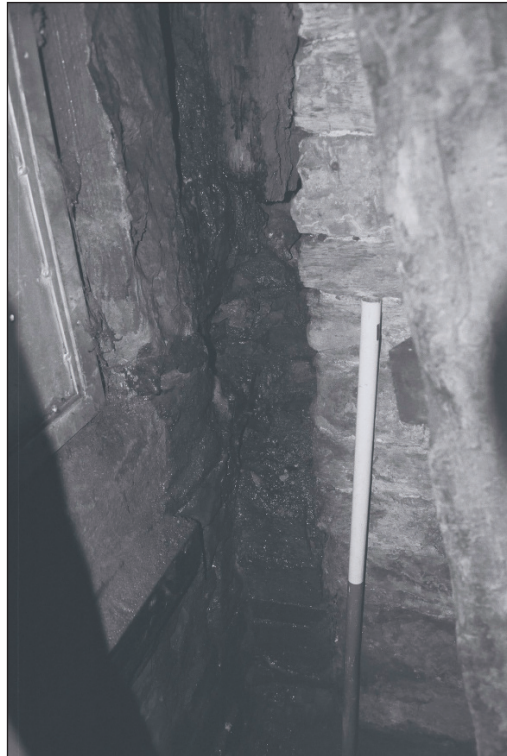
- 5.3.16 Five of the main timber posts of the building, previously encased by stone at ground floor were also exposed during the watching brief. These were originally positioned on large stone built pads. Although the close studding at ground floor had all been removed, the posts, mid-rails and tie beams were all in-situ with the exception of the south-eastern post which had been removed and replaced sometime in the past, likely during phase 5 (**Figure 8, and Plates 169-176**).

Plate 172: Detail of exposed south-west timber post, G4, Building 2, showing decayed base of timber and inserted brick plinth/pad (Film 42.10)

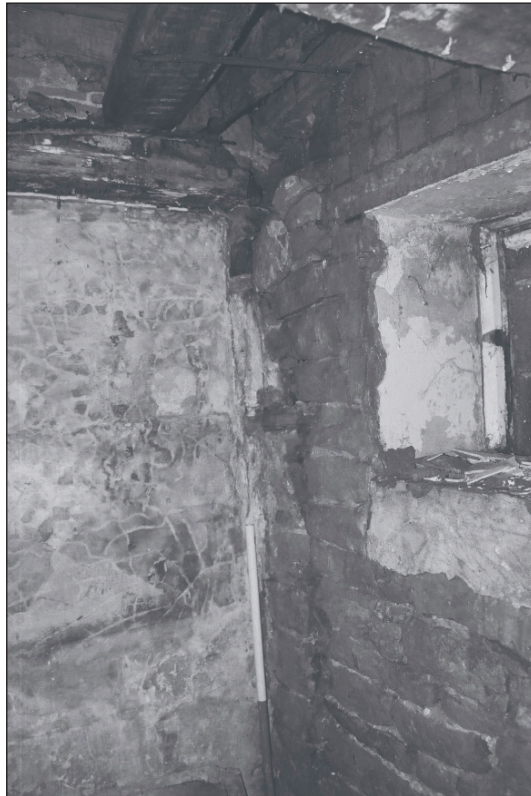
Plate 176: Detail of exposed southeast corner of G1 showing removed timber post, replaced with stone, Building 2 (Film 42.27)

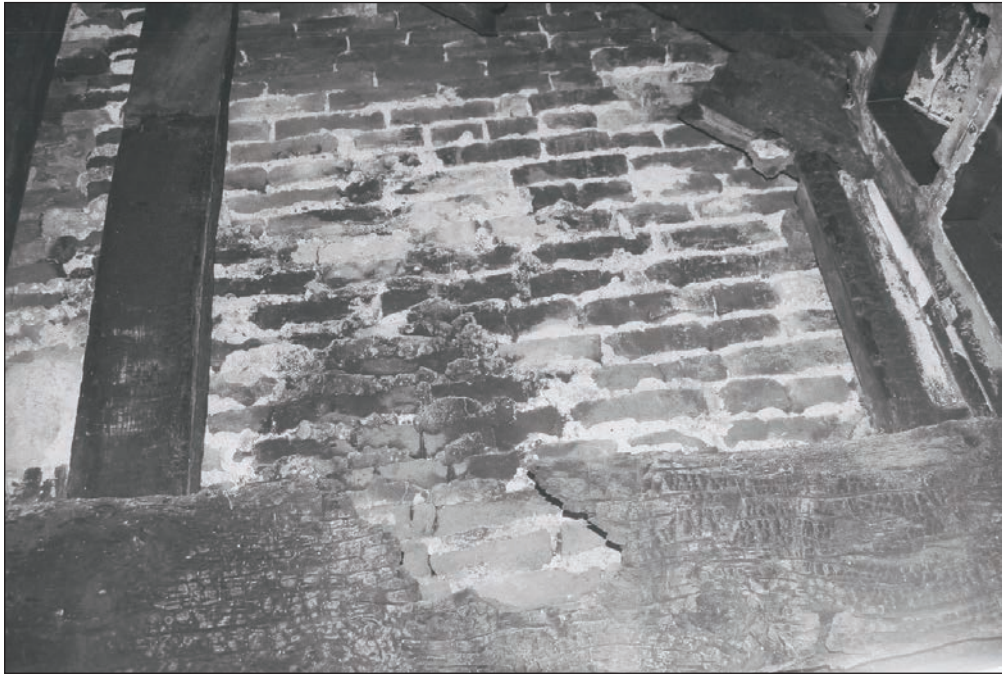
Plate 205: Detail of damaged timber partition/roof and brick gable of Building 3 built abut, west wall of F3, Building 2 (Film 12.01)

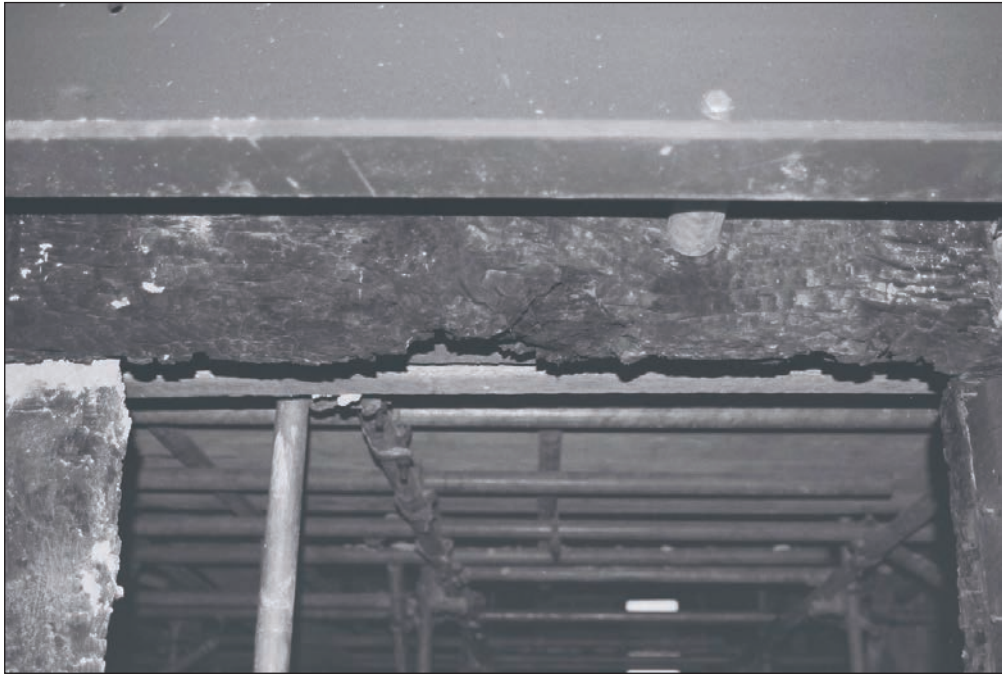
Plate 207: Detail of damaged empty peg holes within inserted doorway of close stud partition, F3, Building 2 (Film 43.05)

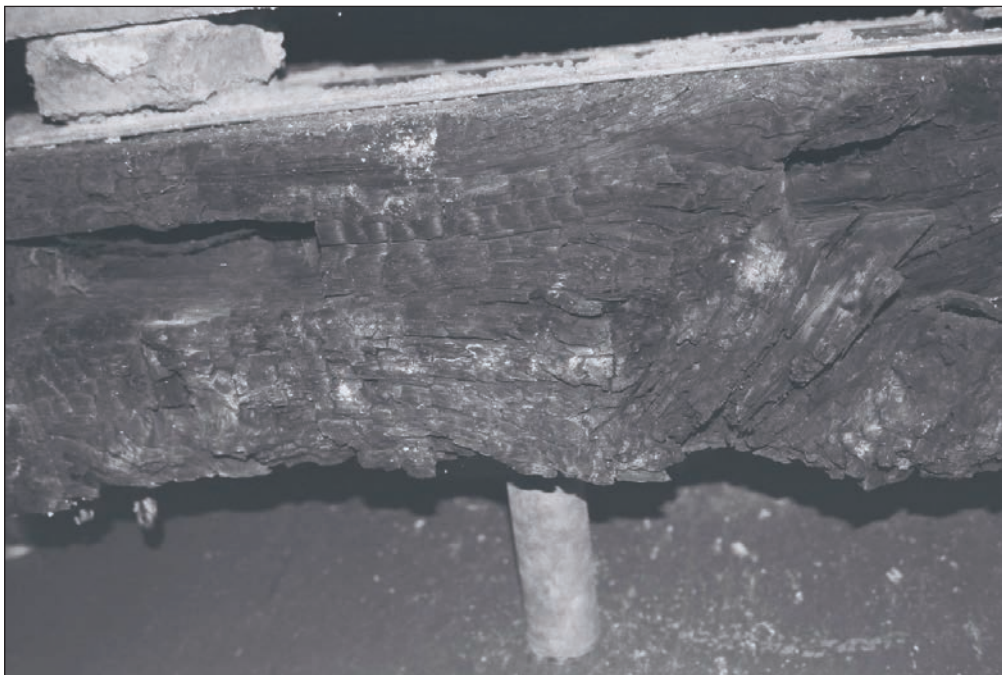
Plate 208: Detail of empty mortice holes in underside of tie beam of close stud partition for inserted door, F3, Building 2 (Film 43.03)
