Field Farm, Ashby Road Kegworth, Leicestershire

Historic Building Record

Ref: 101406.02
February 2017

Prepared for:
CgMs Consulting
140 London Wall
London
EC2Y 5DN

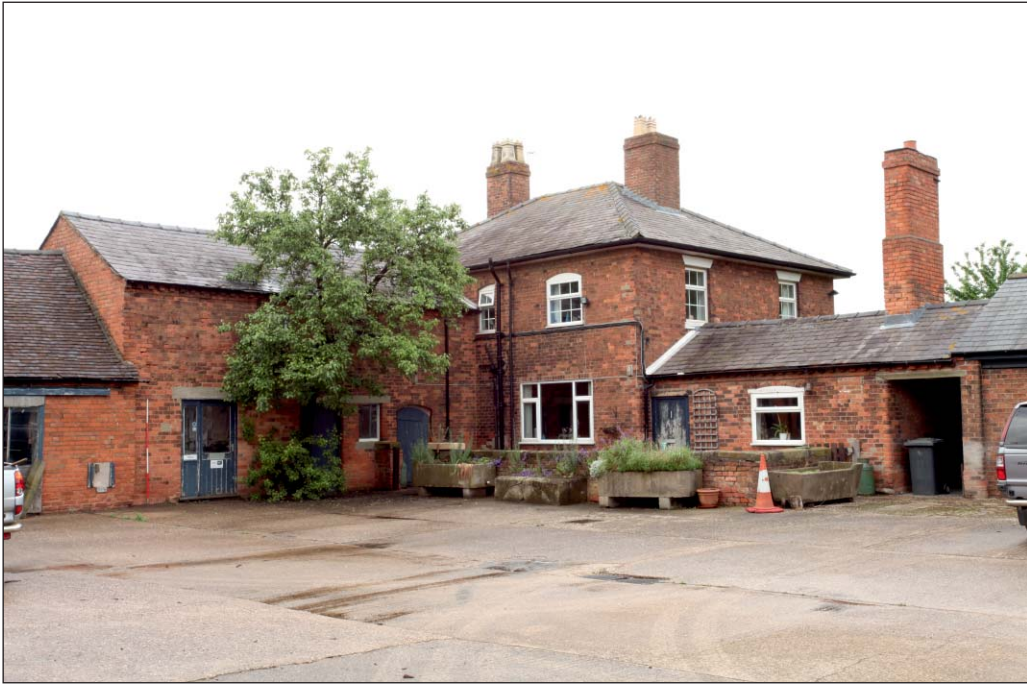
- 6.2.7 The west (rear) elevation of the house (Plate 1) joins the two storey west wing on its north side. The rest of the elevation comprises three windows but these are different from the windows in the other main house elevations. There is a large inserted uPVC casement window to kitchen G05 and two brick arched windows at first floor level. The first floor window to F05 the bathroom has been half infilled with brick and both first floor windows have awning type uPVC replacement frames.

Plate 1: Building 1 farmhouse viewed from the southwest

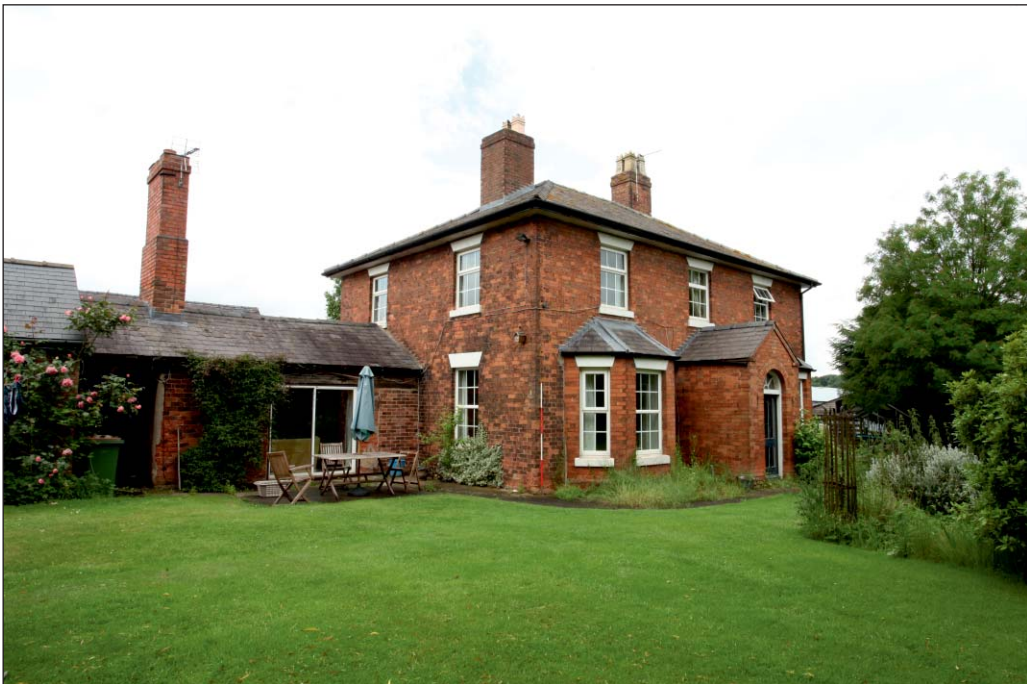
- 6.2.5 The south elevation (Plates 1 and 2) of the main house connects to the south wing at its south-west corner and has three windows identical to those in the east elevation and like them the frames are uPVC replacements. The window sill to room F03 is overlapped by the roof of the south wing, which suggests it was constructed later. However, both appear on the 1884 OS map.

Plate 2: Building 1 viewed from the southeast

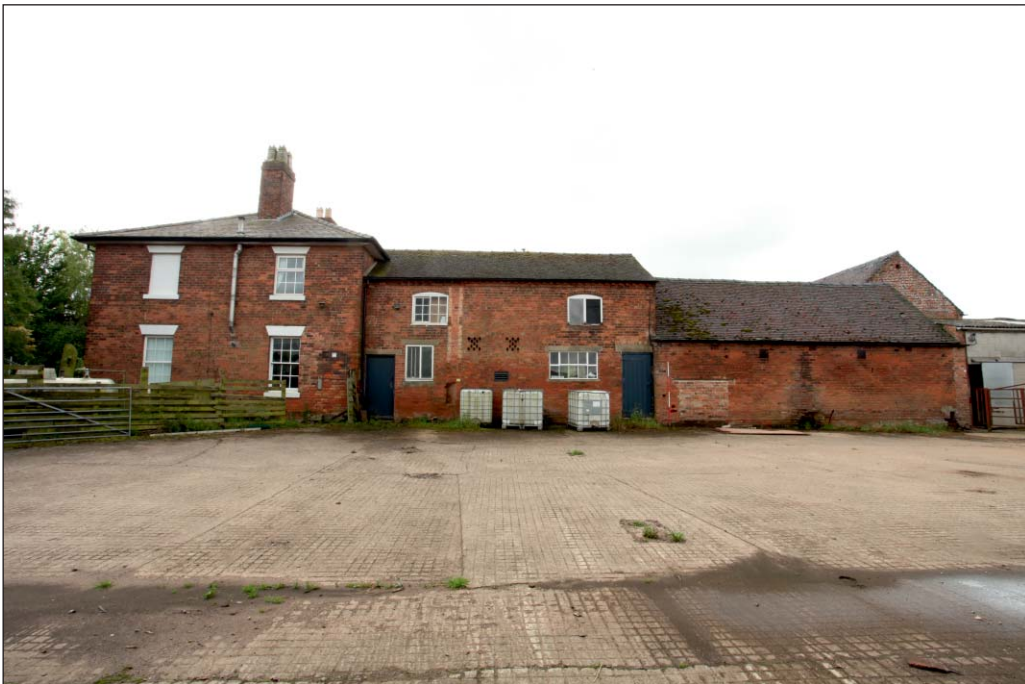
- 6.2.6 The north elevation (Plate 4) of the main house comprises four windows identical in form to those on south elevation and east elevations. The window to F02 has been blocked at an unknown date and those to F04 and G02 have replacement uPVC frames. The window to G06, the utility room, appears to be the only original window that survives within the main house. It is a timber framed sash window, each sash with six panes (Plate 5).

Plate 4: Building 1 main house (left) and west wing (centre) and Building 3 (right), viewed from the north

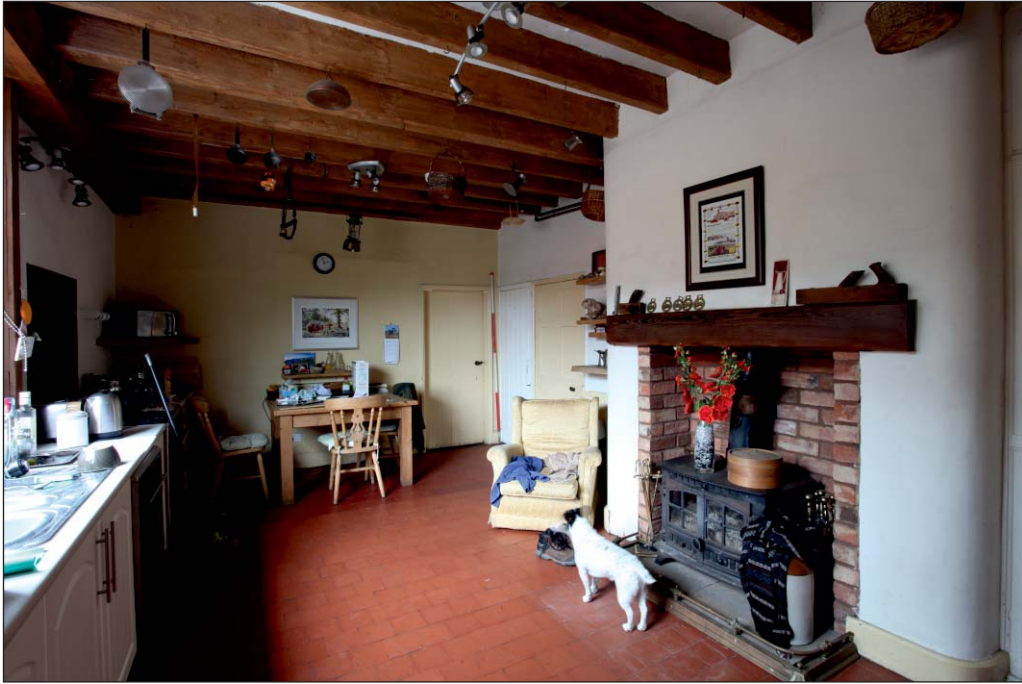
- 6.2.20 The kitchen (G05) (Plate 17) has been updated with modern kitchen units and wood-burning stove inserted in the fireplace on the east side of the room. In addition, the kitchen window is a later insertion (although likely in the position of a smaller original window) with a uPVC frame and there is a blocked door in the north-west corner of the room that previously provided access to F06 via a staircase. This staircase is no longer accessible or visible from ground level. However, the kitchen does retain some historic features consistent with the date of the building including the beams overhead, quarry tiled floor and a dresser/cupboard in the south-east corner of the room with moulded two- and four-panel doors and dentil cornice (Plate 18).

Plate 17: View of kitchen G05, Building 1

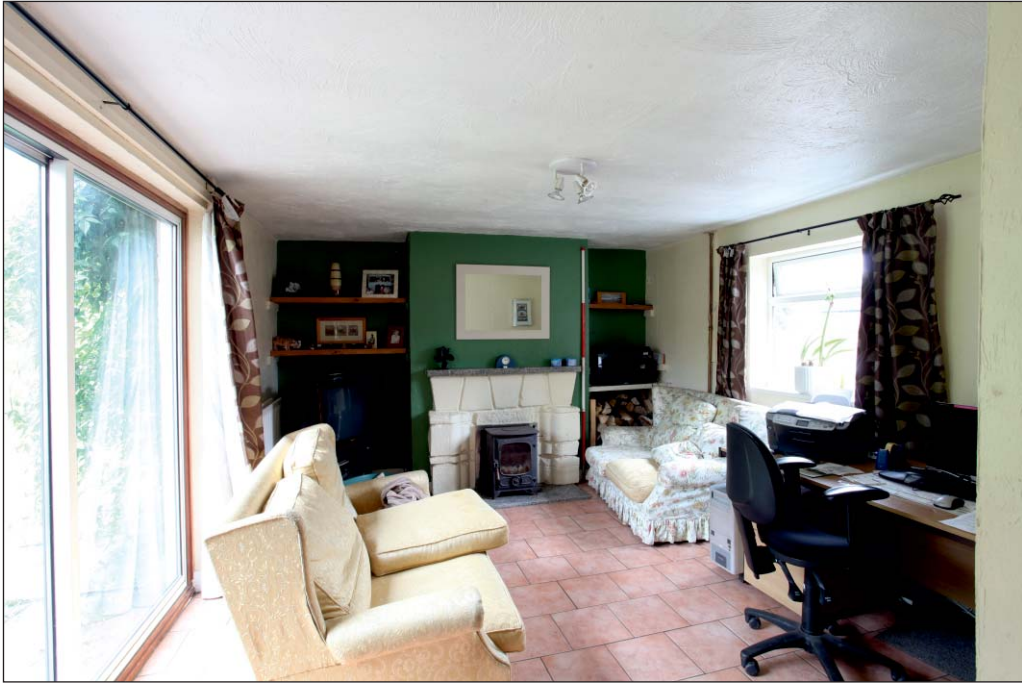
- 6.2.22 The south wing of the building, accessed from G05, is subdivided into a lobby G07 (Plate 22) and living room/office space G04 (Plate 21). The date of the lobby partition is unknown but the lobby door is modern and the wall around the door opening has been rebuilt (Plate 1). G04 has a wood burning stove and modern coarse masonry chimney piece at the south of the room. The office equipment, modern furnishings, modern fireplace and inserted French windows obscures the historic fabric of the building. The blocked door located in the east wall, noted externally, is not visible internally because the walls have been plastered and painted.

Plate 21: General view of the office and living room G04 in the south wing Building 1

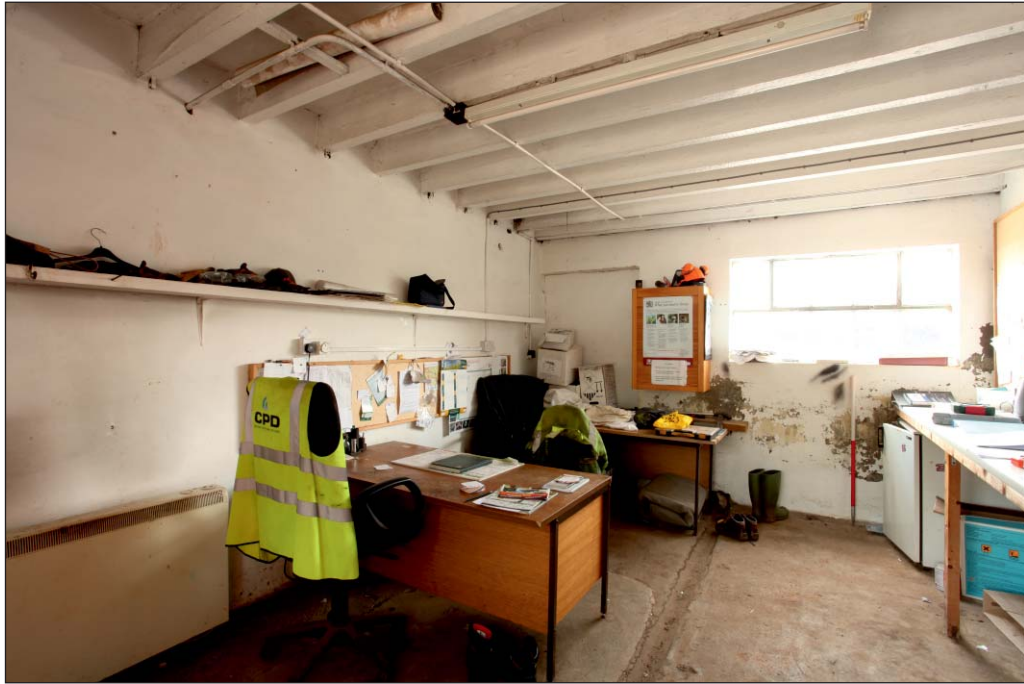
Plate 25: View of office G25 in the west wing, Building 1. Note the blocked door and drainage channel

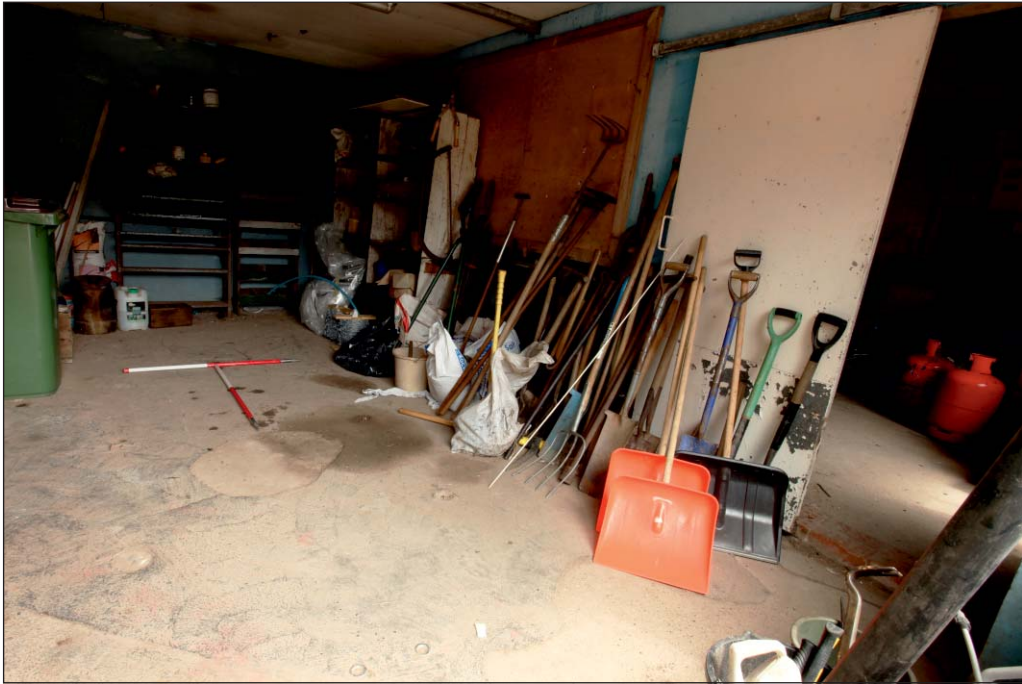
Plate 55: Detail of scars on the floor of G23, Building 3, shown in relation to the door to G24

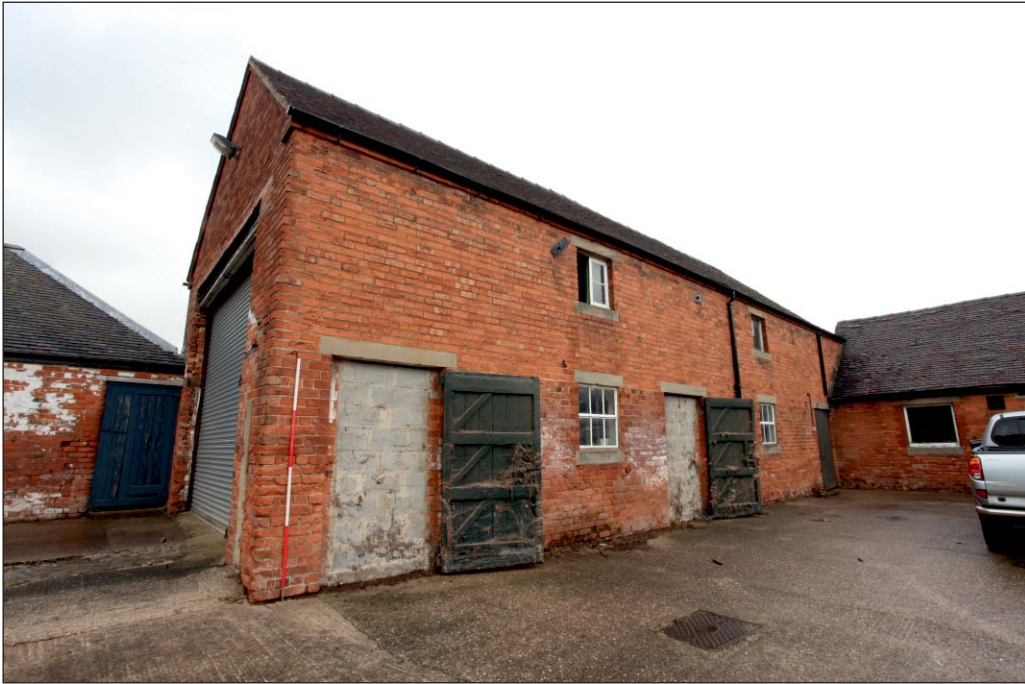
Plate 61: Building 5 viewed from the south-east. Note the blocked doors

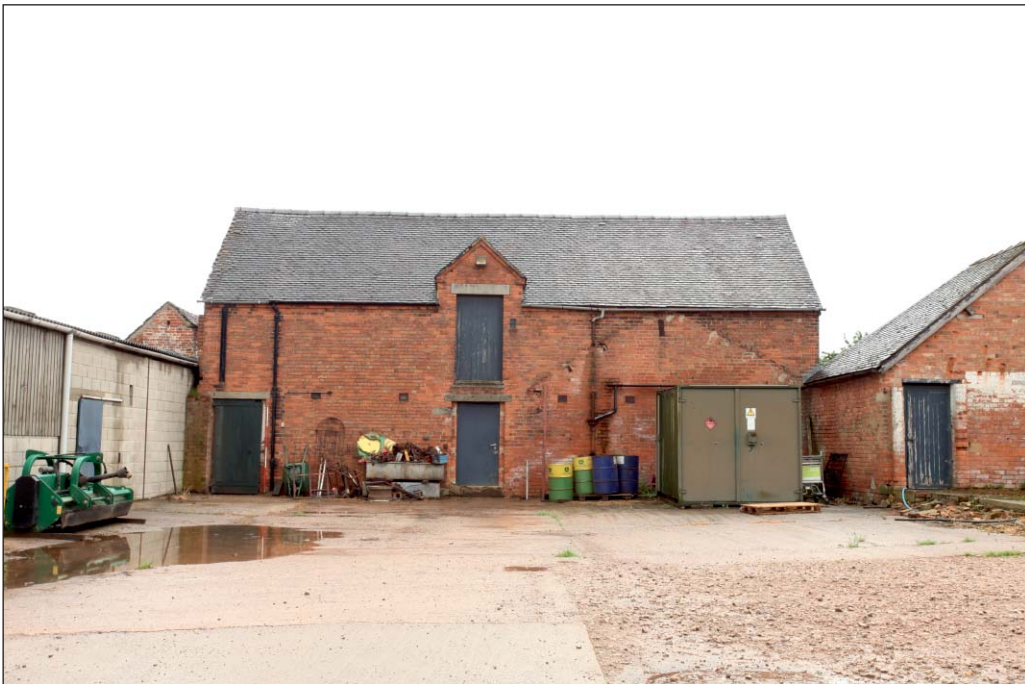
Plate 62: Building 5 viewed from the west. Note the pitched roof scar of a demolished building

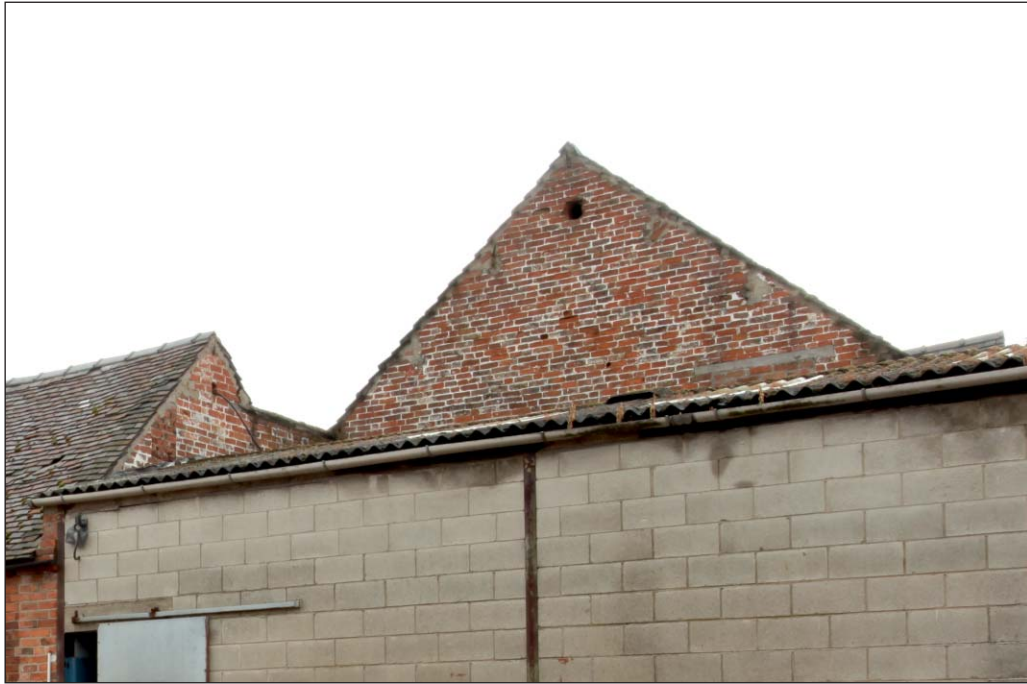
Plate 63: Building 3 west gable and Building 5 north gable viewed from the north-west. Note the partially visible blocked first floor door in the latter

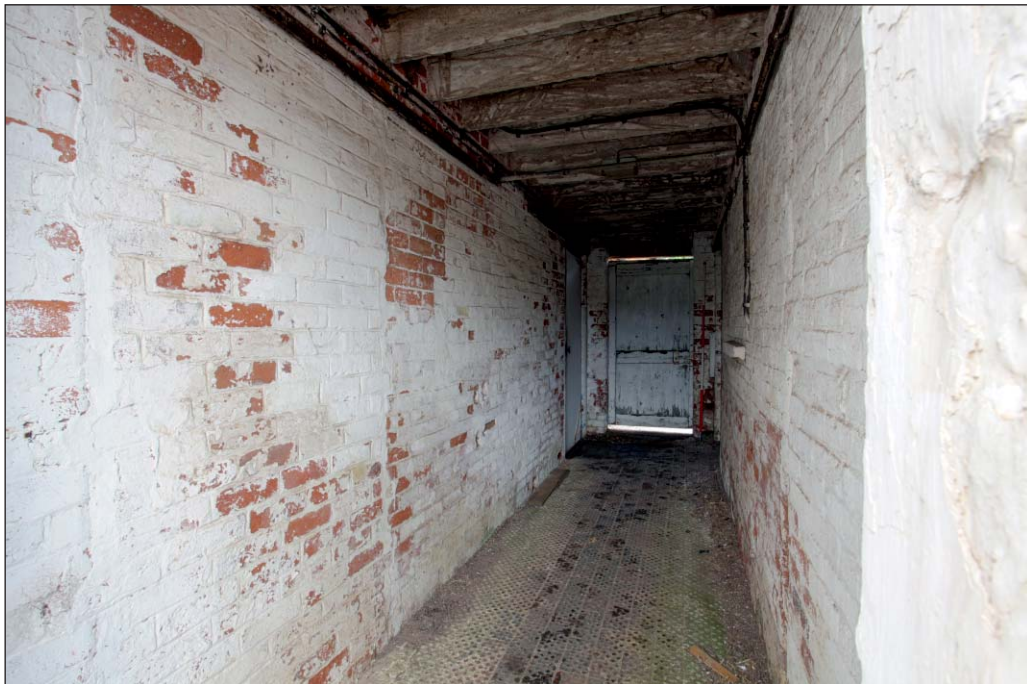
Plate 64: Passage G29, Building 5, viewed from the west. Note the opposing blocked doors in the foreground

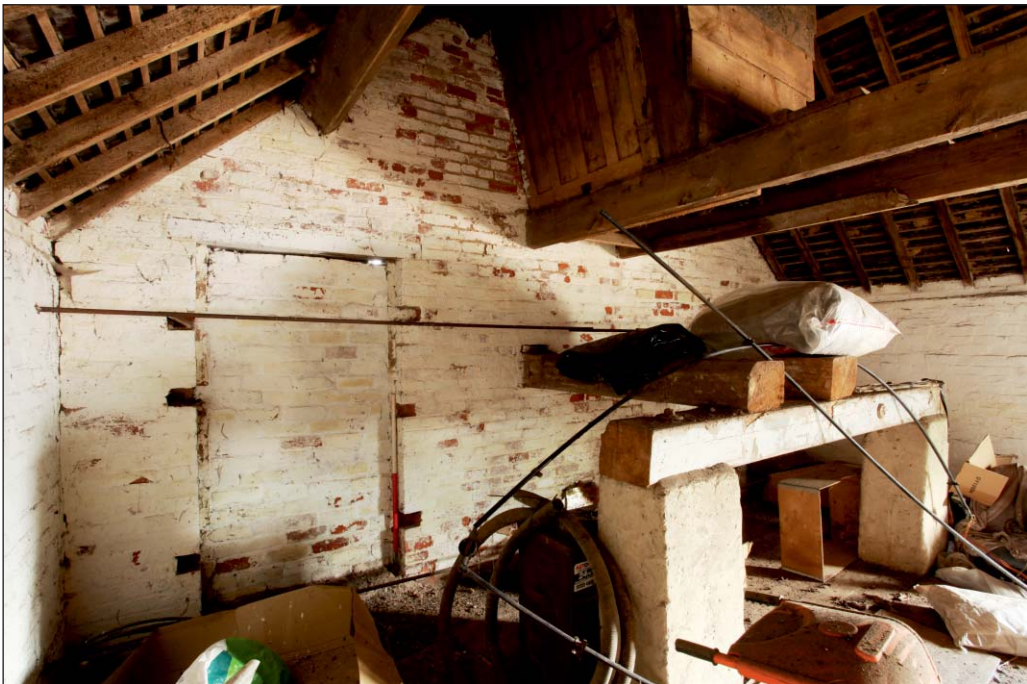
Plate 66: F08, Building 5, viewed from the south-west, showing the hopper overhead, the support platform and blocked door

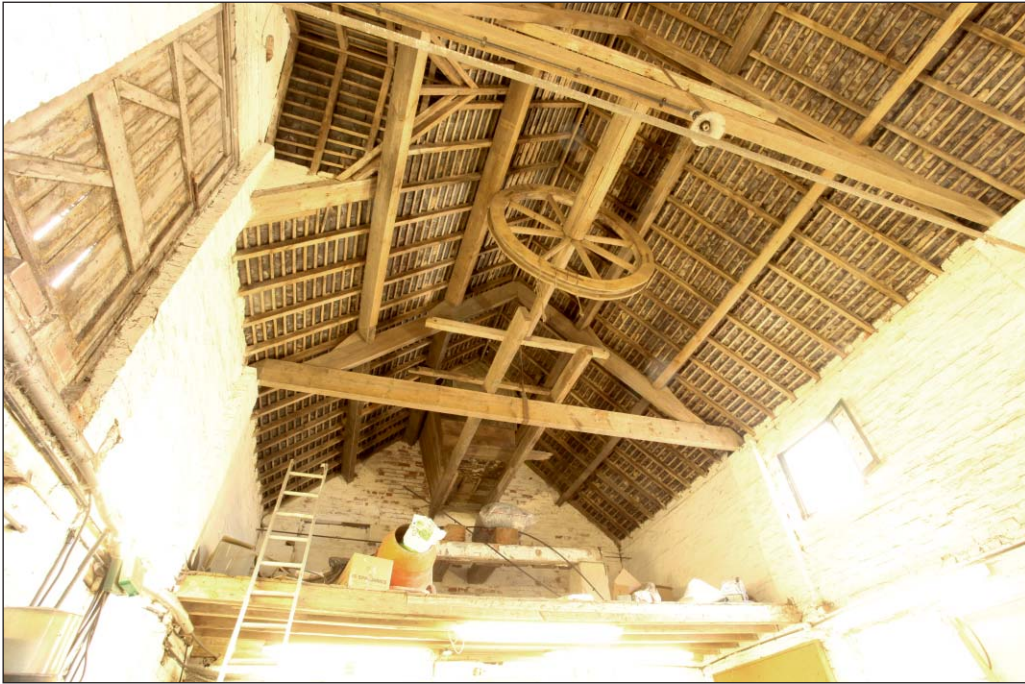
- 7.4.3 As previously stated, Building 5 is likely the Barn listed in the sale particulars. The wheel and drive shaft and hopper within Building 5 suggest it was necessary to hoist materials to the first floor level. The demolished structures on the west side of the complex are depicted as open-sided so may be the covered in cow stalls. Building 2 appears to include a mix of stabling, store rooms and a vehicle shed, so may be the nag stable, loose box and gig house listed, but could also correspond to the cart horse stables or waggon and implement sheds. The horse-gin shown to the north of Building 3 on the 1884 OS map suggests that the latter required power and therefore may be the Chaff House.

Plate 67: Building 5 roof structure with the wheel mechanism and hopper viewed from the south

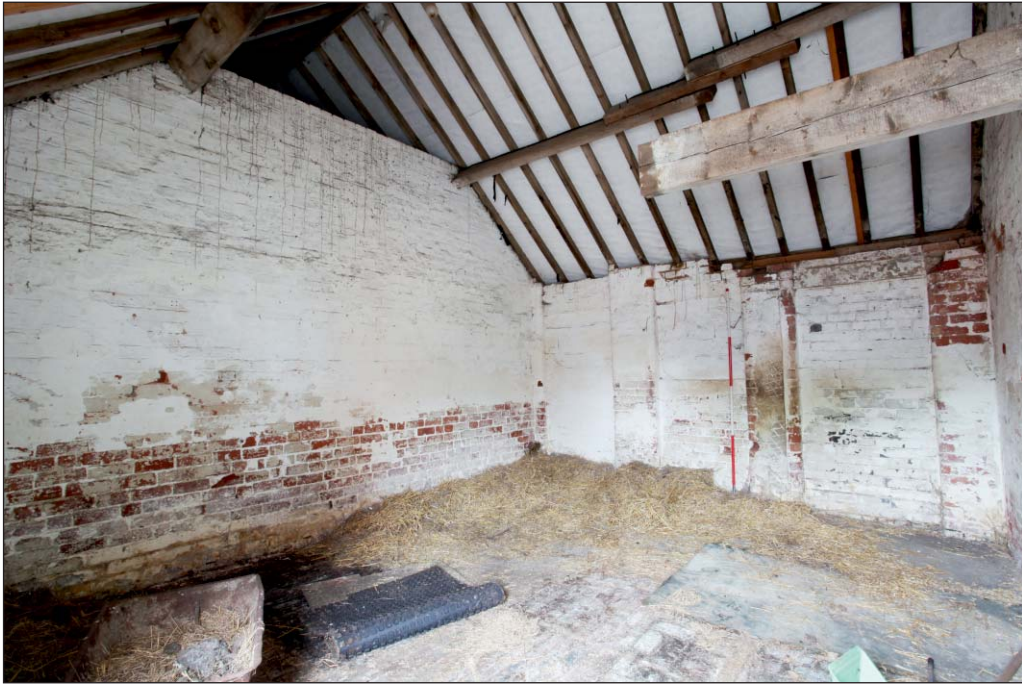
Plate 75: View of G18, Building 6, from the north-east. Note the stepped and bolted join in the purlins overhead and blocked doors and window in the west wall
