# IFA2: The Excavation and Recovery of a MKII Fairey Barracuda from the Solent, Hampshire

Marine archaeological technical report

Ref: 202920.13  
January 2020

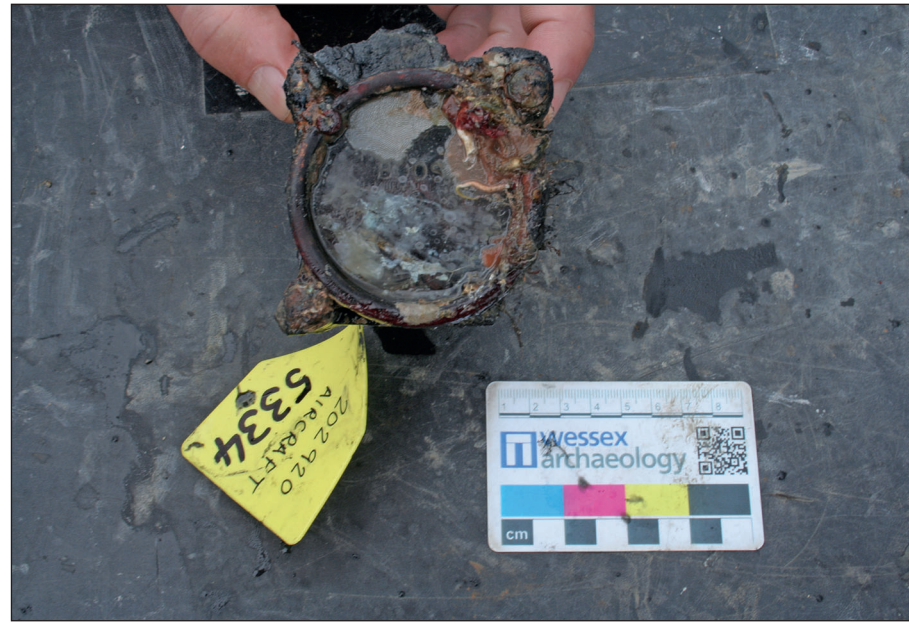
Plate 7: Boost Gauge from pilot's cockpit. Found within starboard wing

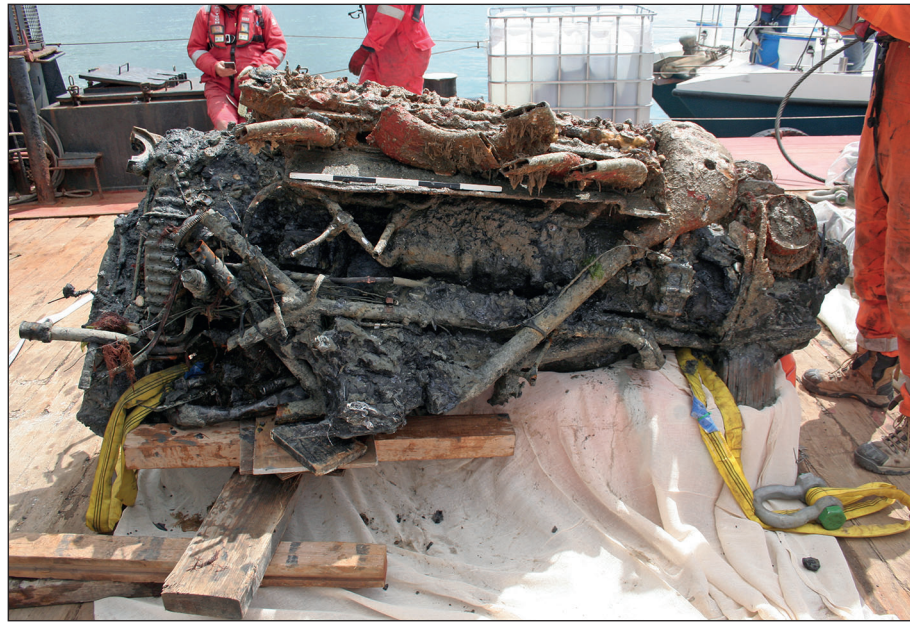
Plate 16: Rolls Royce Merlin 32 engine- starboard side showing damaged exhaust manifolds

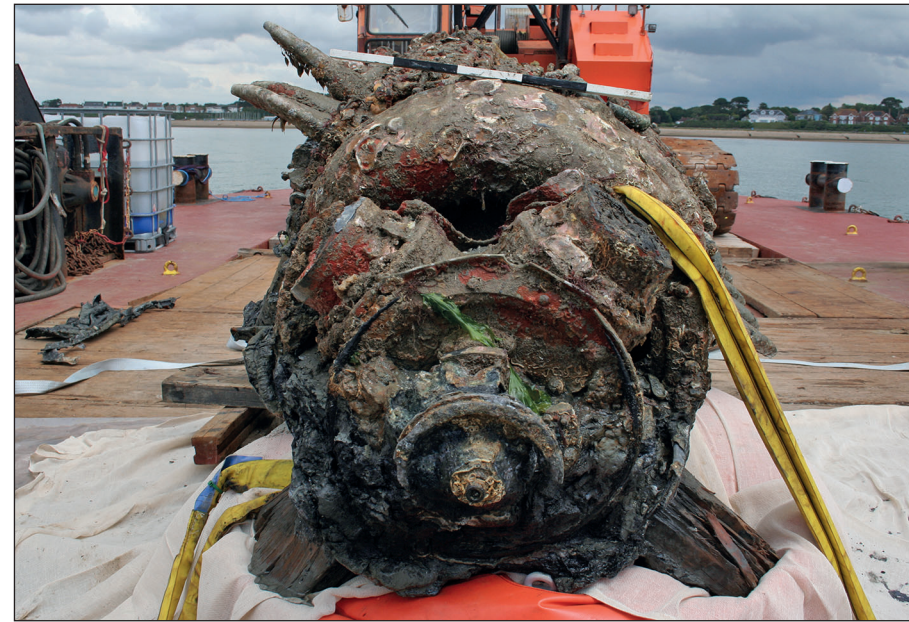
Plate 17: Rolls Royce Merlin 32 engine- front view showing 4 bladed propeller hub without spinner

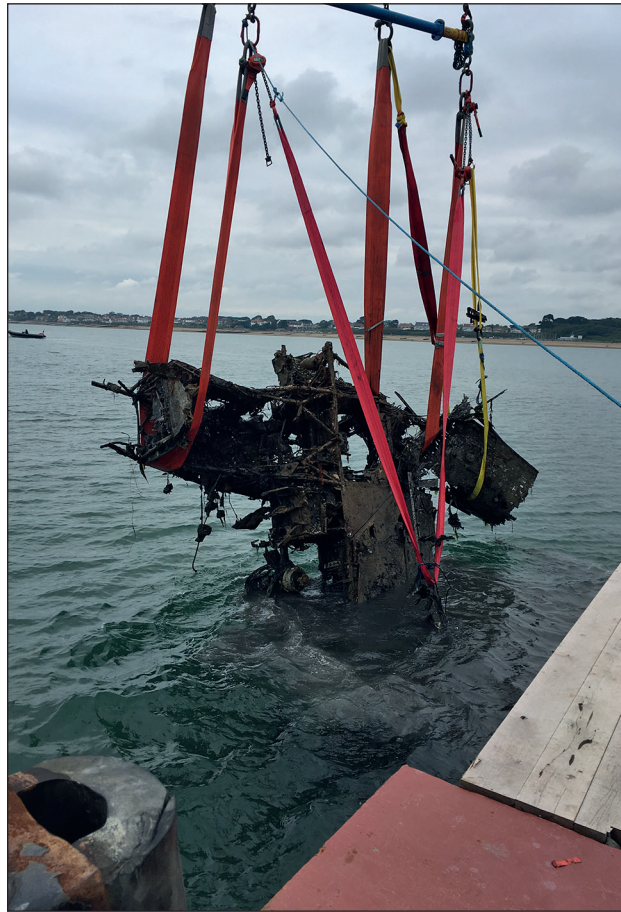
2.5.3 Due to time constraints based on the arrival of the cable laying barge, weather delays and the overburden on the site, a modified method using strops rather than the lifting basket was attempted with the central fuselage and port wing by the diving contractor. Unfortunately, this lift was unsuccessful with the section proving structurally weak and fragmenting as it broke surface. The parts of section in question was subsequently lifted using the lifting basket, with the divers recovering additional loose debris to the surface either via the basket or the recovery line.

2.5.4 Concerns over potential consequences of the failure of this lift have subsequently been allayed by the FAAM team while engaged in disassembling and conserving these parts of the aircraft. Despite the loss of full structural intactness of the fuselage and port wing, significant structural tubing sections have been recovered, cleaned and disassembled, and have been found to be fully reusable, with little or no additional intervention.

Plate 86: Initial Lift Prior to structural failure

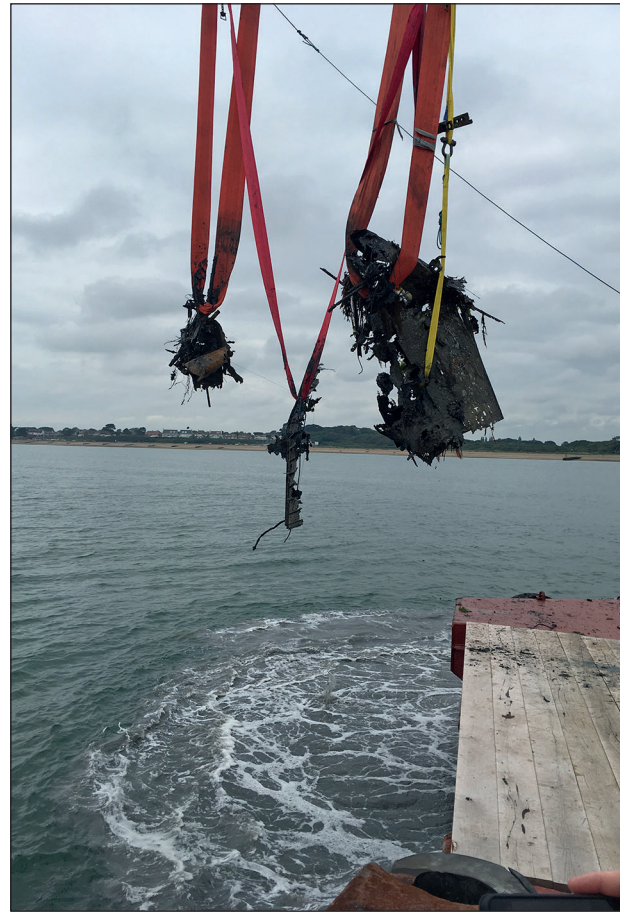
Plate 87: Material Recovered during lift

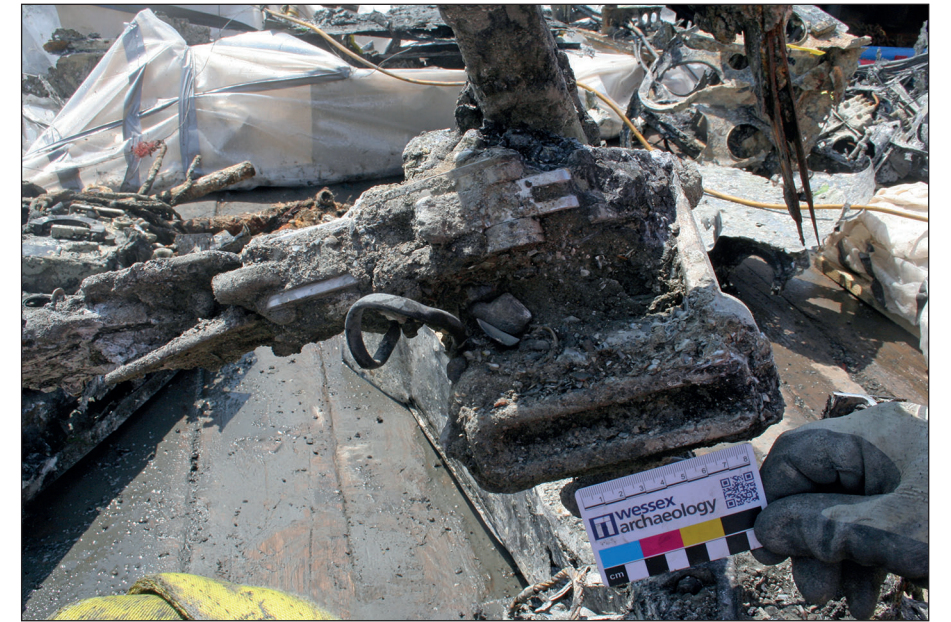
In assessing the material recovered the remains of the torpedo crutch (Plate 98) with part of its torpedo retaining cable that were recovered from the site suggest an aircraft that was carrying out operations with a torpedo carried. Comparing the known information of the two candidate aircraft, LS473 is recorded as having been carrying a torpedo at the time of its loss, though none was found. It is presumed it was jettisoned as soon as the pilot realised that the aircraft was not going to reach or maintain a flying speed- ditching on water with a torpedo underneath the aircraft was not advised. It is thought unlikely that the torpedo retaining cable was left on the aircraft if they were not carrying a torpedo, as the cable was only retained by a bungee cord to prevent it damaging the aircraft once the torpedo was dropped, and its flailing about had been shown to cause significant damage to aircraft before the bungee system was implemented.

Plate 98: Torpedo crutch and retaining cable

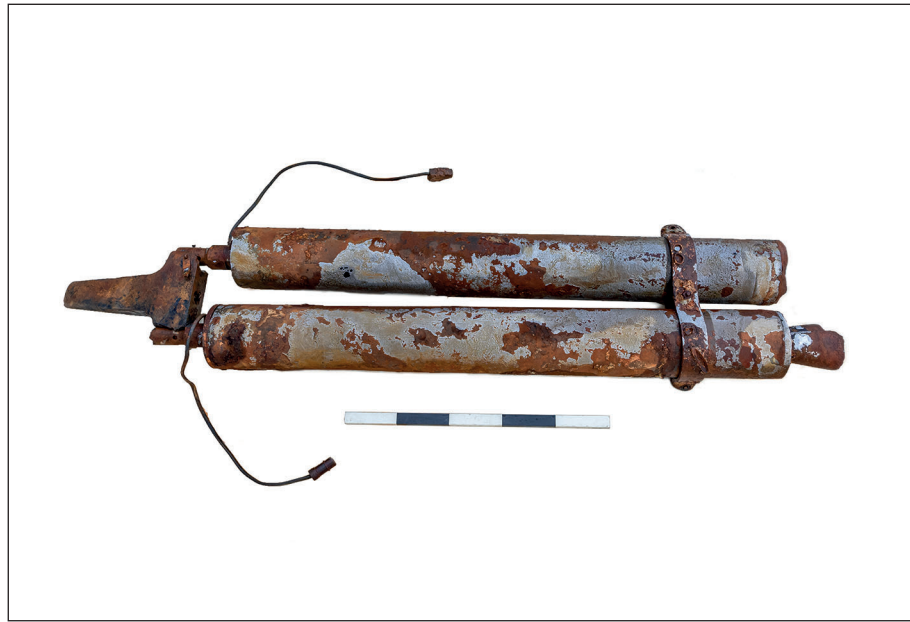
Within the wider area of the crash, three anomalies (6a\_pUXO\_033, 042 and 056) on the boulder clearance investigations was identified as RATOGs (Rocket Assisted Take Off Gear). These were used on a number of FAA aircraft to give extra power on take-off (Plate 101 and Plate 102) particularly on short aircraft carrier decks when the outgoing aircraft would be heavily laden with fuel and munitions. They ensured that the aircraft would reach take off speed, when prevailing weather conditions were poor or there was a lack of catapult or other accelerator gear available. The label on the TAG cockpit about Assisted Take-off (Plate 63) is referring to this process. They were in use for a short period (1944-1995), as the development of carrier based jet aircraft overcame the issue. Each RATOG was made up of twin 5' rocket motors (based on the standard No.5 Mark I rocket tube with a cordite filling and fired by electrical fuses), each 1.14 m long and 0.14 m in diameter, with a connecting bracket that fitted on to the outer fuselage of the Barracuda just above the trailing edge of the wing (Plate 102) on both sides of the fuselage. These would burn for approximately four seconds and provide a mean thrust of 1,150 lbs. The three recovered all have the layout of fittings suggesting they were used on Fairey models- either the Barracuda or the Firefly. These units would be jettisoned from the aircraft following take off and so the discovery of some close to the end of the runway at RNAS Lee-on-Solent, where aircrew would have been trained to use them, is not unexpected.

Plate 101: RATOG found close to wreck (6A/pUXO/015/RATOG)
