Orchard Cottage, Mackworth, Derbyshire

Historic Building Record

Document Ref.: 238642.01
March 2025

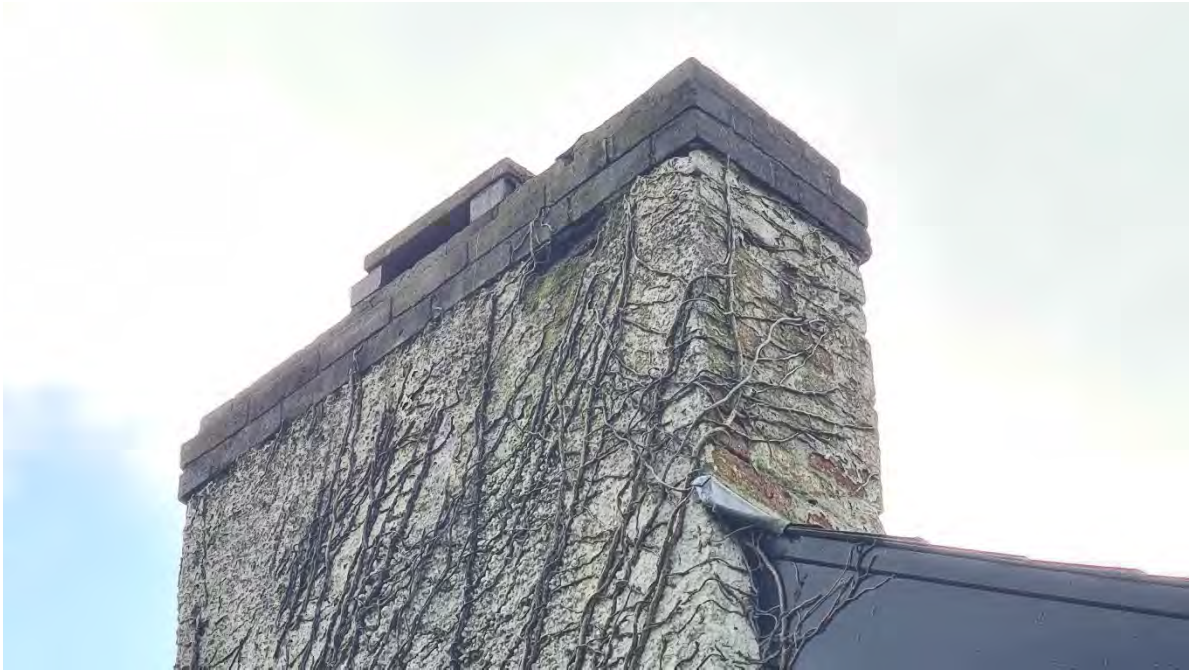
Plate 7 - North chimney

- 4.2.1 The north elevation features a prominent gable end with a projecting chimney stack (**Plate 6**). The chimney is constructed with a Staffordshire blue brick coping, three courses

in depth and laid in running bond (**Plate 7**). A makeshift chimney stack formed from a single course of Staffordshire blue brick and topped with a slab is evident above the main structure. Exposed sections of the render reveal that the primary chimney fabric consists of red brick with compacted clay properties and small stone inclusions (**Plate 8**). This red brick appears more porous than the brick used for the south chimney stack. A two-pane top-hung casement window with a steel frame and a timber sill is positioned on the west side of the first floor. Additionally, a timber gable bargeboard is attached to the chimney stack, with lead lining fixed above for roof fitting. Located at the foot of the chimney, a cast iron air vent (**Plate 9**).

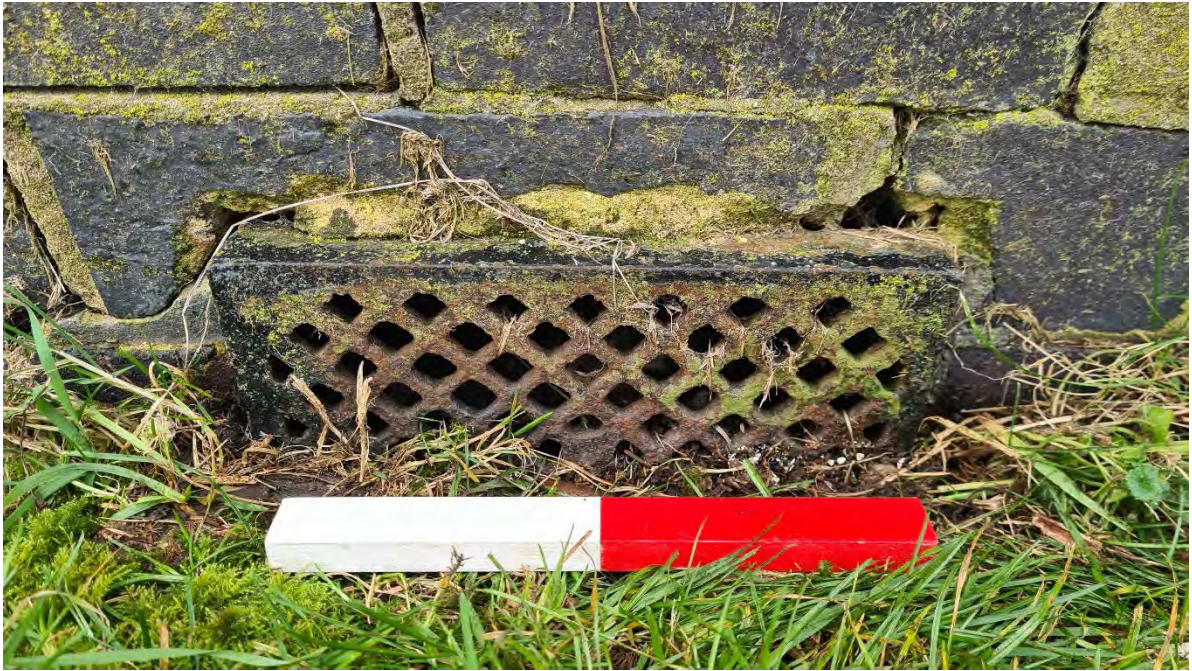
Plate 9 - Cast iron air vent at foot of north chimney

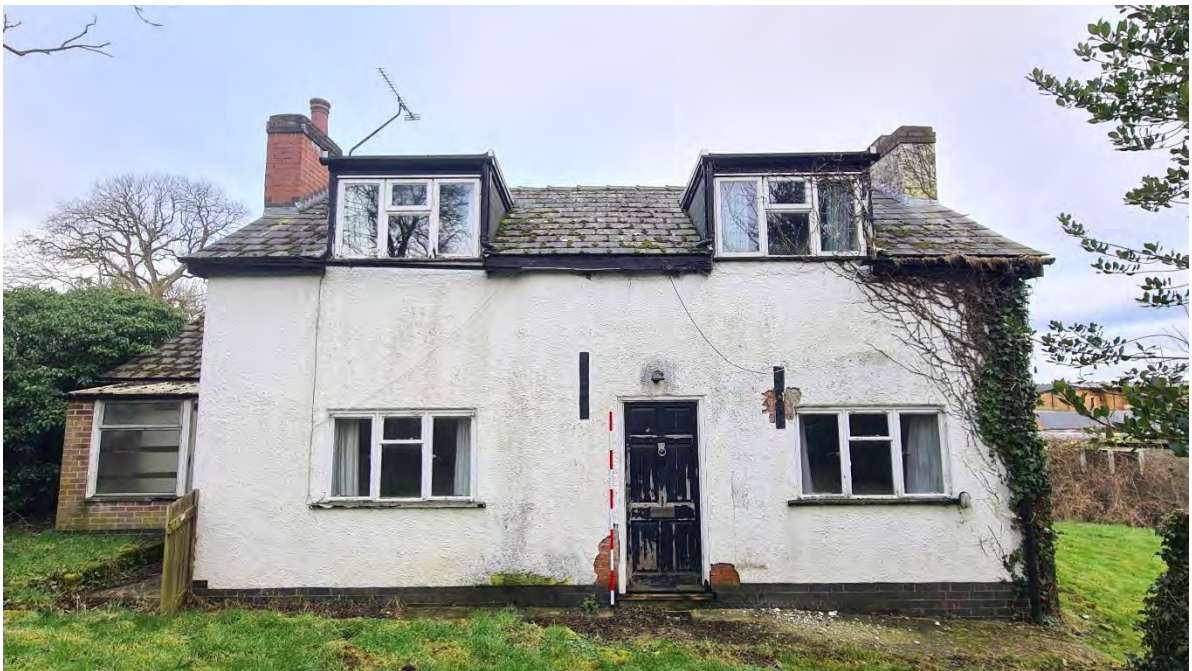
- 4.2.2 The east elevation follows the sloping roofline, covered in uniform rectangular blue slate tiles (**Plate 10**). Two flat dormer windows at the first-floor level are symmetrically aligned along the roofline (**Plate 11**). These dormers are flush with the east elevation wall and feature four-pane casement windows with a timber frame painted white. The dormers have felt-covered sides, and a drainpipe is affixed to the roofline and connected to a cast iron drainpipe.

Plate 10 - East elevation

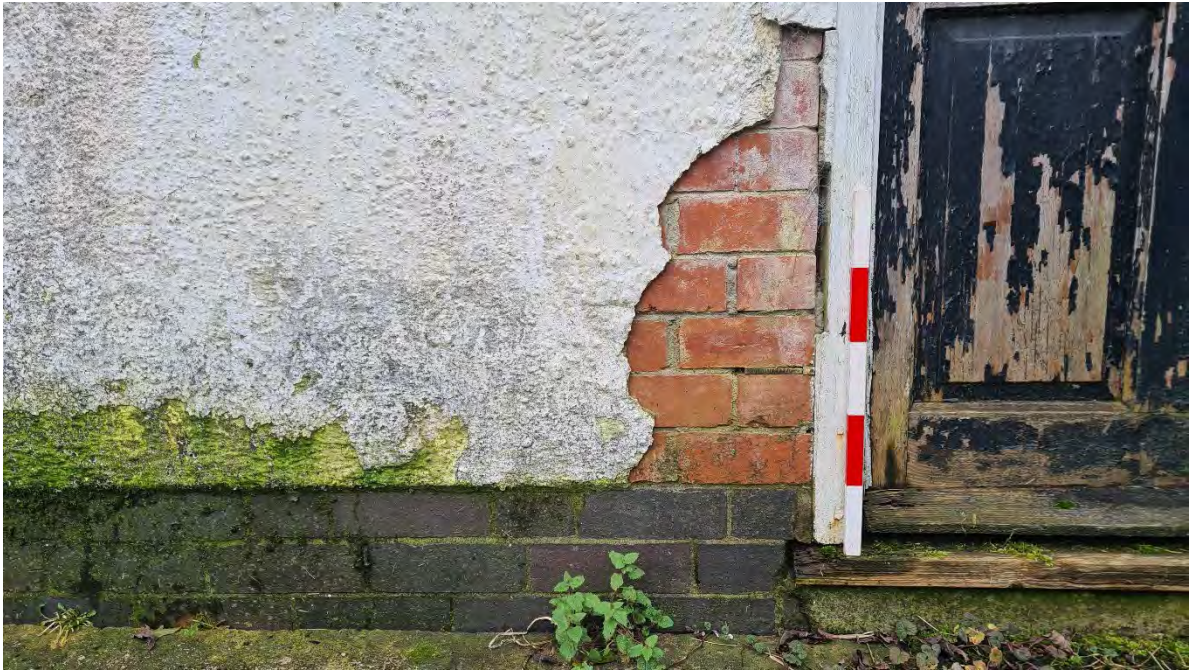
- 4.2.3 At the ground floor level, two rectangular steel-framed windows, similar in design to and contemporary with the dormer windows, are positioned to correspond with each ground-floor room. Each window is a composite consisting of four glass panes, with two large rectangular casement windows featuring external fittings and a smaller top-hung awning window at the centre (**Plate 12**). A centrally located threshold, slightly offset to the north, features a modern six-panelled timber door within a timber frame, sitting atop a concrete sill (**Plate 13**). Exposed sections around the base of the threshold reveal a red brick construction resting on a three-course Staffordshire blue brick footing. The bricks appear to be machine-made due to their uniform shape, compacted clay properties, and parallel sides (**Plate 14**).

Plate 14 - East elevation central threshold into G7 exposed fabric

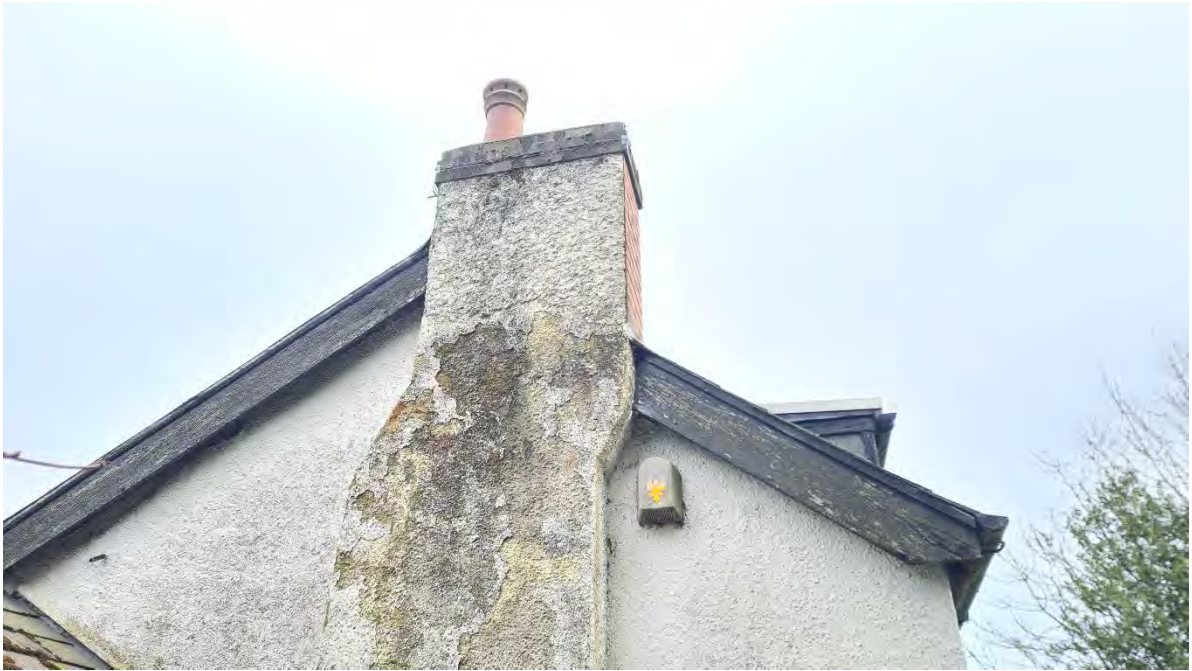
- 5.1.3 The south chimney stack, which extends from the gable end of the two-storey section before shifting slightly eastward at the first-floor level shows signs of modification. The exposed brick on the upper portion of this chimney appears different from that of the north chimney, suggesting a potential later replacement. This modification may have been undertaken during a roof restoration phase, possibly linked to the creation of the southwest boiler/storage room on the first floor. In contrast, the lower portion of the chimney stack may retain original fabric, indicating a phased approach to structural modifications.

Plate 19 - South chimney

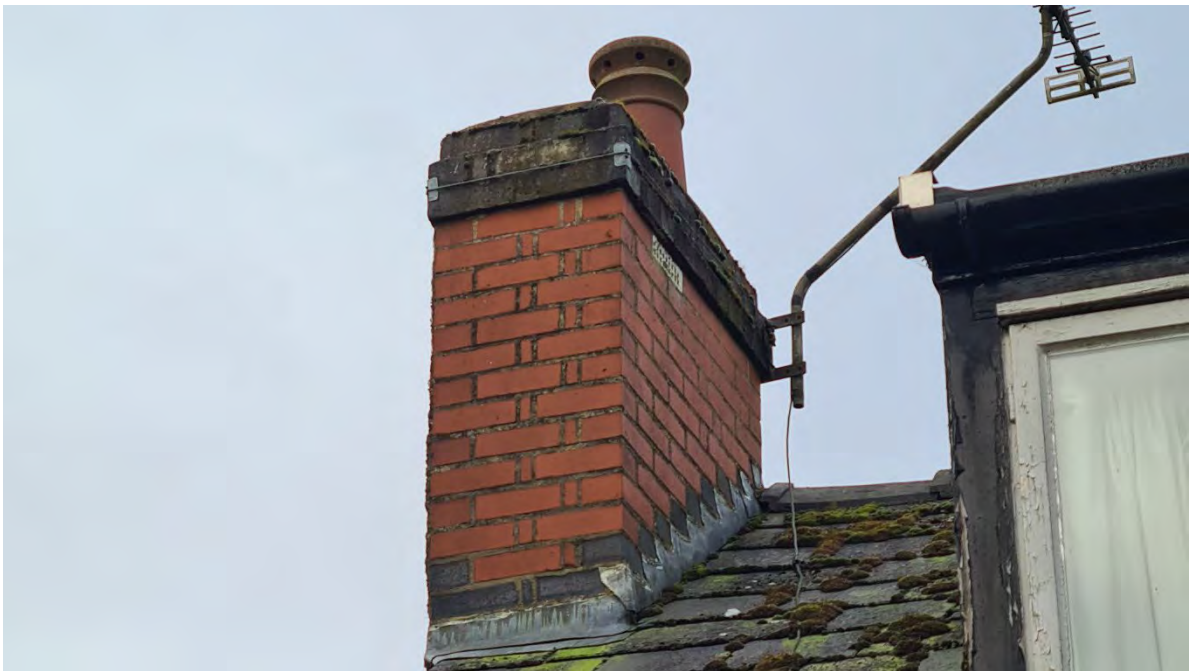
Plate 20 - South chimney detail

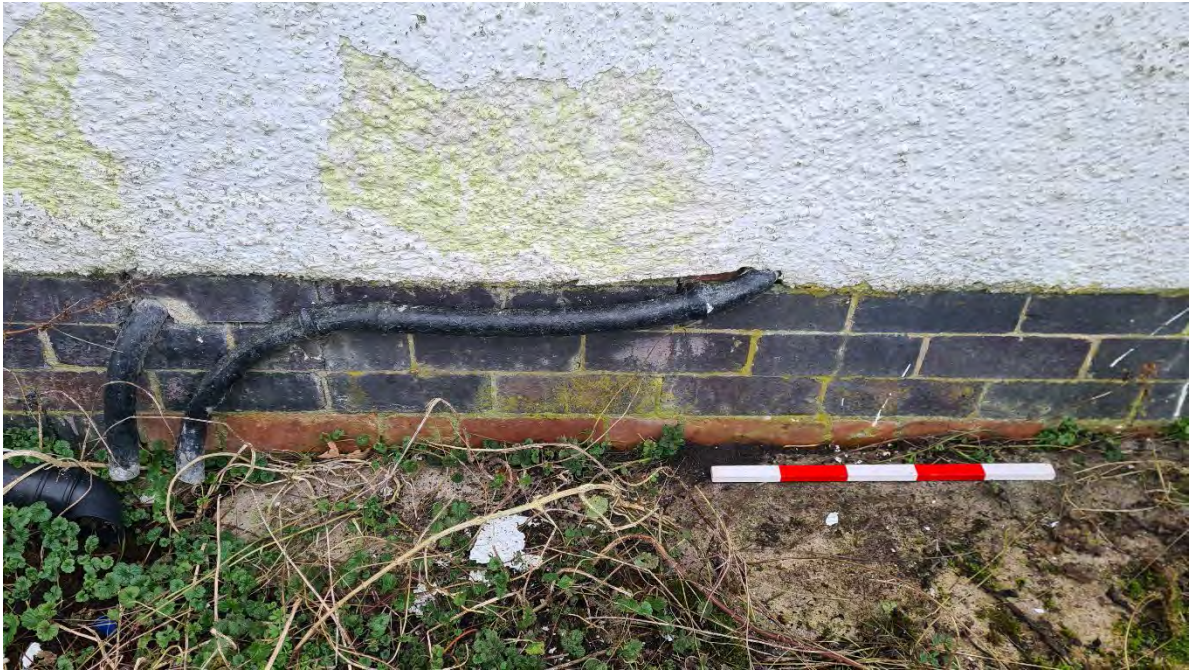
- 4.2.9 Two rectangular plastic air vents are located on the north side of the west elevation, positioned between the windows. At the base of the elevation, a three-course Staffordshire blue brick footing runs continuously along the structure, sitting above a two-course red brick foundation (**Plate 27**).

Plate 27 - Staffordshire blue brick footing west elevation

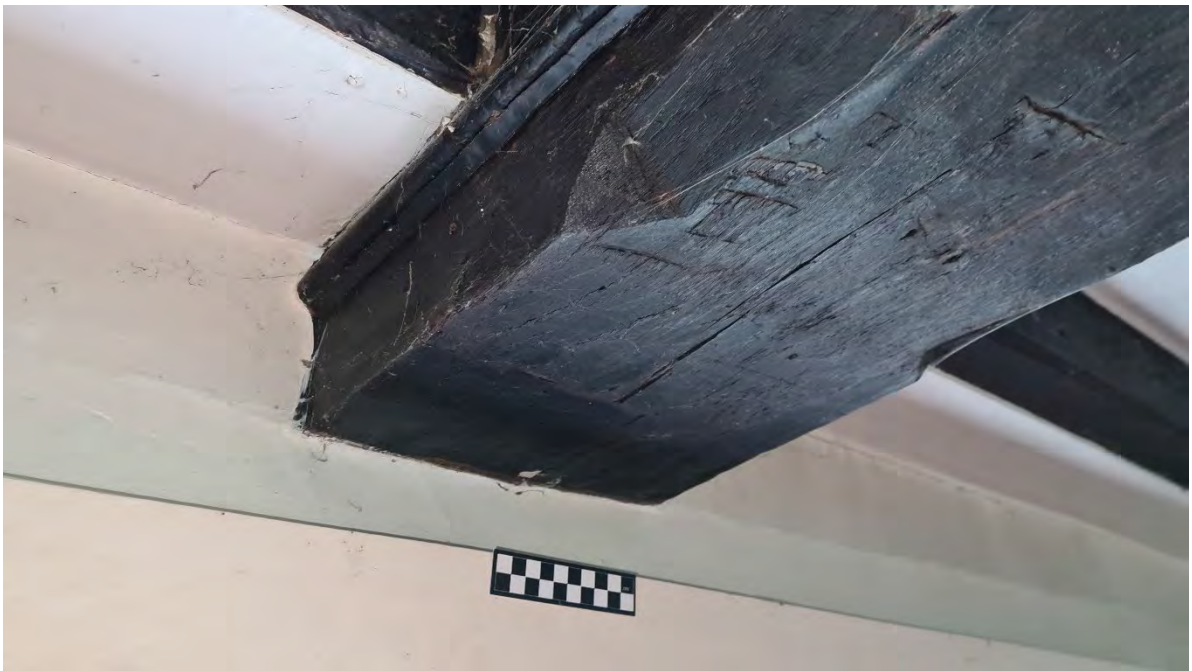
Analysis of Room G7 revealed a substantial stopped and chamfered timber beam, likely dating to the 17th or early 18th century, which has been reused within the cottage. The origins of the beam are unknown as no other timbers of this age were found within the property. This central beam, featuring hand-tool markings, mortice holes, and filled-in peg holes, supports a gypsum floor above alongside 20 chamfered and stopped joists. The gypsum flooring in Room G9, containing straw inclusions, is indicative of an older flooring technique which was prominent across the East Midlands during the 17th-19th centuries.

Plate 78 - West facing photo of restoration of timber beam in Room G7

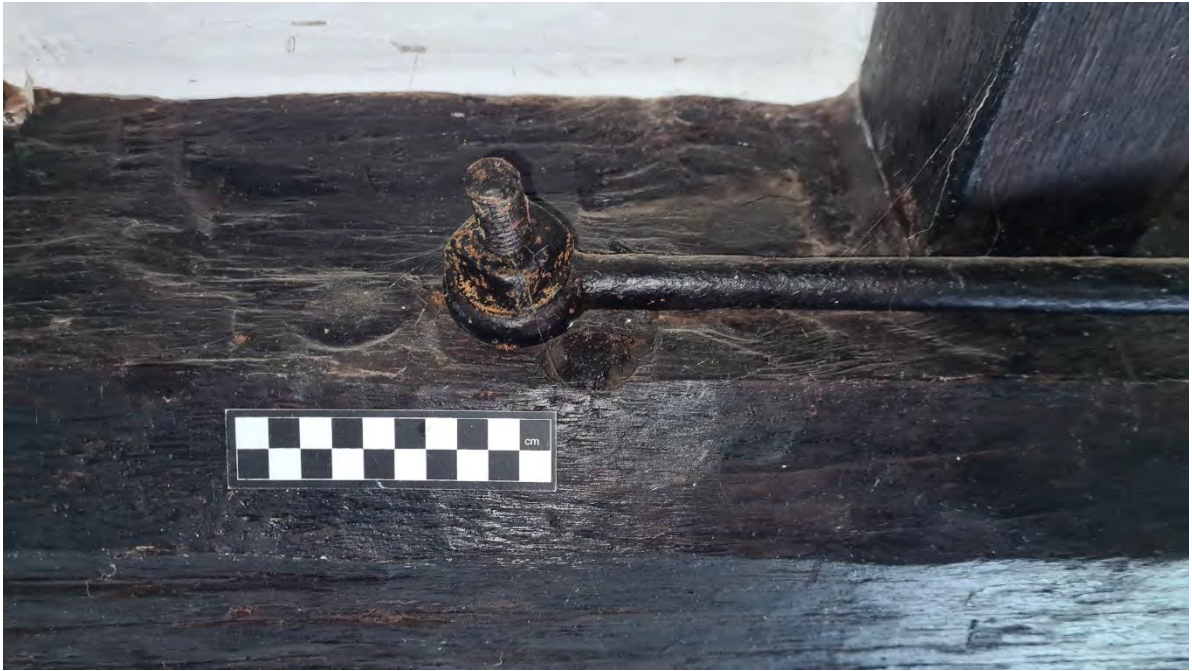
Signs of structural movement were evident, with large metal tie rods securing the central dividing wall. On the west elevation, an exposed cast iron anchor/patress plate set into red brick above a later inserted concrete window lintel suggests reinforcement work undertaken in the later 20th century. Other steelwork was visible in Room G7 around both the ends of the timber beam, likely to help bear its weight as the ends currently sit above later-inserted windows. These findings illustrate the building's evolving construction history, with older structural elements re-purposed and adapted within the building.

Plate 79 - Steel brace on timber beam in Room G7
