**BARN AT TREVOLLARD FARM,
ST VEEP, nr LOSTWITHIEL,
CORNWALL**

PHOTOGRAPHIC SURVEY

January 2012
Report 767

The required photographic survey recorded a redundant barn in the southwest portion of the farmyard at Trevollard prior to proposed conversion to a domestic dwelling. The survey was undertaken to compile a record of the site for posterity.

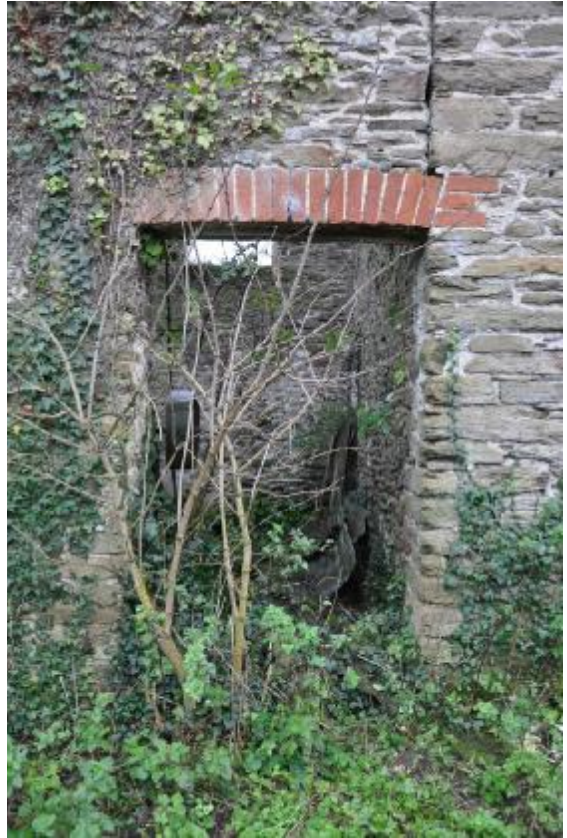
- 4.2.12 Building 2 adjoins the southeast side of Building 1; the northeast wall is butt-jointed to Building 1 (Figure 12, 017) and is therefore later in date. At the time of the survey the roof covering had been removed (the slate tiles were stacked inside the building) although the modern rafters remained. The original building had two floors, as indicated by the holes for the joists in the brick work (Figure 23, 081). The roof-line showed some repair and concrete mortar, which could suggest the upper walls had been slighted; if not, the upper floor of this building had a very low ceiling at its southeast end. In addition, window 13 is unusually close to the wall plate, which forms its lintel.

017: NORTHEAST ELEVATION: BUILDING 2, DOOR 5, SW FACING.

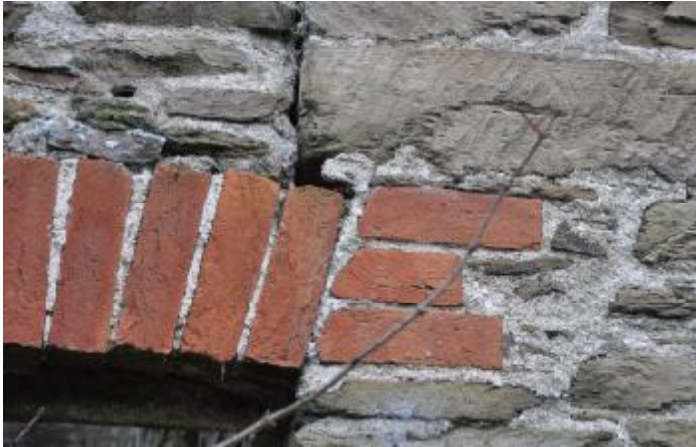
- 4.2.2 With the exception of Extension 3, all elements of the structure are built of stone with slate roof cladding, where it is still intact. The stone for the early elements of the structure, Buildings 1 and 2 and Extension 1, was quarried from the farm itself. The stones are a grey and buff pink colour which are roughly faced on the external and internal faces of the walling, although otherwise unshaped. The stones of the lower storey of Building 1 are larger and thicker than those of the upper storey. They are set in a rough snecked coursework with thick joints held together with a light lime mortar with frequent inclusions. Some stone lintels above opening show mason marks were the stones have been shaped (for example, Figure 12, 018).

018: NORTHEAST ELEVATION: BUILDING 2, DOOR 5 DETAIL, SW FACING.

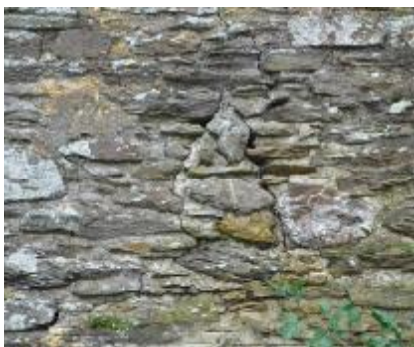
- 4.2.8 The hipped roof is a six bay truss of very basic king post construction which has subsequently been strengthened by hammer beams on the southeast side of the building (Figure 25). Repair in the stonework under the eaves, visible on the external elevations of Building 1, suggests that the roof could have been replaced (Figure 11, 014; Figure 13, 026). The ceiling of the ground floor is divided into three sections.

027: NORTHWEST ELEVATION, BUILDING 1: CRACKS AND PATCHING ABOVE WINDOW 6

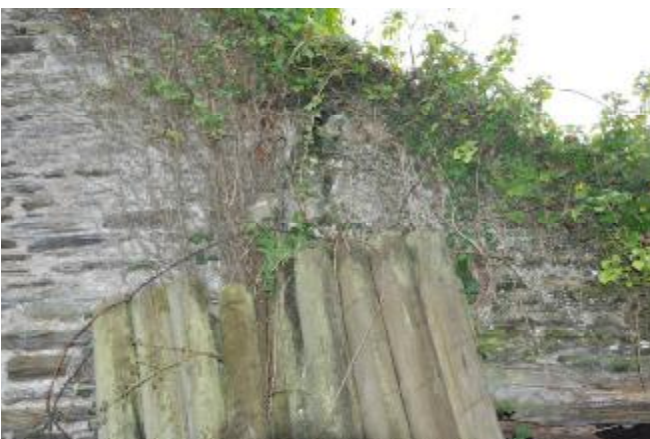
- 4.2.17 A number of cracks are visible in the stonework in Extension 1 and it is beginning to break away from Building 1 on its northwest side. The roof is also no longer present.

032: NORTHWEST ELEVATION, BUILDING 1 AND EXTENSION 1 SHOWING CRACKING BETWEEN THEM. SE FACING SHOT.

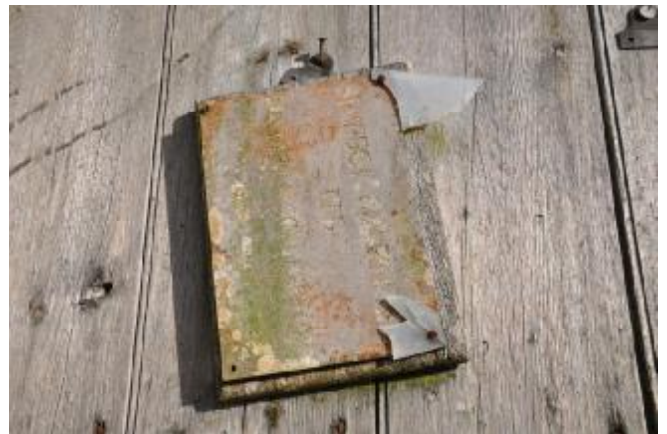
- 4.2.7 The building has recently been used for storage and was so at the time of the survey. A battered plaque on the door of D4 says 'Simpson & Partners Ltd Builders and Contractors' which suggests a later change of use for the building.

042: SOUTHWEST ELEVATION: BUILDING 1, DETAIL SHOWING PLAQUE ON DOOR 4.

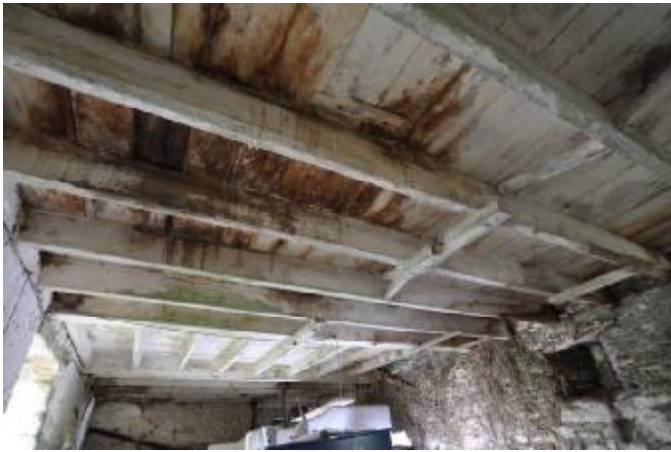
The middle section consists of two large northeast-southwest joists joined with cross-pieces and the sections either side consist of thinner northeast-southwest aligned joists. It is quite heavily repaired with re-used timbers and modern wood and three fairly modern posts with concrete bases prop up the ceiling (Figure 20; 063, 064). Carpenter marks are visible on 4 of the joists at the southeast end of the building (Figure 21). Unfortunately the symbols were not readily identifiable.

063: BUILDING 1, INTERNAL: CEILING. SE FACING.

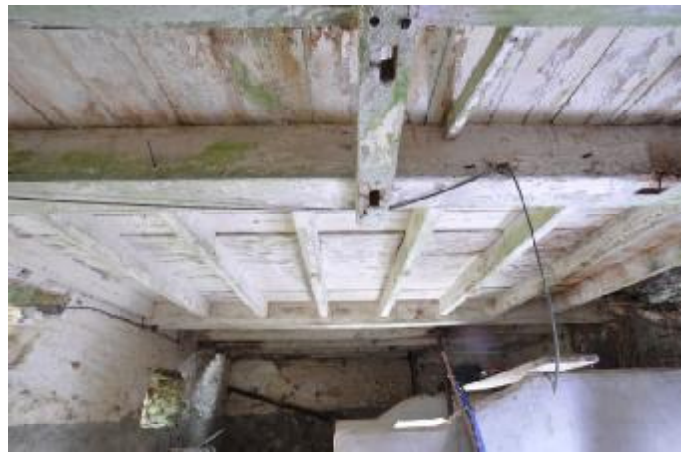
064: BUILDING 1, INTERNAL: CEILING. NW FACING.

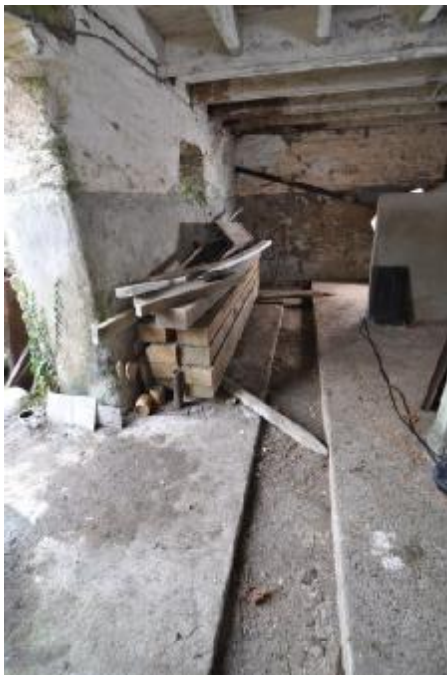
065: BUILDING 1, INTERNAL: DAIRY DRAINAGE GULLY. SE FACING.

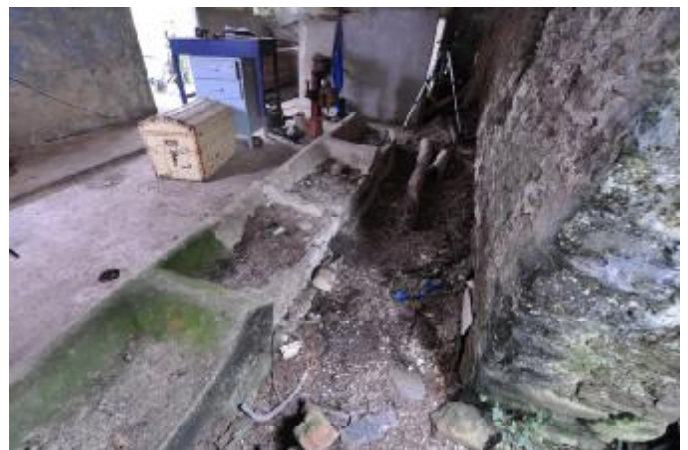
066: BUILDING 1, INTERNAL: DAIRY FEEDING TROUGHS. E FACING.

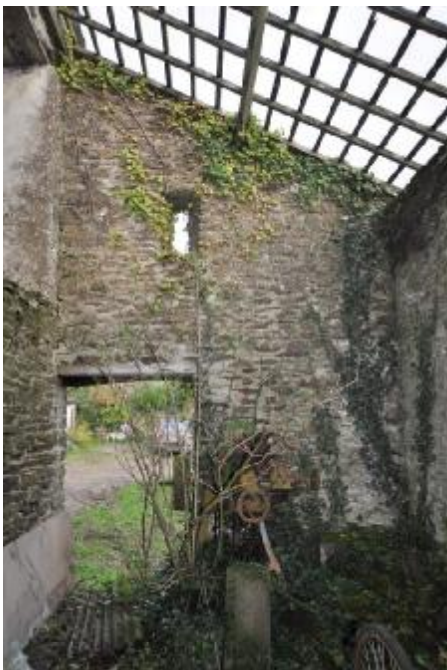
- 4.2.14 The building has been used as a corn mill in living memory. The cast iron 'Bentall Grinder Mill' is still present inside the building, perched upon a large stone block (Figure 24; 089, 090). The mill would probably have only been used for personal use, or possibly, local supply purposes as such mills can yield 20 bags of flour a day.

076: BUILDING 2, INTERNAL: NE WALL AND MILL, NE FACING.

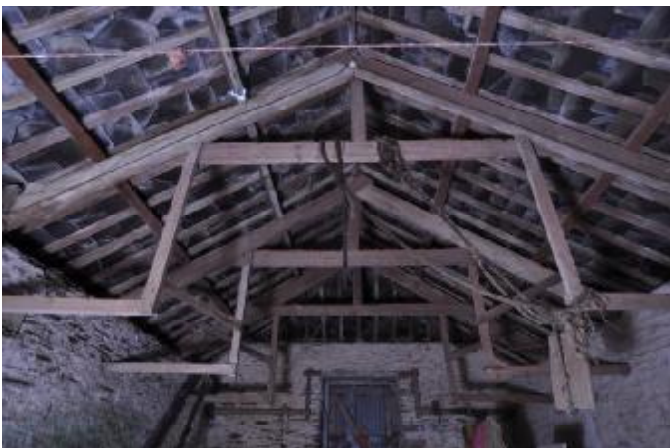
097: BUILDING 1, FIRST FLOOR INTERNAL: ROOF, NW FACING.

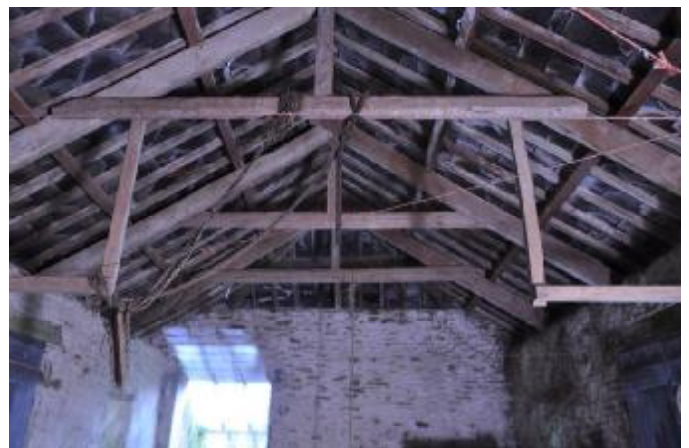
098: BUILDING 1, FIRST FLOOR INTERNAL: ROOF, SE FACING.
