THE BULL HOTEL,
99 MAIN ROAD,
HOCKLEY,
ESSEX

HISTORIC BUILDING RECORDING

**THE BULL HOTEL,
99 MAIN ROAD,
HOCKLEY,
ESSEX, SS5 4RN**

**Report No. 1273
December 2018**

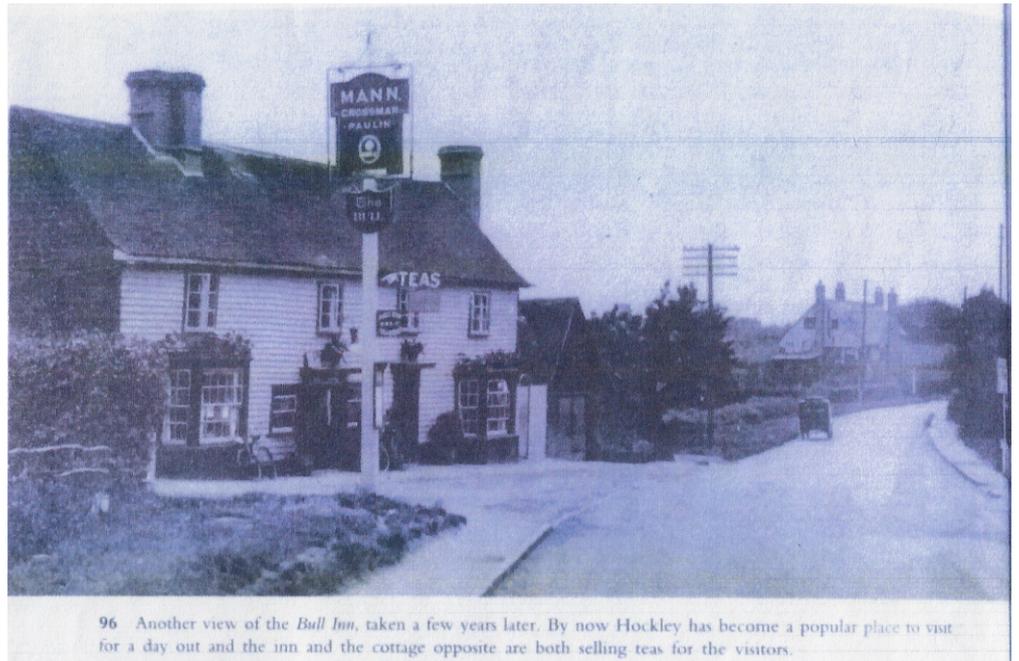
- 8.9.7 The window to front (Plate 41) has replaced double doors which are visible on a photograph of a few years after c. 1910 (Plate 2). The casement window has four lights, six panes per light. The flanking lights open and have iron fittings. The style of the window suggests a mid-20th century date. There is an opening in the rear wall styled as a door, but which appears to be fixed. This is a modern insert.

Plate 2: The Bull a few years after c. 1910

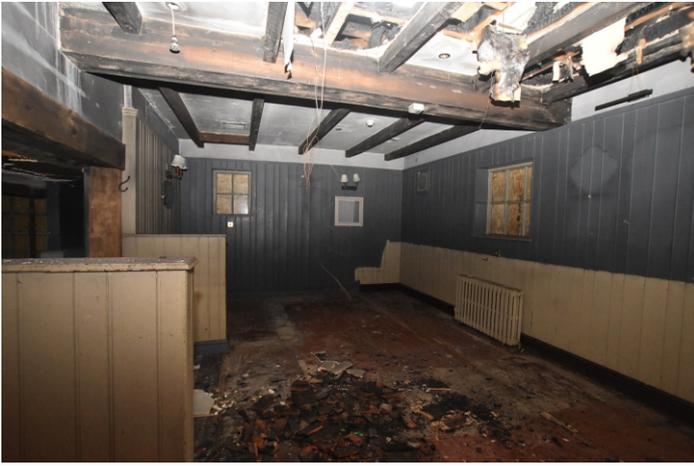
8.2.2 A rectangular single-storey extension (Plates 4 and 5) to left of the main core of the Bull, it has a single pitched timber roof on an east-west (right-left) axis. The truss type appears to be a raking queen strut (Plate 6). The roof timbers were badly burnt, but seemed to be nailed to the ridge piece, indicating a date later than c. 1800. The ceiling was plasterboard. The ceiling joists comprise soft wood, as seen in the rear half of the room which was partially burnt away, and blackened 'exposed' ceiling beams had been inserted to give a sense of age, in-keeping with the historic core of the building. The floor comprises small, square red tiles with concrete levelling over in places. The walls are wood panelled to paint-rail height with plaster above and a modern skirt. Two fixed windows are present within the room to front (four panes) and left (six panes), which have wooden frames and sills and look to be a mid-20th century date. There is a wide opening to the main core of the Bull to right which has 'distressed' uprights and a softwood beam (Plate 7).

Plate 4: Room A looking to front

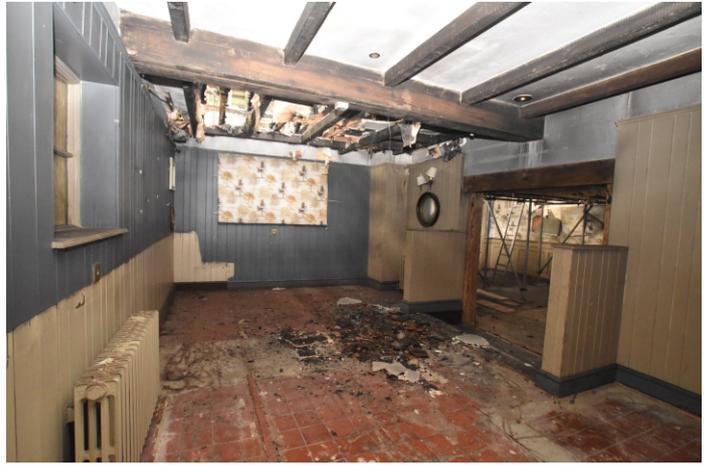
Plate 5: Room A looking to rear

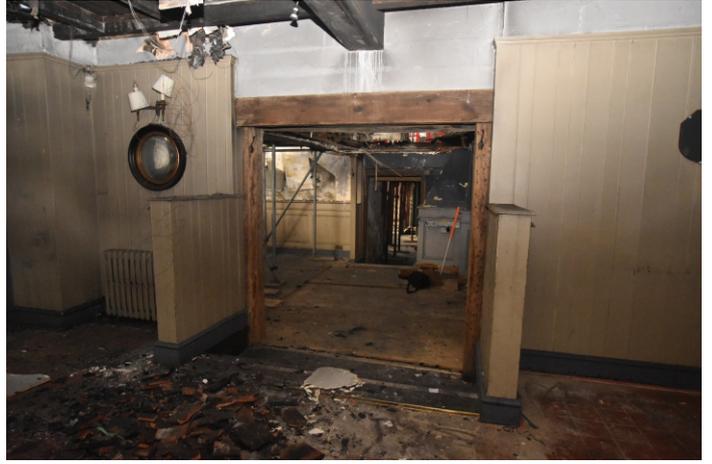
Plate 7: Room A looking right to Room B

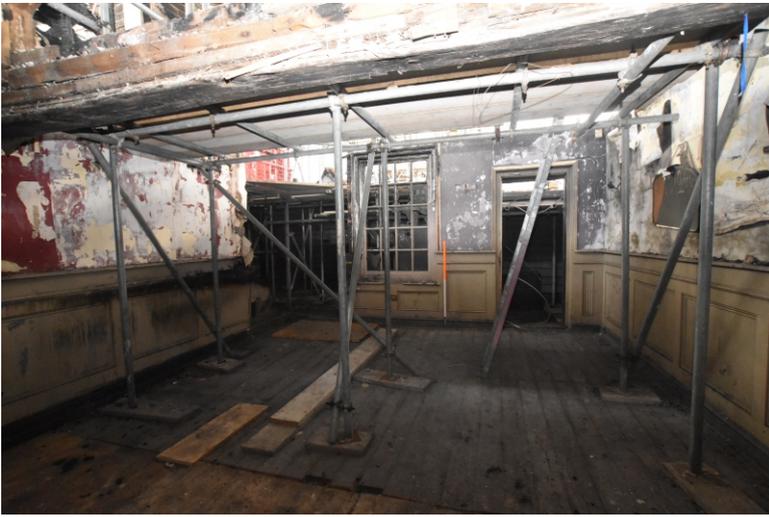
- 8.4.1 This section of the Bull is a later structure attached to the rear of the original core of the building between 1874 and 1897 (Plate 11, Figures 4 and 5). It now forms a single space with Room B. A horizontal ceiling beam marks the position of the original rear wall of the Bull, although there is now some modern repair in amongst earlier timbers, which look themselves to be re-used (Plate 12). The roof and ceiling of this structure have burnt away, although there are some peripheral indications that the ceiling was lath and plaster. The ceiling looks to have been a little higher than the ceiling in Room B. The wooden panelling on the walls of Room B continues into Room C, and there is plaster above the panelling from dado height to ceiling height. The skirting is the same as that in Room A.

Plate 11: Room C looking to rear

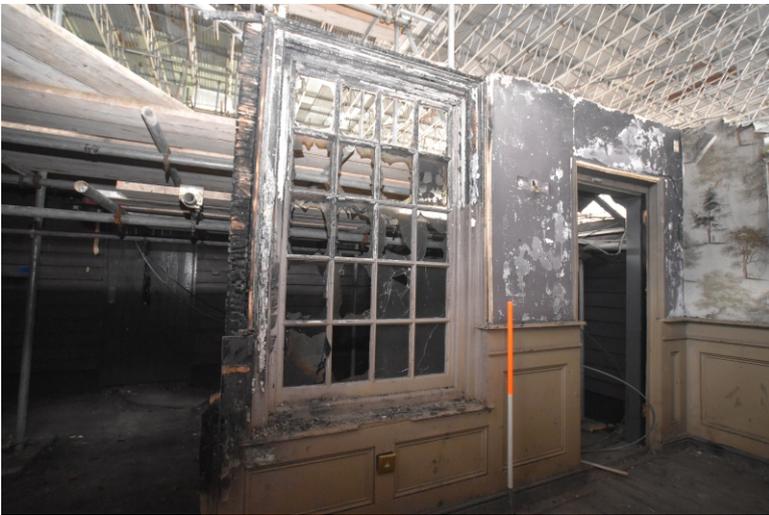
- 8.4.2 To the rear is a 20-pane fixed window with ovolo glazing bars and frame of a similar style to the windows in Rooms A and B (Plate 13) which may be contemporary with the construction of the room. All the panes are smashed. A door opening in the rear wall has architrave which appears to post-date the wall panelling and the door is missing. The floorboards have survived the fire and measure 0.15m in width.

Plate 13: Room C, window and door to rear

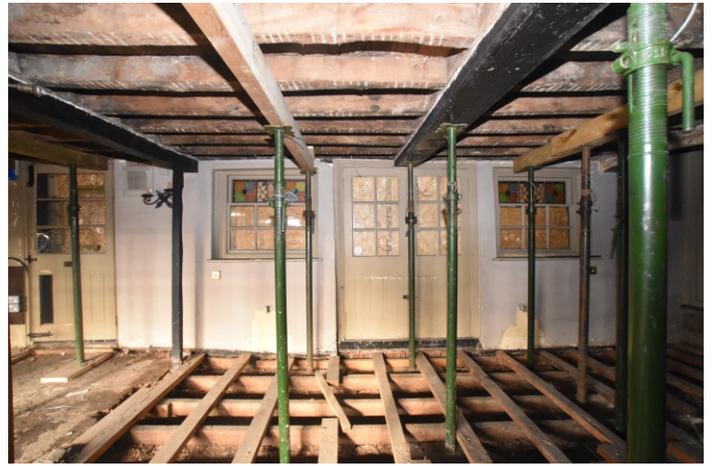
- 8.5.5 Off-centre in the front wall is a half-light, wood-panelled double door, which is flanked by two windows in the upper half of the wall (Plate 16). Each door has six panes, two in each of 'crown glass'. The glazing bars are a simple 'square' design and could be 20th century in date. The windows are sash casements (although they appear fixed) with six clear glass (some of which are 'crown glass') separated by ovolo glazing bars, below three panes of leaded, stained glass set in patterns. There is a further single door in the front wall off-centre to right. This door is also half-light with six panes and wooden panels below. The panels and glazing bars match those of the double doors and the 'crown glass' panels and the plain glass also appear to be 20th century in date. The door fastenings comprise iron decorative back panel and an iron latch of the same design. There was no evidence available at the time of the survey to ascertain whether the openings in the front wall were contemporary with the structure, although the doors and windows themselves are a mixture of 19th-20th century date.

Plate 16: Room D, wall to front showing ceiling beams and doors/windows

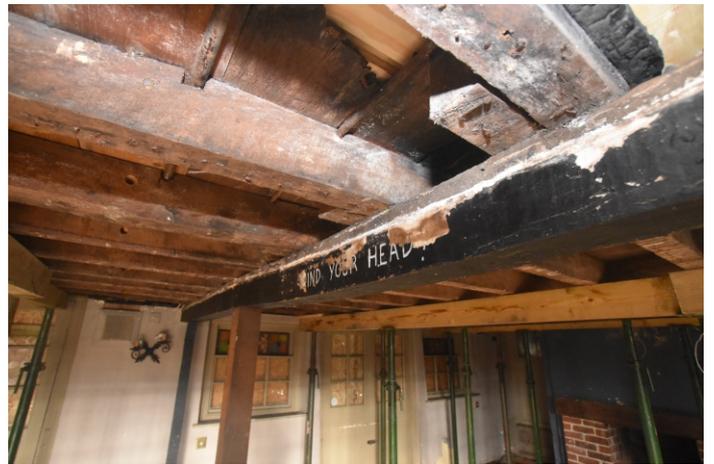
beam to left is supported on wall plates to front and rear and the ceiling joists are jointed into it (Plate 17). The beam to right, however, is supported on modern posts to front and rear and the joists rest atop the timber, overlapping side by side, indicating that this beam is not original (Plate 18). It could, however, be a reuse following repair or remodelling; the position of the beam could have been altered when the rear wall of the original core of the building was removed to make the layout of the area more open-plan. Although there is some modern repair, much of the ceiling seems to be contemporary with the 17th century build.

Plate 18: Room D, ceiling beam to right

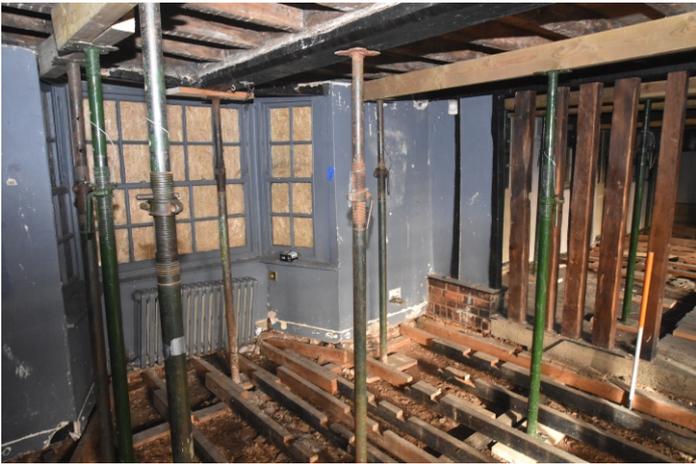
8.6.2 The lath and plaster ceiling is a continuation of that in Room D (Plate 21). The ceiling joists, some of which are original and some are modern replacements, are jointed to a central, horizontal ceiling beam, which is central to the room. The ceiling beam, blackened and intended to be exposed, is also aligned to centre of the window embrasure in the front wall.

Plate 21: Room E, central ceiling beam

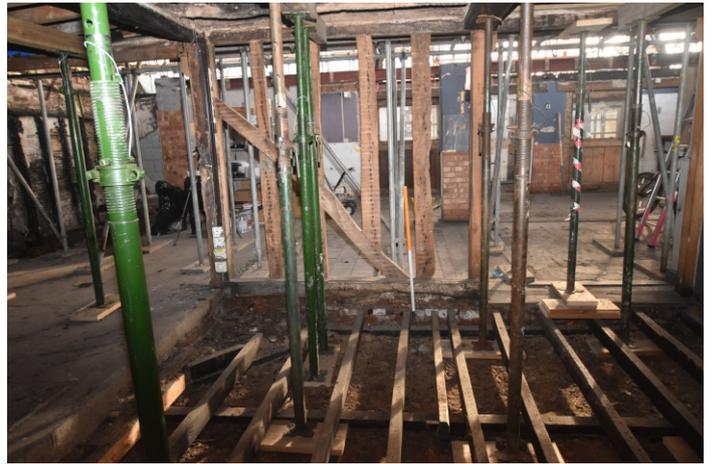
8.6.3 The original wall to rear (Plate 22) is no longer extant, although a section of open timber panelling is present. The struts and the passing diagonal brace of a similar width seem original (although one is a modern replacement) and show markings of lath and plaster. The struts are jointed into beams above and below. The timbers have external carpenters' marks. The lower wood support stands upon at least three courses of brick. To right of the studwork, in the rear right corner of the room, there is a broad timber threshold measuring 0.2m wide, indicating a former rear opening. The wall to right, plastered and painted, contains two doorways and a fireplace. The wall to front is also plastered and sits on a brick plinth.

Plate 22: Room E, wooden stud 'screen' to rear

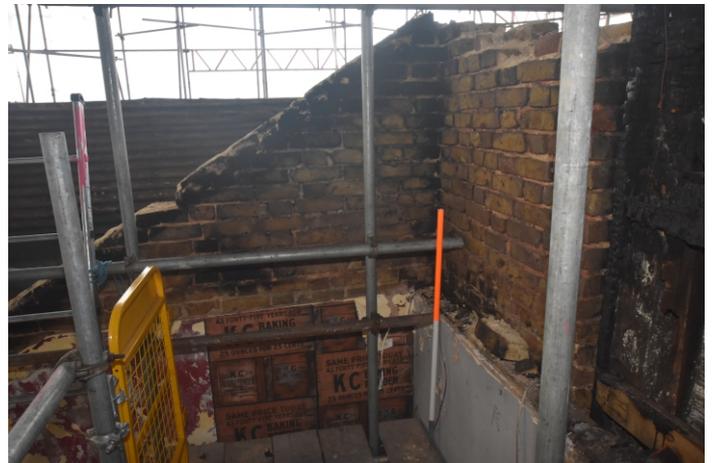
- 8.10.2 The wall to right (Plates 46 and 47) abuts Room I and extends to left at roof height to abut the rear right corner of Room EE. It is constructed of brown yellow brick set in Flemish bond with a reddish lime mortar. At ground level the internal face of the wall is covered with two layers of plaster, the outer a modern 'skim'. The wall to left, up which the staircase ran, comprises timber frame with lath and plaster infill supported on a wooden sill over at least four courses of red brick foundation (Plate 48). Above the timber frame, at a height of 1.7m and to roof height, the wall is red brick set in Stretcher bond with integral horizontal timbers every few courses (Plate 49). This wall is bonded to a modern breezeblock wall to front and a modern brick wall to rear.

Plate 47: Room J to right, upper section

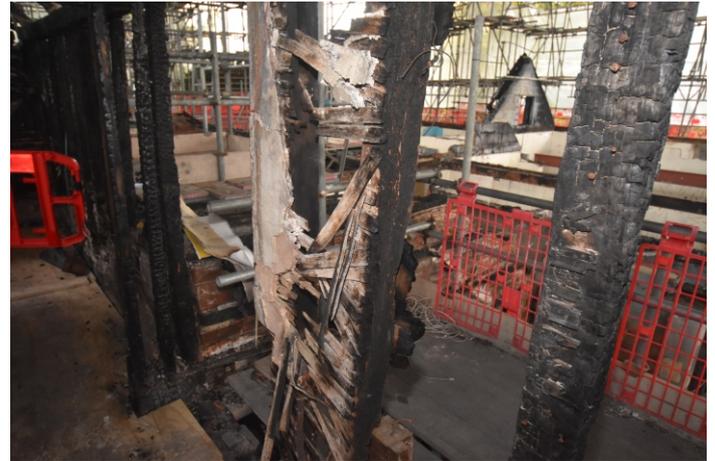
- 8.14 The walls and ceilings comprise timber frame with lath and plaster (Plates 52-56). There are areas of modern repair amongst the older timbers (Plate 57). Although fire-damage has removed much of the evidence, passing braces appear to be a feature of wall construction (Plate 57). It is possible to see from areas of the ground floor that the floors are boarded. The floorboards to Room DD measure 0.21m in width, although some had been replaced with modern boards. The floorboards of Room FF measure 0.24m in width. All architrave and skirting is modern and no doors remain.

Plate 53: First Floor Corridor AA, lath and plaster

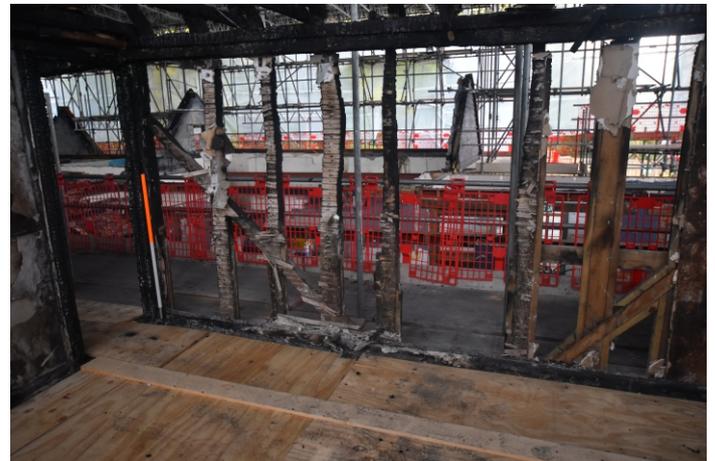
Plate 57: First Floor Room EE looking to rear

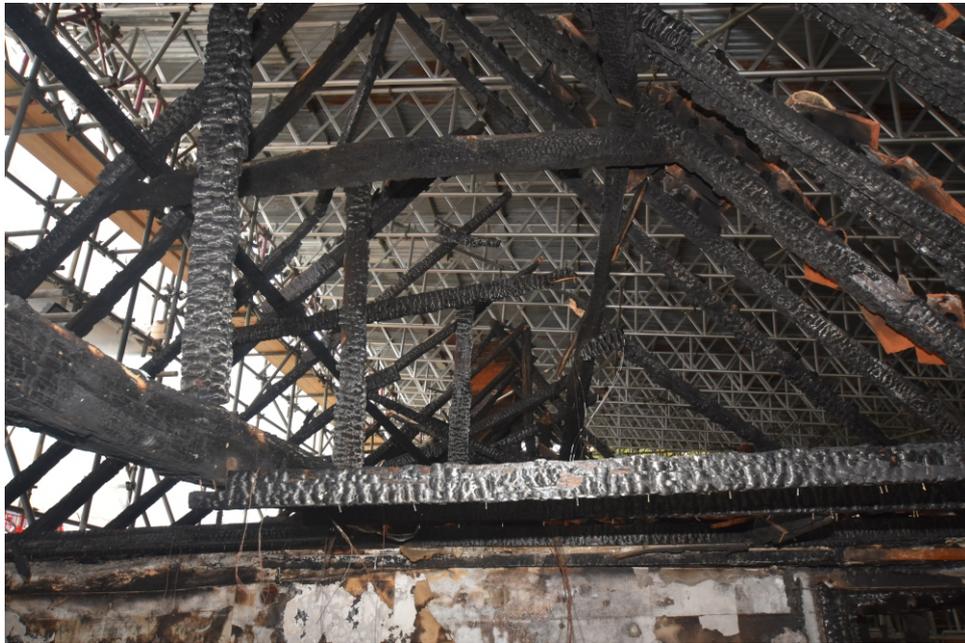
- 8.15 The truss (Plates 68-60) appeared to comprise a crown strut with purlin clasped around the collar, although the severe fire damage hampered interpretation; the measured survey has recorded the truss type as more like Room I, with 'V' struts to purlins supported on a collar (Section C-C, Figure 18). The pitched roof is on an east-west alignment and had been tiled. The style and timbers of the truss, although the evidence was much compromised, suggests it dates to 18th-19th century.

Plate 58: First Floor truss looking left

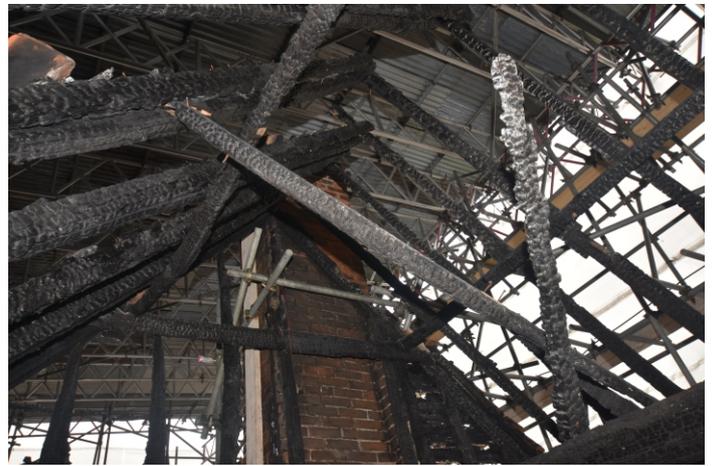
Plate 59: First Floor truss at right gable end
