**LAND AT THE FARMER'S HOUSE,
GLYNN, BODMIN,
CORNWALL**

PHOTOGRAPHIC SURVEY

May 2008
Report 606

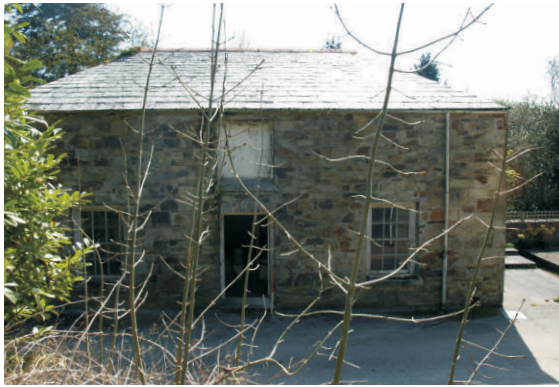
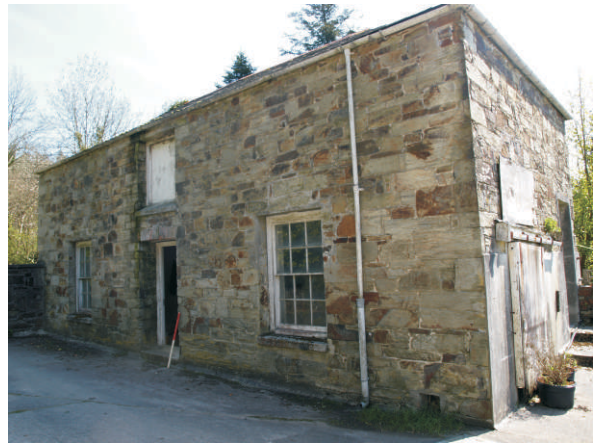
NORTHWEST ELEVATION

- 4.3.3 The **northwest elevation** (Figures 3 and 5) contained two windows and two doors arranged symmetrically within the wall. The windows were set equidistant from the doors and comprised wooden sliding sashes with external concrete sills and panes of glass divided into 12 panes. They were situated at ground floor level. A central doorway is also situated at ground floor level. It has a single concrete step and a brick-built flat archway with a stone keystone. The wooden door and frame is a modern insert. At first floor level is a small doorway leading to an upper floor. It has stone lintel and sill and a modern wooden frame and door.

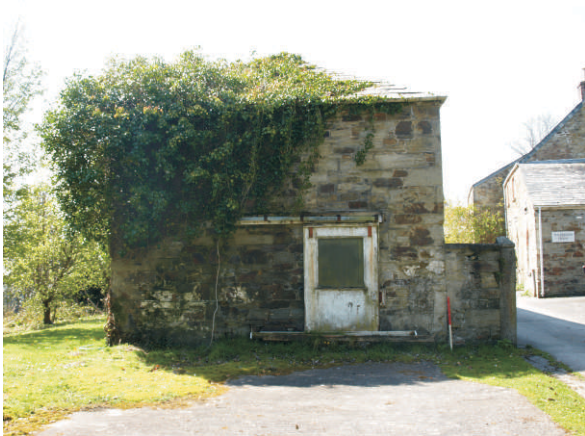
NORTHEAST ELEVATION

- 4.3.4 The **northeast elevation** (Figures 4 and 5) has a single door at ground floor level towards the northwest side. The opening itself was entirely obscured on the outside by a modern sliding door with rails above and below. Internally the doorway was visible although it was heavily concrete rendered. The southeast side of the wall was obscured by ivy, however internal examination showed that there were no further features or openings in this wall.

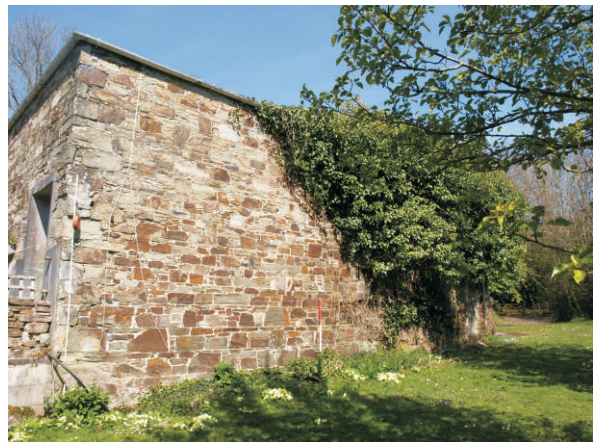
SOUTHEAST ELEVATION

- 4.3.5 The **southeast elevation** (rear) (Figures 4 and 5) had no openings. The northeastern third of the wall was obscured by ivy, internal examination, however showed that there were no features within this wall.

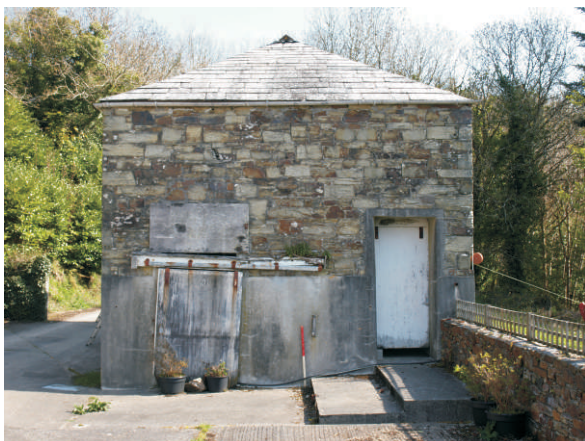
SOUTHWEST ELEVATION

- 4.3.6 The **southwest elevation** (Figures 4 and 5) included two doorways. The northwest doorway had a modern sliding door with a top rail, similar to that in the northeast elevation covering the bottom three quarters of the doorway and a plywood board, nailed to the outside of the wall, covering the top quarter of the entrance. This doorway was much taller than the other entrances. The southeast door jamb was concrete rendered and the entrance was reached via two concrete steps. A modern piece of timber was nailed to the inside of the opening and only part of a modern wooden frame was present on the southwest side. The bottom third of the wall was heavily concrete rendered.

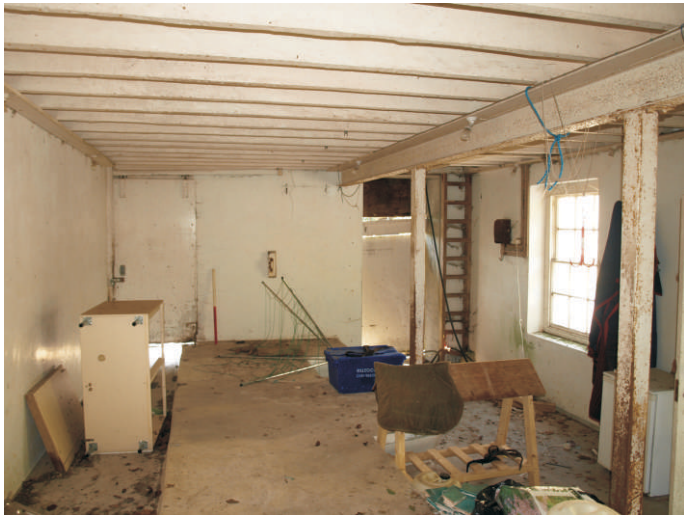
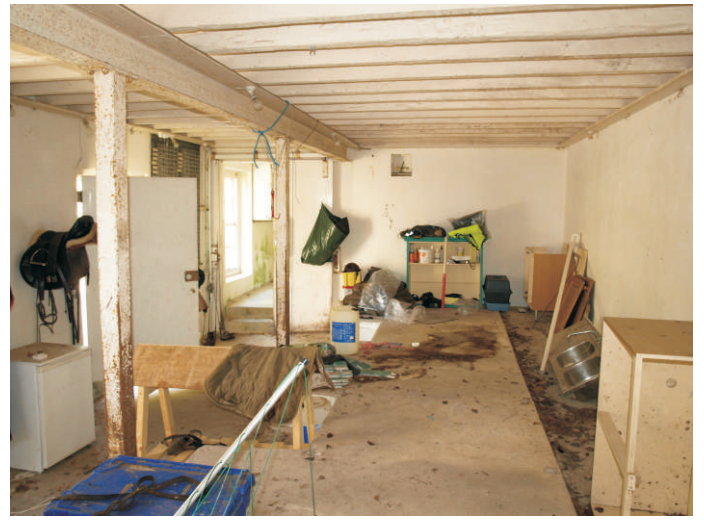
- 4.3.9 The gutter and downpipes were of cast iron.
- 4.3.10 **Internally** the barn was divided into two levels and again into two rooms on the **ground floor** (Figure 6). The internal ground floor level had been entirely re-modelled when the building was converted to a dairy and it had probably been split into two rooms at this time. The main, larger room on the northwest side had a raised floor built of concrete on the southern two thirds of the room. The concrete was moulded into three stalls set equidistant apart on the northern side. The cows would have stood in these stalls and faced southwards (to the rear) where a trough for feed was moulded into the raised concrete floor. The cows would have entered the building through the doorway in the southwest side of the building (the northwest door set into the southwest elevation). The trough was accessible, probably to allow sluicing out, through a door in the same wall (the southeast door in the southwest elevation). The remainder of the floor in the main room was also concrete. The walls were concrete rendered and painted white. No original fixtures or fittings were present in this room. A blackboard on the northwest wall, to the northeast of the door, dated from the time the building was last used as a dairy. The latest date on the board was 1975. A wooden ladder which led to a trap door in the upper floor was also present in the west corner of the building, although it is not clear to which phase it belonged to.

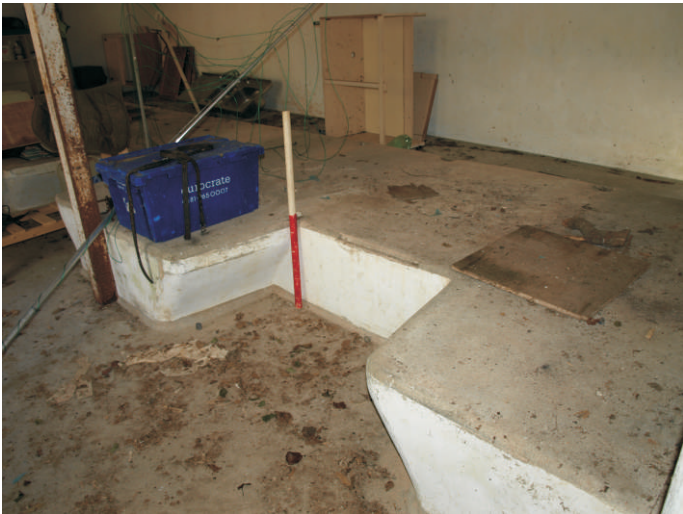
MAIN ROOM, MILKING STALL DETAIL

- 5.4 Mid-late 20th century additions to the barn were probably undertaken at the time of conversion to a dairy. The additions include partition of the ground floor into two rooms, the creation of the concrete milking stalls and associated feeding trough, the insertion of a new floor, the replacement of the roof and the concrete rendering internally on the ground floor and externally on the south-west elevation. The doors in the northeast and southwest walls were probably also inserts when the building was converted to a dairy.
- 5.5 No original fixtures or fittings were present in the building and no decorative detail was identified during the survey.

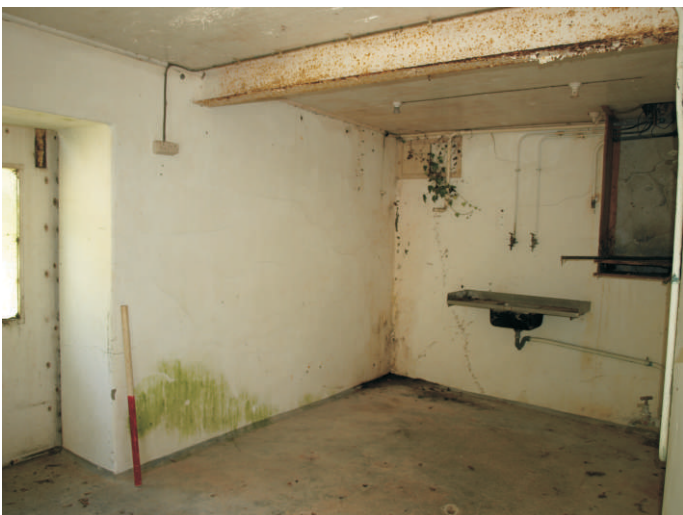
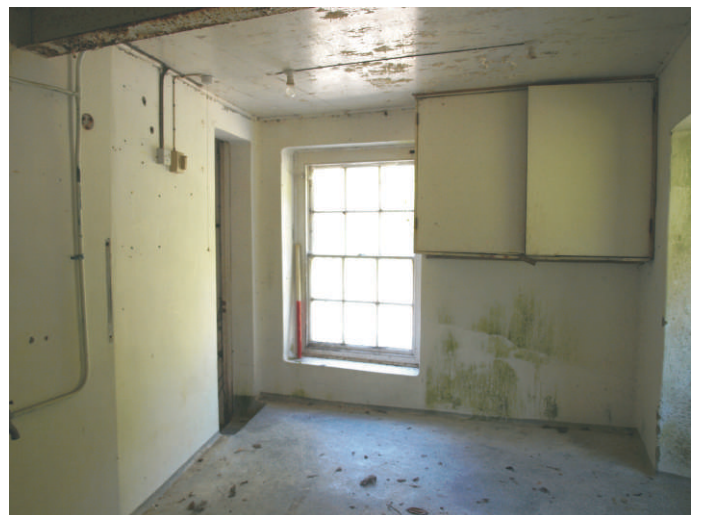
- 4.3.11 At the northeast end of the **ground floor** was a **second room**, partitioned off in the modern period, probably when the building was converted to a dairy. This was accessed by an internal door leading from the main room, which had two concrete steps up to it, and also via an external entrance in the northeast wall. The concrete floor was raised above the level of the main room by almost 0.50m. This floor was a modern installation, probably also inserted when the building was converted to a dairy. As in the main room, the walls were concrete rendered and painted white and the ceiling was plastered. A small hatch in the top northeast corner of the southeast wall was visible, covered with a modern wooden sliding door; this also appeared to be modern in origin. No original fixtures or fittings were present within the room. The

room seemed to have been used as a make-shift kitchen and storage area when the dairy was in use.

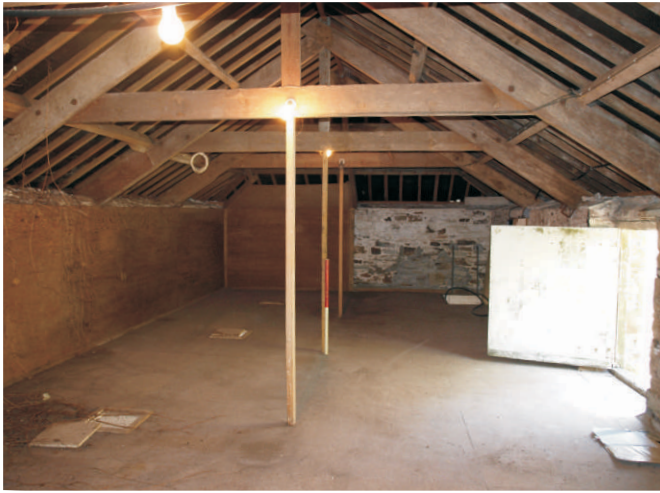
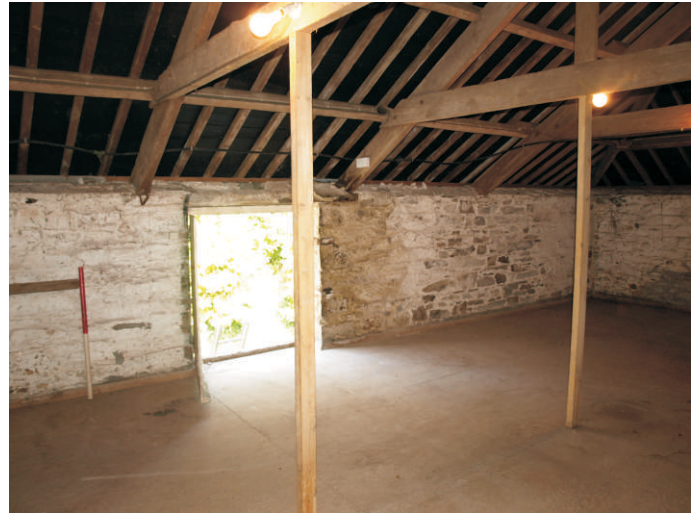
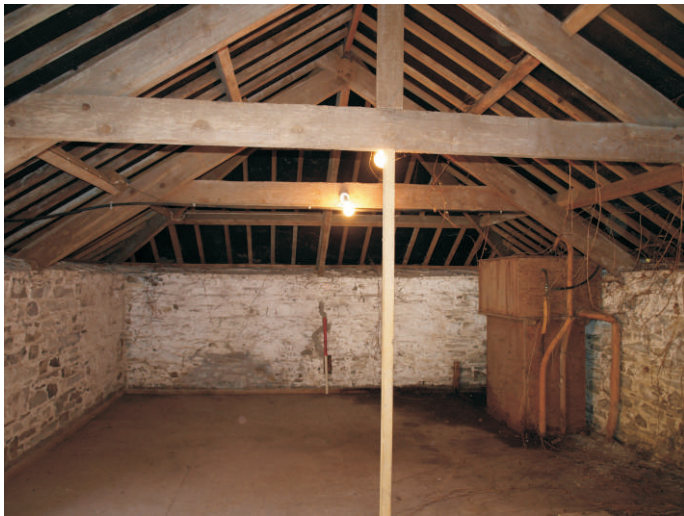
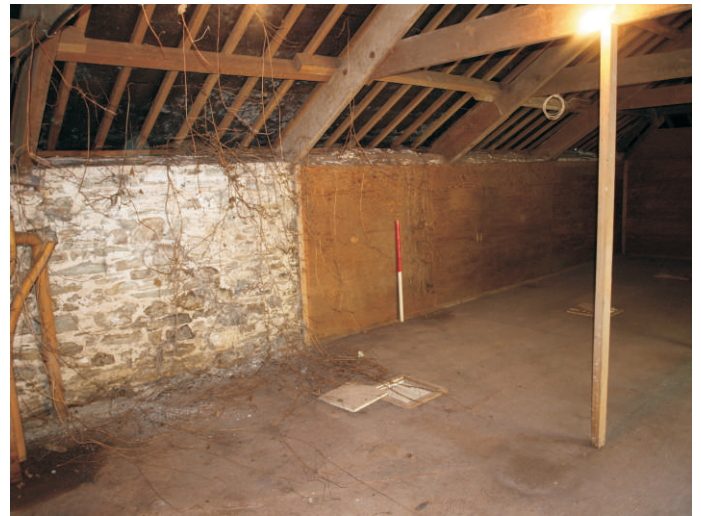
- 4.3.8 The **roof** (Figures 3, 4 and 7) was a timber structure with a slate covering. It was a modern replacement which comprised sawn cut modern timbers in a basic common roof truss with modern black fabric lining between the timbers and the slate covering.

- 4.3.12 The **first floor** comprised a single room open to the roof (Figure 7). The floor there at the time of the inspection was a modern installation, however, it probably replaced an original floor level rather than being a 'new' feature. It was built of wooden joists held up by rigid steel joists (rsj's) constructed from ground level. The wooden joists were covered with modern wooden boarding. Three hatches were cut into the floor which may have been used to drop feed directly into the trough below. This floor could be accessed either from the ground floor via a trapdoor in the west corner of the building or through a half-height door in the northwest wall. The door was probably the original entrance to the floor. The walls were bare stonework, with the exception of the south corner which had modern wooden boarding attached to the stone walls. No original fixtures or fittings were present in the room.

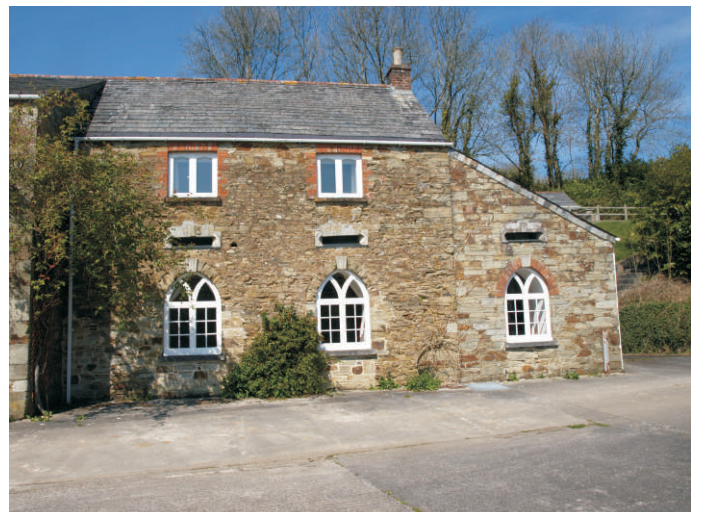
- 5.2 The original build was of simple, utilitarian character, constructed of local stone. It was built of the same materials and in a similar design to The Farmer's House, although was clearly a later build. An extension on the northeast side of the main house was a later addition and was clearly of the same style as the barn, with the same brick lintel design over the openings. The barn and the house extension are almost certainly contemporary and represent later additions to the building complex.

THE FARMER'S HOUSE, SHOWING THE LATER EXTENSION ON
THE NORTHEAST END.
