**BUILDING RECORDING AND ARCHAEOLOGICAL MONITORING**  
**AT ST MARY MAGDALENE CHURCH**  
**WETHERSFIELD**  
**ESSEX**

**June 2011**

**FAU Project No.:** 2333

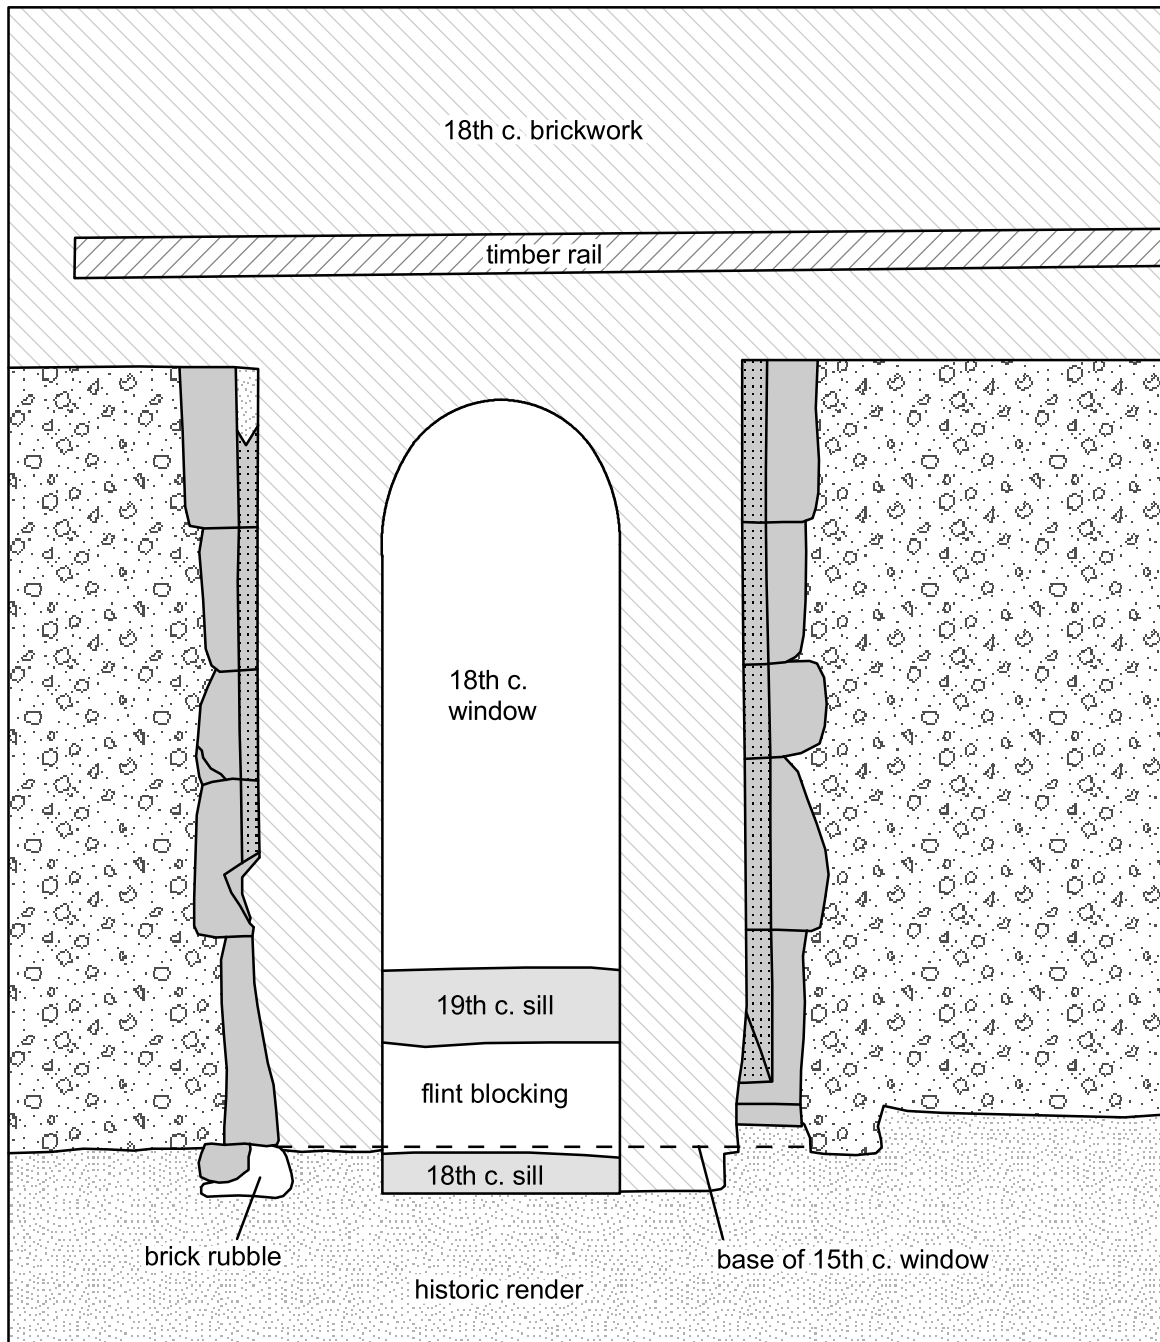
Fig.3. West wall

centred arches (like the doorway), but could only accommodate flatter four-centred heads (figs. 3 & 4).

Of the 18th century plain-arched windows, only the western one is still in use. Originally this was taller than it is today at approximately 2m, with sill level similar to that of the 15th century window (fig. 3). Subsequently the sill was raised, probably during the Victorian restoration, to form the current window. On the other side, the eastern window was completely blocked during the restoration, presumably to create the alcove for the font. Only the window head and north jamb remain; the south jamb has been cut out (fig. 4). There is some evidence that the brick window here was shorter than the other since the outline of the former sill appears to survive (fig. 4), suggesting an opening of approximately 1.5m in height.

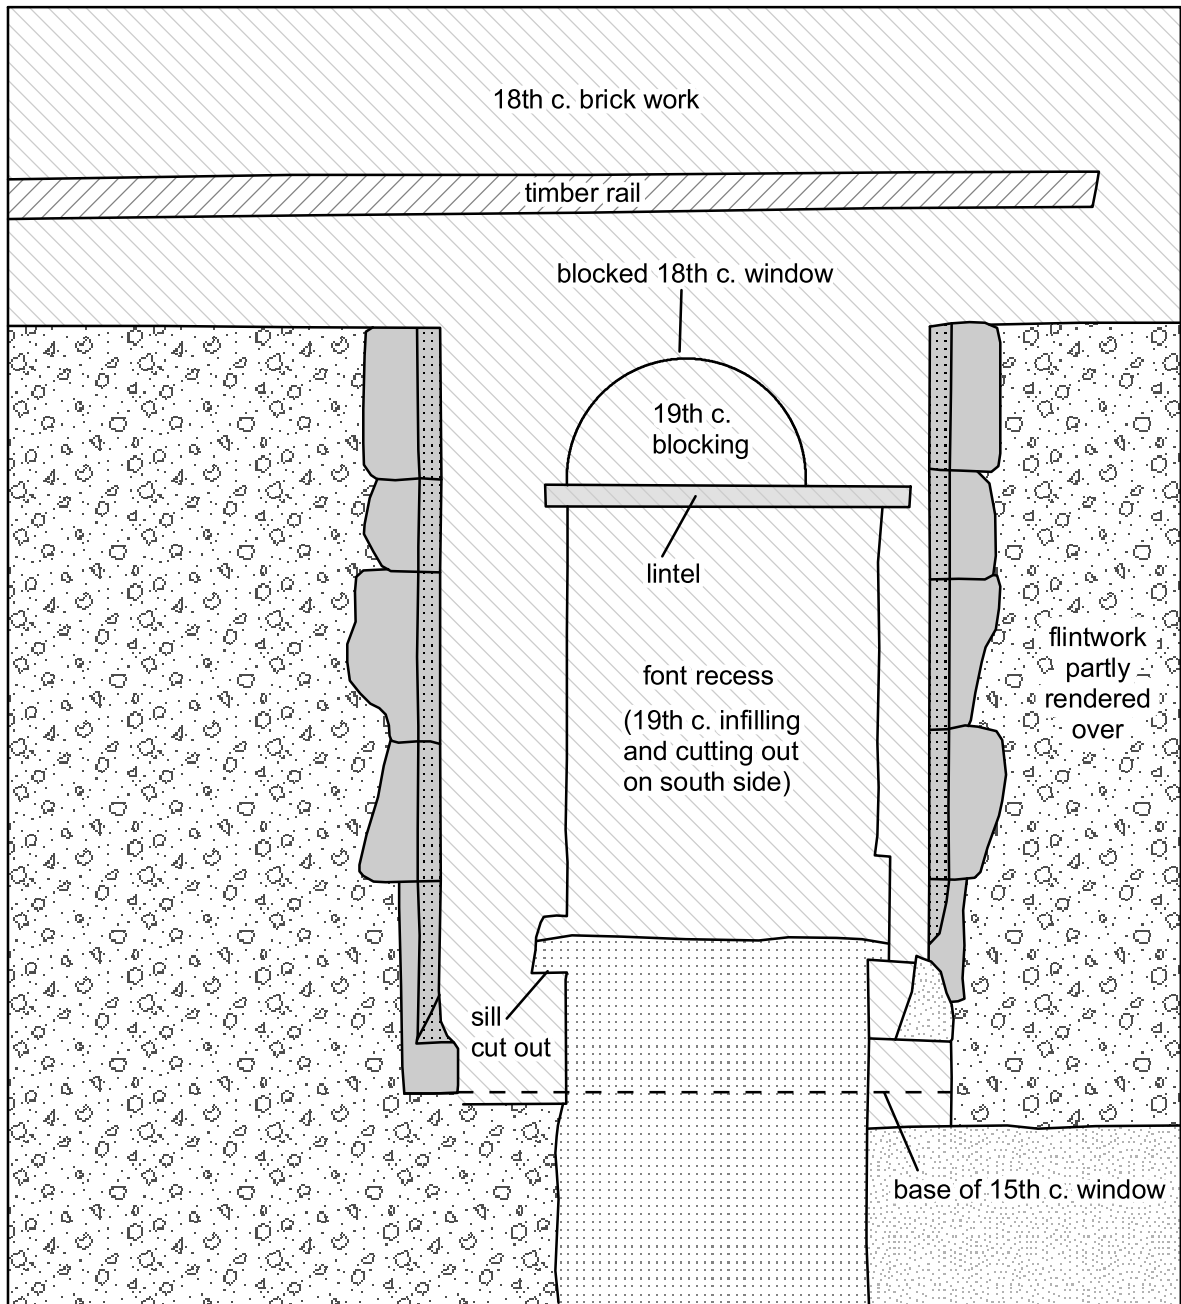
Fig.4. East wall

The replacement 18th century windows were much narrower, with simple plain arches built of soft red bricks. Brick dimensions, form and colour conform to those of 18th end early 19th century date (Ryan 1996). The same bricks were used to build the brick crenellations above. High up in the internal brickwork are timber rails that perhaps held laths for plastering (figs. 3 & 4), brick being a flatter material to 'key in' the plaster than flintwork.

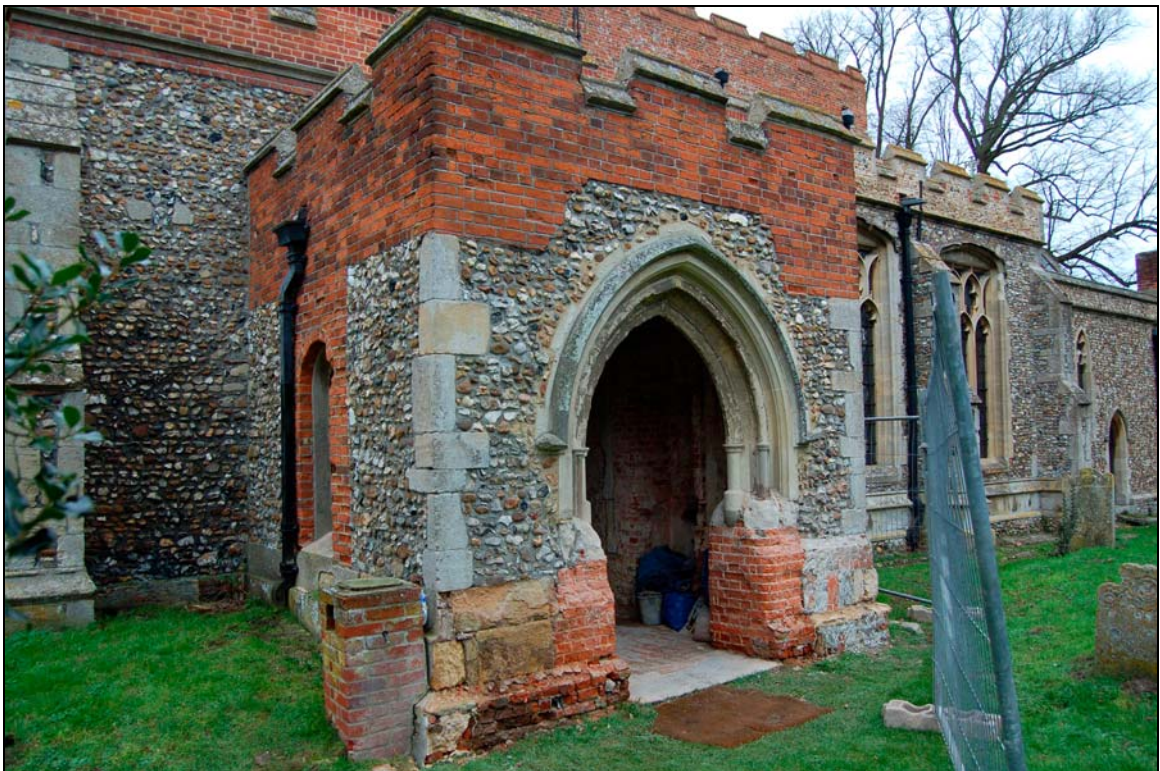
The external walls comprise well-coursed and densely-packed flints and stones below an 18th century crenellated brick parapet, built in English bond (plate 2). The porch is entered through a 15th century moulded two-centred archway, partly restored with plastered brick at the base of the jambs, exposed during the current works. The west wall has a surviving 18th century plain arched window of red brick, (plate 3). A corresponding window on the east wall was blocked-in during the 1874 restoration to form a recess for a disused 15th century font (plate 4). It is interesting to note that the flintwork covering the former window matches the existing flintwork, suggesting the exterior was re-faced in the restoration.

Plate 2 Southern porch

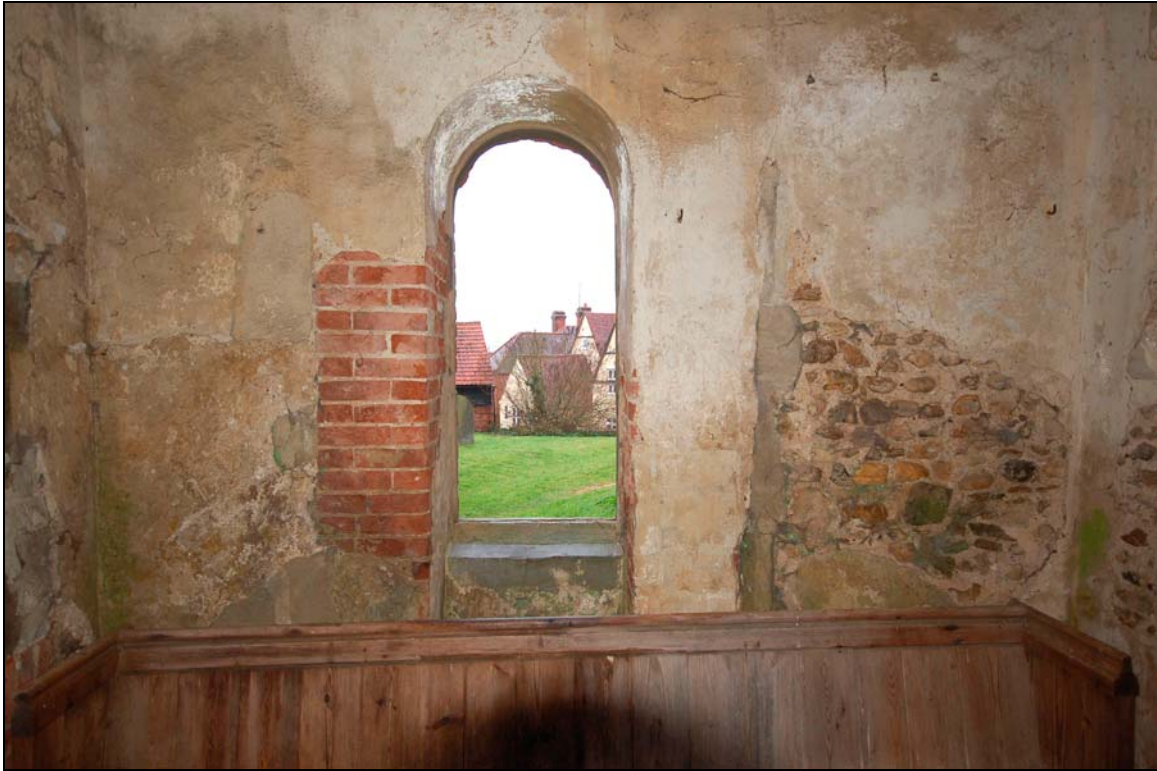
Plate 3 West wall of porch before start of works

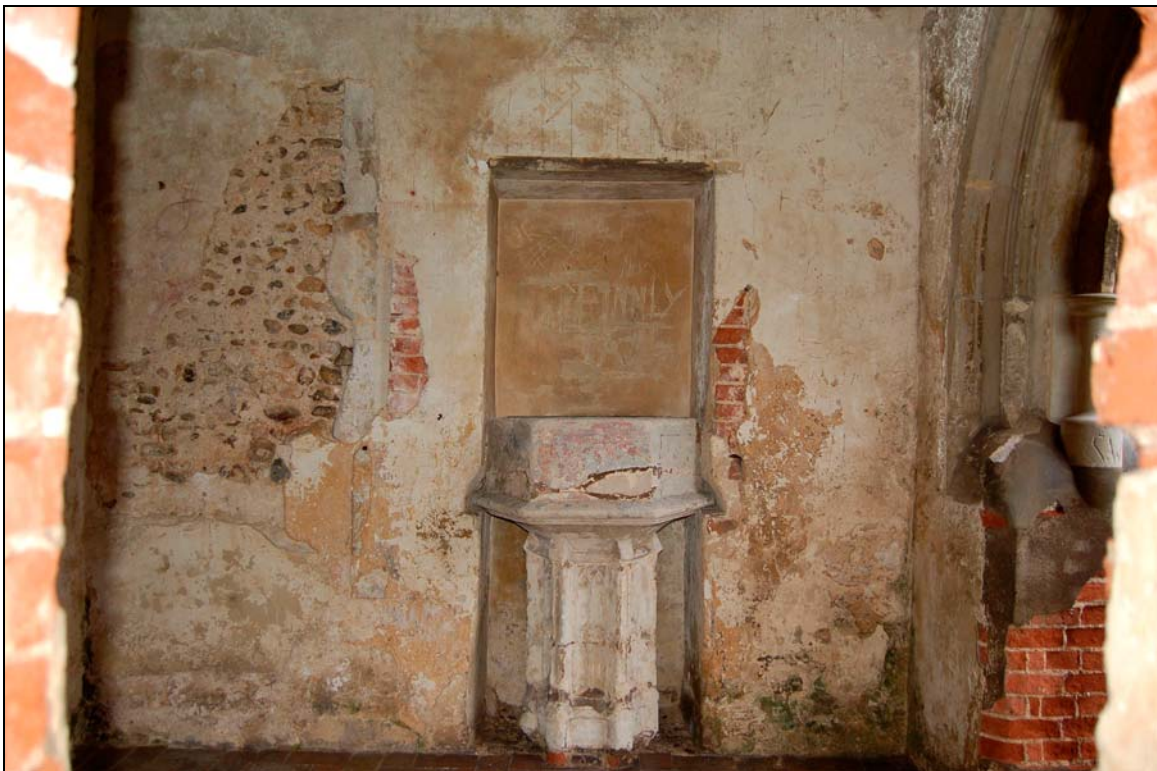
Plate 4 East wall of porch before start of works

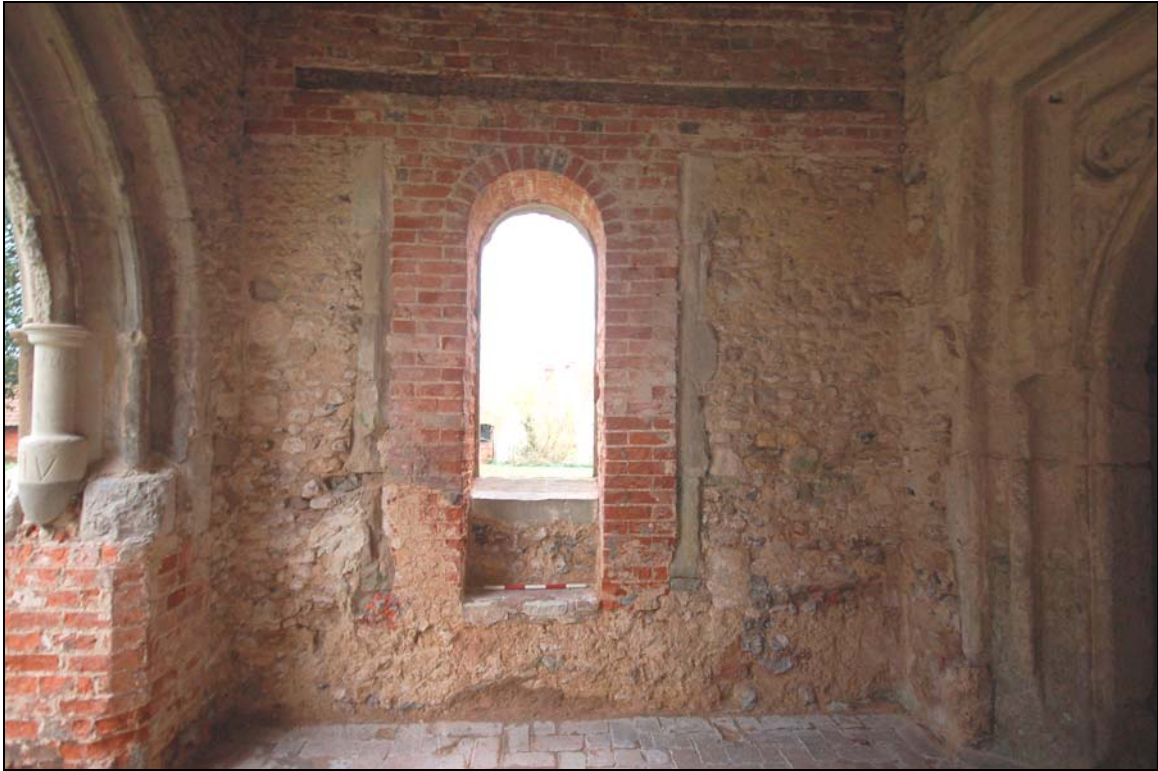
Only the limestone jambs remain of the blocked windows in the porch which are quite large given the size of the structure. They survive to approximately 2.1m in height and 1.5m in width, with an internal opening of c.1.9m by 1.3m. All tracery was removed when the windows were blocked prior to the construction of the new, plainer ones in the 18th century, and their heads levelled off when the upper part of the porch was rebuilt in the same phase. Therefore it is difficult to imagine how the windows originally appeared. It is worth noting that the height of the roof, which by all accounts is original, would not allow for windows with two-

Plate 5 Exposed 15th and 18th-century windows on western wall

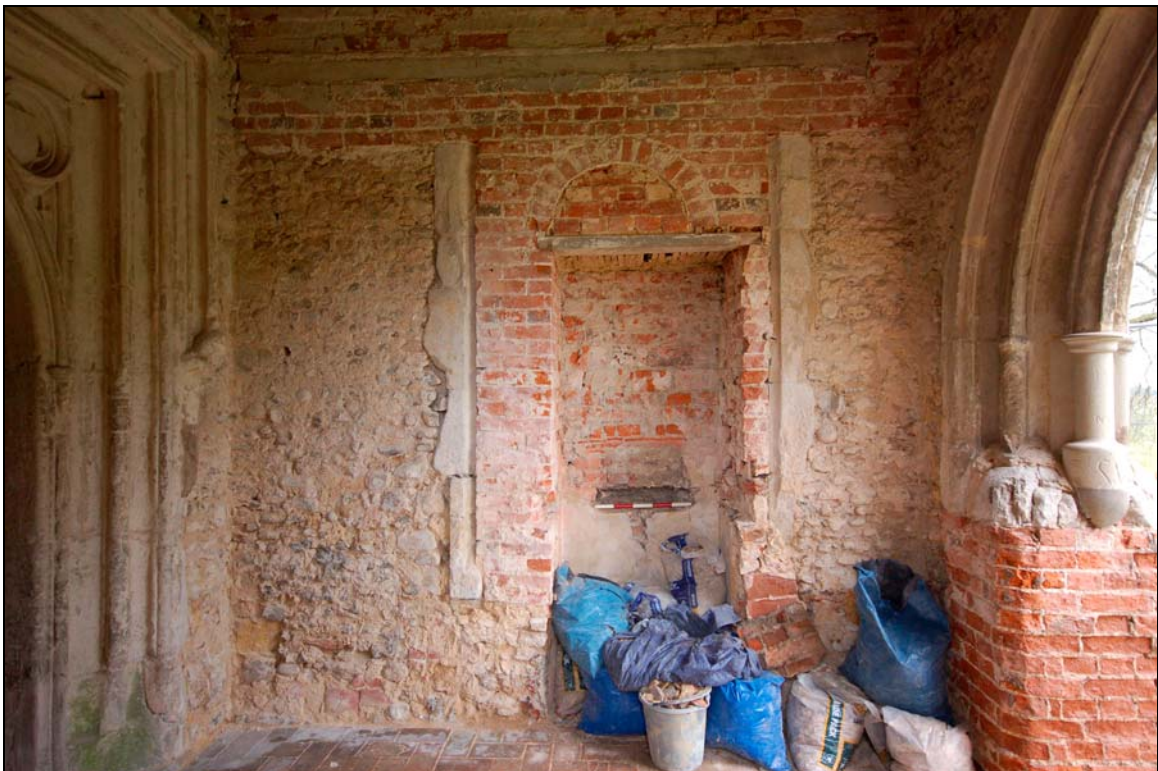
Plate 6 Exposed 15th and 18th-century windows on eastern wall

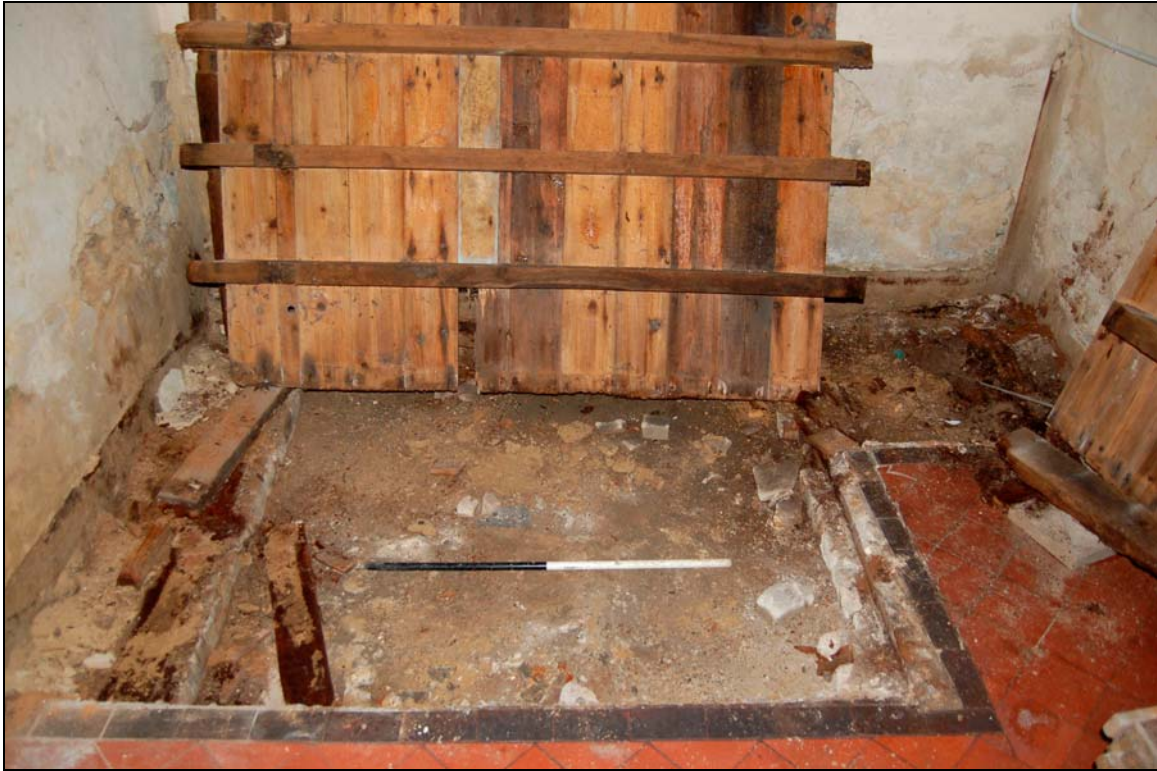
A small area of wooden flooring was lifted in the south-west corner of the church (fig. 1). The surrounding floor is tiled. Beneath it lay a patchy spread of lime mortar (plate 7), probably relating to the 19th century restoration phase. No further excavation took place.

Plate 7 Area of removed flooring

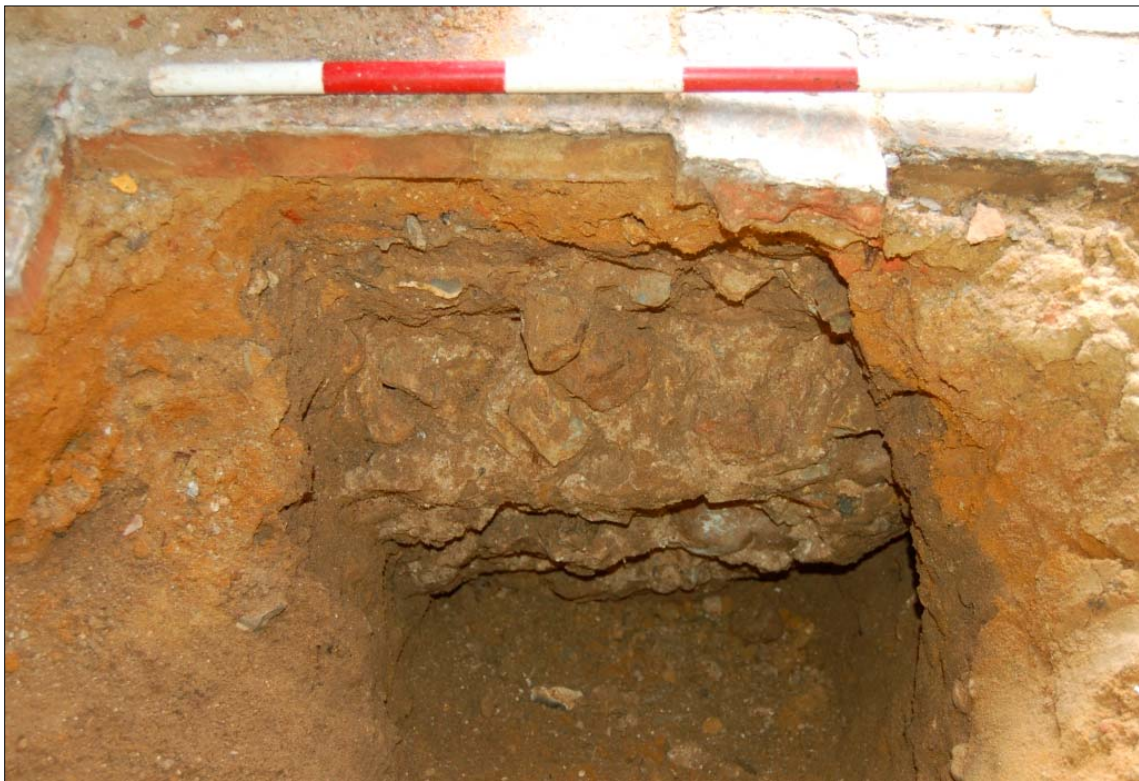
deposits in the south-east corner of the porch on the line of the proposed drainage run (plate 8). The orange sand was revealed in section to be about 0.08 m thick and to overlay a 0.02m thick seam of greyer silty sand. Beneath was 0.05m of more mixed grey sandy silt containing occasional pieces of flint which overlay a foundation deposit of small to medium sub-angular flints in a light brown to buff sandy mortar with small lime inclusions. The foundation deposit protruded 0.10m out from beneath the southern wall of the porch and was in excess of 0.35m thick.

Plate 8 Internal foundation exposed in exploratory pit looking south (0.5m scale)

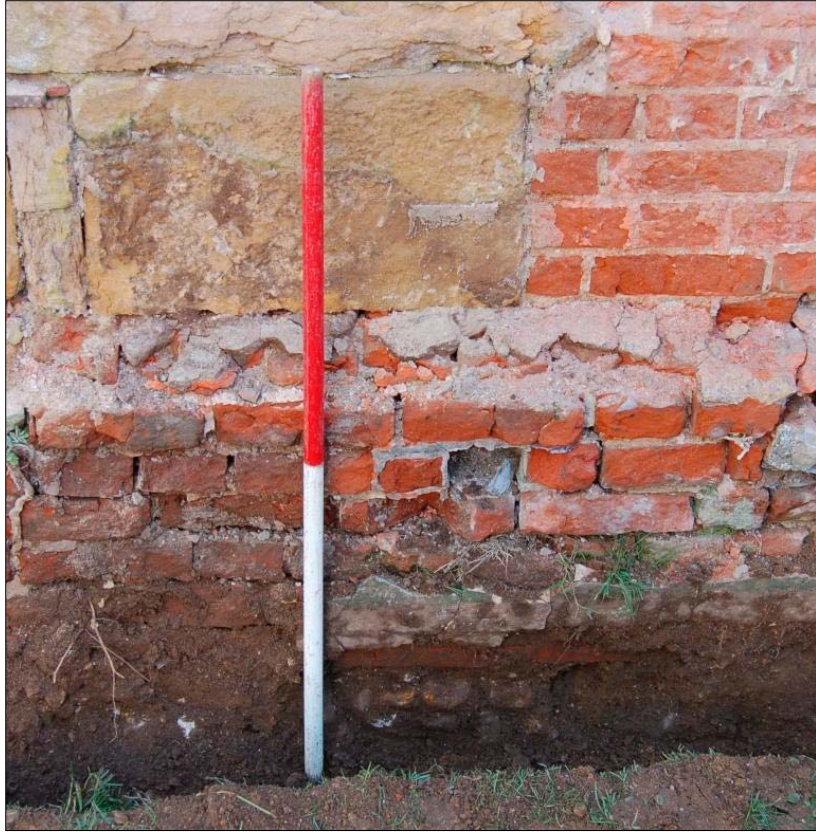
The foundation deposit was further exposed in a shallow drainage trench, c.0.30m wide by 0.30m deep, excavated around the outside of the porch. In the southern wall (west of the entrance) the foundation was sealed by a single course of flat red bricks, measuring 225mm by 60mm, of possible Tudor or 17th century date, though most probably re-used to form the base for the 18th century brickwork supporting the porch doorway (plate 9). The top of the foundation exposed on the western side of the porch was notable for the use of several large flints/stones in its upper courses. A layer of bricks was also noted laying above the foundation but here obscured by render. The excavation of a drainage run beneath the stone slab (coffin lid) of Purbeck marble forming the porch threshold revealed that the foundation was not continuous and that there was a convenient c.0.40m wide break in the foundations beneath the centre of the entrance threshold.

Plate 9 External foundation for porch looking north (1m scale)

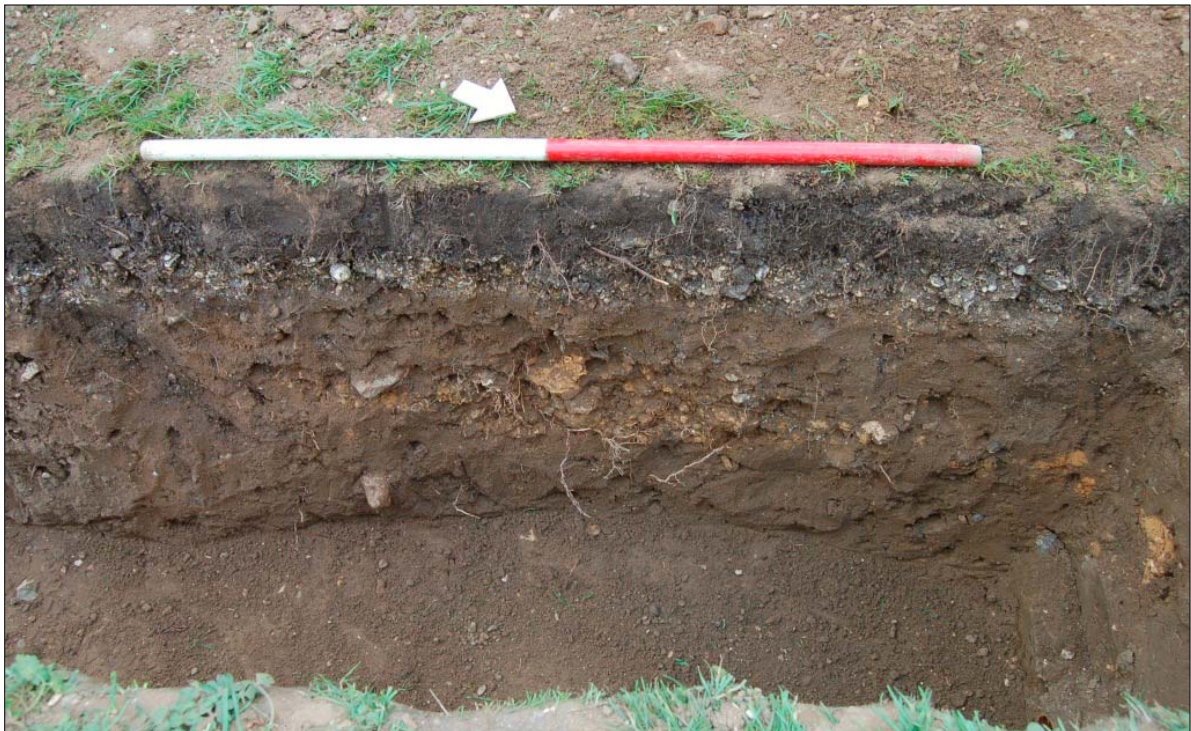
Monitoring was undertaken on the excavation of a new drainage run. This led from the porch doorway to a new manhole and partly along an existing grass pathway that followed the natural slope to the south-east. The trench was mostly 0.60m wide and varied in depth from 0.20m to 0.80m. The overburden generally consisted of 0.10m-0.20m of topsoil overlying greyish brown sandy silt. No distinct features or grave cuts were visible in the silt which is likely to be made up of mixed grave backfill. A large lens of light orangey brown sandy mortar with occasional flints was noted within the silt about halfway along the trench on its western side (plate 10). Also visible in this area was a band of small pebbles that separated the topsoil from the silt and may have been remnants of a former path surface.

Plate 10 Mortar lens and pebble band in drainage run (1m scale)
