**BARNs AT BRICKBARNs FARM
MASHBURY ROAD
CHIGNALL ST JAMES
ESSEX**

LEVEL 1 HISTORIC BUILDING RECORD

Report no. 2440

July 2011

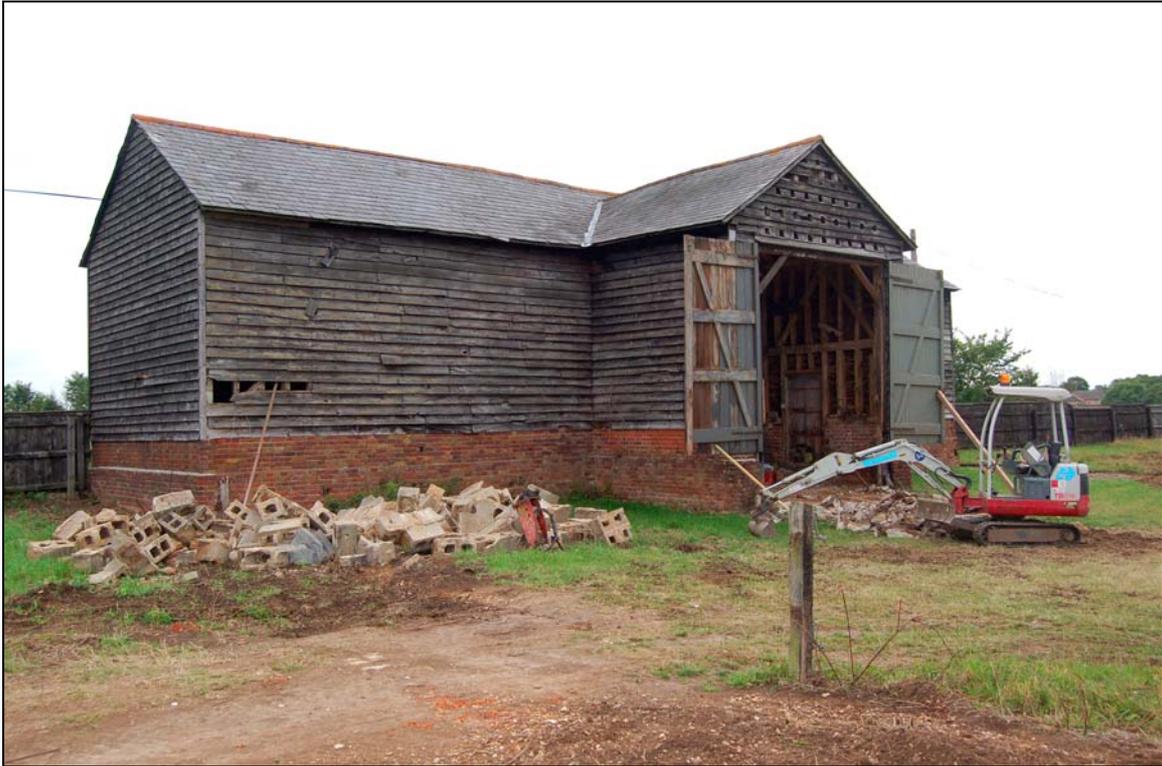
Plate 1 Barn 1 viewed to north-east from yard

This is a redundant five-bayed 19th century timber-framed structure positioned along the north side of the yard, with gabled ends and a porch facing onto the yard (plate 1). It formerly adjoined a large building on the west side, which is no longer standing (fig. 1).

Cart doors face onto the yard and road (plate 2) either end of the midstrey. Above the porch doors is the remains of a dovecote in the form of five rows of nesting holes (plate 1), now blocked internally. There is a separate entrance on the east side of the porch (fig. 2 & cover plate). Slates cover the roof, which has a pitch of c.40°.

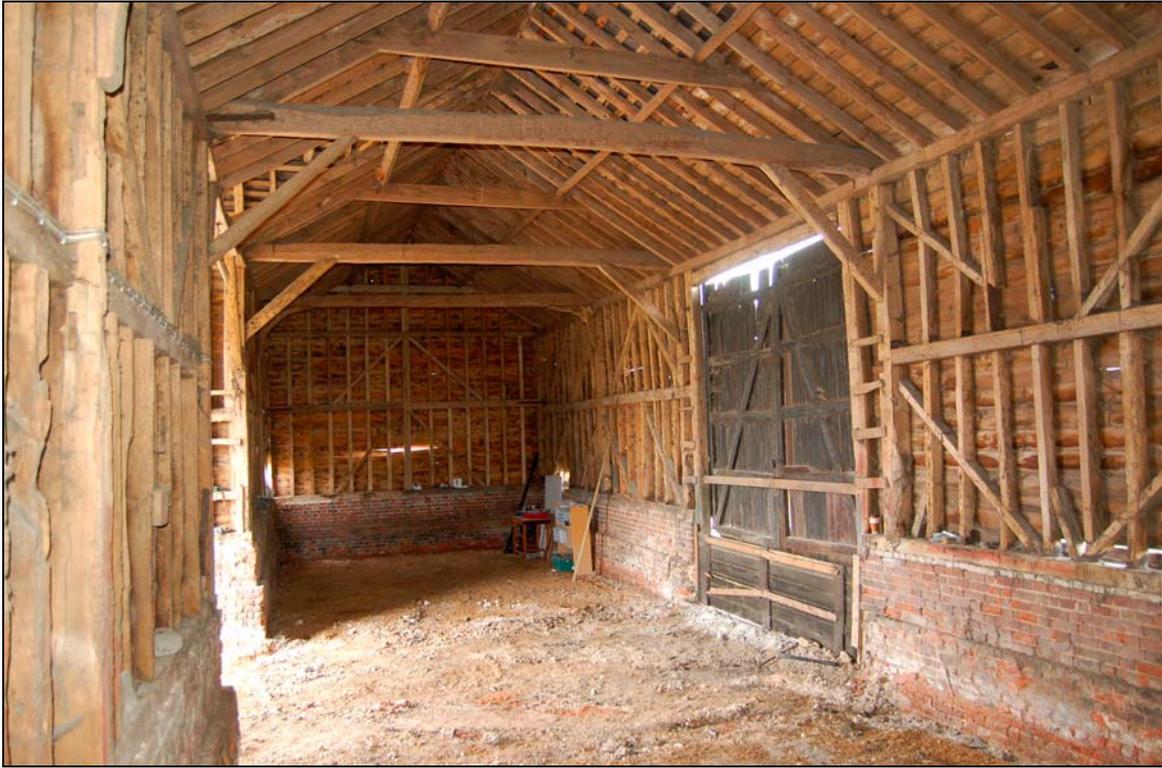
Plate 3 Interior of barn 1 viewed to west

The interior (plate 3) is laid out over five bays, most of which are fairly regular at 3.5m wide, apart from the midstrey, which is canted to the east due to the cart doors being slightly out of line (fig. 2). The modern concrete floor has been recently removed, exposing natural clay deposits below.

Wall framing is built from hand-sawn primary-braced softwood divided by midrails, with single-pegged main members and some reused timbers. Nailed straight braces support the tie beams either side of the midstrey and bolted knee braces are found separating the outer bays (plate 3). Wall plates comprise long lengths of timber connected by double-pegged edge-faced and bladed scarf joints, the common post-medieval form.

Much of the framing remains intact apart from the western wall, which was rebuilt in the modern period using machine-sawn timber (plate 3).

Timbers in the roof are softwood and typically 19th-century in form of nailed collar purlin with ridge piece and plate (plate 3).

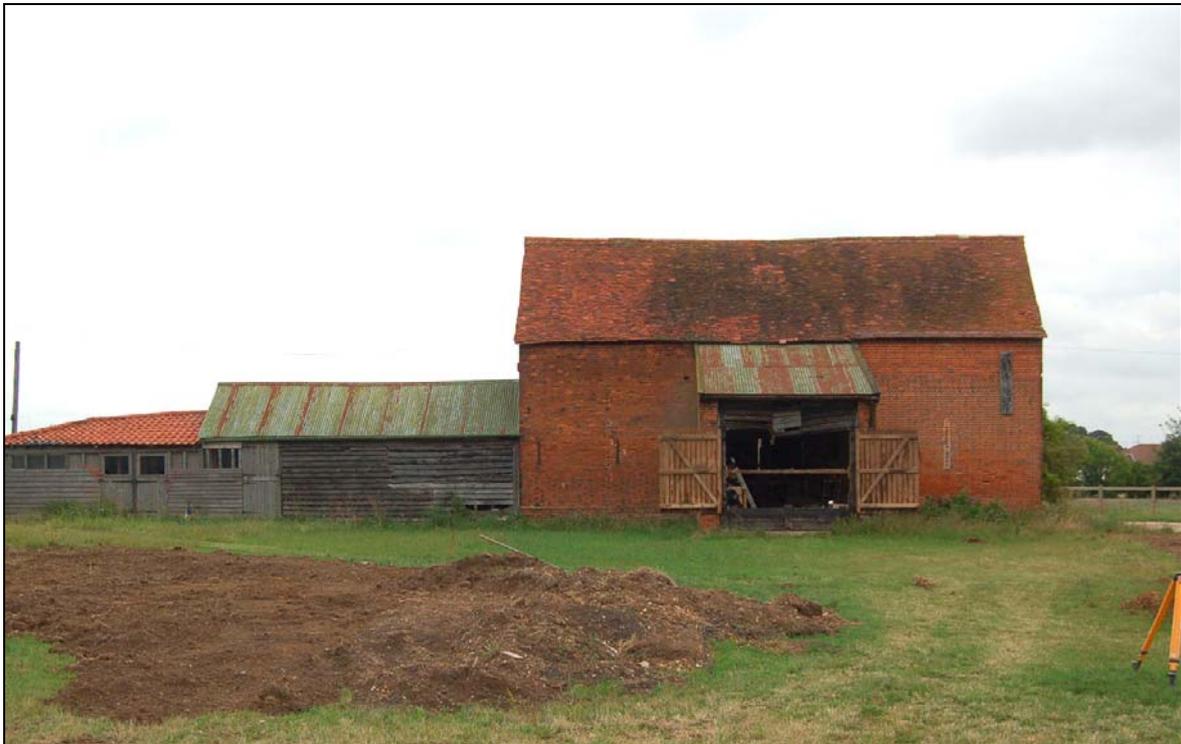
Plate 4 Barn 2 viewed to east

The walls are constructed from 8½-8¾ soft red bricks and built off a low plinth. They are arranged in Flemish bond with frequent burnt headers and laid in lime mortar. Long wall slits originally provided light into the interior but are now bricked on all sides (plates 4 & 6).

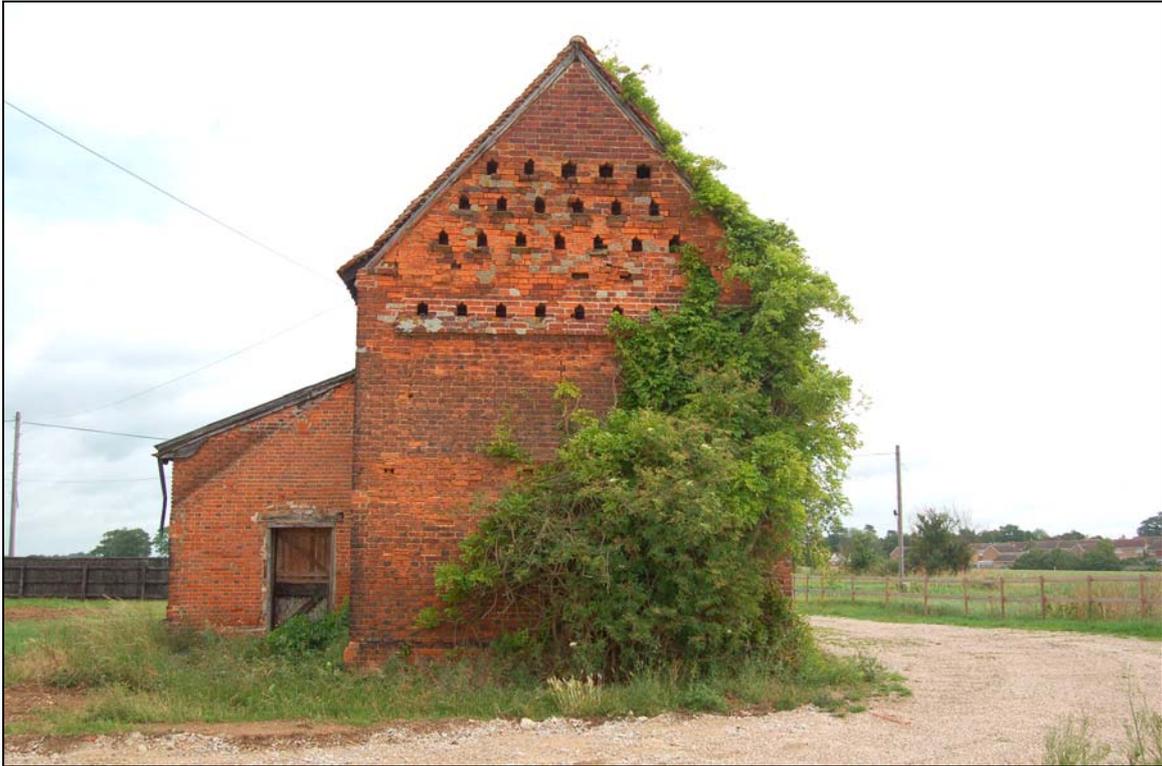
Plate 5 South gable of barn 2

The west elevation includes the porch, which has a single-pitched corrugated iron roof and low cart doors. The door on the south wall of the porch has been inserted and the roof scar of the former outbuilding (fig. 1) is still visible (plate 5).

The two gable walls are identical in having the dovecotes: four neat rows of ogee-arched nesting holes in the upper part of the gables (plates 5 & 6). The three rows above the eaves have individual ledges of protruding bricks, while the lowest row, just below the eaves, has a single continuous three-course brick ledge.

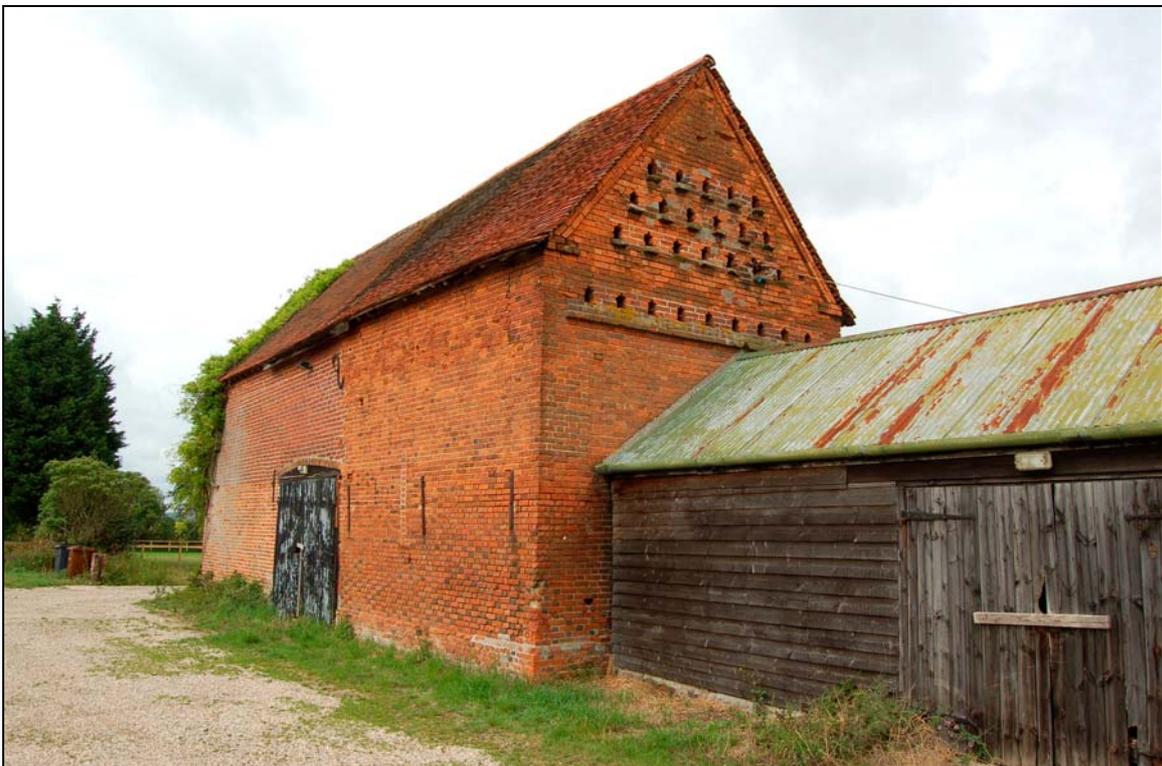
Plate 6 Rebuilt eastern wall and northern dovecote

On the eastern elevation a pair of low cart doors faces the trackway. Much of this side above the doorway, as well as the southern bays, were rebuilt in the 19th century and the only original brickwork to survive is at the north end (plate 6). The roof has a steep 50° pitch and is clad in pegtiles.

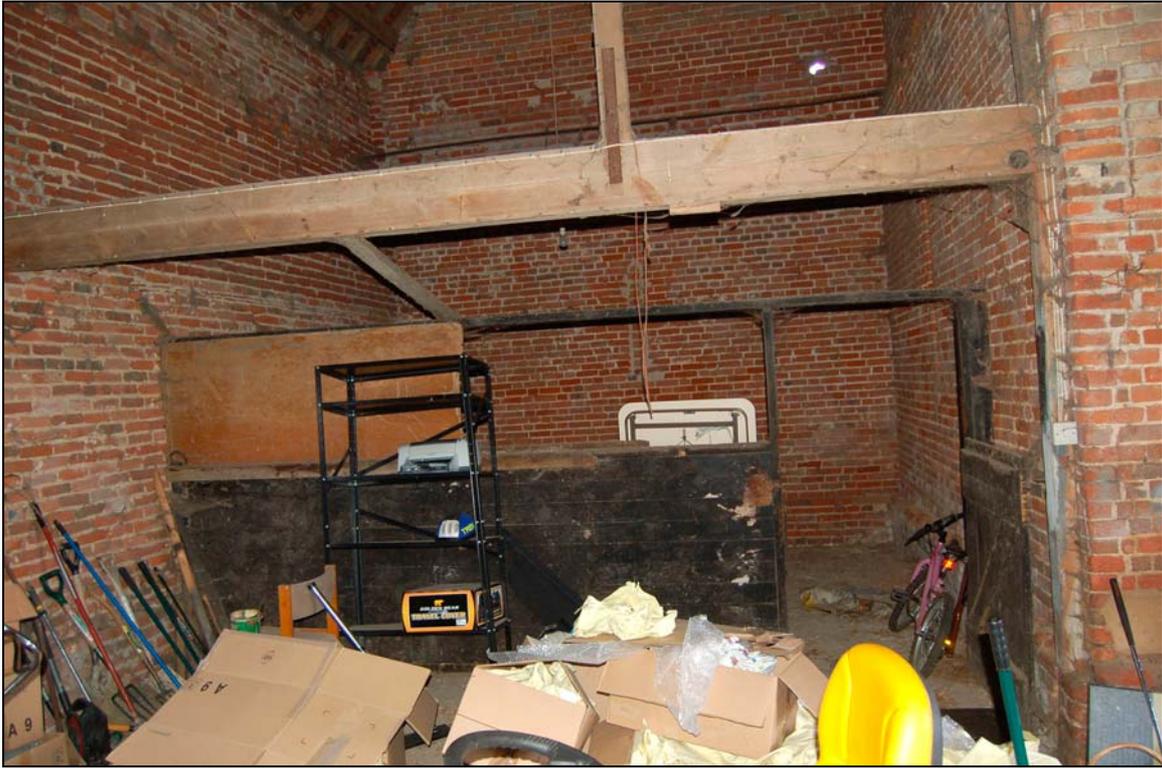
Plate 7 Stall inside barn 2

The interior has a wide midstrey and narrower c.2m wide bays (fig. 3) over a modern concrete floor. Much of the southern end was formerly used as horse stalls (plate 7), though no fixtures or fittings survive apart from the partition. At the north end is a loft, most likely a former granary, built of machine-sawn timbers in the late 19th century (plate 8).

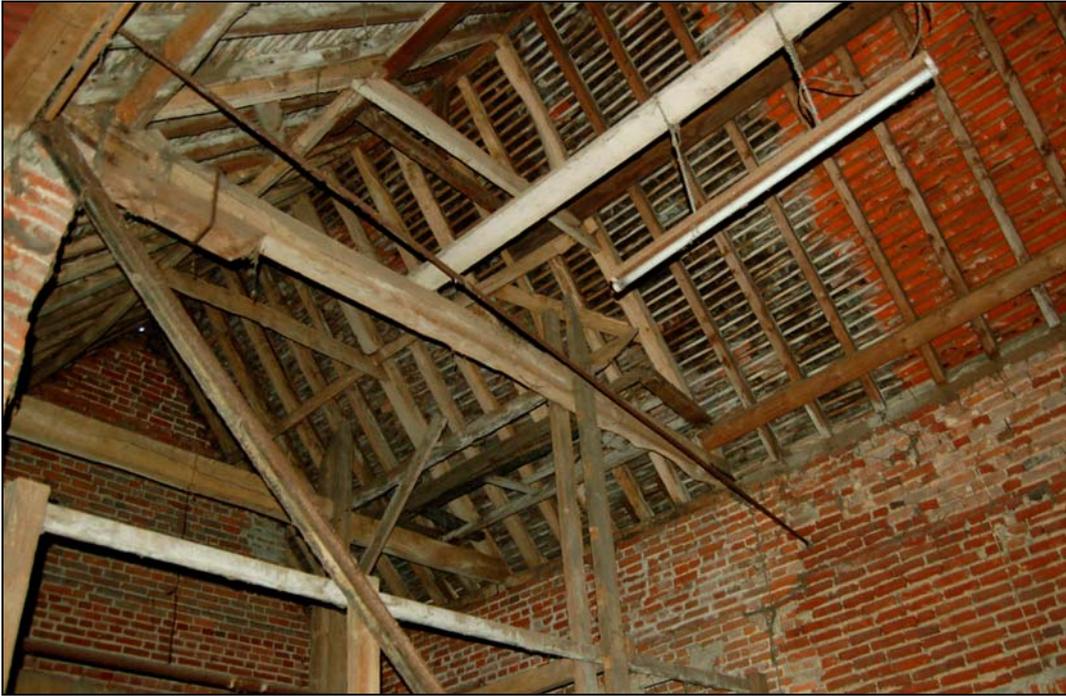
Plate 9 Original roof frame in northern bays

The original 18th century roof survives over the north bays, with quite substantial and closely-spaced elm rafters and pegged wind-braces supported on pegged collar clasped-purlin trusses (plate 9). The three other bays have been rebuilt with machine-sawn timbers and nailed V-strut trusses (plate 10).
